Muhammad Ali Mosque, Cairo: The interior scaffolding for restoration in the 1930s

## The restoration of the Muhammad Ali Mosque in Cairo, 1931-1938

Mercedes Volait

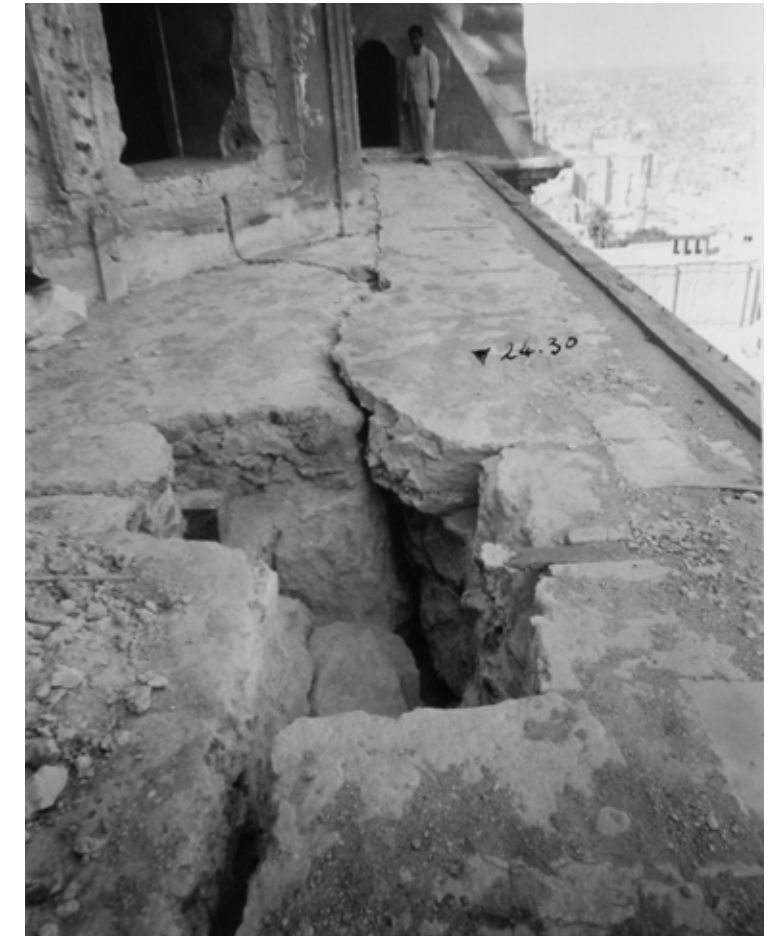
Muhammad Ali Mosque, Cairo: Cracks at the top of the northern wall

de Conservation des Monuments de l'Art Arabe, the protection agency for historic monuments created in 1881, so that its maintenance could be supervised.<sup>370</sup> It was on this occasion that a detailed examination of the building took place, and revealed worrying deterioration. The mosque had cracks all over, some fissures appearing through the entire height of the building; others, located at the bases of pillars, were almost 10 cm wide. Urgent action was required.

of strain were made<sup>374</sup> and indicators were put in place. Sixteen months later, in May 1933, examination cleared the foundations of responsibility for the deterioration. A chemical analysis by Ismail Omar showed that the cracks were caused not by the materials used for the domes (bricks and mortar), but by their support structure: arches, drums, pendentives, and pillars. A verticality check showed that the building was sagging towards the exterior; on the walls, the deformation equalled 10 cm for 11 m in height, while in the minarets, some 20 cm of deflection were measured. The calculation of average strain led to the conclusion that the building's structural mechanics suffered under the thrust from horizontal forces. By elimination, the Commission came to identify the structural reasons for the deformities and tearing as insufficient anchorage of the straps placed at the springing of the arches, as well as rust. The iron dowels, sealed in lead, binding the stones together, like the metal ring around the drum, revealed badly eroded areas. It also appeared that the building had been weakened by a past earthquake, the later explosion of a munitions store, and Cairo temperatures.<sup>375</sup>

From May 1932 to February 1933, the Commission worked on a reconstruction project. Two scenarios were studied: either rebuilding the entire lower part of the structure (the pillars) without touching the domes, or redoing the upper area (the domes) and the pillars. In both cases, the entire building would require interior scaffolding. The first solution was rejected after studying the cost of scaffolding capable of supporting the upper structure whose weight was estimated at 4,000 t (of which 1,750t for the central dome). For reconstructing the domes, the Commission recommended using reinforced concrete framework. Originally, they planned to fill in with bricks, like in the original construction; in the end, prefabricated slabs flashed with lead sheeting were used to roof the structure.<sup>376</sup> The decision was based on the conclusions of the very recent International Congress on the Conservation of Artistic and Historic Monuments which accepted "the principle of using modern materials for the reconstruction of ancient buildings."<sup>377</sup> There, the issue of

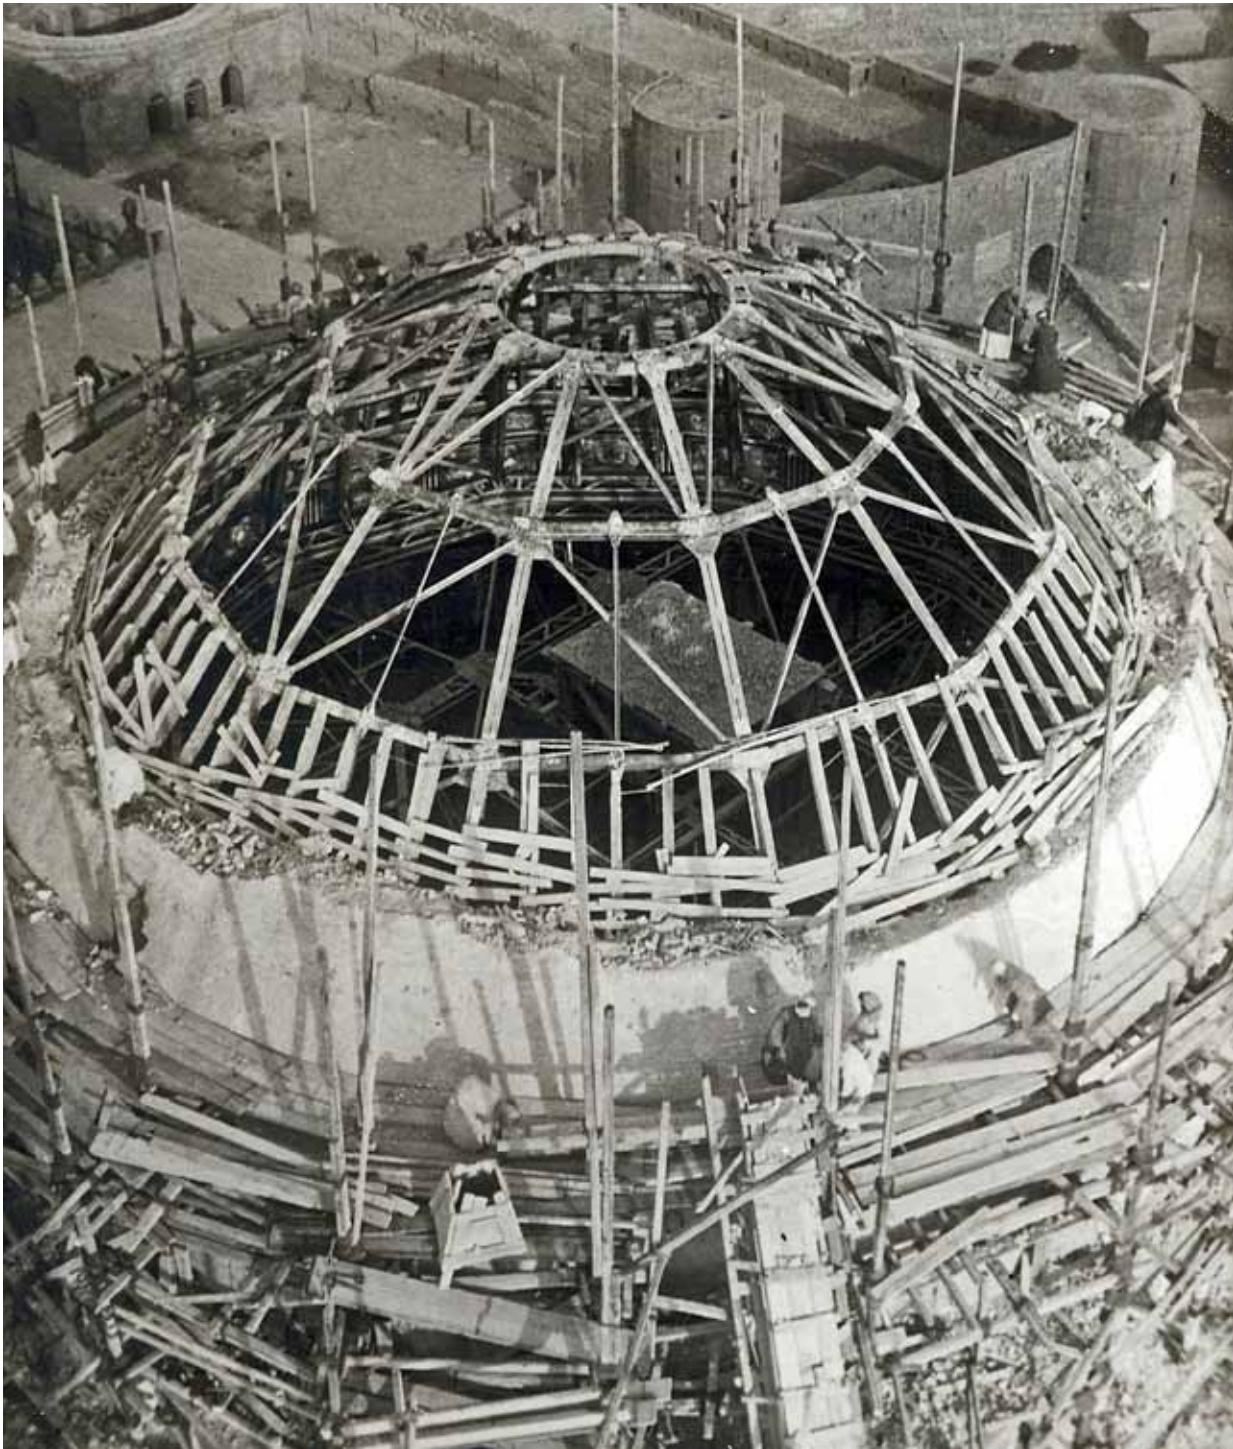
Muhammad Ali Mosque, Cairo: General view after dome demolition, July 1935

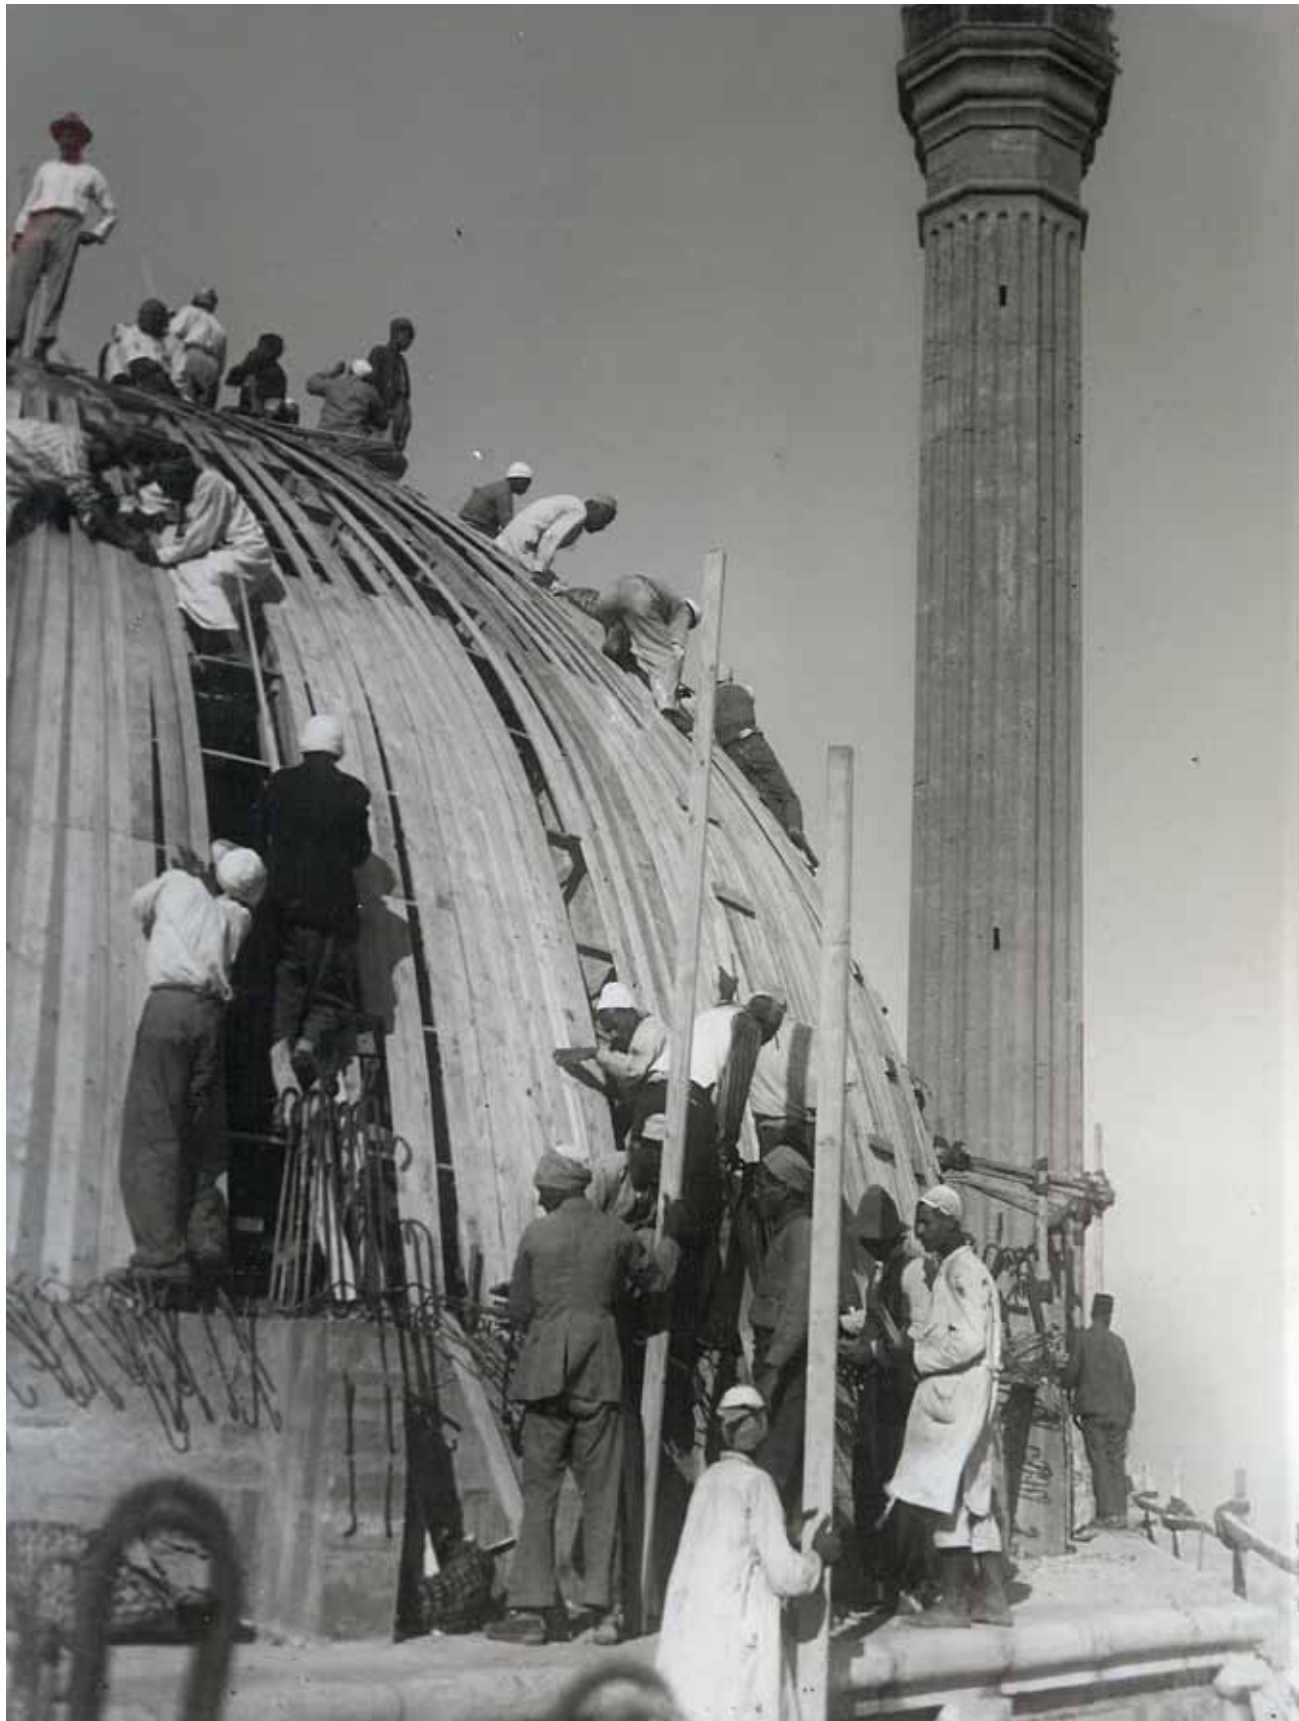
Muhammad Ali Mosque, Cairo: Installing the timber casing for the large reinforced concrete dome, autumn 1935

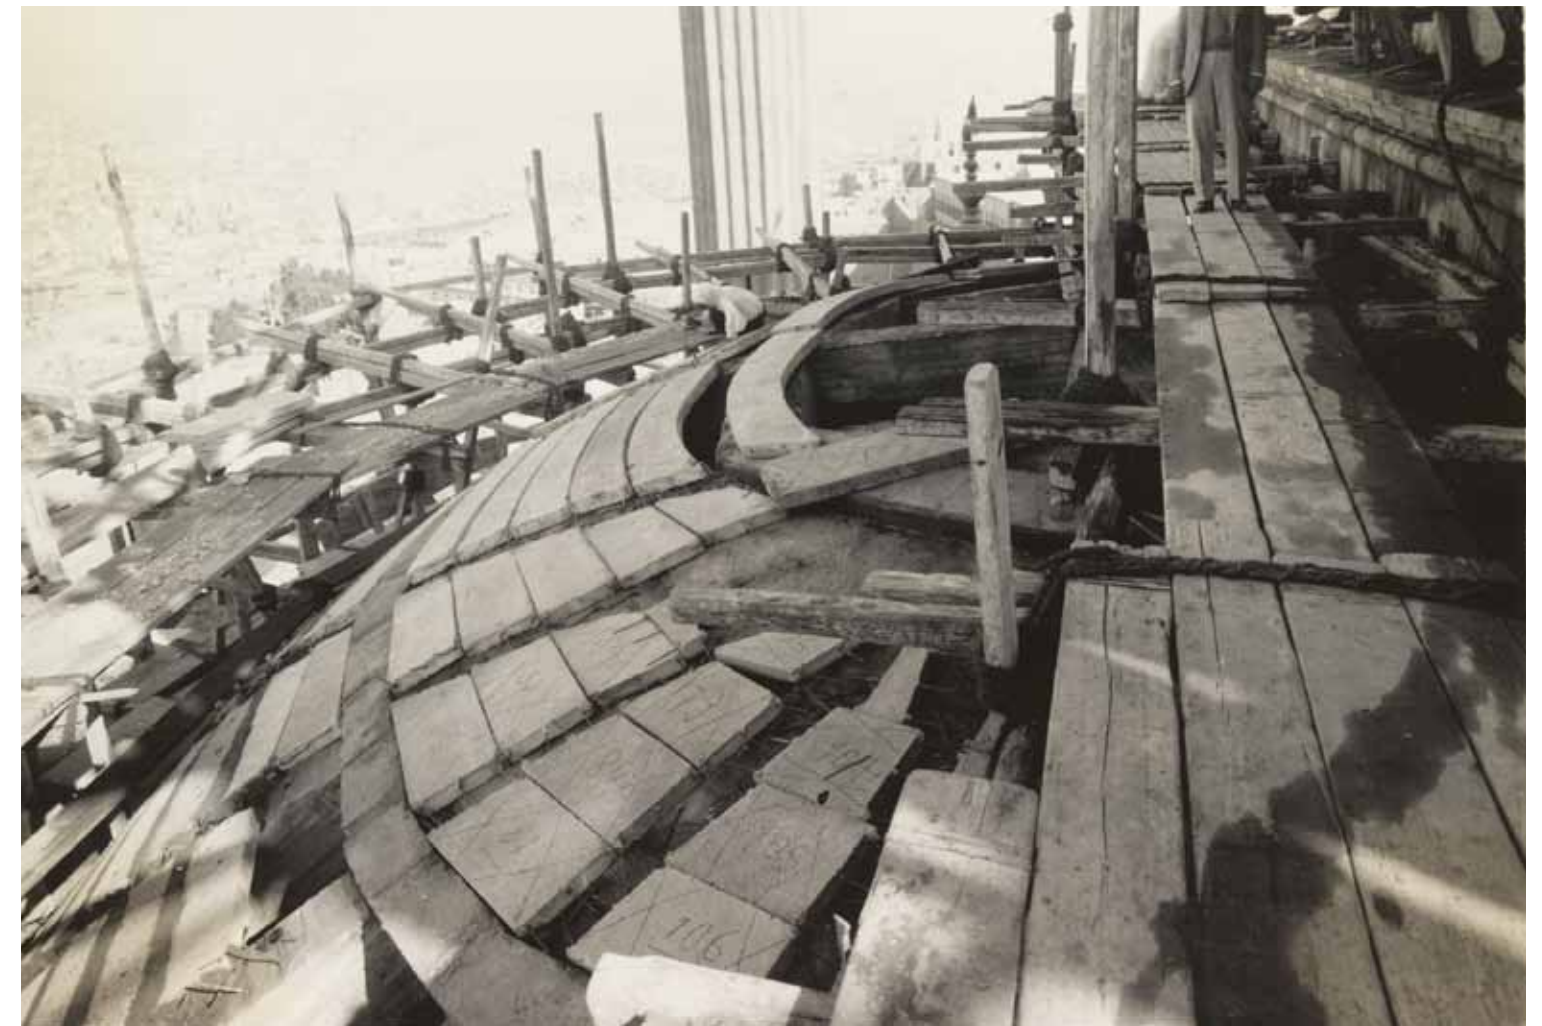
Muhammad Ali Mosque, Cairo:  
Reinforcement of the concrete slab at the  
base of the northern minaret, August 1934  
Plywood forms for a part of the great  
dome, September 1934

was equipped with a lift for the workers (built by the Schindler company at Schlieren near Zurich) and a paternoster (a continuous caterpillar track supplied by the Swiss firm Oehler based at Aarau) to carry the concrete and the mortar. In parallel, the consolidation of the minarets with triangular slabs was done in July 1934. The coffering in wood for the large dome was prepared on the ground (September 6, 1934). Outside scaffolding was erected simultaneously; the demolition of the large dome in brick was begun in February 1935; the demolition works, pillars included, was finished in July 1935. The small domes were finished on December 24, 1935, the central dome on February 6, 1935, the half-cupolas a week later. The original covering in lead was returned to most of these; the large dome received new sheets of lead 3 mm thick. Some of the cut stone for the exterior casing was reused; the missing elements were replaced with imitation stone.

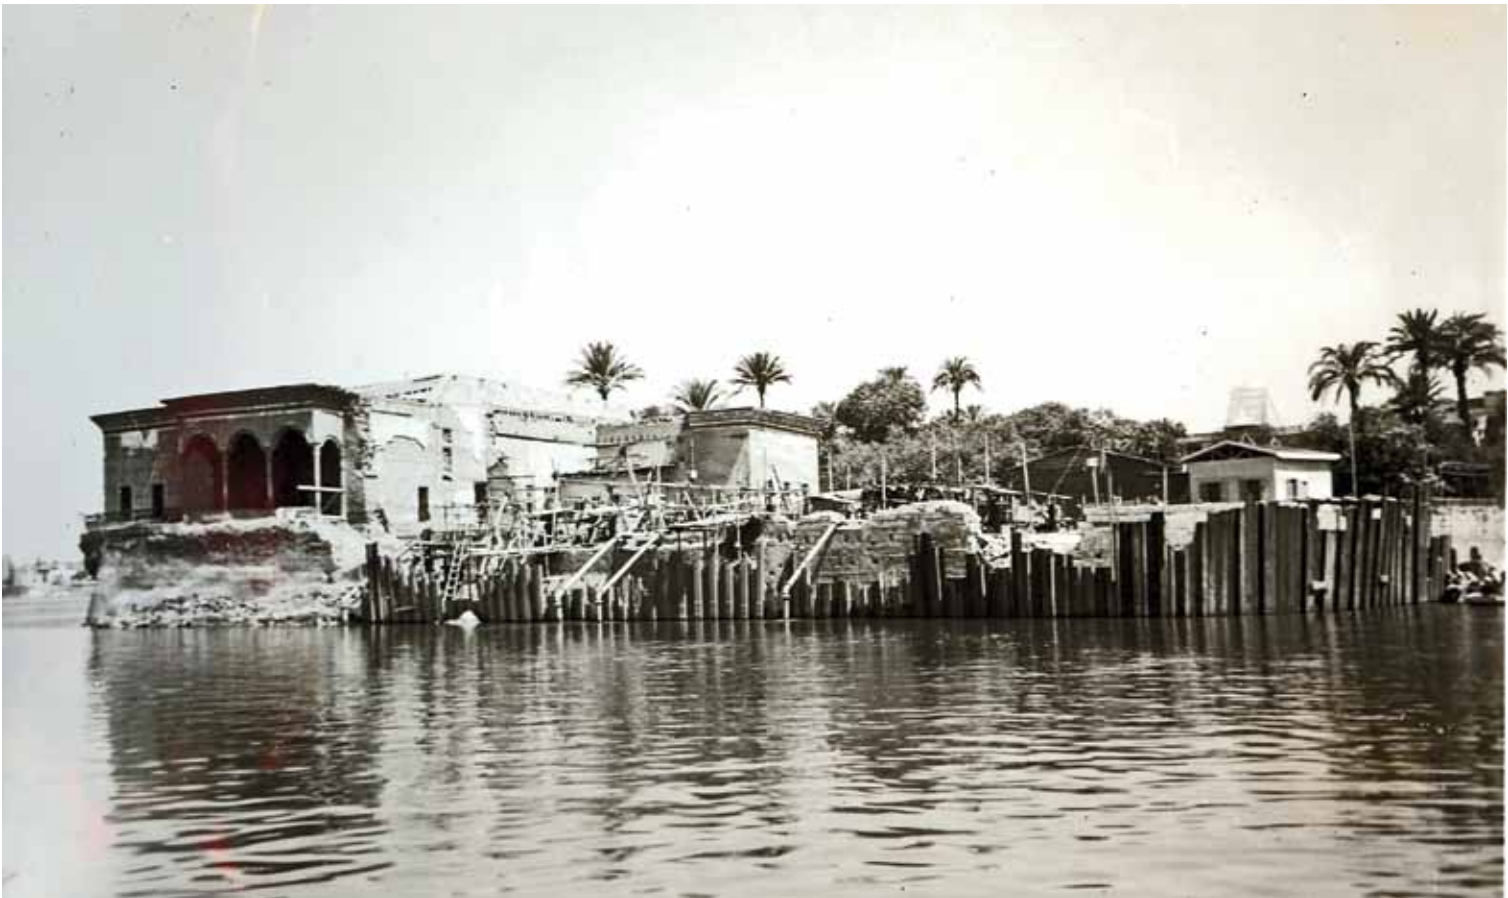
Roda Island Nilometer, Cairo:  
Restoration work in progress (1937–1938)
