The Restoration of Beaufort Castle (South-Lebanon): A 3D Restitution According to Historical Documentation

THE RESTORATION OF BEAUFORT CASTLE (SOUTH-LEBANON) A 3D RESTITUTION ACCORDING TO HISTORICAL DOCUMENTATION

CIPA XIXth International Symposium, 30 September- 4 October 2003, Antalya, Turkey
“New perspectives to save Cultural Heritage”

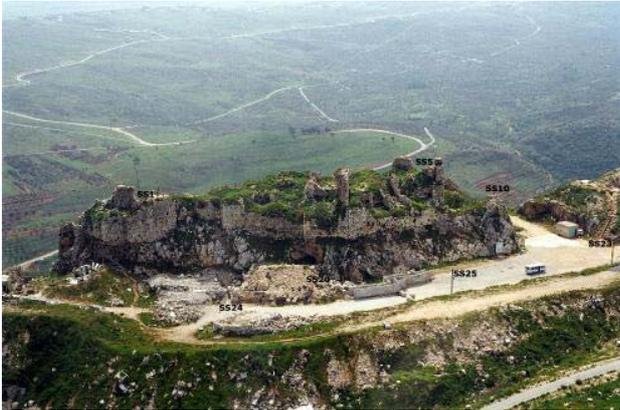
Figure 1. Aerial view of the Beaufort castle (Nikon F3, 2003)

After the end of the war, access to the castle became secure. There was a need to manage to realize a complete documentation of the unreachable parts of the castle (basically the eastern elevation over the valley). That's why a helicopter flight was scheduled in 2003. Aerial oblique views were taken (figure 1) in that flight. They were composed of digital images (Nikon Coolpix 5000, 2560x1920 pixels) and film-based small format color slides (Nikon F3, Nikkor lenses, 55 mm). Last but not least, a complete documentation requested terrestrial views of the castle; digital images and again film-based small format color slides were taken. Thanks to this exhaustive documentation, three-dimensional restitution was possible. All the modern documentation was produced in one day.

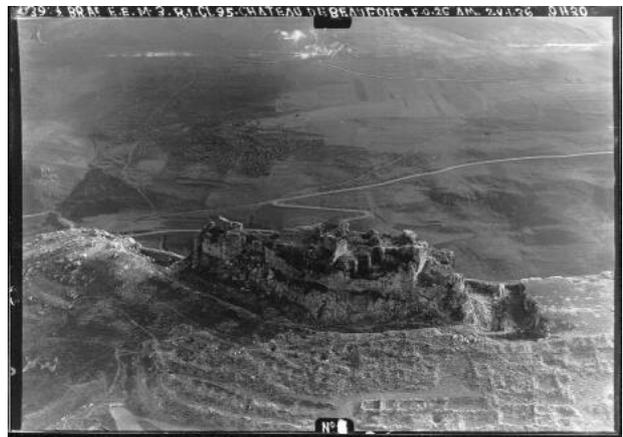
Figure 2. Example of archive photo of 1936 (IFPO), showing in the foreground the archeological hidden remains

b- Serie 2: These are photos still existing in the *Institut Français du Proche-Orient* (IFPO) archives (figure 2). All these photos were taken by the French air force of the *Levant* between the years 1930 and 1936. We were able to get duplicates (contact prints) of the original negatives. They were then scanned.

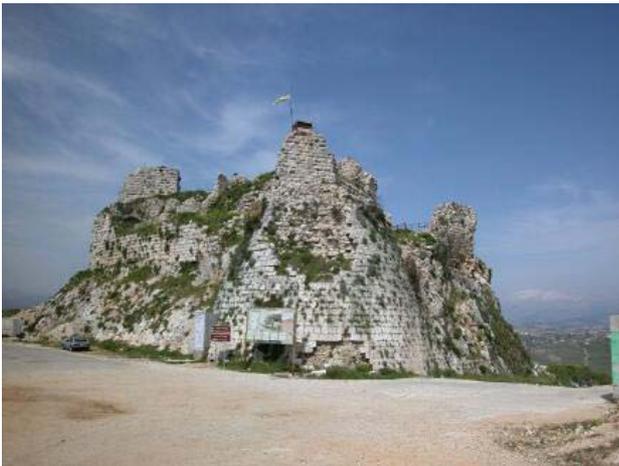
Figure 3. Example of modern photo (Nikon Coolpix 5000, 2003)

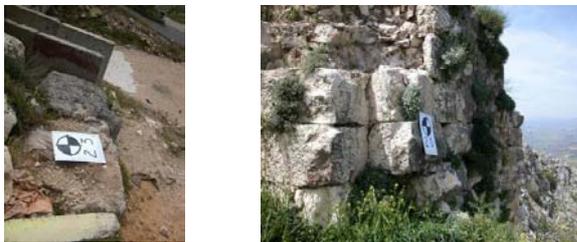
Figure 4. Examples of targets used for the reference points

On that same day, while photos were being taken, a team of geodetic surveyors installed reference points on the ground and elevations of the castle. These points (figure 4) were easy to identify on the photos. A total-station was used by the surveyors to measure the reference points. This generated three-dimensional coordinates for these points.

More than 130 images were realized in spring 2003 with the Nikon F3 and Nikon Coolpix cameras (a hundred images on the ground and about thirty in the helicopter). A first block of 18 oblique views of the castle was oriented in June 2003 using the control points materialized on the ground by targets (figure 4). Standard deviations of about 10 cm on the co-ordinates of the points measured on the images have been obtained. We then selected in this project ten visible points simultaneously on the images of 1931-1936, in order to define approximations of the photogrammetric parameters, and to calculate a block based on a selection of these archive images.

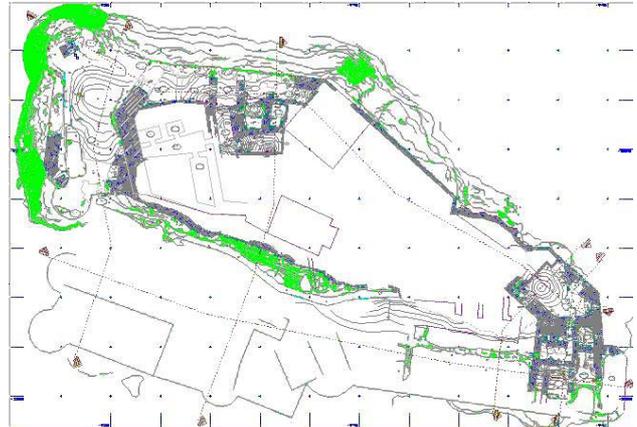
Figure 5. Example of 2D AutoCAD map from the tacheometric survey of 2002 (level 4 of the castle).

The first topographic surveys conducted during the preliminary study were not very accurate due to the difficulties encountered in trying to access some of the areas of the castle. These first surveys were performed using GPS and tacheometric techniques. The AutoCAD maps (figures 5 and 6) used to establish the tender documents for the restoration of the castle

were based on these surveys. The inaccuracies of these surveys did not represent a major problem for the restoration of the visible areas of the castle. However, these inaccuracies prevented us from computing the exact position of the archaeological hidden remains. We plan to generate a new AutoCAD documentation showing the surroundings of the castle and the archaeological hidden remains that should be dug out (§5).

From the block of images previously oriented, the restitution initially carried out in 2D in Autocad (e.g. fig. 5 and 6) will be enriched by a 3D restitution corresponding to the objectives of the documentation. We are then able to calculate and draw the visible structures on the aerial and terrestrial photographs of 2003 by digitalizing on the images (fig. 8).

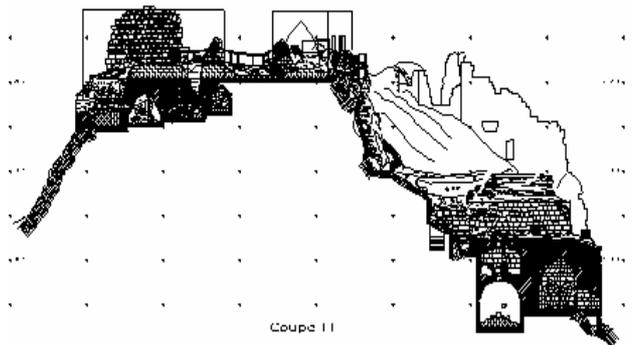
Figure 6. Example of 2D AutoCAD section.

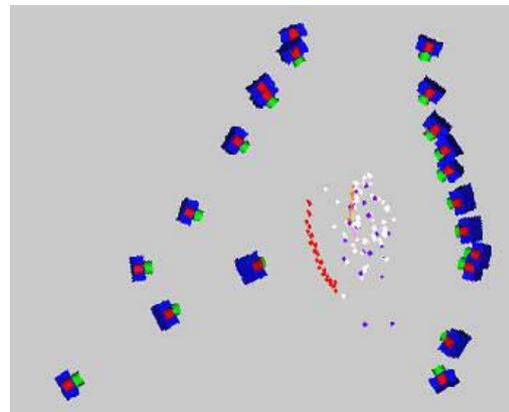
Figure 7a. Overview of the camera stations and the block configuration after the exterior orientation

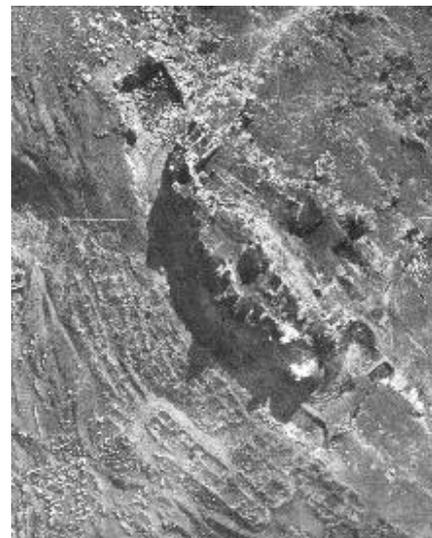
Figure 7b. Aerial view of 1935, allowing to locate the camera stations of the figure 7a

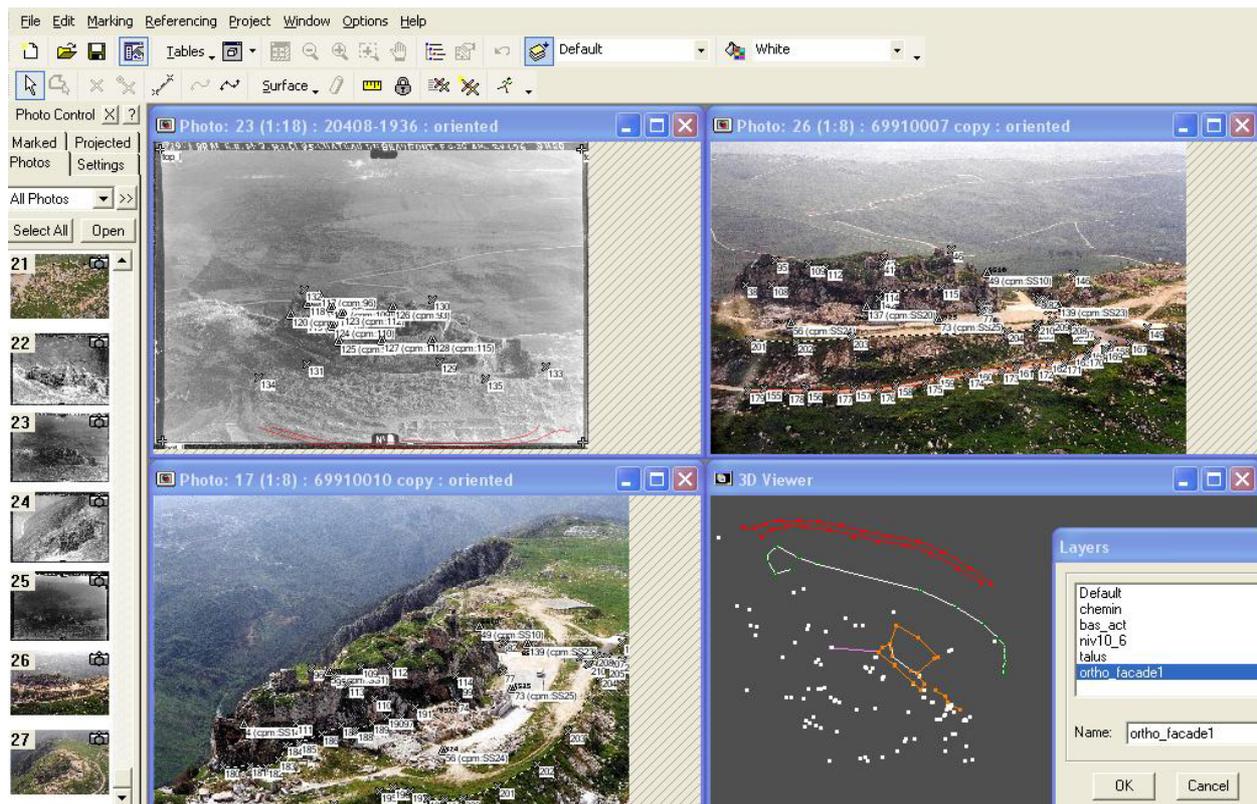
Figure 8. Multi-image restitution within PhotoModeler 5.0

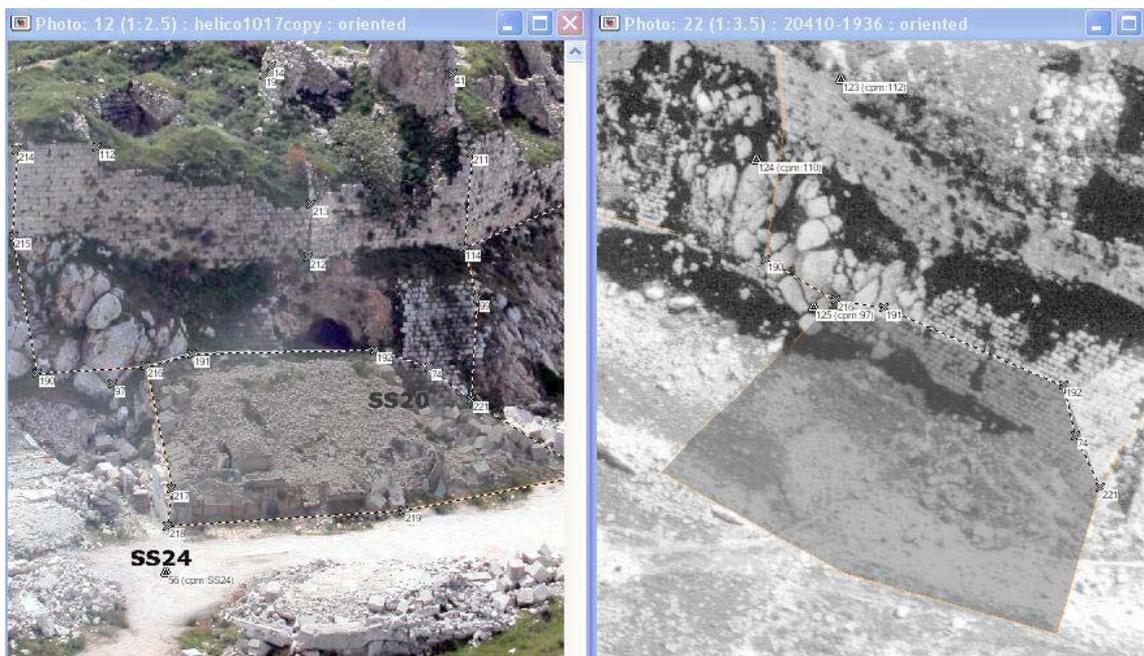
Figure 9. Restitution of the embankment areas.

On the left, the boundary of the embankment is marked on a photo of 2003 and on the right, the corresponding surface is projected on an archive photo of 1936

One will proceed in an identical way on the archive photographs to measure the archaeological structures currently covered by the remains of the war, or to plot in 3D parts of the castle currently embanked or destroyed (fig. 9).

The superposition of the two restitutions make it possible to highlight the areas of interest (figures 9 and 10) for archaeological work and to estimate work of civil engineering (fill, cubature, rebuilding, etc). Moreover, the restitution of the site in wire frame and surface model can be supplemented by the addition of textures

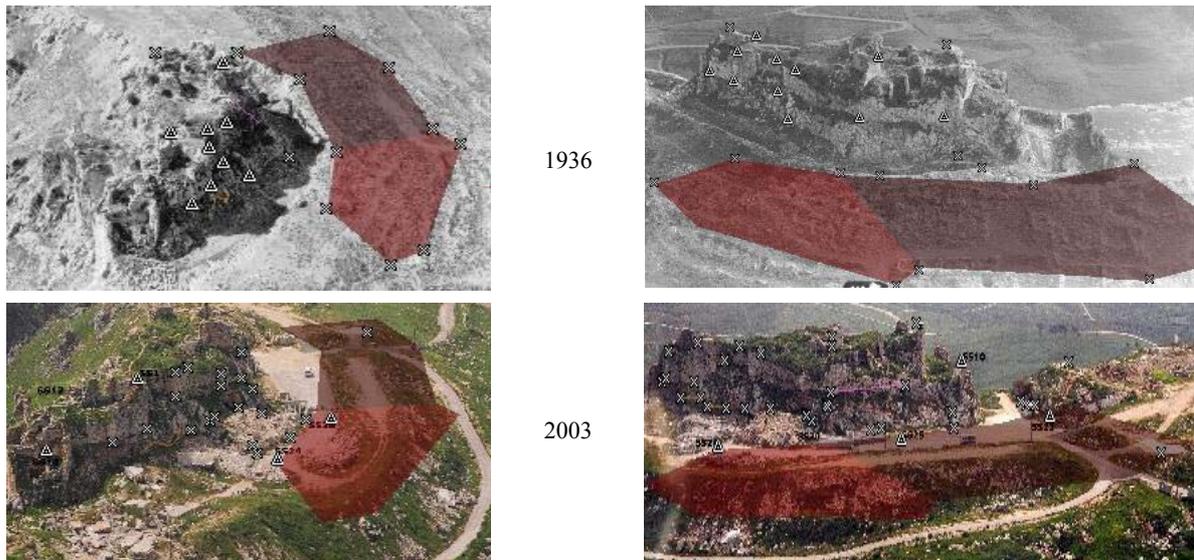
Figure 10. Archaeological structures are measured on the archive images of 1936 and the corresponding surface is shown on the photos of 2003

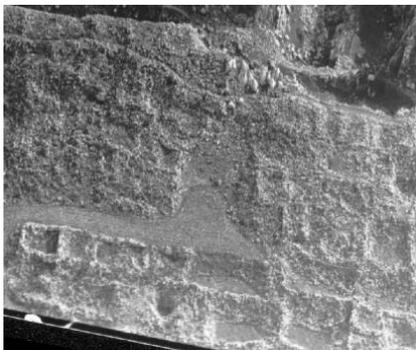
Figure 11. Example of orthophoto of the archeological structure (computed from archive images)

coming either from the images of 1936, or of those of 2003. From the resulting 3D photomodels, orthophotos can be calculated for the two periods, as e.g. for the frontages of the castle or the installations around the site covering the archaeological structures (fig. 11).
