# THE RESTORATION OF BEAUFORT CASTLE (SOUTH-LEBANON) A 3D RESTITUTION ACCORDING TO HISTORICAL DOCUMENTATION

Pierre Grussenmeyer <sup>a</sup>, Jean Yasmine <sup>b</sup>

CIPA XIXth International Symposium, 30 September- 4 October 2003, Antalya, Turkey  
“New perspectives to save Cultural Heritage”

**KEY WORDS:** Lebanon, Beaufort, Architectural & Archaeological heritage conservation, Photographic recording, Documentation, Archive images.

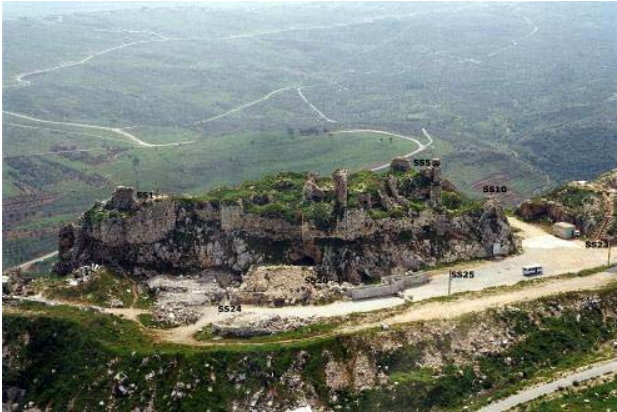
Figure 1. Aerial view of the Beaufort castle (Nikon F3, 2003)

After the end of the war, access to the castle became secure. There was a need to manage to realize a complete documentation of the unreachable parts of the castle (basically the eastern elevation over the valley). That's why a helicopter flight was scheduled in 2003. Aerial oblique views were taken (figure 1) in that flight. They were composed of digital images (Nikon Coolpix 5000, 2560x1920 pixels) and film-based small format color slides (Nikon F3, Nikkor lenses, 55 mm). Last but not least, a complete documentation requested terrestrial views of the castle; digital images and again film-based small format color slides were taken. Thanks to this exhaustive documentation, three-dimensional restitution was possible. All the modern documentation was produced in one day.

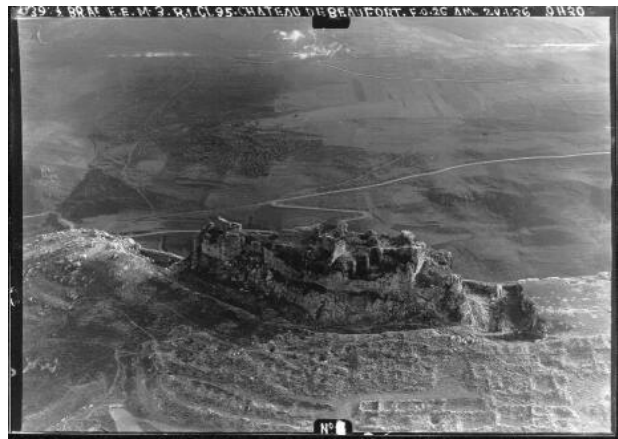
Figure 2. Example of archive photo of 1936 (IFPO), showing in the foreground the archeological hidden remains

**b- Serie 2:** These are photos still existing in the *Institut Français du Proche-Orient* (IFPO) archives (figure 2). All these photos were taken by the French air force of the *Levant* between the years 1930 and 1936. We were able to get duplicates (contact prints) of the original negatives. They were then scanned.

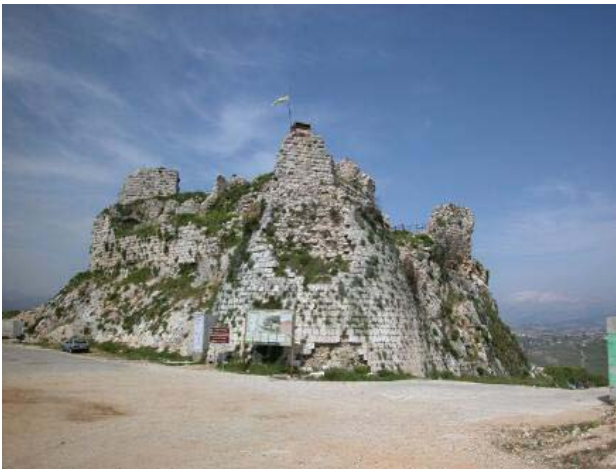
Figure 3. Example of modern photo (Nikon Coolpix 5000, 2003)

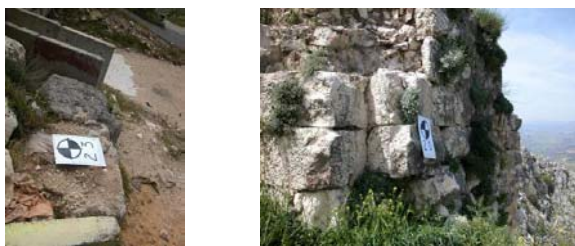
Figure 4. Examples of targets used for the reference points

On that same day, while photos were being taken, a team of geodetic surveyors installed reference points on the ground and elevations of the castle. These points (figure 4) were easy to identify on the photos. A total-station was used by the surveyors to measure the reference points. This generated three-dimensional coordinates for these points.

More than 130 images were realized in spring 2003 with the Nikon F3 and Nikon Coolpix cameras (a hundred images on the ground and about thirty in the helicopter). A first block of 18 oblique views of the castle was oriented in June 2003 using the control points materialized on the ground by targets (figure 4). Standard deviations of about 10 cm on the co-ordinates of the points measured on the images have been obtained. We then selected in this project ten visible points simultaneously on the images of 1931-1936, in order to define approximations of the photogrammetric parameters, and to calculate a block based on a selection of these archive images.

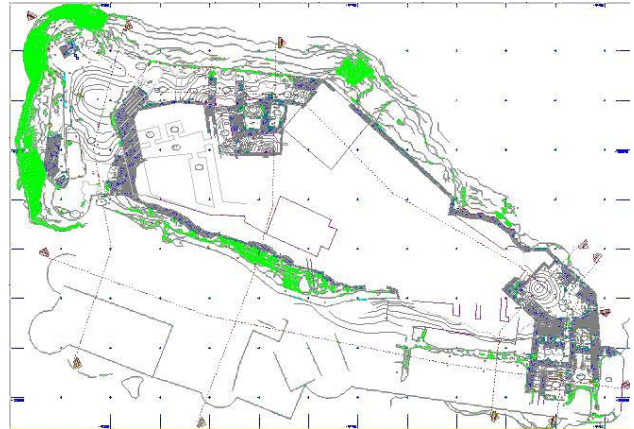
Figure 5. Example of 2D AutoCAD map from the tacheometric survey of 2002 (level 4 of the castle).

The first topographic surveys conducted during the preliminary study were not very accurate due to the difficulties encountered in trying to access some of the areas of the castle. These first surveys were performed using GPS and tacheometric techniques. The AutoCAD maps (figures 5 and 6) used to establish the tender documents for the restoration of the castle

were based on these surveys. The inaccuracies of these surveys did not represent a major problem for the restoration of the visible areas of the castle. However, these inaccuracies prevented us from computing the exact position of the archaeological hidden remains. We plan to generate a new AutoCAD documentation showing the surroundings of the castle and the archaeological hidden remains that should be dug out (§5).

From the block of images previously oriented, the restitution initially carried out in 2D in Autocad (e.g. fig. 5 and 6) will be enriched by a 3D restitution corresponding to the objectives of the documentation. We are then able to calculate and draw the visible structures on the aerial and terrestrial photographs of 2003 by digitalizing on the images (fig. 8).

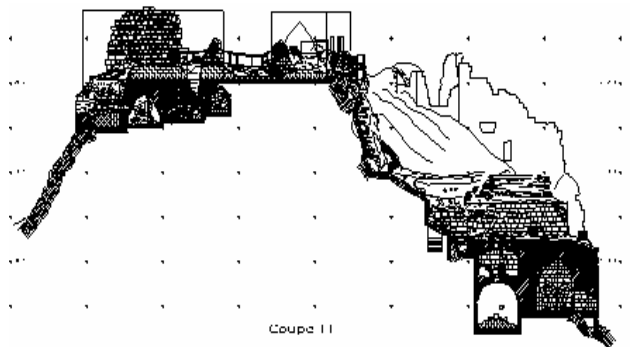
Figure 6. Example of 2D AutoCAD section.

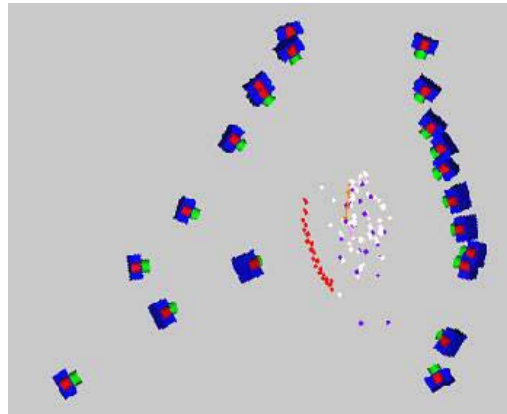
Figure 7a. Overview of the camera stations and the block configuration after the exterior orientation

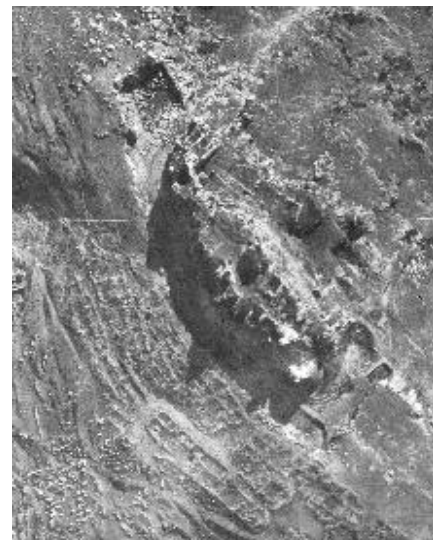
Figure 7b. Aerial view of 1935, allowing to locate the camera stations of the figure 7a

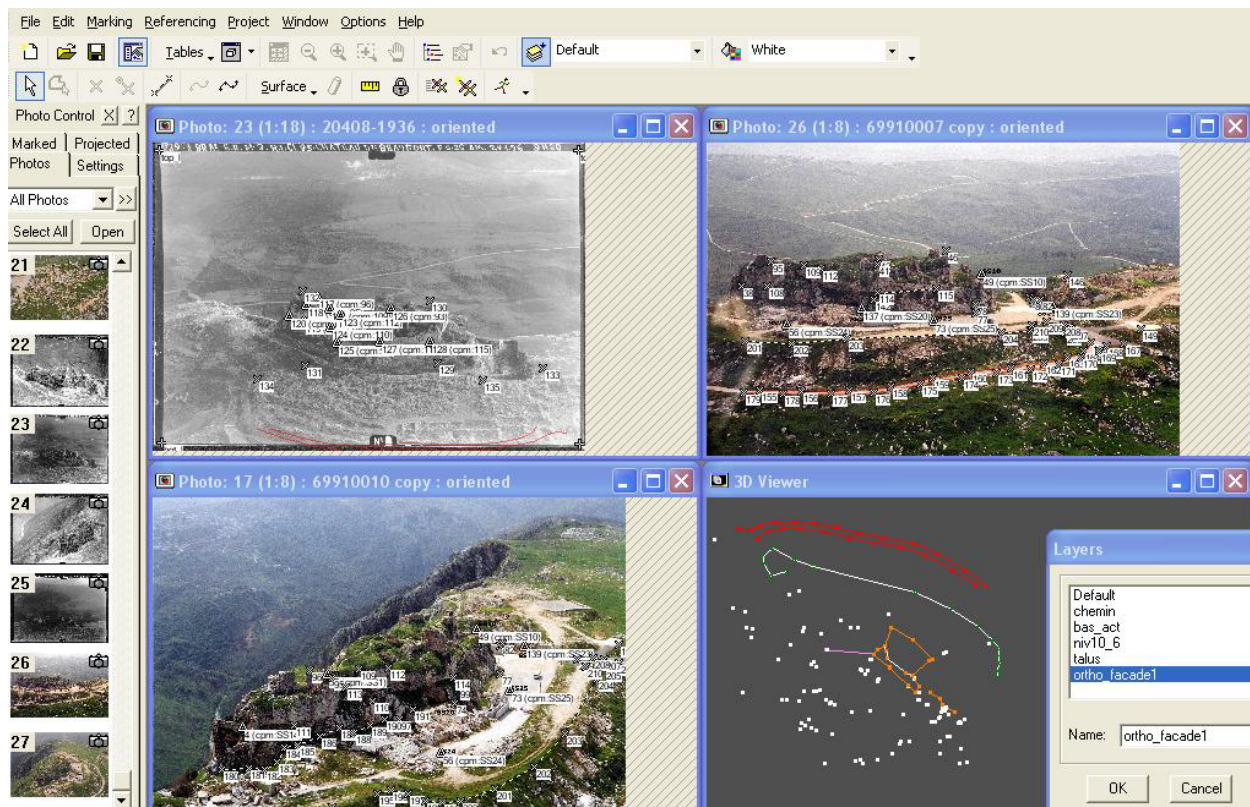
Figure 8. Multi-image restitution within PhotoModeler 5.0

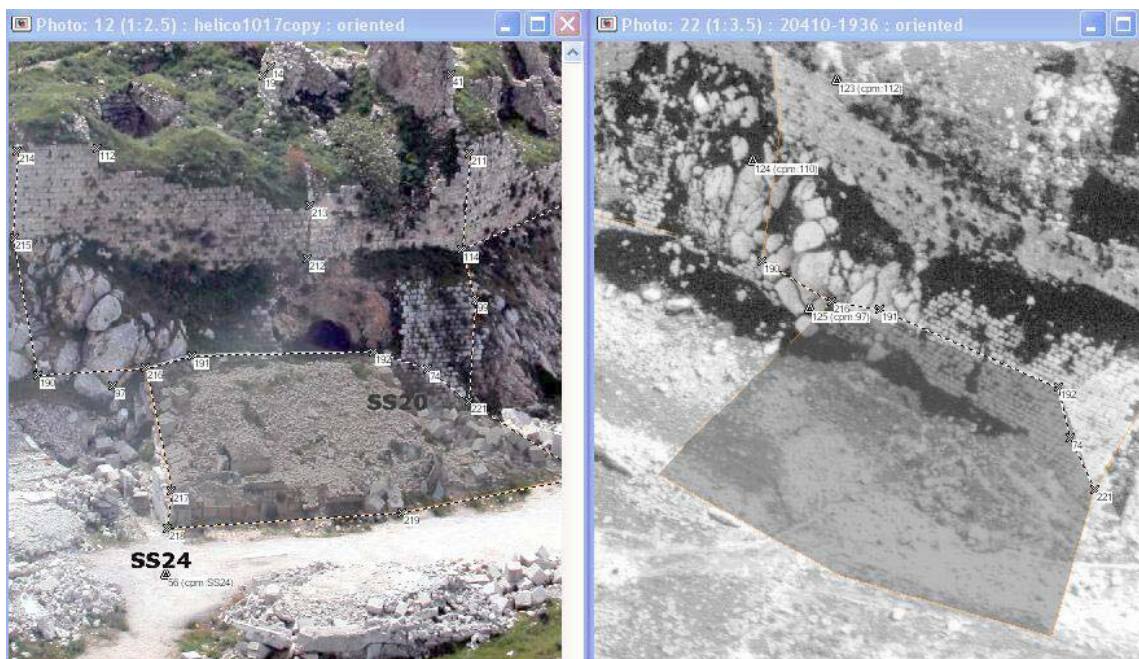
Figure 9. Restitution of the embankment areas.

On the left, the boundary of the embankment is marked on a photo of 2003 and on the right, the corresponding surface is projected on an archive photo of 1936

One will proceed in an identical way on the archive photographs to measure the archaeological structures currently covered by the remains of the war, or to plot in 3D parts of the castle currently embanked or destroyed (fig. 9).

The superposition of the two restitutions make it possible to highlight the areas of interest (figures 9 and 10) for archaeological work and to estimate work of civil engineering (fill, cubature, rebuilding, etc). Moreover, the restitution of the site in wire frame and surface model can be supplemented by the addition of textures

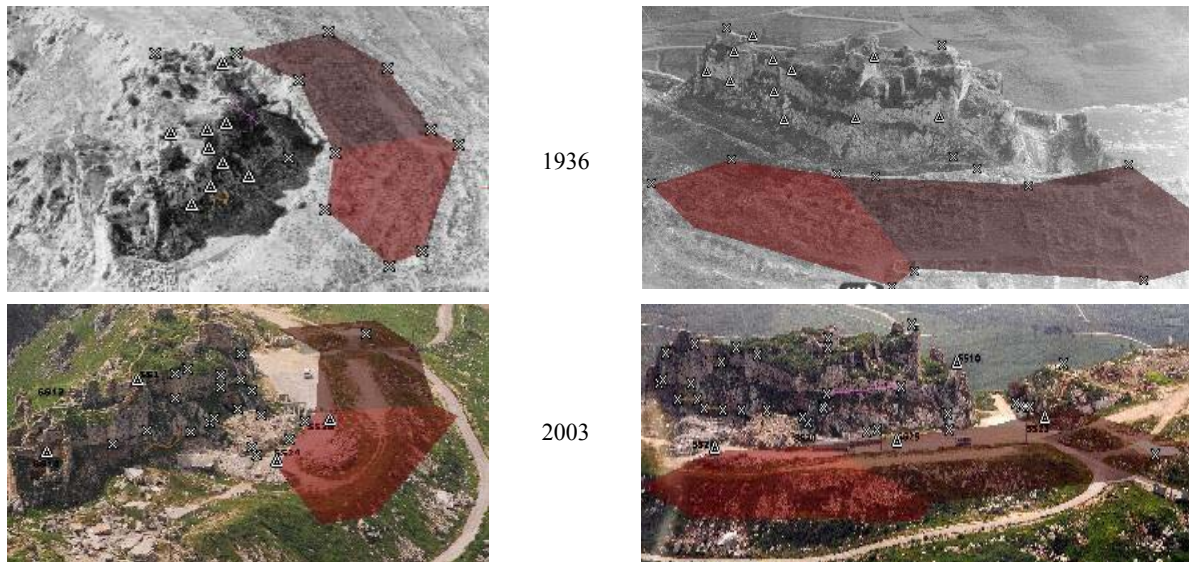
Figure 10. Archaeological structures are measured on the archive images of 1936 and the corresponding surface is shown on the photos of 2003

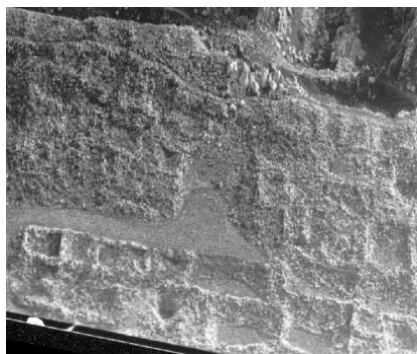
Figure 11. Example of orthophoto of the archeological structure (computed from archive images)

coming either from the images of 1936, or of those of 2003. From the resulting 3D photomodels, orthophotos can be calculated for the two periods, as e.g. for the frontages of the castle or the installations around the site covering the archaeological structures (fig. 11).
