The Restoration of Beaufort Castle (South-Lebanon): A 3D Restitution According to Historical Documentation

THE RESTORATION OF BEAUFORT CASTLE (SOUTH-LEBANON) A 3D RESTITUTION ACCORDING TO HISTORICAL DOCUMENTATION

CIPA XIXth International Symposium, 30 September- 4 October 2003, Antalya, Turkey
“New perspectives to save Cultural Heritage”

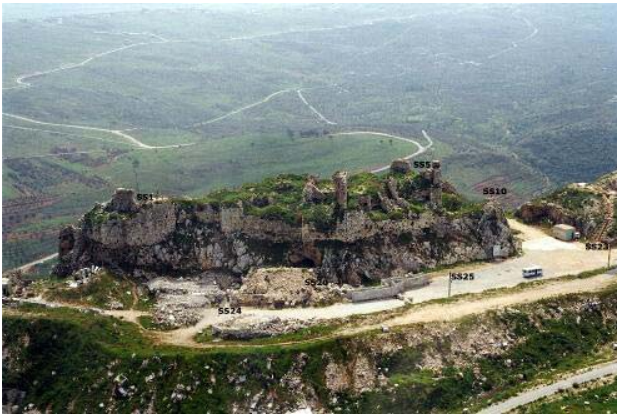
Figure 1. Aerial view of the Beaufort castle (Nikon F3, 2003)

After the end of the war, access to the castle became secure. There was a need to manage to realize a complete documentation of the unreachable parts of the castle (basically the eastern elevation over the valley). That's why a helicopter flight was scheduled in 2003. Aerial oblique views were taken (figure 1) in that flight. They were composed of digital images (Nikon Coolpix 5000, 2560x1920 pixels) and film-based small format color slides (Nikon F3, Nikkor lenses, 55 mm). Last but not least, a complete documentation requested terrestrial views of the castle; digital images and again film-based small format color slides were taken. Thanks to this exhaustive documentation, three-dimensional restitution was possible. All the modern documentation was produced in one day.

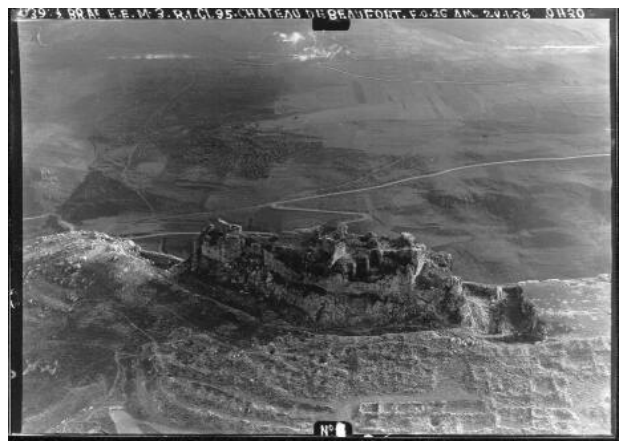
Figure 2. Example of archive photo of 1936 (IFPO), showing in the foreground the archeological hidden remains

b- Serie 2: These are photos still existing in the *Institut Français du Proche-Orient* (IFPO) archives (figure 2). All these photos were taken by the French air force of the *Levant* between the years 1930 and 1936. We were able to get duplicates (contact prints) of the original negatives. They were then scanned.

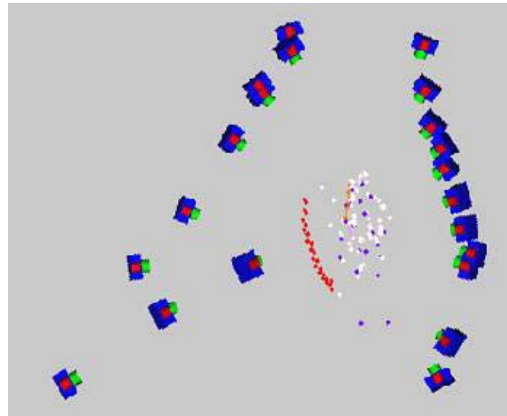
Figure 7a. Overview of the camera stations and the block configuration after the exterior orientation

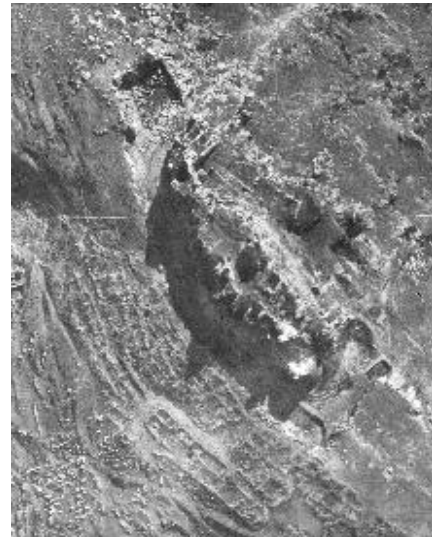
Figure 7b. Aerial view of 1935, allowing to locate the camera stations of the figure 7a

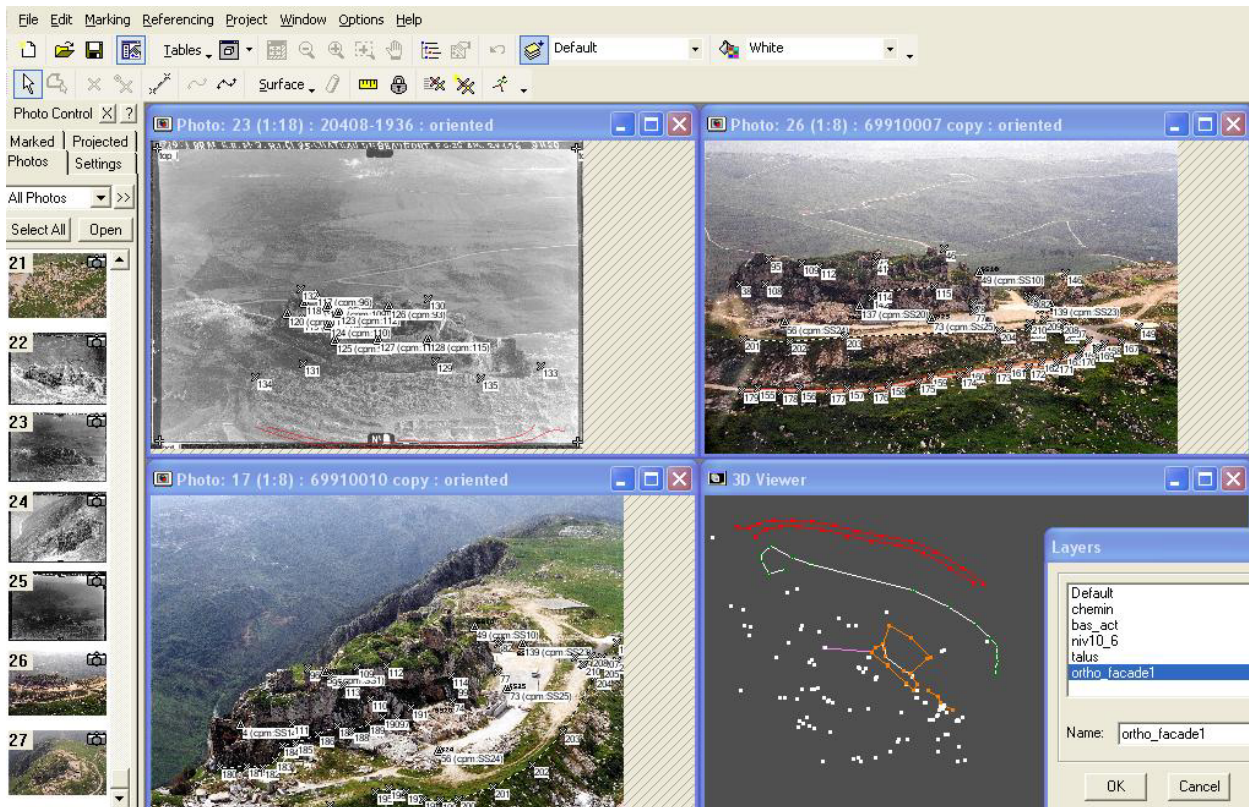
Figure 8. Multi-image restitution within PhotoModeler 5.0

From the block of images previously oriented, the restitution initially carried out in 2D in Autocad (e.g. fig. 5 and 6) will be enriched by a 3D restitution corresponding to the objectives of the documentation. We are then able to calculate and draw the visible structures on the aerial and terrestrial photographs of 2003 by digitalizing on the images (fig. 8).

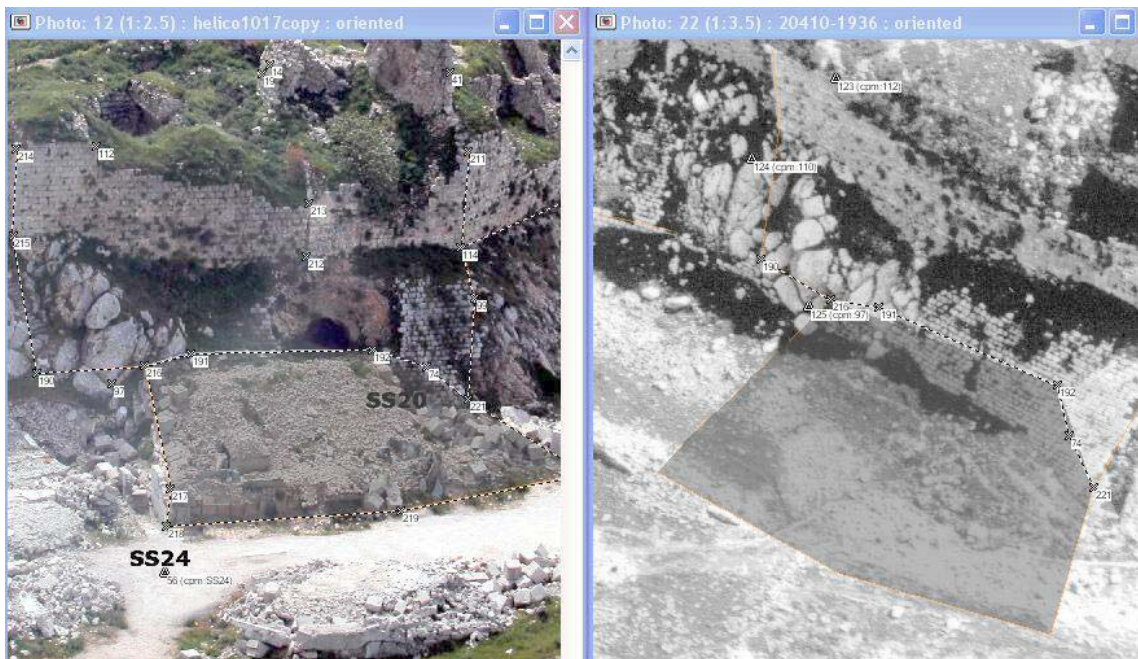
Figure 9. Restitution of the embankment areas.

On the left, the boundary of the embankment is marked on a photo of 2003 and on the right, the corresponding surface is projected on an archive photo of 1936

One will proceed in an identical way on the archive photographs to measure the archaeological structures currently covered by the remains of the war, or to plot in 3D parts of the castle currently embanked or destroyed (fig. 9).

The superposition of the two restitutions make it possible to highlight the areas of interest (figures 9 and 10) for archaeological work and to estimate work of civil engineering (fill, cubature, rebuilding, etc). Moreover, the restitution of the site in wire frame and surface model can be supplemented by the addition of textures
