## Preliminary Report on the Excavations at Burgut Kurgan in 2015

Ladislav Stančo, Shapulat Shaydullaev, Julio Bendezu-Sarmiento, Johanna Lhuillier, Jan Kysela, Alisher Shaydullaev, Odiljon Khamidov, Jakub Havlík, Johana Tlustá

This text summarizes the preliminary results of the first season of archaeological excavations at the site of Burgut Kurgan in Pashkhurt Valley, south Uzbekistan, which were conducted by the Czech-Uzbekistani-French team in 2015. The site represents a unique walled settlement of the transitional period between the Late Bronze and Early Iron Age of southern Central Asia.

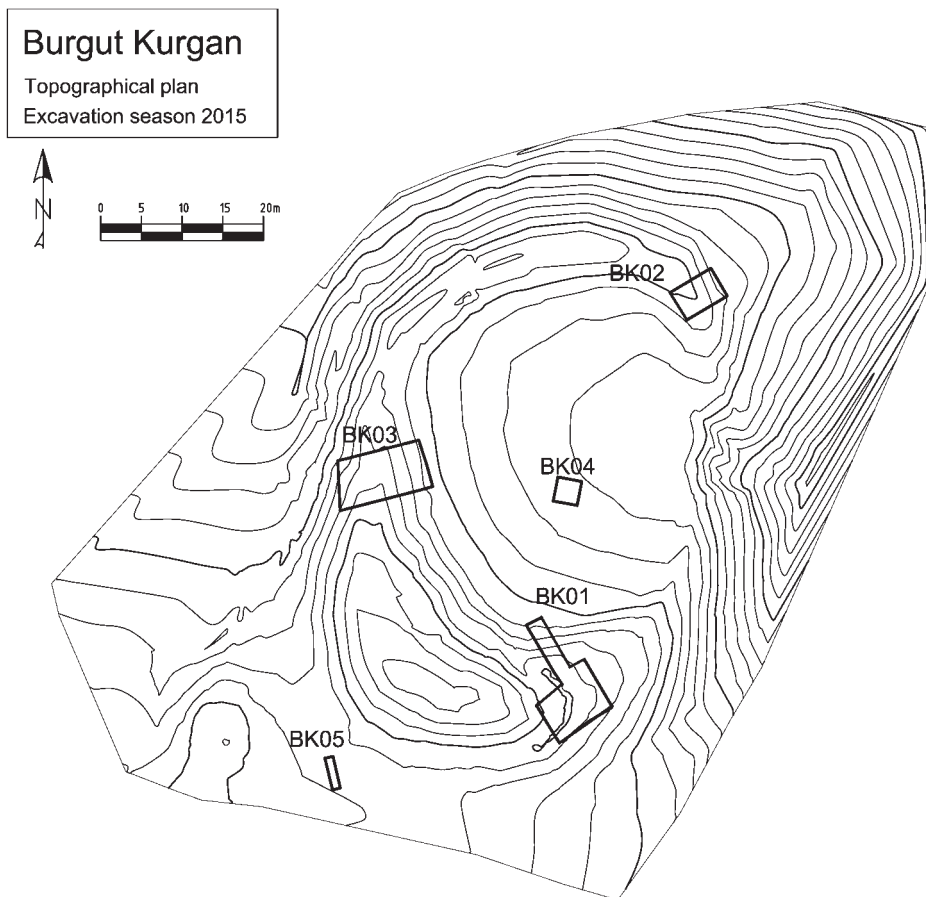
**Fig. 1: Topographic plan of Burgut Kurgan (by J. Havlík, J. Tlustá and J. Souček).**

The Trench BK01 was opened (4×7 m) in the SE part of the site (**Fig. 1 and 2**), in a place where the bank enclosing the collapsed rampart broadens into a flat terrace of ca. 12×9 m. In the west, the terrace is separated from the micro-citadel by the ridge of a canal which skirts the foot of the citadel and breaks into the interior of the settlement. In the east, the terrace grows narrower and stonier. In the south, the terrace is delimited by the outline of the rampart whence a low and soft slope descends towards the exterior of the settlement while in the north the somewhat higher and steeper slope falls to its inside.

Trench BK02 is located in the northern part of the site (**Fig. 1** and **7**), in a place where both the rampart and the archaeological levels were apparently well-preserved according to the topography.

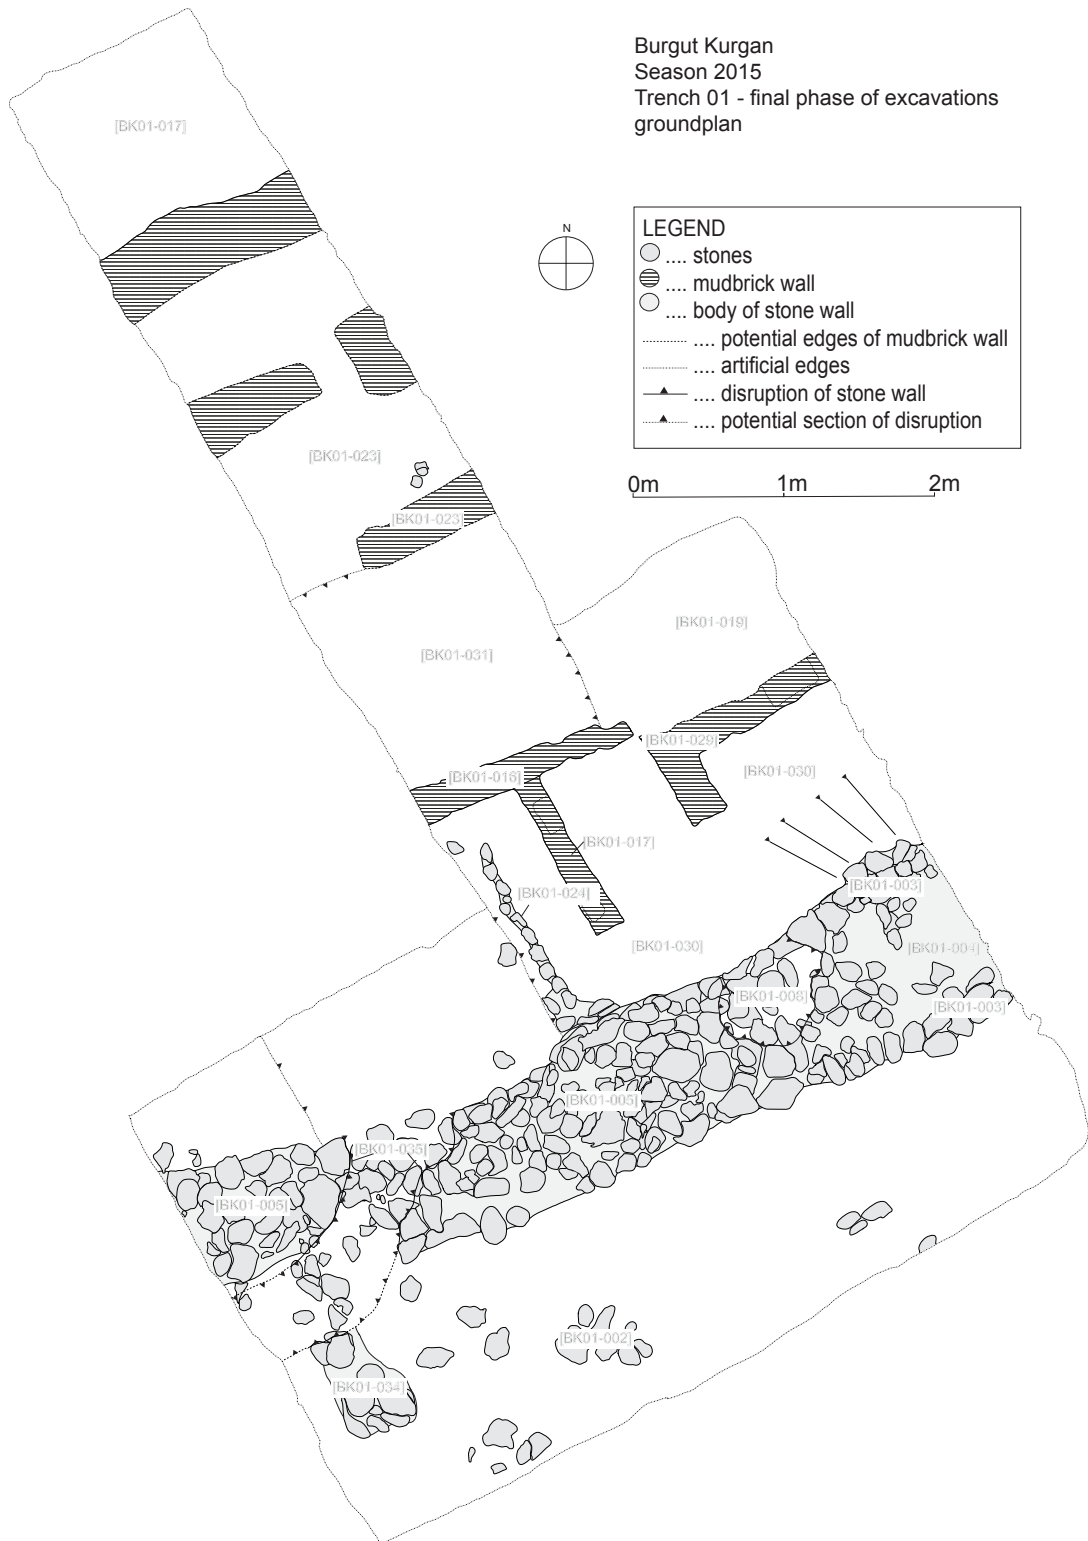
**Fig. 2: Ground plan of the Trench BK01, final phase of the excavations (by J. Kysela, J. Souček and J. Havlík).**

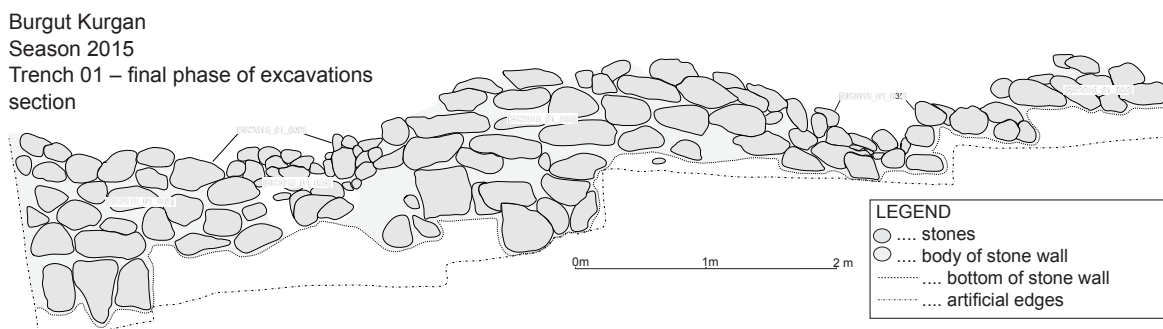
**Fig. 3: Section A of the BK01 showing inner face of the rampart (by J. Kysela, J. Souček and J. Havlík).**

In plan (**Fig. 3**), the rampart runs in the direction E-W. Despite a slight curvature, its greater part is almost straight and it is only in its last third that it turns more decisively in the direction of the micro-citadel.

Unlike the situation in Trenches BK02 and BK03 where the rampart features a homogenous structure, in trench BK01 it consists of two very different portions. The wall portion BK2015\_01\_005 in the western part of the trench (some 5.5–6 m were unearthed) corresponds in its construction roughly to the wall documented in the trenches BK02 and BK03: width ca. 1.2–1.3 m, built prevalently of longish boulders ca. 30–40 cm long with occasionally some over 50 cm long. The stones are laid with their longer axis corresponding to the direction of the wall itself. The wall is constructed as a compact mass with its inside closely packed with stones.

The latest settlement horizon is marked with the stone rampart wall (**Fig. 3**). Only a few settlement horizons are associated with it. An interesting point to note is the contrast between the workmanship and effort invested into the construction (and/or the first reconstruction) of the wall and the sloppiness of the buttress intended to stop its decay.

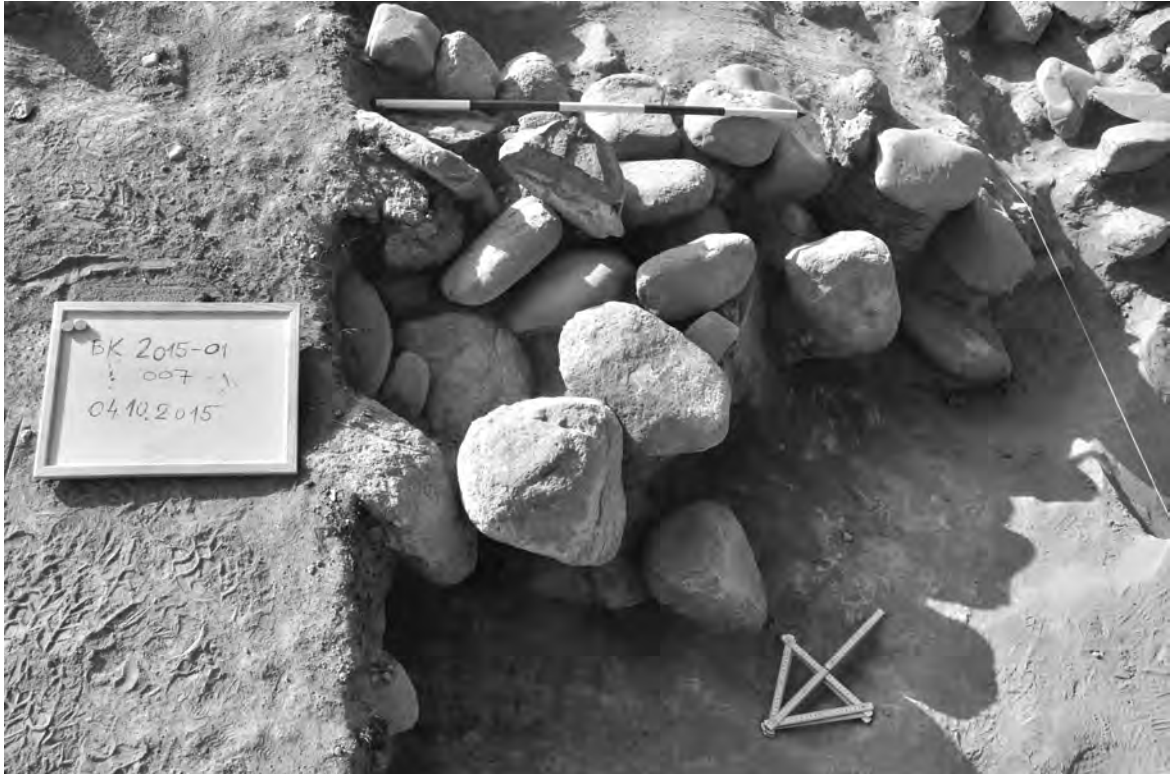
**Fig. 4:** The stone buttress BK2015\_01\_007 of the wall BK2015\_01\_003 (photo by J. Kysela).

the settlement horizons. In the easternmost part of the pit, an accumulation of thickly packed stones (BK2015\_01\_007) is best interpreted as a buttress meant to reinforce the inner face of the wall. The stones are not regularly structured, sometimes with substantial gaps between them, giving the construction quite a makeshift impression (**Fig. 4**).

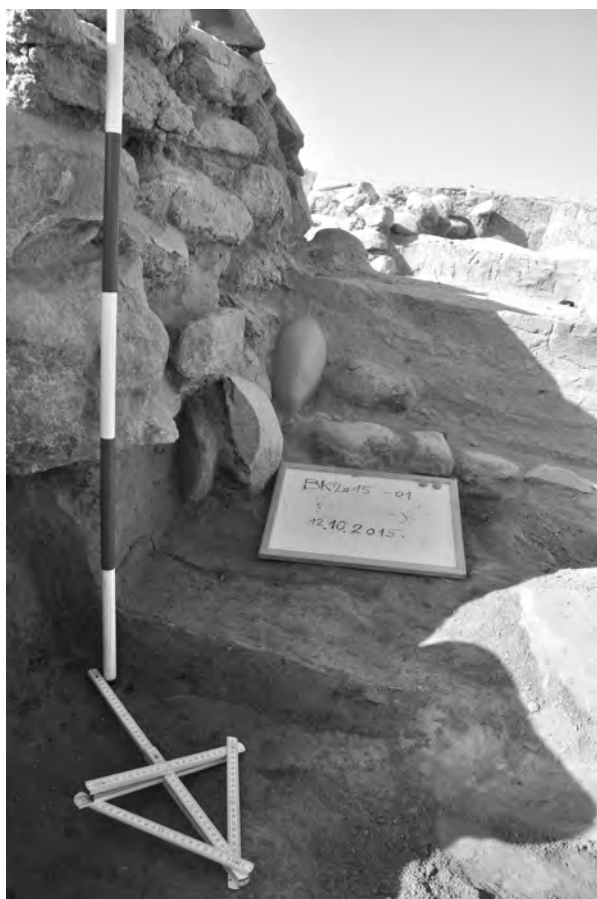
**Fig. 5: Vertically set stones sticking to the inner face of the wall BK2015\_01\_005 - probably remains of the bolstering of the original foundation trench (photo by J. Kysela).**

No foundation trench was identified during the excavation. Nevertheless, when the inner faces of the wall became unearthed in the course of the following excavation, it became clear that: 1) there are no settlement horizons functioning with the wall at the level of its foundation (while there are some higher above) and 2) close to the foundations of BK2015\_01\_005 there are two stones set vertically and adhering to the wall face only because they are stuck to it by means of clay. These stones were very probably meant to bolster the wall's foundation in the – no longer recognizable – trench. The wall was therefore very probably built into a foundation trench. Its depth varied according to the thickness, resistance and stability of the horizons encountered during its carving (**Fig. 5**).

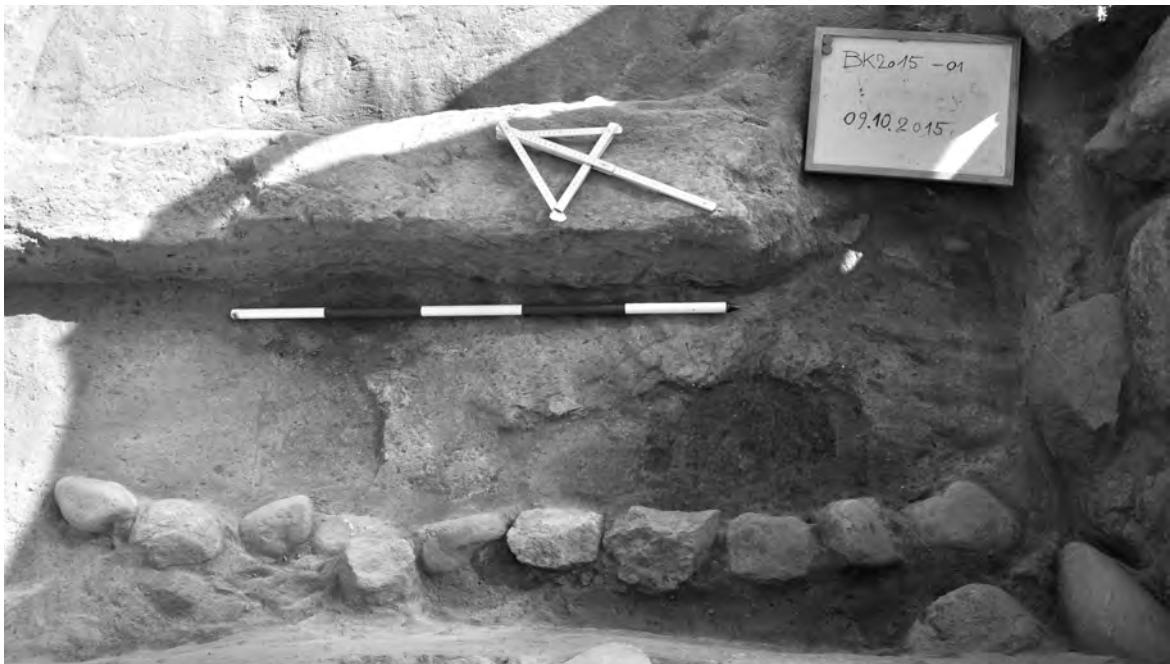
**Fig. 6:** The earthen wall BK2015\_01\_027, course of pebbles (foundation?) BK2015\_01\_024 and a preserved portion of floor BK2015\_01\_025 (photo by J. Kysela).

South of the wall BK2015\_01\_027 runs a course of pebbles BK2015\_01\_024 parallel with it. The hard trodden level into which it seems to be set can be reasonably interpreted as a floor.

No obvious floors have been identified in the rest of the trench. Although the deposits associated with the mudbrick walls featured quite frequent horizons of accumulations of big pottery fragments lying flat, which may have been on the surface at one point, there is no stratigraphic confirmation of this hypothesis (**Fig. 6**).

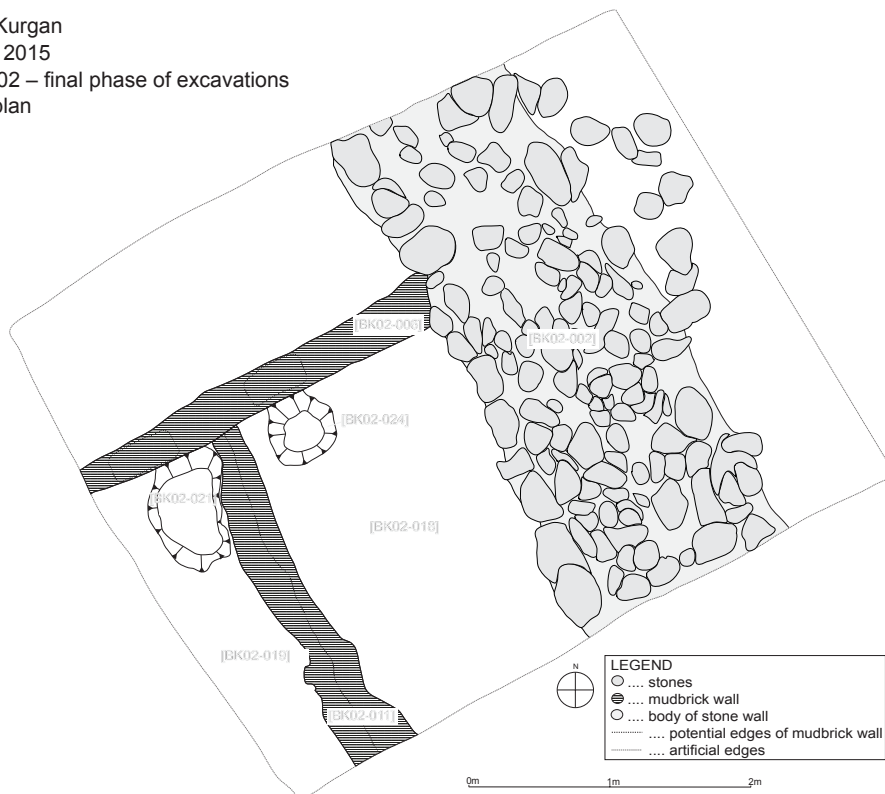
Burgut Kurgan  
Season 2015  
Trench 02 – final phase of excavations  
groundplan

**Fig. 7: Ground plan of the Trench BK02, final phase of the excavations (by J. Kysela, J. Souček and J. Havlík).**

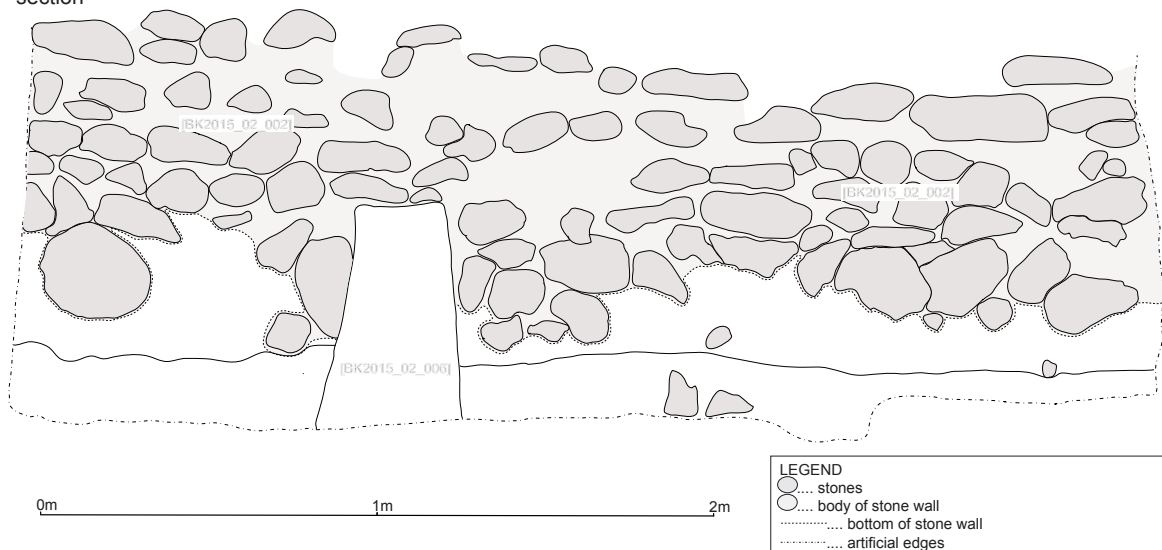
Burgut Kurgan  
Season 2015  
Trench 02 – final phase of excavations  
section

**Fig. 8: Section A of the BK02 showing inner face of the rampart (BK2015\_02\_002; by J. Kysela, J. Souček and J. Havlík).**

Immediately under the surface layer BK2015\_02\_001, a line of boulders appeared, corresponding to the inner face of the rampart, with a NNE-SSW orientation (BK2015\_02\_002). While the inner face was well-preserved (**Fig. 8**), the outer face of the wall was extremely damaged. Collapsed stones were numerous at the surface and at more than 1 m depth, and, once the face could be identified, it appeared that it was not continuous anymore, with many stones lacking. Considering the position of this part of the wall on the northern border of the site at a place facing the wind, this is not surprising.

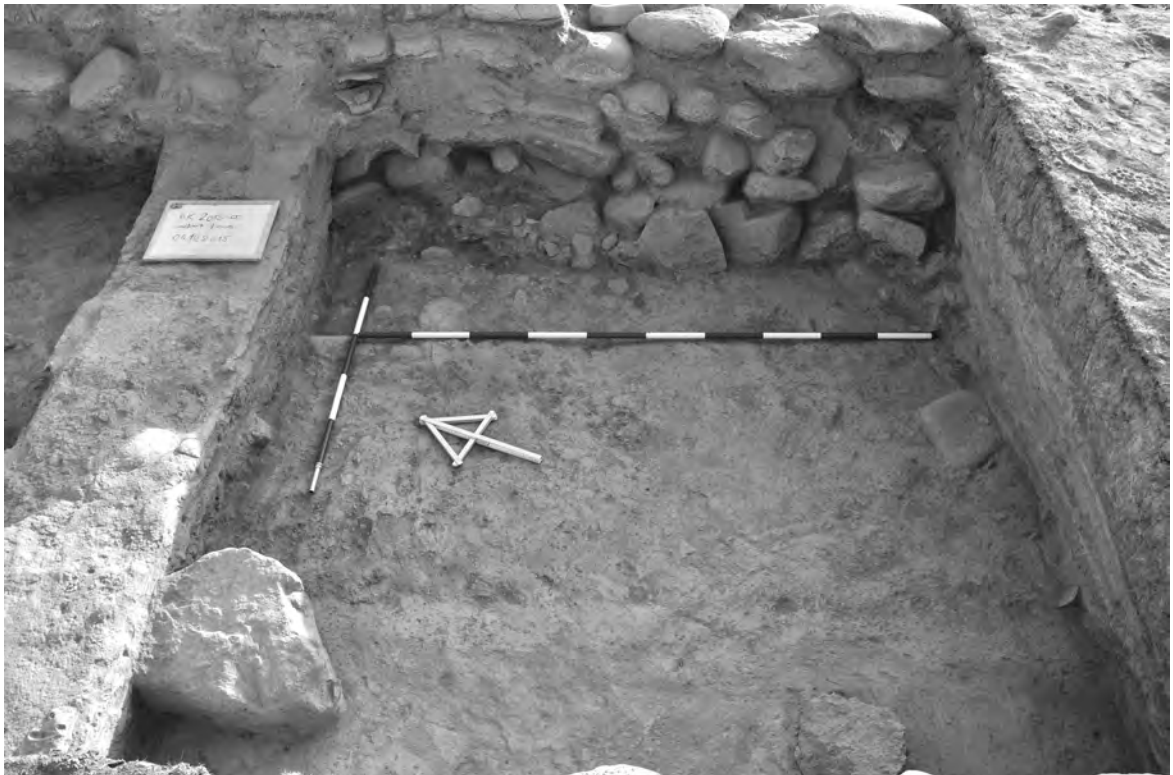
**Fig. 9:** Inner face of the stone rampart BK2015\_02\_002 and the mud-brick wall BK2015\_02\_006 separating the two rooms. In the southern one, part of a floor BK2015\_02\_007 was uncovered (photo by J. Kysela).

We identified the earliest evidence of occupation of the area beneath this thin layer. It is obviously linked to the use of the stone rampart BK2015\_02\_002. While its five uppermost rows of stones can be attributed to the later stage, the lowest rows on the other hand belong to the earliest occupation (see below), and the wall shows clear evidence of repair. In particular, some potsherds belonging to the earliest occupation (BK2015\_02\_008, see below) were covered by stones used to repair the wall (**Fig. 9**). The wall is built with medium-sized boulders

ca. 30–40 cm long, closely packed in their longer axis. Spaces between the stones, as well as both faces of the wall, were probably coated with clay.

This wall delimits two different areas (**Fig. 9**) that can be interpreted as rooms, which were probably covered since no water infiltrations were evidenced, and whose limits could not be determined due to the small extent of the trench.

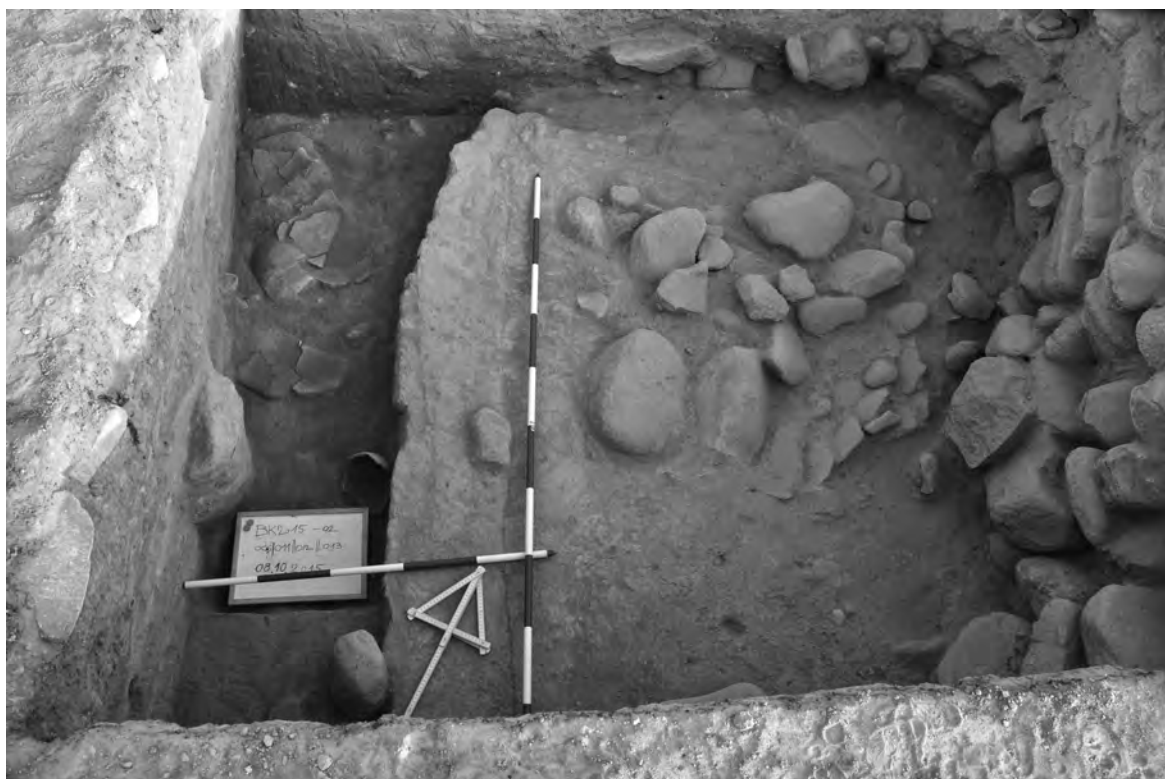
**Fig. 10: Collapsed stones (BK2015\_02\_010) inside the room formed by rampart and the two mudbrick walls (BK2015\_02\_006 and BK2015\_02\_011) (photo by J. Kysela).**

The area located between the walls BK2015\_02\_011, BK2015\_02\_002, and BK2015\_02\_006 (though this wall is later), east of the collapsed stones, was filled with layer BK2015\_02\_012 (**Fig. 10**). The stones were lying on a level of floor BK2015\_02\_015, covered with numerous potsherds. In the area located north of wall BK2015\_02\_006, BK2015\_02\_014 was found under the collapsed stones. It corresponds to a floor, hardened by circulation but not built on, like BK2015\_02\_015. The area located west of the wall BK2015\_02\_011 was filled with layer BK2015\_02\_013 and below it by BK2015\_02\_016 (**Fig. 10**). There too, numerous large potsherds belonged to vessels crushed when the area was abandoned. BK2015\_02\_016 contains one quern and one pestle. The layer below, BK2015\_02\_019, also contains one quern and sherds from cooking pots. These discoveries evidence a domestic purpose of this room.

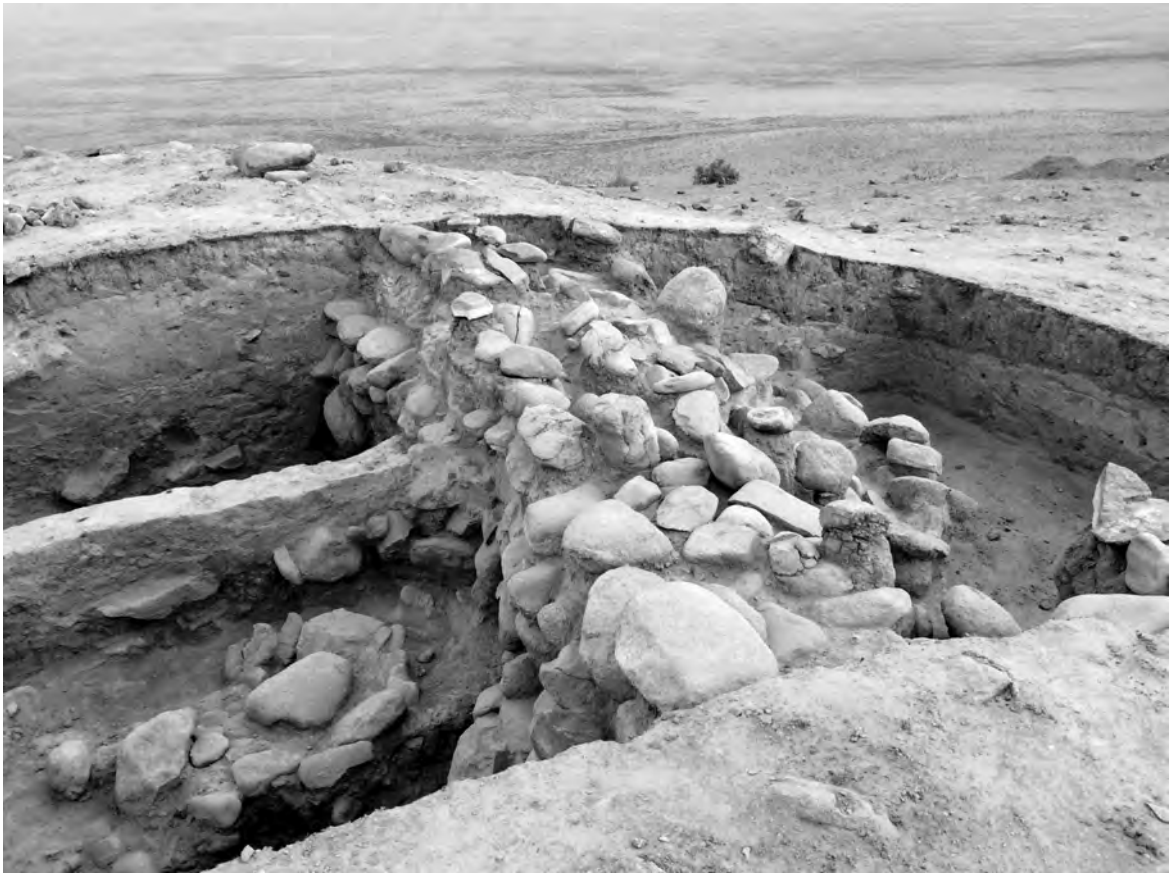
**Fig. 11: Stone rampart in BKo2 (BK2015\_02\_002; photo by J. Kysela).**

The collapsed stones covered the remains of the first occupation of the area. It corresponds to the construction and first use of the stone wall BK2015\_02\_002. At this level, it is clear that the wall was not straight, but curved in order to follow the natural topography of the hill. It is 1.50–1.67 m wide, preserved at a total height of 1.1–1.3 m, corresponding to six courses of stones (**Fig. 11**). The three lowest courses are of one stone (ca. 20–25 cm) larger than the upper ones, a technique used to stabilize the wall. It likely corresponds to the filling of a foundation trench that could not be identified due to the later rebuilding of the wall.

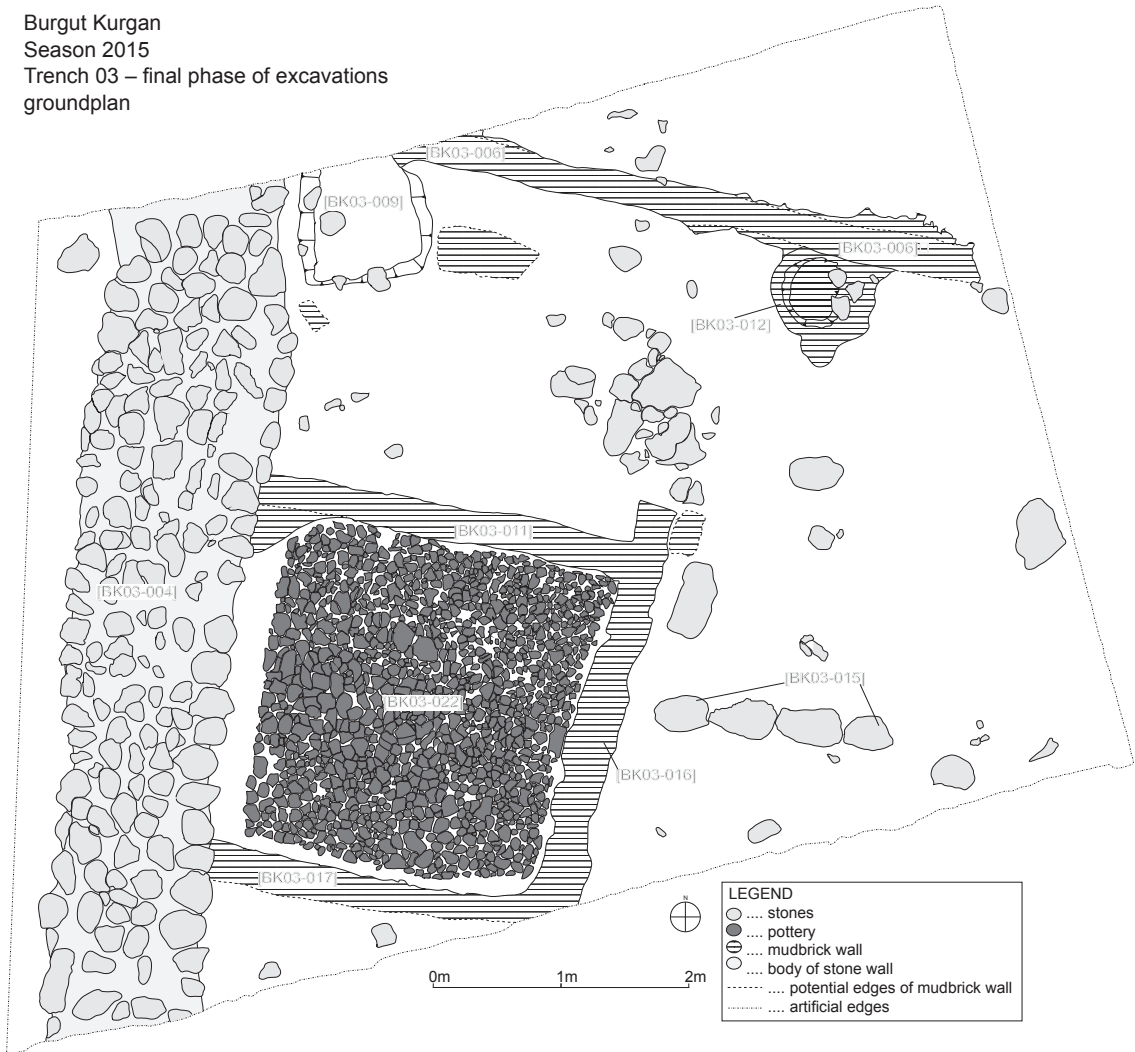
Burgut Kurgan  
Season 2015  
Trench 03 – final phase of excavations  
groundplan

**Fig. 12: Ground plan of the Trench BK03, final phase of the excavations (by J. Kysela, J. Souček and J. Havlík).**

The highest and best-preserved structure is the surrounding stone wall BK2015\_03\_004 (**Figs. 12 and 13**). It was better preserved than we expected. It is ca. 1.30 m wide, made of five parallel rows of boulders. We cleaned four courses of stones and reached the footing bottom of the wall just beneath. In the northern part of the trench, the wall seems to be higher; but in the southern one, the three uppermost courses are erected on layers related to a previous occupation, though we cannot exclude the hypothesis that a first rampart wall was already present in this earliest settlement, since we reached only the top of these layers. This discrepancy in the conservation of the wall provide another argument suggesting the collapse of some parts of the wall and its rebuilding later on. Furthermore, a layer made of hard clay, very similar in its nature to bricks, was found between a mudbrick wall (BK2015\_03\_011) and this rampart wall, maybe in order to support it. This point has to be investigated further by the future excavations.

Four mudbrick walls have been identified (**Figs. 12–14**). The first wall BK2015\_03\_006 is oriented roughly east-west. It is made of one row of bricks and it is visible in the trench at a ca. 5 m length, but continues further westwards. The second wall BK2015\_03\_011 is parallel to BK2015\_03\_006 at 2.58 m to the south-east. It is also made of one row of mudbricks. Further south-east, the third wall BK2015\_03\_017 is parallel to walls BK2015\_03\_006 and BK2015\_03\_011. The fourth wall BK2015\_03\_016 is perpendicular to the walls BK2015\_03\_006, BK2015\_03\_011 and BK2015\_03\_017. It was well preserved at a ca. 3.5 m length but we may not exclude the possibility that it joined the wall BK2015\_03\_006. The mudbricks used in these walls are of two different sizes, some 23–25×18×10 cm, and the others 41×24×10 cm, separated by a ca. 4 cm thick jointing. The described mudbrick walls delimited rooms which were probably roofed since no traces of an exposure to water or wind have been identified.

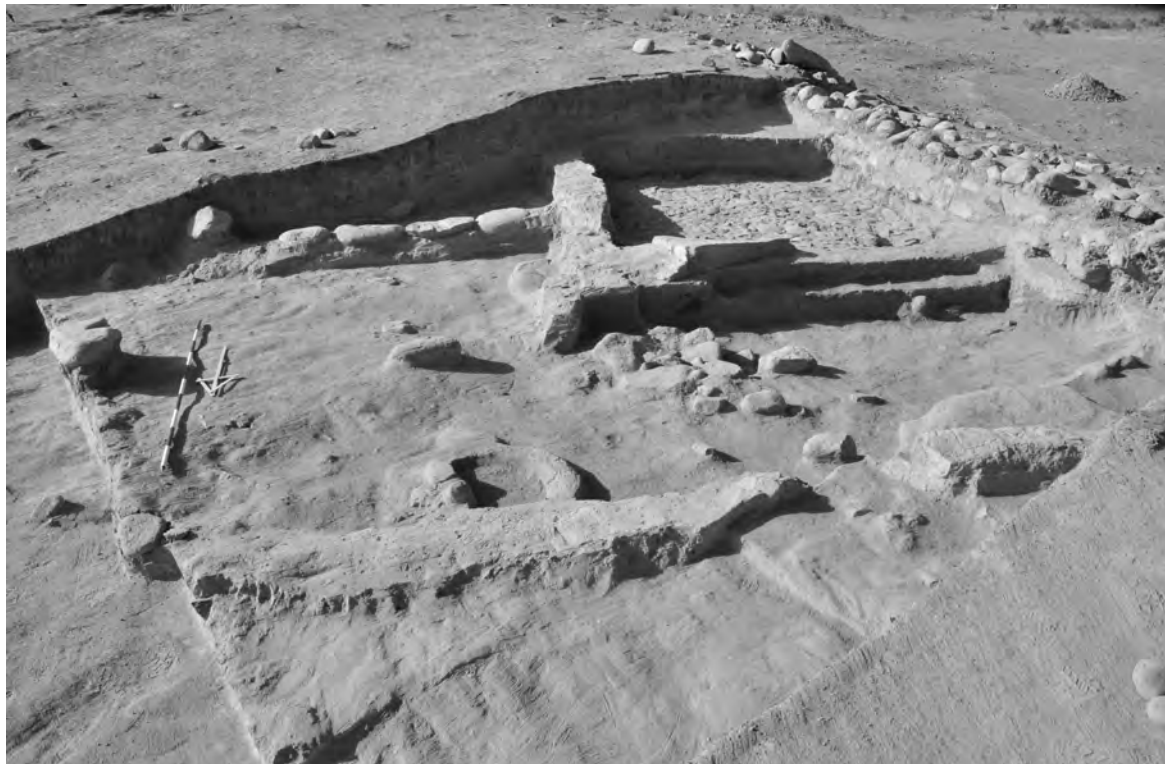
**Fig. 13:** Trench BK03, general view from the north with rampart (BK2015\_03\_004) on the right (photo by J. Kysela).

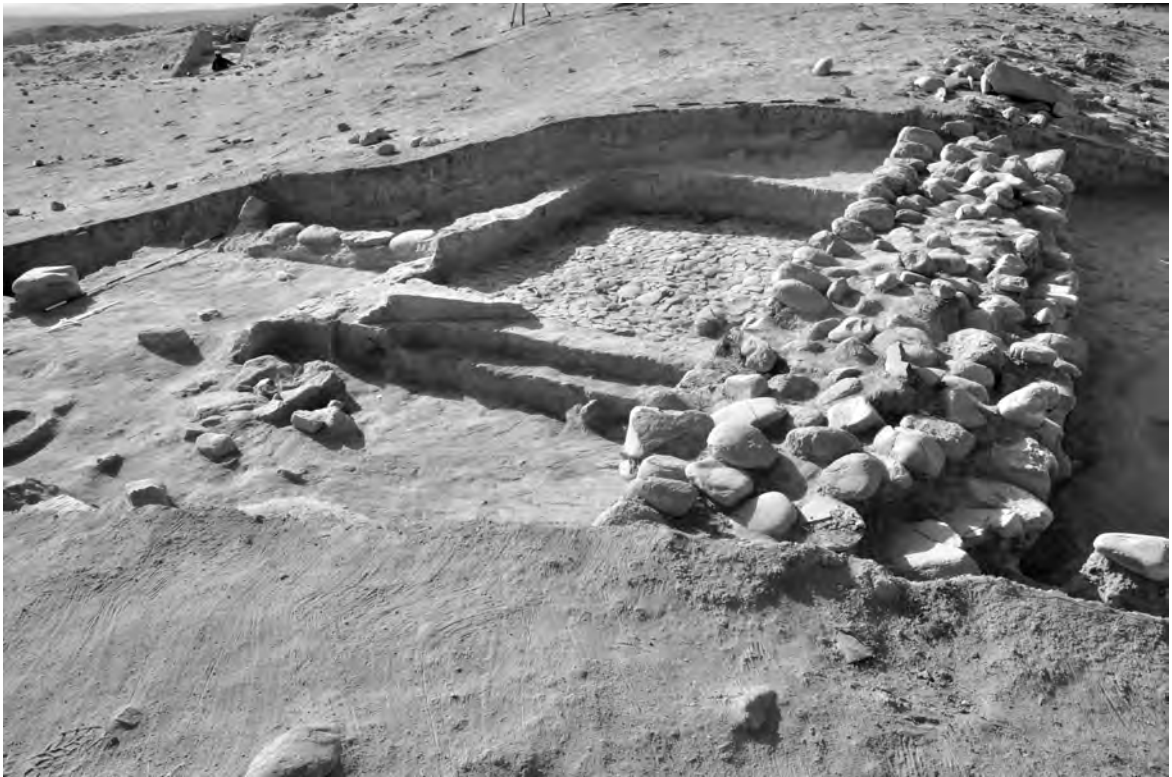
**Fig. 14: Trench BK03, general view from the north-west with rampart (BK2015\_03\_004) on the right and pottery-plastered room (a kata?) in the centre (photo by J. Kysela).**

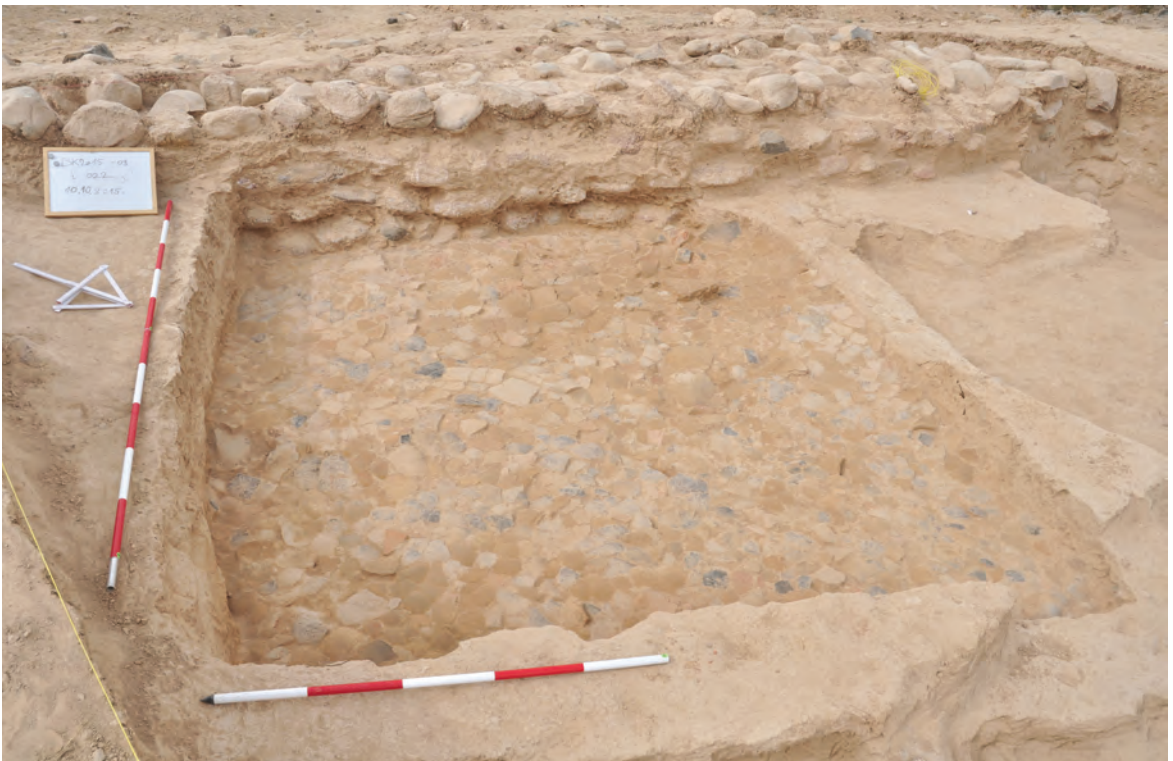
**Pl. 3/3: Room plastered with pottery sherds in Trench BKo3 (photo by J. Kysela).**

The most intriguing discovery is represented by the floor paved with potsherds. No similar discoveries have been made so far in an Early Iron Age settlement; however, some analogies may be found with structures from the Bronze Age settlement of Gonur-depe in Margiana (Turkmenistan). V. I. Sarianidi identified in Gonur South a group of three buildings he considered as part of a water temple. There, in the hall occupying the central part of the eastern building, he excavated structures he interprets as double-hearths raised on low platforms; the burner's floor of one such double-hearth is covered with fragments of pottery (SARIANIDI 2006, 179, Fig. 49). According to Sarianidi, this complex was used to prepare food sacrifices. Although we may consider this interpretation with caution, it raises the hypothesis of a religious or cultic function of this structure. According to Sh. Shaydullaev, another possible explanation is linked to the mortuary practices: the most common practice during the Early Iron Age was excarnation (BENDEZU-SARMIENTO - LHUILLIER 2015), and this room may have been used as a *kata*, a temporary shelter for the corpse when it is impossible to move it to the *dakhma* (Vendidad VIII, 2). Indeed, a corpse may be left in a room before its transport to the *dakhma*, if it is in a place larger than the body with the arms and the legs stretched. The text from the Vendidad refers to a place located in private houses (CANTERA 2002), where the floor "is the cleanest and the driest, and the least passed through by flocks and herds, by the fire of Ahura Mazda, by the consecrated bundles of Baresma, and by the faithful" and is covered "with dust of bricks, of stones, or of dry earth". Although we may notice some differences with the text - and especially the location of this room near a living space with a domestic use - we observe at Burgut Kurgan the same will to protect the floor. This important point has to be investigated by further excavation in the area.
