## Hull structure

Giulia Boetto, Sabrina Marlier, Irena Radic Rossi

# PAKOŠTANE VELI ŠKOLJ

The Late Roman shipwreck in its geological-geographic  
and cultural-historical context

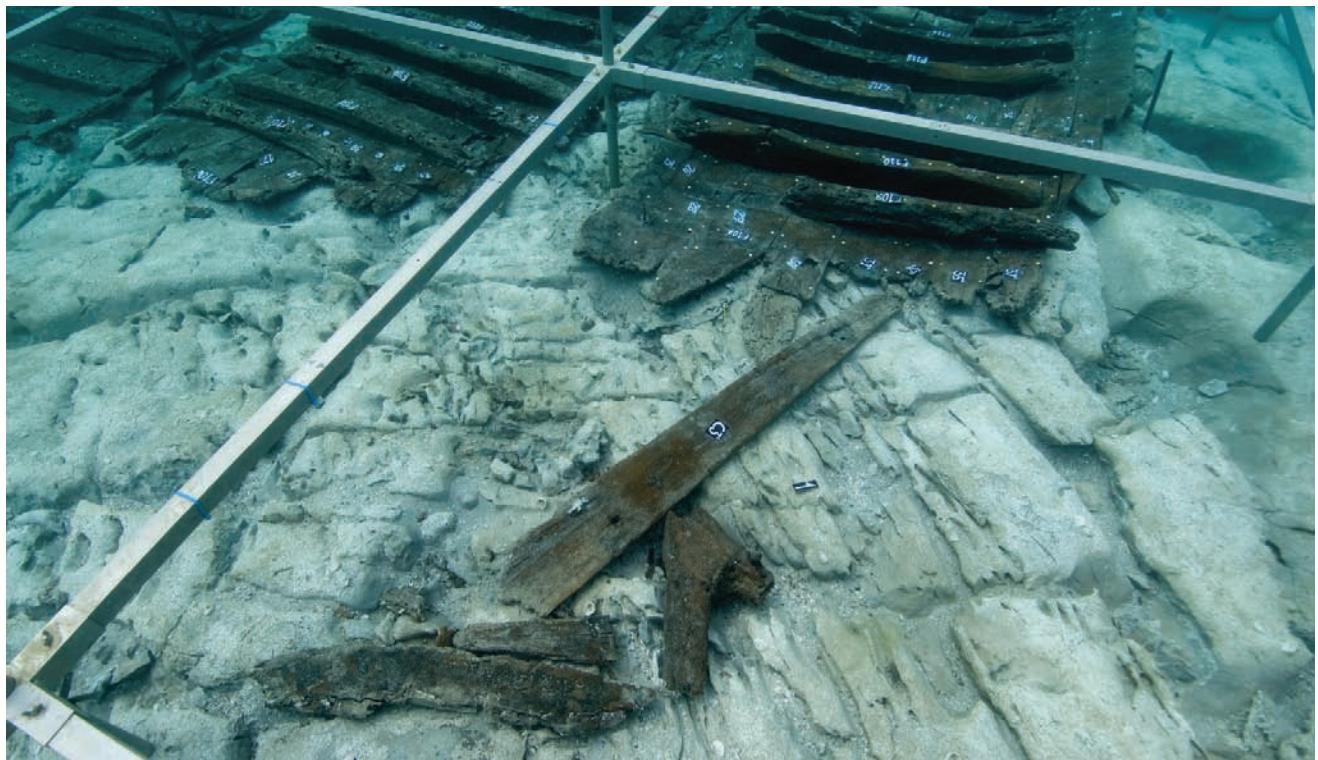
Fig. 48 Displaced fragments of frames and ceiling in the south-eastern area (photo: Ph. Groscaux).

The preserved transversal elements include 33 frames (from F99W to F132E)<sup>34</sup> in 99 pieces, which are mostly broken at their ends (Fig. 57). Among the frames, 8 floor timbers<sup>35</sup> and 7 half-frames<sup>36</sup> could be discerned in the western section of the ship. During study of the finds *in situ*, it seemed that 24 futtocks and 10 various pieces of frames were inserted during repairs. Upon completion of the documentation, however, it would appear that there are no valid grounds for this assertion, for despite the fact that repairs were numerous, there are no genuine grounds to distinguish between subsequently inserted and original parts of the frames.<sup>37</sup> In any case, the different elements, which are components of a frame were set on the same line (or centred) generally 1 to 5 cm away from each other. In some cases, the framing scheme deviates somewhat from the basic applied system: the ends of these frames have been moved from their original direction, and at some places they overlap, so the link between the parts was rendered with the help of a recess but always without any assembly by nails or treenails (Fig. 58). And finally, the already mentioned two floor-timbers from the ship's stem and stern (Fig. 48, 57) also belong to this group of finds.

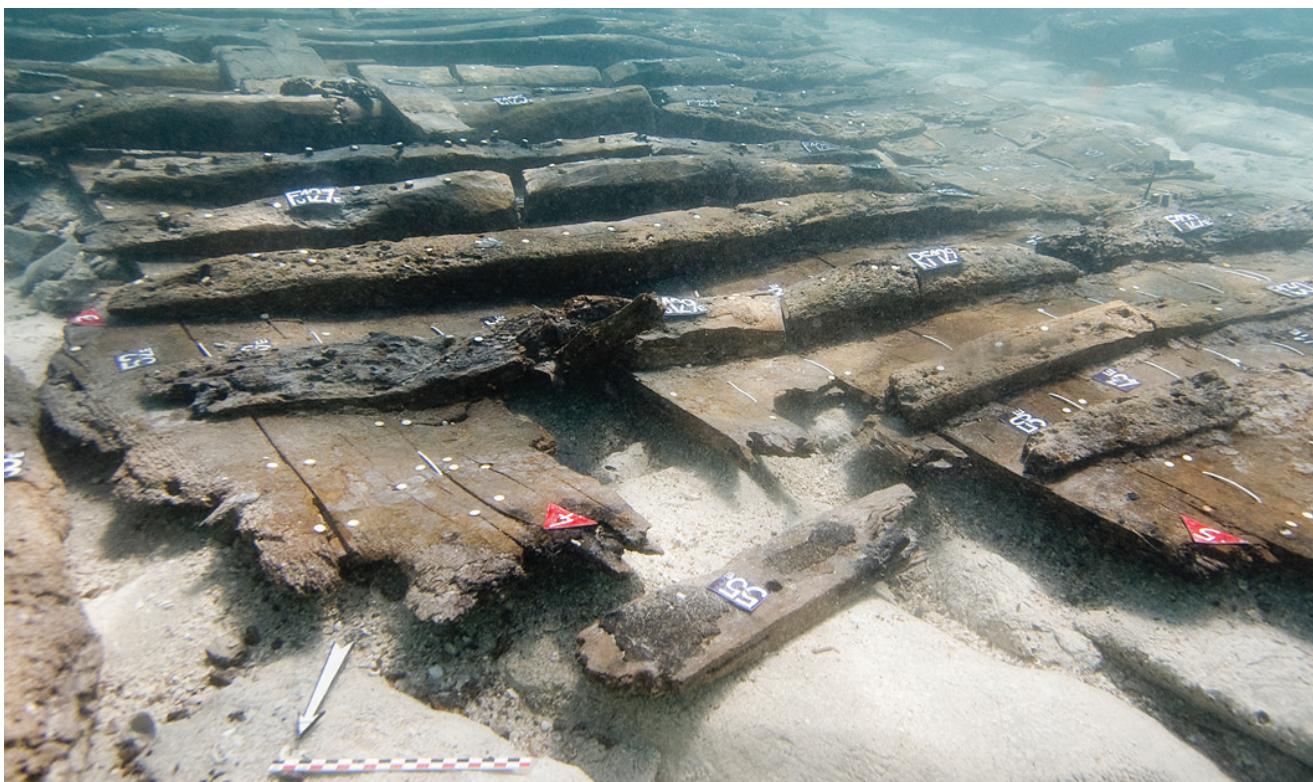
Fig. 49 Frames damaged by shipworms in the north-eastern area (photo: Ph. Groscaux).

With regard to the state of preservation of wood, it is noteworthy that the ends of the frames were rather damaged by the aggressive activity of a marine mollusc known as

shipworms (*Teredo navalis*), (Fig. 49). The planks were also rather damaged, so, for example, the northern end of plank P45E was found jutting from the bottom and bent at a 45° angle. Additionally, cracks were recorded at a number of places on the planking, and by far the majority was noted in the western section of the ship, between the floor timbers and futtocks which correspond to frames F123W and F125W (Fig. 50), and in the eastern section at the end of frame F127E.

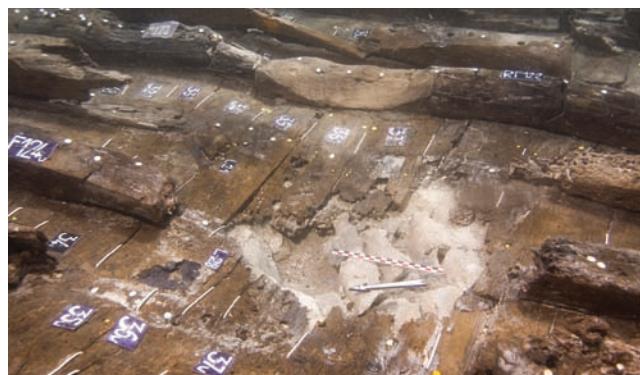
Fig. 50 Hole in planking, between the frames and futtocks, at the level of frames F123W and F125W (photo: Ph. Groscaux).

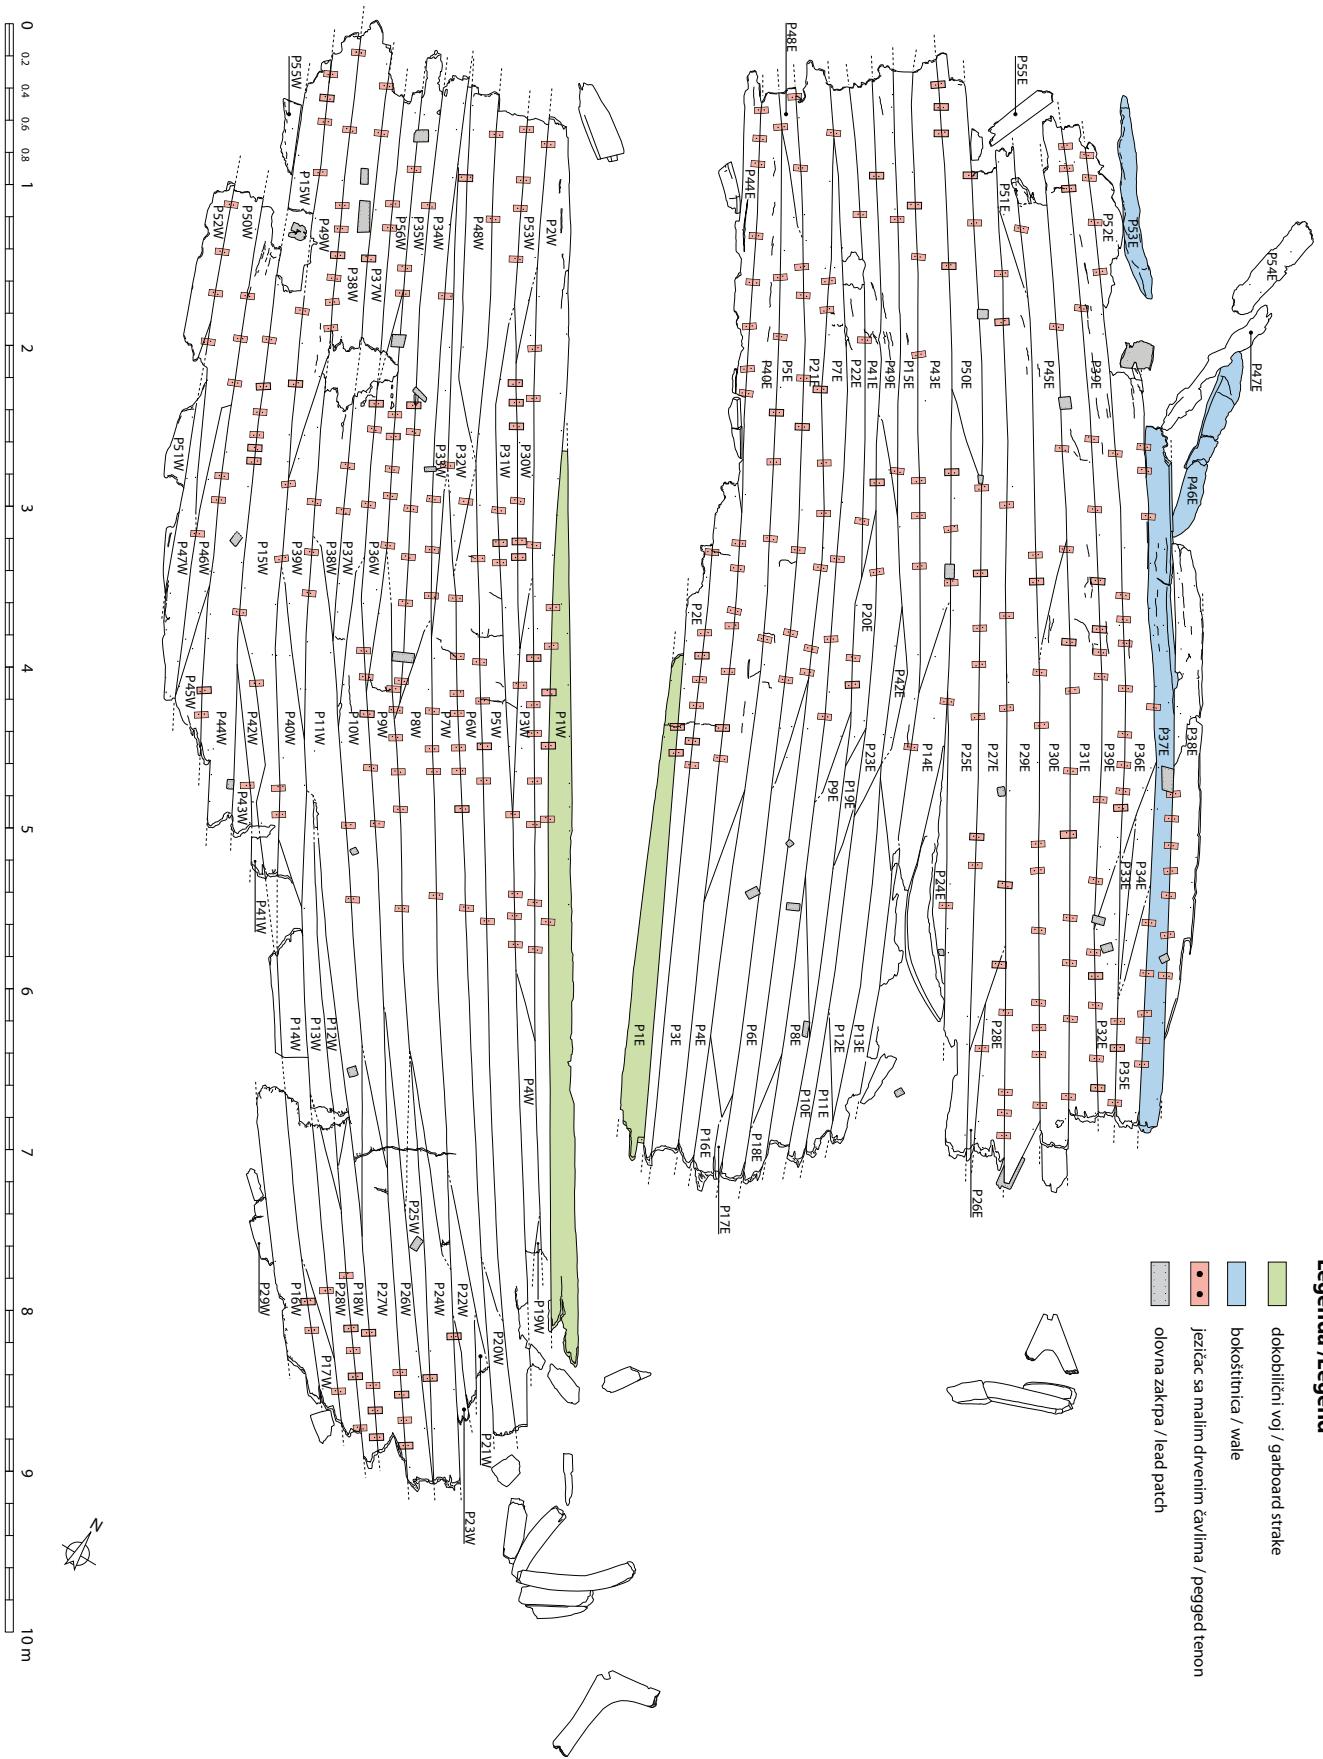
Fig. 51 Schematic of the planking (M. Rival, V. Dumas).

All along the eastern perimeter of the ship's hull, traces of the lower wale were noticed which belonged to three pieces designated P37E, P46E and P53E (Fig. 51). Element P37E is 15 cm wide and 8.3 cm thick (Fig. 55). Element P46E, overturned and shifted from its original location, has been preserved at a length of 1.28 m. This wale fragment, 13.5 cm wide and 10.2 cm thick, bears traces of protective lining made of a piece of lead sheet on its external face, probably installed during one of the many repairs. The lead sheeting was fastened with small copper nails, of which two heads can still be seen 77.5 cm apart from one another. The sheet metal plate L27, found north of plank P36E, near the aforementioned P46E, probably served to repair a part of the wale<sup>27</sup> (Fig. 56). As to traces of shipbuilders' tools used to make the elements

The planks of the planking were connected by mortise and tenon joints. Most of the tenons were fastened by small wooden pegs, but along the edge of garboard plank P1W (toward the keel), at the level of frames F118W and F123W, few unfastened tenons were also noticed. It would appear that this was an oversight on the part of the shipbuilders, rather than some specific purpose. The system of mortises on both sides of the plank was conceived according to a scheme (alternating the joints from one side and the other of the keel) that would cause the least possible weakening of the wood (Fig. 51).

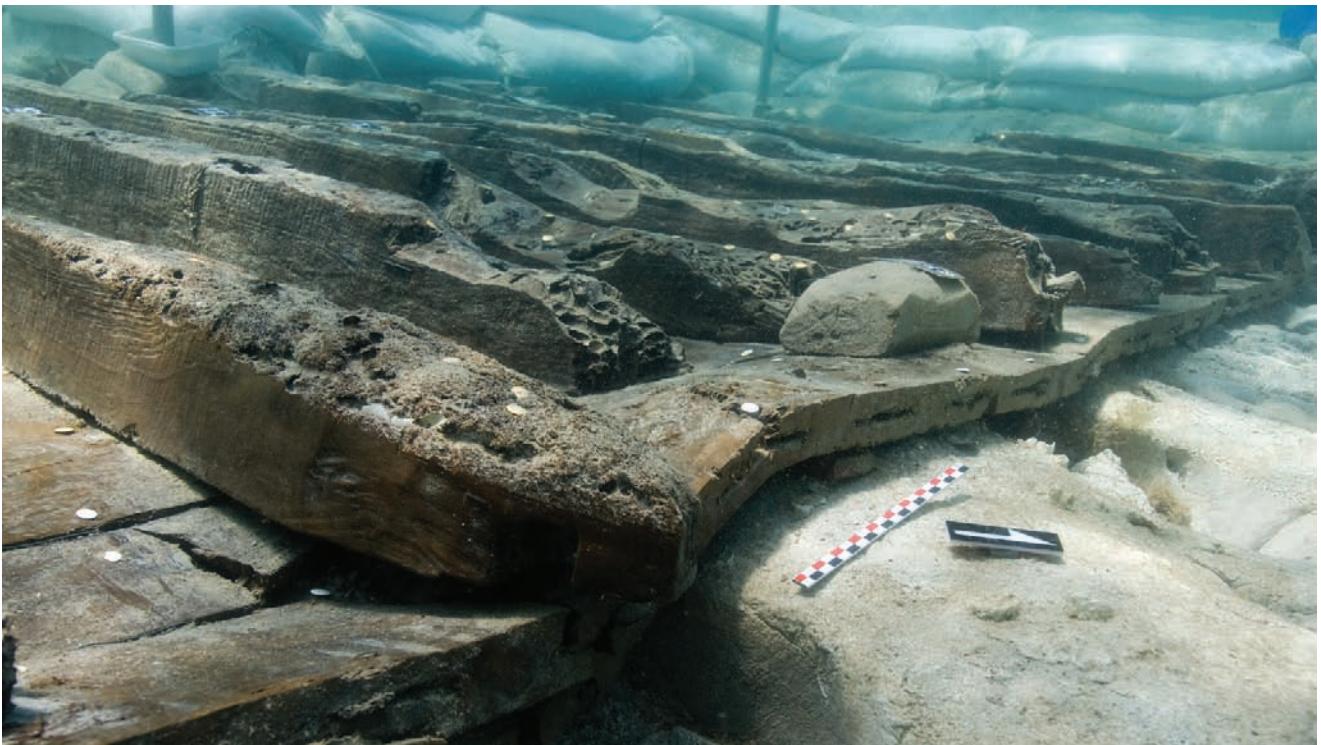
Fig. 52 View of the garboard P1W from the south-east (photo: Ph. Groscaux).

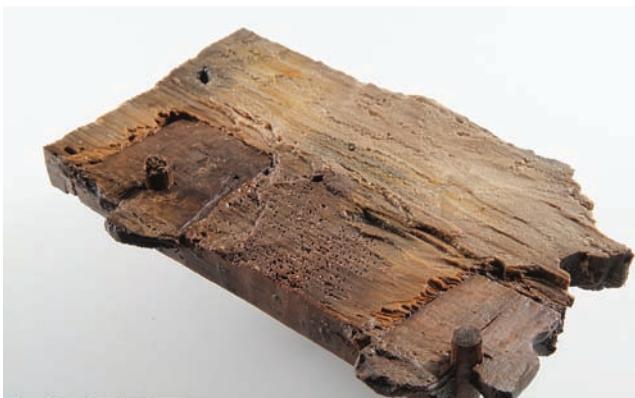
Fig. 53 Internal assemblage of the planking, on dislocated plank fragment PK07/P11 (photo: Ph. Groscaux).

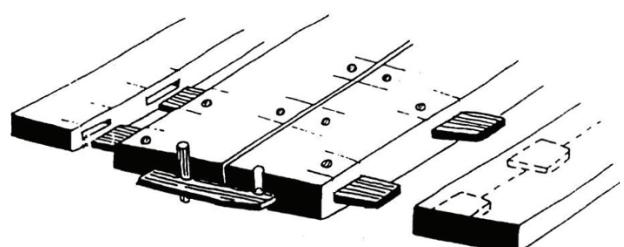
Fig. 54 Schematic representation of planks with mortise and tenon joints (after Pomey, Rieth 2005).

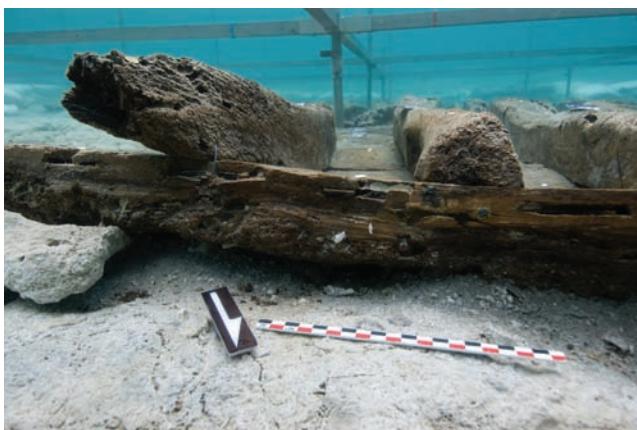
Fig. 55 View of wale P37E and plank P38E from the north-east (photo: Ph. Groscaux).

And finally, horizontally set nails were used to fasten the tapered ends of planks. This feature was observed on plank P38E on which three horizontally pounded metal nails were used to fasten the tip of the plank to wale P37E (Fig. 32). There should be no doubt that the other metal nails may have been used at the ends of the remaining planks, but even this could not be verified without dismantling the elements of the hull.

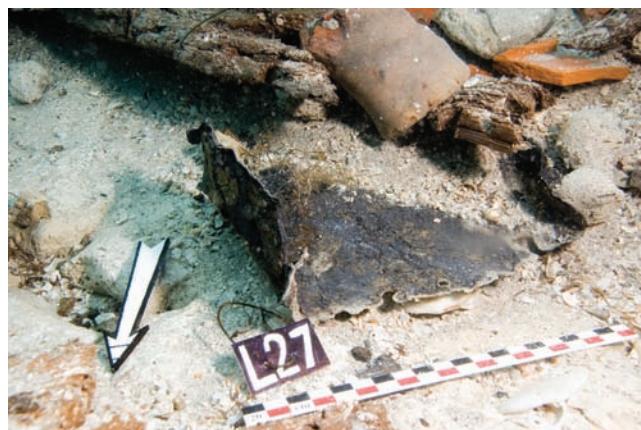
Fig. 56 View of lead plate L27 used to repair the hull, from the north-east (photo: Ph. Groscaux).

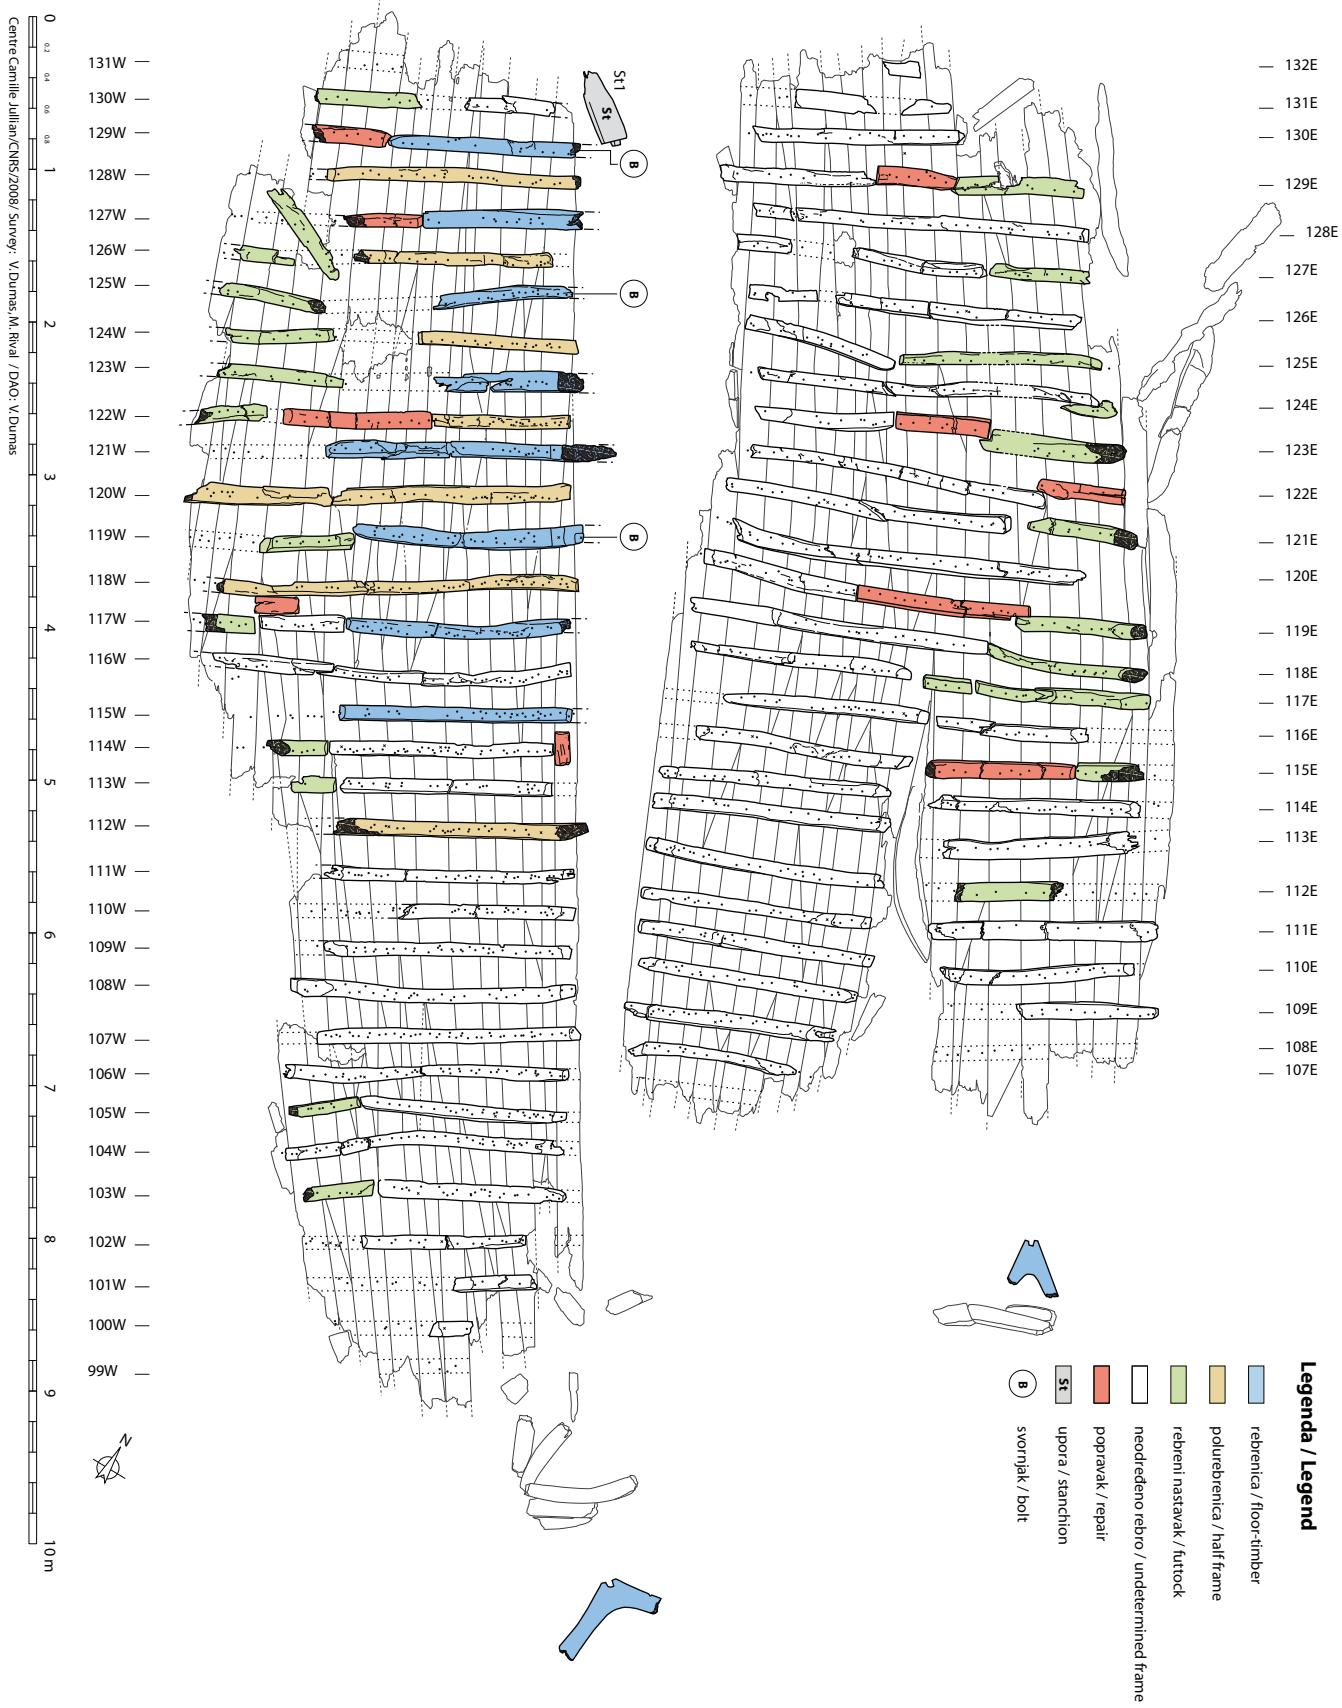
Fig. 57 Framing schematic (M. Rival, V. Dumas).

The average distance between frames is 17.3 cm (from 10 to 23 cm), (Fig. 57). Given that this gap is less than two widths of a frame, showing the ratio between the average width of a frame and the average width of the gap between them is 1.84, it may be concluded that these are relatively densely distributed frames.

Based on many elements (arrangement of the frames, a high number of treenails connecting the frames to the planking, different types of wood) it may be concluded that during its use many of the ship's frames underwent repairs. Some repairs only encompassed smaller parts, which was the case with the elements longitudinally placed at the end of frame F114W, the element near garboard plank P1W (Fig. 75) and the element inserted between frames F117W and F11W (Fig. 57).

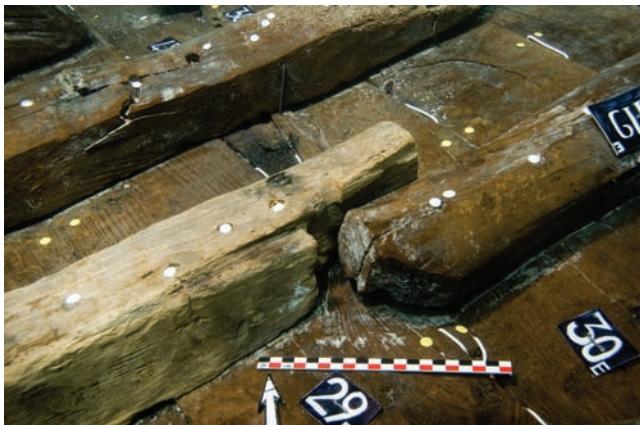
Fig. 58 View of the recess fitting between the two parts of frame F119E, from the north-west (photo: Ph. Groscaux).

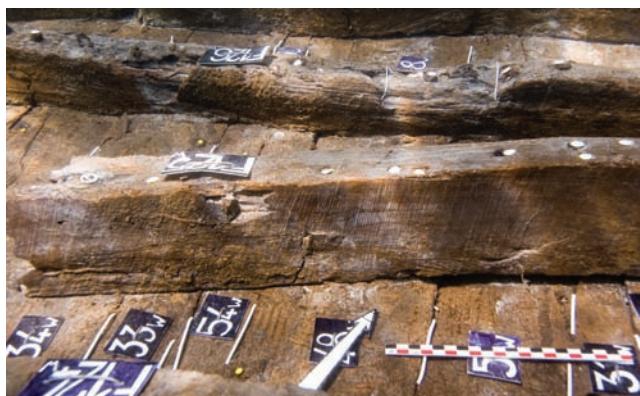
Fig. 60 Sawing marks on the side of the frame (photo: Ph. Groscaux).

All of the frames have a rectangular cross-section, and in some cases the upper edges are rounded. The average width of the frames is 9.4 cm (from 7 to 14 cm), while the average height is 9.8 cm (from 5 to 14 cm), (Fig. 47). Traces of a saw and hatchet were observed on the lateral sides of almost all transversal elements (Fig. 60).

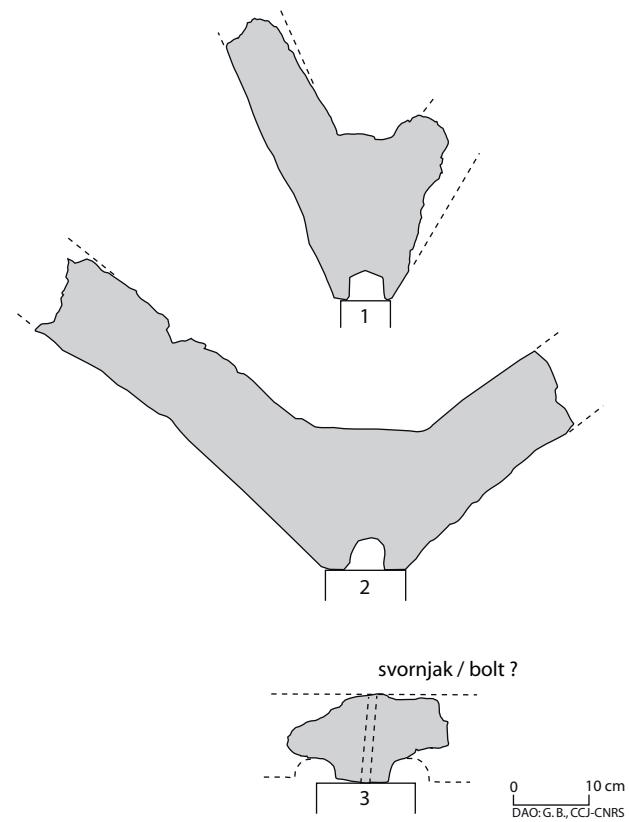
Fig. 59 The limber holes on the floor-timbers from bow or stern, and on the fragment of floor-timber PK07/F2 (drawing: G. Boetto).

The floor timbers have rectangular limber holes (wid. 4-5 cm and ht. 2-3.5 cm on the floor timbers; wid. 5 cm and ht. 4 cm on floor-timbers from the bow or stern area), which facilitated the flow of water<sup>38</sup> into the bilge. In the ship's central section, two holes situated on each side of the keel were made on the floor-timbers and half-frames (Fig. 59.3, 61), while there is only a single hole, directly above the keel, on the floor-timbers from the bow or stern area (Fig. 59.1-2).

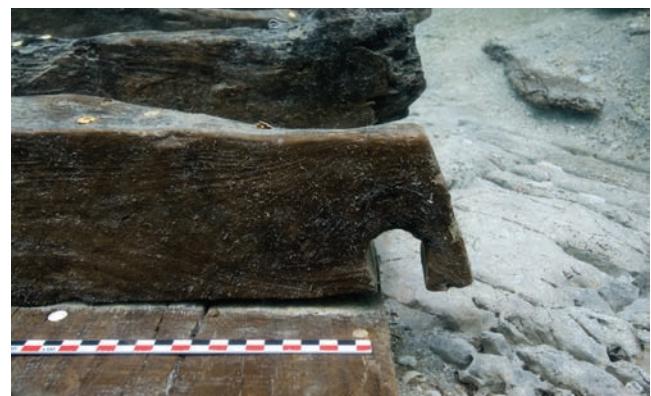
Fig. 61 View of the extremity of half frame F112W, from the south-east (photo: Ph. Groscaux).

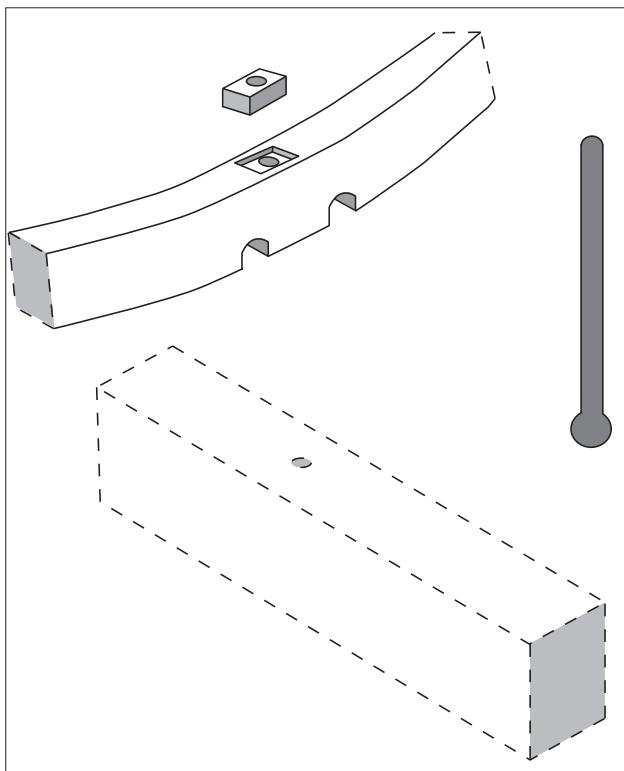
Fig. 62 Schematic representation of bolting the floor-timbers to the keel (drawing: G. Boetto).

Several floor timbers<sup>39</sup> were fastened to the keel with metal bolts. Such a connection was thoroughly studied on floor timber F119W. A bolt with 1.9 cm diameter was inserted from the external side of the keel, and it was fastened from the upper side of the floor timber with the help of a square plate that rested in a square hole with dimensions of 4.7 x 4.7 x 1 cm (Fig. 62-65). Such a detail was noted, for example, on a shipwreck from Monaco (end of 2<sup>nd</sup>/mid-3<sup>rd</sup> cent. AD; Mouchot 1968-1969). There is also a similar connection to the keel between two limber holes on a floor timber piece found away from its original position and marked as PK07/F2 (Fig. 57.3).<sup>40</sup> In this case, the bolt's diameter was 1.7 cm.

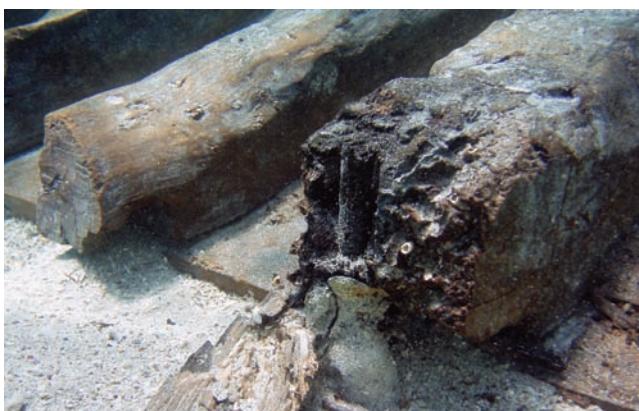
Fig. 64 Broken extremity of floor-timber F119W with the corroded bolt *in situ* (photo: Ph. Groscaux).

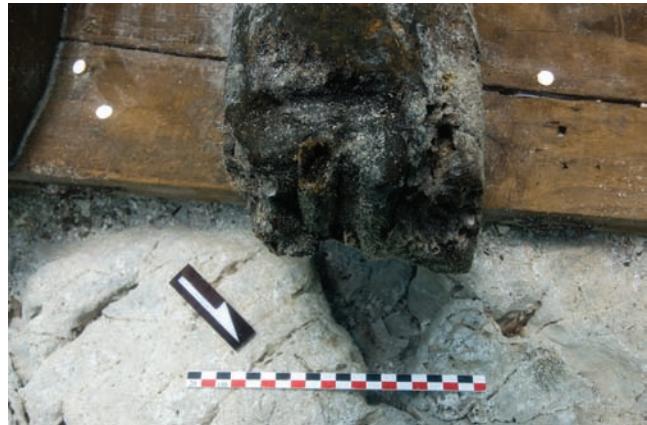
Fig. 63 Quadrangular recess on the upper surface of the floor-timber F119W (photo: Ph. Groscaux).

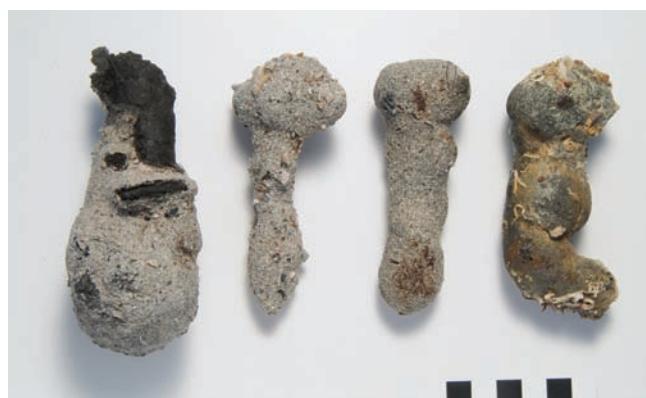
Fig. 65 Bolt remains (photo: Ph. Groscaux).

The joints connecting the frames to the planking were rendered with the help of treenails having an average diameter of 1.3 cm (from 0.7 to 1.9 cm, measured from the inside of the ship) and copper and iron nails<sup>41</sup> inserted from the ship's exterior (Fig. 65, 67). On the upper sides of the frames, the tops of nails were not clenched for greater reinforcement. It is noteworthy that in some places the wooden nails are exceptionally numerous (up to roughly forty on the parts of frames longer than 2 m), which very likely may be linked to hull repairs (Fig. 47).

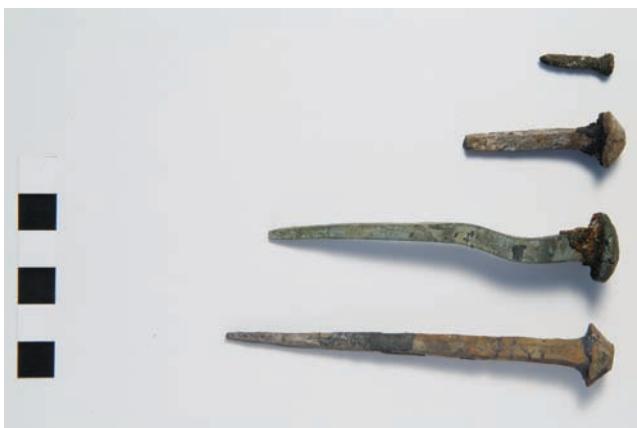
Fig. 66 Nails of various sizes, used for building and repairing the hull (photo: Ph. Groscaux).

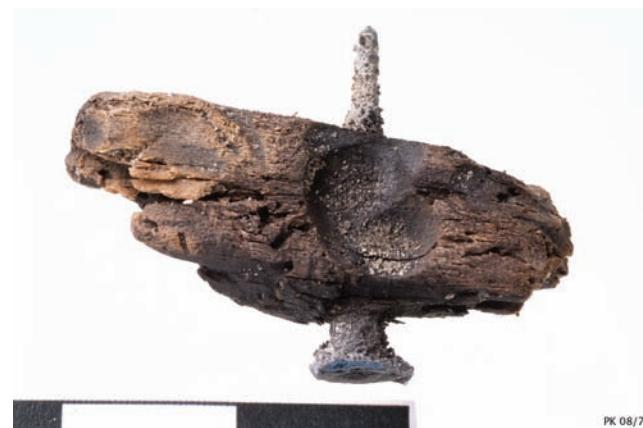
Fig. 67 Metal nail in a fragment of wood (photo: Ph. Groscaux).

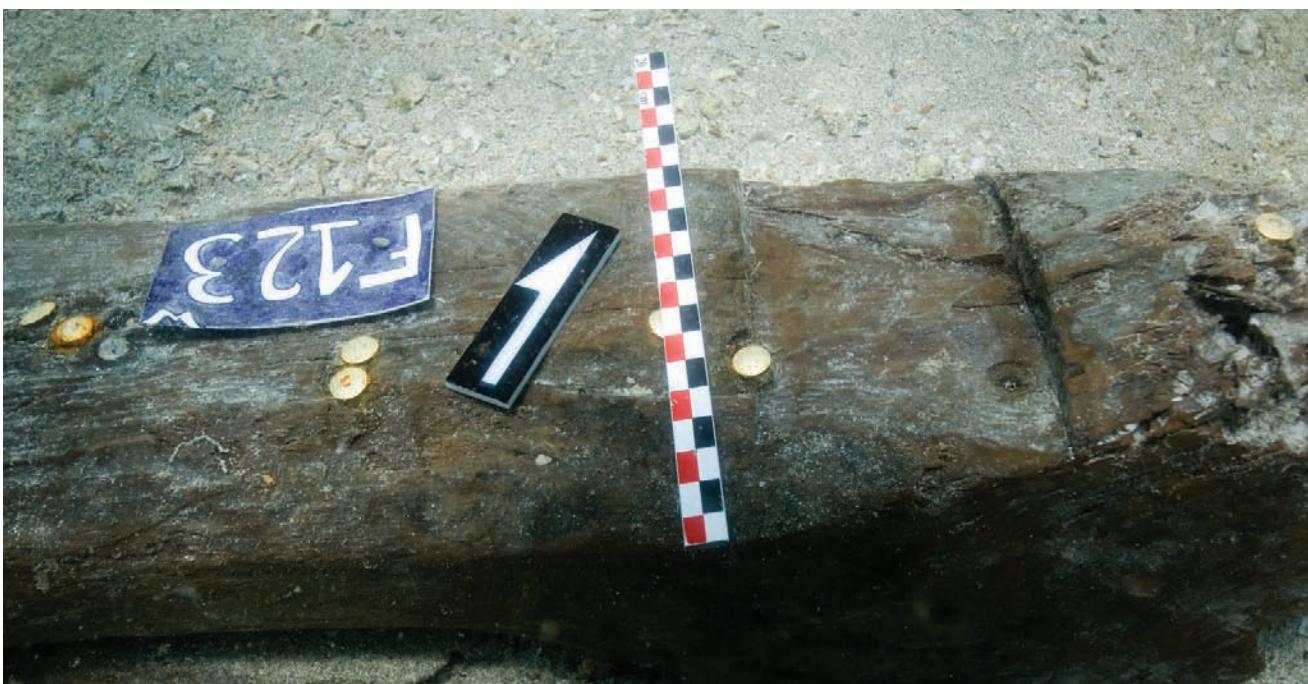
Fig. 68 Recesses for sister (bilge) keelson (photo: Ph. Groscaux).

It is, however, possible to notice on several frames in the ship's western section (F121W and F123W)<sup>42</sup> recesses with widths ranging from 7.5 to 8.5 cm and depths of 1 to 2 cm. These recesses were situated along the same axis, at the level of the joint between the first and second garboard planks (P1W and P2W), slightly closer to the second one (Fig. 68). It may be assumed that these are fittings for one of the bilge

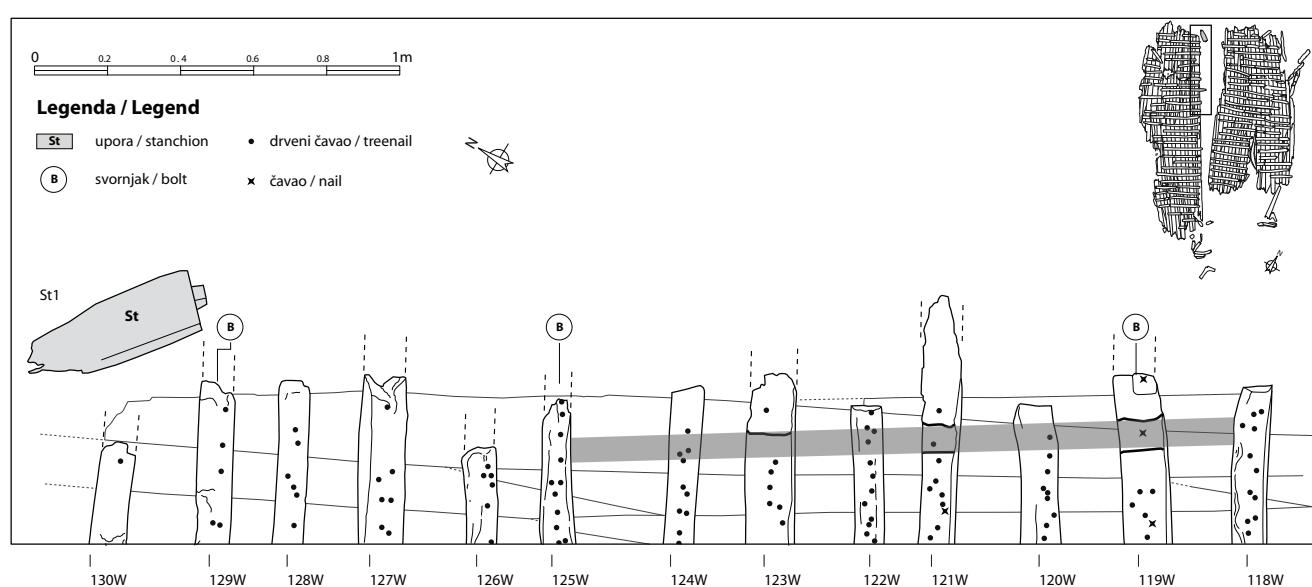
Fig. 69 Schematic representation of the preserved recesses for the western bilge keelson, and its hypothetical position (drawing: V. Dumas).

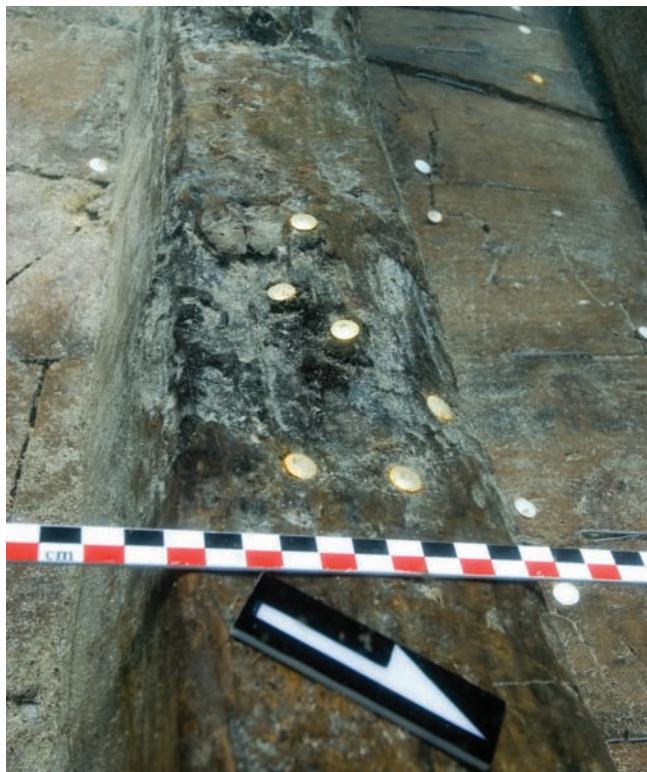
Fig. 70 Dark imprint on the upper surface of a frame (photo: Ph. Groscaux).

During the excavations, only two small pieces of ceiling planks were found (Fig. 47), but based on the numerous darker imprints and traces of joints observed on the frames (Fig. 70) it may be concluded that it covered almost the entire ship's bottom.<sup>45</sup>

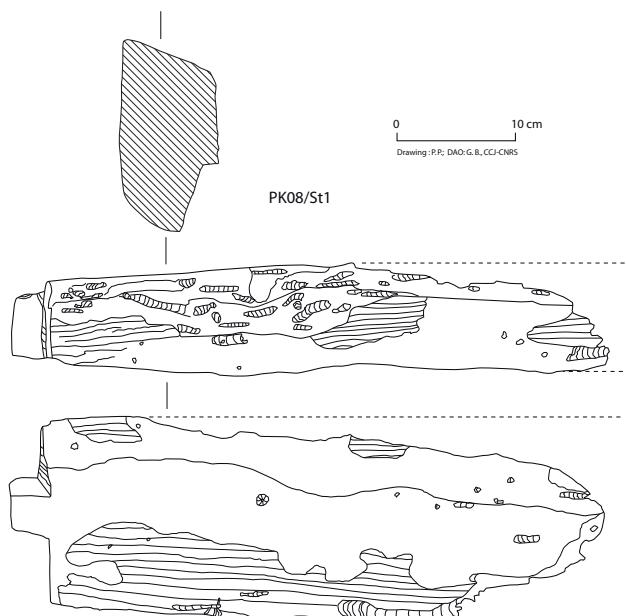
Fig. 71 Preserved fragment of stanchion St1 (drawing: G. Boetto).

During the 2008 excavation campaign, a worked wooden element was found in the northern part of the site, between two eastern sections of the hull. It was identified as the lower part of the stanchion (St1), (Fig. 46) that supported the deck beams on which the deck rested (Fig. 71, 73). This is an element of rectangular cross-section, measuring 14 x 7 cm, preserved to the height of 47 cm, which has a tenon on its base, 5 cm wide, 3 cm thick, and 3.5 cm high (Fig. 74). The tenon was set into a notch on the upper surface of the keelson or stringer.

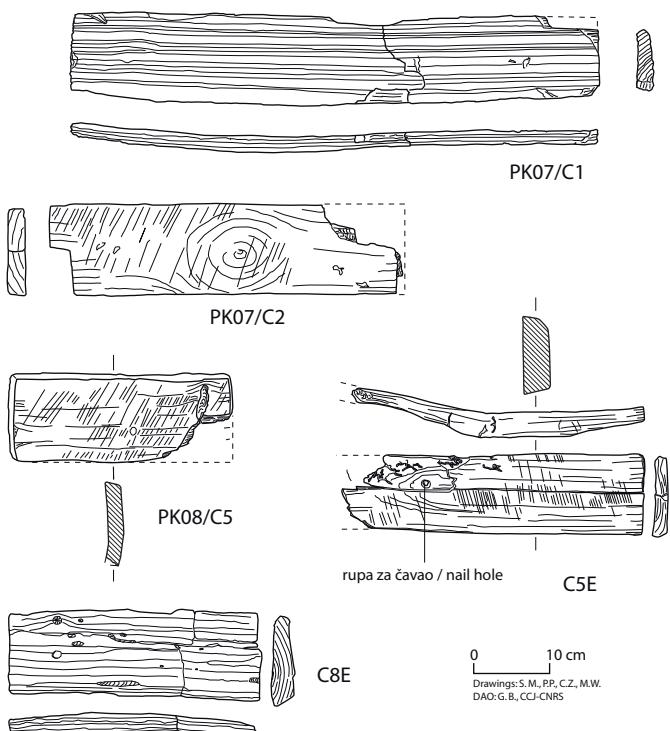
Sl. 72 Ulomci proveza i dasaka podnice (crtež: G. Boetto).  
Fig. 72 Fragments of stringers and limber boards (drawing: G. Boetto).

Moreover, six fragments of stringers were observed, although only two were still *in situ* (C4E and C5E), fastened to frames F122E and F125E (Fig. 71, Tab. 1). Fragment C3E was found between the southern end of the ship and the smaller floor-timber from the bow or stern area, shifted from its original position (Fig. 46 and 48). The next two fragments (PK08/C5 and PK08/C57) were found in the eastern, and only one (C5W) in the western section of the ship. The precise position of the last noted fragment is not known. The width of these fragments runs from 11 (C5E and PK08/C5) to 21 cm (C4E), and their average thickness is 3 cm. Traces of corrosion from metal nails or holes to hold treenails, used to fasten these elements to the frames, were observed on all examples.

Seven fragments were interpreted as the remains of movable limber boards (Tab. 1). These are small planks (from 17.6 to 70 cm in length) set between the bilge stringers and without fixed joints on the frames (Fig. 71). The edges of these planks (C4W and PK08/C61) were in some cases bevelled so that they could be better set between the fixed stringers. In

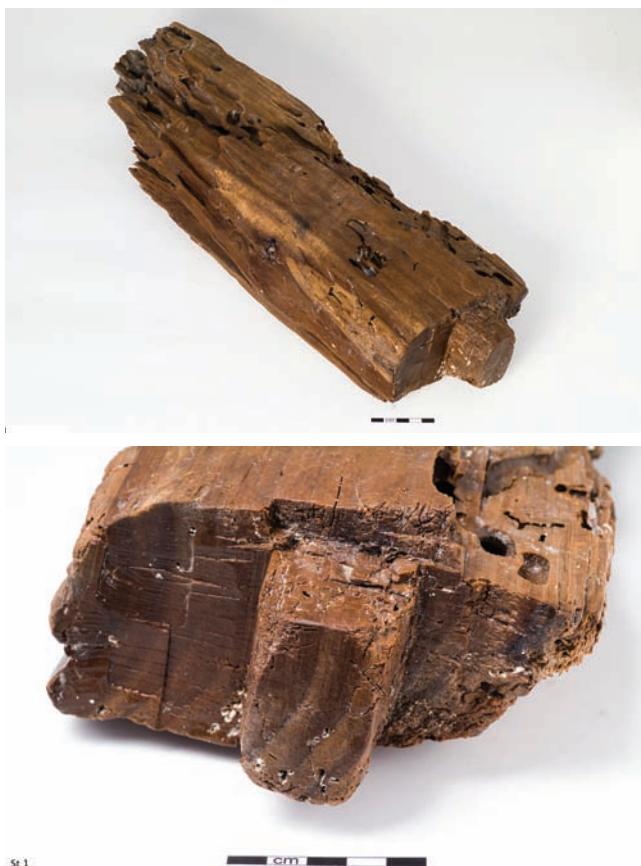
Sl. 73-74 Očuvani dio upore St1 (foto: Ph. Groscaux).  
Fig. 73-74 Preserved fragment of stanchion St1 (photo: Ph. Groscaux).

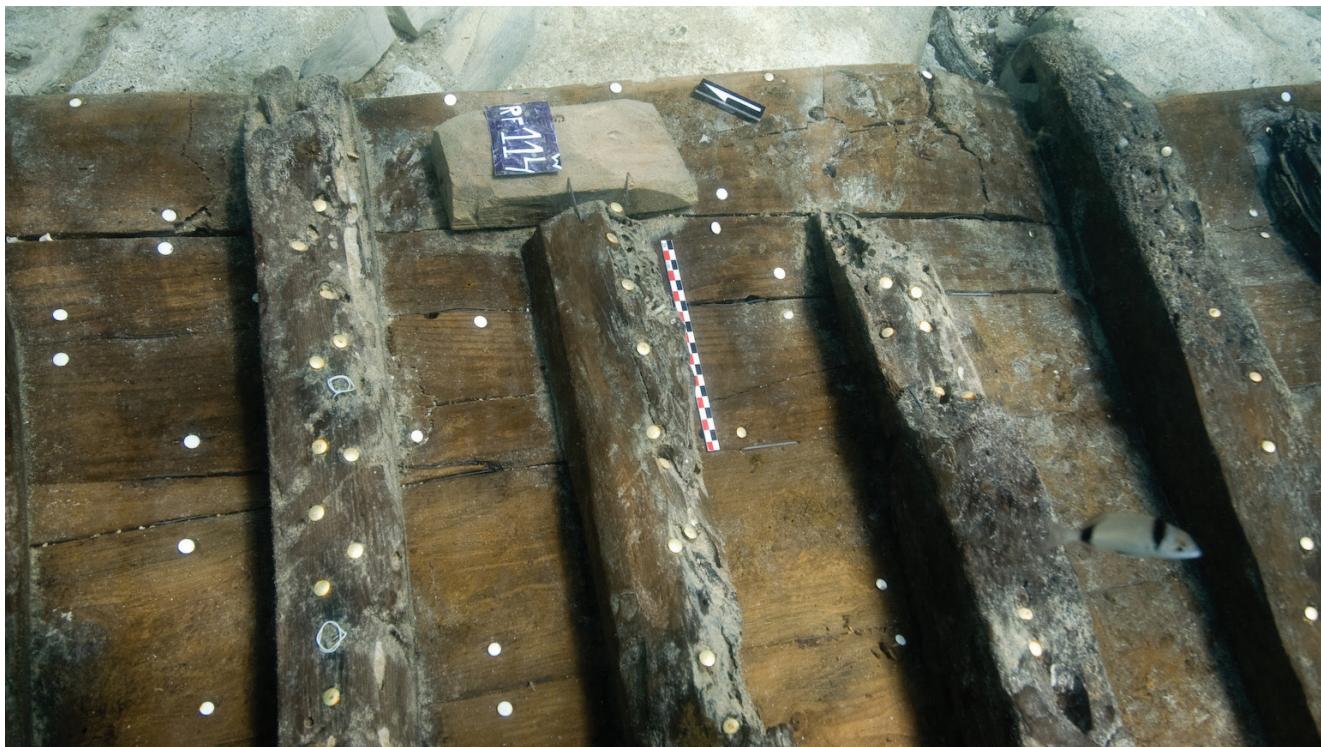
Sl. 75 Pogled s jugozapada na popravak rebra RF114W (foto: Ph. Groscaux).  
Fig. 75 View from the south-west of the frame repair RF114W (photo: Ph. Groscaux).

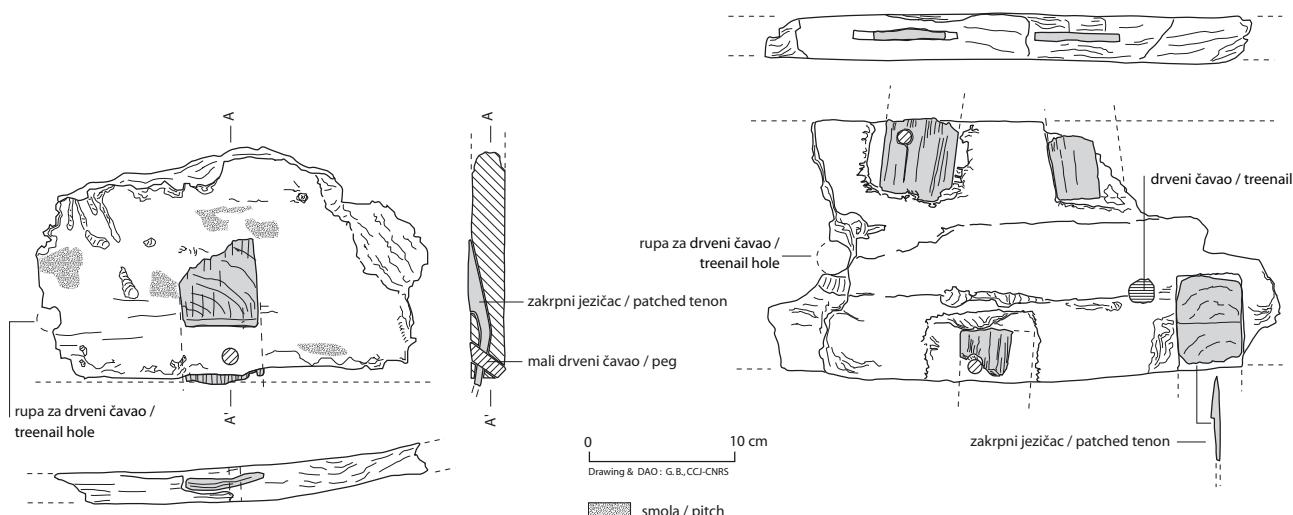
Fig. 76 Detached fragments of planks with patched tenons (drawing: G. Boetto).

Patched tenons, used to fasten repaired planks, were observed on the pieces of planks away from their original positions.<sup>46</sup> All of them were added to the exterior of the ship's hull, which explains the fact that the traces of such repairs were not observed *in situ* in its interior. Patched tenons, preserved at lengths of 6 to 9 cm, an average width of 4.8 cm and thickness of 0.75 cm, were inserted into replacement planks through rectangular mortises made on their external surface (Fig. 76, 77).

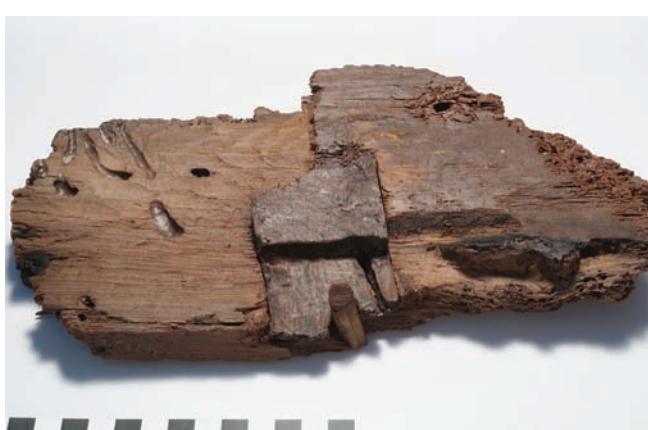
Fig. 77 Patch tenon (photo: Ph. Groscaux).
