## Hull structure

Giulia Boetto, Sabrina Marlier, Irena Radic Rossi

# PAKOŠTANE VELI ŠKOLJ

The Late Roman shipwreck in its geological-geographic  
and cultural-historical context

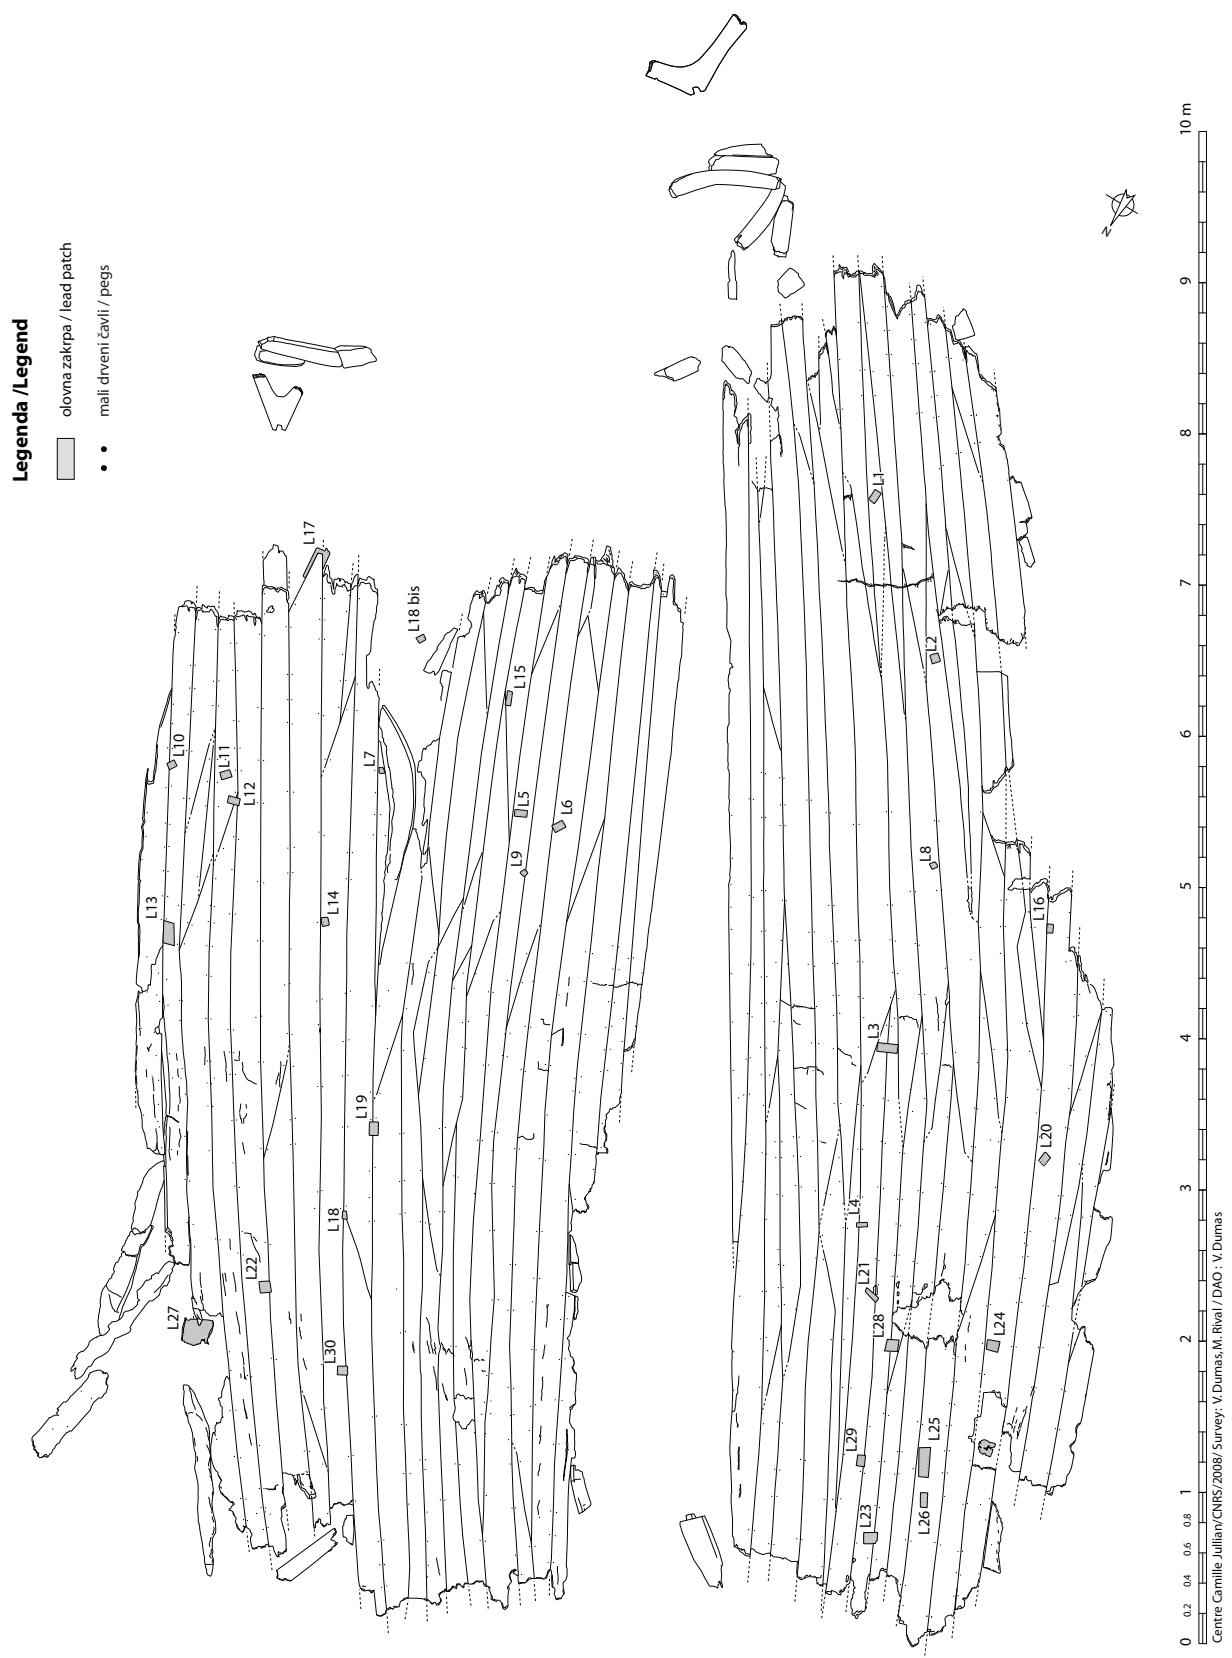
Fig. 78 Distribution plan of lead patches (M. Rival, V. Dumas).

Two bigger lead plates and 28 smaller patches, or their traces *in situ*, were recorded on the outside and inside of the hull (Tab. 2). Rectangular plate L17 (Ing. 25 cm, wid. 13 cm) was found in the ship's south-eastern section (Fig. 46, 48 and 78), below plank P28E, while plate L27 was in its north-eastern section, near wale fragment P46E (Fig. 46, 56, 78). The other aforementioned plate was bent into a U shape (Ing. 17 cm; wid. 15.5 cm; ht. 6.5 cm) so that it could rest more snugly against the wale. Both plates were attached to the wood by a row of small nails at their edges.

The lead patches of somewhat smaller dimensions are rectangular or square shaped. Their length runs from 5 (L7 and L10) to 18.5 cm (L25), while their width ranges from 3 (L4, L18) to 11 cm (L2). They were also attached to the wood by a series of small metal nails, from 1 to 3 cm high with the diameter of their heads ranging from 0.5 to 0.7 cm (Fig. 81, 82). It should be noted that most of the patches were below some part of the frames (Tab. 2), which would mean that they

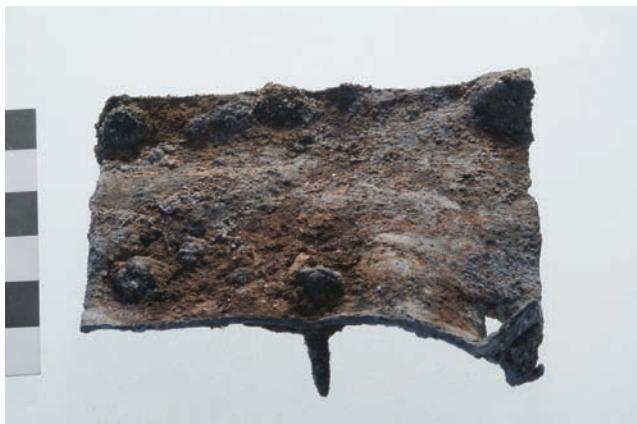
Fig. 79 Example of lead patch (PK07/03), fixed with small metal nails (photo: Ph. Groscaux).

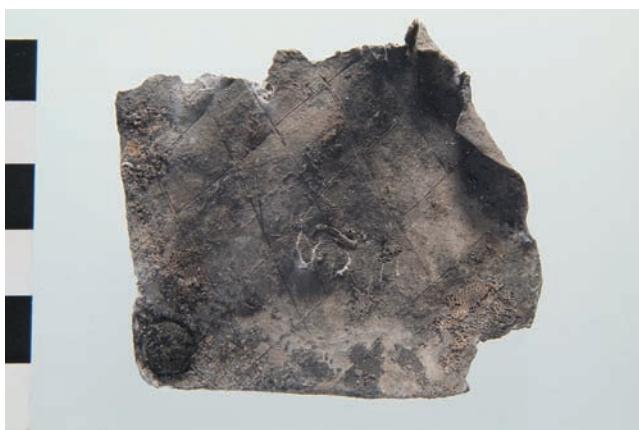
Fig. 80 Fragment of lead patch (PK07/06), with the inner surface incised with a crosshatched pattern (photo: Ph. Groscaux).

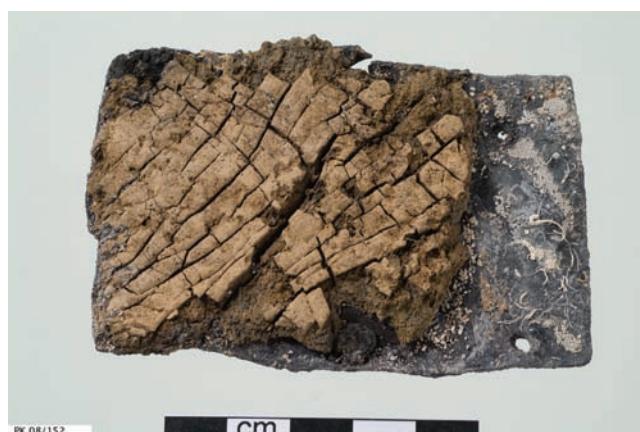
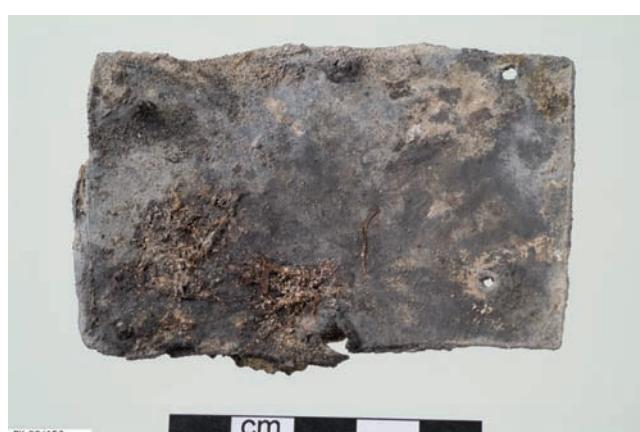
Sl. 81 Zakrpna olovna pločica PK08/152: a) sloj smole na vanjskoj strani pločice; b) unutrašnja strana pločice (u kontaktu s drvom), (photo: Ph. Groscaux; drawing: N. Lete).

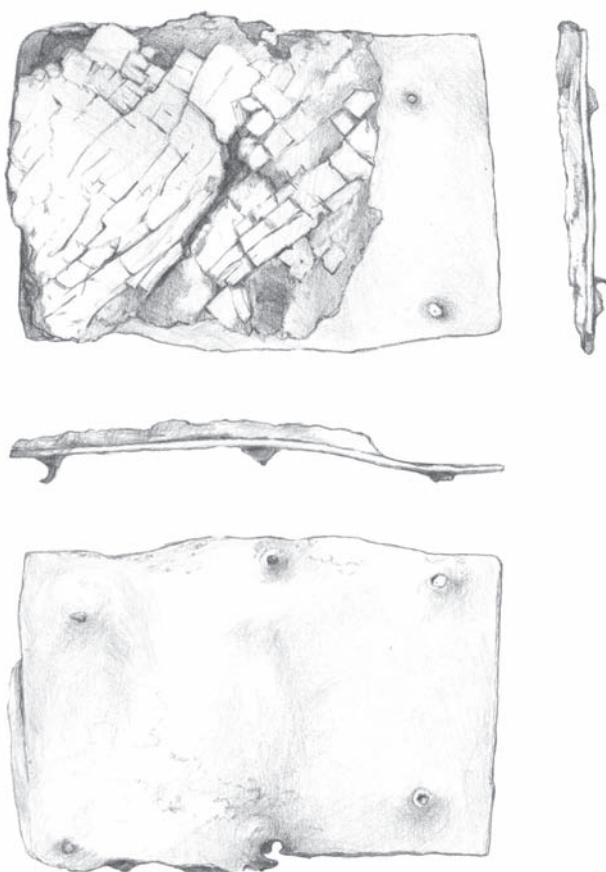
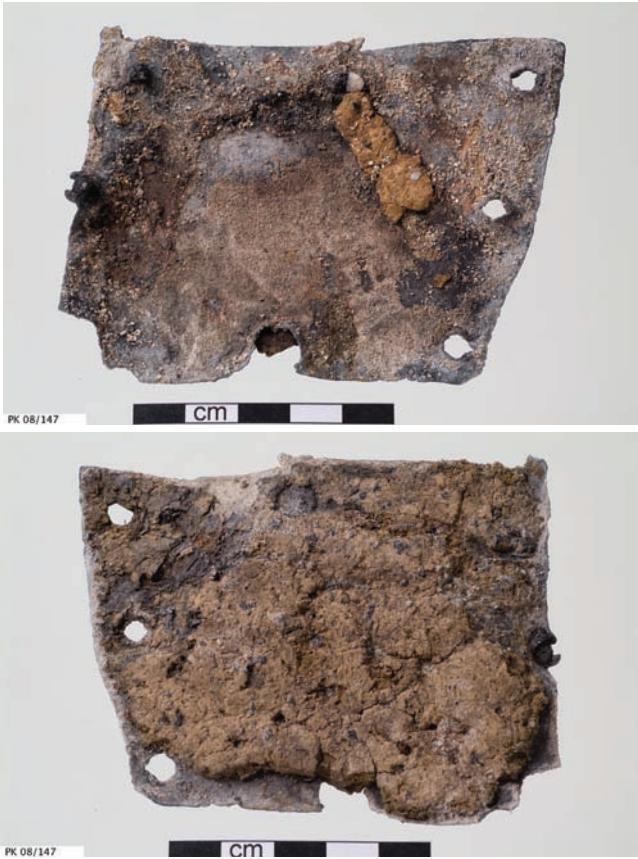
Fig. 82 Lead patch PK08/147 (photo: Ph. Groscaux).

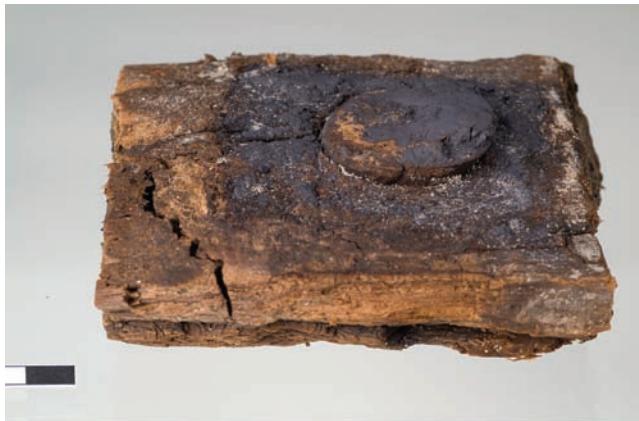
Fig. 83 Sampled part of planking with natural knot, under lead patch L24 (photo: Ph. Groscaux).

Based on the removal and analysis of sample L24 (of which only a greyish trace of the original lead patch remains, it may be said that the original patch measured 7.2 x 6.5 cm. It was determined that the knot in the wood was at the level of the mortise made on plank P15W (Fig. 83, 85). The knot, which had a tendency to move inward on the planking, caused the plank to crack. In order to avoid additional weakening of the planking and, most importantly, prevent leakage at this point, the shipwright solved the situation with a repair.

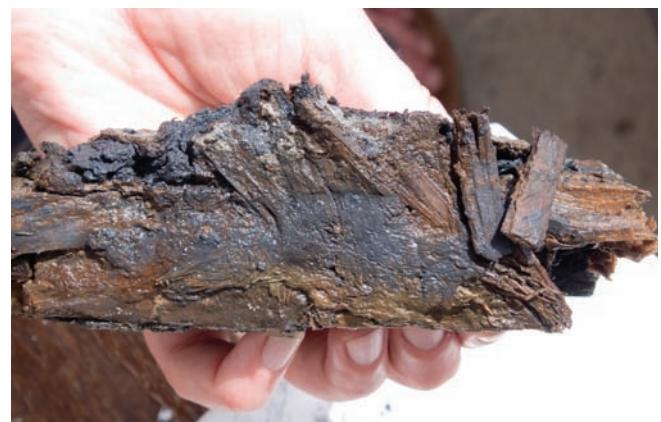
Fig. 84 Sample of planking under lead patch L29; wood shavings used to fill the gap around the knot (photo: Ph. Groscaux).

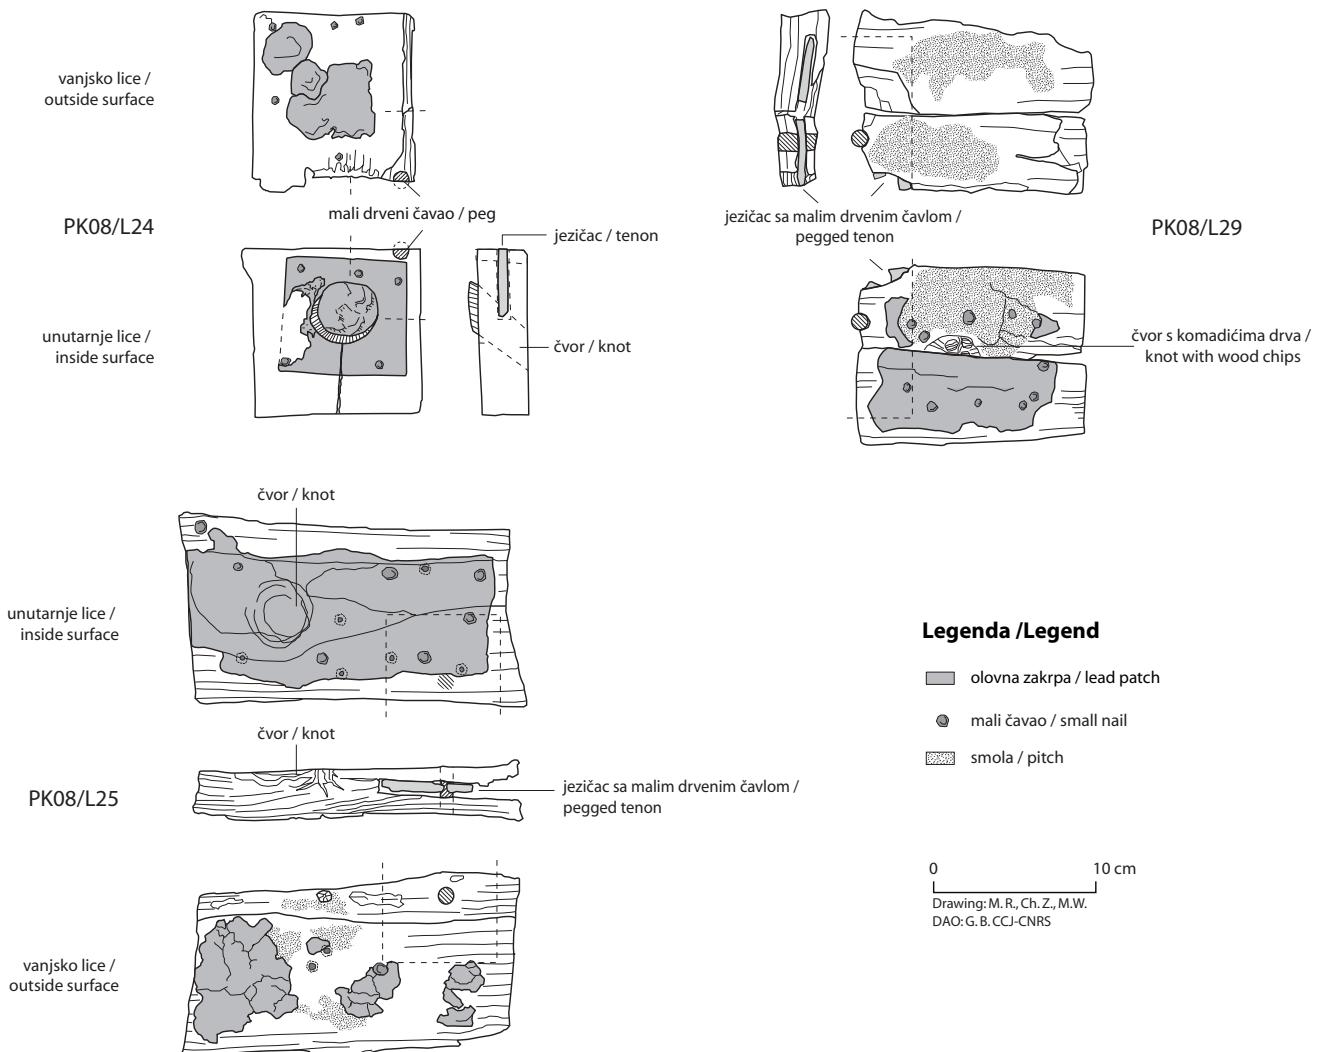
Fig. 85 Lead patches L24, L29 and L25 (drawing: G. Boetto).

With the aim of gaining greater insight into this type of repair, patches L24, L25 and L29 were removed from the sea in 2008, together with the wooden parts of the ship to which
