## Hull structure

Giulia Boetto, Sabrina Marlier, Irena Radic Rossi

The Late Roman shipwreck in its geological-geographic  
and cultural-historical context

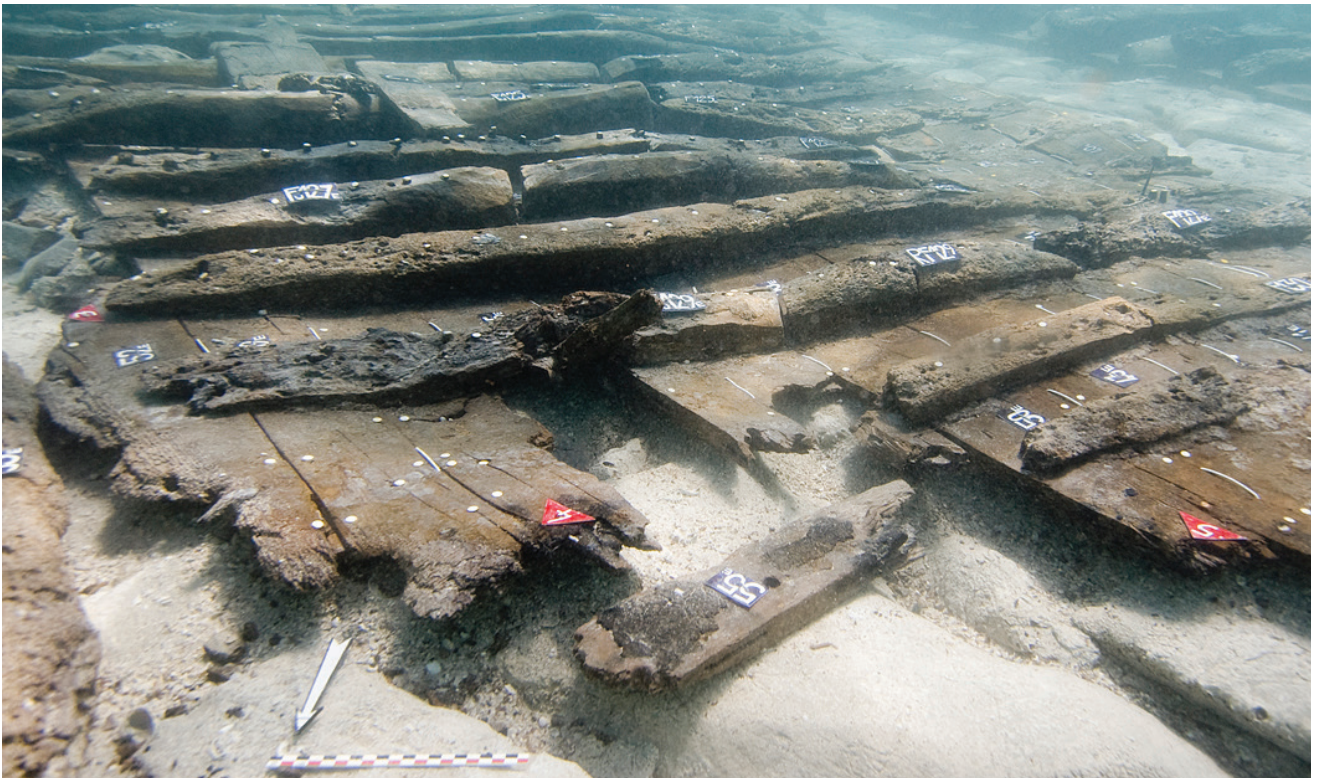
Fig. 49 Frames damaged by shipworms in the north-eastern area (photo: Ph. Groscaux).

shipworms (*Teredo navalis*), (Fig. 49). The planks were also rather damaged, so, for example, the northern end of plank P45E was found jutting from the bottom and bent at a 45° angle. Additionally, cracks were recorded at a number of places on the planking, and by far the majority was noted in the western section of the ship, between the floor timbers and futtocks which correspond to frames F123W and F125W (Fig. 50), and in the eastern section at the end of frame F127E.

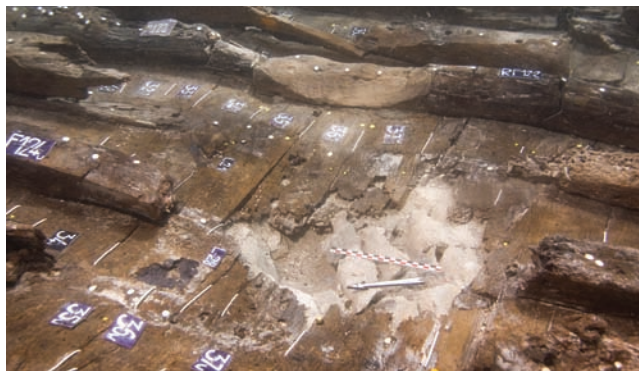
Fig. 50 Hole in planking, between the frames and futtocks, at the level of frames F123W and F125W (photo: Ph. Groscaux).

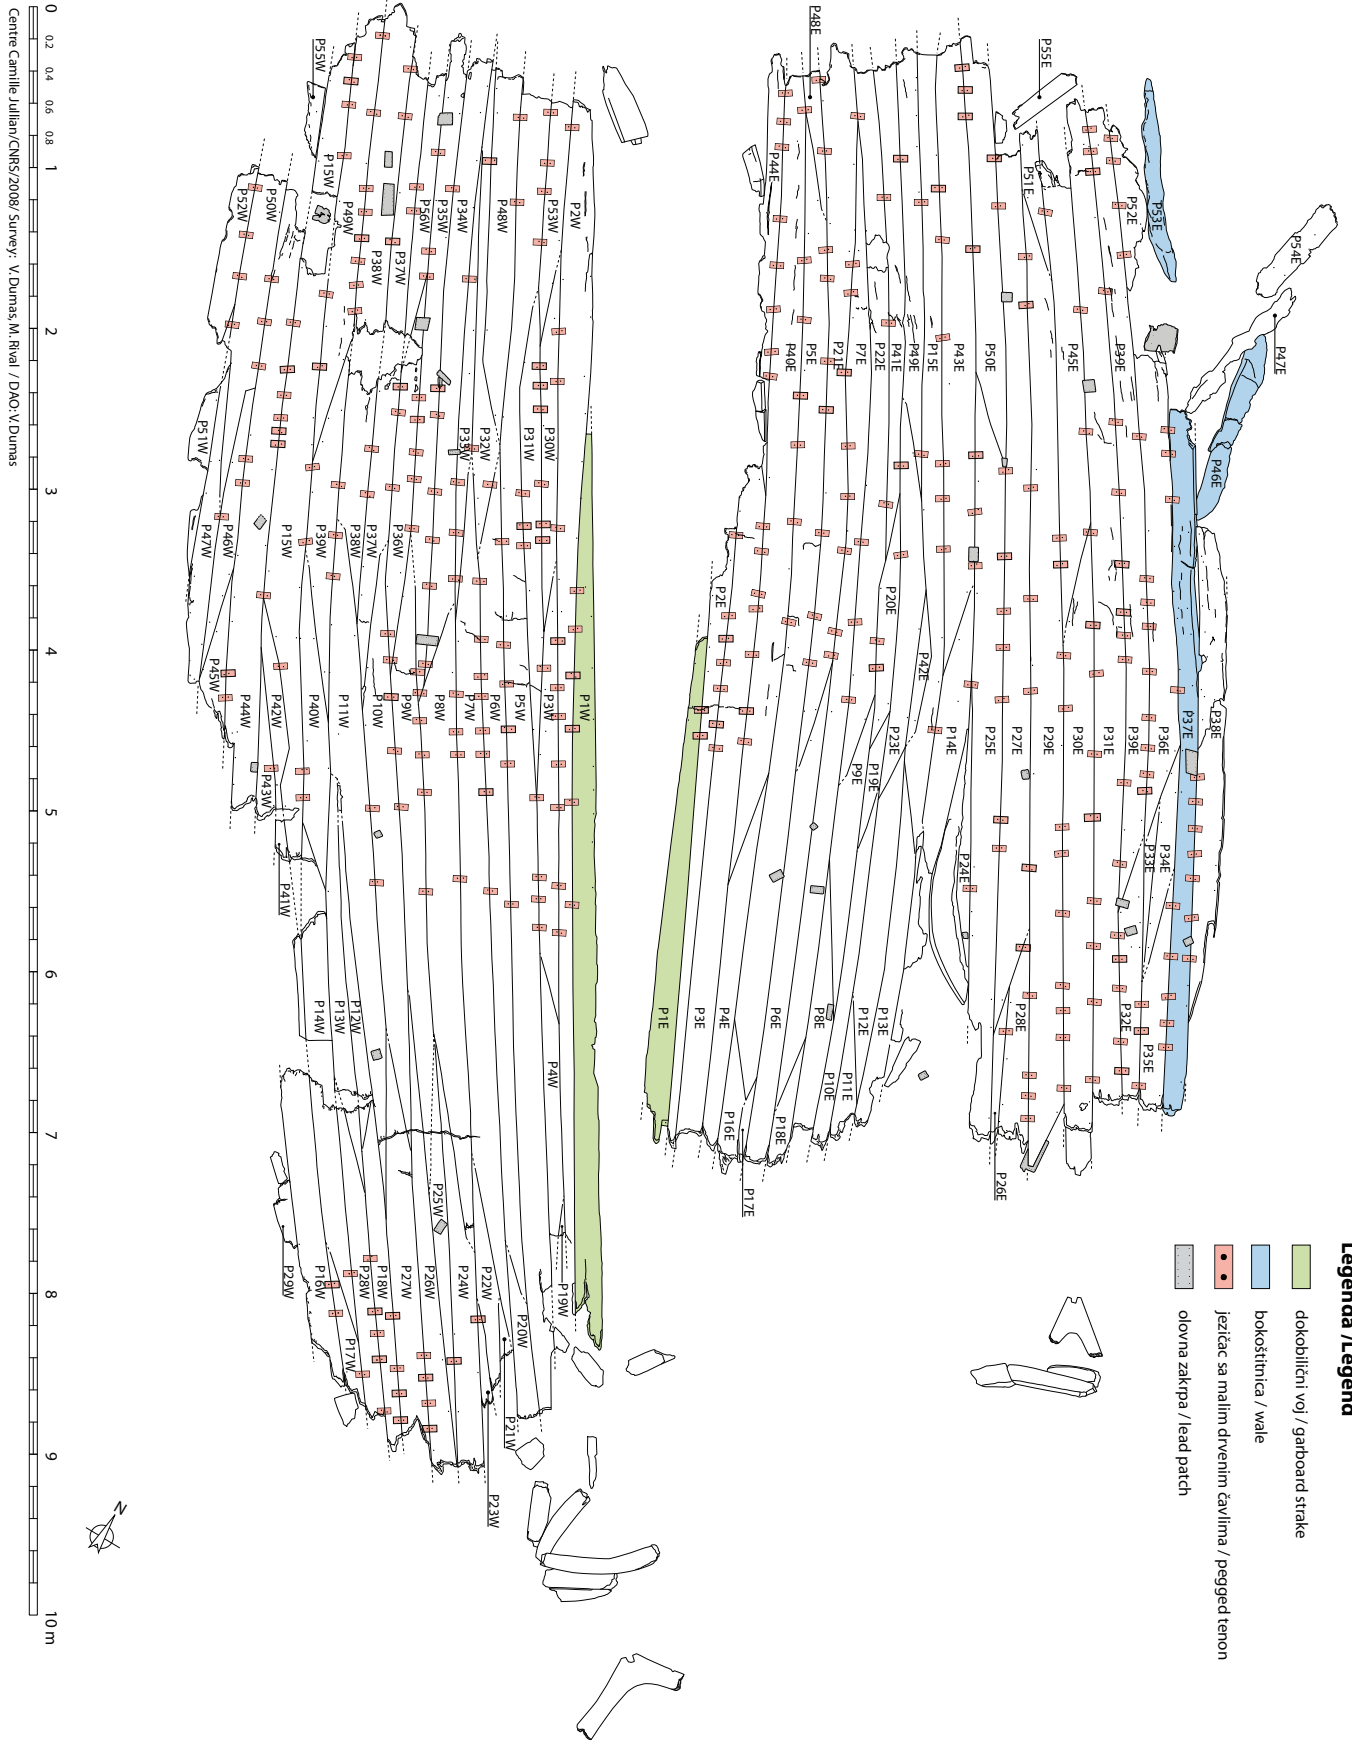
Fig. 51 Schematic of the planking (M. Rival, V. Dumas).

All along the eastern perimeter of the ship's hull, traces of the lower wale were noticed which belonged to three pieces designated P37E, P46E and P53E (Fig. 51). Element P37E is 15 cm wide and 8.3 cm thick (Fig. 55). Element P46E, overturned and shifted from its original location, has been preserved at a length of 1.28 m. This wale fragment, 13.5 cm wide and 10.2 cm thick, bears traces of protective lining made of a piece of lead sheet on its external face, probably installed during one of the many repairs. The lead sheeting was fastened with small copper nails, of which two heads can still be seen 77.5 cm apart from one another. The sheet metal plate L27, found north of plank P36E, near the aforementioned P46E, probably served to repair a part of the wale<sup>27</sup> (Fig. 56). As to traces of shipbuilders' tools used to make the elements

The planks of the planking were connected by mortise and tenon joints. Most of the tenons were fastened by small wooden pegs, but along the edge of garboard plank P1W (toward the keel), at the level of frames F118W and F123W, few unfastened tenons were also noticed. It would appear that this was an oversight on the part of the shipbuilders, rather than some specific purpose. The system of mortises on both sides of the plank was conceived according to a scheme (alternating the joints from one side and the other of the keel) that would cause the least possible weakening of the wood (Fig. 51).

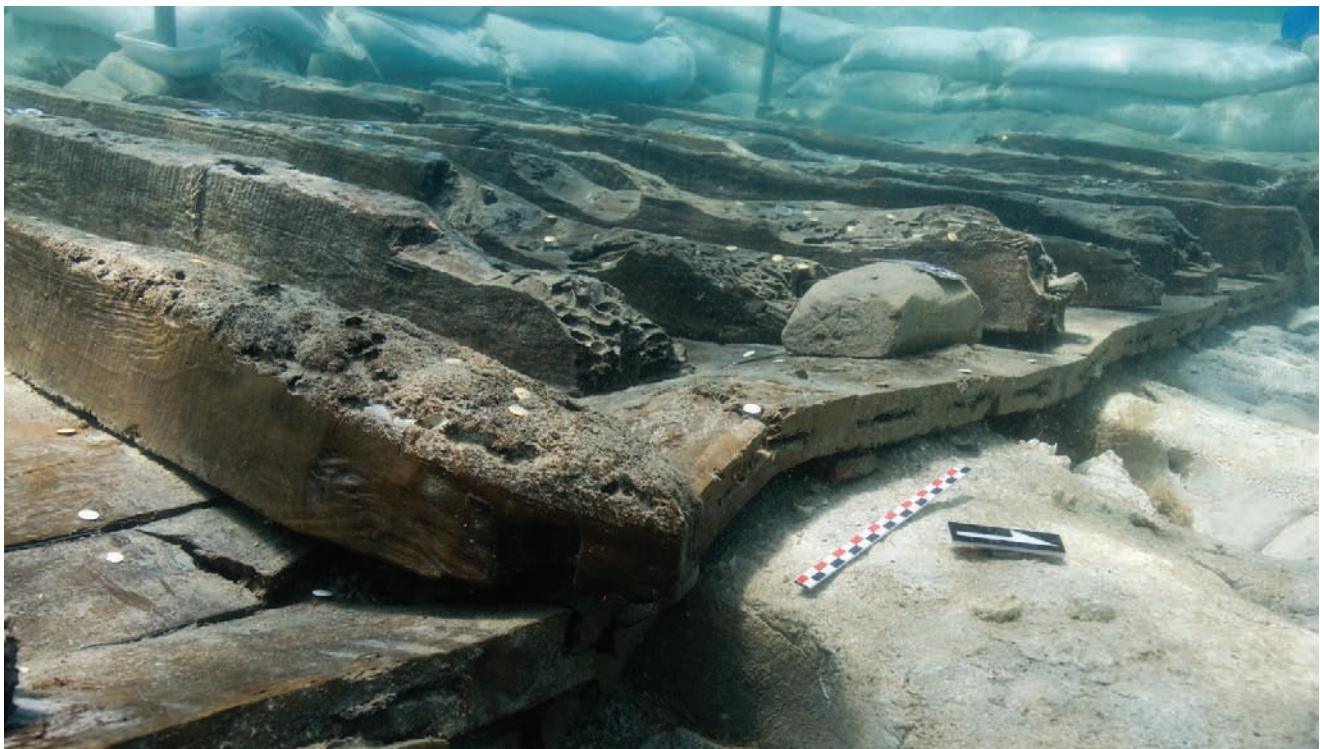
Sl. 52 Pogled s jugoistoka na dokobiličnu platicu P1W (foto: Ph. Groscaux).  
Fig. 52 View of the garboard P1W from the south-east (photo: Ph. Groscaux).

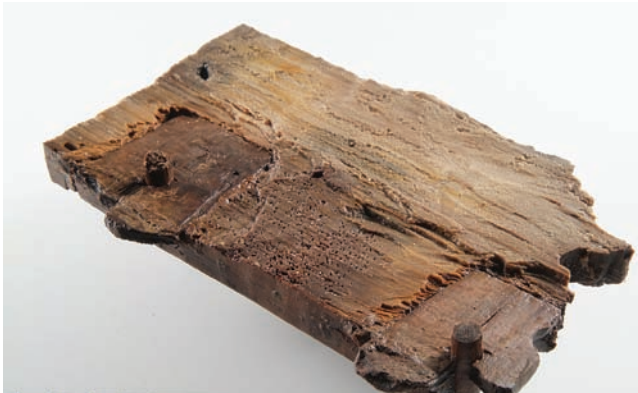
Sl. 53 Detalj spajanja platica na dislociranom ulomku platice PK07/P11 (foto: Ph. Groscaux).  
Fig. 53 Internal assemblage of the planking, on dislocated plank fragment PK07/P11 (photo: Ph. Groscaux).

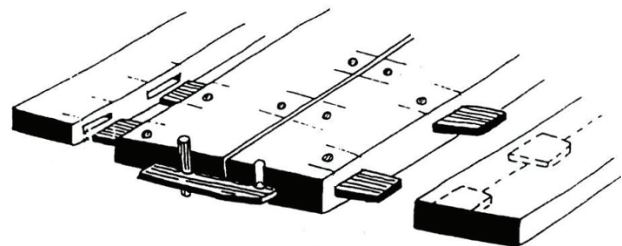
Sl. 54 Shematski prikaz spajanja platica sistemom utora i jezičaca (iz Pomey, Rieth 2005).  
Fig. 54 Schematic representation of planks with mortise and tenon joints (after Pomey, Rieth 2005).

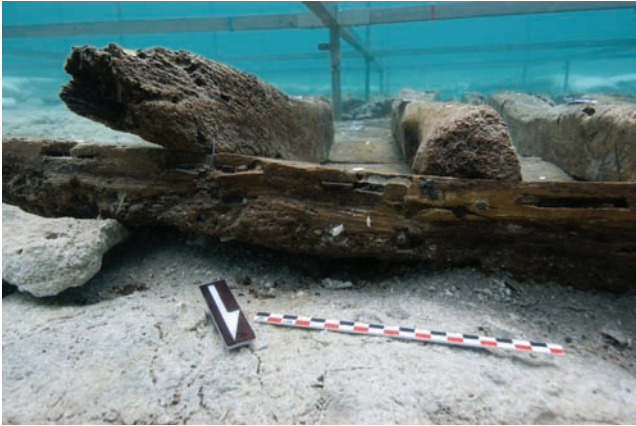
Fig. 55 View of wale P37E and plank P38E from the north-east (photo: Ph. Groscaux).

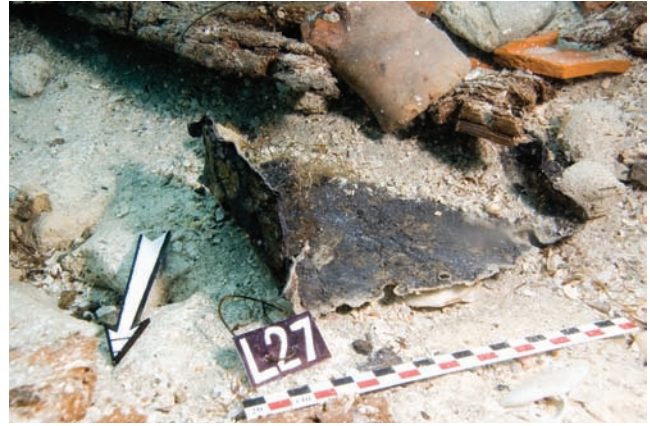
Fig. 56 View of lead plate L27 used to repair the hull, from the north-east (photo: Ph. Groscaux).

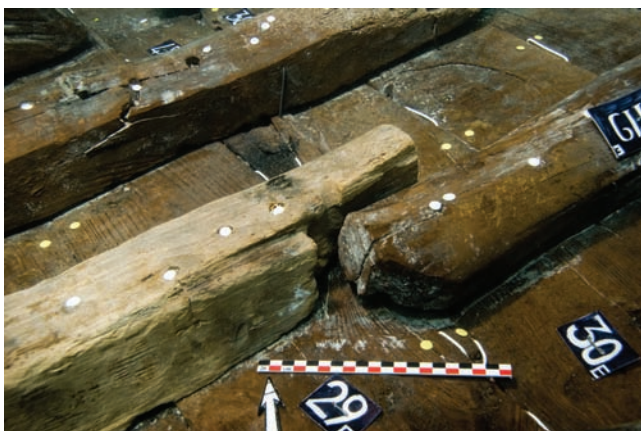
Fig. 58 View of the recess fitting between the two parts of frame F119E, from the north-west (photo: Ph. Groscaux).

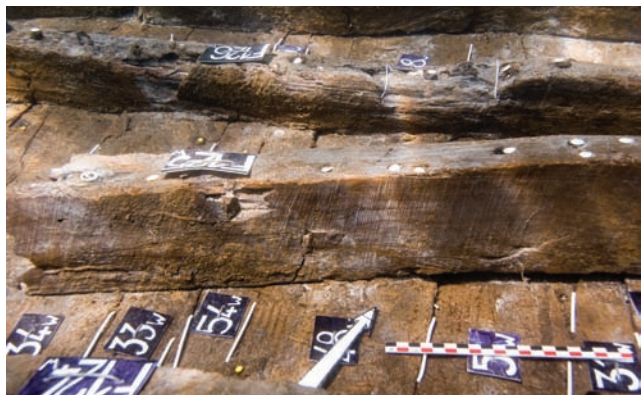
Fig. 60 Sawing marks on the side of the frame (photo: Ph. Groscaux).

All of the frames have a rectangular cross-section, and in some cases the upper edges are rounded. The average width of the frames is 9.4 cm (from 7 to 14 cm), while the average height is 9.8 cm (from 5 to 14 cm), (Fig. 47). Traces of a saw and hatchet were observed on the lateral sides of almost all transversal elements (Fig. 60).

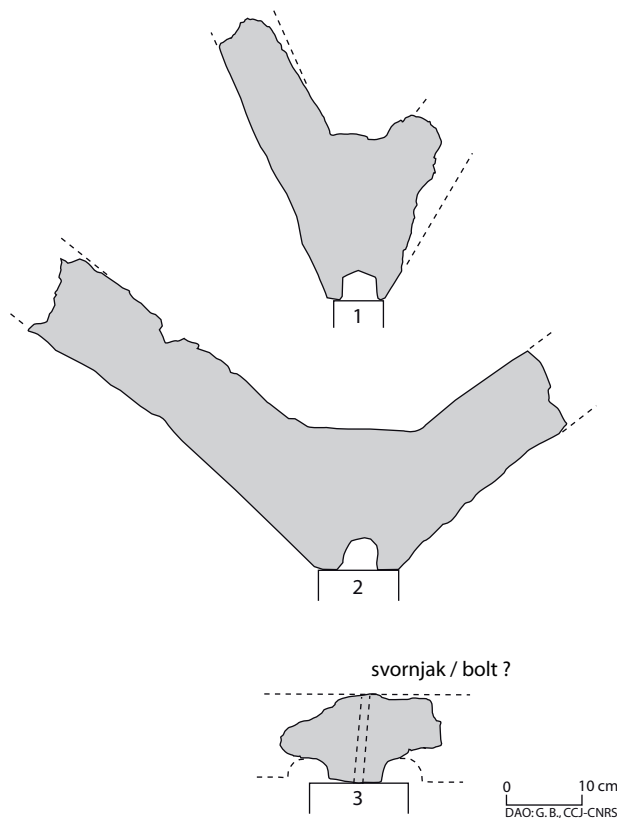
Fig. 59 The limber holes on the floor-timbers from bow or stern, and on the fragment of floor-timber PK07/F2 (drawing: G. Boetto).

The floor timbers have rectangular limber holes (wid. 4-5 cm and ht. 2-3.5 cm on the floor timbers; wid. 5 cm and ht. 4 cm on floor-timbers from the bow or stern area), which facilitated the flow of water<sup>38</sup> into the bilge. In the ship's central section, two holes situated on each side of the keel were made on the floor-timbers and half-frames (Fig. 59.3, 61), while there is only a single hole, directly above the keel, on the floor-timbers from the bow or stern area (Fig. 59.1-2).

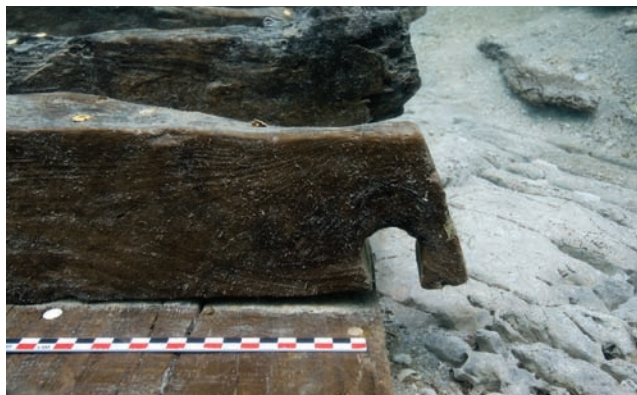
Fig. 61 View of the extremity of half frame F112W, from the south-east (photo: Ph. Groscaux).

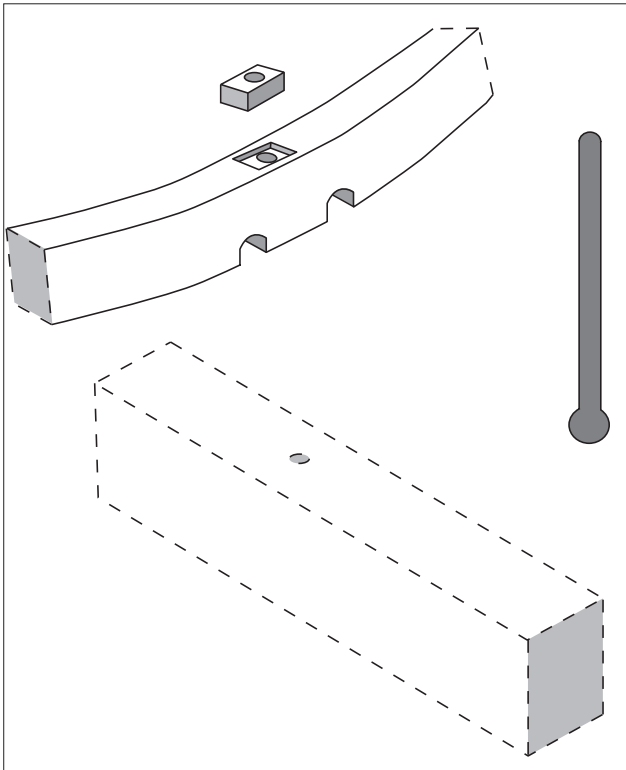
Fig. 62 Schematic representation of bolting the floor-timbers to the keel (drawing: G. Boetto).

Several floor timbers<sup>39</sup> were fastened to the keel with metal bolts. Such a connection was thoroughly studied on floor timber F119W. A bolt with 1.9 cm diameter was inserted from the external side of the keel, and it was fastened from the upper side of the floor timber with the help of a square plate that rested in a square hole with dimensions of 4.7 x 4.7 x 1 cm (Fig. 62-65). Such a detail was noted, for example, on a shipwreck from Monaco (end of 2<sup>nd</sup>/mid-3<sup>rd</sup> cent. AD; Mouchot 1968-1969). There is also a similar connection to the keel between two limber holes on a floor timber piece found away from its original position and marked as PK07/F2 (Fig. 57.3).<sup>40</sup> In this case, the bolt's diameter was 1.7 cm.

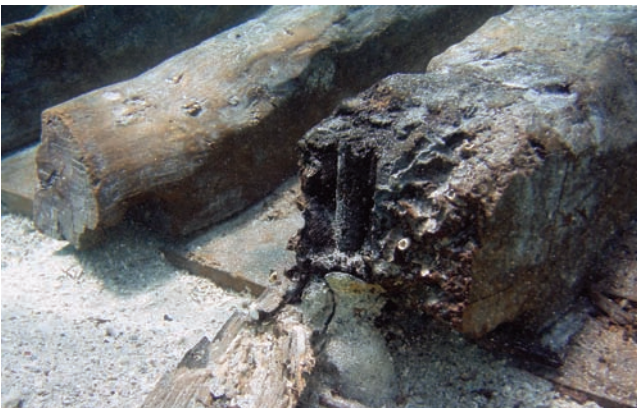
Fig. 64 Broken extremity of floor-timber F119W with the corroded bolt *in situ* (photo: Ph. Groscaux).

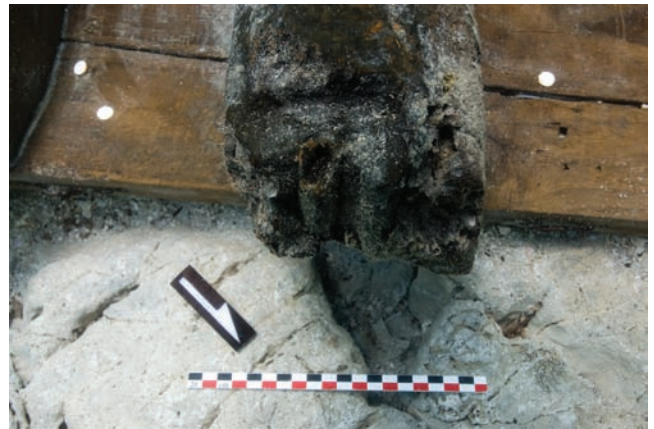
Fig. 63 Quadrangular recess on the upper surface of the floor-timber F119W (photo: Ph. Groscaux).

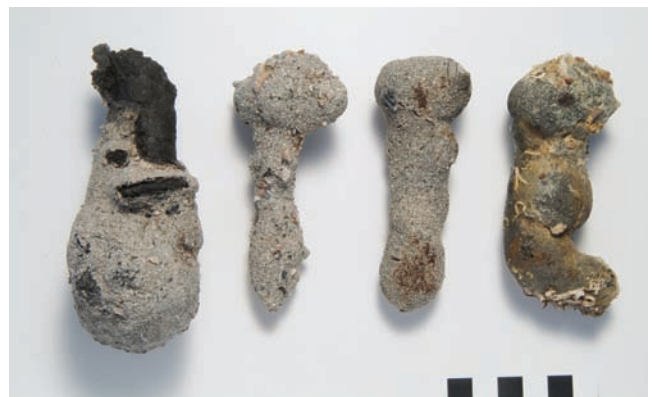
Fig. 65 Bolt remains (photo: Ph. Groscaux).

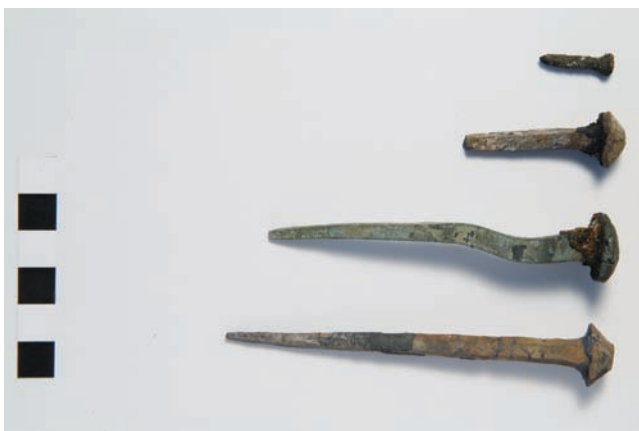
Fig. 66 Nails of various sizes, used for building and repairing the hull (photo: Ph. Groscaux).

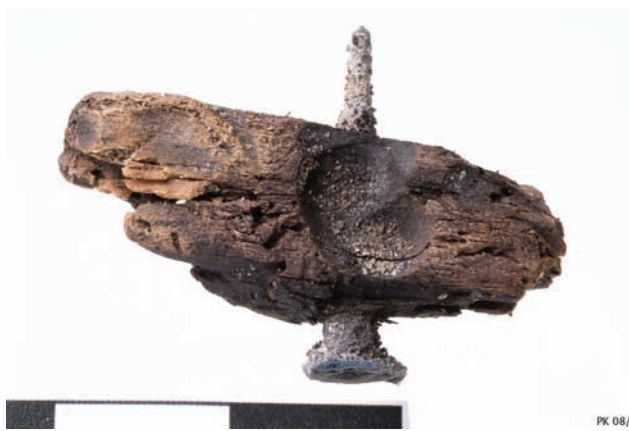
Fig. 67 Metal nail in a fragment of wood (photo: Ph. Groscaux).

The joints connecting the frames to the planking were rendered with the help of treenails having an average diameter of 1.3 cm (from 0.7 to 1.9 cm, measured from the inside of the ship) and copper and iron nails<sup>41</sup> inserted from the ship's exterior (Fig. 65, 67). On the upper sides of the frames, the tops of nails were not clenched for greater reinforcement. It is noteworthy that in some places the wooden nails are exceptionally numerous (up to roughly forty on the parts of frames longer than 2 m), which very likely may be linked to hull repairs (Fig. 47).

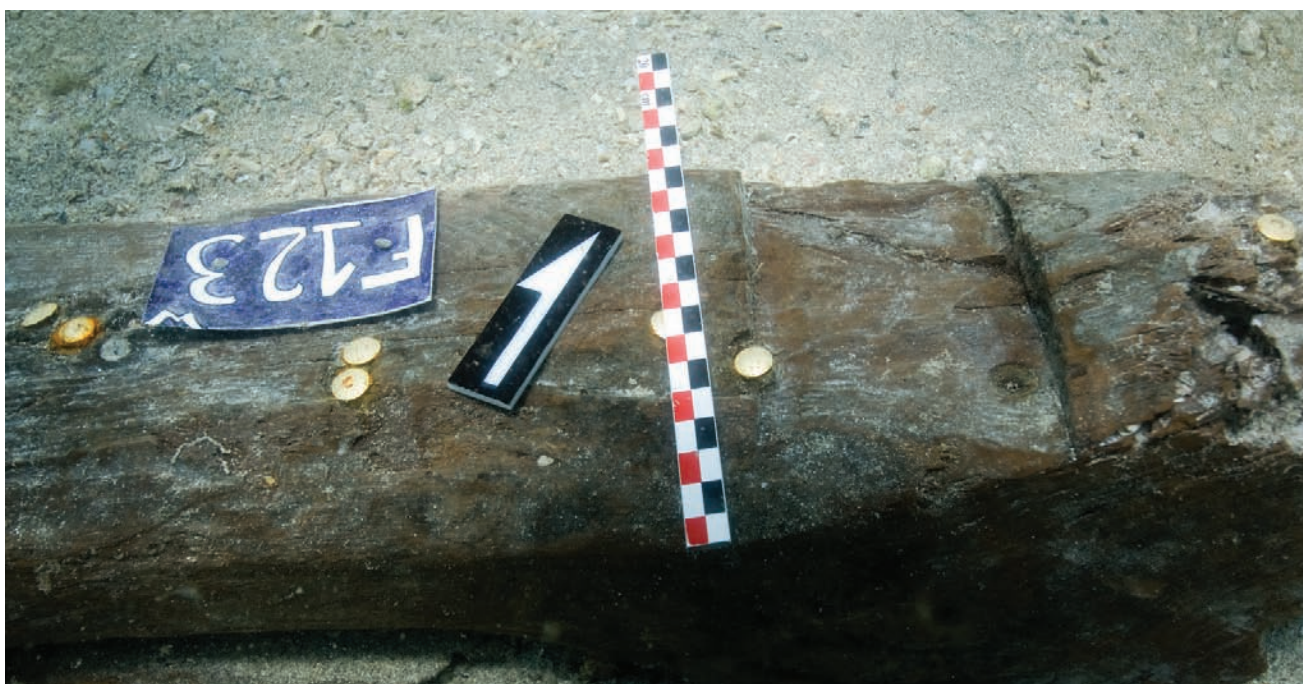
Fig. 68 Recesses for sister (bilge) keelson (photo: Ph. Groscaux).

It is, however, possible to notice on several frames in the ship's western section (F121W and F123W)<sup>42</sup> recesses with widths ranging from 7.5 to 8.5 cm and depths of 1 to 2 cm. These recesses were situated along the same axis, at the level of the joint between the first and second garboard planks (P1W and P2W), slightly closer to the second one (Fig. 68). It may be assumed that these are fittings for one of the bilge

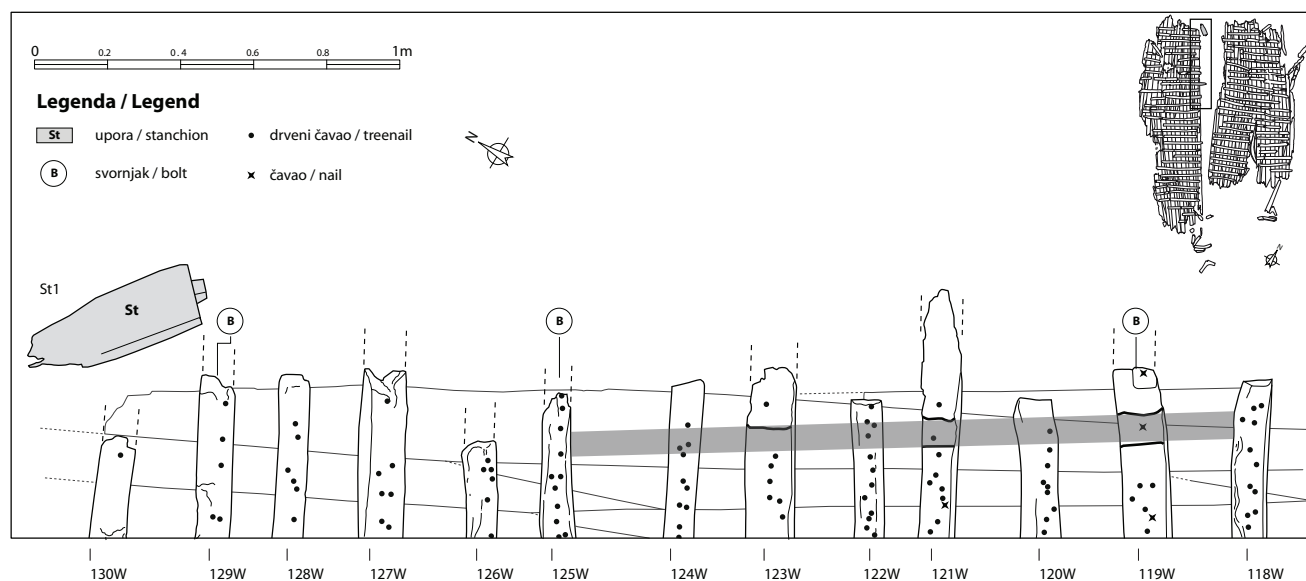
Fig. 69 Schematic representation of the preserved recesses for the western bilge keelson, and its hypothetical position (drawing: V. Dumas).

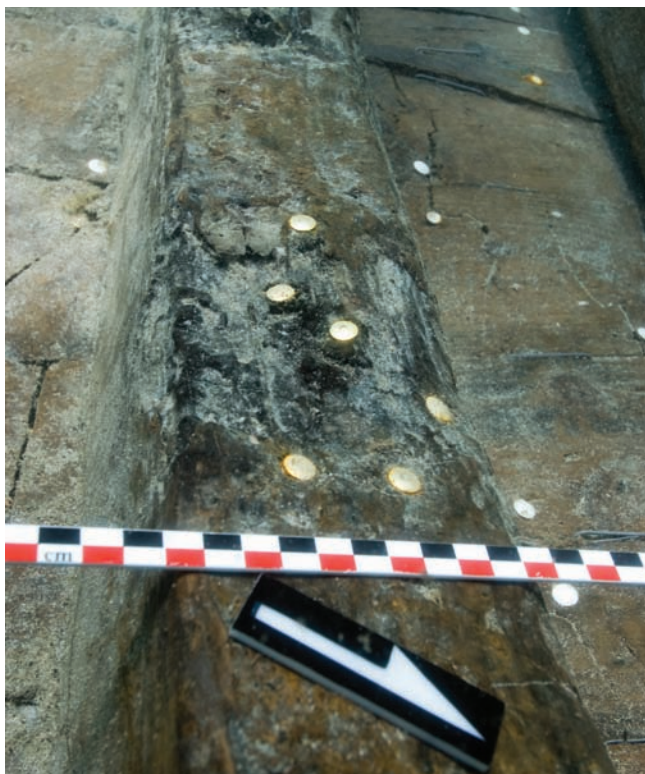
Fig. 70 Dark imprint on the upper surface of a frame (photo: Ph. Groscaux).

During the excavations, only two small pieces of ceiling planks were found (Fig. 47), but based on the numerous darker imprints and traces of joints observed on the frames (Fig. 70) it may be concluded that it covered almost the entire ship's bottom.<sup>45</sup>

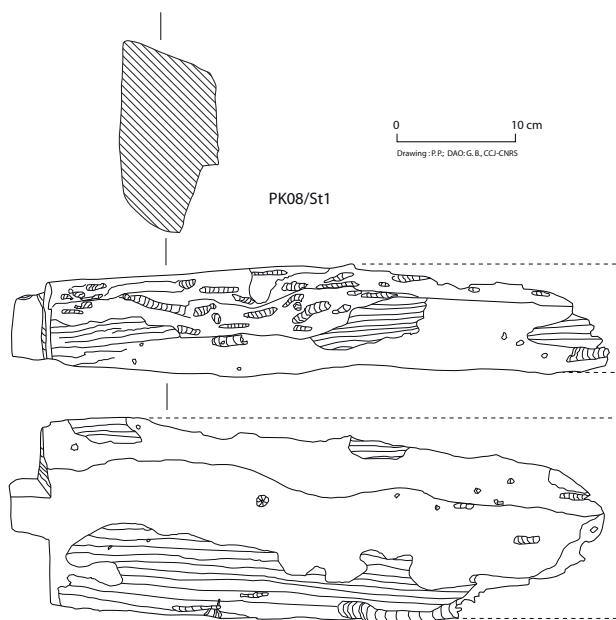
Fig. 71 Preserved fragment of stanchion St1 (drawing: G. Boetto).

During the 2008 excavation campaign, a worked wooden element was found in the northern part of the site, between two eastern sections of the hull. It was identified as the lower part of the stanchion (St1), (Fig. 46) that supported the deck beams on which the deck rested (Fig. 71, 73). This is an element of rectangular cross-section, measuring 14 x 7 cm, preserved to the height of 47 cm, which has a tenon on its base, 5 cm wide, 3 cm thick, and 3.5 cm high (Fig. 74). The tenon was set into a notch on the upper surface of the keelson or stringer.

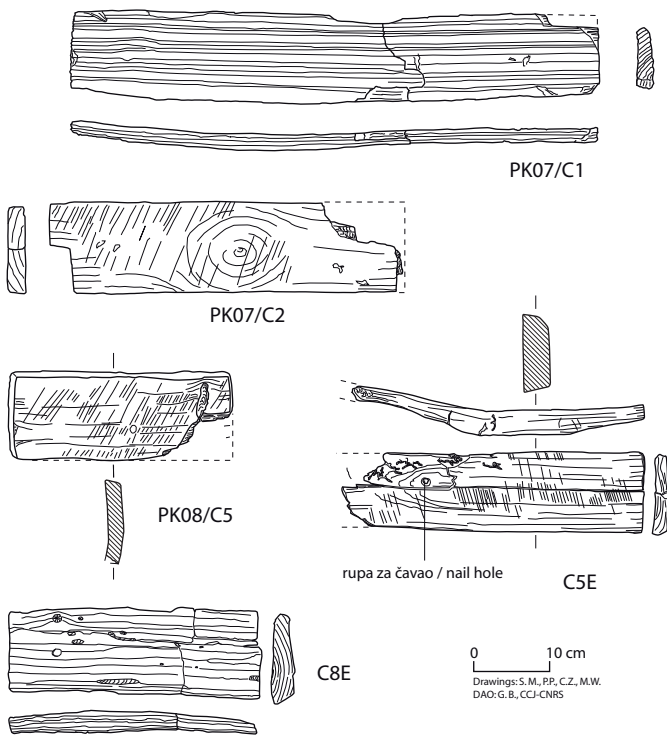
Sl. 72 Ulomci proveza i dasaka podnice (crtež: G. Boetto).  
 Fig. 72 Fragments of stringers and limber boards (drawing: G. Boetto).

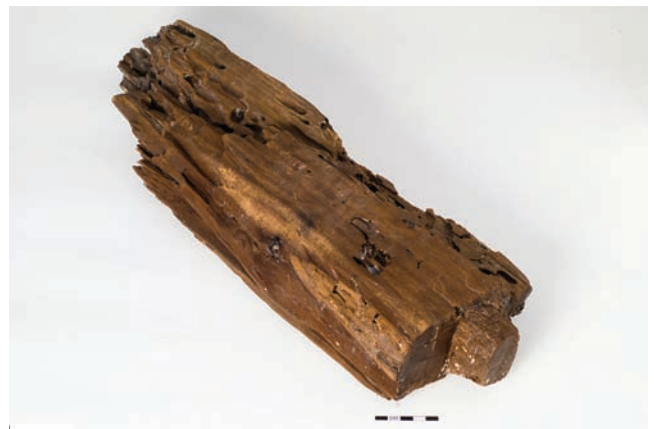
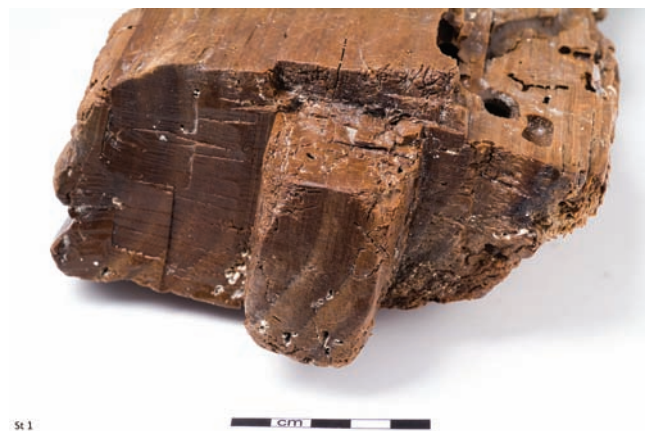
Sl. 73-74 Očuvani dio upore St1 (foto: Ph. Groscaux).  
 Fig. 73-74 Preserved fragment of stanchion St1 (photo: Ph. Groscaux).

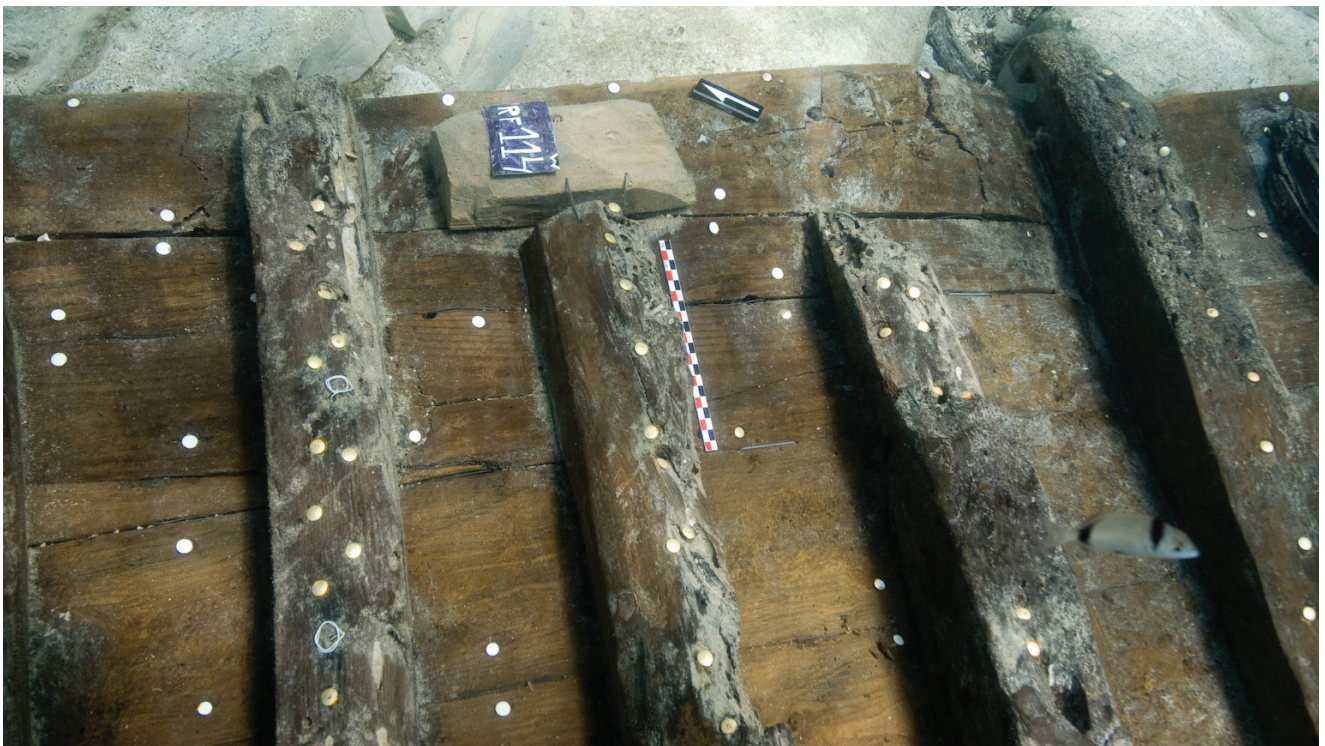
Sl. 75 Pogled s jugozapada na popravak rebra RF114W (foto: Ph. Groscaux).  
 Fig. 75 View from the south-west of the frame repair RF114W (photo: Ph. Groscaux).

Based on many elements (arrangement of the frames, a high number of treenails connecting the frames to the planking, different types of wood) it may be concluded that during its use many of the ship's frames underwent repairs. Some repairs only encompassed smaller parts, which was the case with the elements longitudinally placed at the end of frame F114W, the element near garboard plank P1W (Fig. 75) and the element inserted between frames F117W and F11W (Fig. 57).

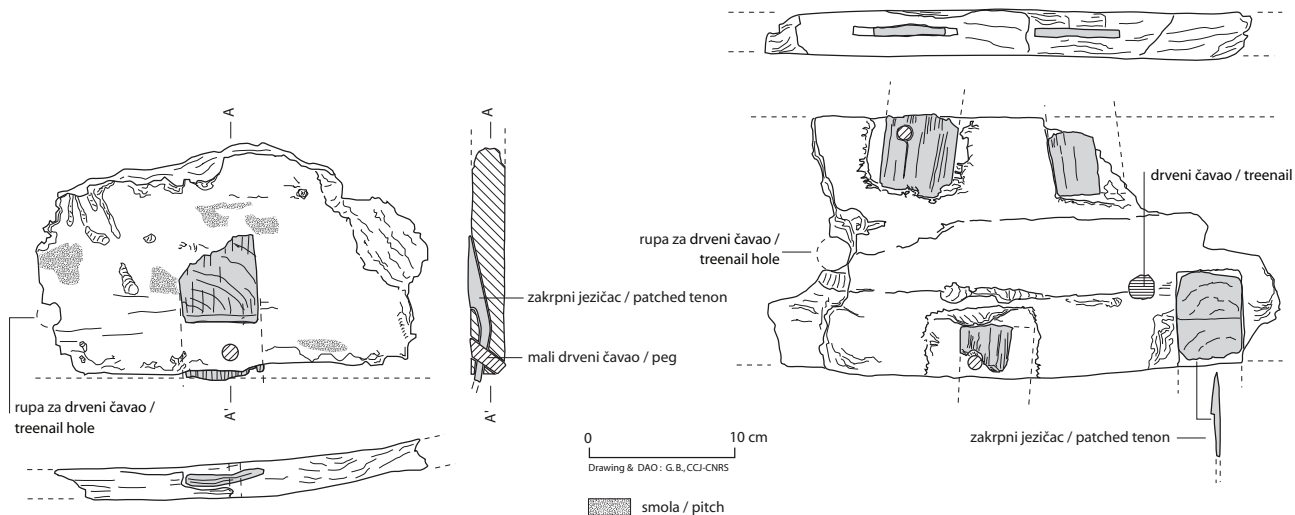
Fig. 76 Detached fragments of planks with patched tenons (drawing: G. Boetto).

Patched tenons, used to fasten repaired planks, were observed on the pieces of planks away from their original positions.<sup>46</sup> All of them were added to the exterior of the ship's hull, which explains the fact that the traces of such repairs were not observed *in situ* in its interior. Patched tenons, preserved at lengths of 6 to 9 cm, an average width of 4.8 cm and thickness of 0.75 cm, were inserted into replacement planks through rectangular mortises made on their external surface (Fig. 76, 77).

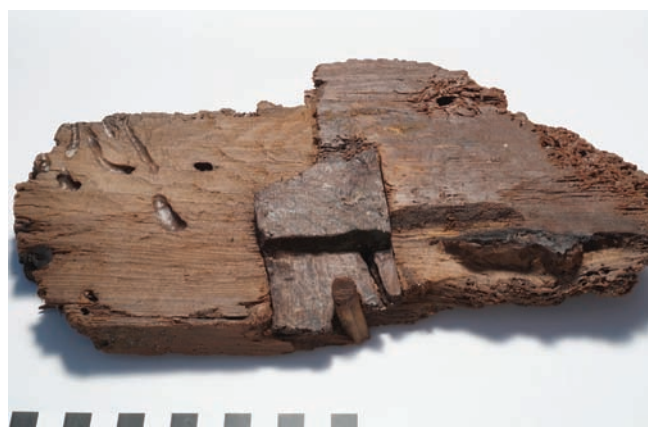
Fig. 77 Patch tenon (photo: Ph. Groscaux).

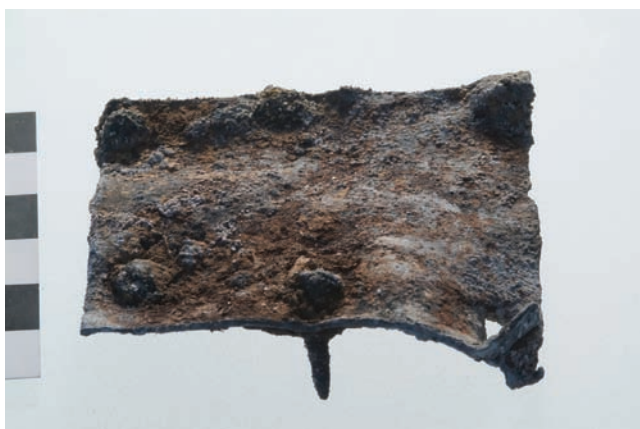
Fig. 79 Example of lead patch (PK07/03), fixed with small metal nails (photo: Ph. Groscaux).

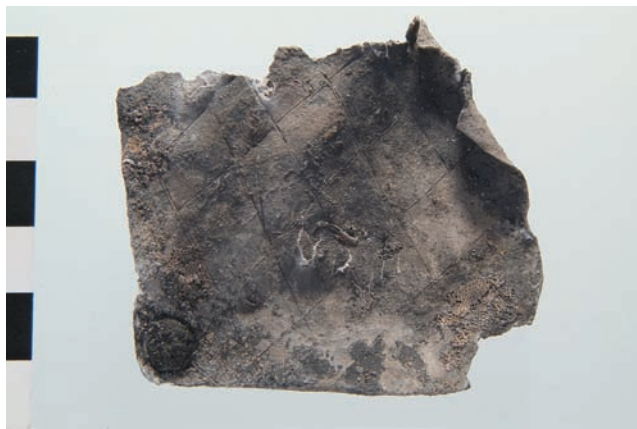
Fig. 80 Fragment of lead patch (PK07/06), with the inner surface incised with a crosshatched pattern (photo: Ph. Groscaux).

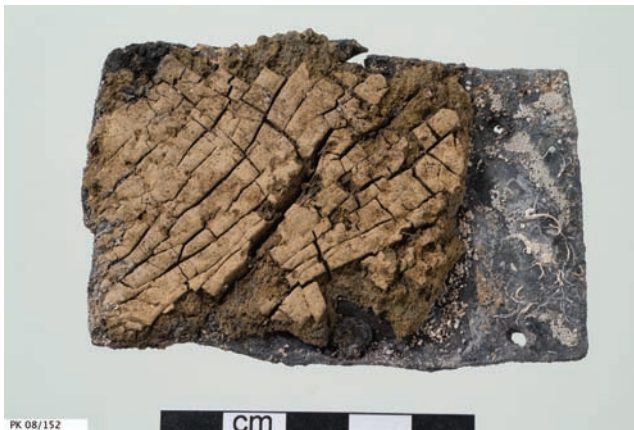
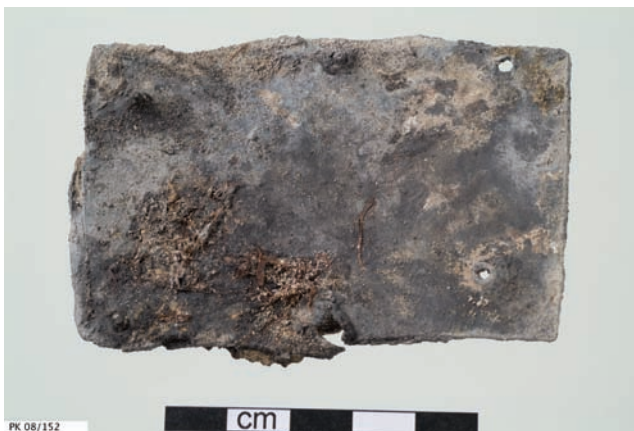
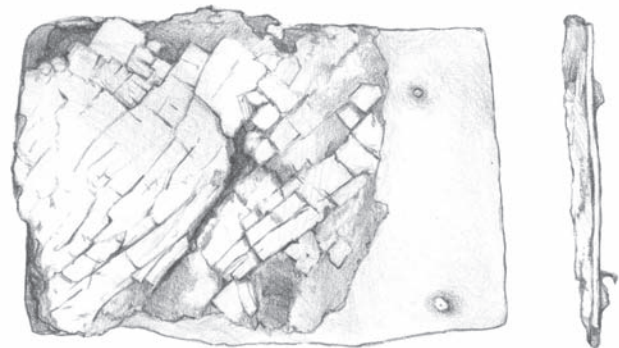
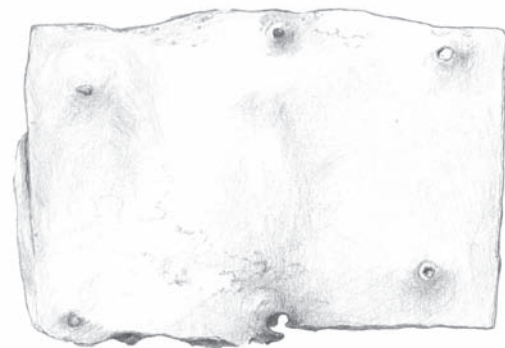
Fig. 81 Lead patch PK08/152: a) layer of pitch on the outer side of the patch; b) inner side of the patch (in contact with wood), (photo: Ph. Groscaux, drawing: N. Lete).

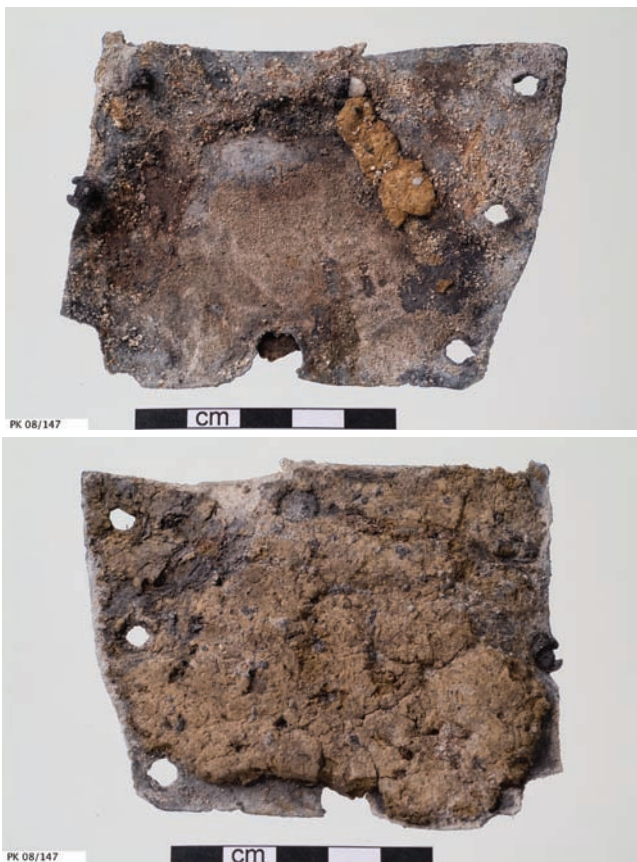
Fig. 82 Lead patch PK08/147 (photo: Ph. Groscaux).

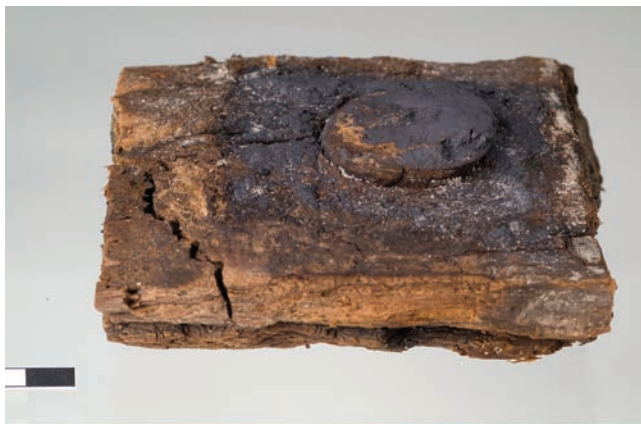
Fig. 83 Sampled part of planking with natural knot, under lead patch L24 (photo: Ph. Groscaux).

Based on the removal and analysis of sample L24 (of which only a greyish trace of the original lead patch remains, it may be said that the original patch measured 7.2 x 6.5 cm. It was determined that the knot in the wood was at the level of the mortise made on plank P15W (Fig. 83, 85). The knot, which had a tendency to move inward on the planking, caused the plank to crack. In order to avoid additional weakening of the planking and, most importantly, prevent leakage at this point, the shipwright solved the situation with a repair.

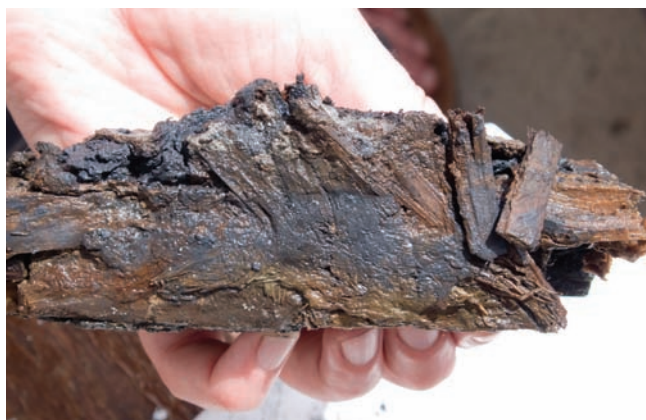
Fig. 84 Sample of planking under lead patch L29; wood shavings used to fill the gap around the knot (photo: Ph. Groscaux).

Na oplati su proučeni čvorovi pokriveni olovnim pločicama. Oni su velik problem samo u slučaju kad se nalaze na mjestu na kojem je i utor za jezićac, kojega prisutnost izaziva njihovo pomicanje. Stoga se na takvim mjestima, s ciljem povećanja čvrstoće, primjenjivao sistem zaštite izveden pomoću ljepljive mase na bazi smole, same smole, drvenih čavlića i pločice (Sl. 84, 85). Isti je sistem bio primijenjen na pukotinama u oplati<sup>47</sup>.

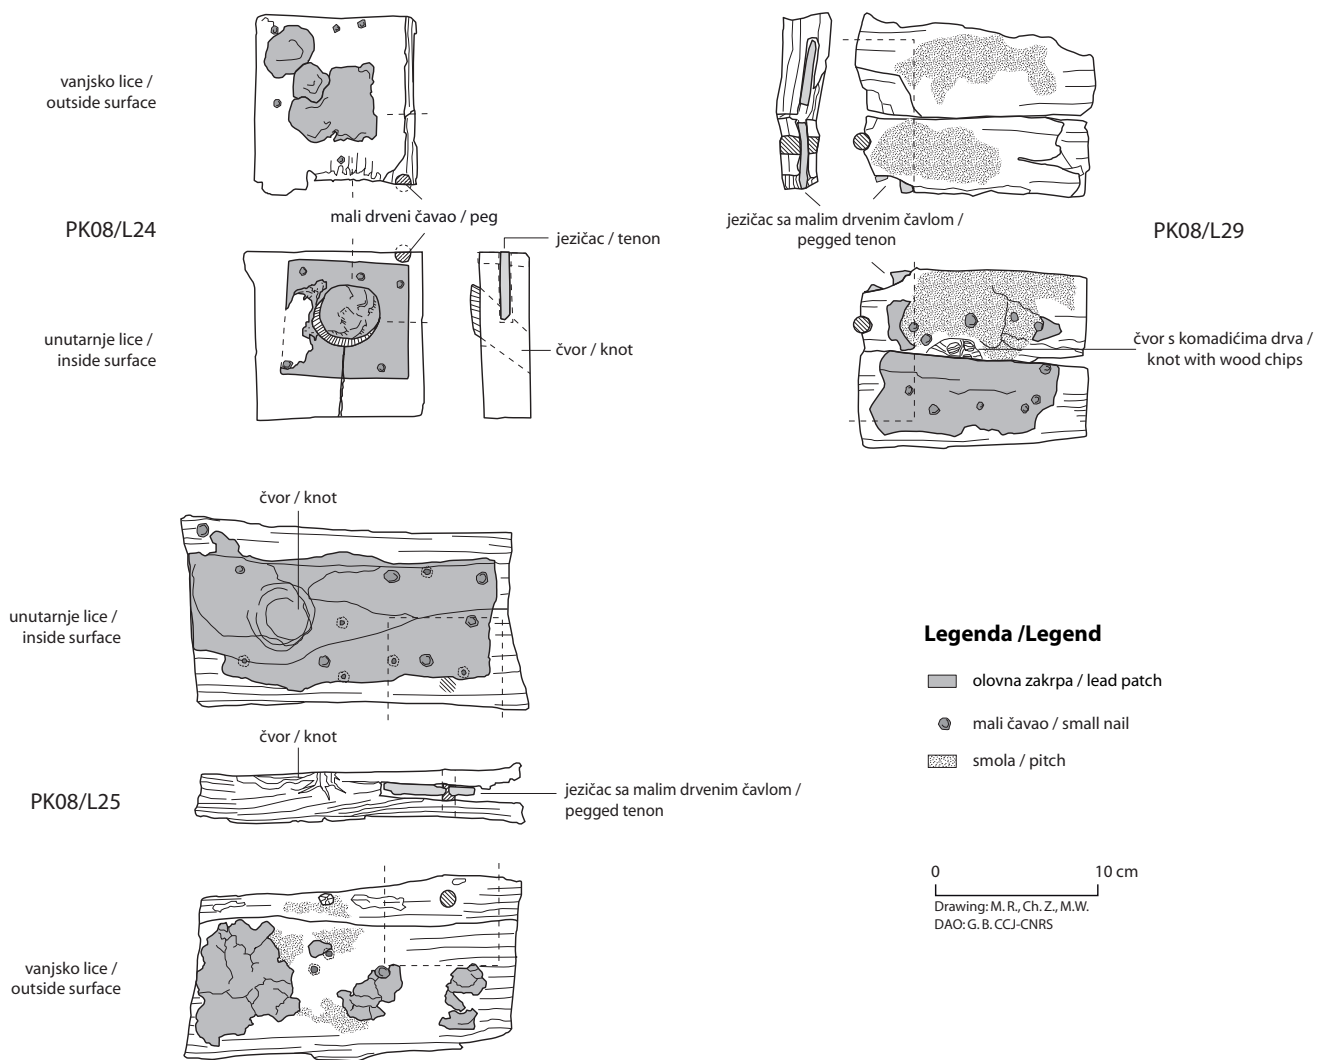
Fig. 85 Lead patches L24, L29 and L25 (drawing: G. Boetto).

With the aim of gaining greater insight into this type of repair, patches L24, L25 and L29 were removed from the sea in 2008, together with the wooden parts of the ship to which
