Monique Fort, Joëlle Smadja, Narendra Raj Khanal, Buddhi Raj Shrestha

## **Landslides and other damage to buildings and infrastructures following the April–May 2015 earthquake sequence, Solukhumbu District, Eastern Nepal**

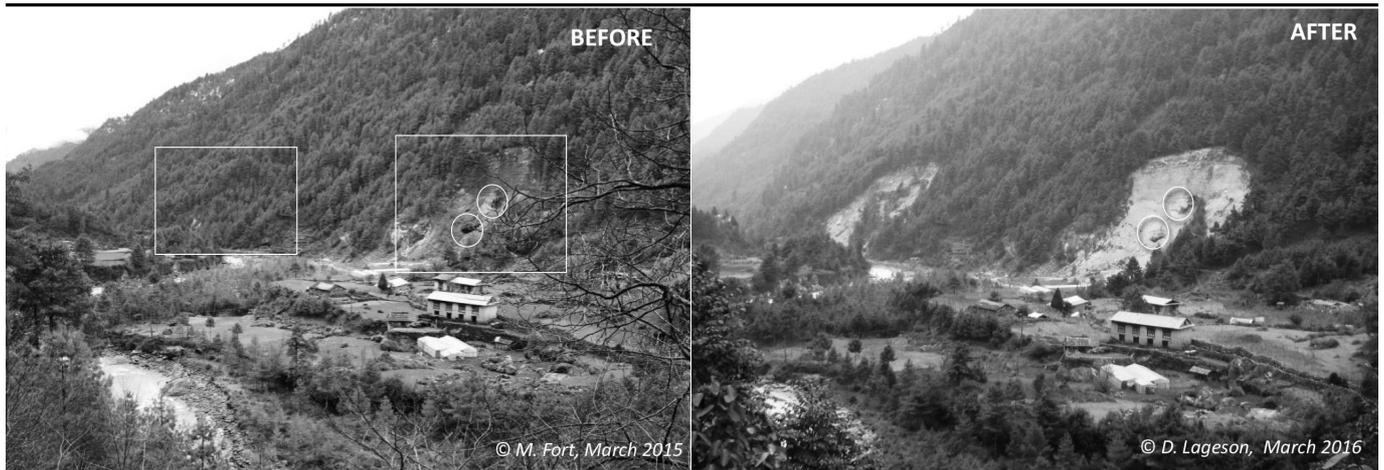
**Fig. 6:** Lower slope collapses along the Dudh Koshi valley, between Chuserma and Chermading (right bank, opposite Chutawa-Ghat): comparison of landscapes before and after the 2015 earthquake sequence. Note in both cases the large boulders (circles) attesting to the limited thickness of collapse. (Photos: © M. Fort, 2015, D. Lageson, 2016).

The second example corresponds to the section along the Dudh Koshi valley between Ghat and Phakding. The right bank, between Chuserma and Chermading, was affected by two slope collapses that occurred after the 12th May earthquake. They appeared to be quite dramatic as the forest was clearly affected (Fig. 6). Yet they correspond to a rather superficial (about 1 m thick) remobilisation of loose, Quaternary material, as attested to by two large boulders visible before and after the earthquakes. The comparison with the pre-earthquake landscape suggests that both collapses pre-existed. The same is true along the left bank between Chutawa and Ghat, where the collapse of banks affected lacustrine deposits (as a result of the valley dam by the large undated Thadokoshi rockslide) (Fig. 7). Once again, the collapse of all these banks occurred exactly at the same sites as those initiated by the 1985 GLOF (Vuichard and Zimmermann, 1987). They were later stabilised and revegetated, before being reactivated by the 12th May 2015 earthquake. As reported by Utra Bahadur Rai (Ghat), “Earthquake shaking likely initiated additional movement along or across pre-existing fractures, and this deformation progressed gradually in the days following the earthquake until failure occurred on May 22” (quoted by Shrestha, 2017).

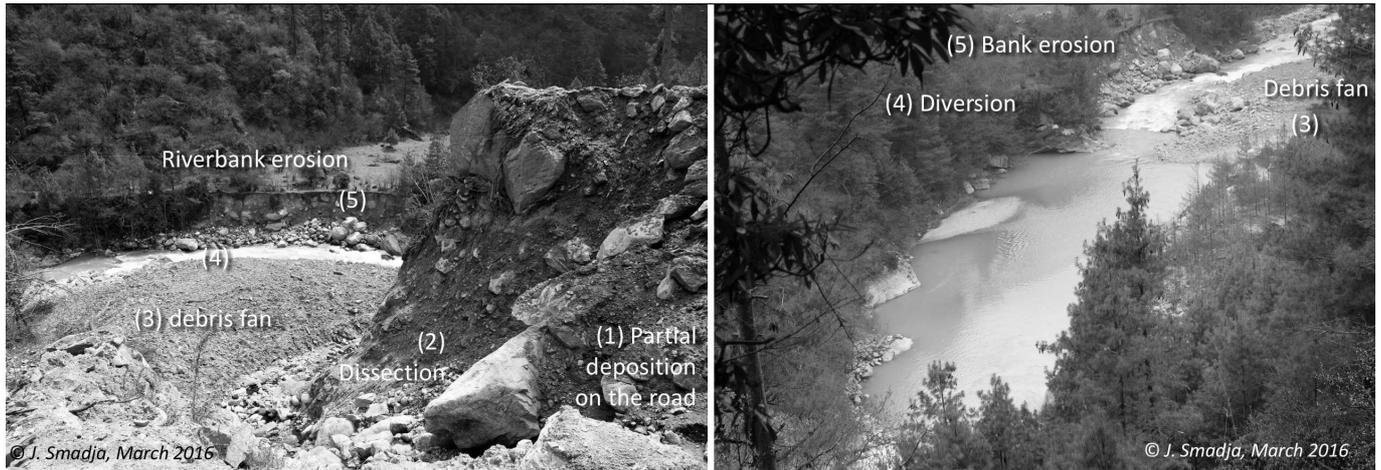
**Fig. 8: Series of cascading processes between Tok Tok and Benkar villages, revealing effective hillslope-channel connectivity along the right bank of the Dudh Koshi River. Succession of processes triggered from the upper slope (right photo) down to the channel (left photo). Downhill view, from the trail descending from Benkar village (Photos: © J. Smadja, 2016).**

- (1) Partial deposition on the road
- (2) Dissection and spread of debris down to the river bed
- (3) Partial damming of the Dudh Kosi (debris fan)

- (4) Diversion of the Dudh Kosi on its left bank
- (5) Erosion of the left bank

The first site is located between Tok Tok and Benkar villages (Fig. 8) at a section where the right bank of the Dudh Koshi River is very steep. The site is quite dramatic: the earthquake triggered a debris landslide (middle part of the slope), the material of which “jumped” over a rockwall and the related waterfalls, resulting in a debris flow that was partially deposited on the major Lukla-Namche trail. Yet the volume of debris was such that it extended down to the riverbed, forming a large fan that nearly dammed the Dudh Koshi River, causing the flow of the river to be diverted on its opposite (left) bank, leading to bank undercutting (Fig. 9a). Three years on (Dec. 2018), the debris fan has gradually been revegetated, but relicts of the “damming” episode can still be observed through uncommon white sands still present in the riverbed, reflecting the quiet waters and deposition of suspended sediment by decantation (Fig. 9b).

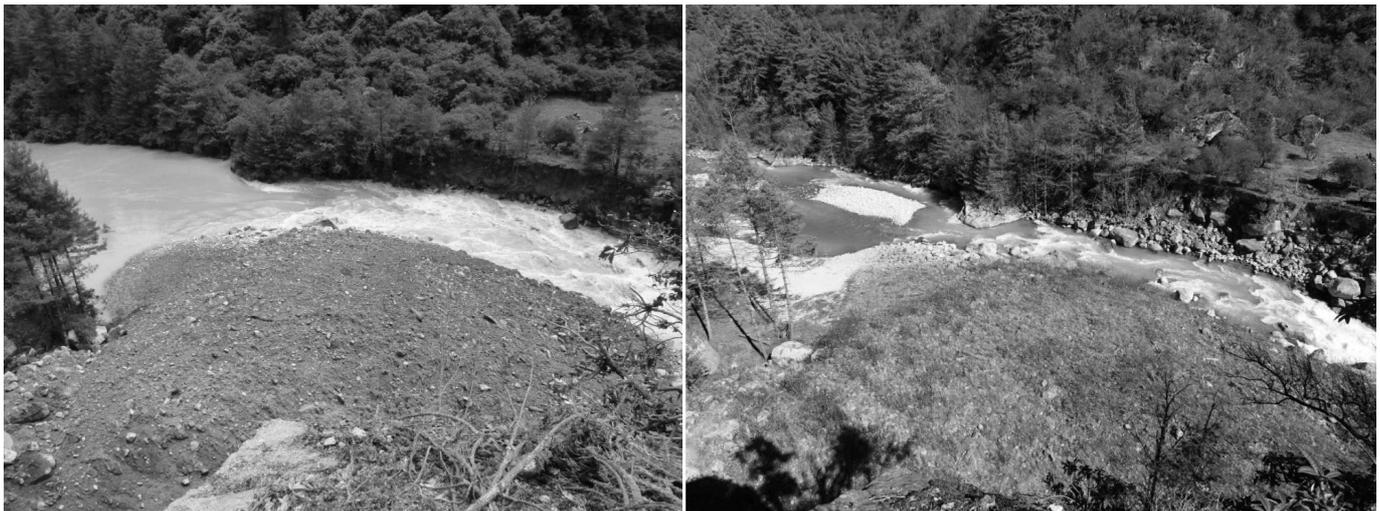
**Fig. 9: (a) Focus on the junction between Tok Tok gully and the Dudh Koshi channel (see Fig. 8 for the general context). Note the change in river width, with partial damming of the Dudh Koshi upstream of the debris fan (note the quiet waters), and the resulting erosion of the left bank downstream (fresh section with large boulders) together with the narrow active channel (Photos: © J. Smadja), and (b) Comparison between spring 2016 and December 2018 shows rapid re-vegetation of the junction fan, whereas the accumulation of white sand deposited in the Dudh Koshi channel testifies to former river blockage (Photos: © B.R. Shrestha, 2016 and M. Fort, 2018).**
