## **Landslides and other damage to buildings and infrastructures following the April–May 2015 earthquake sequence, Solukhumbu District, Eastern Nepal**

**\*Monique Fort<sup>1,4</sup>, Joëlle Smadja<sup>2,4</sup>, Narendra Raj Khanal<sup>3,4</sup>, and Buddhi Raj Shrestha<sup>3,4</sup>**

### **ABSTRACT**

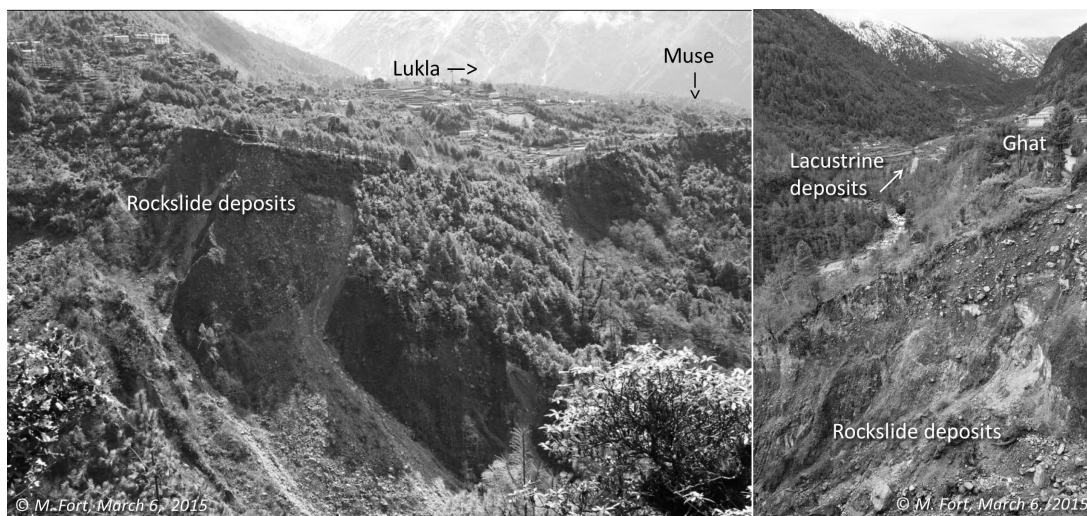
Fig. 3: Examples of legacies of large prehistoric landslides and rockslides, as observed near Ghat-Thado Khosi (left) and Cheplung (right). Note the unsorted, matrix-rich coarse deposits, superficially reworked by slope deposits (colluvium) or fluvial (alluvial) deposits. In some cases, like below Ghat, the volume of landslide material was large enough to dam the valley, which gradually created a landslide-dammed lake, as attested to by lacustrine deposits (Photos: © M. Fort).

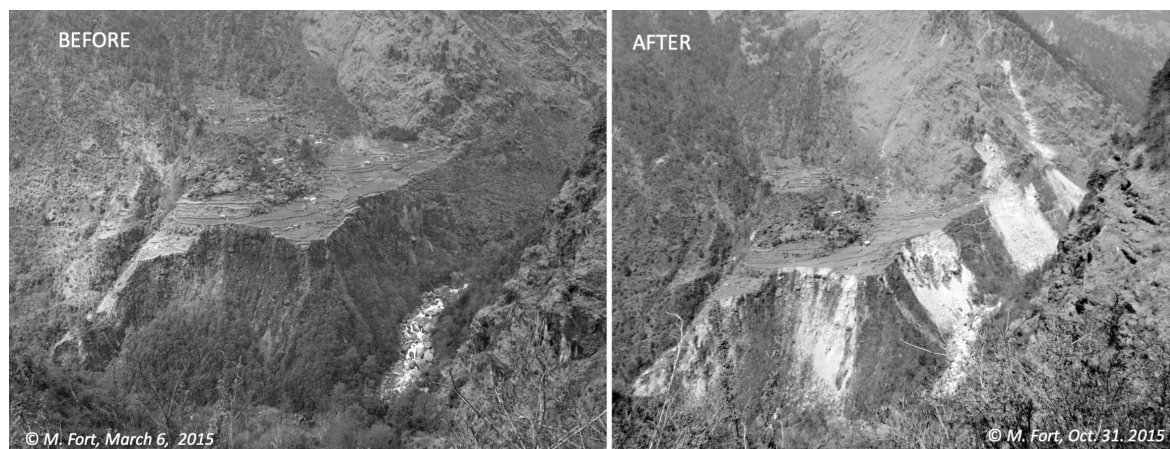
**Fig. 4:** Nakchung terrace, Solukhumbu, before and after the earthquake. The site of the village corresponds to a terrace partly cut into the Lukla rockslide and filled in with Dudh Koshi River gravel. The surface of the terrace is partly covered by a massive rockfall cone, whereas the edges of the terrace are rather sharp. Recent earthquake-triggered landslides destroyed the vegetation, and reactivated collapses initiated by the 1985 Digh Tsho GLOF. (© M. Fort, March 2015 and Oct. 2015)

Among them, the Nakchung village site appears to be most significant. The observed landslides did not exist seven weeks prior to the earthquake sequence, which triggered two types of landslides: rock falls and debris slides (Fig. 4). According to villagers, the slopes were first destabilised during the 25th April earthquake, but major collapse occurred after the main 12th May aftershock. Two rock falls originated from a paragneissic ridge ( $35\text{--}40^\circ\text{N}$  dip), north of the village, along the steep  $50^\circ$  slope above the Dudh Koshi River. Details of the scarp reveal bedrock dip and orthogonal fractures (Fig. 5) that had been extended in the past by weathering, causing loose blocks to fall down. Two rock fall tracks (350 m long for the northernmost one) run across the main trail from Lukla to Nakchung down to the river, isolating villagers from the main valley; they had to be flown to Lukla where they stayed for three months while the trail was being repaired. Yet this trail is no longer safe: in addition to rock falls, debris slides affected the edges of Nakchung cultivated terraces, which lie upon loose, alluvial material superposed on old rockslide deposits (Fig. 4). In fact, most of the new debris slides collapsed at the same sites as those previously affected by bank erosion which had been generated by the 1985 DigTsho GLOF event (Vuichard and Zimmermann 1987).

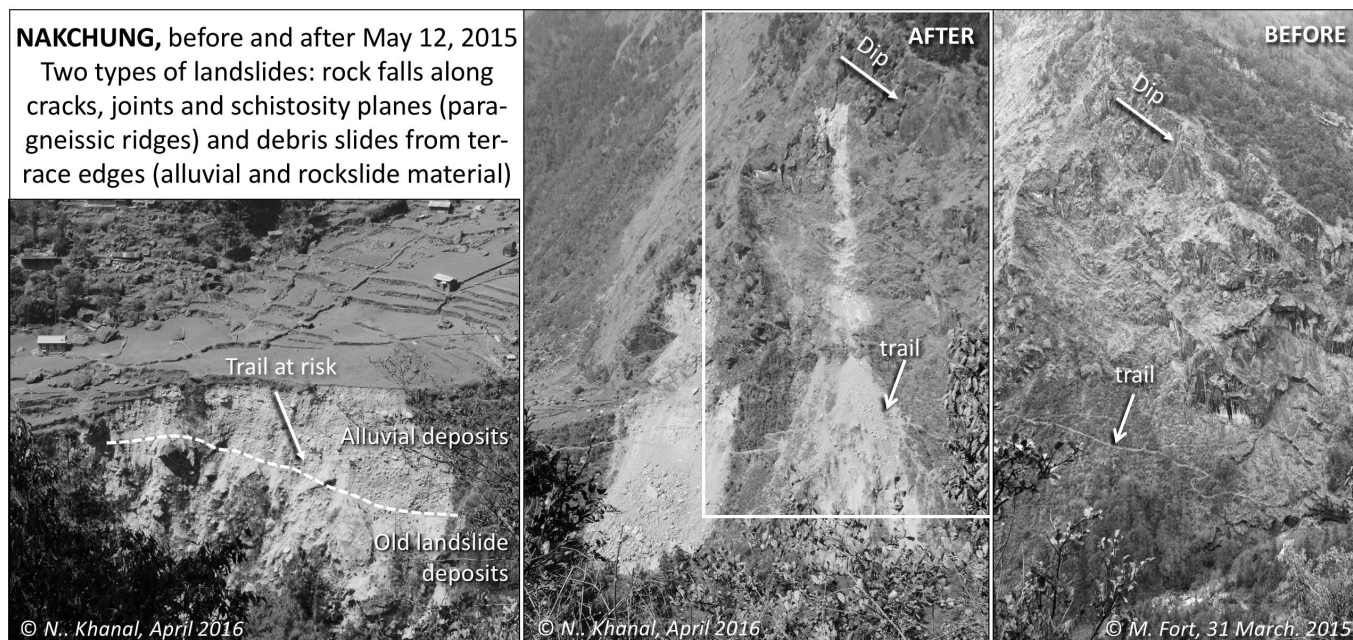
**Fig. 5:** Two types of landslides affected Nakchung village and its main trail. Rockfalls developed along cracks, joints and schistosity planes (paragneissic ridges) whereas debris slides affected terrace edges (rockslide material topped by alluvial gravels). (© M. Fort, March 2015, and N.R. Khanal, April 2016).

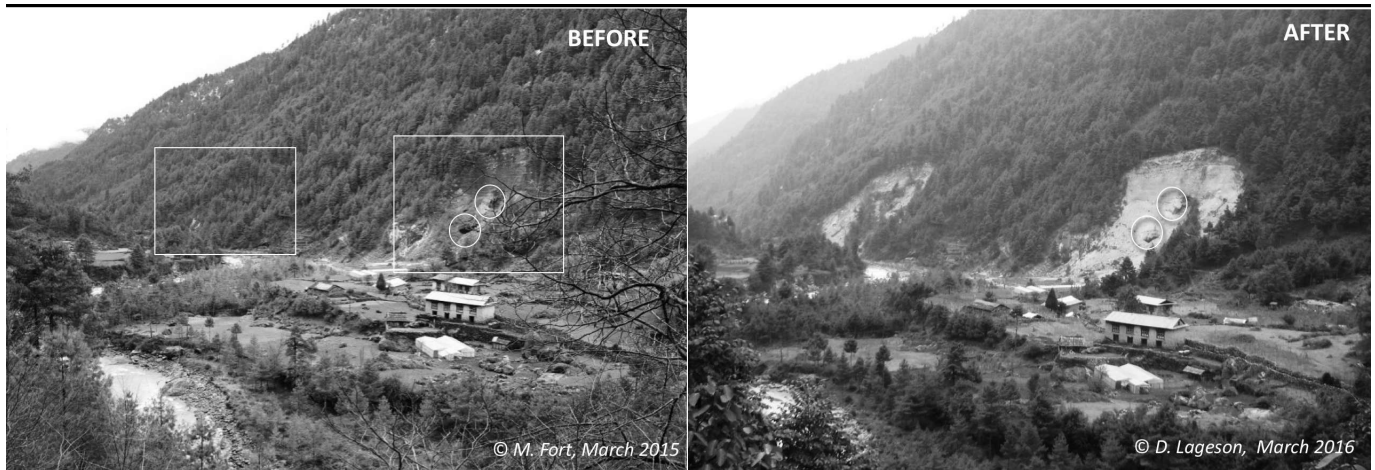
**Fig. 6:** Lower slope collapses along the Dudh Koshi valley, between Chuserma and Chermading (right bank, opposite Chutawa-Ghat): comparison of landscapes before and after the 2015 earthquake sequence. Note in both cases the large boulders (circles) attesting to the limited thickness of collapse. (Photos: © M. Fort, 2015, D. Lageson, 2016).

The second example corresponds to the section along the Dudh Koshi valley between Ghat and Phakding. The right bank, between Chuserma and Chermading, was affected by two slope collapses that occurred after the 12th May earthquake. They appeared to be quite dramatic as the forest was clearly affected (Fig. 6). Yet they correspond to a rather superficial (about 1 m thick) remobilisation of loose, Quaternary material, as attested to by two large boulders visible before and after the earthquakes. The comparison with the pre-earthquake landscape suggests that both collapses pre-existed. The same is true along the left bank between Chutawa and Ghat, where the collapse of banks affected lacustrine deposits (as a result of the valley dam by the large undated Thadokoshi rockslide) (Fig. 7). Once again, the collapse of all these banks occurred exactly at the same sites as those initiated by the 1985 GLOF (Vuichard and Zimmermann, 1987). They were later stabilised and revegetated, before being reactivated by the 12th May 2015 earthquake. As reported by Utra Bahadur Rai (Ghat), “Earthquake shaking likely initiated additional movement along or across pre-existing fractures, and this deformation progressed gradually in the days following the earthquake until failure occurred on May 22” (quoted by Shrestha, 2017).

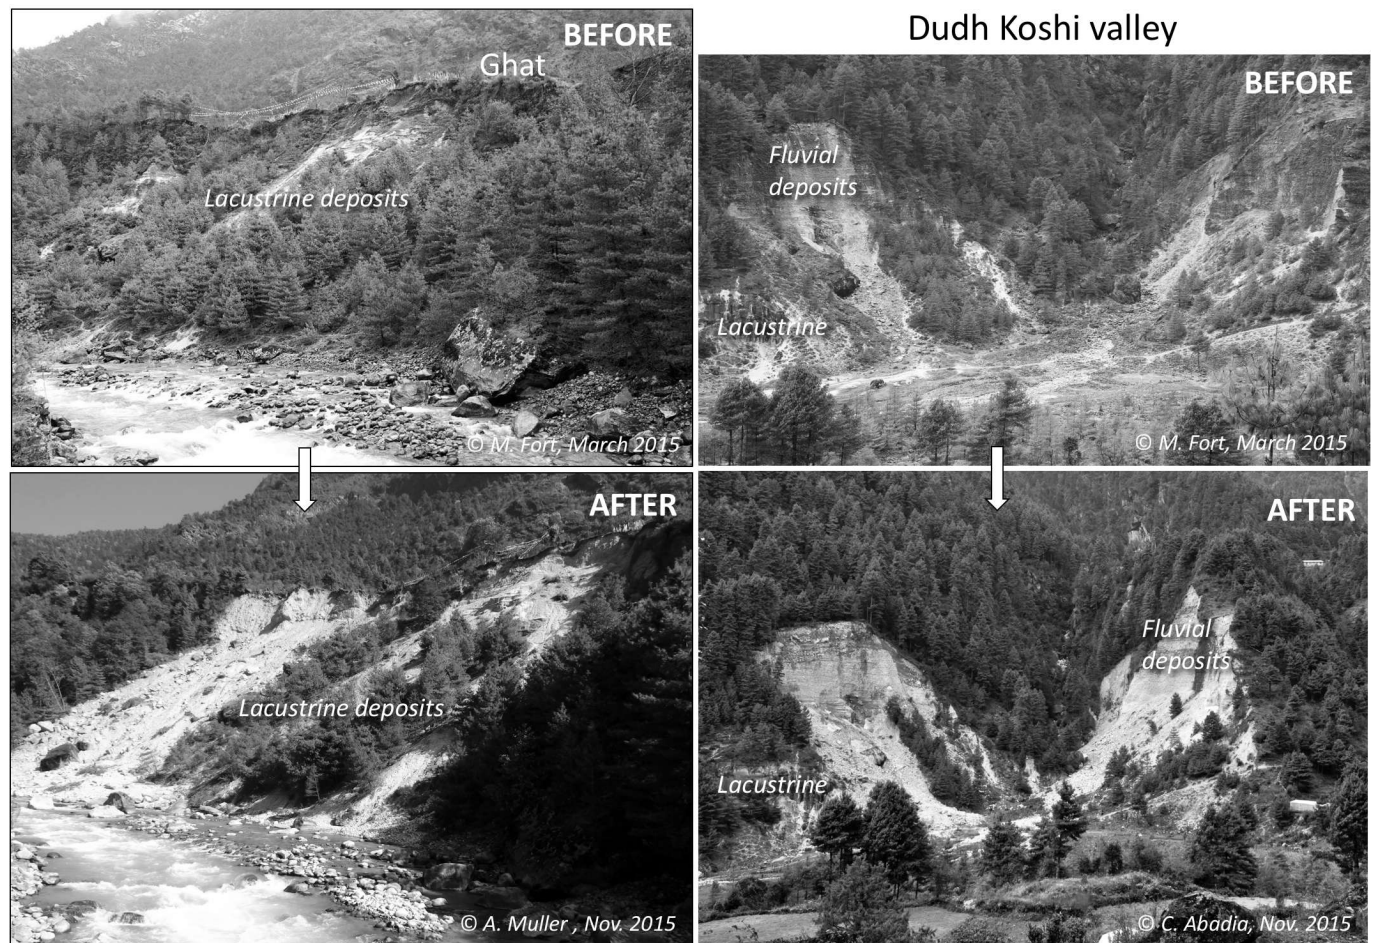
**Fig. 7:** Slope collapse affecting loose, lacustrine and alluvial deposits along the Dudh Koshi valley near Ghat (left photographs: left bank Ghat, right photos: right bank Chermading). The vegetation is the most damaged, with limited volumes of displaced material. (Photos: © M. Fort, 2015, A. Muller and C. Obadia, 2015)

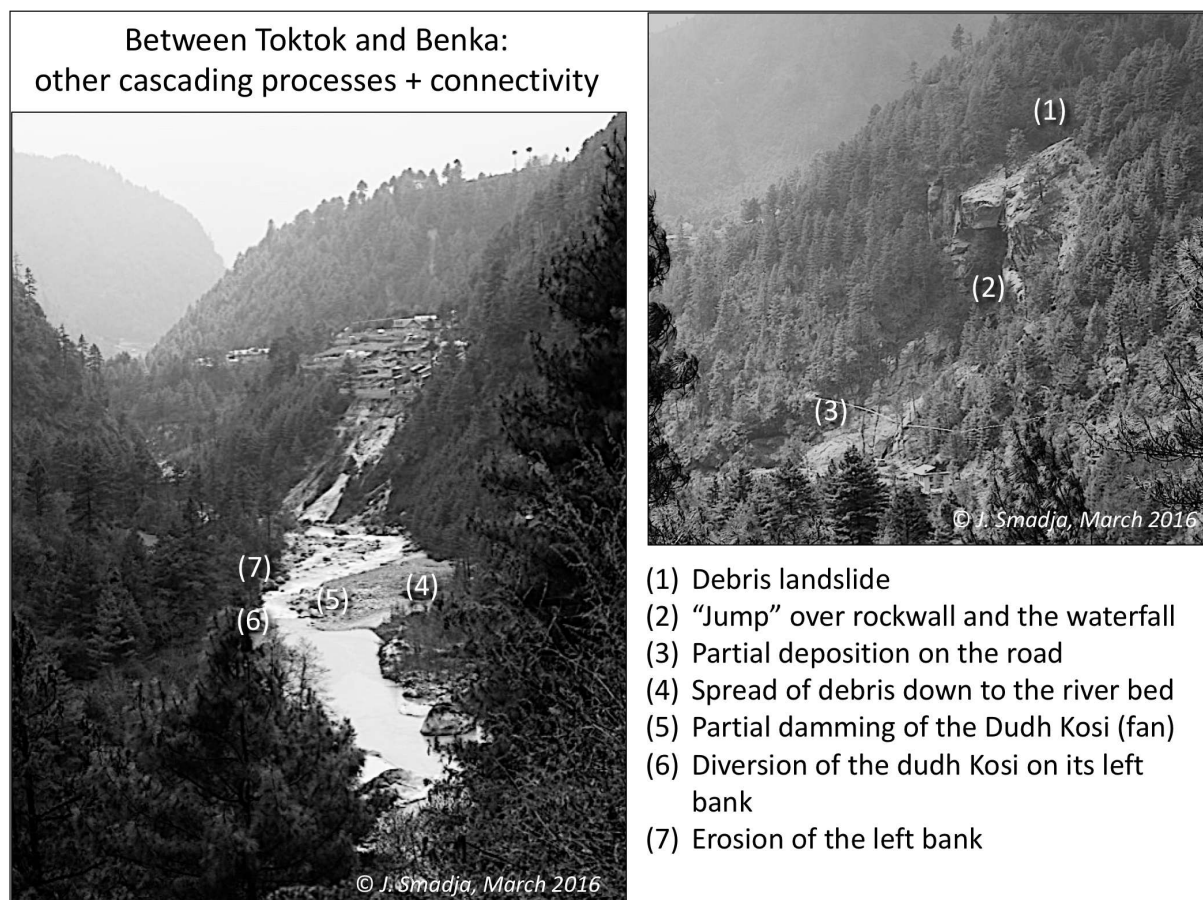
**Fig. 8: Series of cascading processes between Tok Tok and Benkar villages, revealing effective hillslope-channel connectivity along the right bank of the Dudh Koshi River. Succession of processes triggered from the upper slope (right photo) down to the channel (left photo). Downhill view, from the trail descending from Benkar village (Photos: © J. Smadja, 2016).**

The first site is located between Tok Tok and Benkar villages (Fig. 8) at a section where the right bank of the Dudh Koshi River is very steep. The site is quite dramatic: the earthquake triggered a debris landslide (middle part of the slope), the material of which “jumped” over a rockwall and the related waterfalls, resulting in a debris flow that was partially deposited on the major Lukla-Namche trail. Yet the volume of debris was such that it extended down to the riverbed, forming a large fan that nearly dammed the Dudh Koshi River, causing the flow of the river to be diverted on its opposite (left) bank, leading to bank undercutting (Fig. 9a). Three years on (Dec. 2018), the debris fan has gradually been revegetated, but relicts of the “damming” episode can still be observed through uncommon white sands still present in the riverbed, reflecting the quiet waters and deposition of suspended sediment by decantation (Fig. 9b).

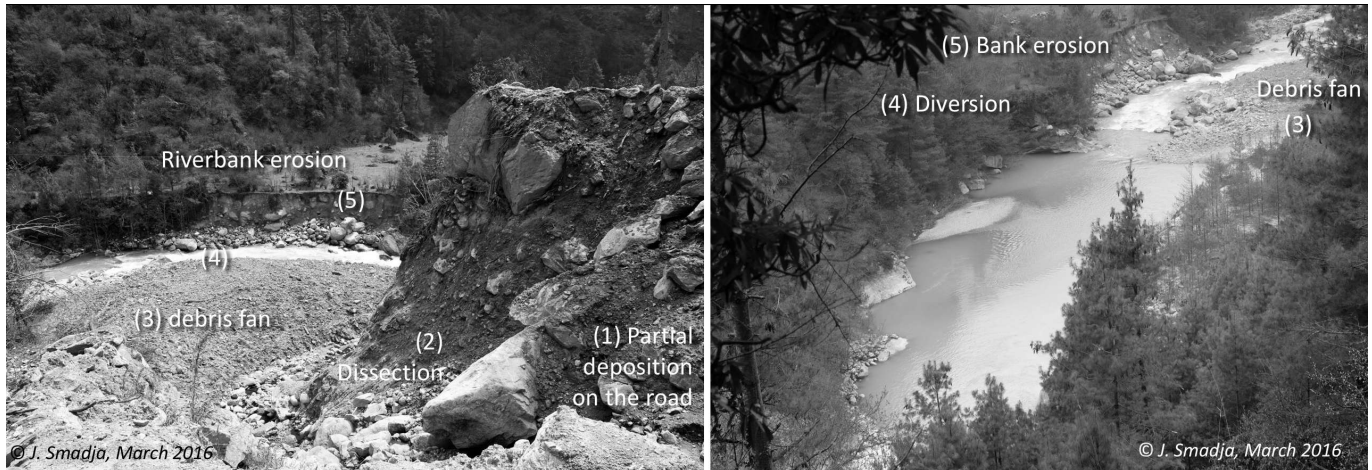
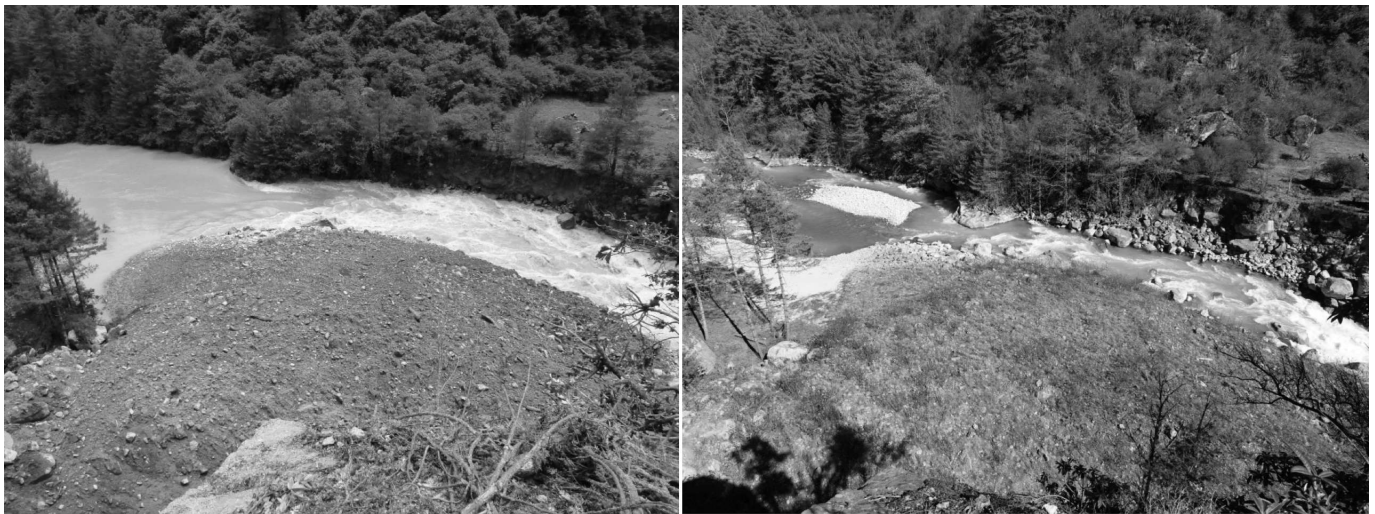
- (1) Partial deposition on the road
- (2) Dissection and spread of debris down to the river bed
- (3) Partial damming of the Dudh Kosi (debris fan)

- (4) Diversion of the Dudh Kosi on its left bank
- (5) Erosion of the left bank

**Fig. 9: (a) Focus on the junction between Tok Tok gully and the Dudh Koshi channel (see Fig. 8 for the general context). Note the change in river width, with partial damming of the Dudh Koshi upstream of the debris fan (note the quiet waters), and the resulting erosion of the left bank downstream (fresh section with large boulders) together with the narrow active channel (Photos: © J. Smadja), and (b) Comparison between spring 2016 and December 2018 shows rapid re-vegetation of the junction fan, whereas the accumulation of white sand deposited in the Dudh Koshi channel testifies to former river blockage (Photos: © B.R. Shrestha, 2016 and M. Fort, 2018).**

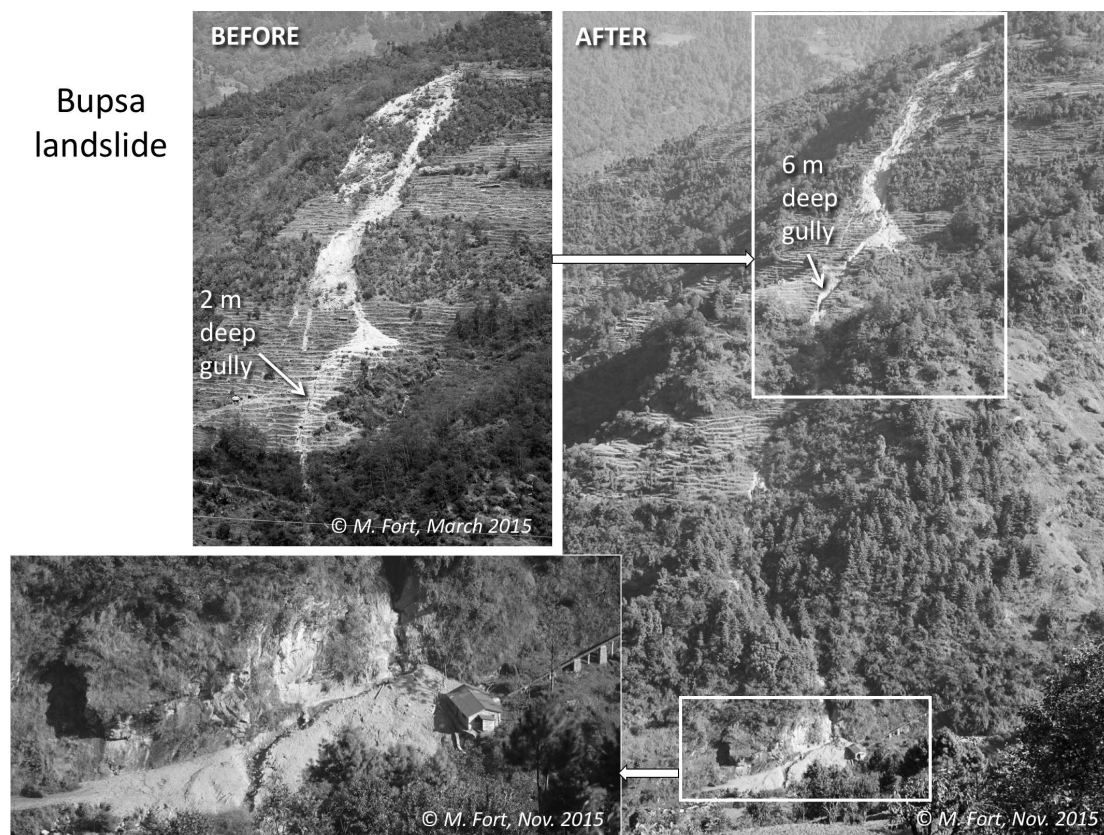
**Fig. 10: Cascading processes and impact of the monsoon in Bupsa in 2015. The main gully considerably deepened, and the eroded debris was transported down to Khari Khola junction, hence damaging the new Khari Khola power plant (lower left). (Photos: © M. Fort)**

The second site is located west of the Bupsa village (Kharikhola VDC) and close to the top of the ridge. In March

2015 a landslide pre-existed on the southern slope of the village, together with an incipient gully (<2 m deep) cut across the cultivated terraces downhill of the landslide (Fig. 10). Following the 12th May earthquake, the upslope section of the landslide crown expanded, as expressed by crescentic tension cracks and small fresh scarps, observations confirmed by inhabitants. Then, during that year’s monsoon, running waters deeply eroded (>6 m) the incipient gully across cultivated terraces: the eroded debris was carried directly downhill, and then fanned out at the junction leading to the Khari Khola where it damaged the new Khari Khola power plant.

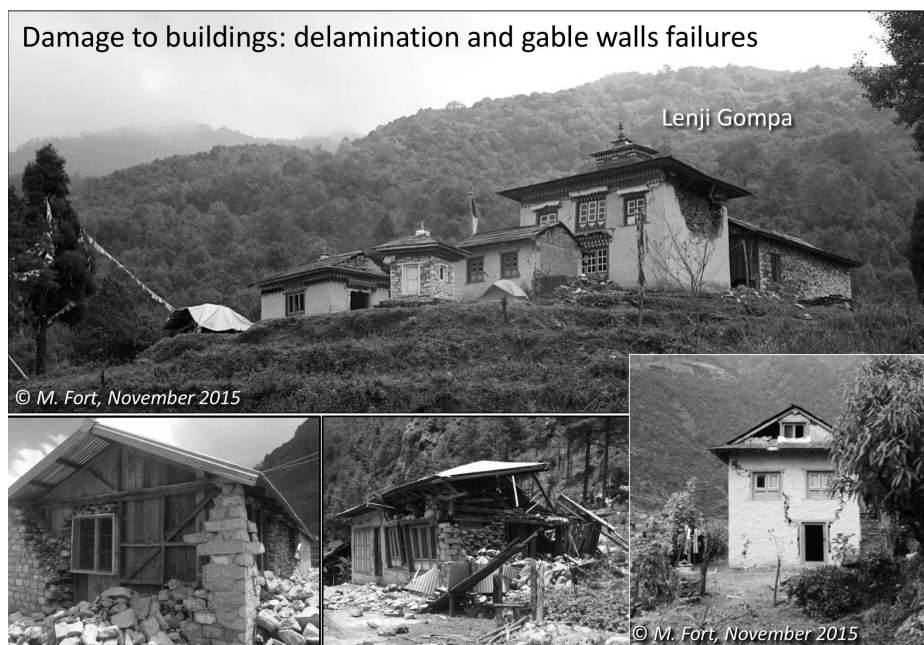
**Fig. 11: Significant damage to buildings (Lenji Gompa and houses) in the Khari Khola catchment. “X-cracking” and gable wall failures both due to the type of building and to colluvium soil being susceptible to shaking. (Photos: © M. Fort, November 2015)**

External structural walls of older traditional buildings were affected by cracks originating from the corners of windows and of door jambs (“X-cracking”) since they are made of uncut

“field stone” with no mortar or external plaster, just small stones placed between larger stone blocks to fill gaps (Lageson et al., 2016). Other buildings with inside wood panelling, were mostly affected by failure at the top of external rock walls (unreinforced masonry), leaving relatively intact the inside part (Lageson et al., 2016), which explains the very few fatalities (Fig.11). Recent houses with longitudinal and transverse bonding did indeed resisted better, as also observed closer to the Gorkha area (Parajuli and Kiyono, 2015).

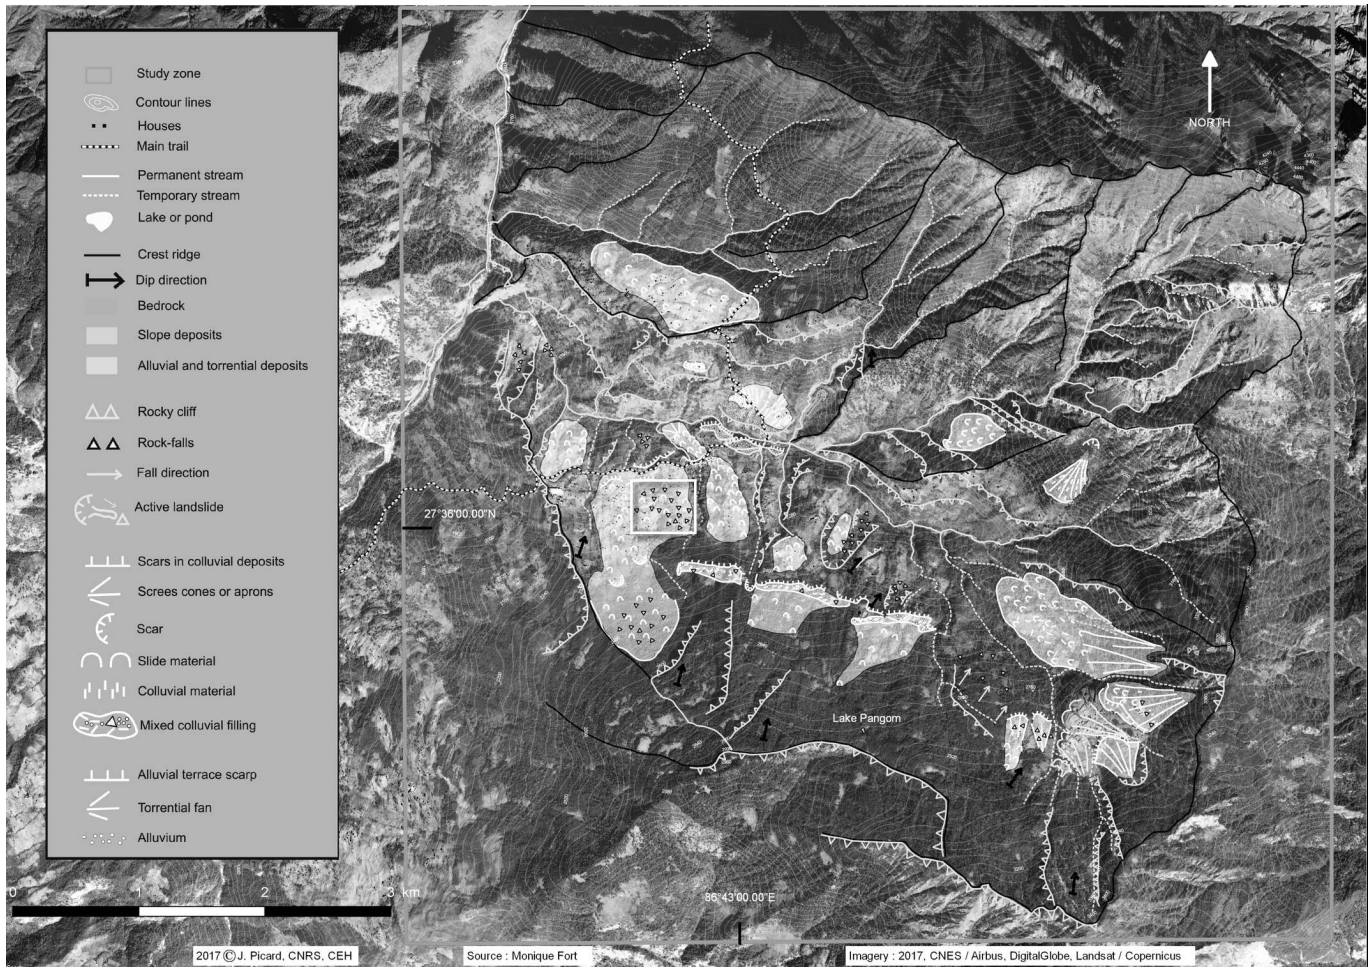
**Fig. 12: Geomorphic map of the Khari Khola catchment, showing the importance of slope deposits (colluvium) and their sensitivity to different types of landslides well developed on the southern part of the catchment. The white rectangle (middle part) indicates “Dharyan” blocks (see Fig. 13), whereas immediately to their right colluvium material has been remobilised as an elongated earthflow. (Field mapping M. Fort, © final drawing J. Picard)**

of damaged buildings, other parameters such as the nature and depth of colluvium combined with slope gradient appear to be significant factors that are likely to amplify the effects of ground shaking, as observed in the Khari Khola catchment (Fig. 12) and developed in the Lesser Himalayan series (schists and quartzites). Several houses were damaged in the Khari Khola bazaar, which is built across the axis of an earthflow (loose material) highly susceptible to ground shaking, especially when water-saturated, as during the 12th May aftershock (early spring in this area was quite wet, with unusually abundant rainfall and snowfall). The remaining part of the village extends across the north-oriented hill slopes covered by “colluvium”, a mixture

of fine material (weathered schists) and large blocks. A larger number of damaged houses in the middle of the slope seems to be locally related to a significant concentration of larger blocks ( $>150 \text{ m}^3$ ) that villagers call “Dharyan” (Fig. 13). The notable permeability of these blocks makes them highly susceptible to ground shaking. Following the collapse of the quartzite scarp which dominates the hillslope, we hypothesise that Dharyan might be inherited from, and triggered by, former undated seismic events, though so far we cannot confirm it.

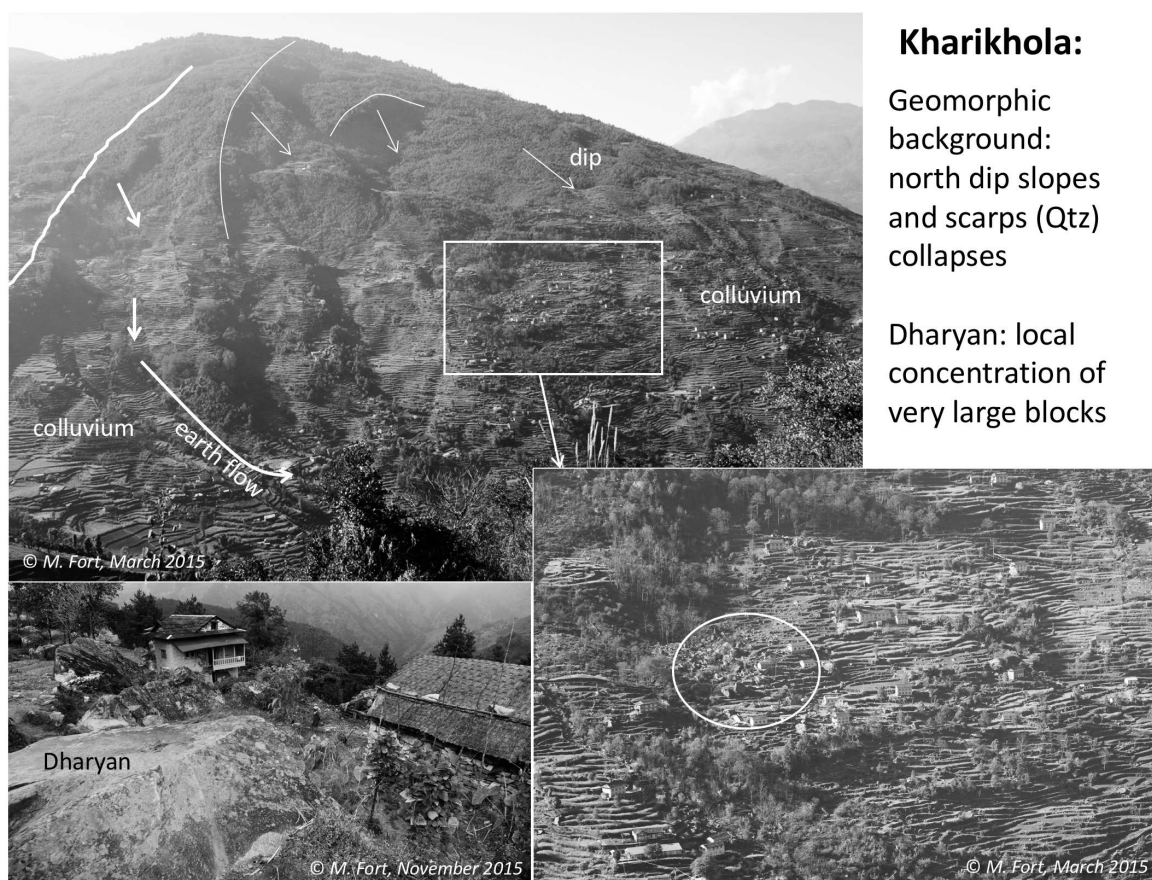
**Fig. 13: Geomorphic context of the Khari Khola village, a north-oriented slope with colluvium cover on its lower part, locally reworked as debris flows. “Dharyan”, local concentration of large blocks collapsed from quartzitic scarps (cf. dip slope), might be legacies of former seismic events. (Photos: © M. Fort, March and November 2015)**
