Geo-hydrological hazards induced by Gorkha Earthquake 2015: A Case of Pharak area, Everest Region, Nepal

Buddhi Raj Shrestha^{1,4*}, Narendra Raj Khanal^{1,4}, Joëlle Smadja^{2,4},
Monique Fort^{3,4}

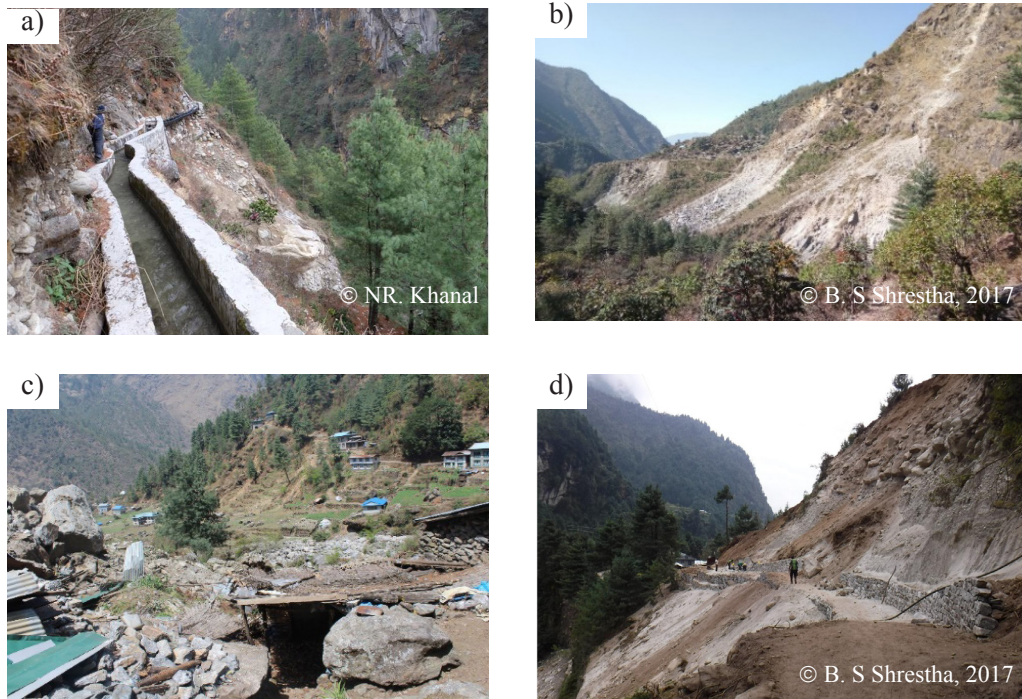
Figure 4: Earthquake induced hazards losses and damages in study area. a) Canal damage at Manjo by landslide b) landslide induced at Nackchung village c) Destroyed stone masonry building and collapse crops and cultivated land at Surke village south of Lukla, d) Trail damage by Landslide north of Phakding.

The maximum crops and cultivated land have damaged by landslide. A total of 0.56 hectare *khet* land with 0.28 hectare *bari* land, 3,300 kg potato, 970 kg maize, 670 kg buckwheat and 1480 kg of wheat were destroyed. Rock fall has damaged 0.05 hectare *bari* land and 200 kg potato, 50 kg maize. Similarly, debris flow damaged 0.05 hectare *bari* land with 300 kg of potato (Table 6). Two significant landslides found in Nackchung (Figure 4 b) village west of Lukla and destroyed cultivated land ,shed and trial and these landslides run across the main trail from Lukla to Nackchung down to the river, isolating villagers from the main valley. They had to be flown to Lukla where they stayed for three months while the trail was being repaired (Fort, M., Smadja, J., Khanal, N. R., & Shrestha, B. R., 2019). Another landslide from Phakding landslide (Figure 4 d) right side of the Dudh koshi river has destroyed the major trekking trail (Lukla -Namche). The examples of house damaged and canal damaged are shown in (Figure 4 a and c).

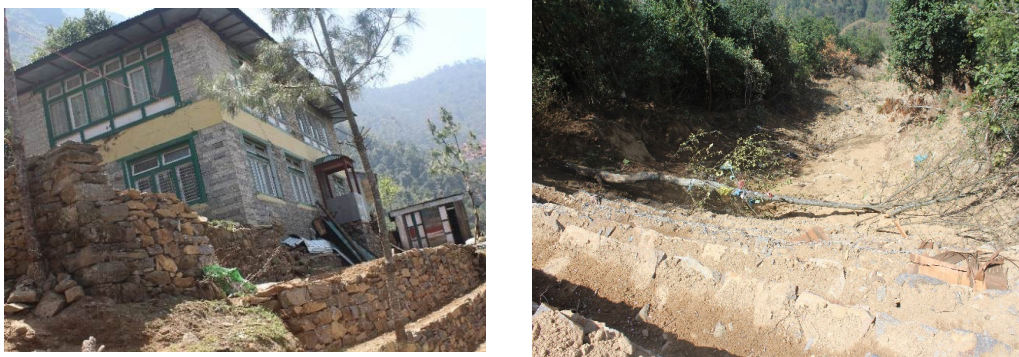
Figure 5: Wall constructions to mitigate house and trail at Surke village a) landslide affected house upper part b) wall construction (stone and mud) to control headward extension of landslide.

Local people perceived that geo-hazards like, landslide, rock fall etc. occur in their settlements. Yet, the 2015 Gorkha earthquake had resulted damages and losses in the study area and it damaged trail and bridges. This event had changed the mindset of local people to construct earthquake resisting buildings and other infrastructures too. People think that tree plantation, wall construction and bio-engineering could reduce the effect of landslide, rock fall and debris flow (Figure 5 a and b). Villagers on average felt that a geological hazard would likely occur at their settlements frequently and did not know the mitigation action clearly during a geological hazard. Local people felt that there is no more open spaces and safe land during the disaster period and lacking disaster preparedness. Respondents think that building and other infrastructures should be constructed earthquake resisting
