The hull structure

Giulia Boetto, Marko Uhač, Ida Koncani Uhač

Giulia Boetto, Marko Uhač, Ida Koncani Uhač. The hull structure. I. Koncani Uhač; G. Boetto; M. Uhač. Zambratija. Prapovijesni šivani brod. Rezultati arheološkog istraživanja, analiza i studija / Prehistoric sewn boat. Results of the Archaeological Research, Analysis and Study, 33, Arheološkom muzeju Istre, pp.62-87, 2020, Monografije i katalozi, 978-953-8082-50-4. halshs-02986179

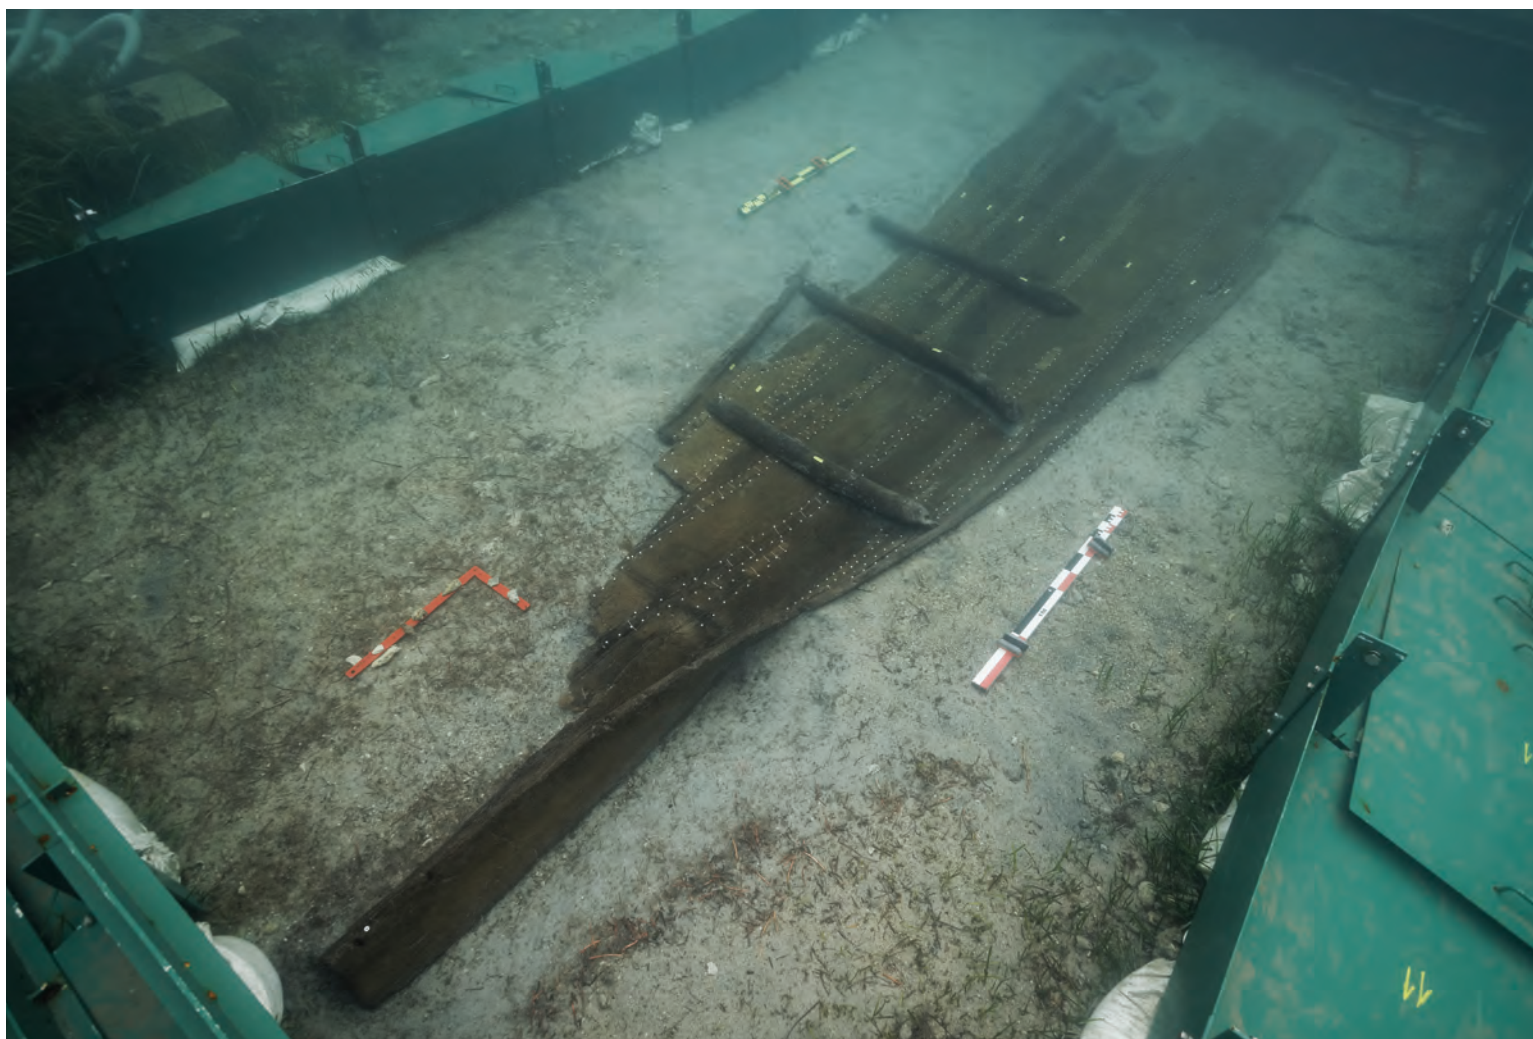
View of the wreck from the north. Two quadrants and two photographic scales are positioned around the wreck remains for the purposes of photogrammetric survey (fotografija / photo by: Ph. Groscaux)

The wreck is oriented NE - SW with one preserved end of the hull pointing towards the beach. When the vessel sunk, it came to rest on one side, thus the western side is poorly preserved while the eastern side survives up to the sheerstrake (Figs II.1 – II.3).

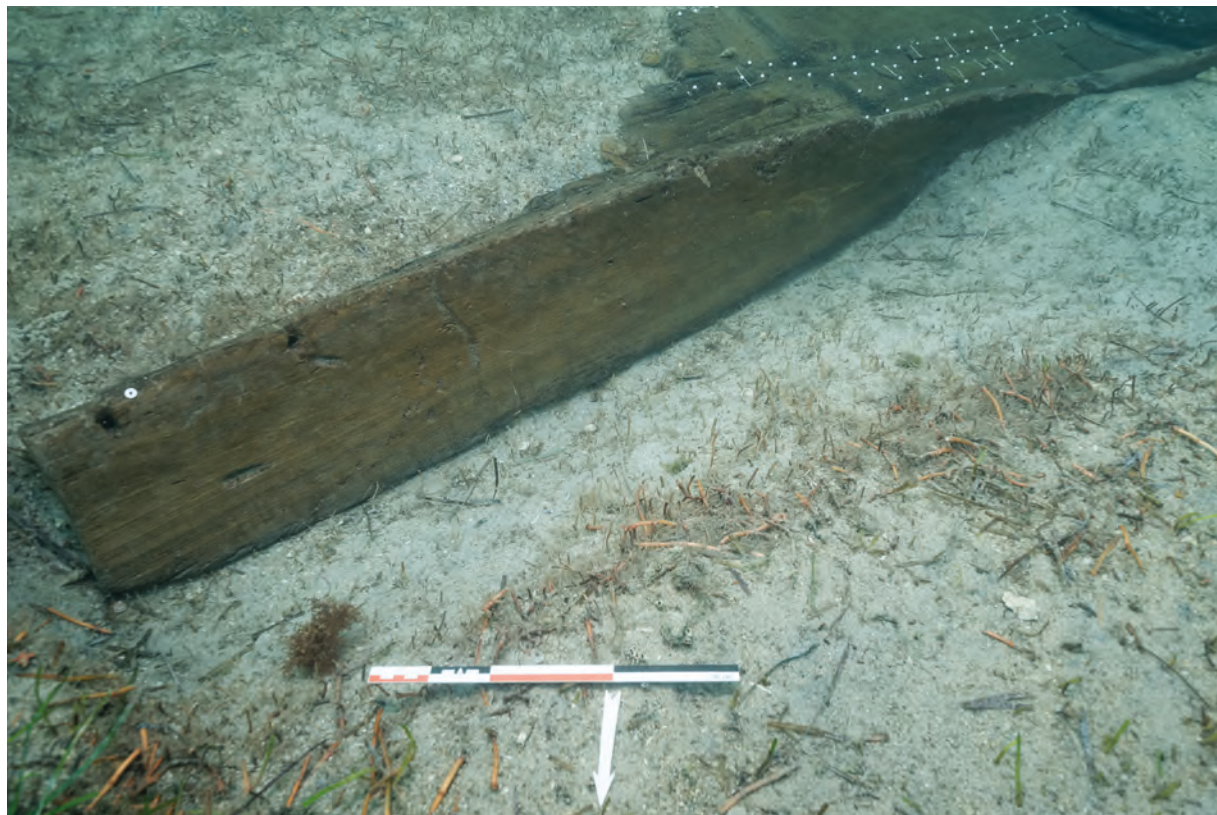
II.6

Tragovi alatki vidljivi na unutrašnjoj površini šiljatog sjevernog kraja
The woodworking marks visible on the interior surface of the pointed northern end
(fotografija / photo by: Ph. Groscaux)

carved to a sharp point. Some tool marks, either made with an axe or adze, are visible in the inboard surface. This major longitudinal timber plays, from an architectural and structural point of view, the role of a keel.

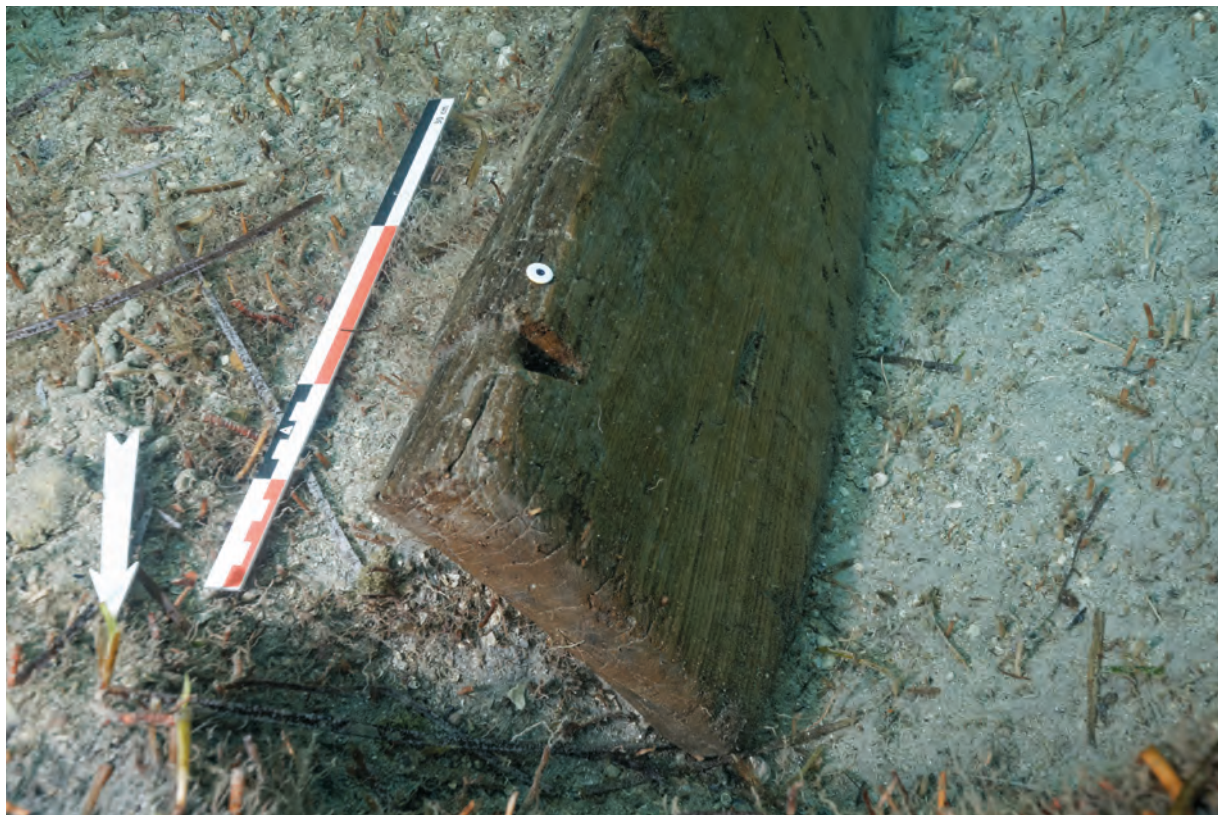
II.7

Detailed view of the pair of horizontal stitch holes carved in the pointed end of the keel-like timber
(fotografija / photo by: Ph. Groscaux)

At a distance of 7.6 cm from the keel-like timber's northern end, two horizontal holes, rectangular in section (1.3-1.5 cm wide and 2-2.8 cm high) and spaced 19 cm apart, have been noted (Fig. II.7). These were probably used to assemble another timber on top of the pointed end of the keel-like timber. This missing timber was probably carved from a single piece of wood to hold the ends of the strakes.

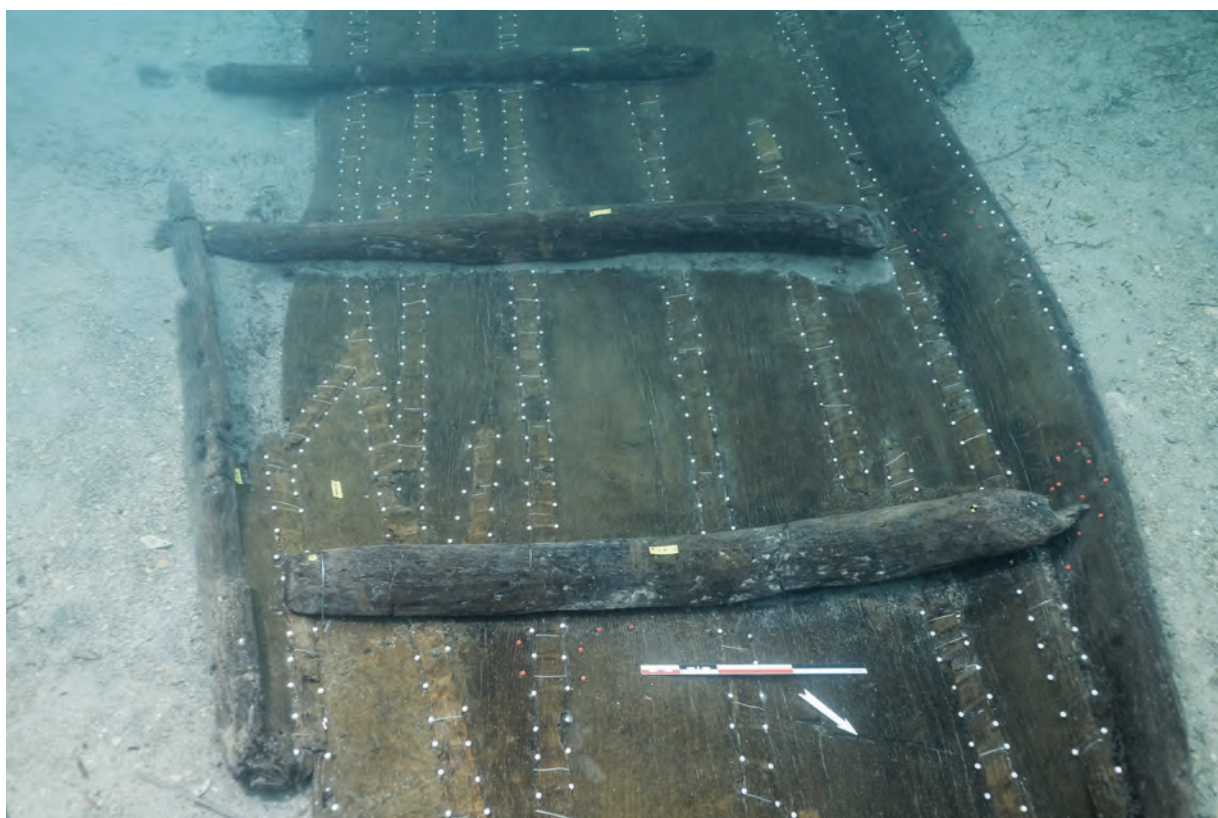
The L-shaped shearstrake and the central part of the wreck from the north
(fotografija / photo by: Ph. Groscaux)

The fifth and upper strake (P7) is the sheerstrake (Figs II.8 – II.10). It has an L-shaped section oriented towards the interior of the hull and is 3-4.3 cm thick. This carved L-shaped timber has two (possibly three) rectangular, open mortises, the function of which is still uncertain (Fig. II.10). The mortises are, respectively, 4.5 cm and 7 cm long, 1.3 cm and 2.5 cm wide, and are spaced 20 cm apart. The possible third mortise at the southern end is placed 23 cm from the previous one.

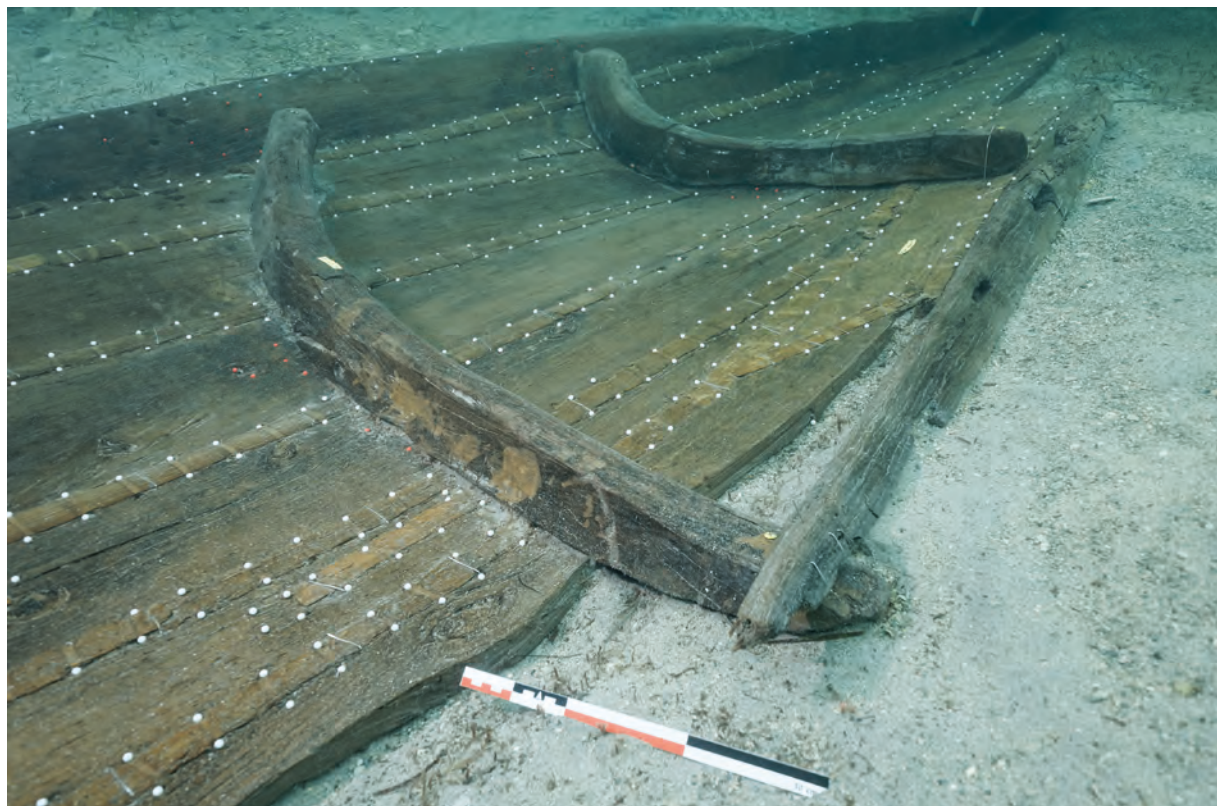
II.9

Završni voj L profila i rebrenice R2 i R1
The L-shaped sheerstrake and the floor-timbers R2 and R1
(fotografija / photo by: Ph. Groscaux)

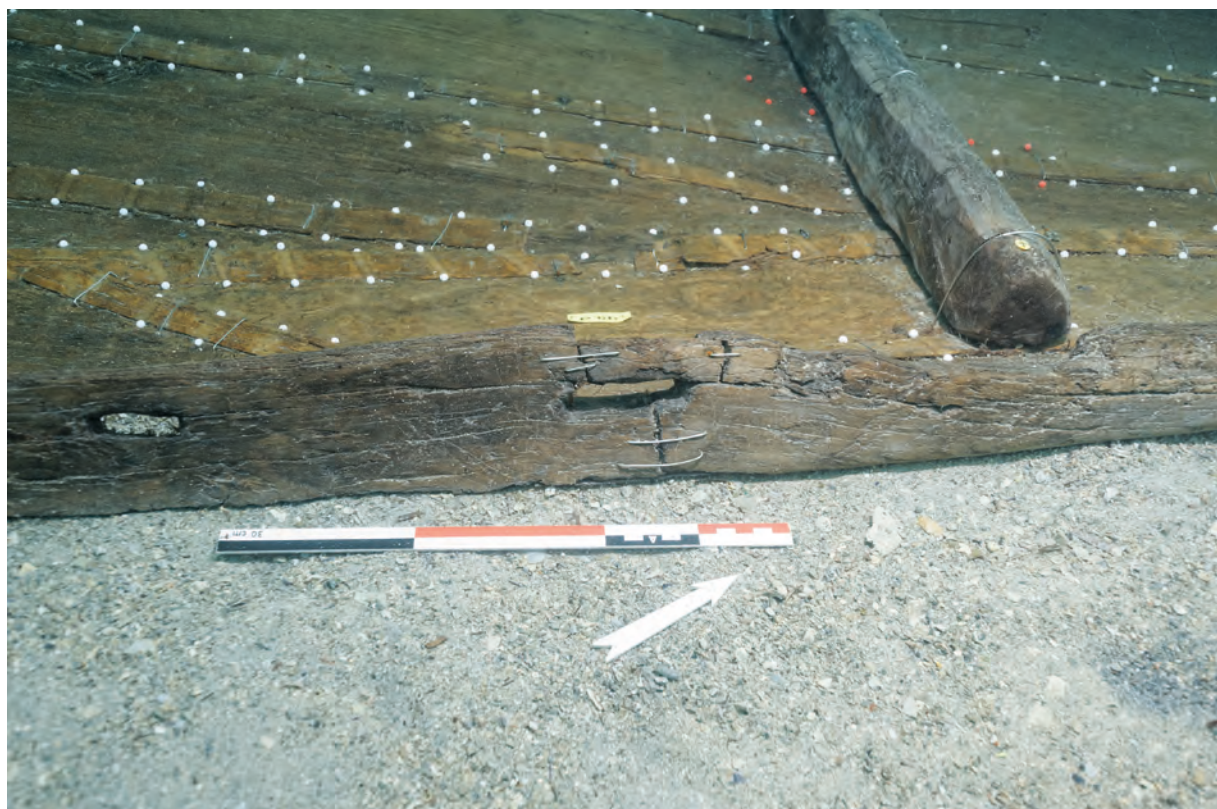
II.10

Četverokutni utori na gornjoj strani završnog voja L profila. Na fotografiji se s desne strane vidi gornji kraj rebrenice R1
The pair of rectangular holes carved in the upper face of the L-shaped sheerstrake. On the right side of the image, the top end of floor-timber R1 is visible
(fotografija / photo by: Ph. Groscaux)

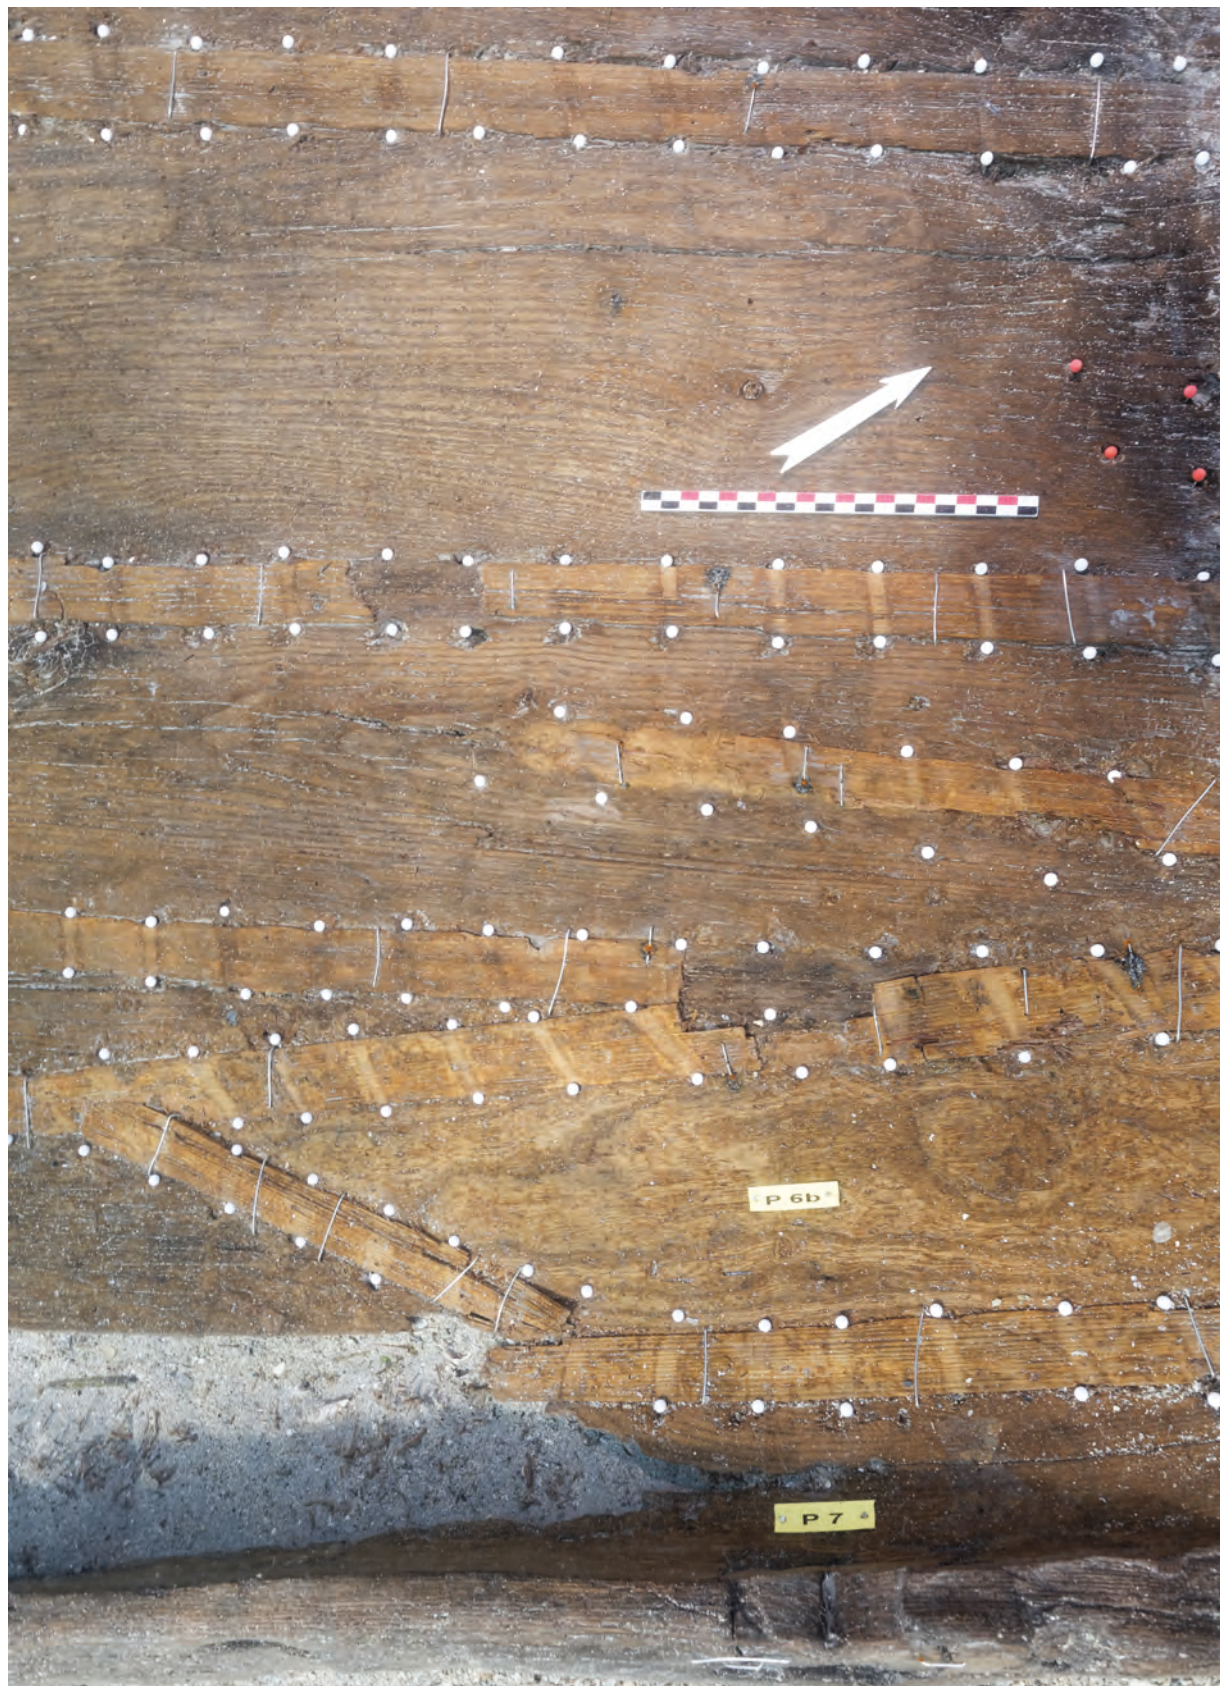
II.11

The strakes from P3 (top) to the L-shaped sheerstrake P7 (bottom). Note the diagonal scar in the strake joining planks P6a and P6b, and the repair of a crack in the middle of plank P4. The white drawing pins indicate the position of pegs locking the stitches in place (fotografija / photo by: Ph. Groscaux)

The strakes, which are flush-laid, are assembled using a longitudinal sewing system (Figs II.11, II.12). The stitches were made of vegetal fibres but have not been preserved. Instead, traces left by the cord are clearly visible on laths, placed over the seams before the planks

Thin laths, 3-4 cm wide, made of fir (*Abies alba*), were placed over the seams before sewing to hold wadding (Figs II.11, II.12, II.21). Under the lath, some loose vegetal fibres were found mostly belonging to sea-grasses (*Cymodocea nodosa*) and, to a minor extent, to moss (*Neckera crispa*). Reasonable doubt exists about whether the sea-grass remains were part of the original material used for waterproofing. The roots of these marine plants covered the wooden structures and entered

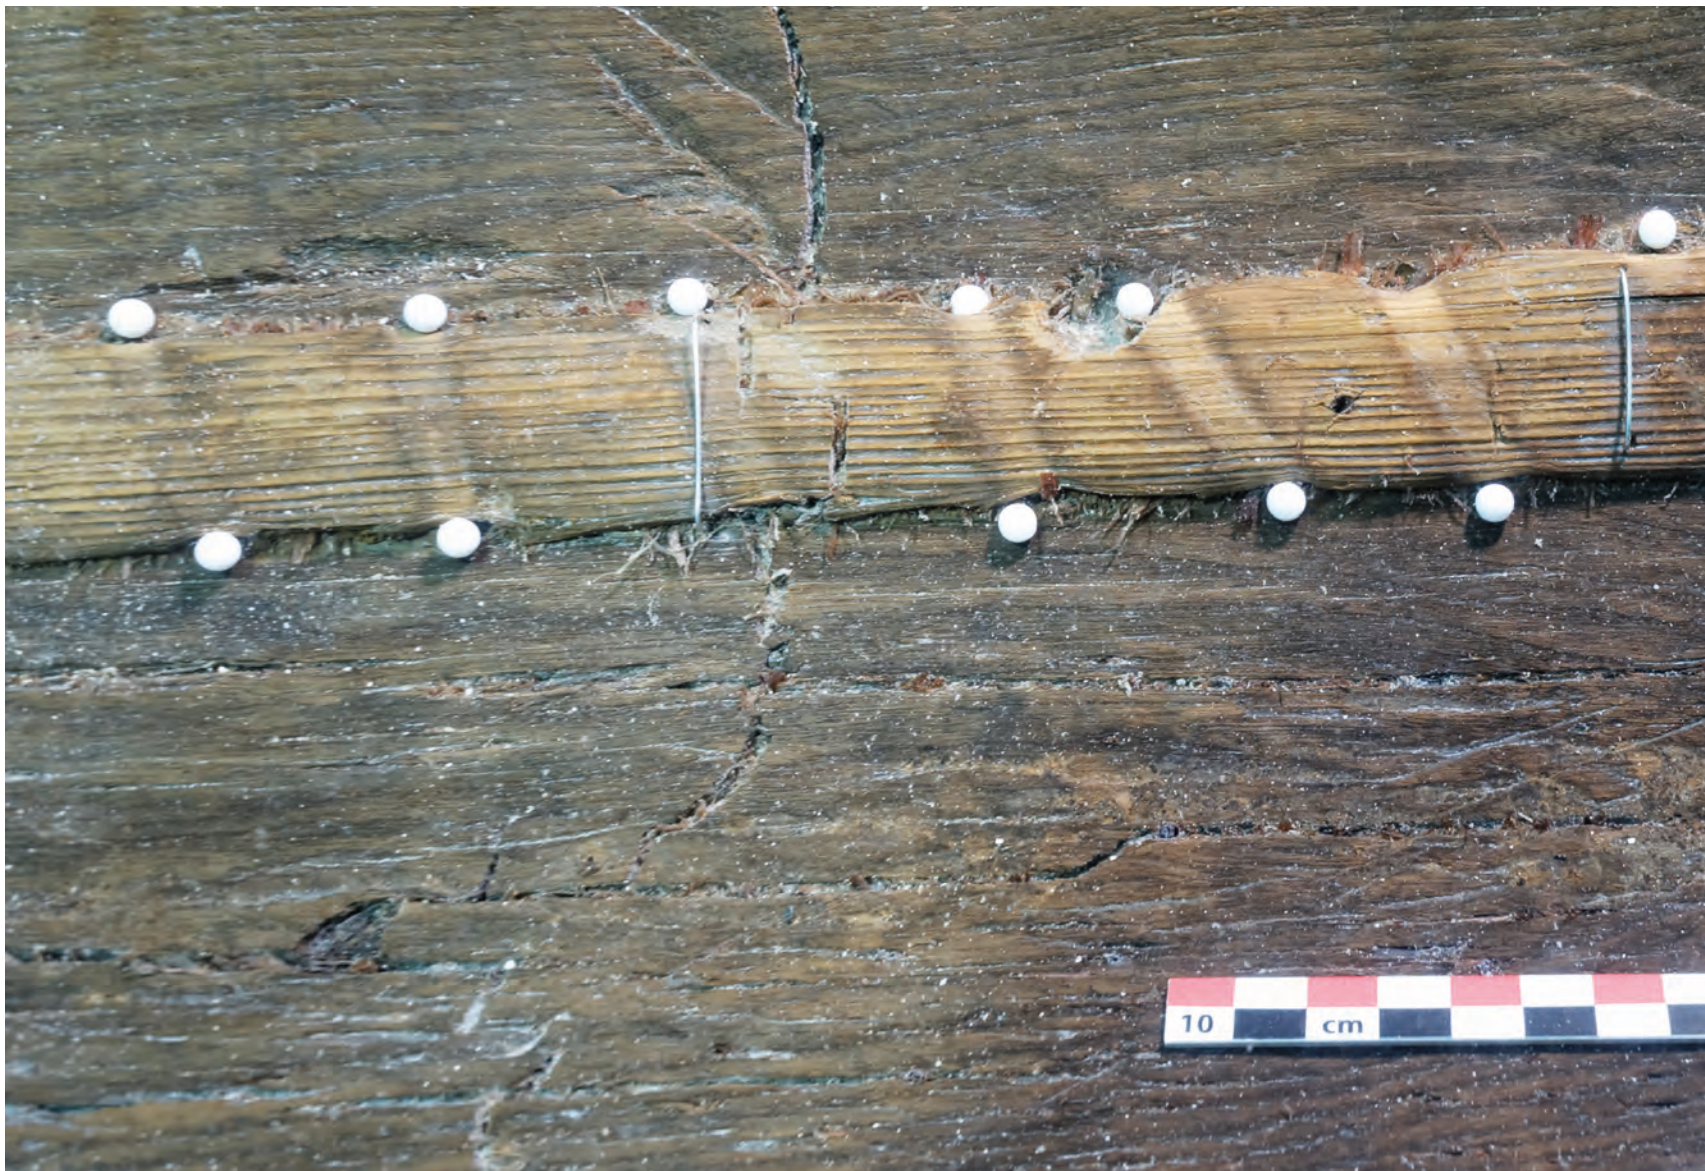
II.12

Detalj tragova od ligature na letvici postavljenoj preko sljubnica platica
Detail of the marks left by ligature on the laths placed over the seams
 (fotografija / photo by: Ph. Groscaux)

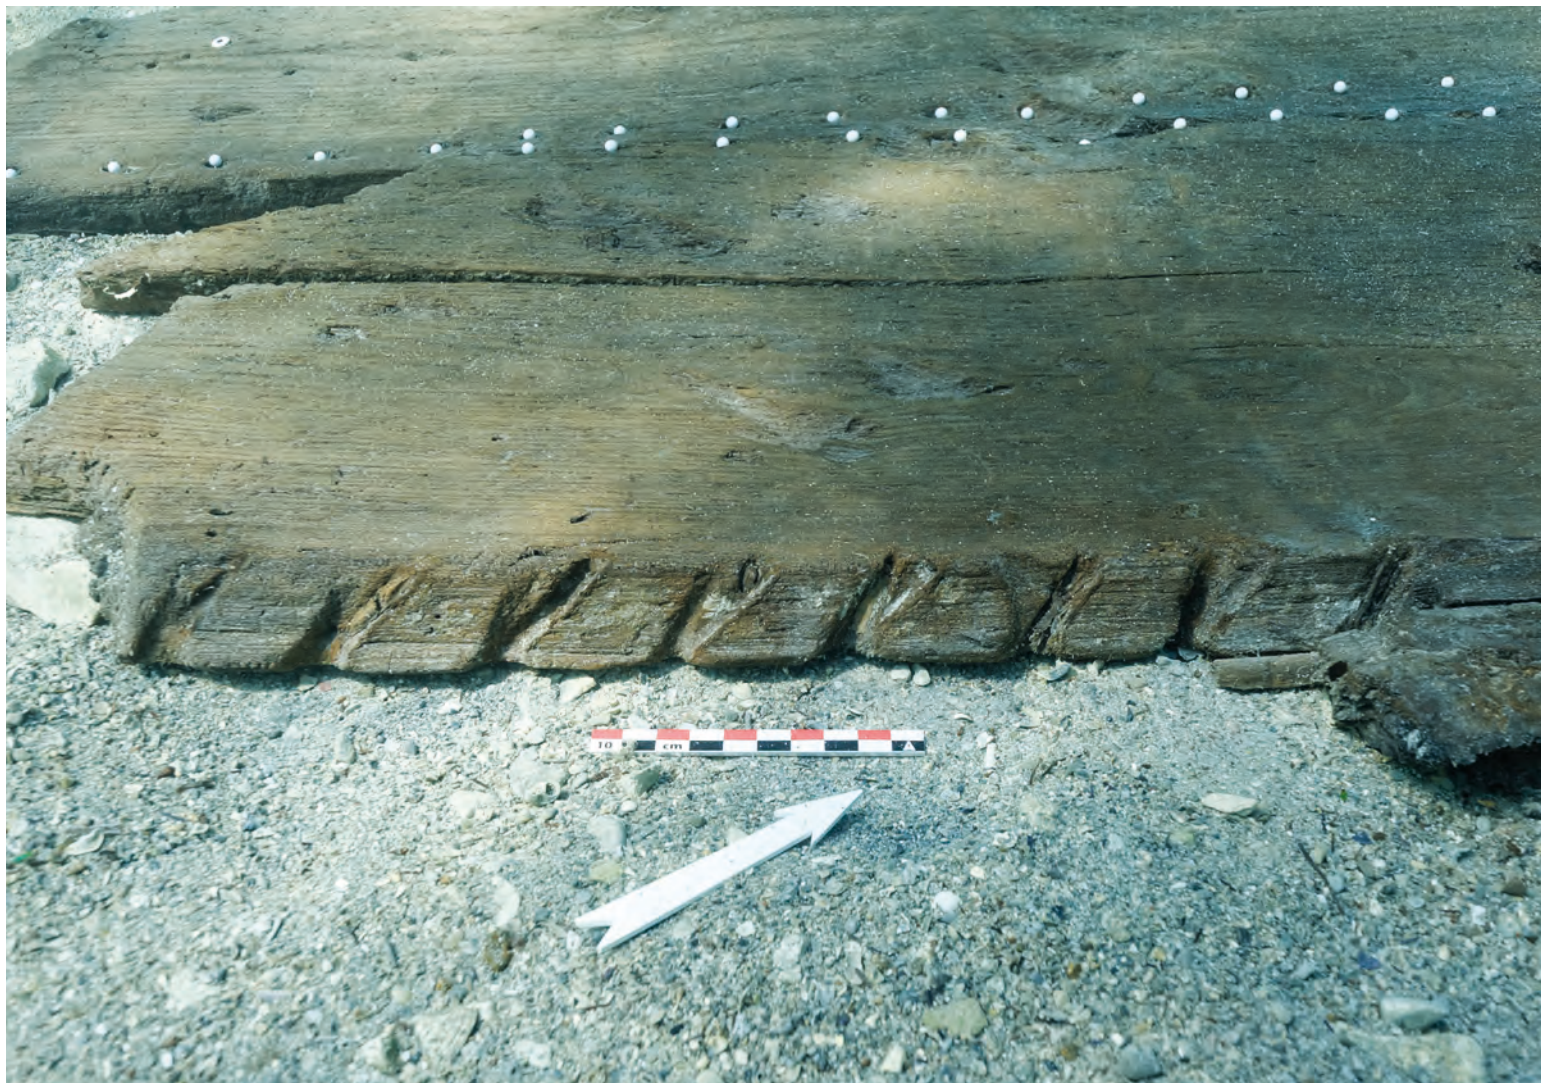
II.15
Pogled na slomljeni kraj kobiličnog
 elementa P2 sa zakošenim rupama
 za šavove
View of the broken end of the
 keel-like timber P2 with oblique
 holes for stitches
 (fotografija / photo by: Ph. Groscaux)

The sewing consists of simple over-edge stitches (/// pattern) going through oblique stitch holes cut diagonally, rather than perpendicularly, to the plank edges (Fig. II.13, II.15, II.16). The angle of the sewing isn't regular, the angle of the stitches varies while they remain parallel to each other. The stitches were spaced 2 to 4.5 cm apart.

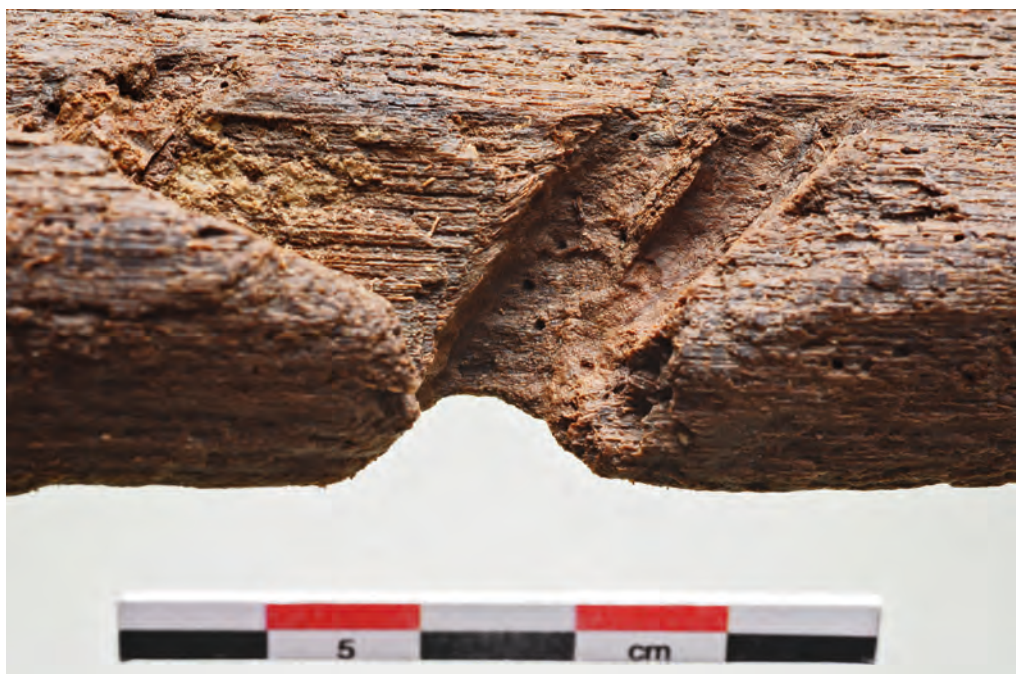
II.16
Detaljni prikaz žljebova koji čine
 rupu na fragmentu platiće PRL19
Detail of the grooves composing a
 stitch hole on plank fragment PRL19
 (fotografija / photo by: Ph. Groscaux)

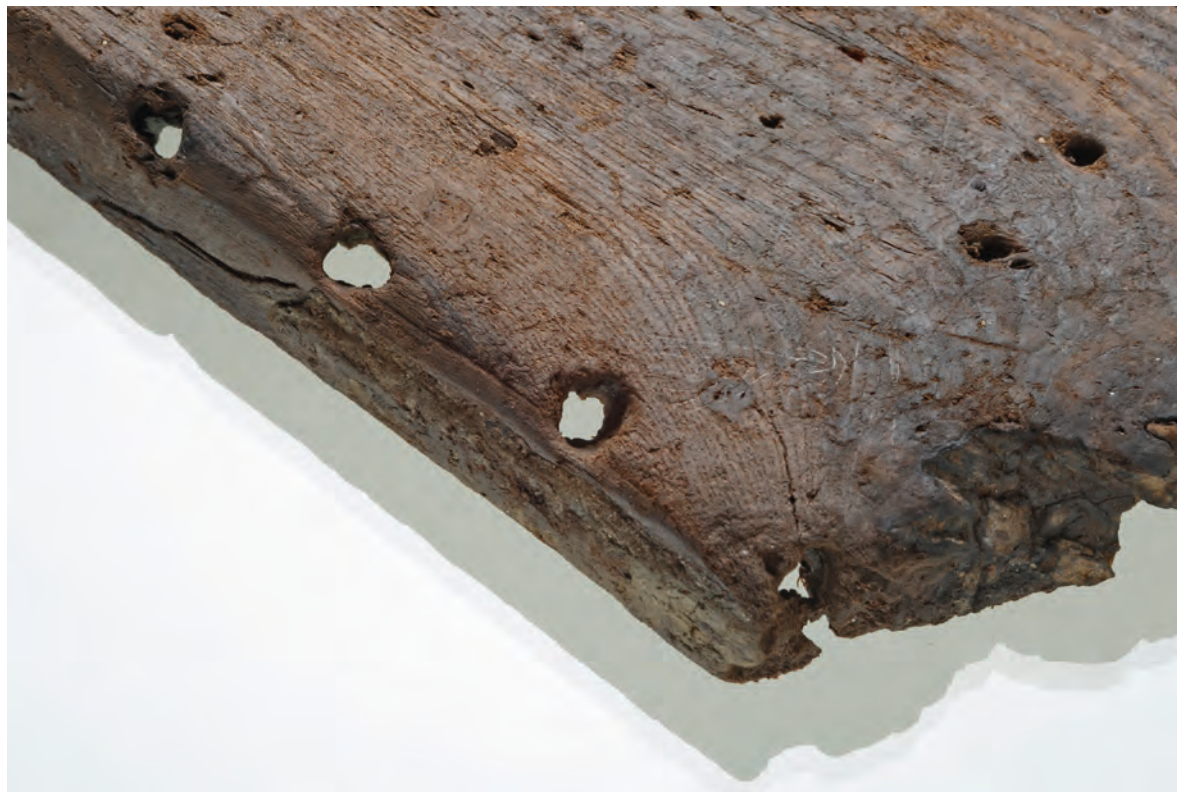
II.18

Detail of the outboard chamfered edge of plank fragment PRL11
(fotografija / photo by: Ph. Groscaux)

The external plank edges are chamfered to allow the passage of the ligature without it protruding (Figs II.14, II.18). Each stitch hole is composed of two or three grooves carved with a gouge or a drill (Fig. II.17). For that reason, the section of these holes isn't circular but oval and measures around 1 to 2 cm in width.

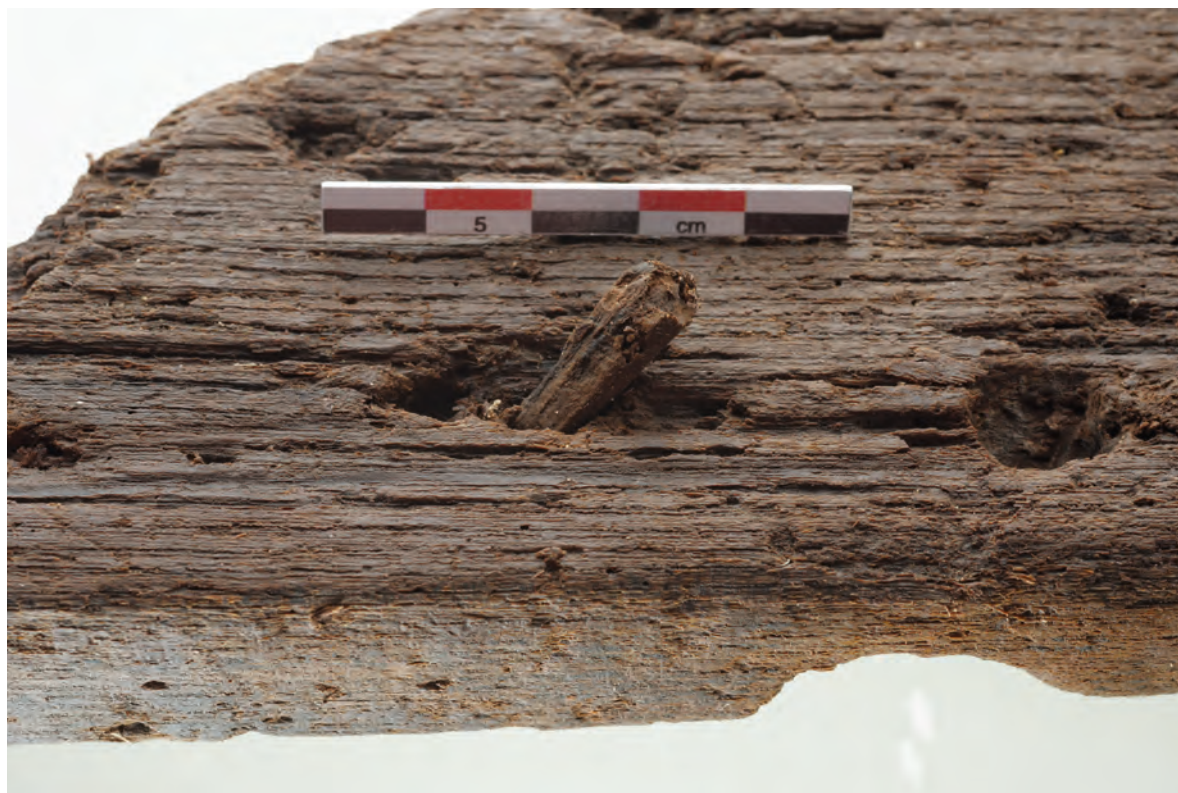
II.19
Detalj malog drvenog čavla koji je služio za zaptivanje šava, na fragmentu platiće PRL19
Detail of a peg used to lock the stitching on plank fragment PRL19 (fotografija / photo by: Ph. Groscaux)

Small tapered and sharpened pegs, at least one to three for each stitch hole, locked each stitch in place (Fig. II.19, II.20). The pegs, obtained from splitting

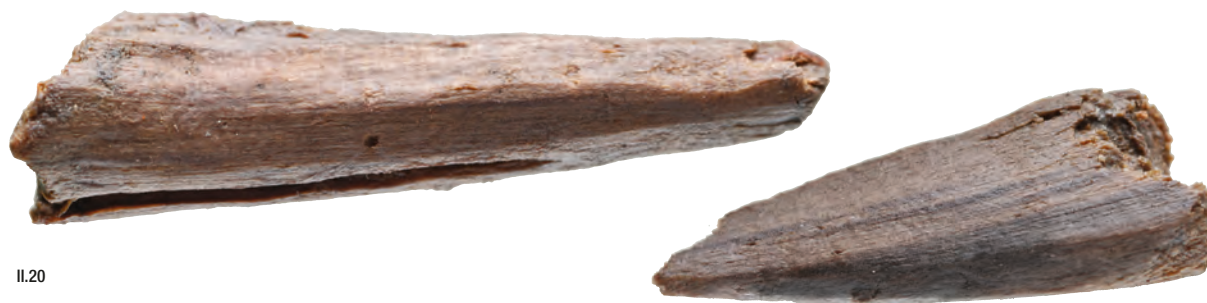
II.20
Mali drveni čavli za zaptivanje rupe šava
Pegs used to lock a stitch (fotografija / photo by: Ph. Groscaux)

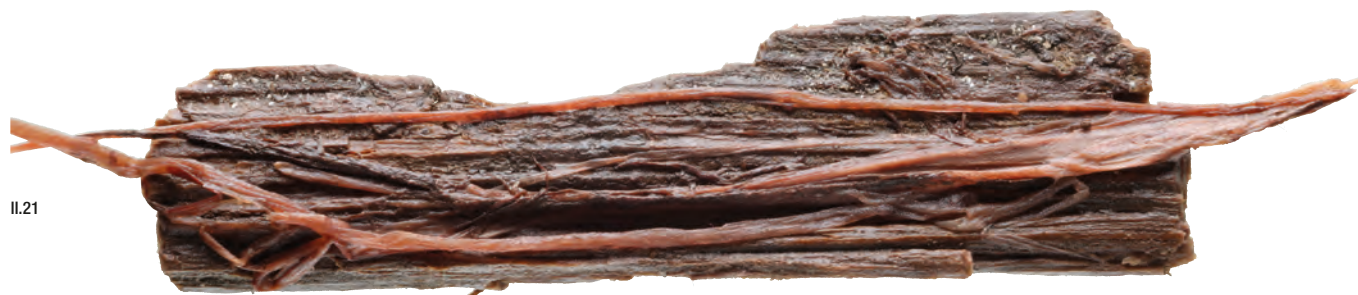
II.21
Ulomak letvice s ostatkom biljnog materijala koji je korišten za osiguravanje vodonepropusnosti sljubnica
Fragment of a lath with remains of the vegetal fibres used for waterproofing (fotografija / photo by: Ph. Groscaux)

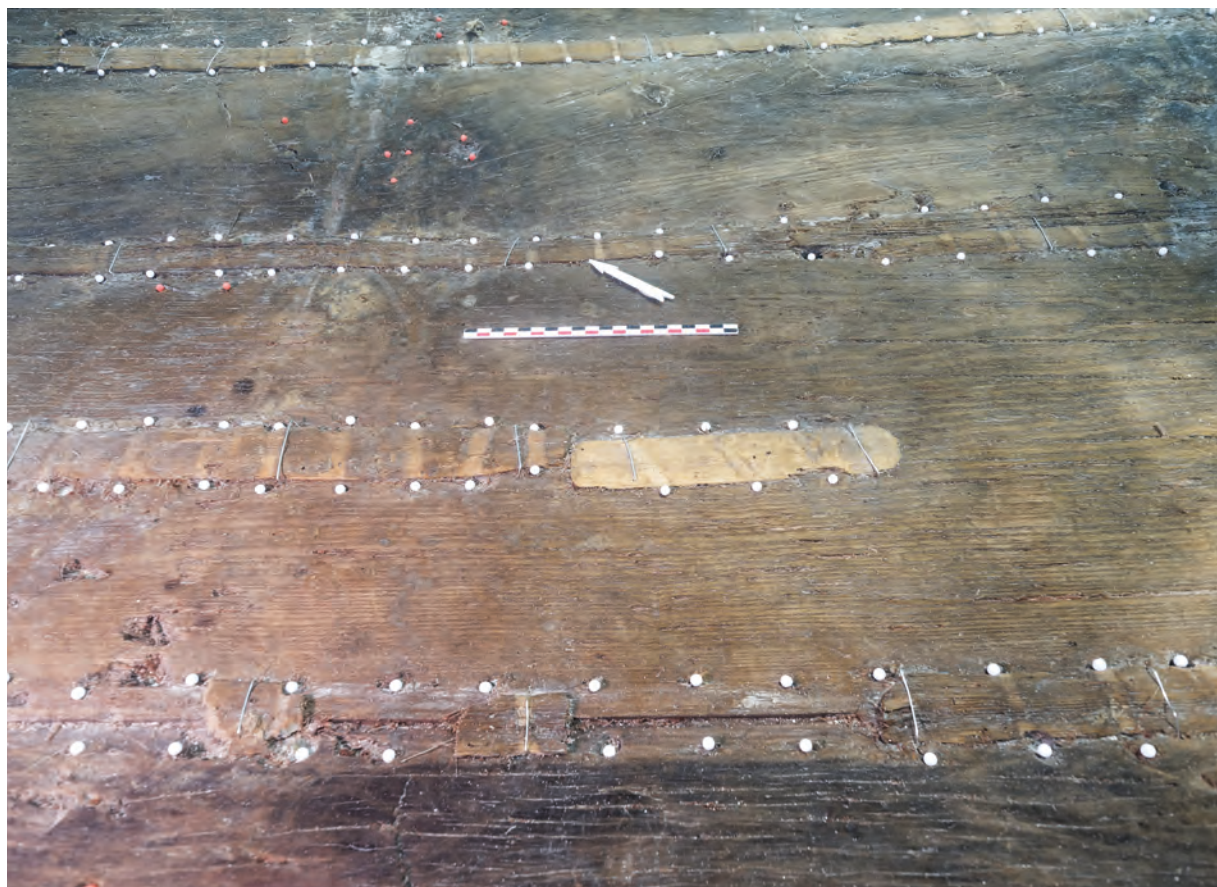
II.22
 Pogled na popravak pukotine u
 sredini kobiličnog elementa P2
 View of the crack repairs in the
 middle of keel-like timber P2
 (fotografija / photo by: Ph. Groscaux)

Some cracks in the planking (P4 and P5) and the keel-like timber P2, were repaired using the same sewing technique and the same system of wadding and ensuring the watertightness of the vessel (Figs II.2, II.22). It is difficult to know if these repairs were done during the construction or later during the working life of the boat.

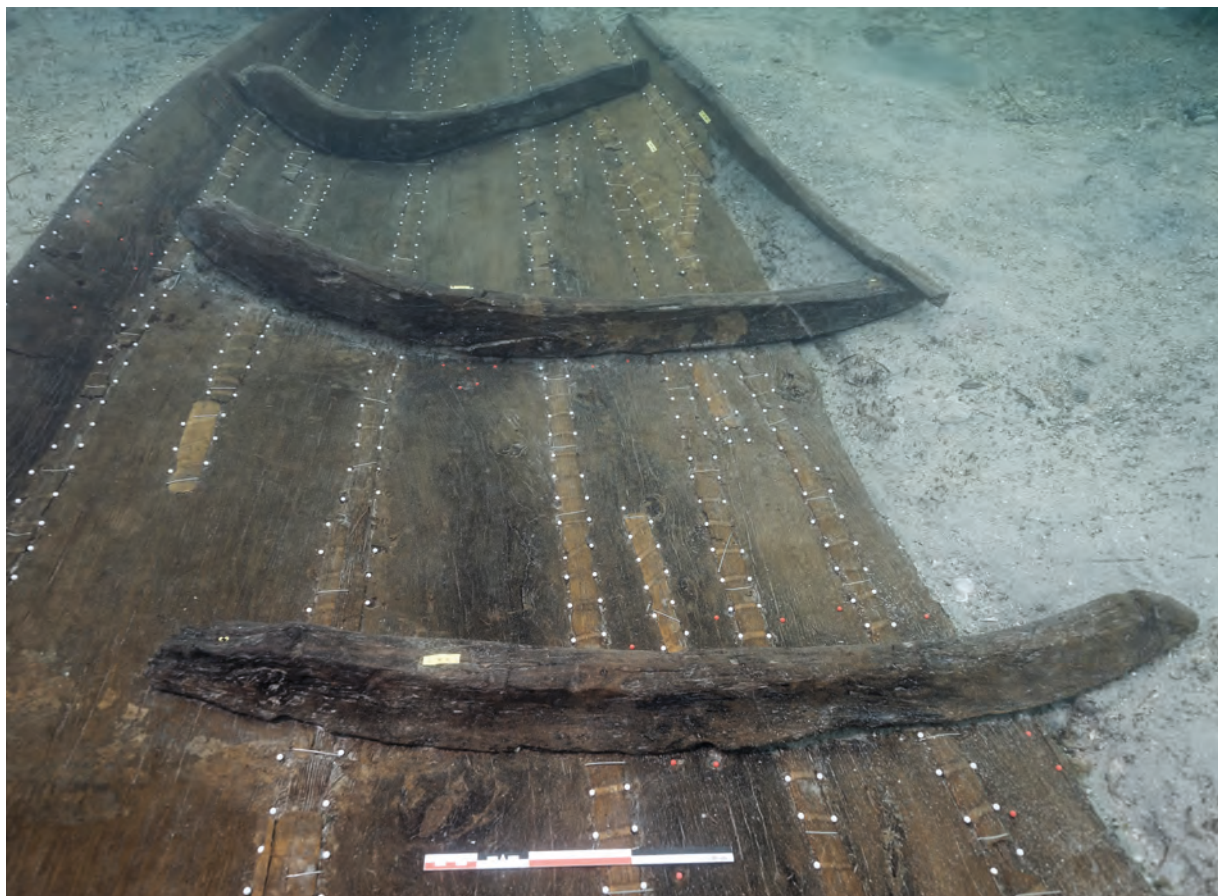
II.24
Pogled s juga na tri sačuvane rebrenice
View from the south of the three preserved floor-timbers
(fotografija / photo by: Ph. Groscaux)

Three floor-timbers (R1, R2 and R3) were found *in situ*, and traces of three additional frames were identified, one at the north (R0), and two at the south (R4 and R5) (Fig. II.23). The tops of the eastern arms are preserved, while the western arm is broken (Figs II.24 – II.26).

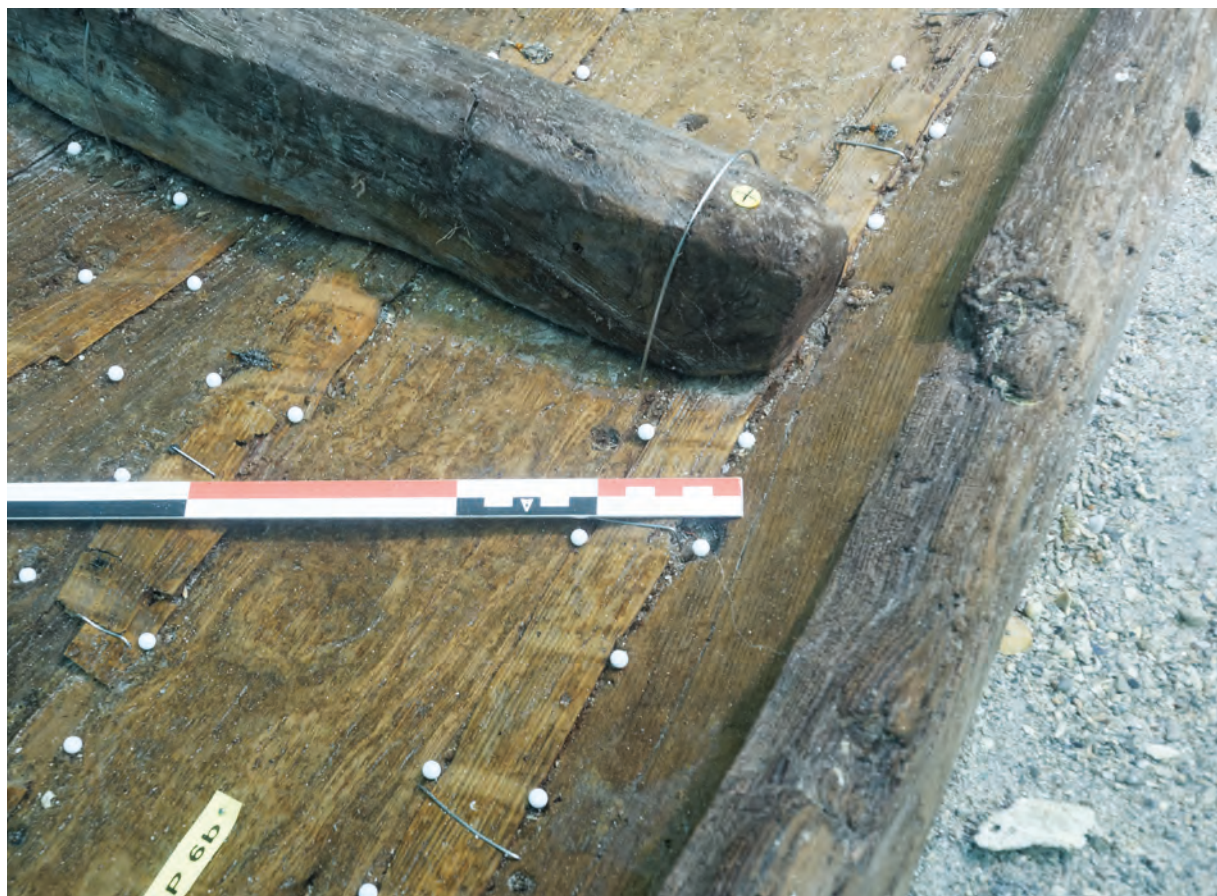
II.25
Potpuno sačuvani istočni kraj
rebrnice R1
The complete eastern end of
floor-timber R1
(fotografija / photo by: Ph. Groscaux)

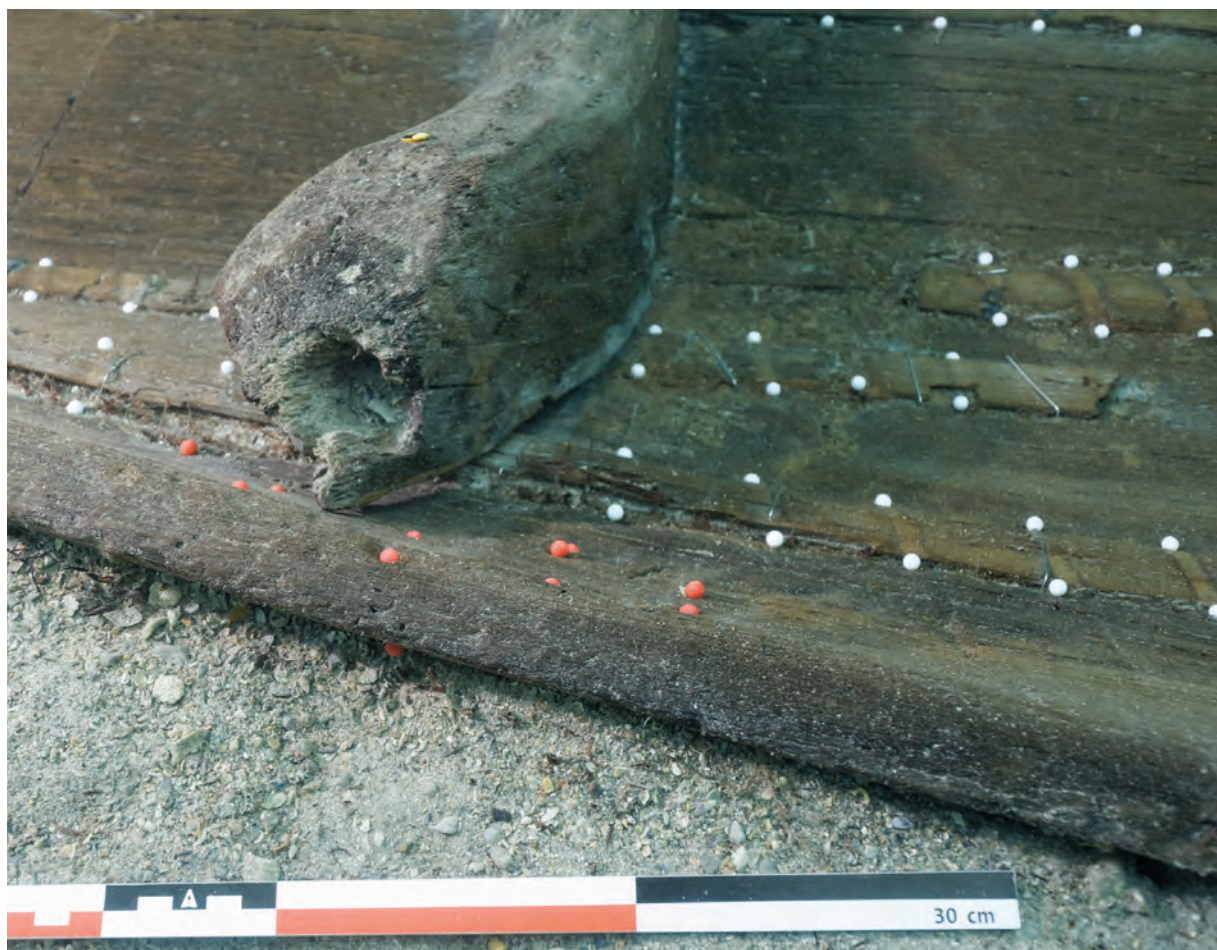
II.26
Uništeni zapadni kraj
rebrnice R1
The broken western end
of floor-timber R1
(fotografija / photo by: Ph. Groscaux)

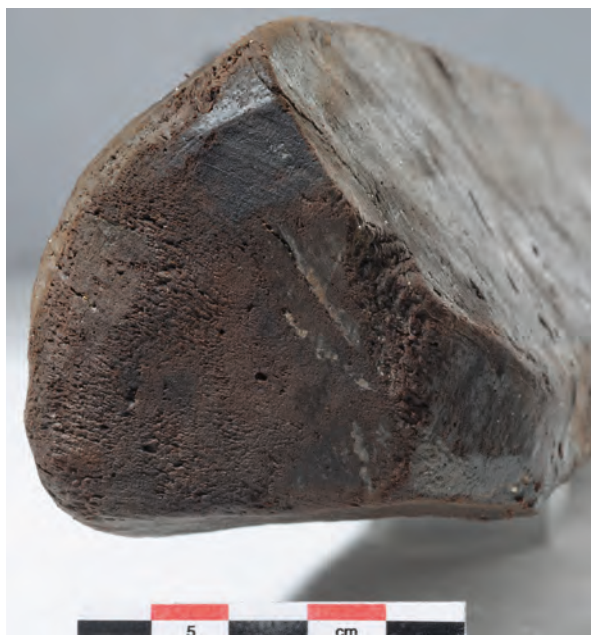
II.27
Trapezoidni presjek s uskom bazom i zaobljenom gornjom površinom rebrenice R1
The trapezoidal section with a narrow foot and rounded upper surface of floor-timber R1
 (fotografija / photo by: Ph. Groscaux)

Widely spaced (around 83 cm on average), these floor-timbers have a trapezoidal section (8.4 cm wide, 11.3 cm high on average) with a narrow foot and a rounded, wider upper surface (Fig. II.27). Two of these frames (R1 and R3) are made of alder (*Alnus* sp.), while the third (R2) was obtained from a wild pear tree (*Pyrus communis* L.).

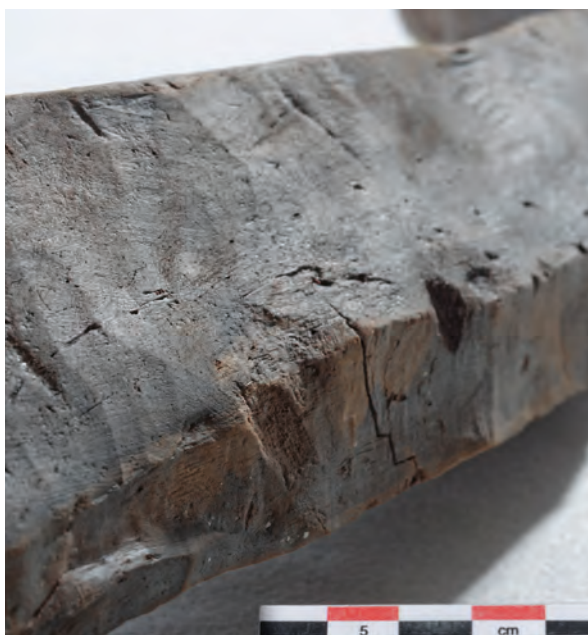
II.28
Tragovi obrade drva na bočnoj strani i bazi rebrenice R1
Woodworking marks on the side and foot of floor-timber R1
 (fotografija / photo by: Ph. Groscaux)

The lower face of the floor-timbers is smooth and shaped to match the inner surface of the planking (Fig. II.28). Fine marks visible on the lower face may have been produced by friction between the frames and the laths.

The surface of the frames is carefully worked and many tool marks left by the axes used are evident (Figs II.28, II.31). The use of chisels and other cutting blades is attested in particular for fashioning the limber holes (Figs II.32, II.34).
