The hull structure

Giulia Boetto, Marko Uhač, Ida Koncani Uhač

Giulia Boetto, Marko Uhač, Ida Koncani Uhač. The hull structure. I. Koncani Uhač; G. Boetto; M. Uhač. Zambratija. Prapovijesni šivani brod. Rezultati arheološkog istraživanja, analiza i studija / Prehistoric sewn boat. Results of the Archaeological Research, Analysis and Study, 33, Arheološkom muzeju Istre, pp.62-87, 2020, Monografije i katalozi, 978-953-8082-50-4. halshs-02986179

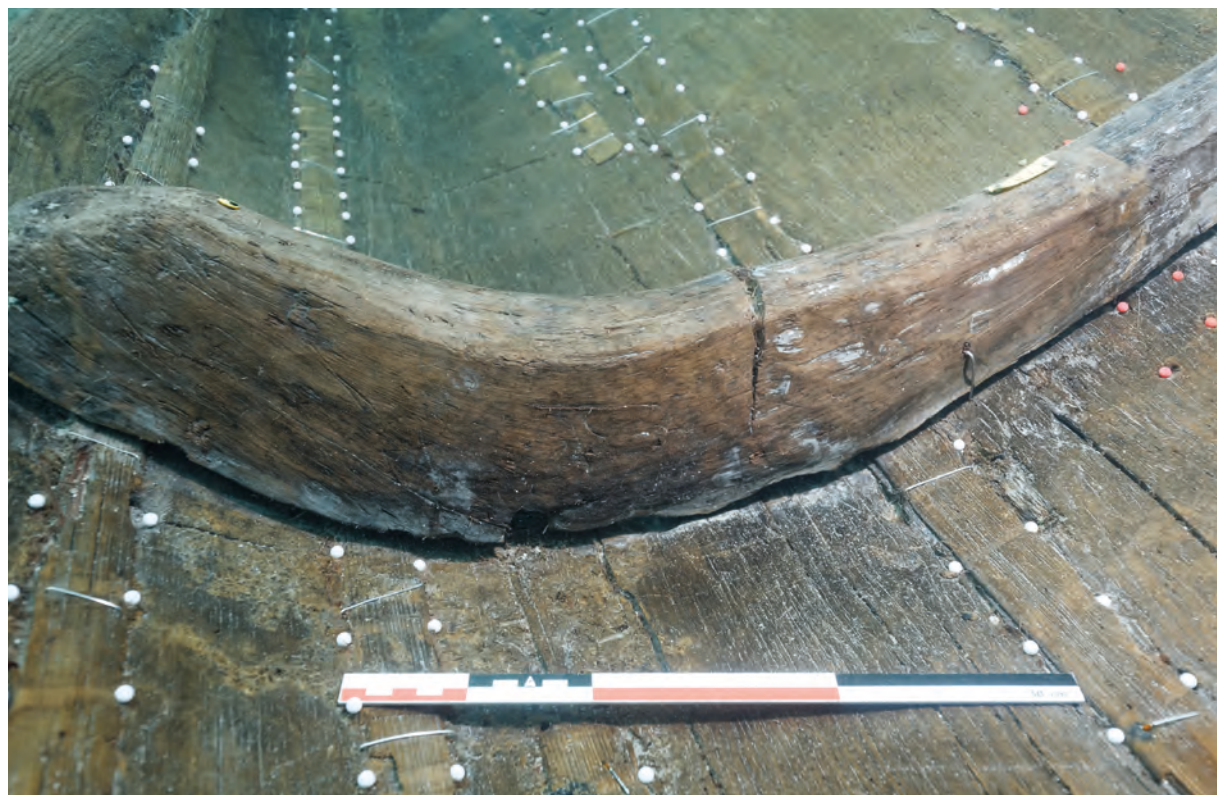
II.30
Četverokutna središnja slivnica
rebrenice R1
The quadrangular central limber
hole of floor-timber R1
(fotografija / photo by: Ph. Groscaux)

Additionally, the foot of each floor-timber was carved with limber holes, allowing the circulation of bilge water. Floor-timber R1 has a single quadrangular central limber hole (2.6 cm wide, 1-1.6 cm high) (Figs II.29 – II.32), while floor-timber R2 has two trapezoidal limber holes spaced 16 cm apart and 3 cm wide, 1.1-1.8 cm high (Figs II.33, II.34). No limber holes are present in floor-timber R3.

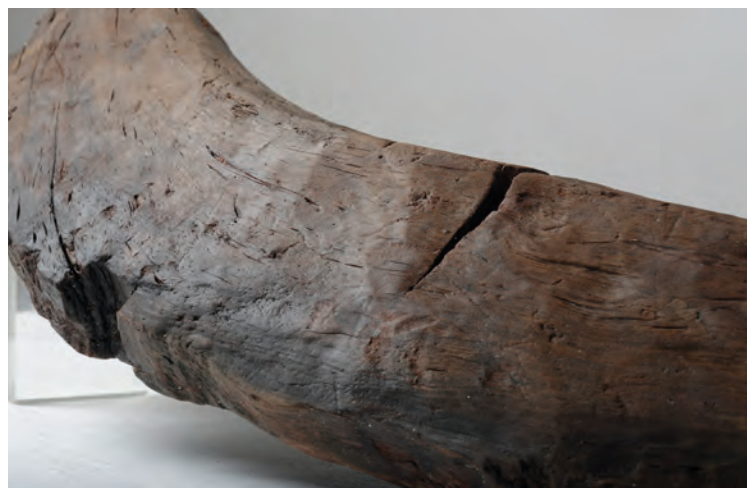
II.31
Četverokutna središnja slivnica
rebrenice R1
The quadrangular central limber
hole of floor-timber R1
(fotografija / photo by: Ph. Groscaux)

The surface of the frames is carefully worked and many tool marks left by the axes used are evident (Figs II.28, II.31). The use of chisels and other cutting blades is attested in particular for fashioning the limber holes (Figs II.32, II.34).

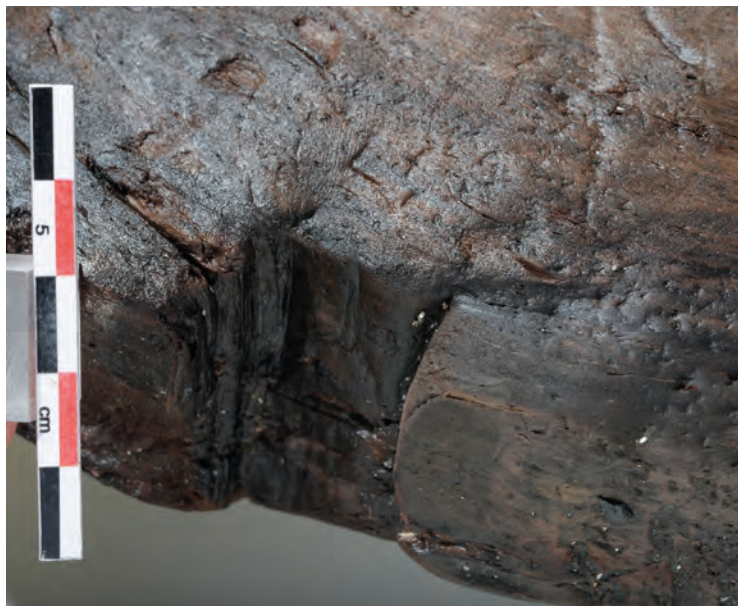
II.32
Tragovi obrade na četverokutnoj
 središnjoj slivnici rebrenice R1
Woodworking marks on the
 quadrangular central limber hole of
 floor-timber R1
 (fotografija / photo by: Ph. Groscaux)

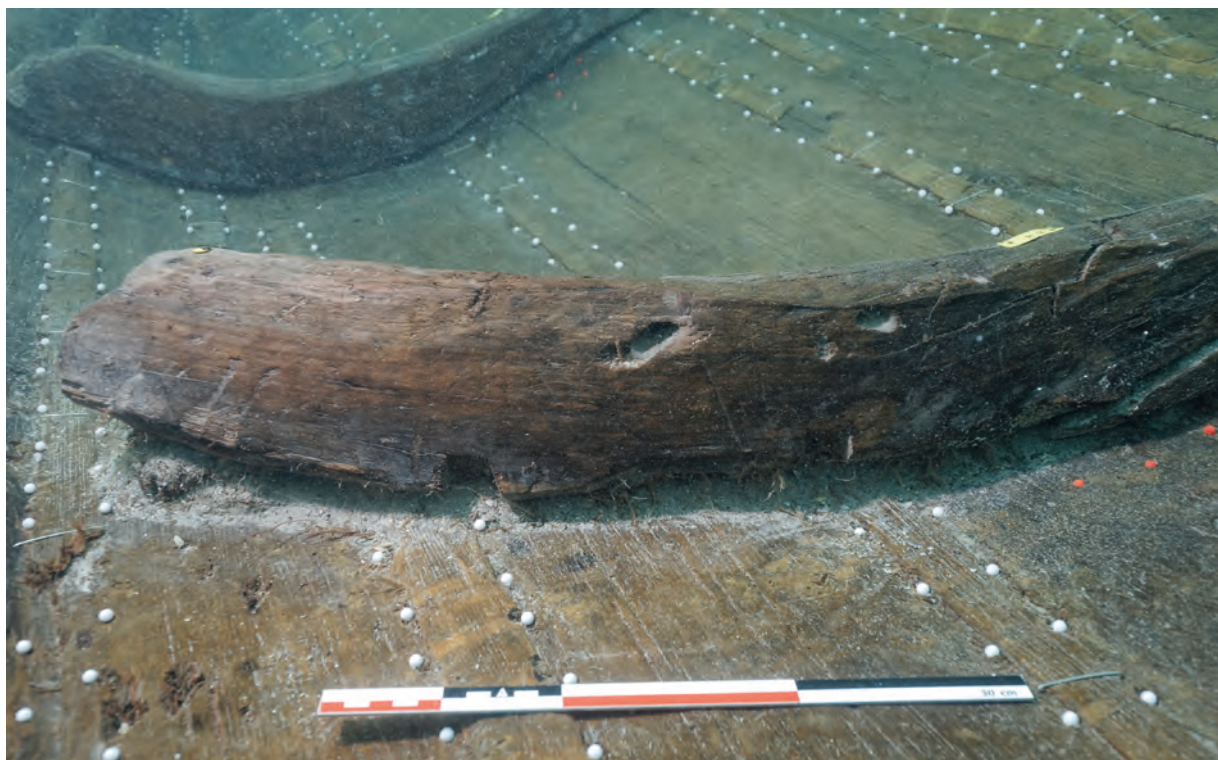
II.33
Pogled s juga na rebrenicu R2.
 Dvije slivnice su vidljive na njenom
 dnu
View from the south of floor-timber
 R2. The two limber holes are visible
 at its base
 (fotografija / photo by: Ph. Groscaux)

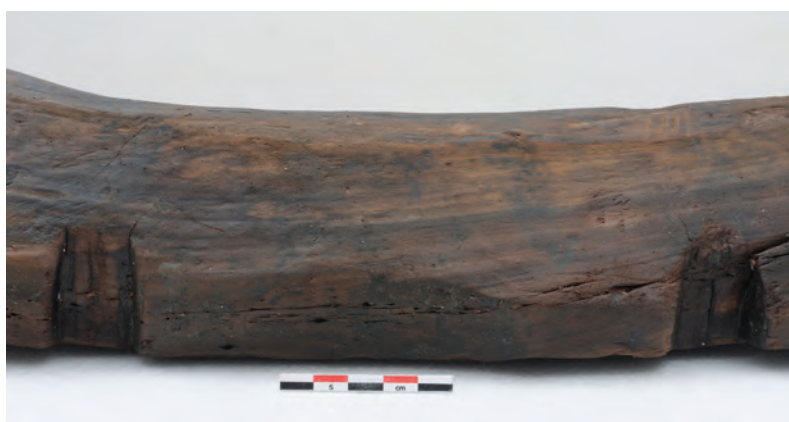
II.34
Par četverokutnih slivnica na
 rebrenici R2
Detail of the pair of rectangular
 limber holes of floor-timber R2
 (fotografija / photo by: Ph. Groscaux)

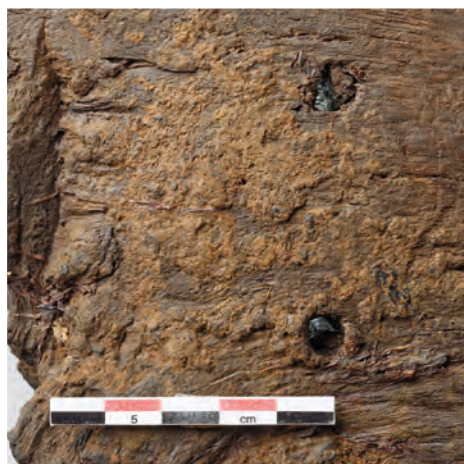
Fragment platice PRL11 s vidljivim rupama za šavove i parom rupa u sredini za vezanje rebra

(Figs II.14, II.35 – II.38). Groups of plugged holes in the planking were observed along the frames (Fig. II.23), but the reconstruction of the lashing pattern is not possible without a more detailed observation of the wooden remains, which will be possible only after the planks are raised from the seabed. Nevertheless, the displaced plank fragment (PRL19), which was retrieved from the seabed, fortunately retained a pair of lashing holes. These holes have an inboard diameter (8 mm) slightly bigger than the outboard diameter (6-7 mm), so the space between them is 2.4 cm inboard and 3.5 cm on the outboard face of the plank. The lashing seems to be very basic, and on the outer face the holes are not joined by a groove that would protect the lashing.

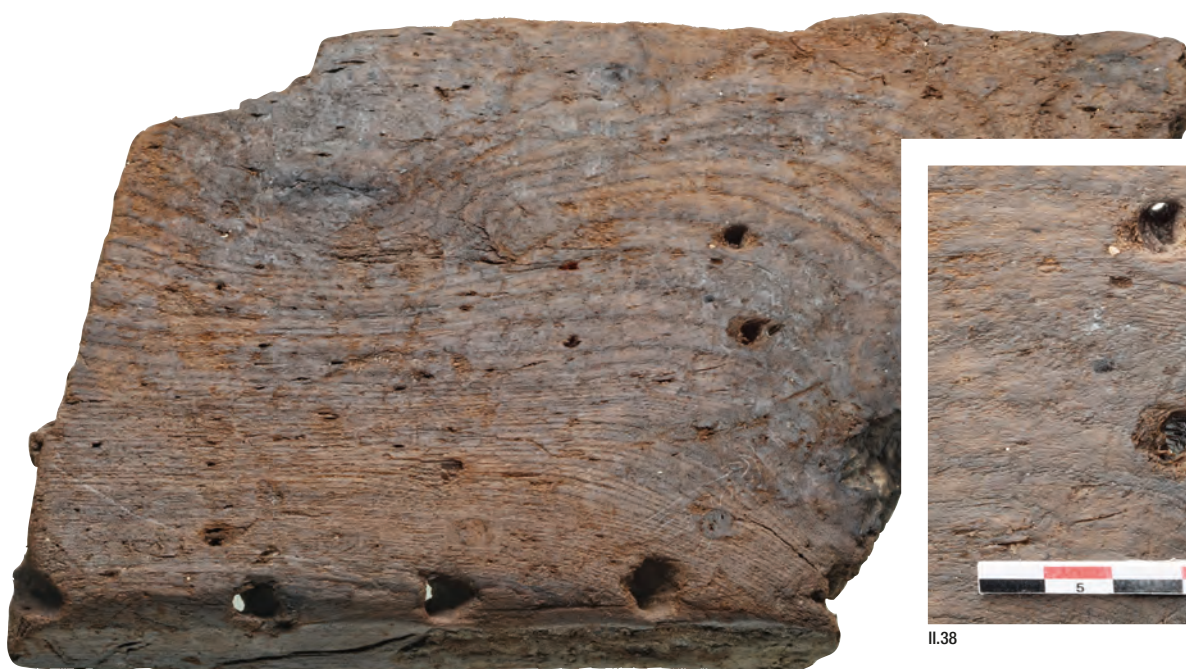
Detail of the pair of oblique holes used for lashing the frame in place on the outside surface of plank fragment PRL11 (fotografija / photo by: Ph. Groscaux)
