The hull structure

Giulia Boetto, Marko Uhač, Ida Koncani Uhač

Giulia Boetto, Marko Uhač, Ida Koncani Uhač. The hull structure. I. Koncani Uhač; G. Boetto; M. Uhač. Zambratija. Prapovijesni šivani brod. Rezultati arheološkog istraživanja, analiza i studija / Prehistoric sewn boat. Results of the Archaeological Research, Analysis and Study, 33, Arheološkom muzeju Istre, pp.62-87, 2020, Monografije i katalozi, 978-953-8082-50-4. halshs-02986179

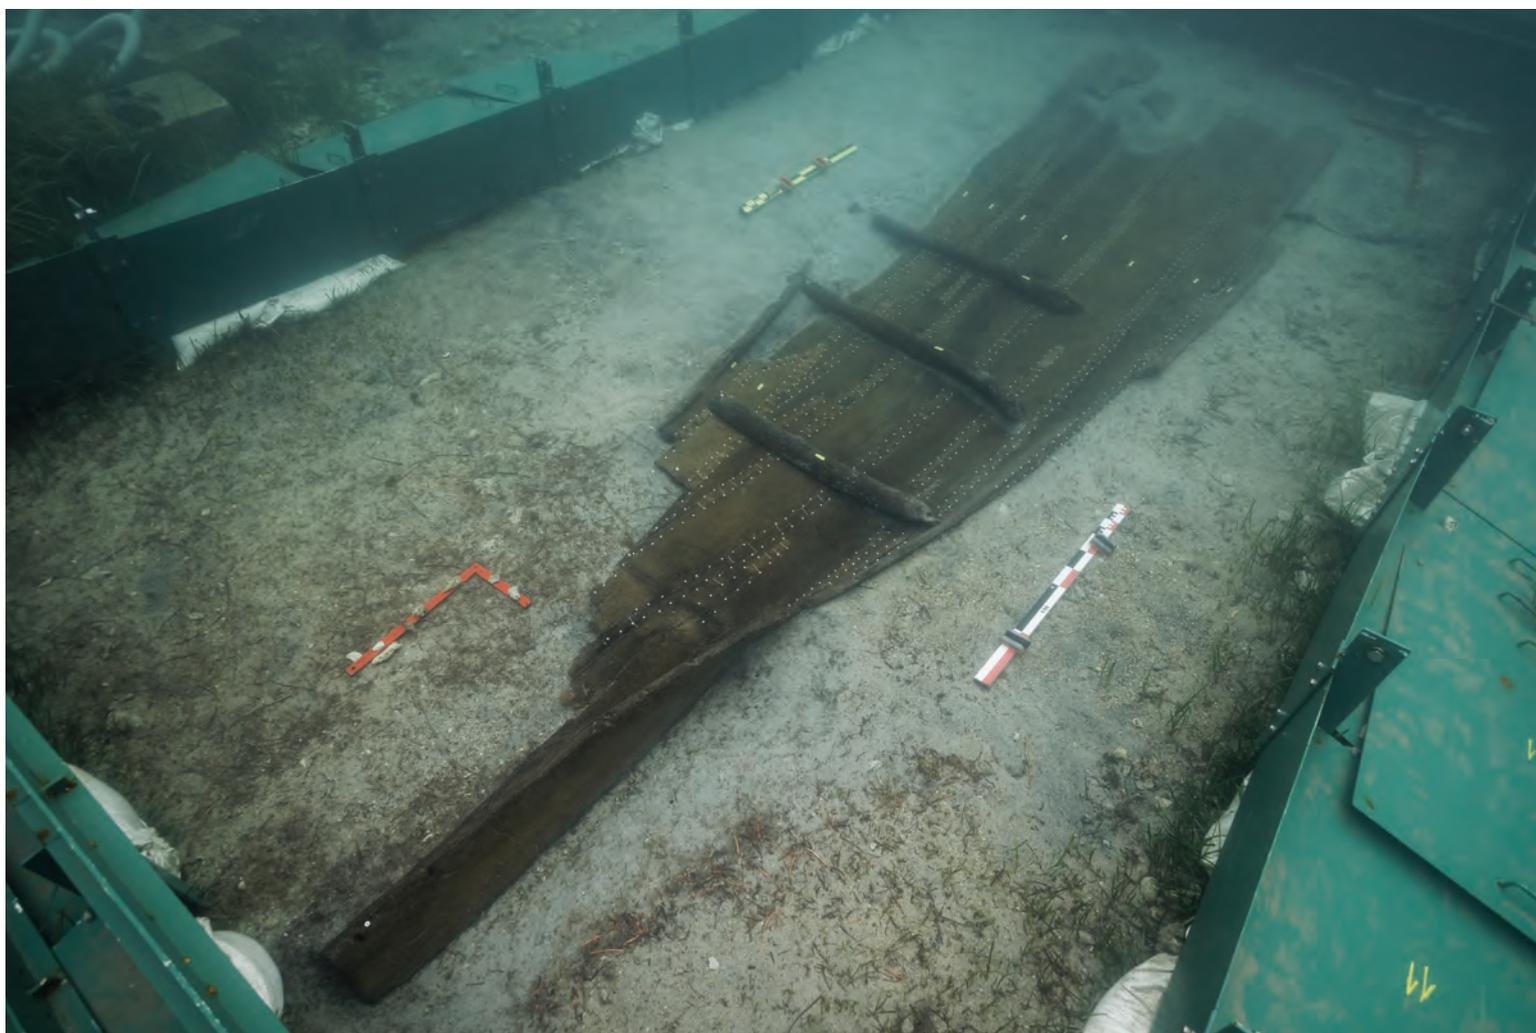
View of the wreck from the north. Two quadrants and two photographic scales are positioned around the wreck remains for the purposes of photogrammetric survey (fotografija / photo by: Ph. Groscaux)

The wreck is oriented NE - SW with one preserved end of the hull pointing towards the beach. When the vessel sunk, it came to rest on one side, thus the western side is poorly preserved while the eastern side survives up to the sheerstrake (Figs II.1 – II.3).

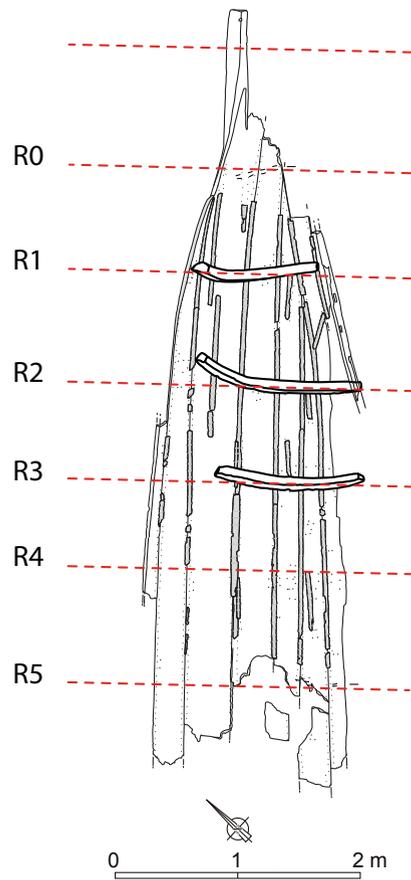
II.3
Poprečni presjeci
Cross sections
(crtež / drawing by: V. Dumas)

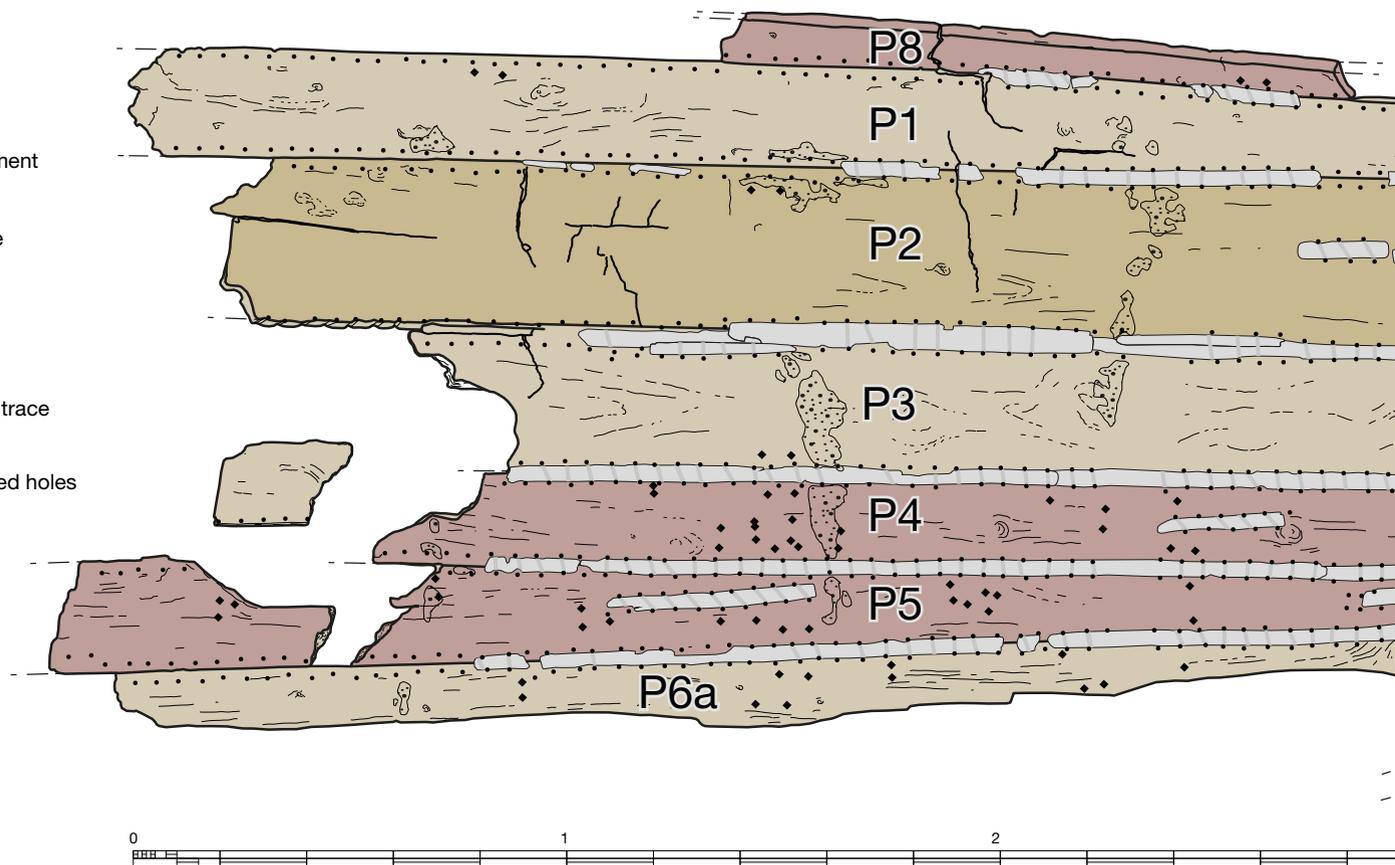
II.4
Brodsko oplata
The planking
(crtež / drawing by: V. Dumas)

A single piece of wood (P2) obtained from the trunk of an elm (*Ulmus* sp.) with a diameter of more than 40 cm constitutes the longitudinal axial element of the vessel (Fig. II.4). At the main frame, it is flat, and 3 cm thick, while towards the north end its thickness increases to 21-23 cm (Figs II.5 – II.7).

Two strakes on the west side (P1 and P8) and five strakes on the east side (from P3 to P7) are also preserved (Fig. II.4). The planks are 2.8 cm thick on average (range 1.9 cm to 3.3 cm). Their width varies between 13.5 cm (P7) and 24.6 cm (P1). All are made of elm.

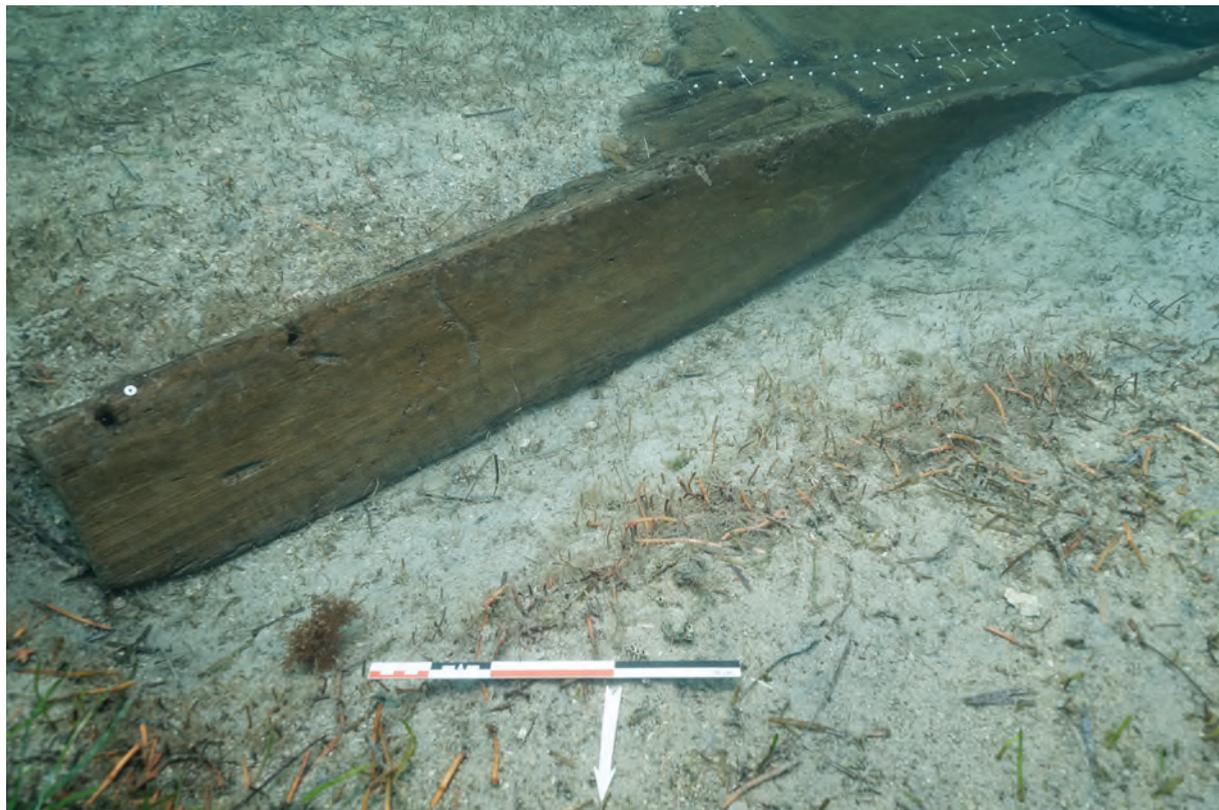
II.5

Šiljati sjeverni kraj kobličnog elementa, pogled sa sjevera
The pointed northern end of the keel-like timber viewed from the north
(fotografija / photo by: Ph. Groscaux)

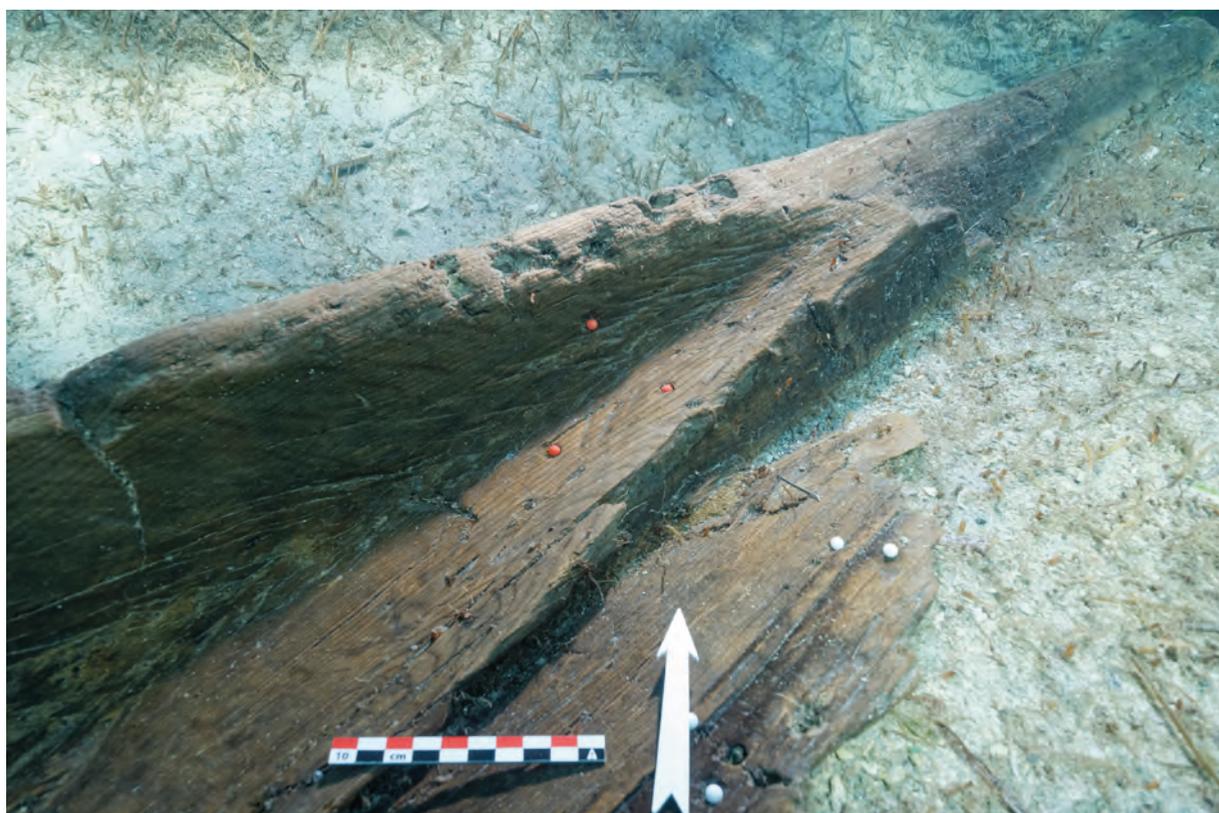
II.6

Tragovi alatki vidljivi na unutrašnjoj površini šiljatog sjevernog kraja
The woodworking marks visible on the interior surface of the pointed northern end
(fotografija / photo by: Ph. Groscaux)

carved to a sharp point. Some tool marks, either made with an axe or adze, are visible in the inboard surface. This major longitudinal timber plays, from an architectural and structural point of view, the role of a keel.

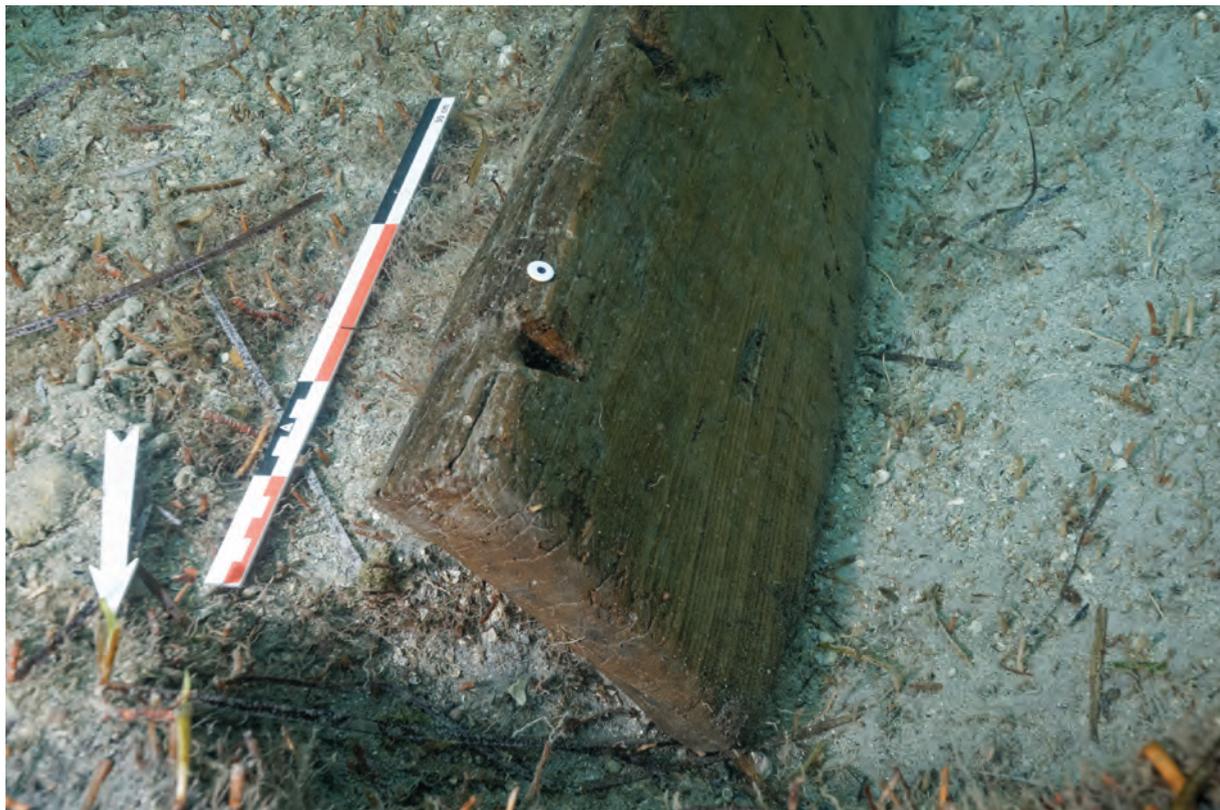
II.7

Detailed view of the pair of horizontal stitch holes carved in the pointed end of the keel-like timber
(fotografija / photo by: Ph. Groscaux)

At a distance of 7.6 cm from the keel-like timber's northern end, two horizontal holes, rectangular in section (1.3-1.5 cm wide and 2-2.8 cm high) and spaced 19 cm apart, have been noted (Fig. II.7). These were probably used to assemble another timber on top of the pointed end of the keel-like timber. This missing timber was probably carved from a single piece of wood to hold the ends of the strakes.

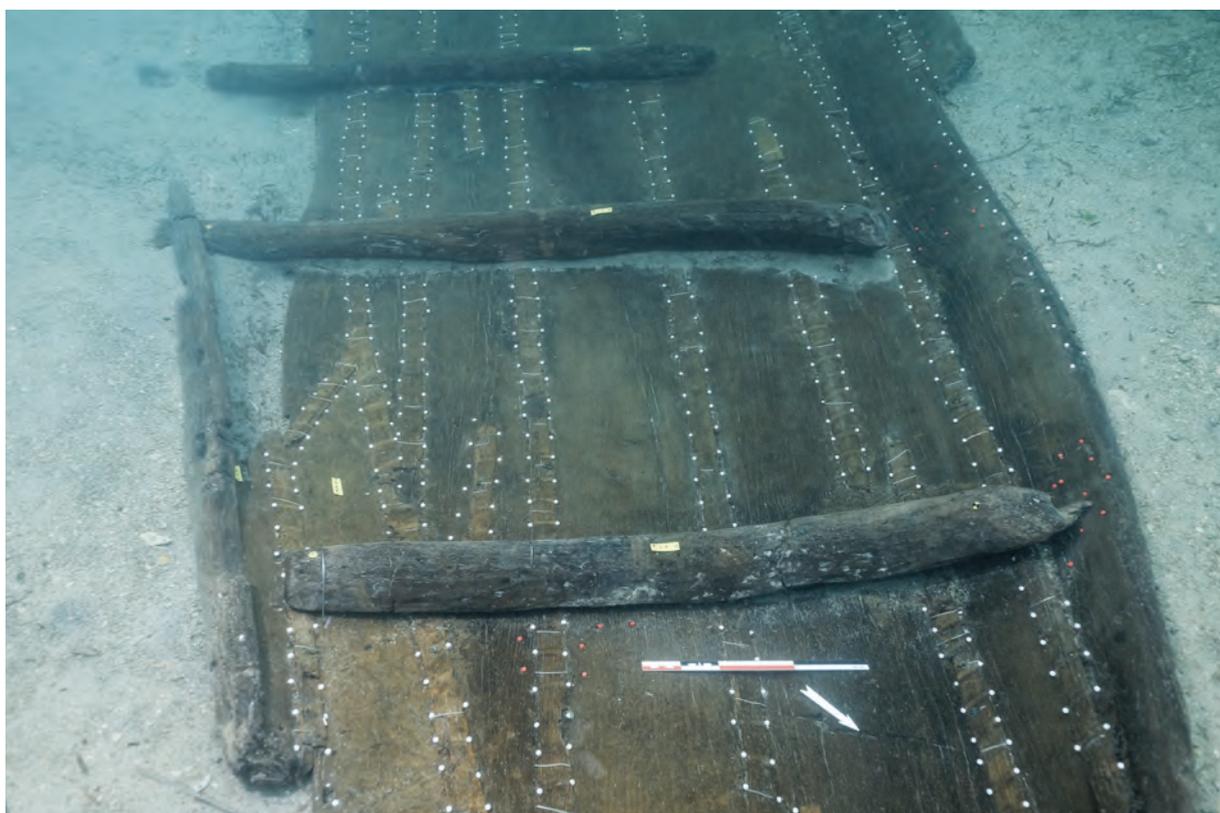
The L-shaped shearstrake and the central part of the wreck from the north
(fotografija / photo by: Ph. Groscaux)

The fifth and upper strake (P7) is the sheerstrake (Figs II.8 – II.10). It has an L-shaped section oriented towards the interior of the hull and is 3-4.3 cm thick. This carved L-shaped timber has two (possibly three) rectangular, open mortises, the function of which is still uncertain (Fig. II.10). The mortises are, respectively, 4.5 cm and 7 cm long, 1.3 cm and 2.5 cm wide, and are spaced 20 cm apart. The possible third mortise at the southern end is placed 23 cm from the previous one.

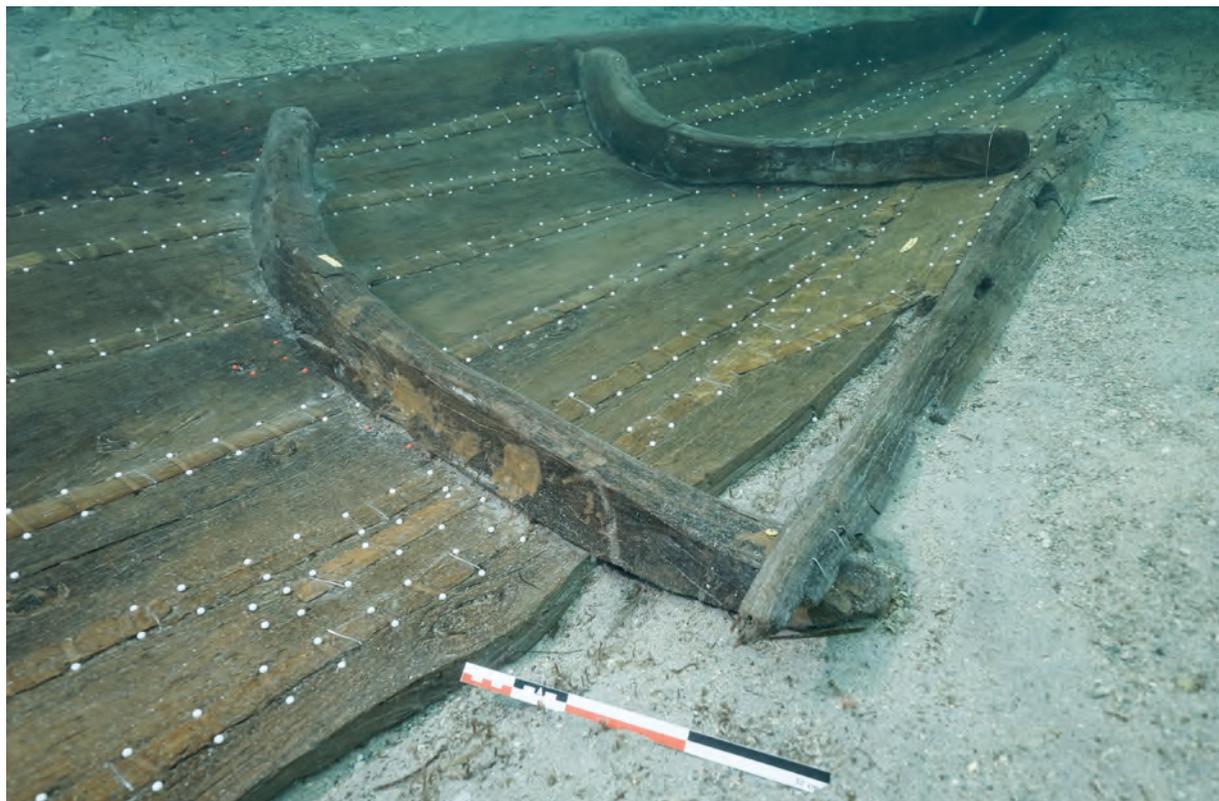
II.9

Završni voj L profila i rebrenice R2 i R1
The L-shaped sheerstrake and the floor-timbers R2 and R1
(fotografija / photo by: Ph. Groscaux)

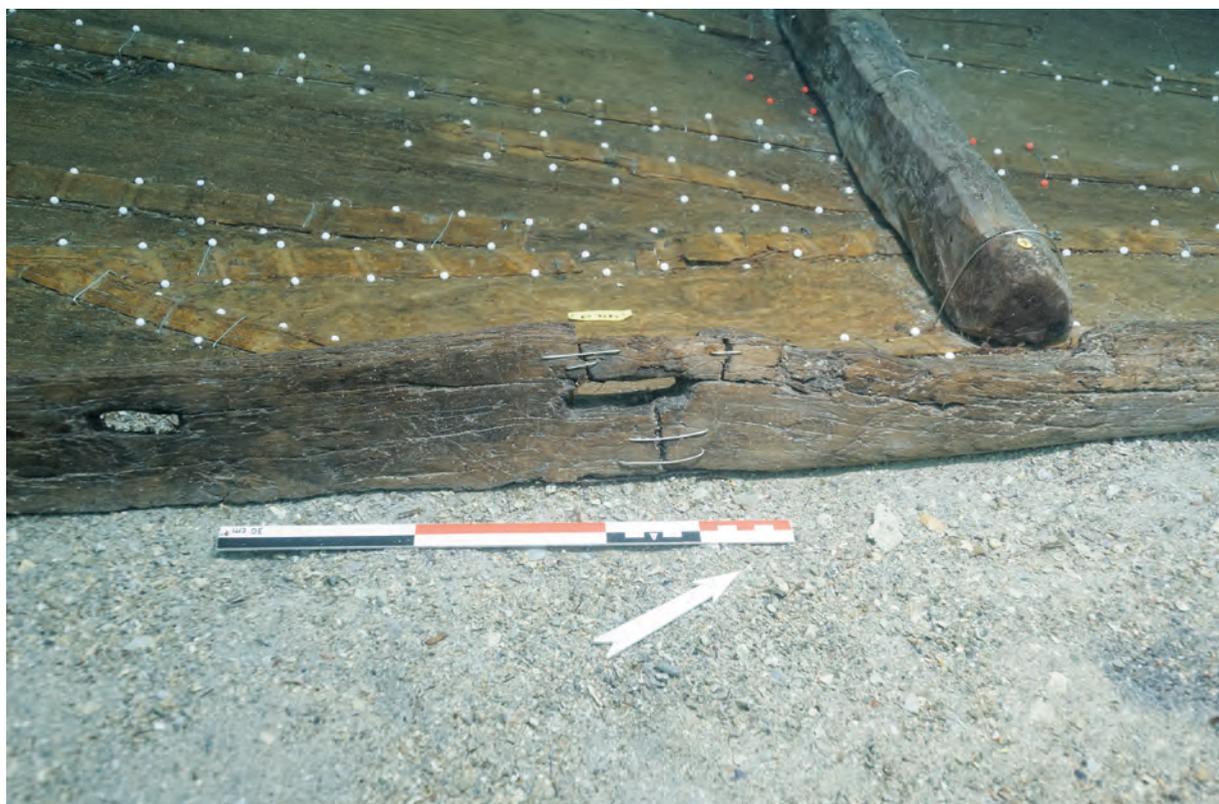
II.10

Četverokutni utori na gornjoj strani završnog voja L profila. Na fotografiji se s desne strane vidi gornji kraj rebrenice R1
The pair of rectangular holes carved in the upper face of the L-shaped sheerstrake. On the right side of the image, the top end of floor-timber R1 is visible
(fotografija / photo by: Ph. Groscaux)

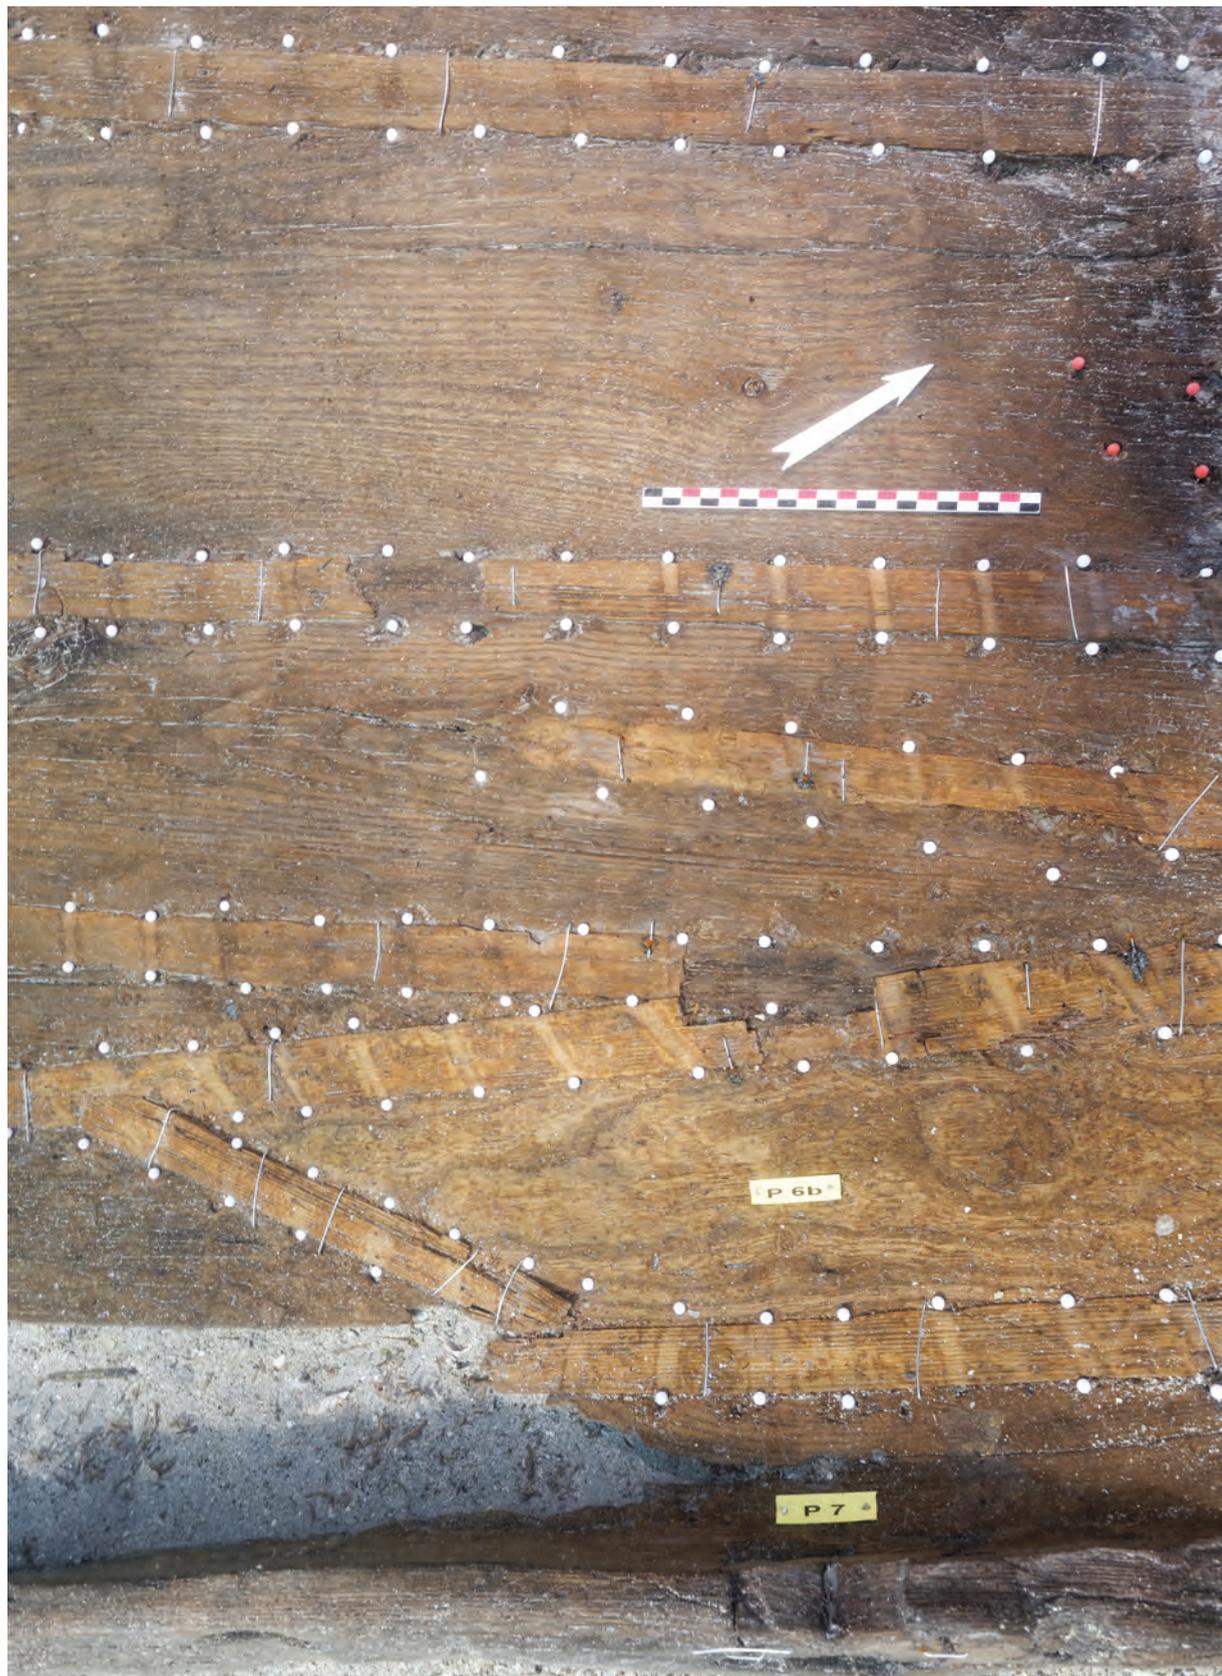
II.11

The strakes from P3 (top) to the L-shaped sheerstrake P7 (bottom). Note the diagonal scar in the strake joining planks P6a and P6b, and the repair of a crack in the middle of plank P4. The white drawing pins indicate the position of pegs locking the stitches in place (fotografija / photo by: Ph. Groscaux)

The strakes, which are flush-laid, are assembled using a longitudinal sewing system (Figs II.11, II.12). The stitches were made of vegetal fibres but have not been preserved. Instead, traces left by the cord are clearly visible on laths, placed over the seams before the planks

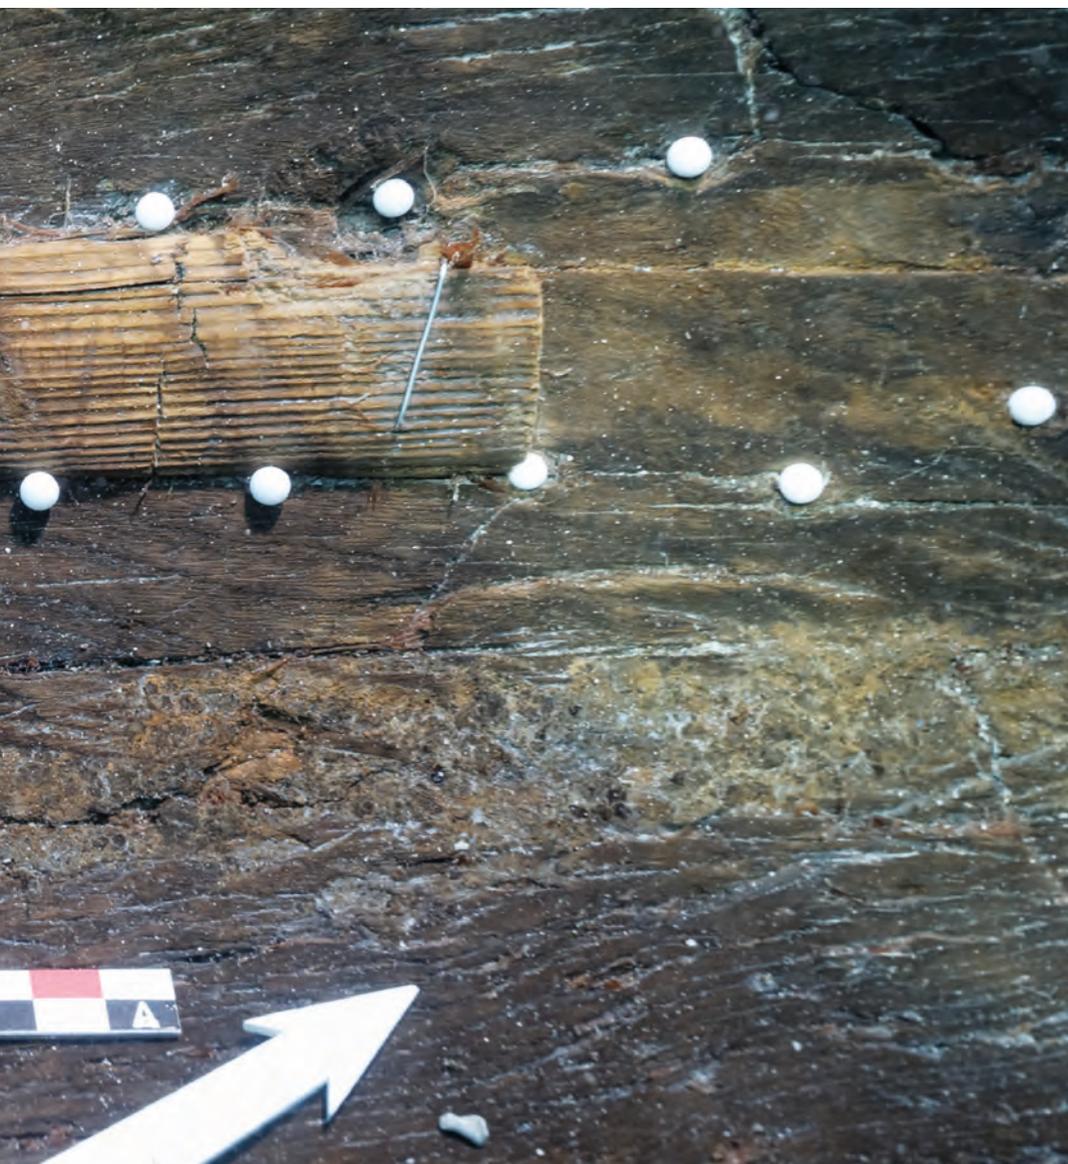
II.12

Detalj tragova od ligature na letvici postavljenoj preko sljubnica platica
Detail of the marks left by ligature on the laths placed over the seams
 (fotografija / photo by: Ph. Groscaux)

Thin laths, 3-4 cm wide, made of fir (*Abies alba*), were placed over the seams before sewing to hold wadding (Figs II.11, II.12, II.21). Under the lath, some loose vegetal fibres were found mostly belonging to sea-grasses (*Cymodocea nodosa*) and, to a minor extent, to moss (*Neckera crispa*). Reasonable doubt exists about whether the sea-grass remains were part of the original material used for waterproofing. The roots of these marine plants covered the wooden structures and entered

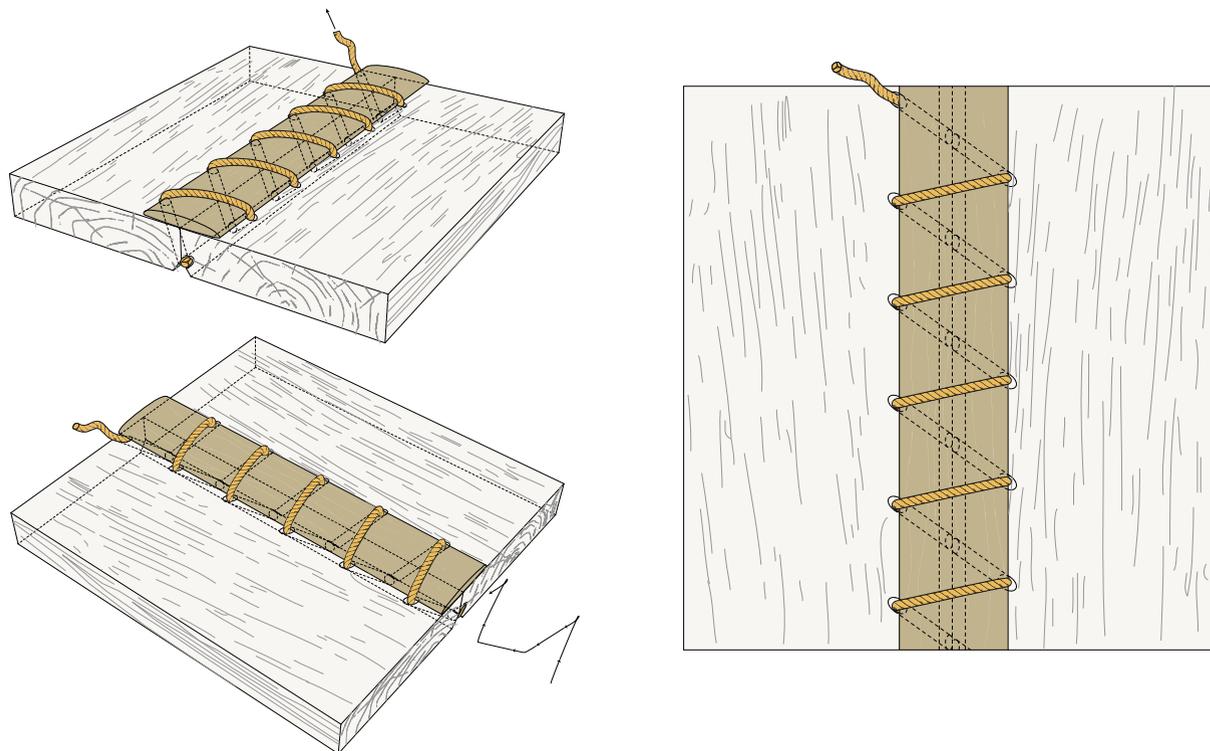
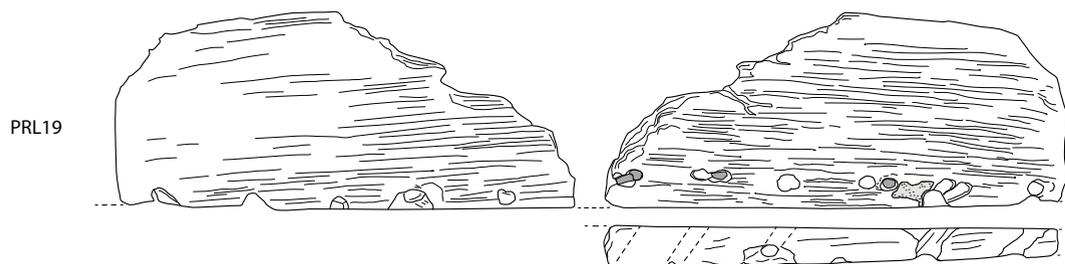
Il.13
Aksonometrijska rekonstrukcija
 sistema šivanja oplata
Axonometric reconstruction of the
 sewing system used for the planking
 (crtež / drawing by: P. Poveda)

The sewing consists of simple over-edge stitches (/// pattern) going through oblique stitch holes cut diagonally, rather than perpendicularly, to the plank edges (Fig. II.13, II.15, II.16). The angle of the sewing isn't regular, the angle of the stitches varies while they remain parallel to each other. The stitches were spaced 2 to 4.5 cm apart.

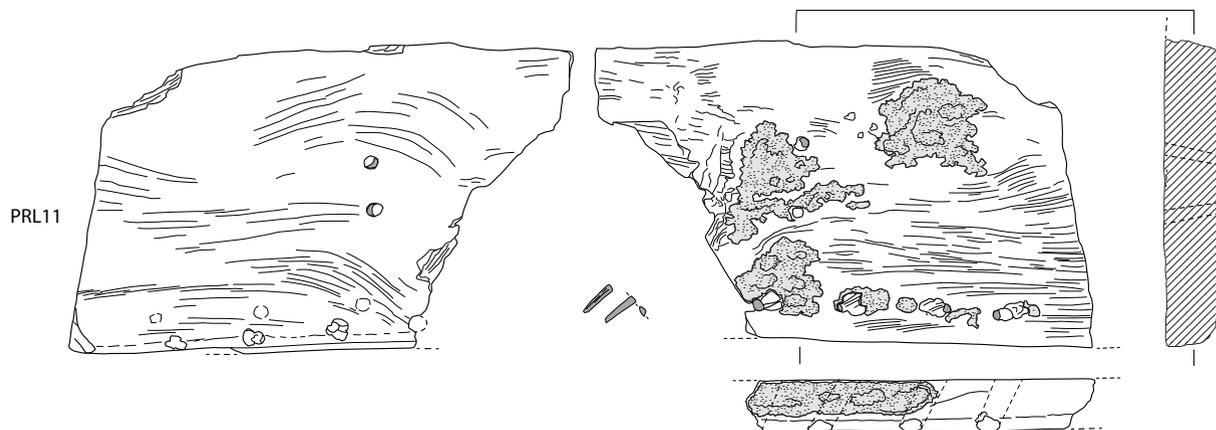
Il.14
Dva ulomka oplata, PRL19 i
 PRL11, izvađenih s nalazišta
Two planking fragments, PRL19
 and PRL11, recovered from the
 seabed
 (crtež / drawing by: G. Boetto)

The external plank edges are chamfered to allow the passage of the ligature without it protruding (Figs II.14, II.18). Each stitch hole is composed of two or three grooves carved with a gouge or a drill (Fig. II.17). For that reason, the section of these holes isn't circular but oval and measures around 1 to 2 cm in width.

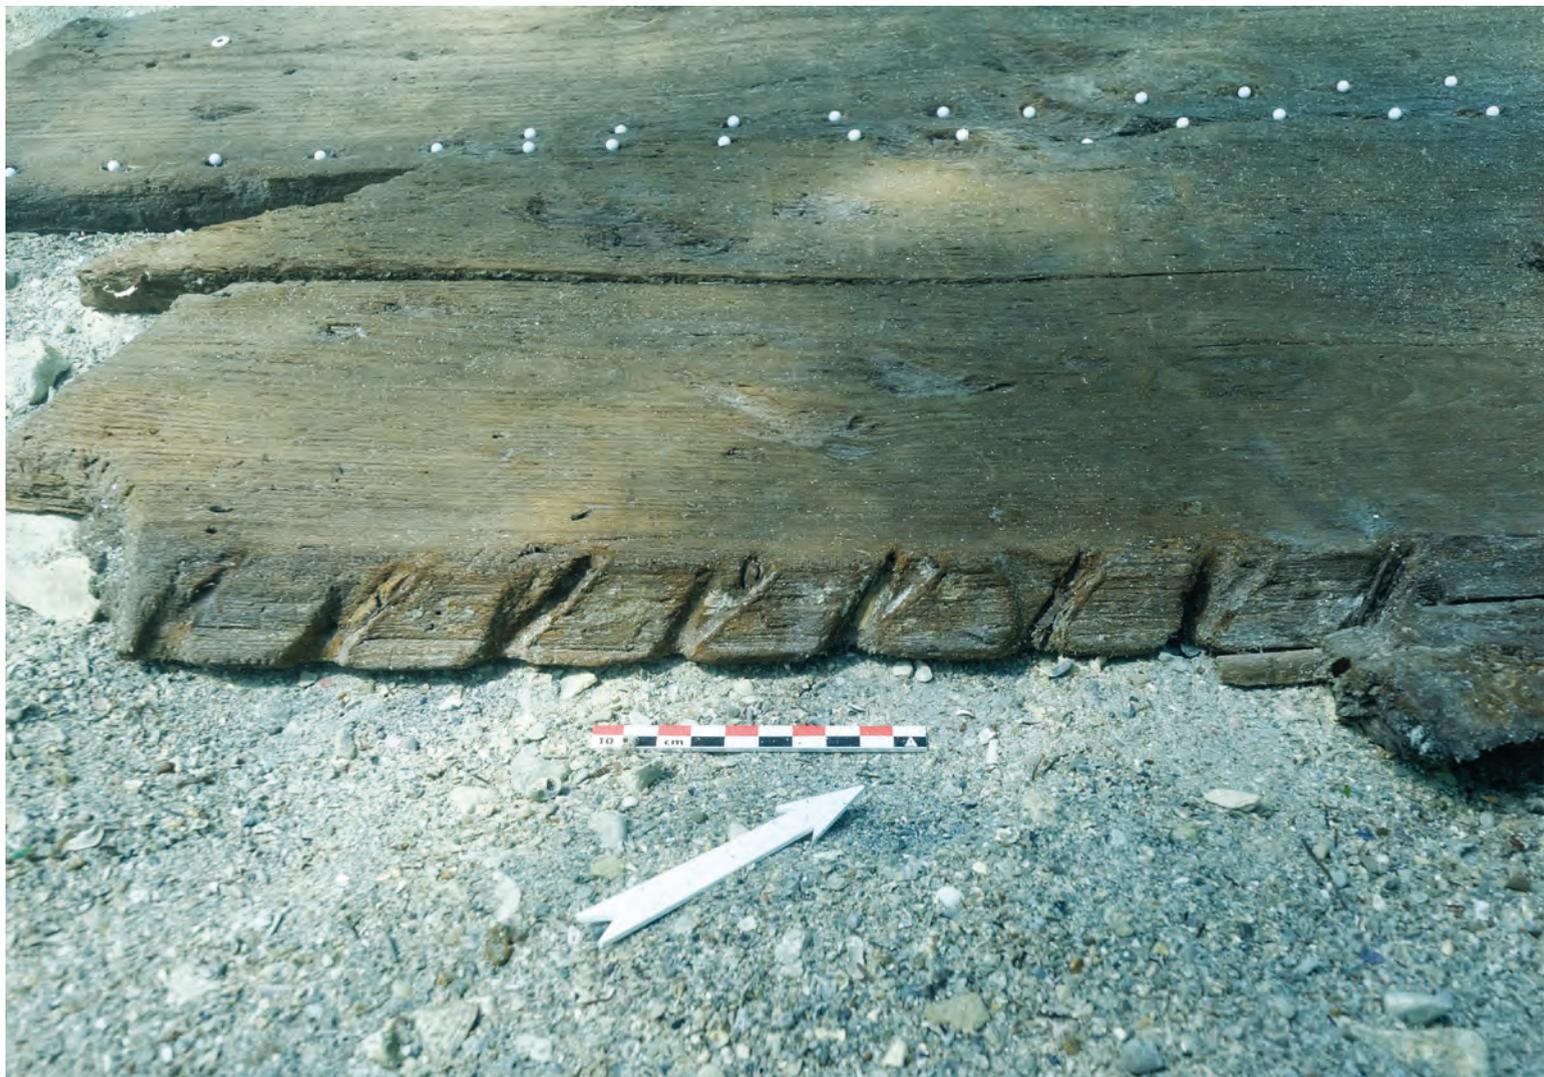
II.15
Pogled na slomljeni kraj kobličnog
 elementa P2 sa zakošenim rupama
 za šavove
View of the broken end of the
 keel-like timber P2 with oblique
 holes for stitches
 (fotografija / photo by: Ph. Groscaux)

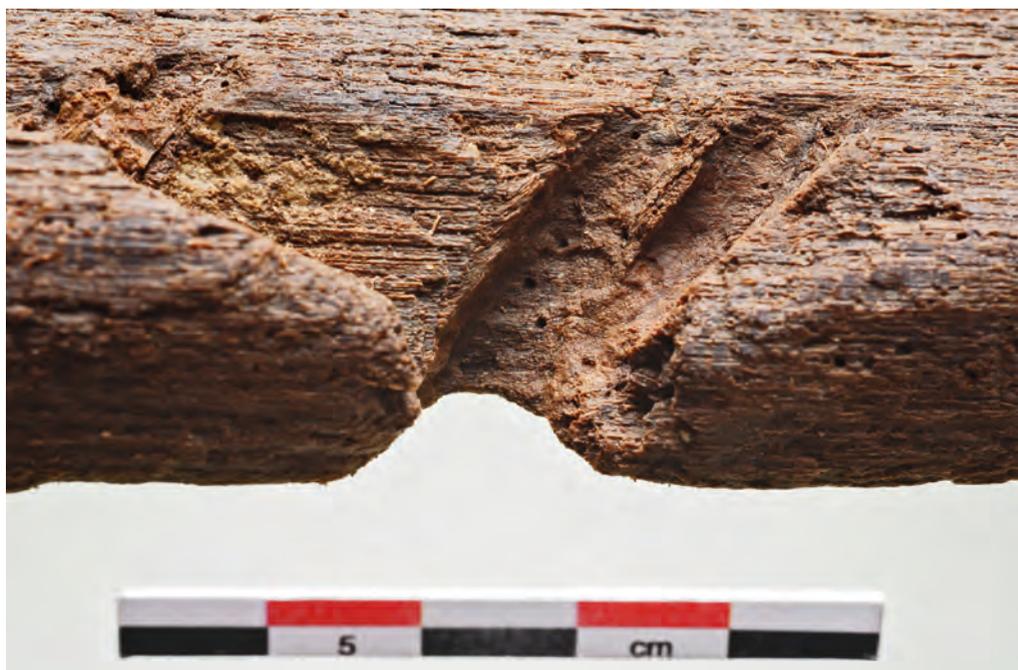
II.16
Detaljni prikaz žljebova koji čine
 rupu na fragmentu plance PRL19
Detail of the grooves composing a
 stitch hole on plank fragment PRL19
 (fotografija / photo by: Ph. Groscaux)

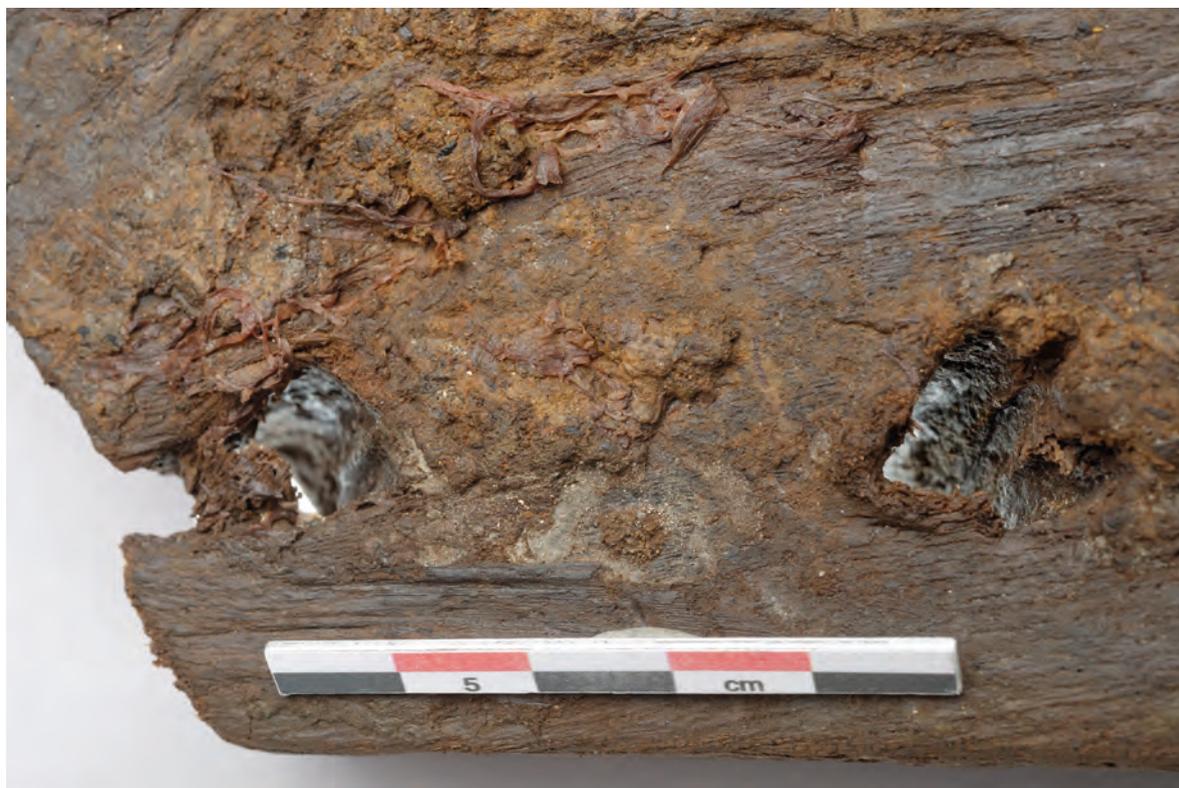
II.18

Detail of the outboard chamfered edge of plank fragment PRL11
(fotografija / photo by: Ph. Groscaux)

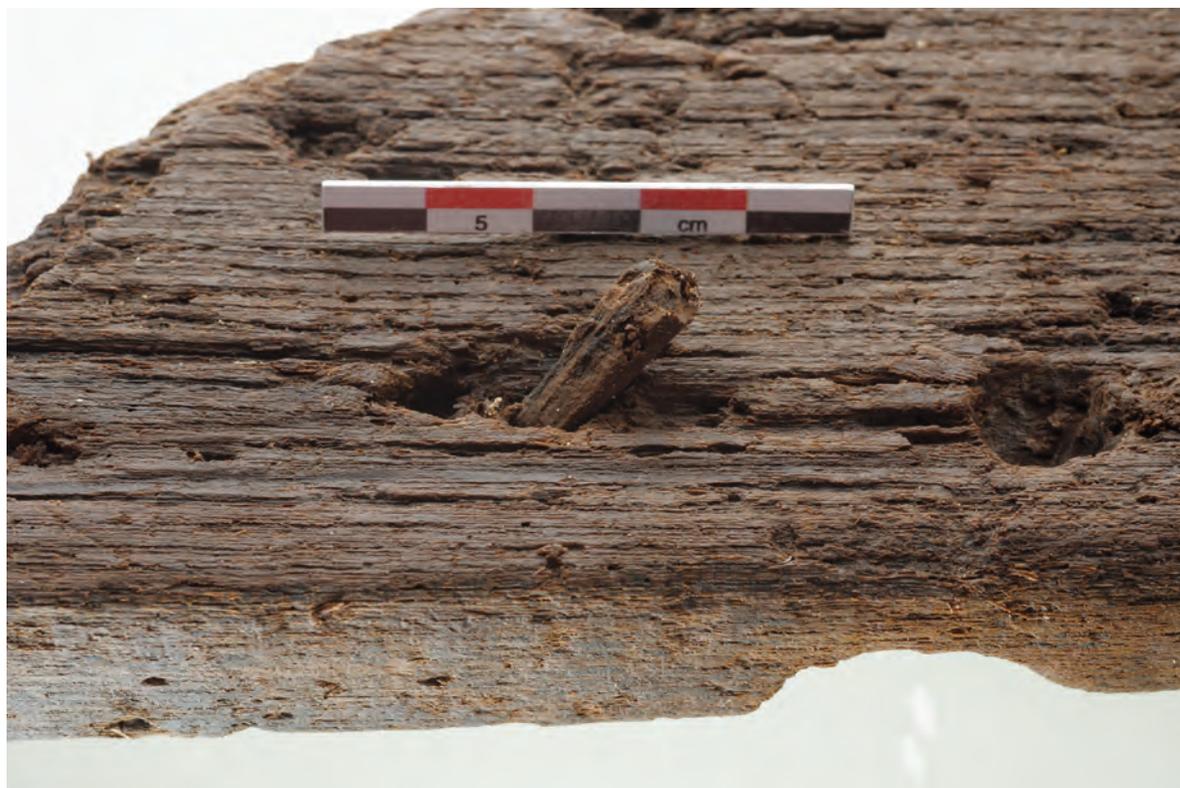
II.19
Detalj malog drvenog čavla koji je služio za zaptivanje šava, na fragmentu platiće PRL19
Detail of a peg used to lock the stitching on plank fragment PRL19
 (fotografija / photo by: Ph. Groscaux)

Small tapered and sharpened pegs, at least one to three for each stitch hole, locked each stitch in place (Fig. II.19, II.20). The pegs, obtained from splitting

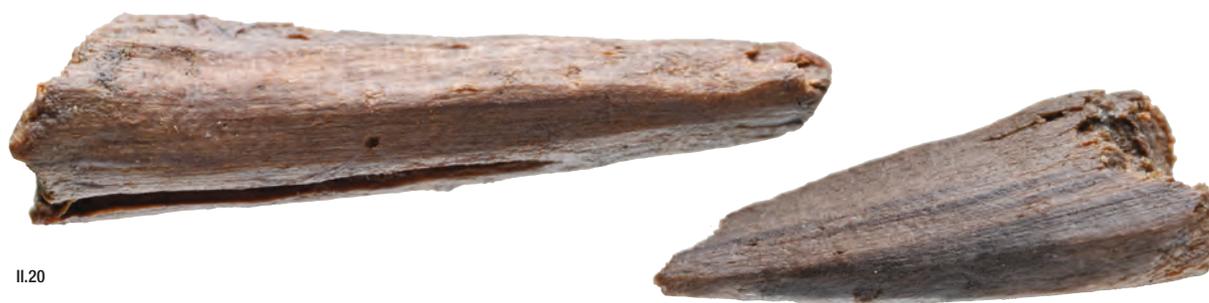
II.20
Mali drveni čavli za zaptivanje rupe šava
Pegs used to lock a stitch
 (fotografija / photo by: Ph. Groscaux)

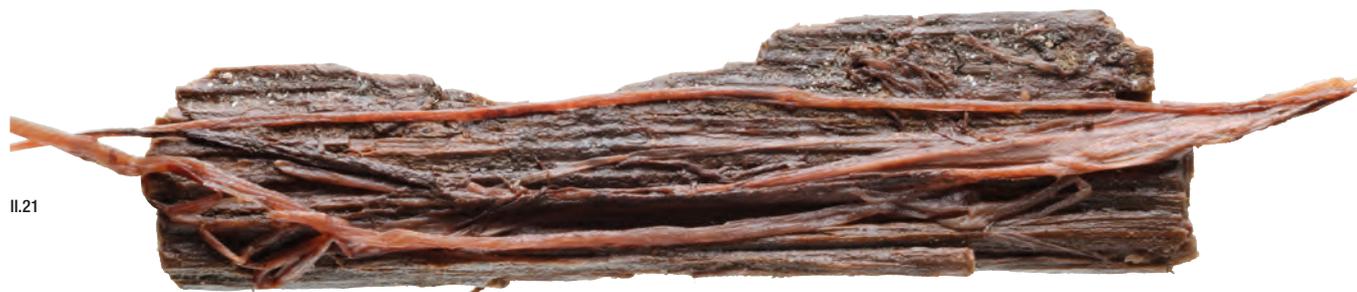
II.21
Ulomak letvice s ostatkom biljnog materijala koji je korišten za osiguravanje vodonepropusnosti sljubnica
Fragment of a lath with remains of the vegetal fibres used for waterproofing
 (fotografija / photo by: Ph. Groscaux)

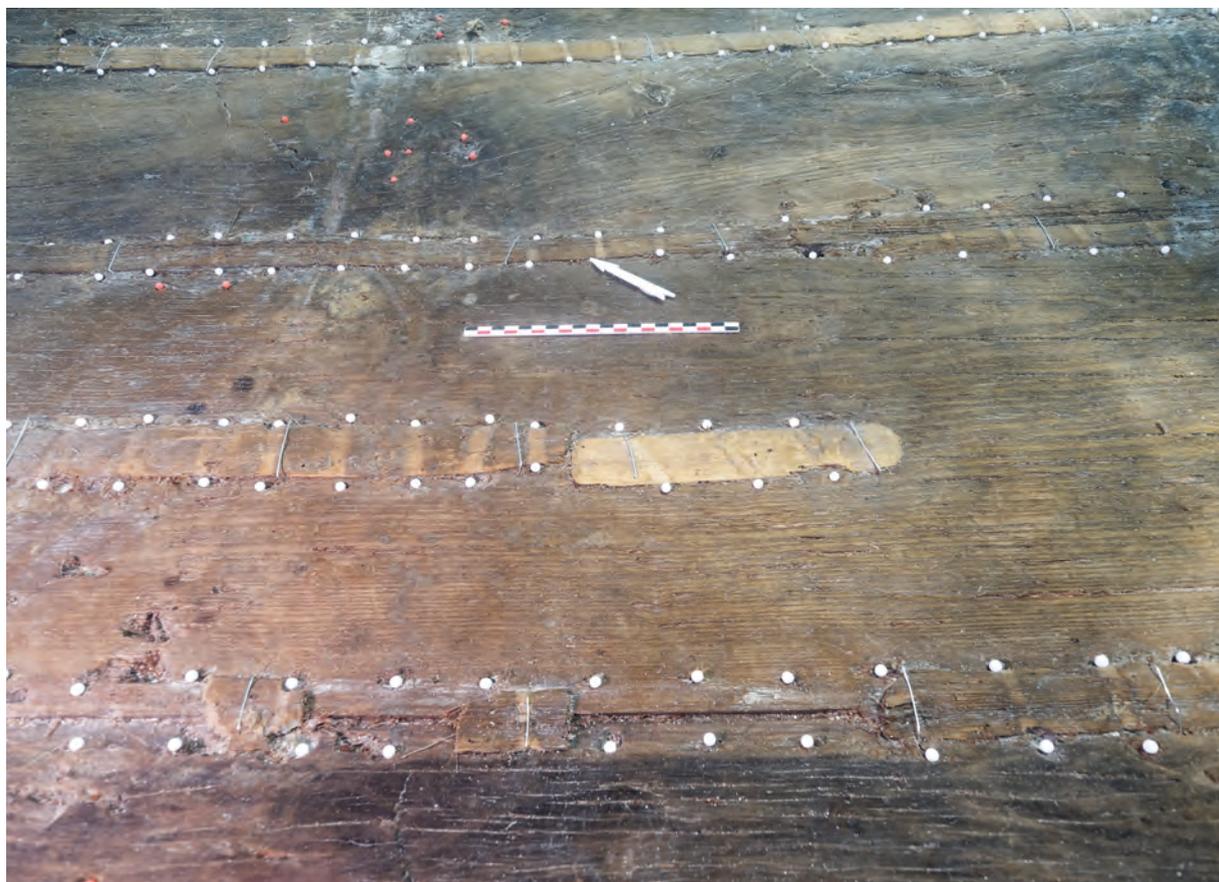
II.22
Pogled na popravak pukotine u sredini kobiličnog elementa P2
View of the crack repairs in the middle of keel-like timber P2
(fotografija / photo by: Ph. Groscaux)

Some cracks in the planking (P4 and P5) and the keel-like timber P2, were repaired using the same sewing technique and the same system of wadding and ensuring the watertightness of the vessel (Figs II.2, II.22). It is difficult to know if these repairs were done during the construction or later during the working life of the boat.
