The hull structure

Giulia Boetto, Marko Uhač, Ida Koncani Uhač

Giulia Boetto, Marko Uhač, Ida Koncani Uhač. The hull structure. I. Koncani Uhač; G. Boetto; M. Uhač. Zambratija. Prapovijesni šivani brod. Rezultati arheološkog istraživanja, analiza i studija / Prehistoric sewn boat. Results of the Archaeological Research, Analysis and Study, 33, Arheološkom muzeju Istre, pp.62-87, 2020, Monografije i katalozi, 978-953-8082-50-4. halshs-02986179

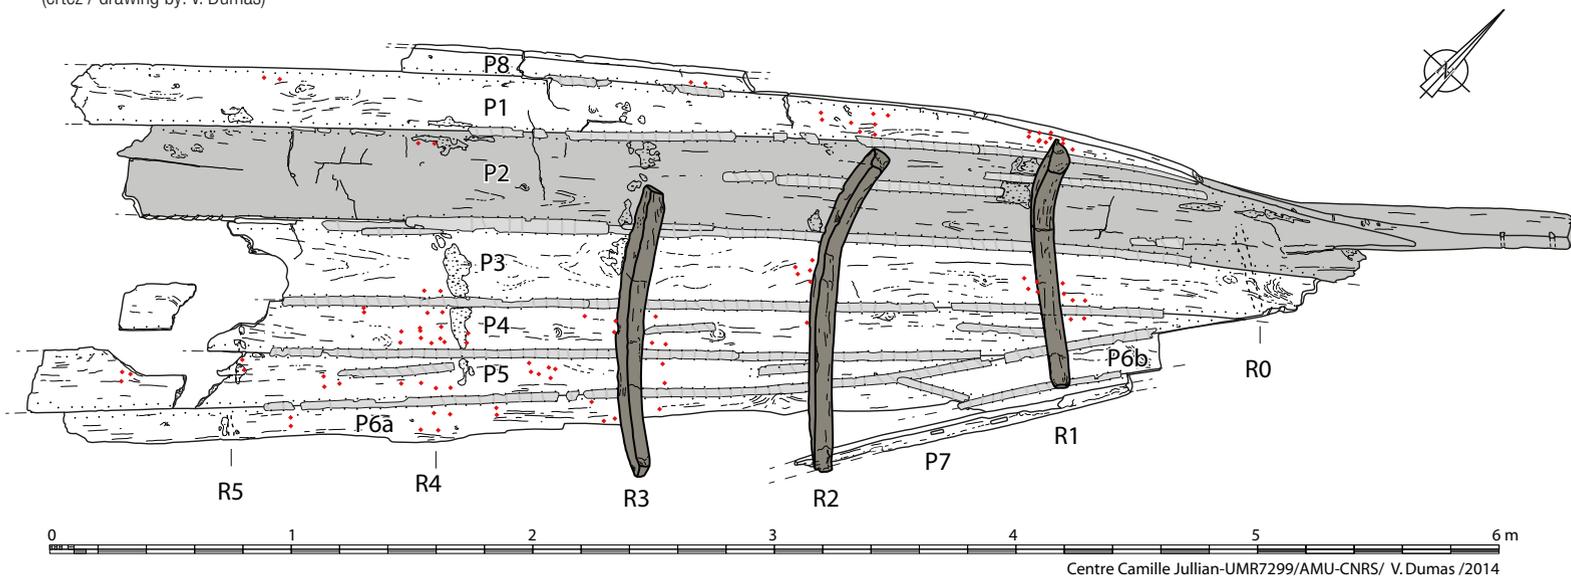
II.23
Brodsko rebra
The frames
(crtež / drawing by: V. Dumas)

Three floor-timbers (R1, R2 and R3) were found *in situ*, and traces of three additional frames were identified, one at the north (R0), and two at the south (R4 and R5) (Fig. II.23). The tops of the eastern arms are preserved, while the western arm is broken (Figs II.24 – II.26).

(Figs II.14, II.35 – II.38). Groups of plugged holes in the planking were observed along the frames (Fig. II.23), but the reconstruction of the lashing pattern is not possible without a more detailed observation of the wooden remains, which will be possible only after the planks are raised from the seabed. Nevertheless, the displaced plank fragment (PRL19), which was retrieved from the seabed, fortunately retained a pair of lashing holes. These holes have an inboard diameter (8 mm) slightly bigger than the outboard diameter (6-7 mm), so the space between them is 2.4 cm inboard and 3.5 cm on the outboard face of the plank. The lashing seems to be very basic, and on the outer face the holes are not joined by a groove that would protect the lashing.

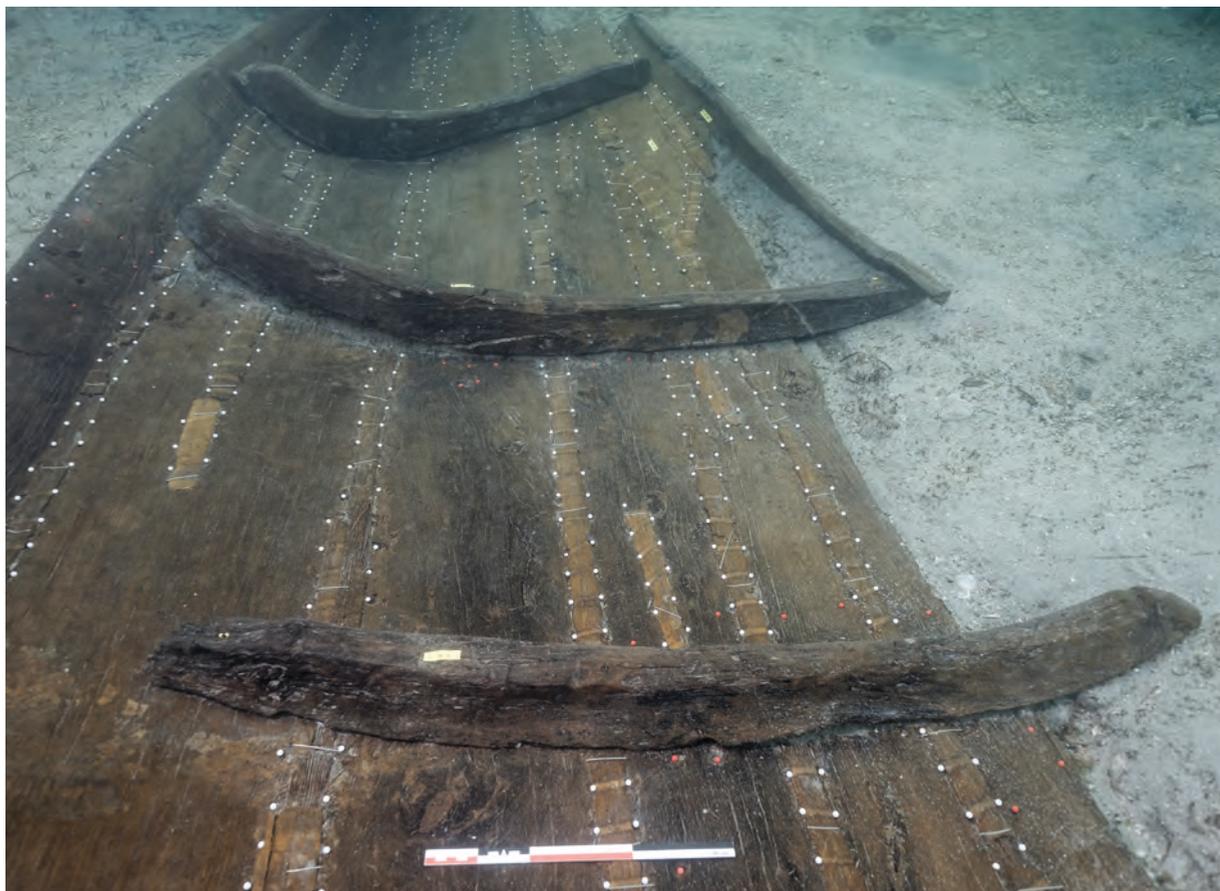
II.24
Pogled s juga na tri sačuvane rebrenice
View from the south of the three preserved floor-timbers
(fotografija / photo by: Ph. Groscaux)

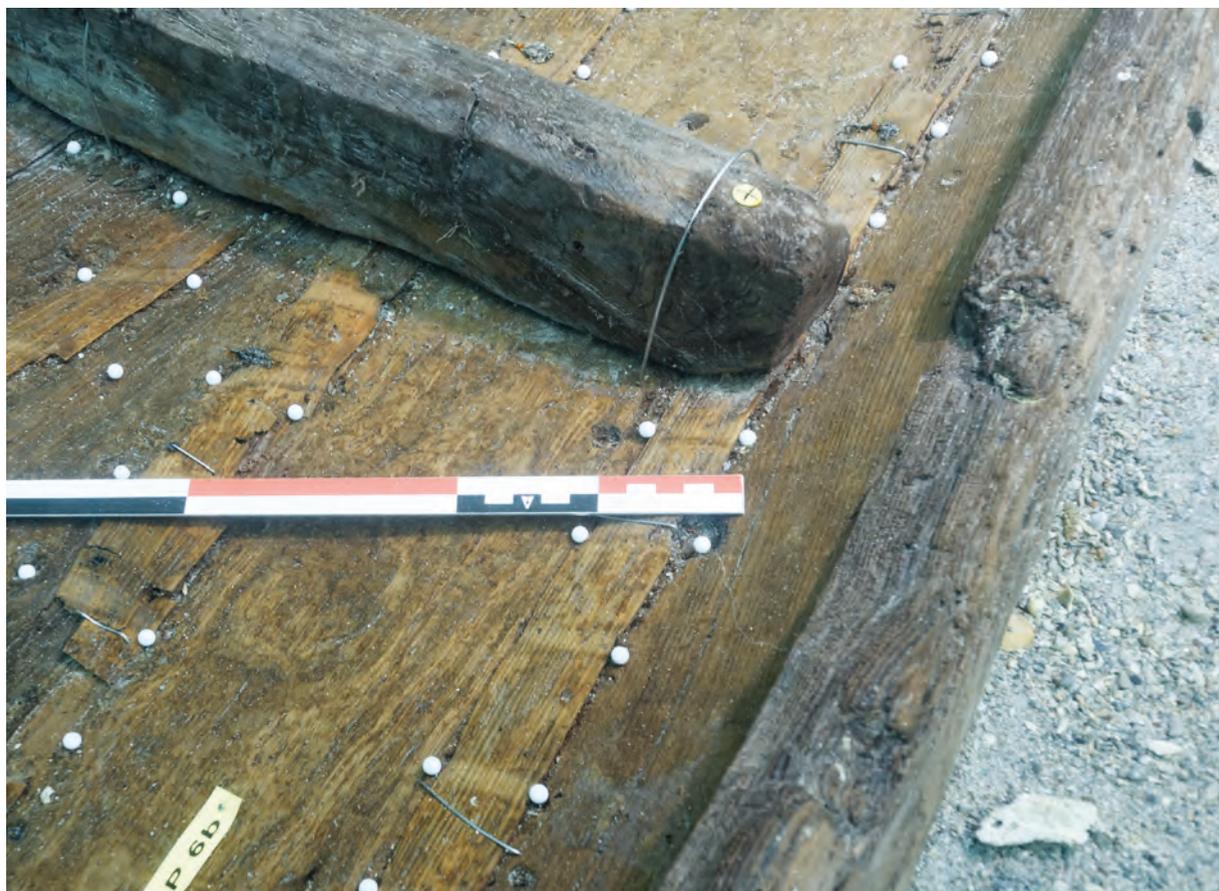
II.25
Potpuno sačuvani istočni kraj
rebrnice R1
The complete eastern end of
floor-timber R1
(fotografija / photo by: Ph. Groscaux)

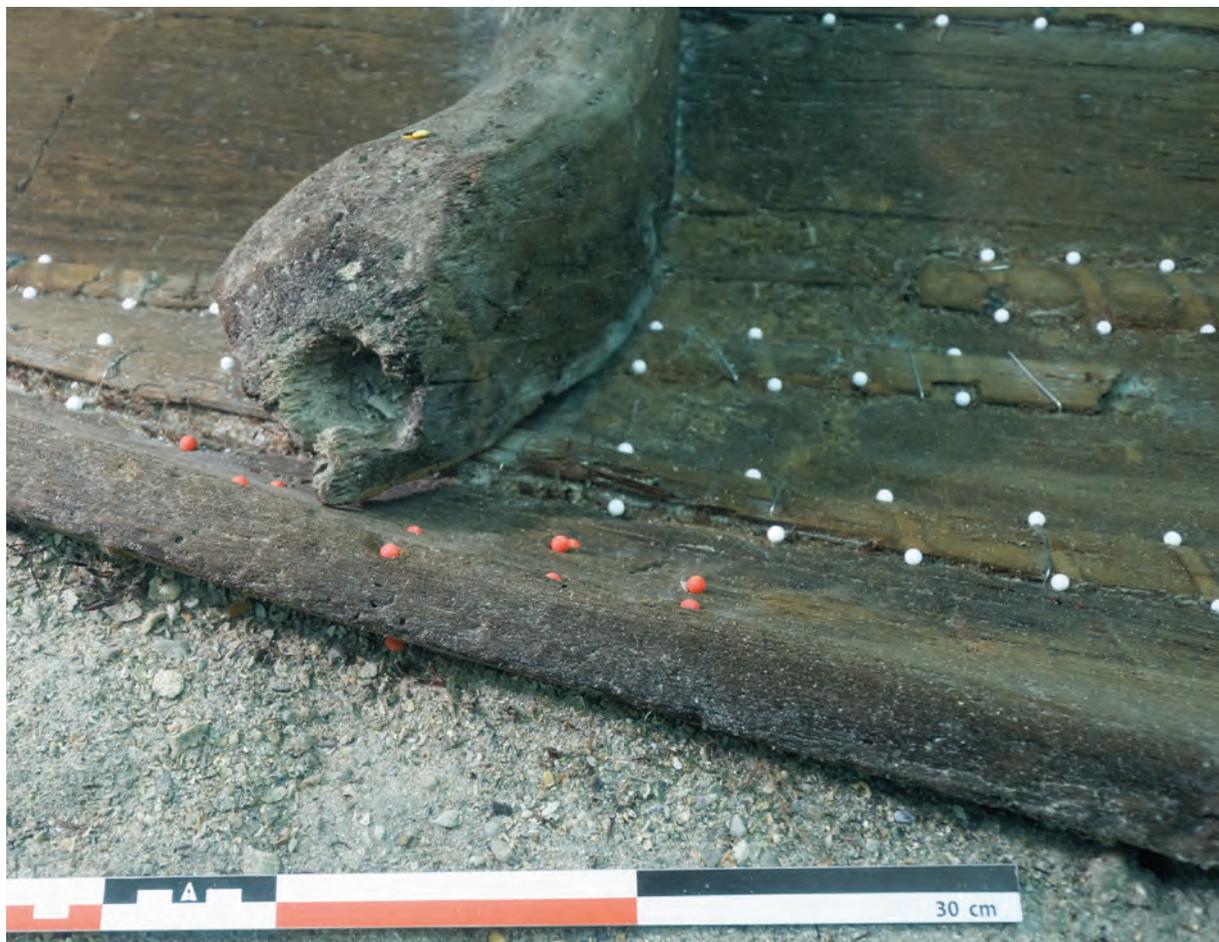
II.26
Uništeni zapadni kraj
rebrnice R1
The broken western end
of floor-timber R1
(fotografija / photo by: Ph. Groscaux)

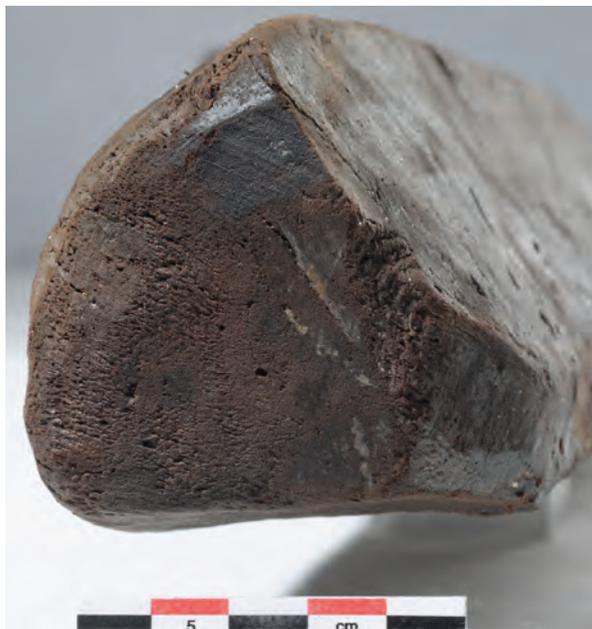
II.27
Trapezoidni presjek s uskom bazom i zaobljenom gornjom površinom rebrenice R1
The trapezoidal section with a narrow foot and rounded upper surface of floor-timber R1
 (fotografija / photo by: Ph. Groscaux)

Widely spaced (around 83 cm on average), these floor-timbers have a trapezoidal section (8.4 cm wide, 11.3 cm high on average) with a narrow foot and a rounded, wider upper surface (Fig. II.27). Two of these frames (R1 and R3) are made of alder (*Alnus* sp.), while the third (R2) was obtained from a wild pear tree (*Pyrus communis* L.).

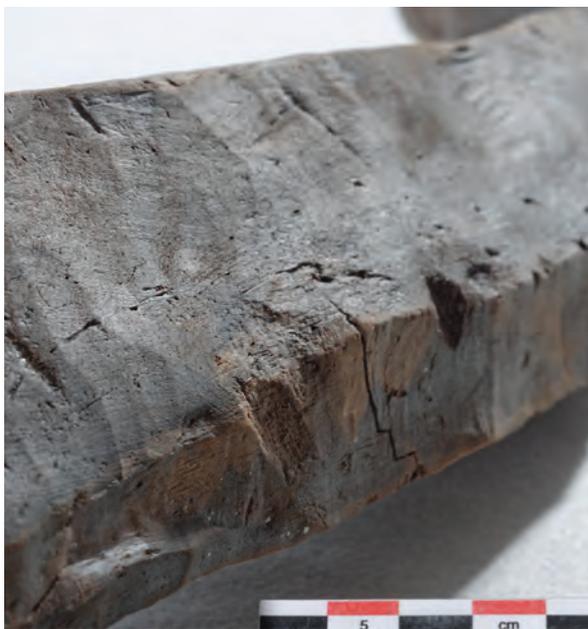
II.28
Tragovi obrade drva na bočnoj strani i bazi rebrenice R1
Woodworking marks on the side and foot of floor-timber R1
 (fotografija / photo by: Ph. Groscaux)

The lower face of the floor-timbers is smooth and shaped to match the inner surface of the planking (Fig. II.28). Fine marks visible on the lower face may have been produced by friction between the frames and the laths.

The surface of the frames is carefully worked and many tool marks left by the axes used are evident (Figs II.28, II.31). The use of chisels and other cutting blades is attested in particular for fashioning the limber holes (Figs II.32, II.34).

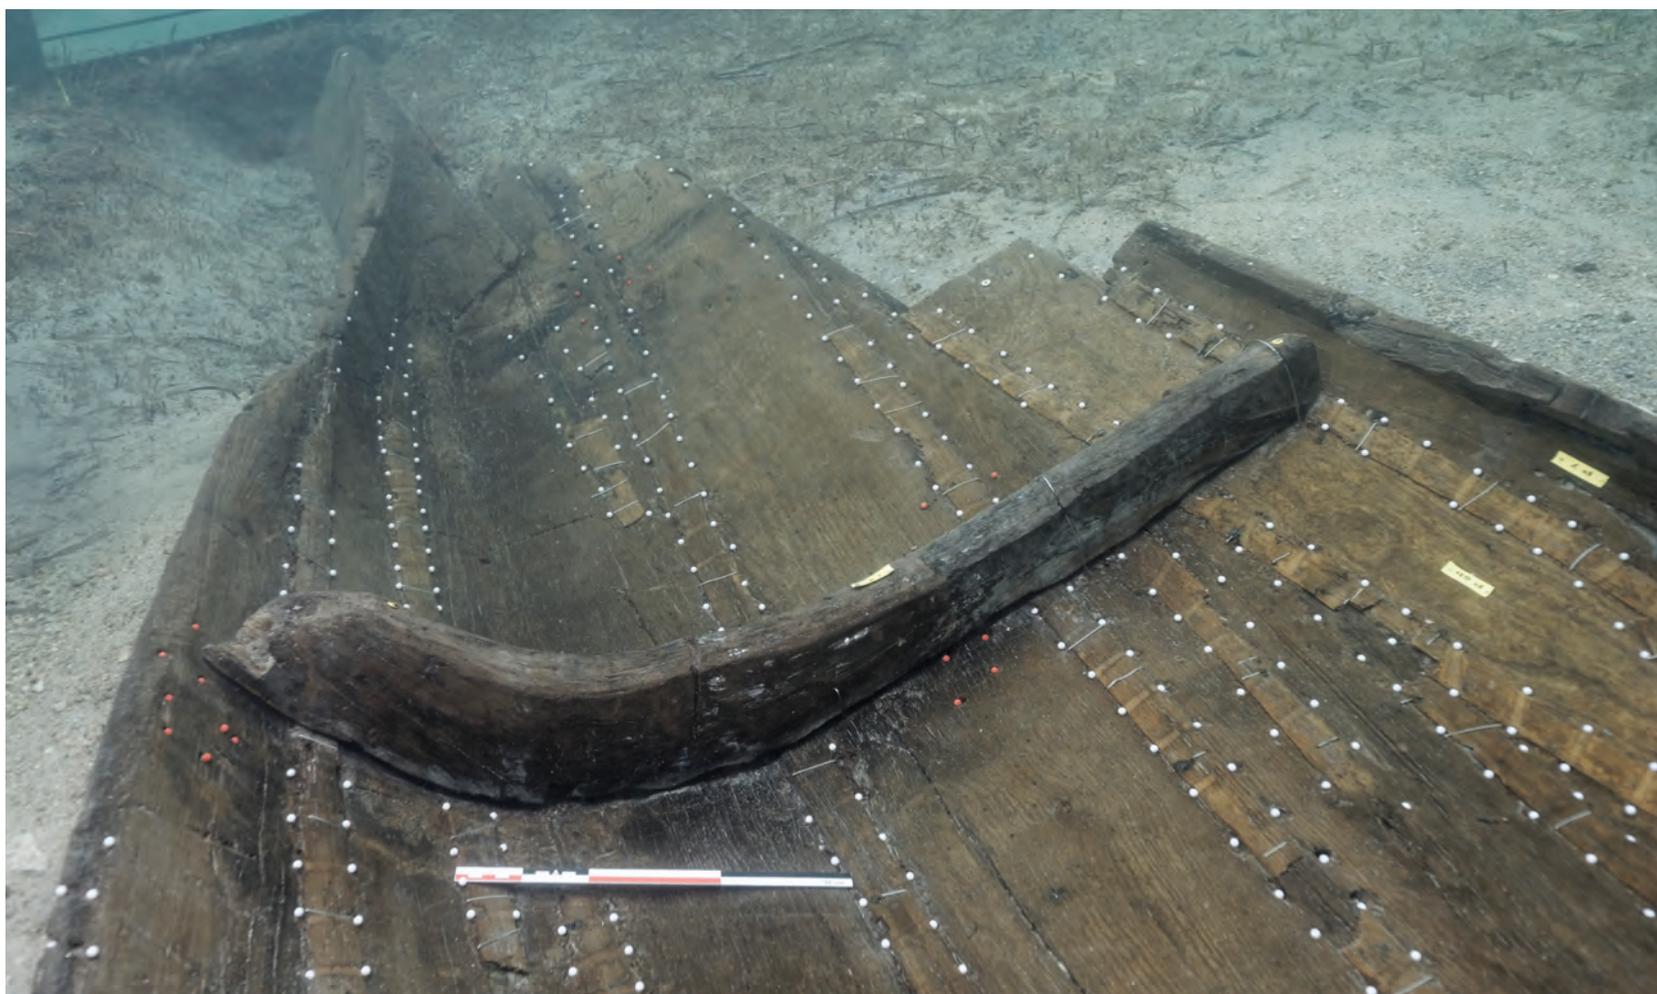
II.29
Pogled s juga na rebrenicu R1
View from the south of floor-timber R1
 (fotografija / photo by: Ph. Groscaux)

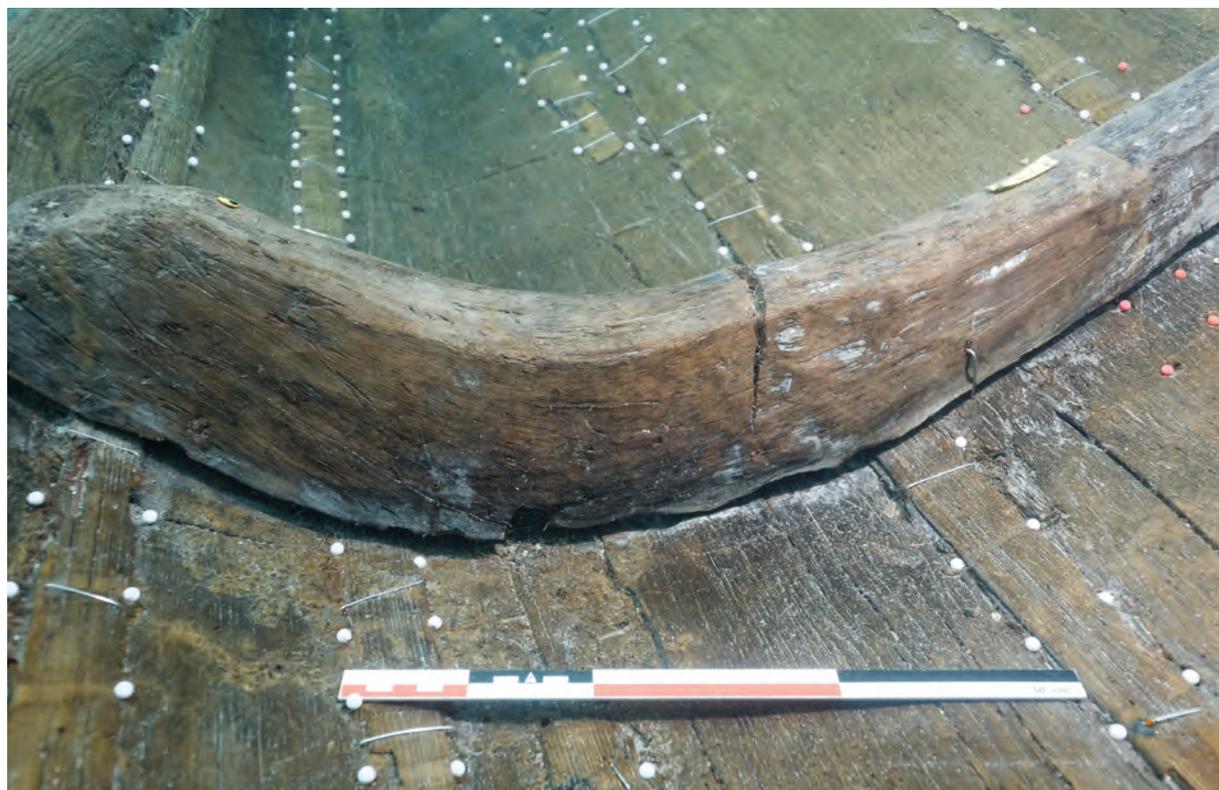
II.30
Četverokutna središnja slivnica
rebrenice R1
The quadrangular central limber
hole of floor-timber R1
(fotografija / photo by: Ph. Groscaux)

Additionally, the foot of each floor-timber was carved with limber holes, allowing the circulation of bilge water. Floor-timber R1 has a single quadrangular central limber hole (2.6 cm wide, 1-1.6 cm high) (Figs II.29 – II.32), while floor-timber R2 has two trapezoidal limber holes spaced 16 cm apart and 3 cm wide, 1.1-1.8 cm high (Figs II.33, II.34). No limber holes are present in floor-timber R3.

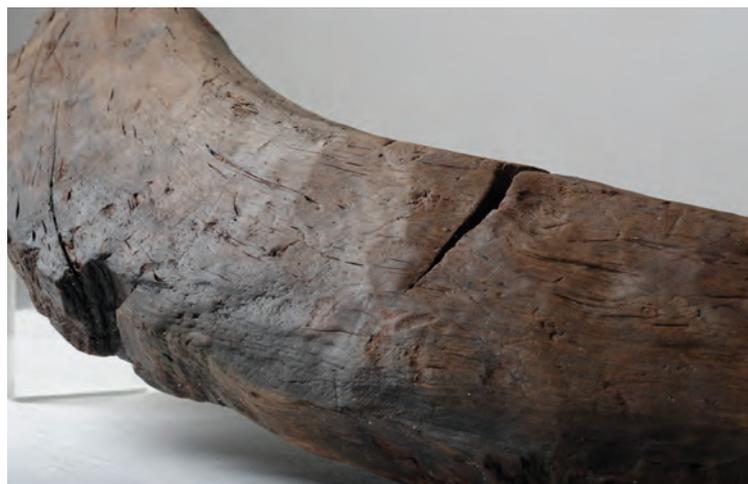
II.31
Četverokutna središnja slivnica
rebrenice R1
The quadrangular central limber
hole of floor-timber R1
(fotografija / photo by: Ph. Groscaux)

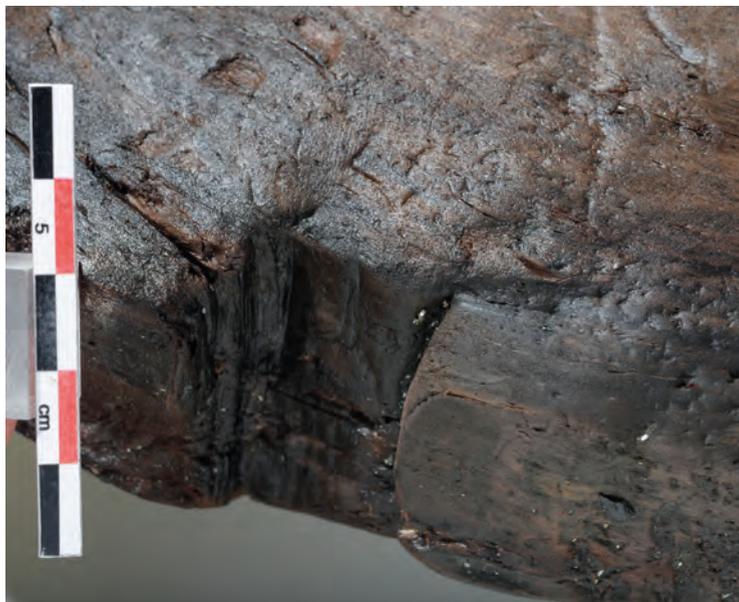
II.32
Tragovi obrade na četverokutnoj
 središnjoj slivnici rebrenice R1
Woodworking marks on the
 quadrangular central limber hole of
 floor-timber R1
 (fotografija / photo by: Ph. Groscaux)

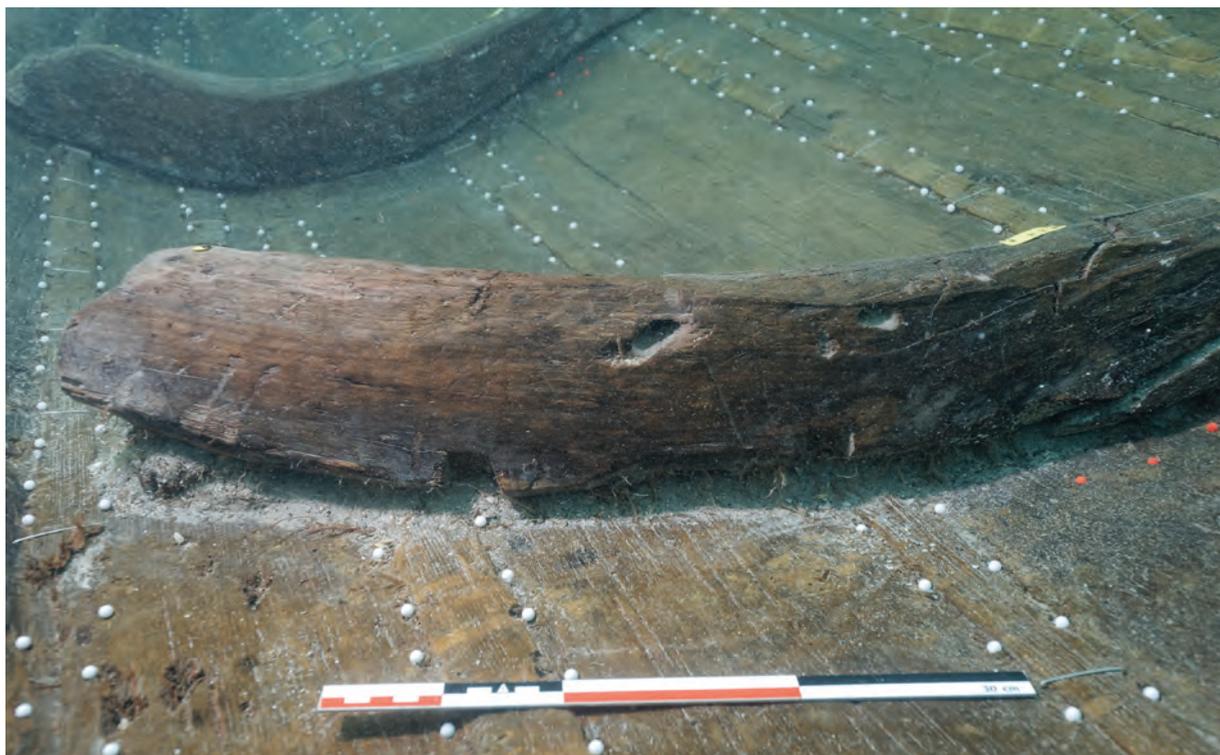
II.33
Pogled s juga na rebrenicu R2.
 Dvije slivnice su vidljive na njenom
 dnu
View from the south of floor-timber
 R2. The two limber holes are visible
 at its base
 (fotografija / photo by: Ph. Groscaux)

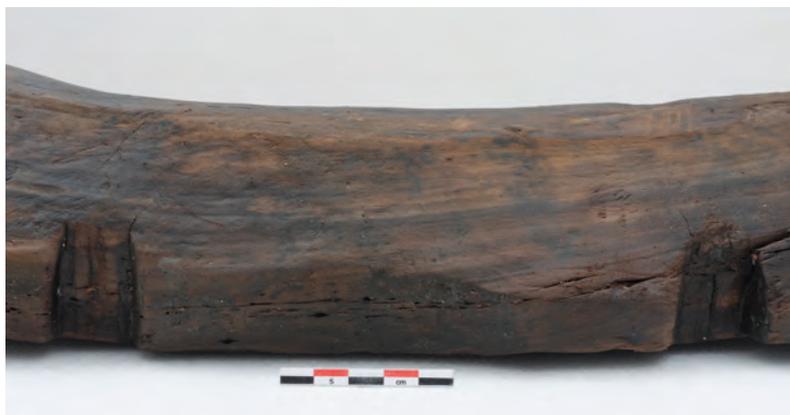
II.34
Par četverokutnih slivnica na
 rebrenici R2
Detail of the pair of rectangular
 limber holes of floor-timber R2
 (fotografija / photo by: Ph. Groscaux)

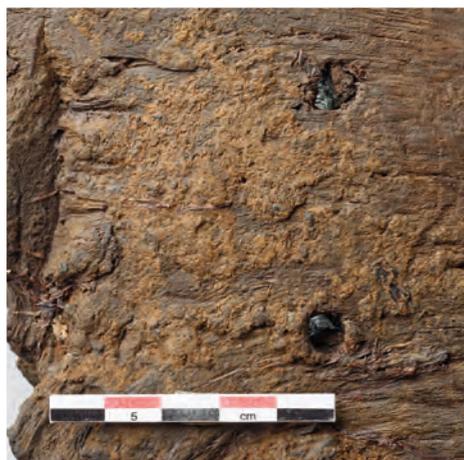
II.35

Fragment platice PRL11 s vidljivim rupama za šavove i parom rupa u sredini za vezanje rebra

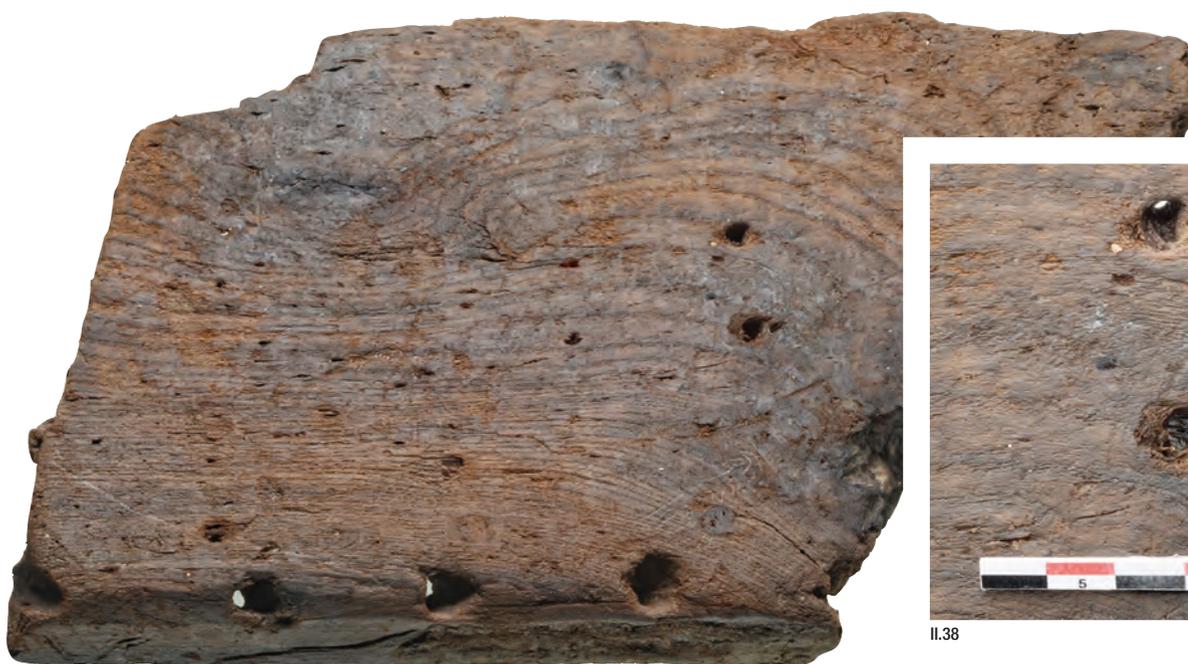
II.37

Detail of the pair of oblique holes used for lashing the frame in place on the outside surface of plank fragment PRL11 (fotografija / photo by: Ph. Groscaux)
