HAL
open science

The Qalhât Development Project and Qalhât Project : Final report on the 2013b/2014a season

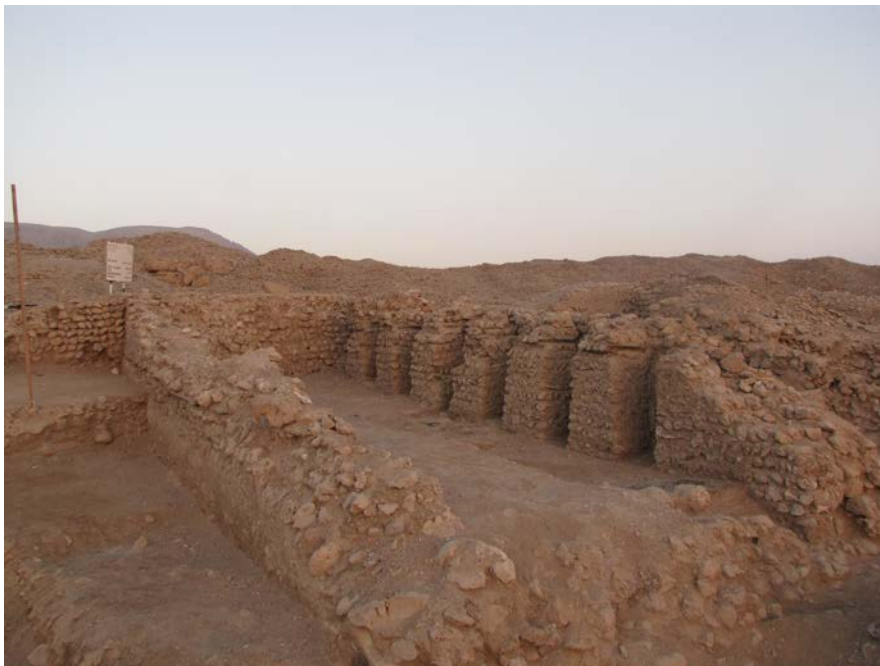
Fig. 25 - General view of the building B95

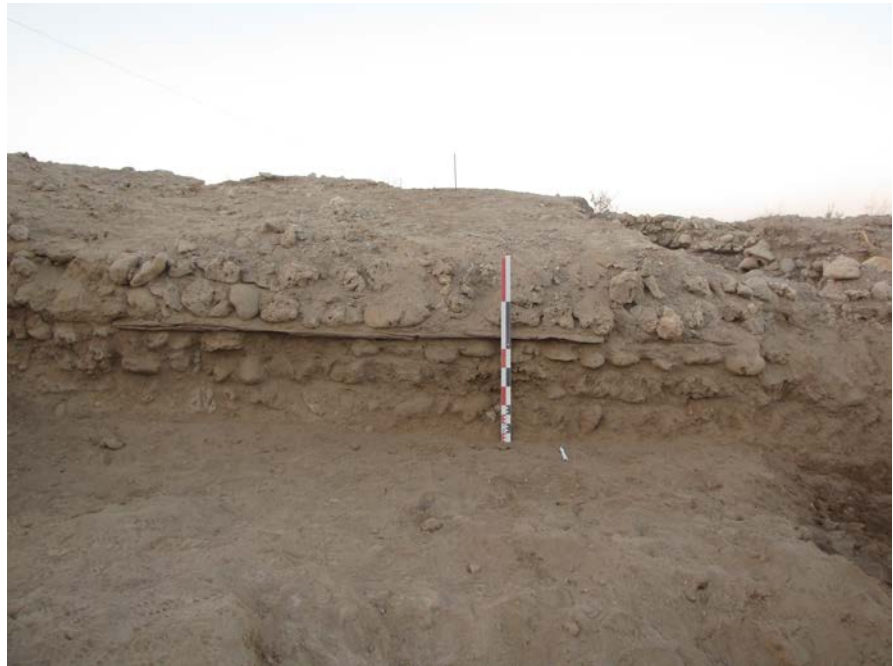
Fig. 26 - The south wall B95-01 with the beams

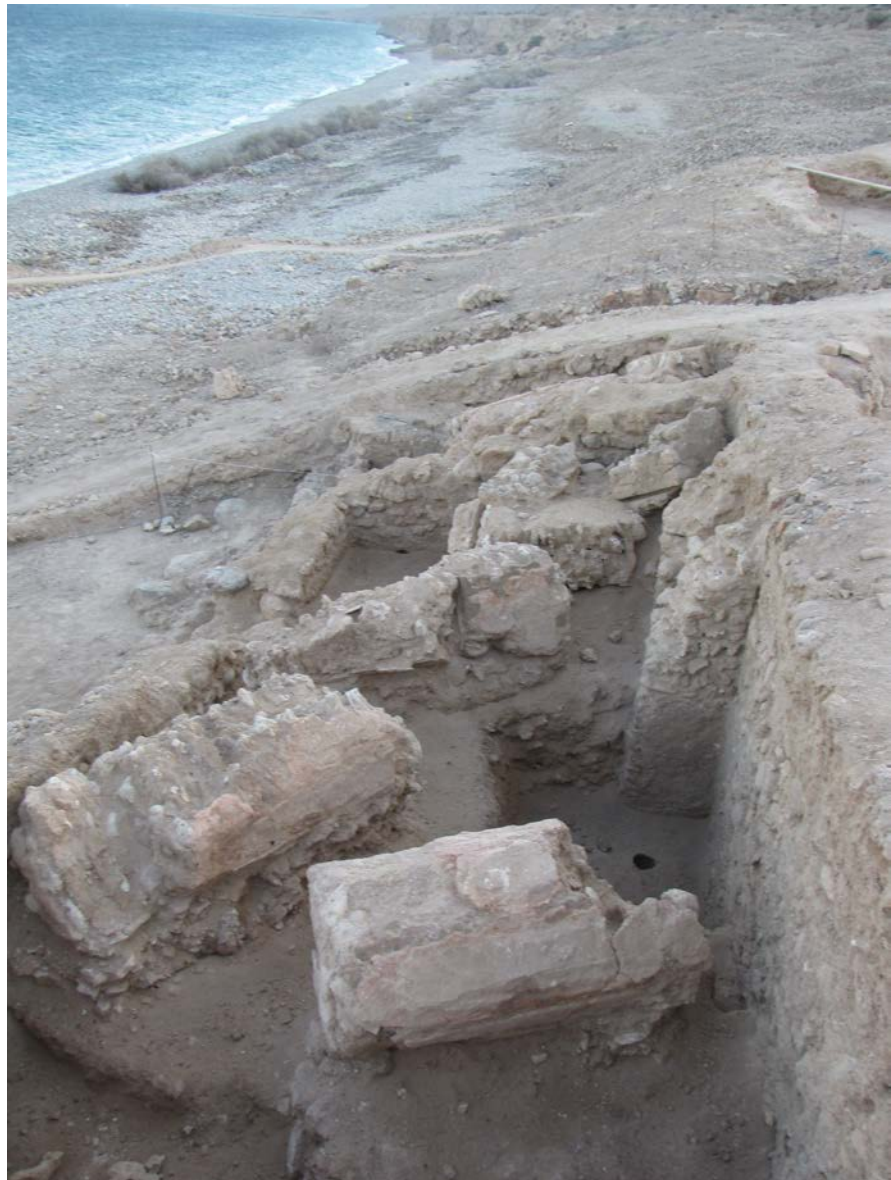
*Fig. 36 - General view of
room H*

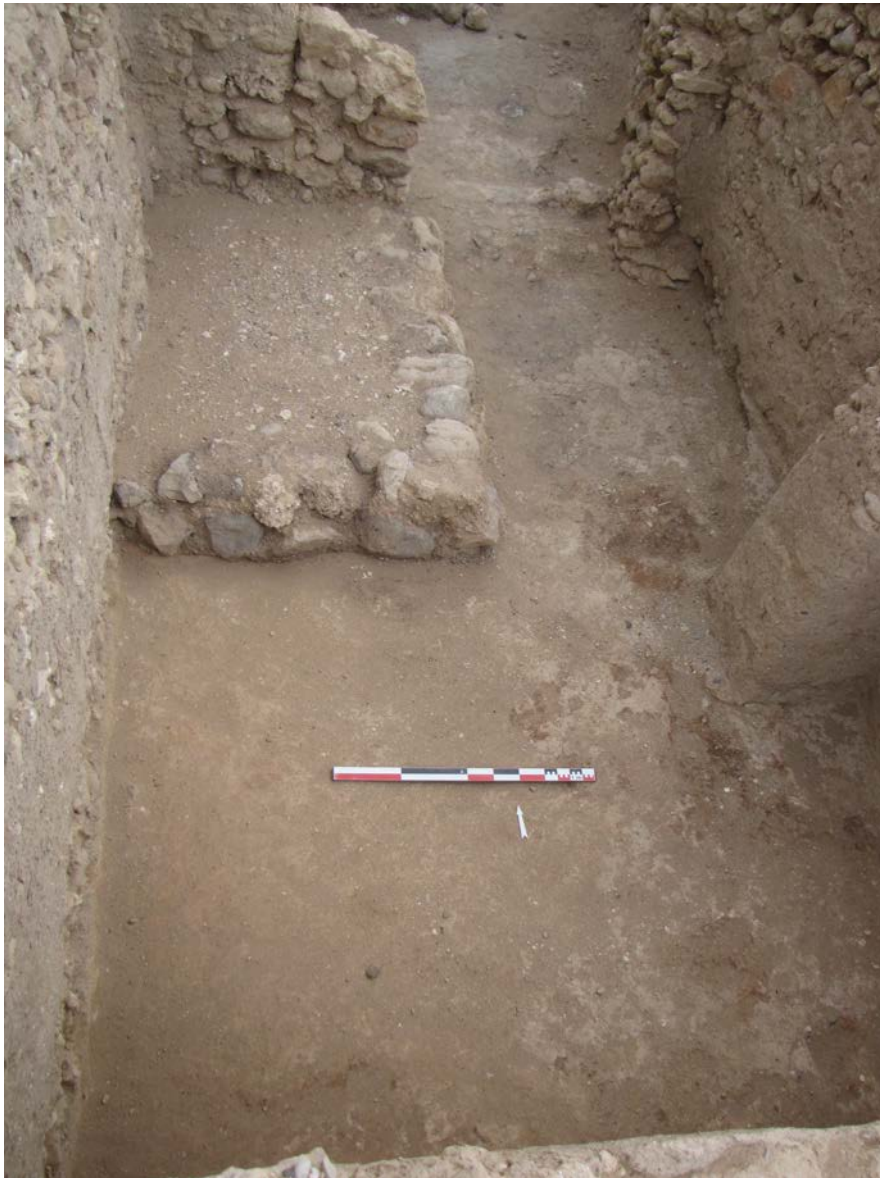
Fig. 43 - View of room B12-G

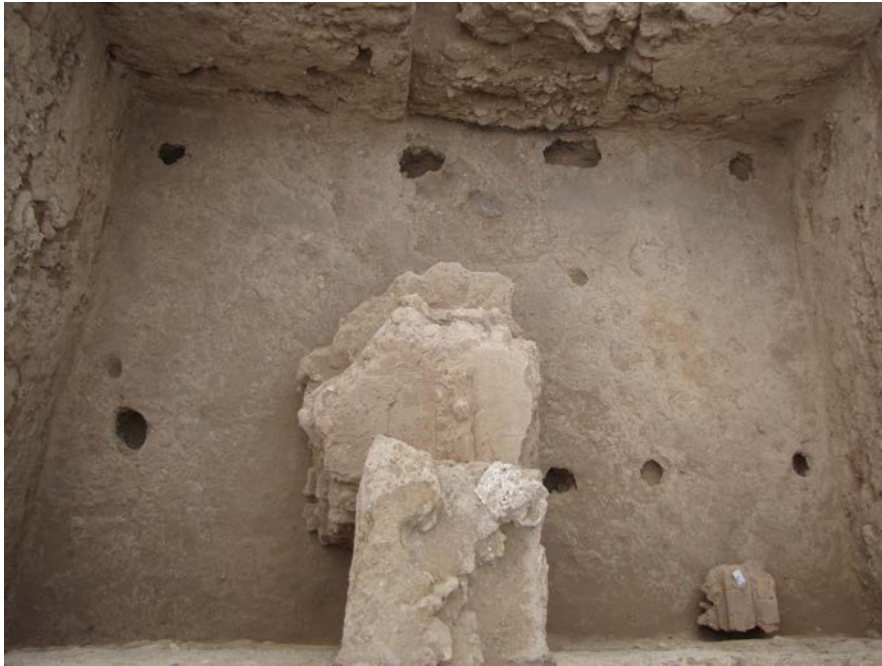
Fig. 45 - View of room B12-Q after excavations

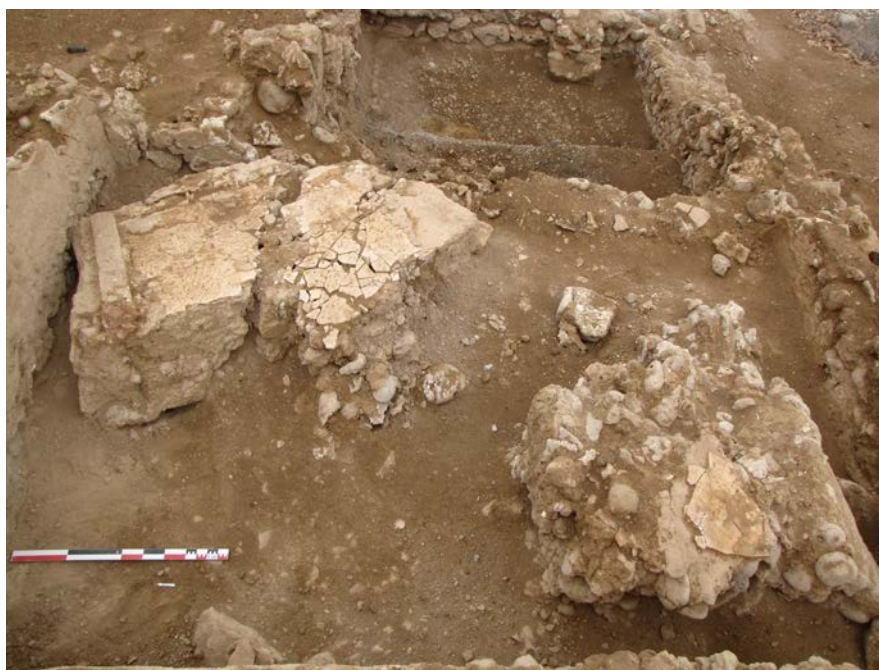
*Fig. 47 - View of room
B12-R in March 2014*

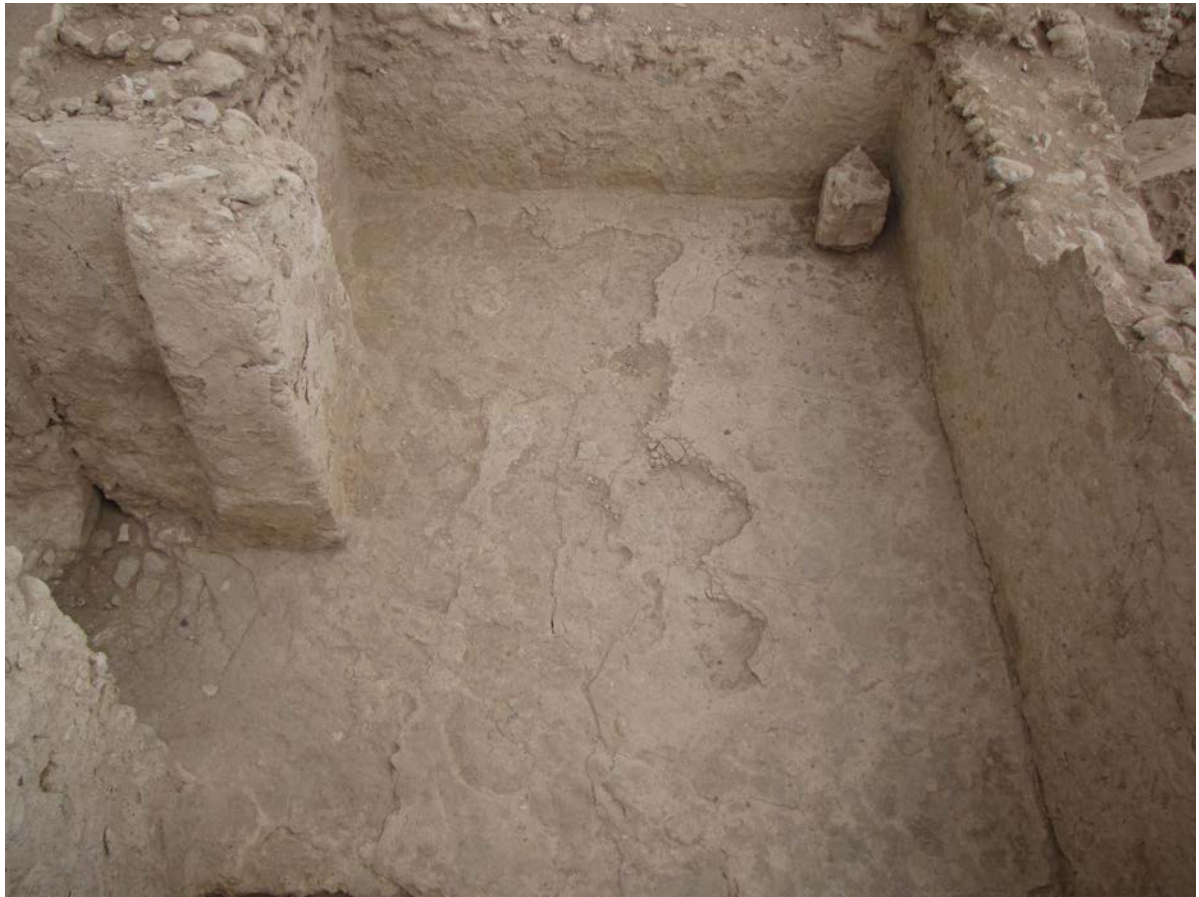
*Fig. 50 - View of room
B12-A*

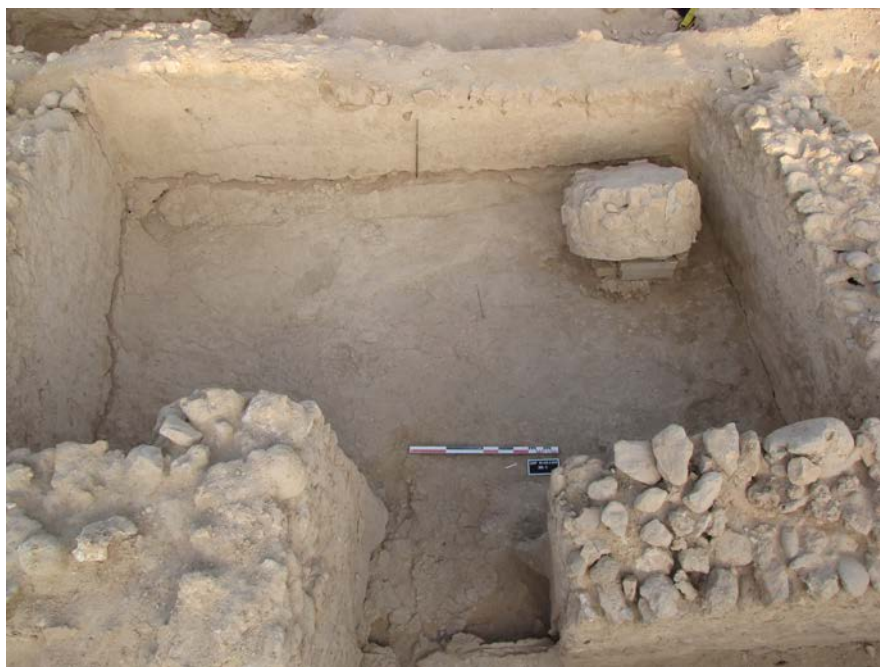
Fig. 54 - View of room B12-C after excavations

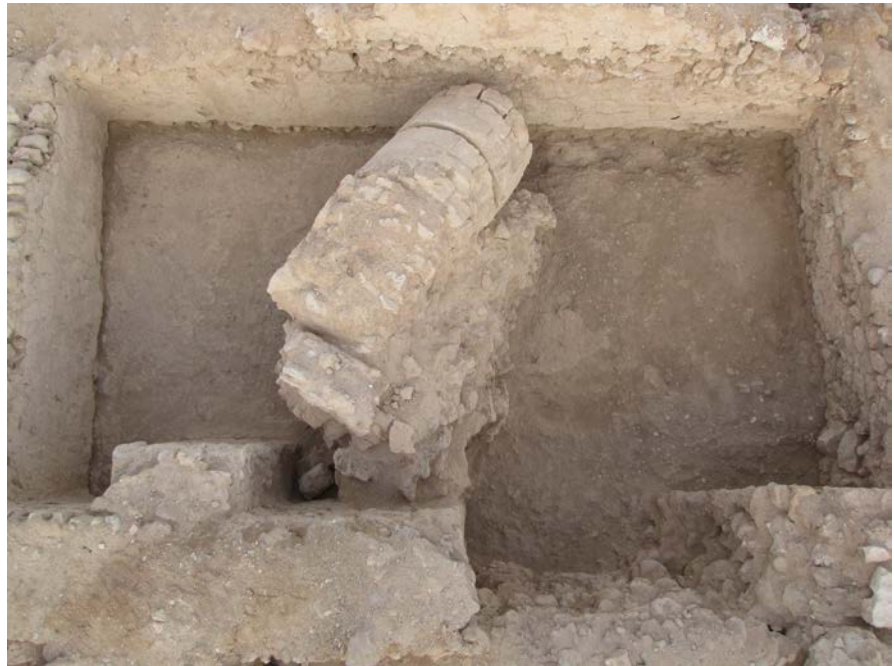
*Fig. 57 - View of room
B12-F*

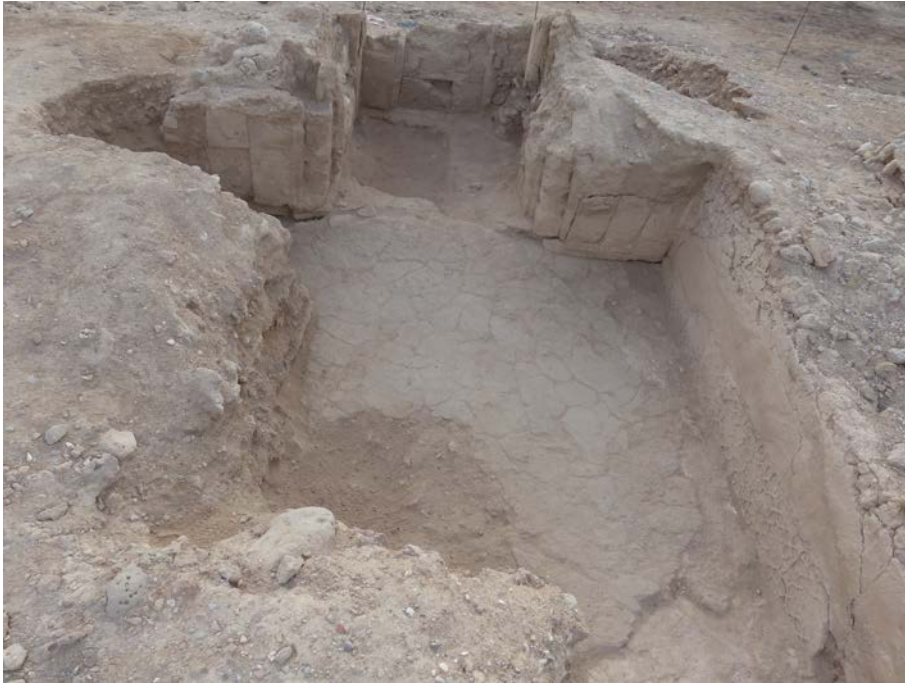
Fig. 61 - View of the mihrab

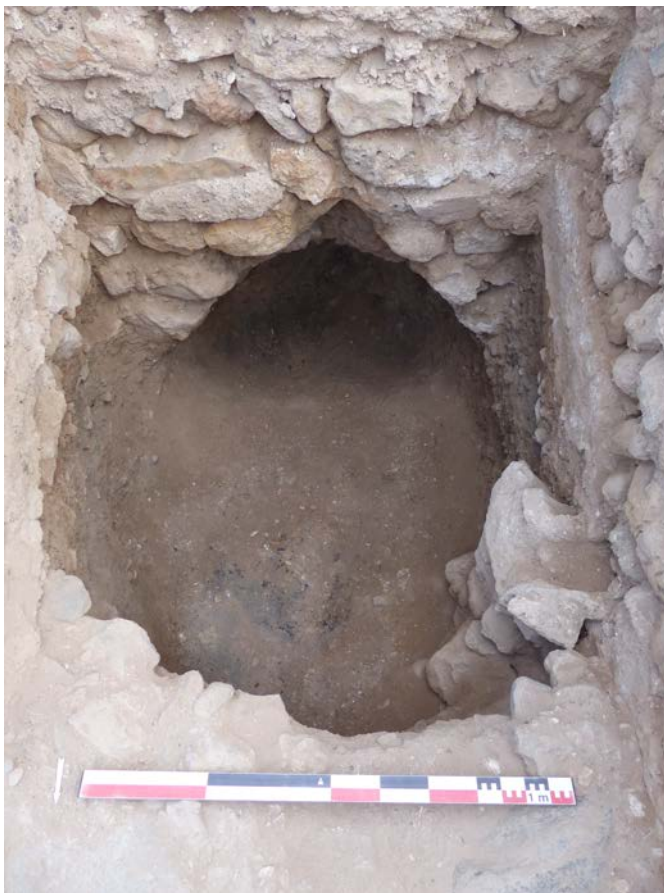
Fig. 67 - View of the pit B12-254

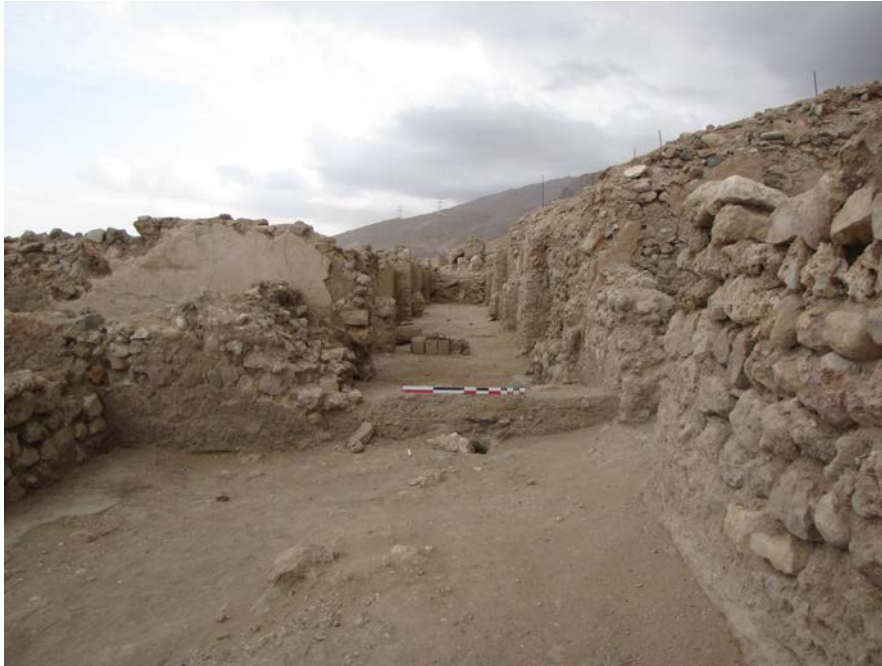
Fig. 69 - View of area M in March 2014

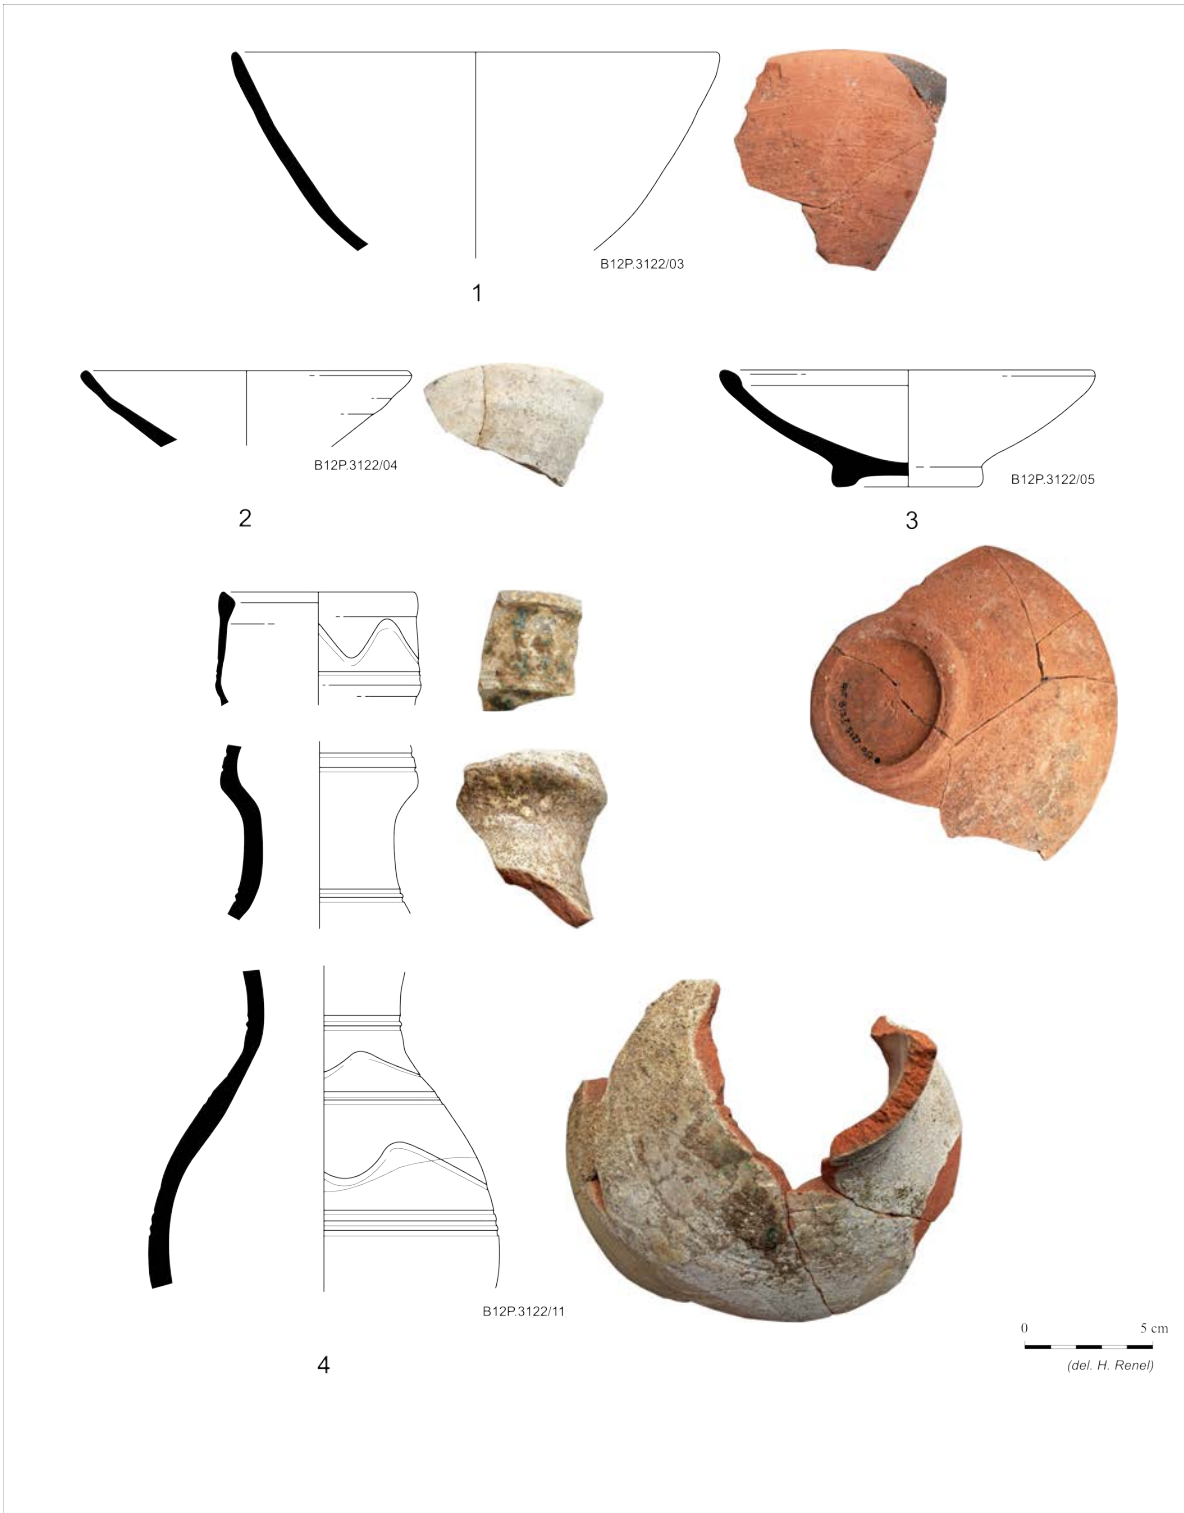
Fig. 97 - Ceramics from the area P from the mosque (UF3122), 2nd half of the 15th cent., 1st half of the 16th cent.

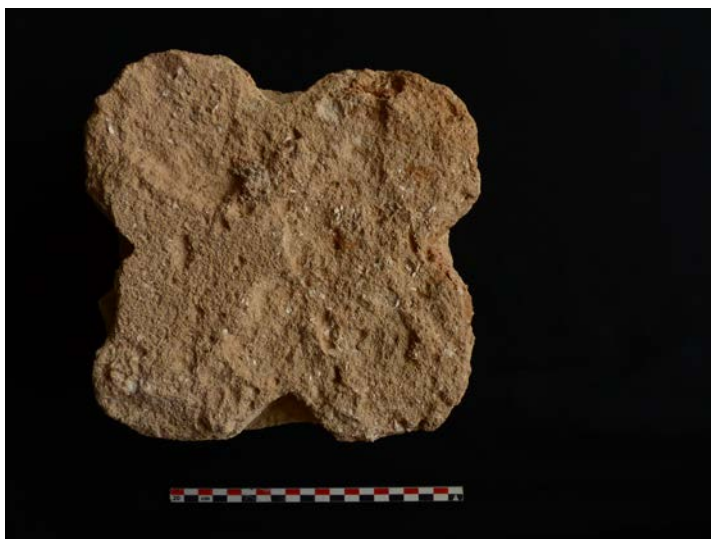
*Fig. 104 -
Quatrefoil*

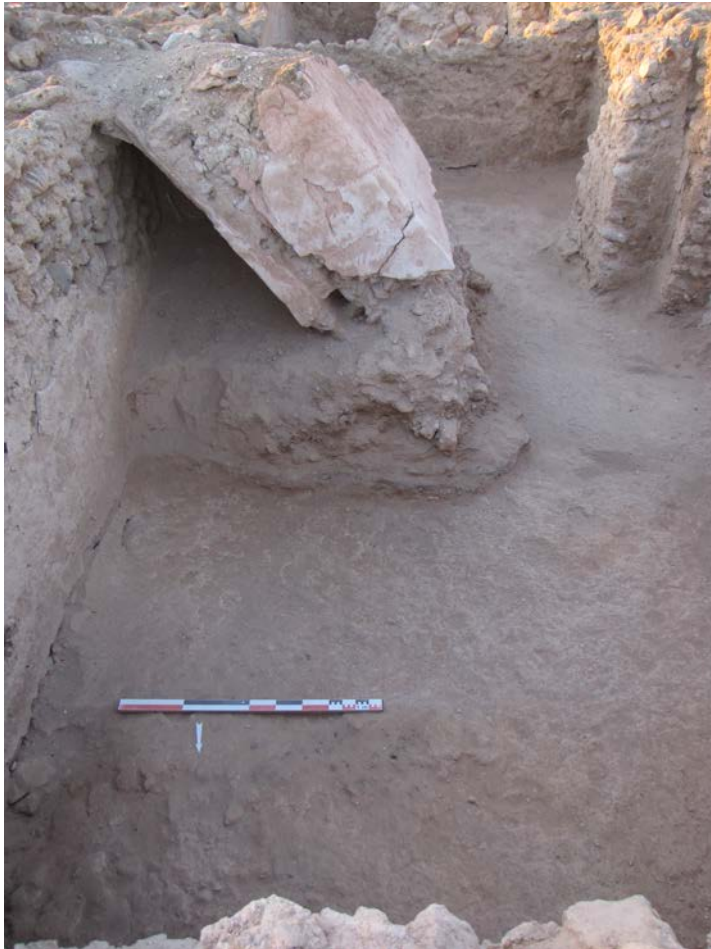
Fig. 166 - IsoArc 295

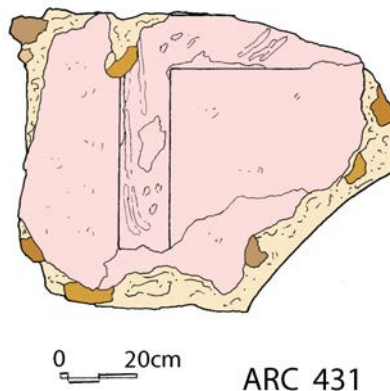
Fig. 168 - IsoArc 431 (V. Bernard)

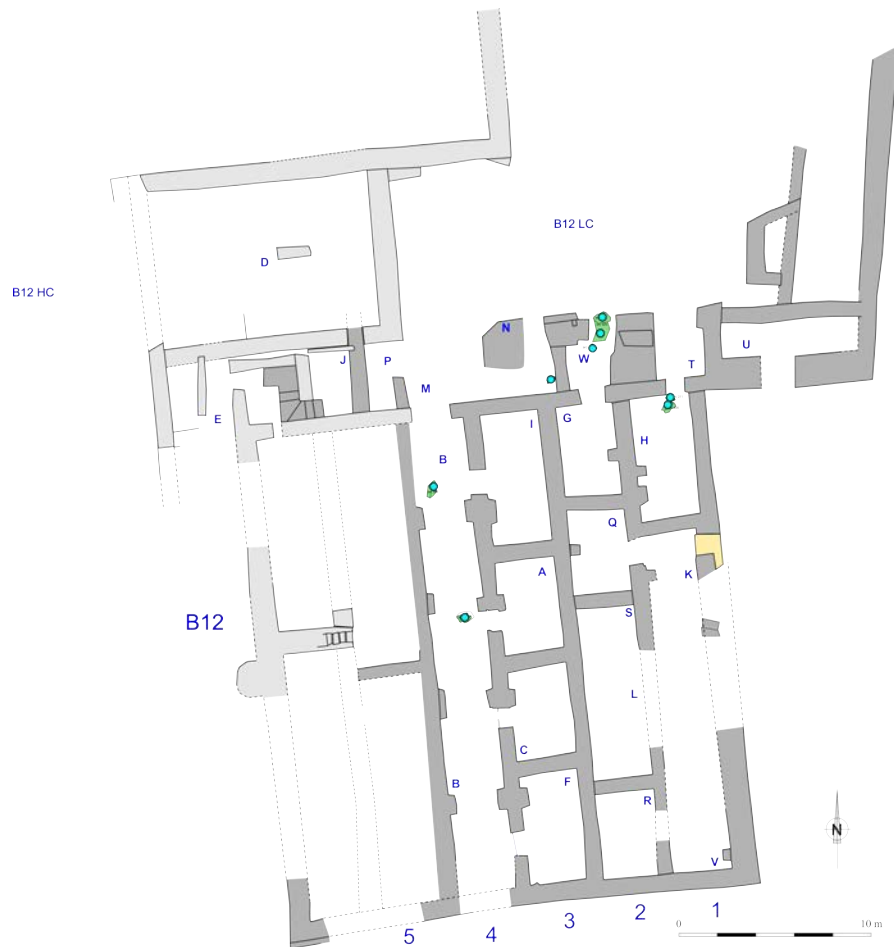
Fig. 171 - Location of the fragments of cupolas
