HAL
open science

The Qalhât Development Project and Qalhât Project : Final report on the 2013b/2014a season

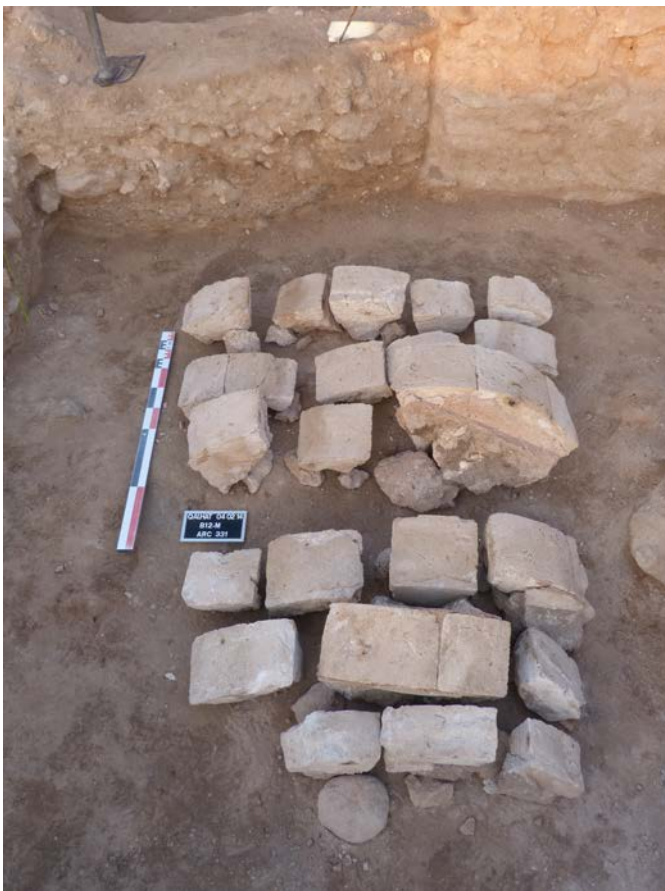
Fig. 14 - Half-column IsoArc 331 after methodical dismantling

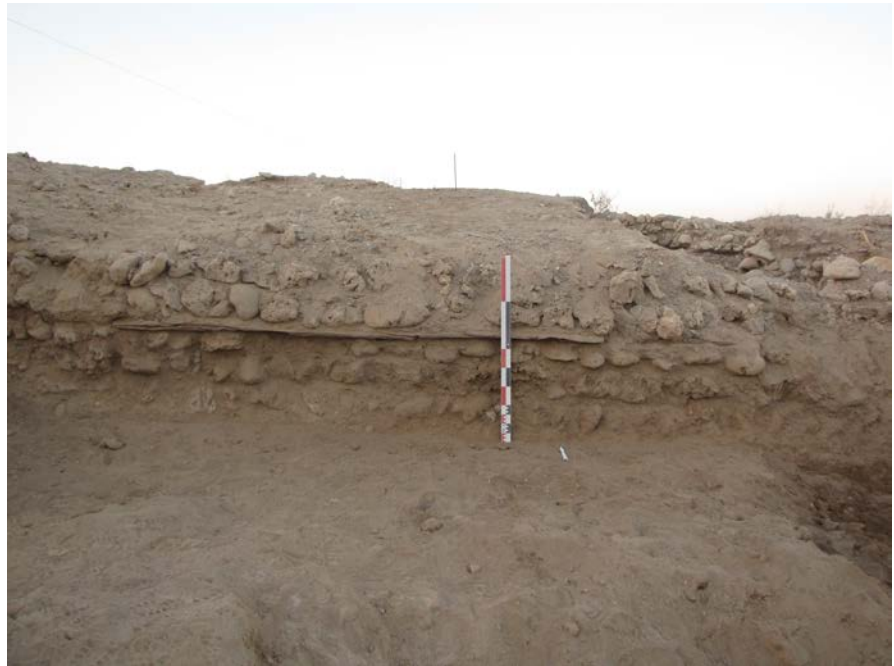
Fig. 26 - The south wall B95-01 with the beams

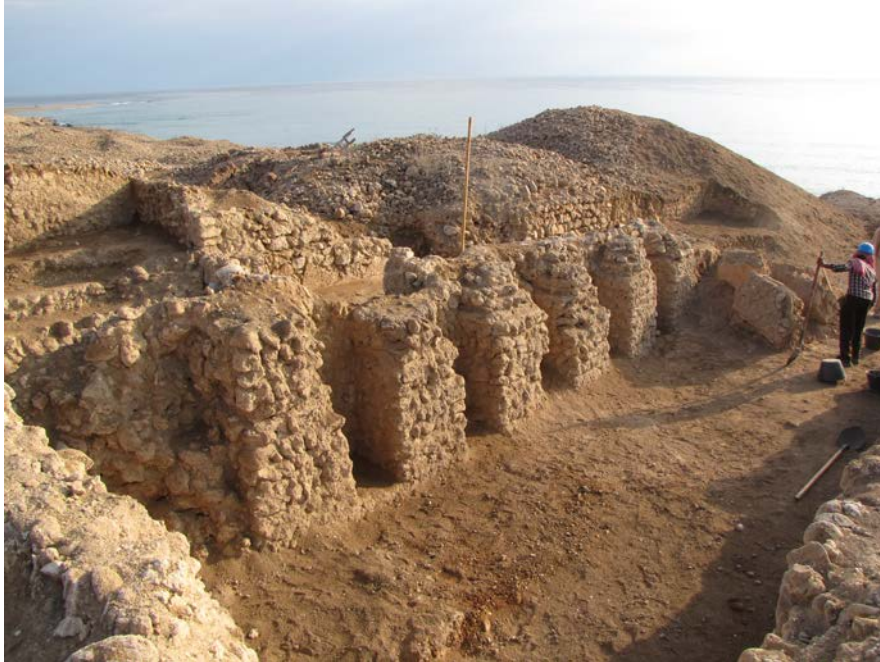
Fig. 27 - General view of the northern pillars

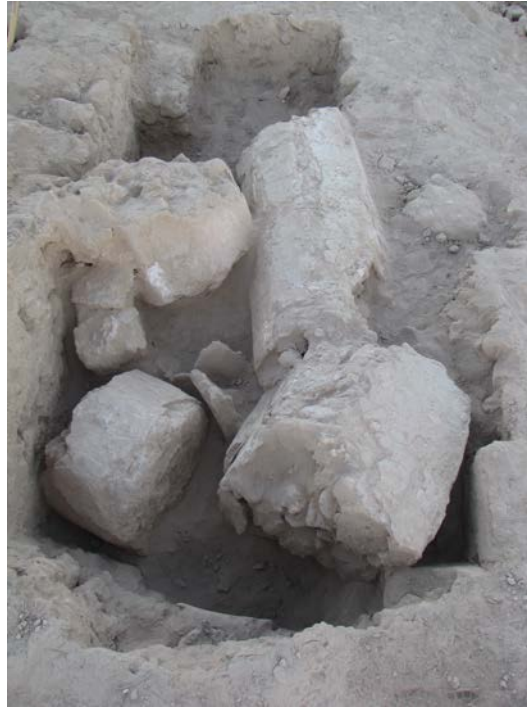
Fig. 40 - General view of room K

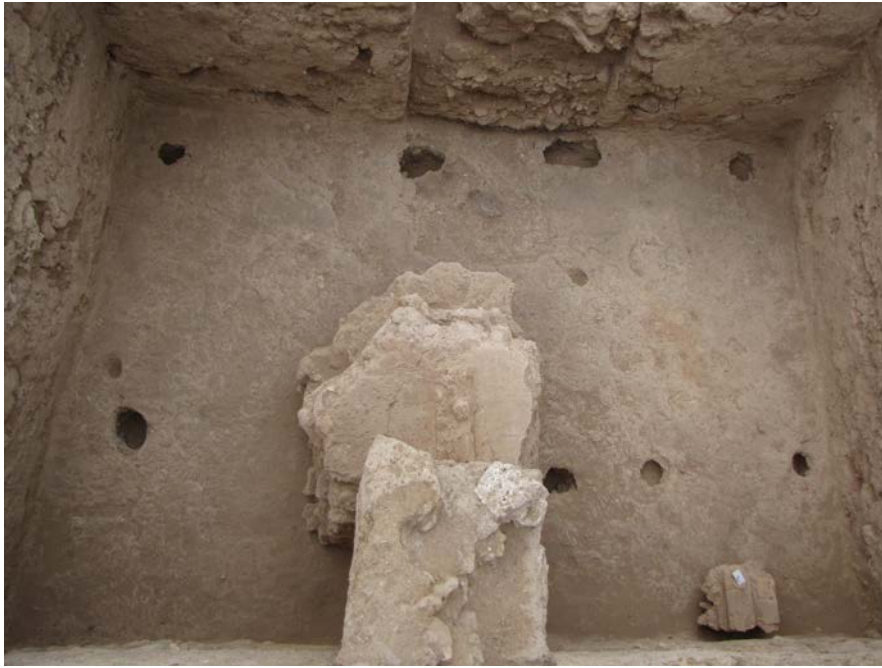
Fig. 45 - View of room B12-Q after excavations

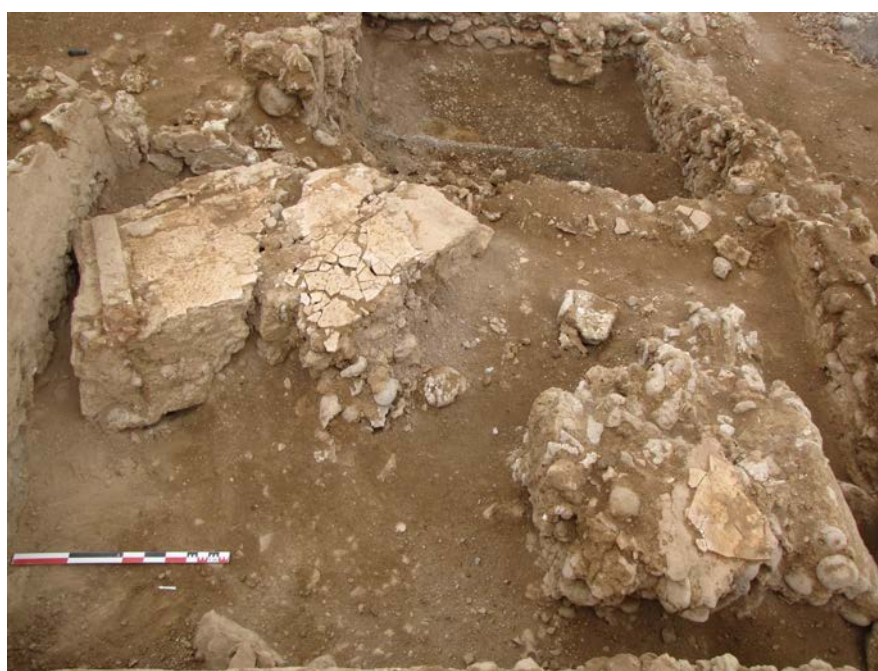
*Fig. 47 - View of room
B12-R in March 2014*

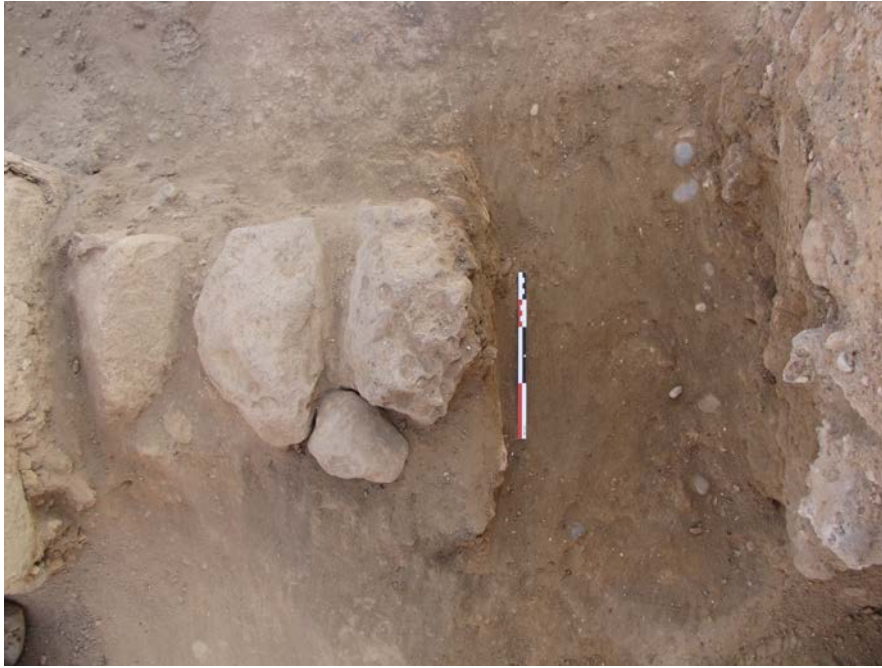
*Fig. 49 - The threshold
B12-170 half-excavated*

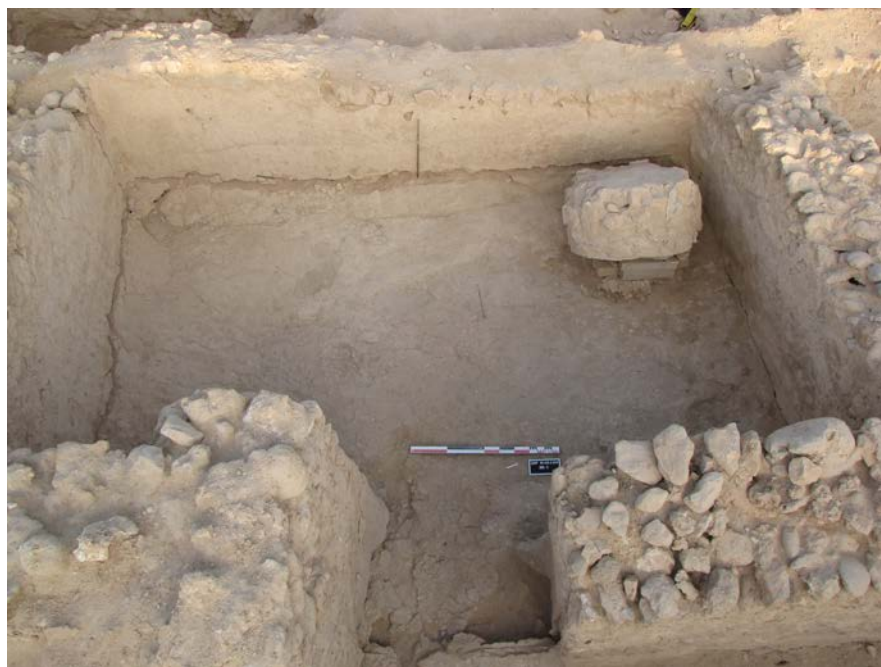
Fig. 54 - View of room B12-C after excavations

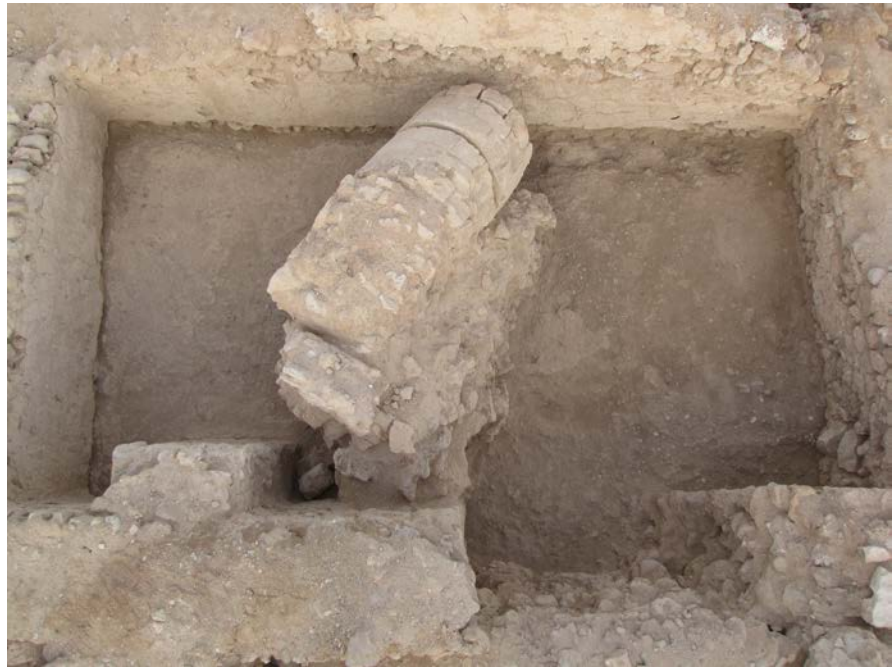
*Fig. 57 - View of room
B12-F*

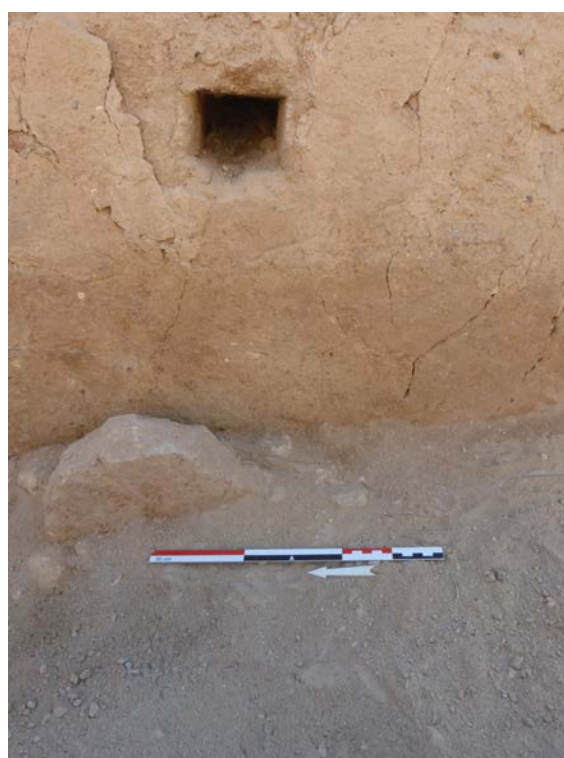
*Fig. 60 - Beam hole
B12-130*

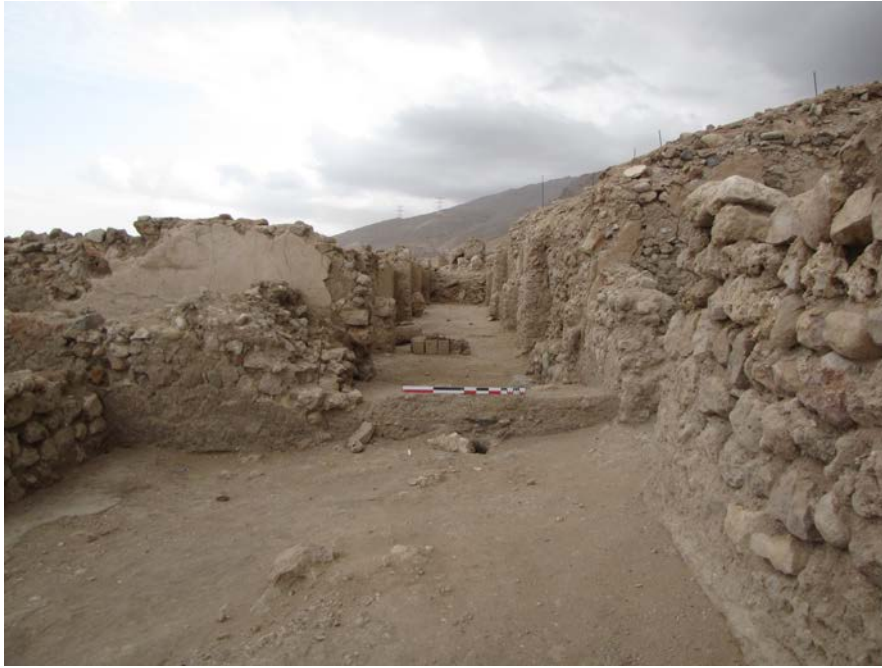
Fig. 69 - View of area M in March 2014

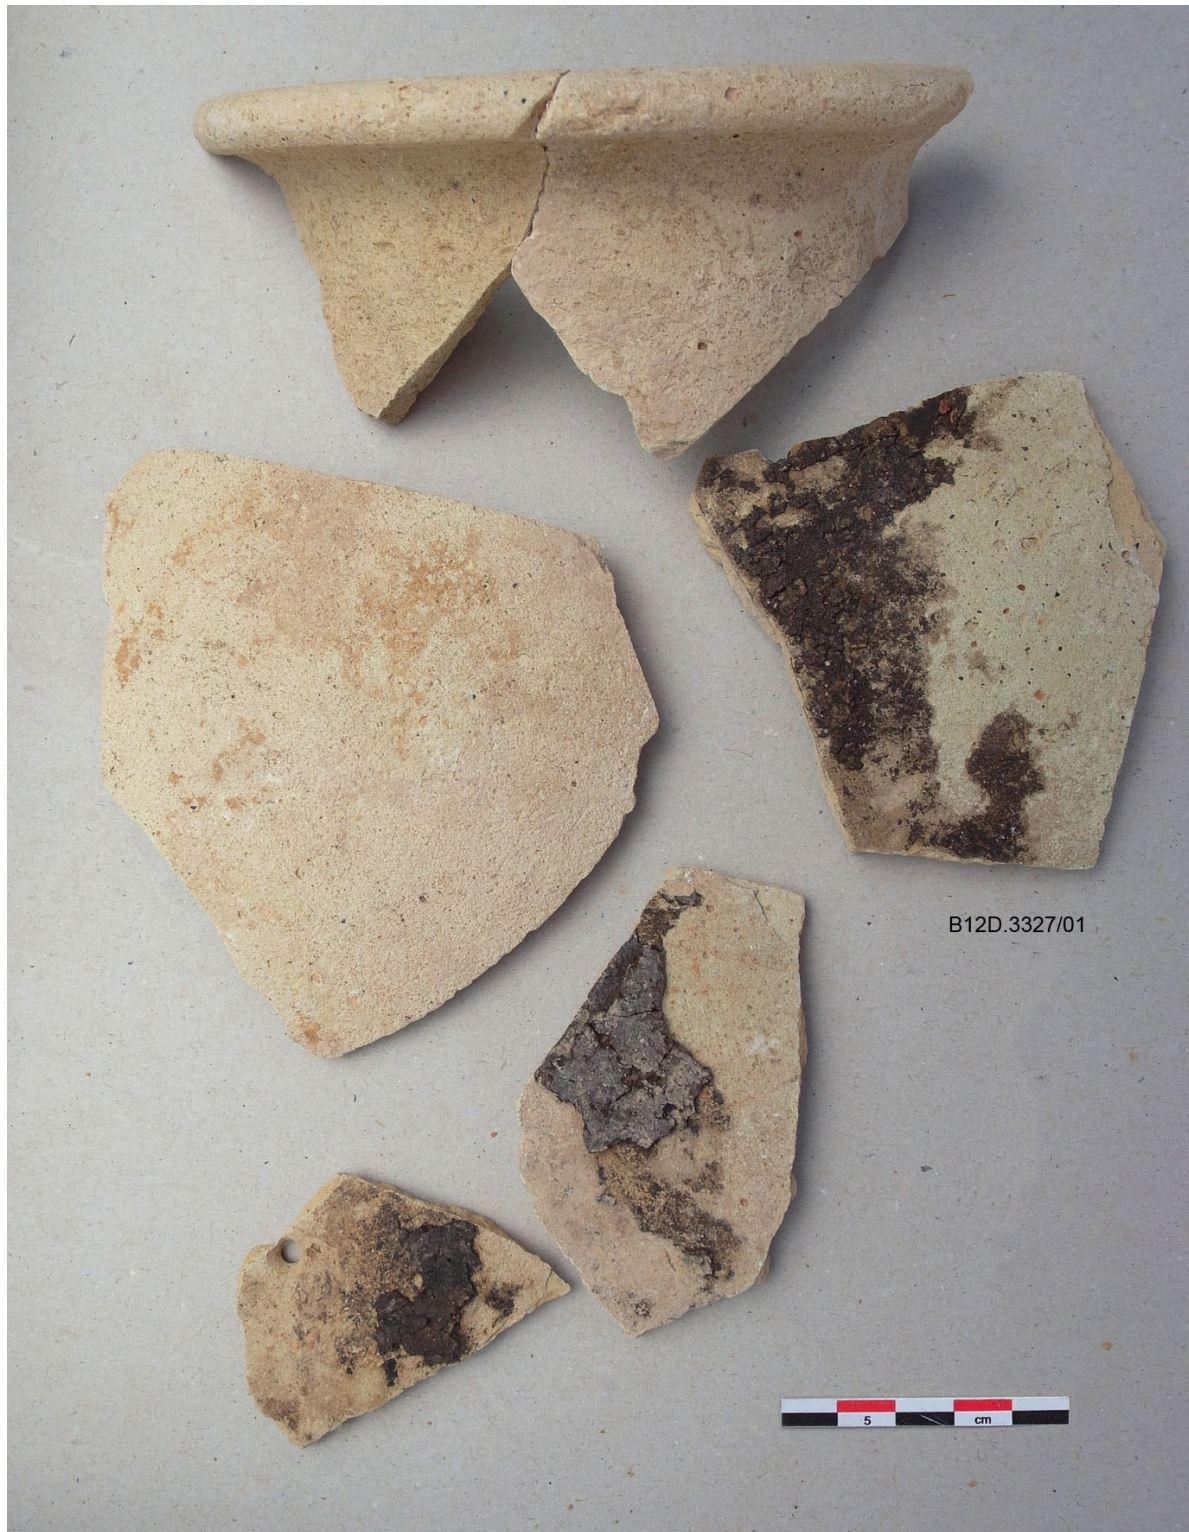
Fig. 82 - Ceramics from the area D from the mosque (UF3327), 16th cent.

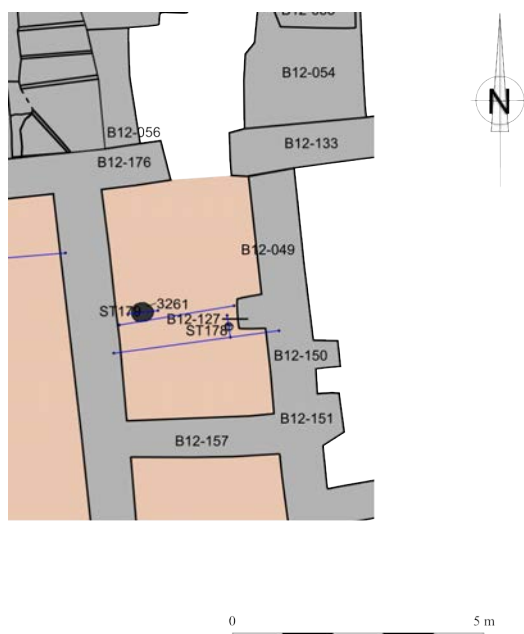
Fig. 85 - Ground plan of room G

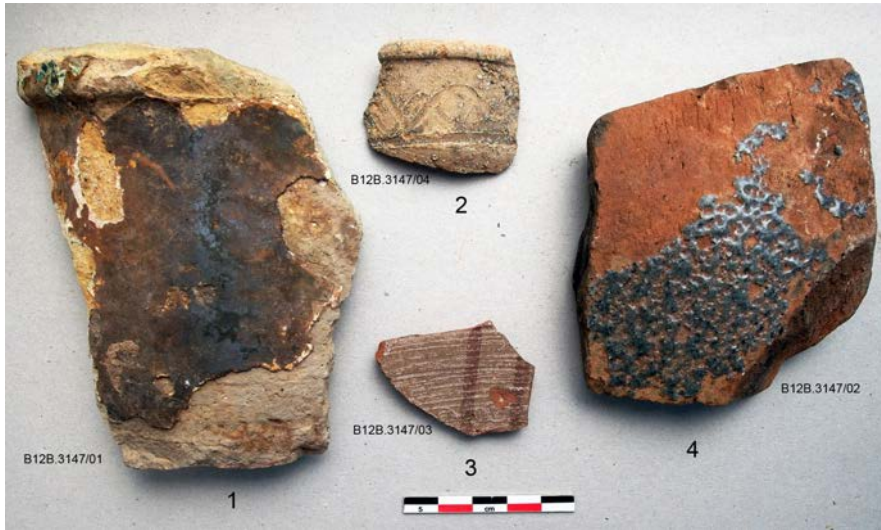
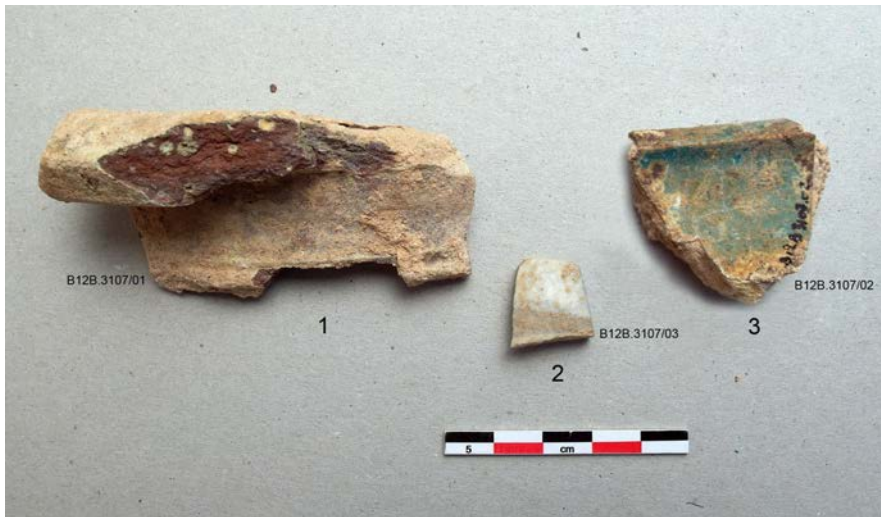
Fig. 92 - Ceramics from the area B from the mosque (UF3147), 2nd half of the 15th cent., 1st half of the 16th cent.

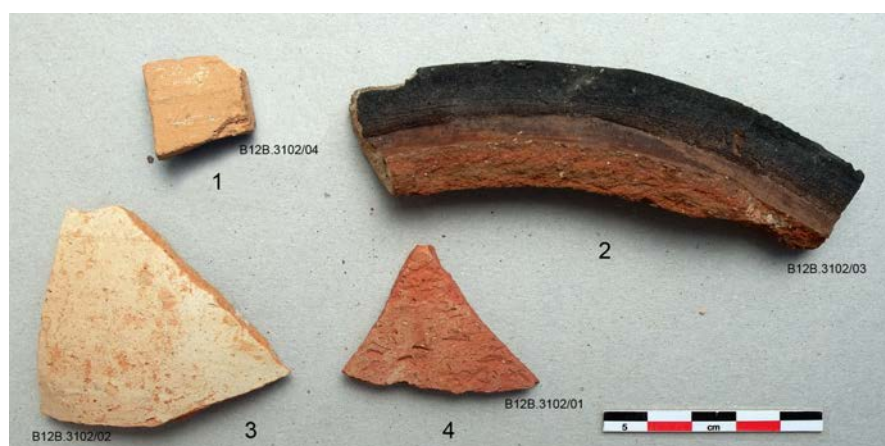
Fig. 95 - Ceramics from the area B from the mosque (UF3102), 14th cent.

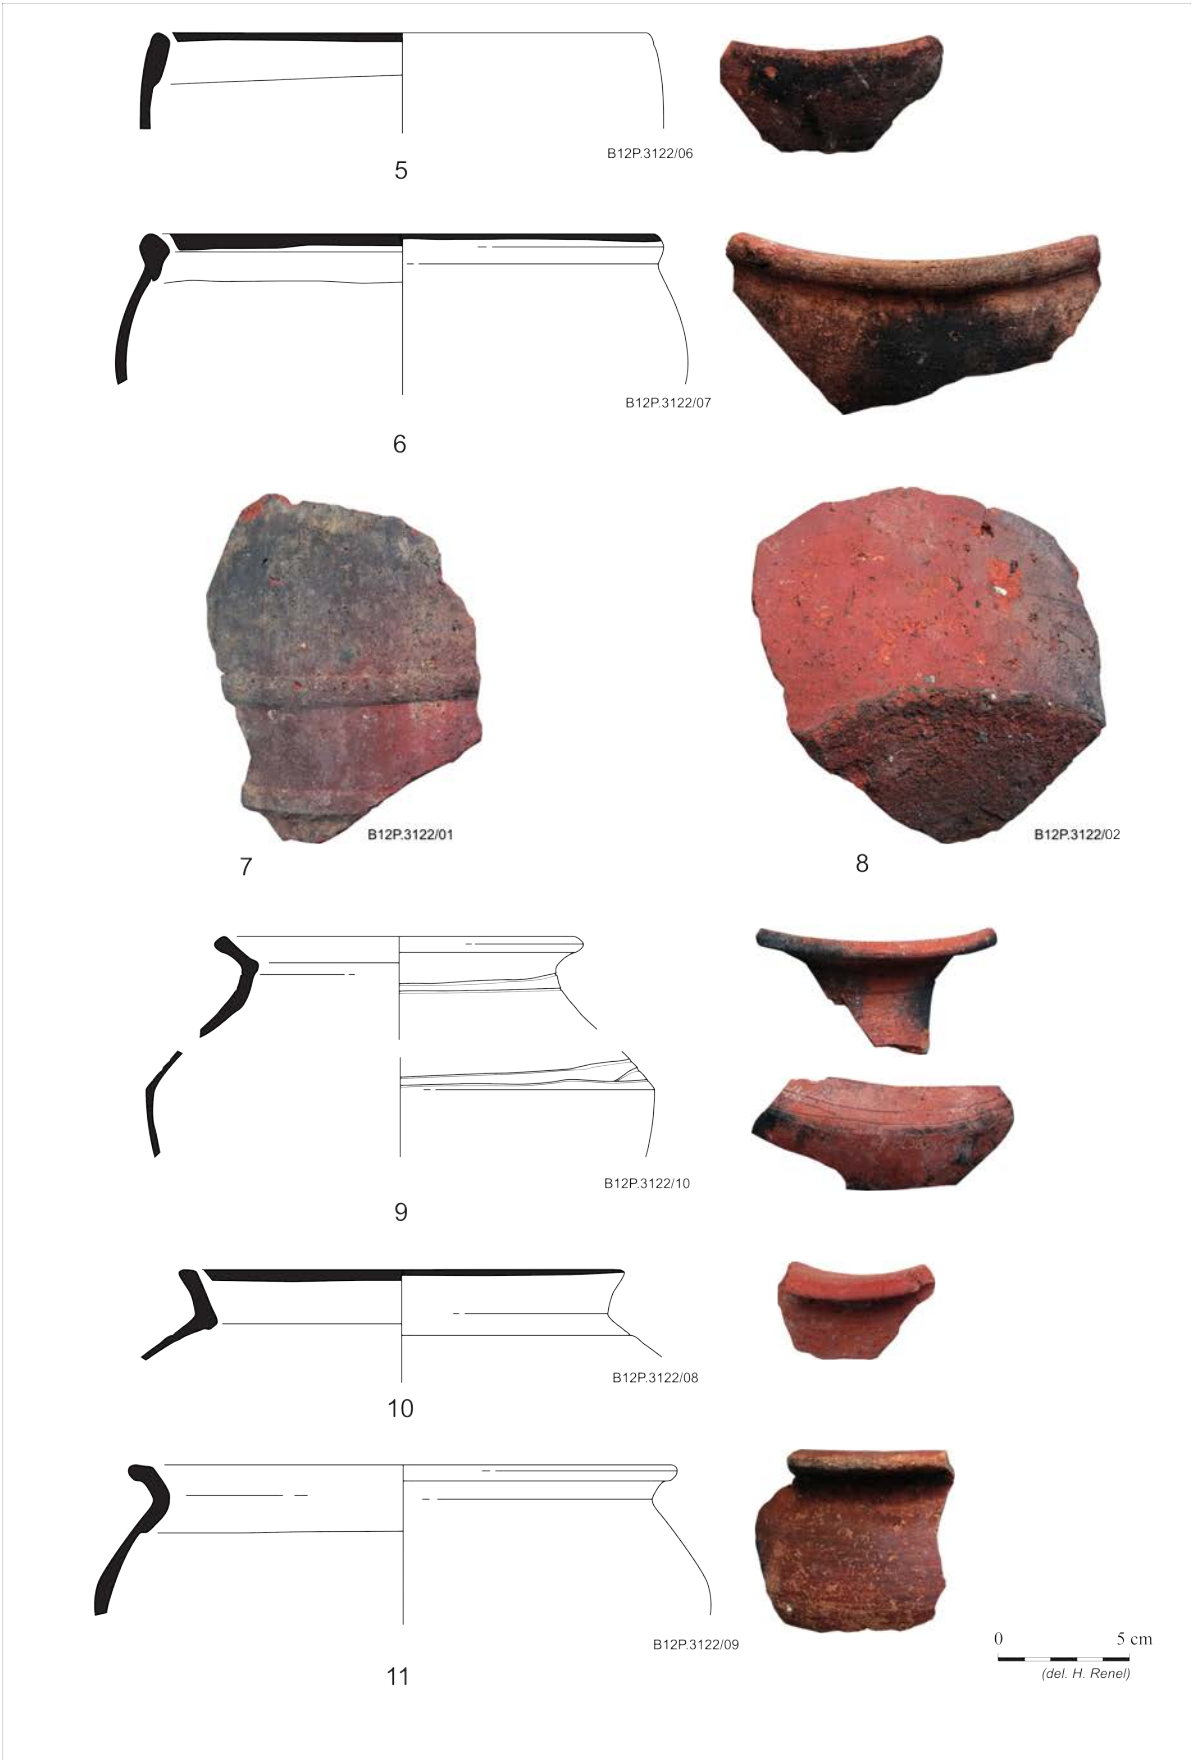
Fig. 98 - Ceramics from the area P from the mosque (UF3122), 2nd half of the 15th cent., 1st half of the 16th cent.

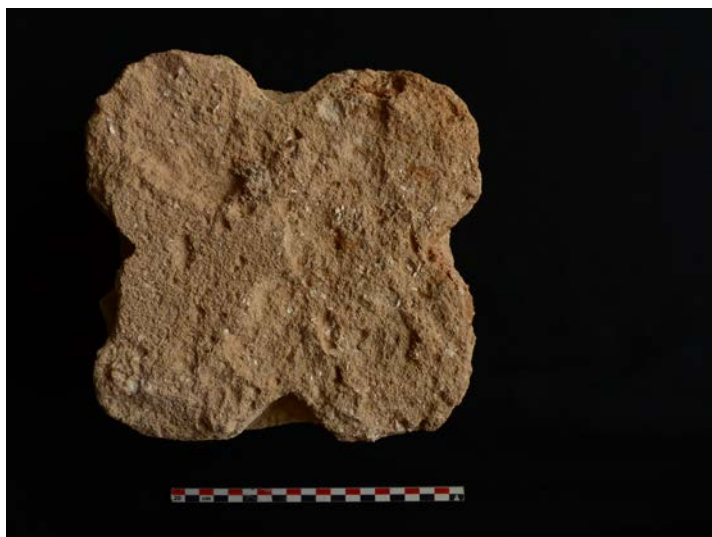
*Fig. 104 -
Quatrefoil*

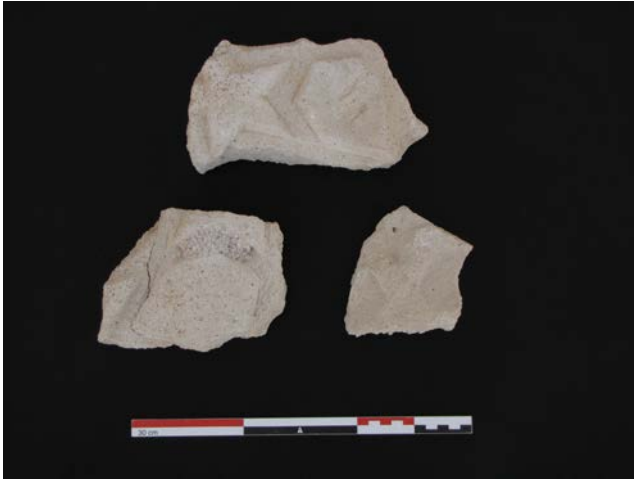
Fig. 110 - EM 10 is a mortar mold

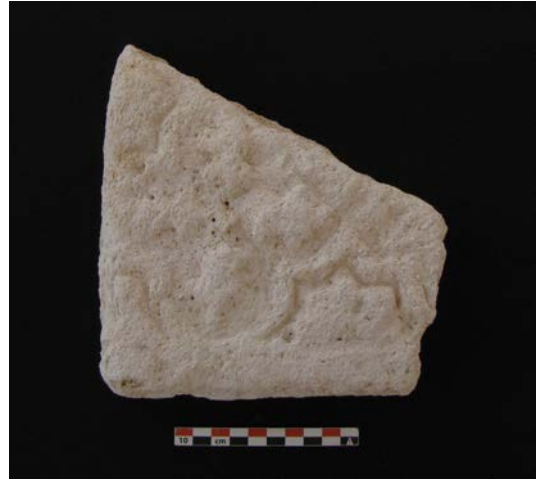
Fig. 111 - EM 14; a mortar mold for EC 5 or EC 6

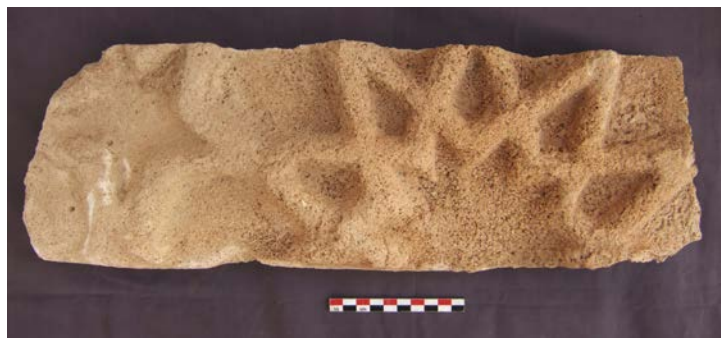
world. No complete panel has been found out yet, which does not allow to produce measurements and so, the full restitution of this panel. (fig. 113)

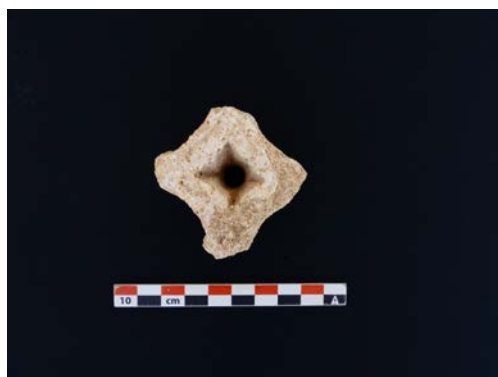
Fig. 114 - EM3 fragment,
B95_3525

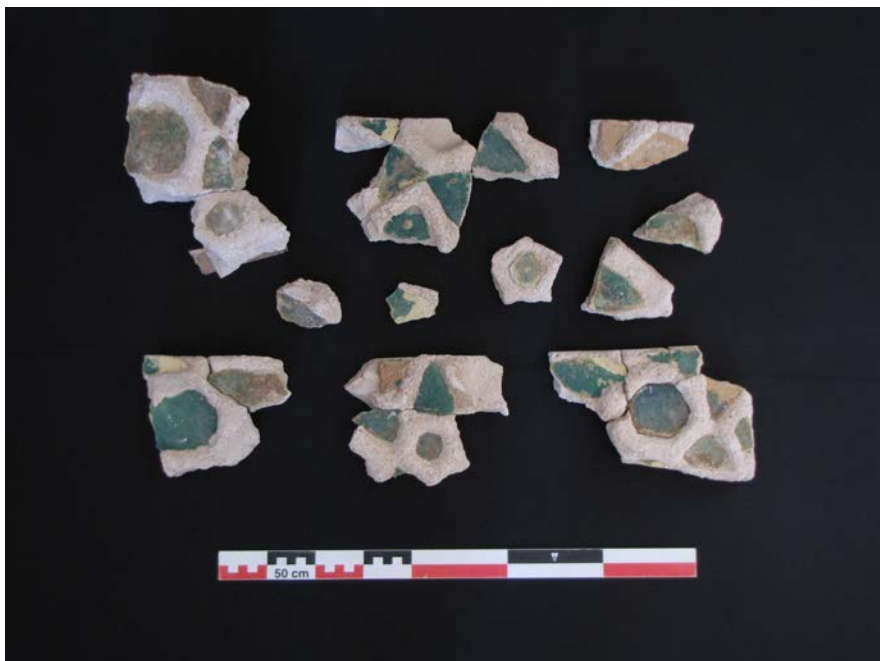
Once again, the discovered elements are too fragmented to reconstitute a full pattern, even if with some comparison, an hypothetical restitution could be possible (fig. 125).

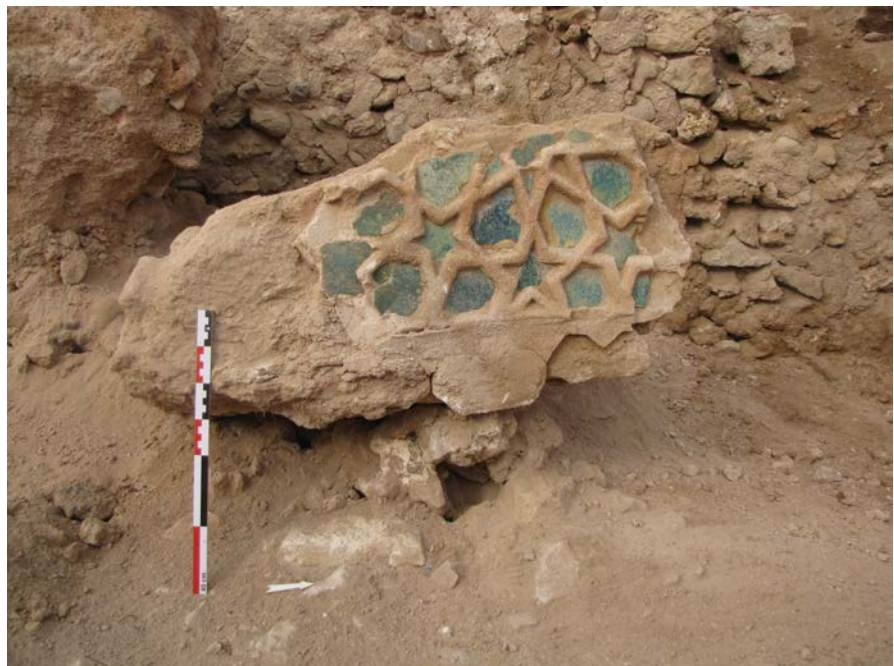
Fig. 132 - *Style G*

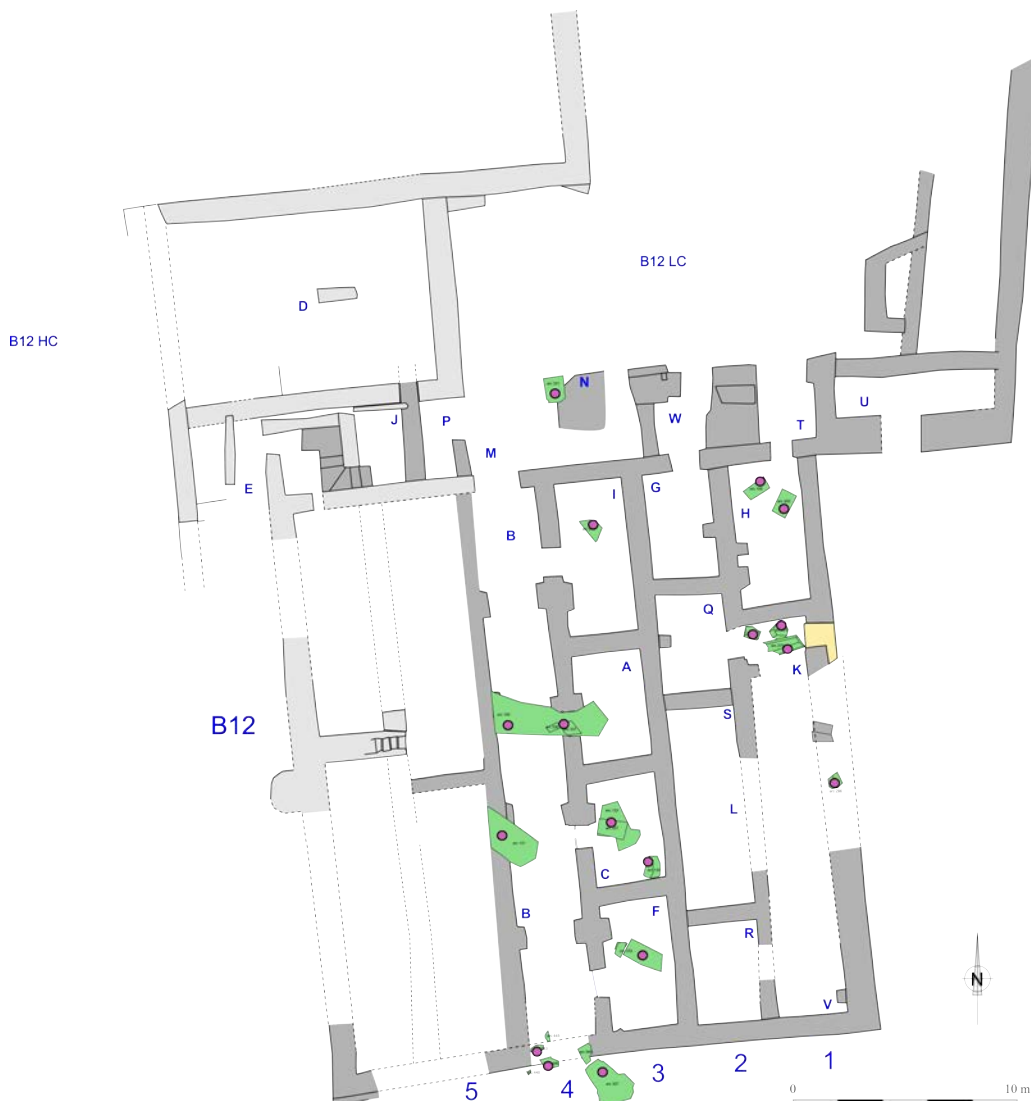
Fig. 146 - Location of pillars elements

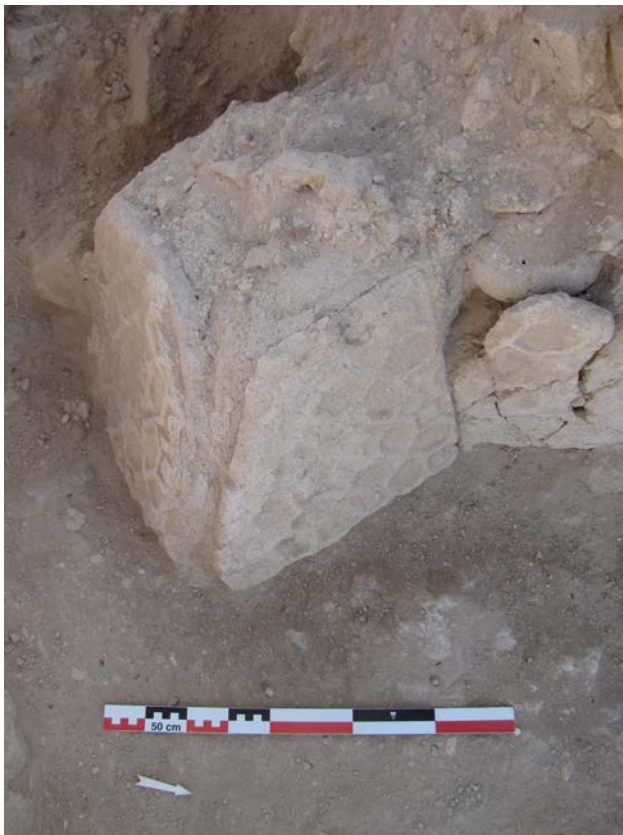
Fig. 164 - IsoArc 335

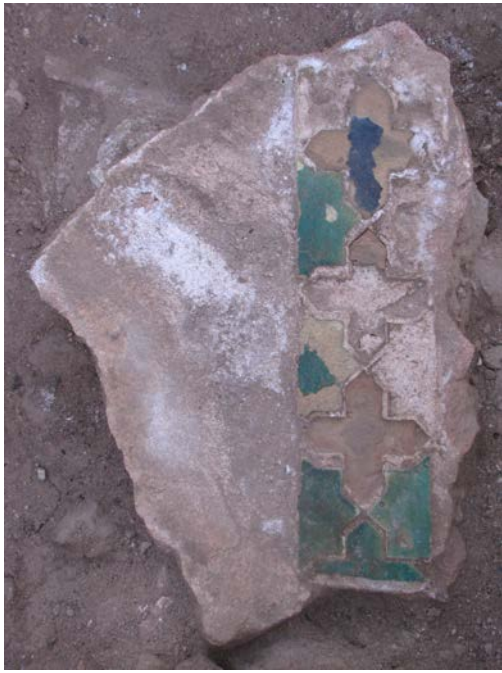
Fig. 173 - IsoArc 206

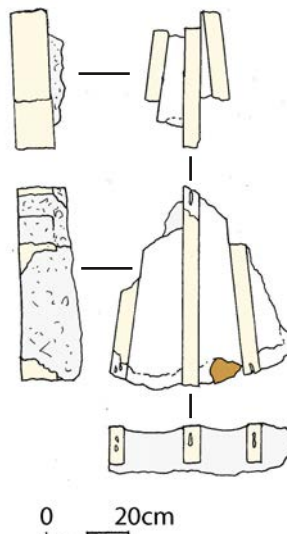
Fig. 181 - Technical drawing of a fan vault (V. Bernard)

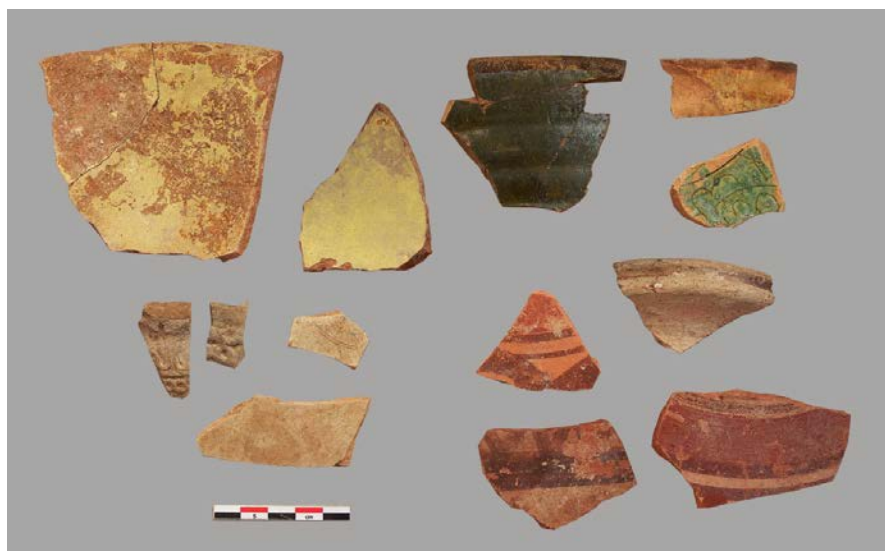
Fig. 208 - Ceramics coming from the Uf 4020 and 4031.
