**HAL**  
open science

## **The Qalhât Development Project and Qalhât Project : Final report on the 2013b/2014a season**

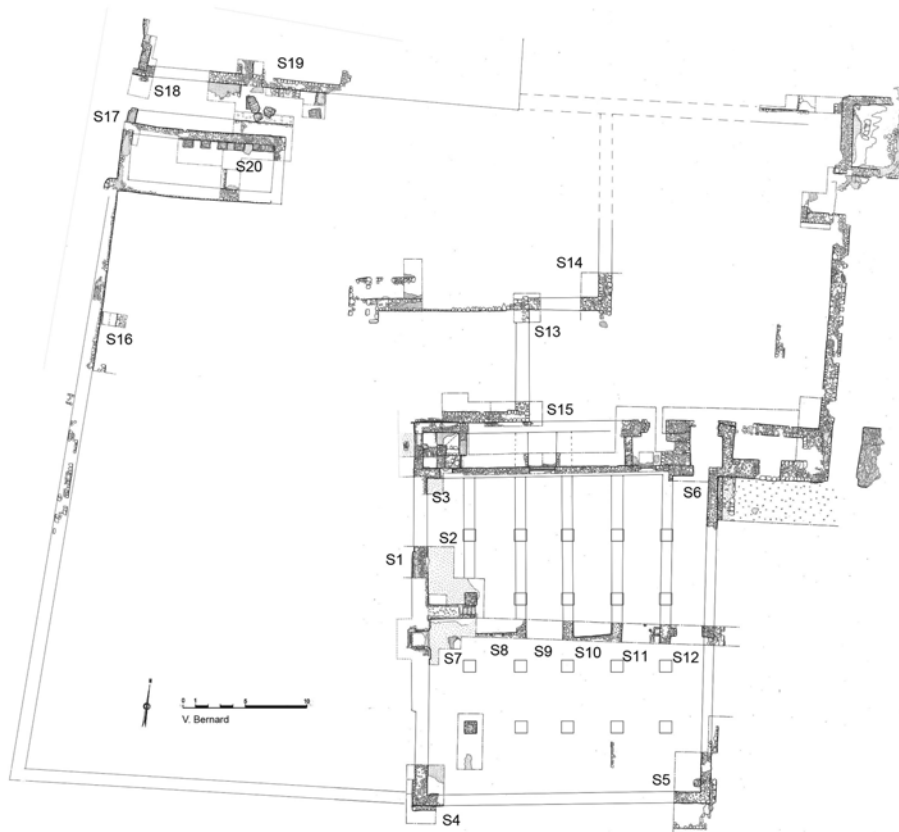
*Fig. 3 - Plan of the mosque unit at the end of the QP excavations (2011)*

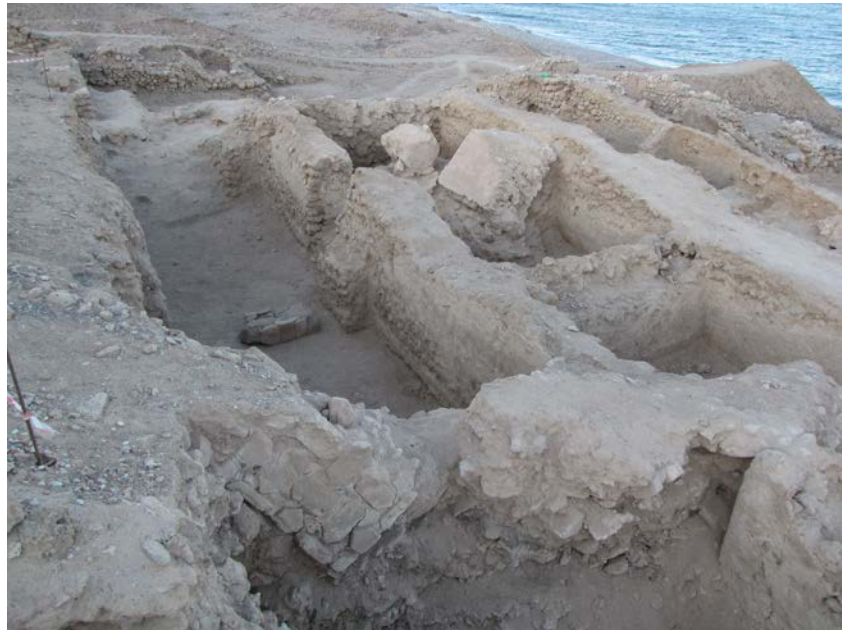
*Fig. 6 - General view of the north-east part of the Mosque at the end of December 2013*

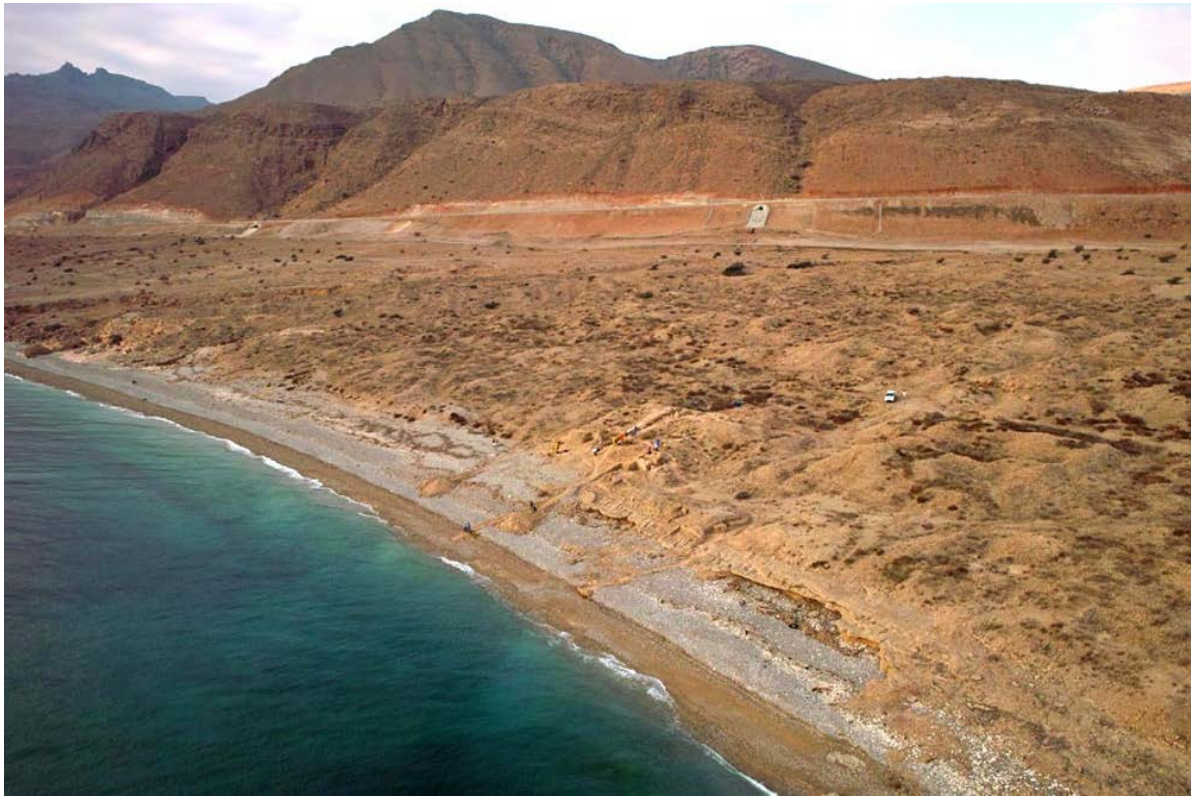
*Fig. 16 - General view of the depression and the beach.*

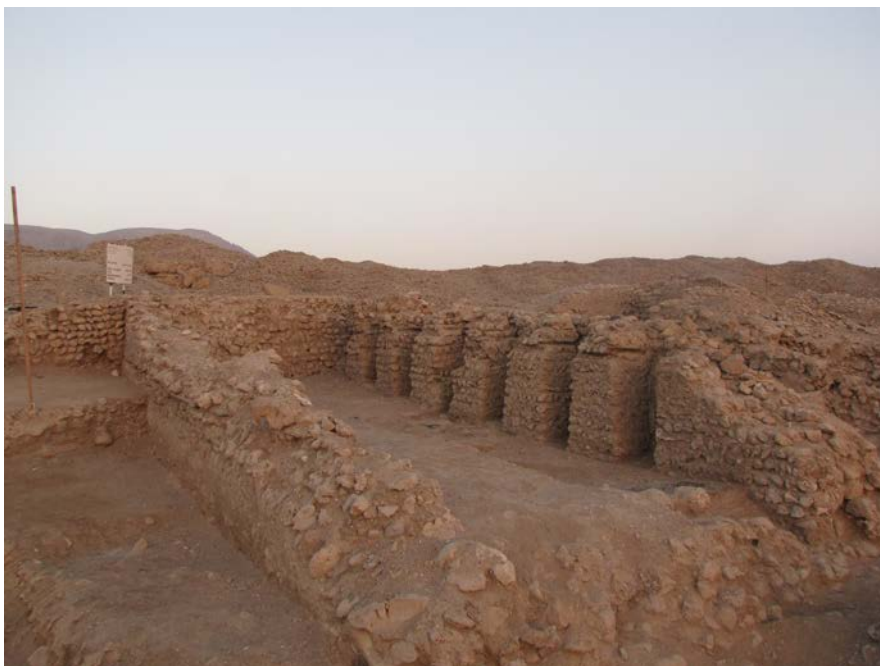
*Fig. 25 - General view of the building B95*

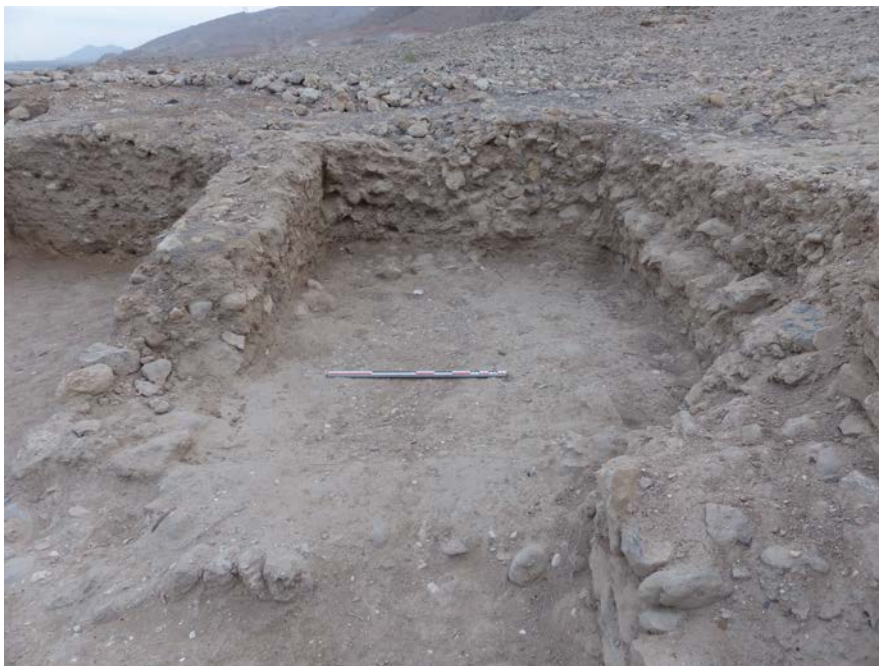
*Fig. 34 - View of room B139-C*

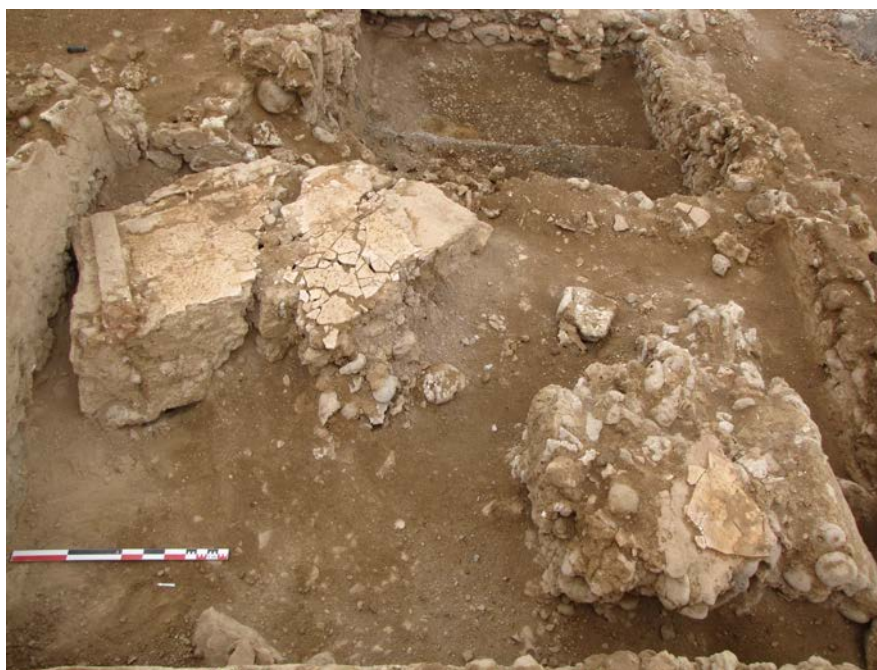
*Fig. 47 - View of room  
B12-R in March 2014*

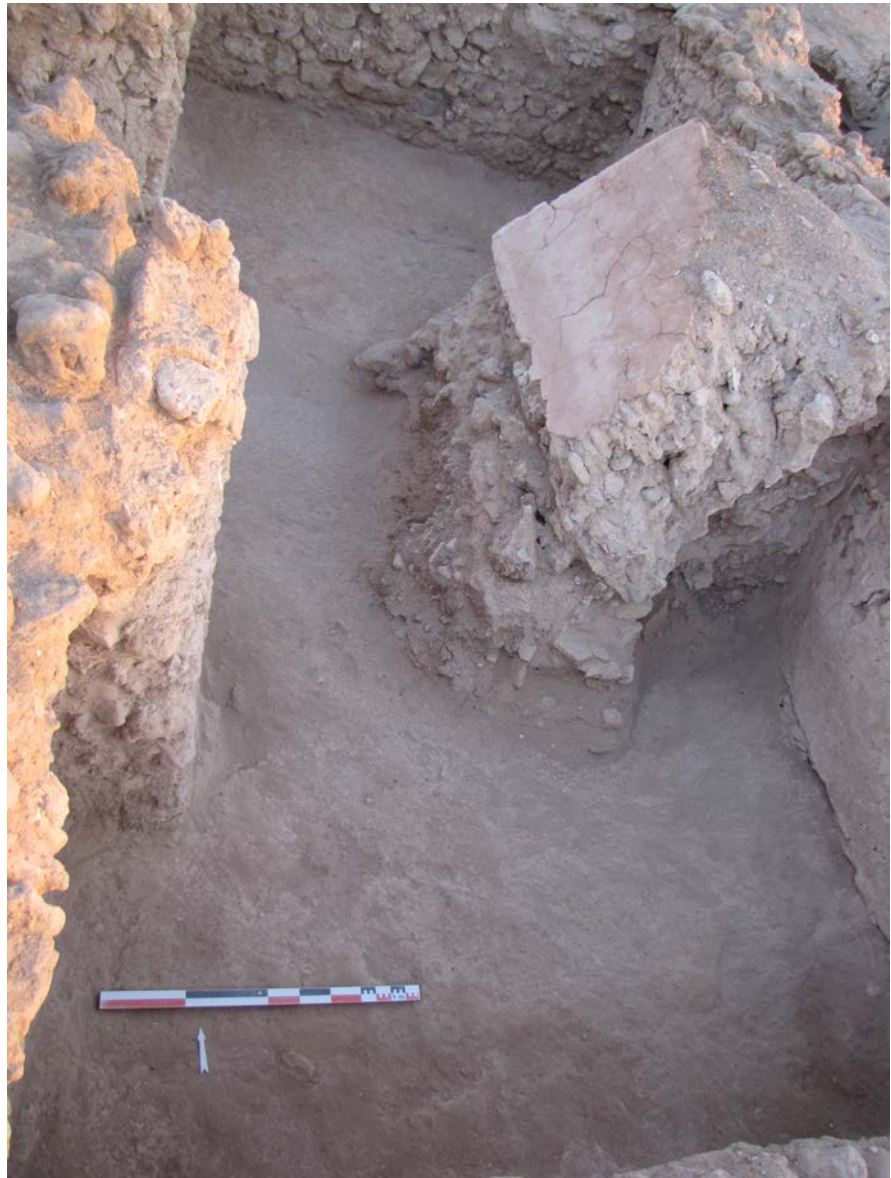
*Fig. 48 - View of room  
B12-I*

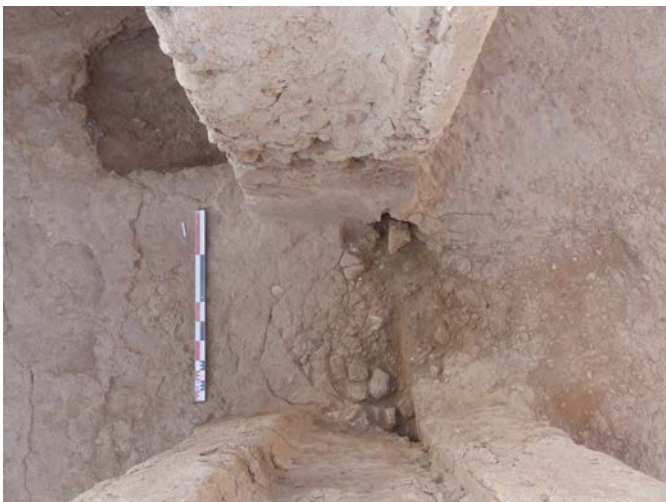
*Fig. 52 - The threshold  
B12-267*

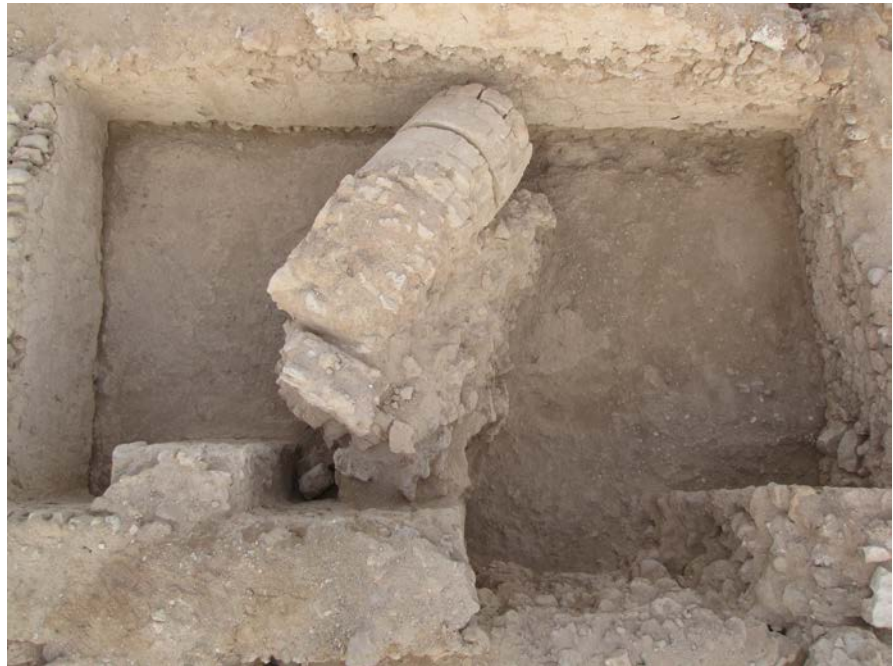
*Fig. 57 - View of room  
B12-F*

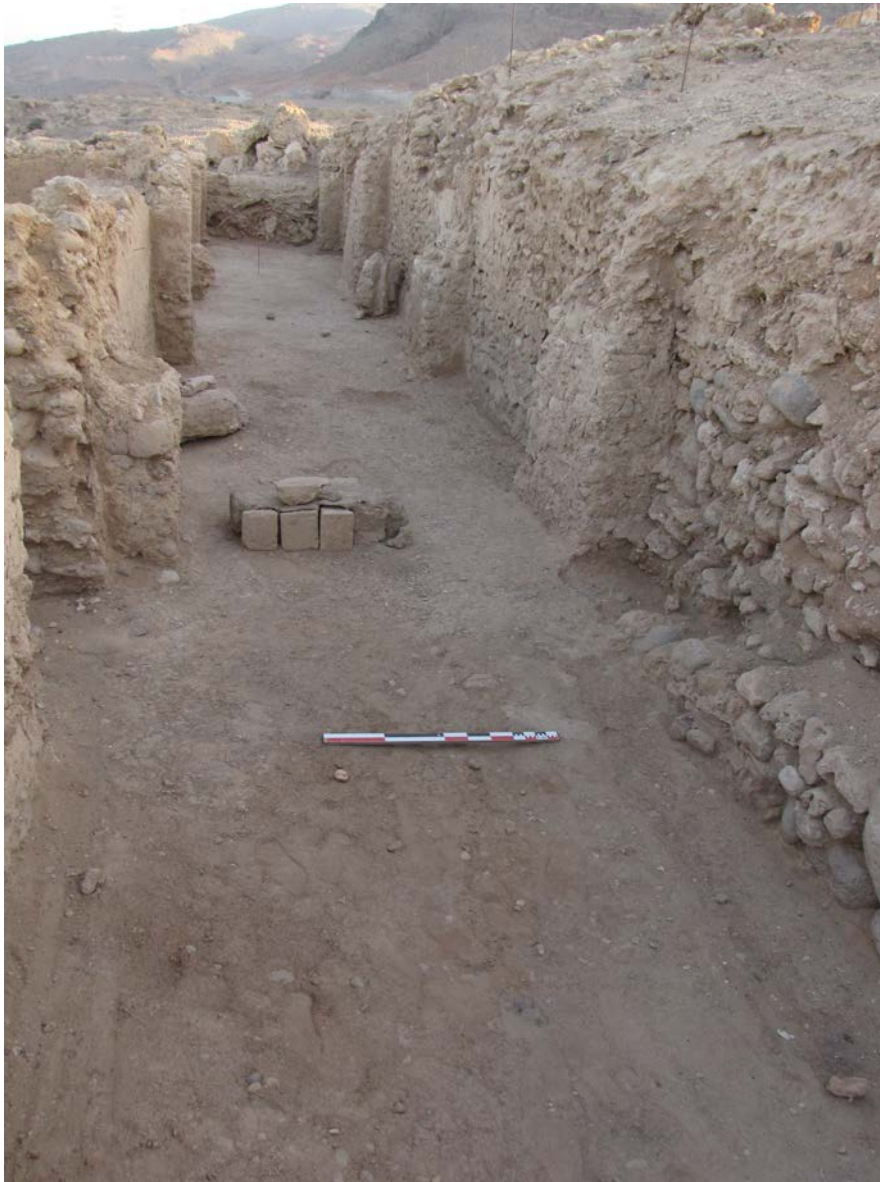
*Fig. 58 - View of room  
B12-B*

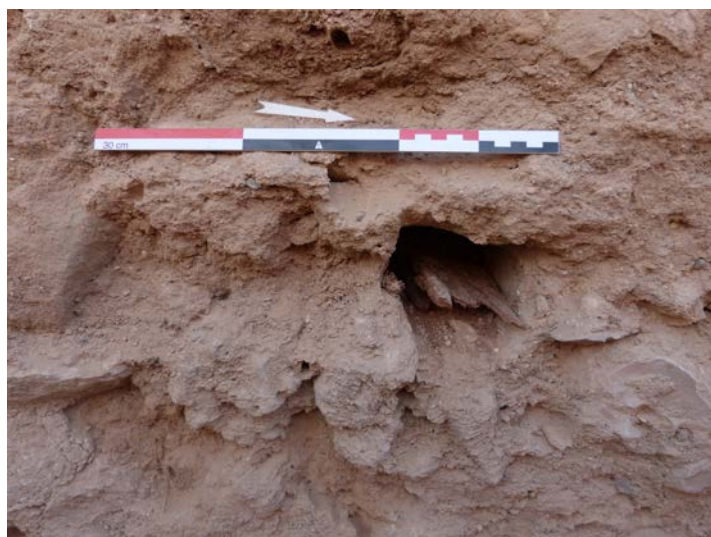
*Fig. 59 - Beam hole  
B12-122*

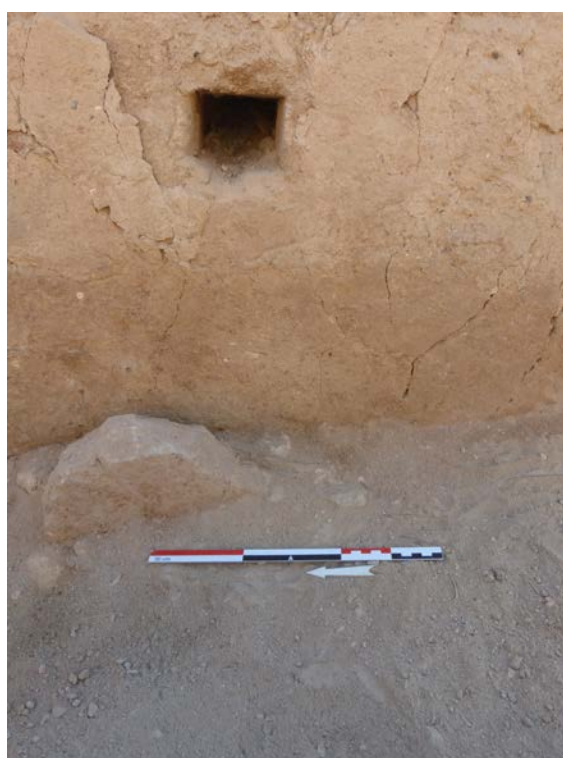
*Fig. 60 - Beam hole  
B12-130*

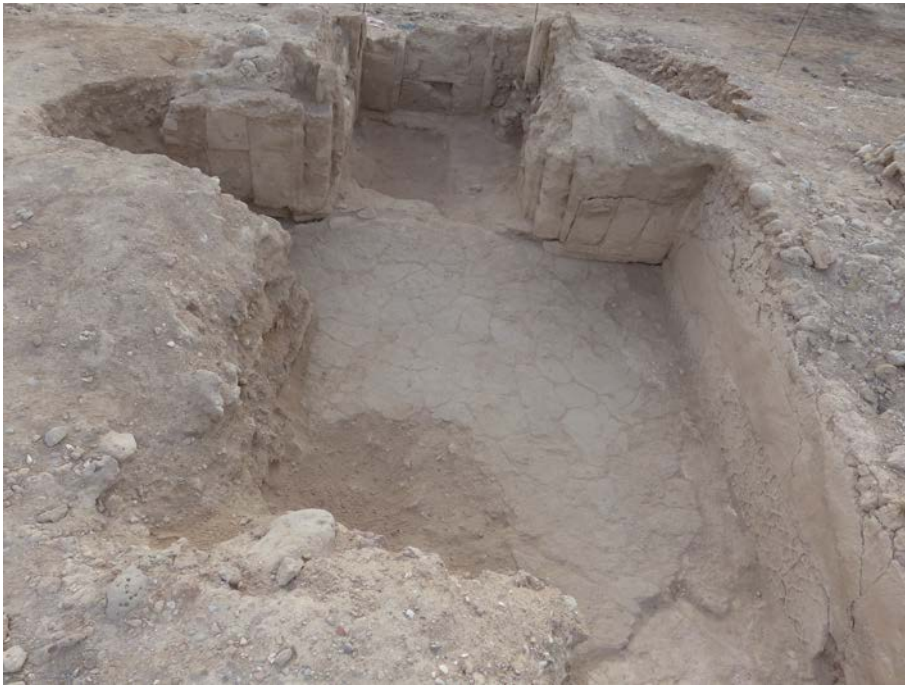
*Fig. 61 - View of the mihrab*

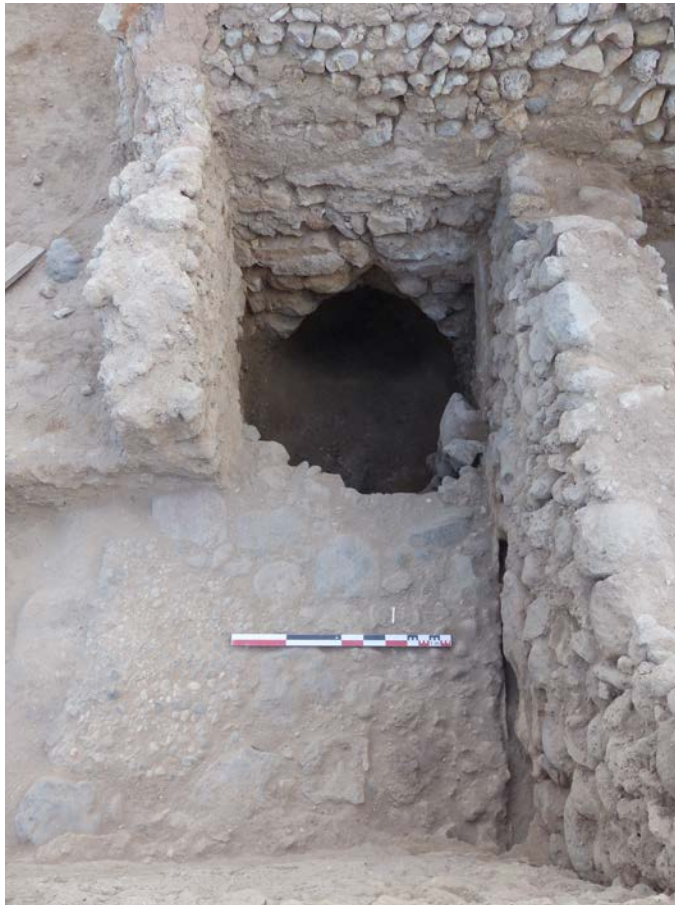
*Fig. 66 - View of  
the ground floor  
in room P*

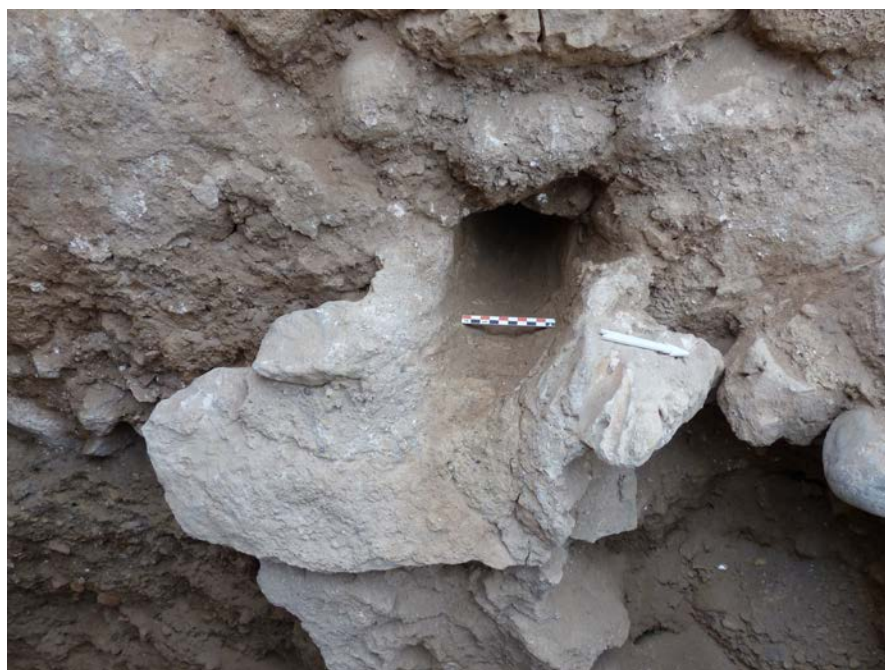
*Fig. 68 - View of gutter B12-255*

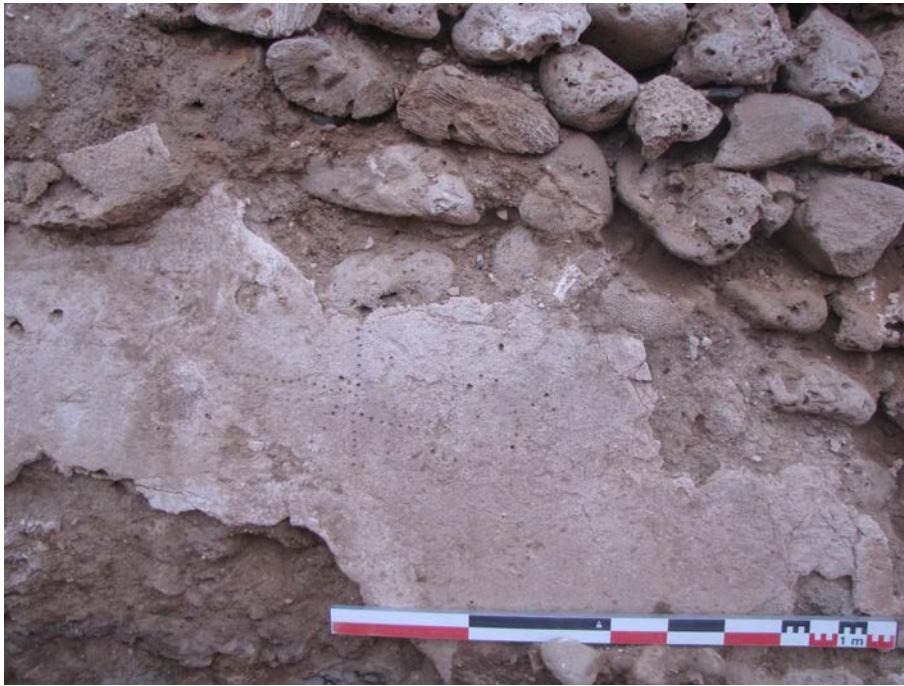
*Fig. 72 - View of the engraving in room B12-T*

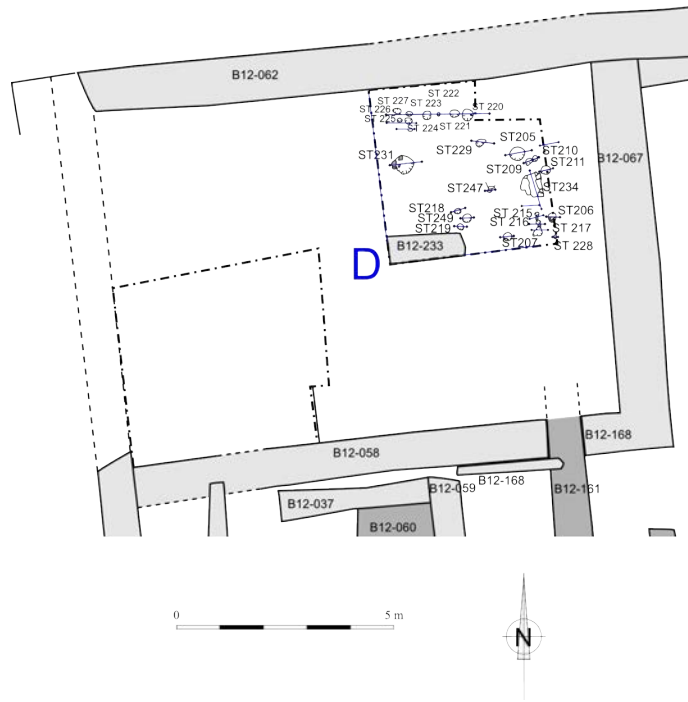
Fig. 78 - Occupancy structures in B12-D

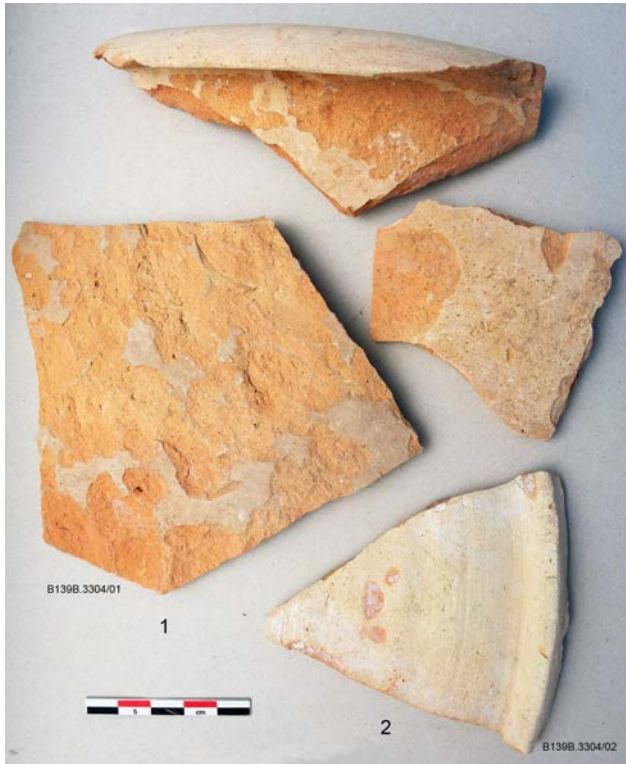
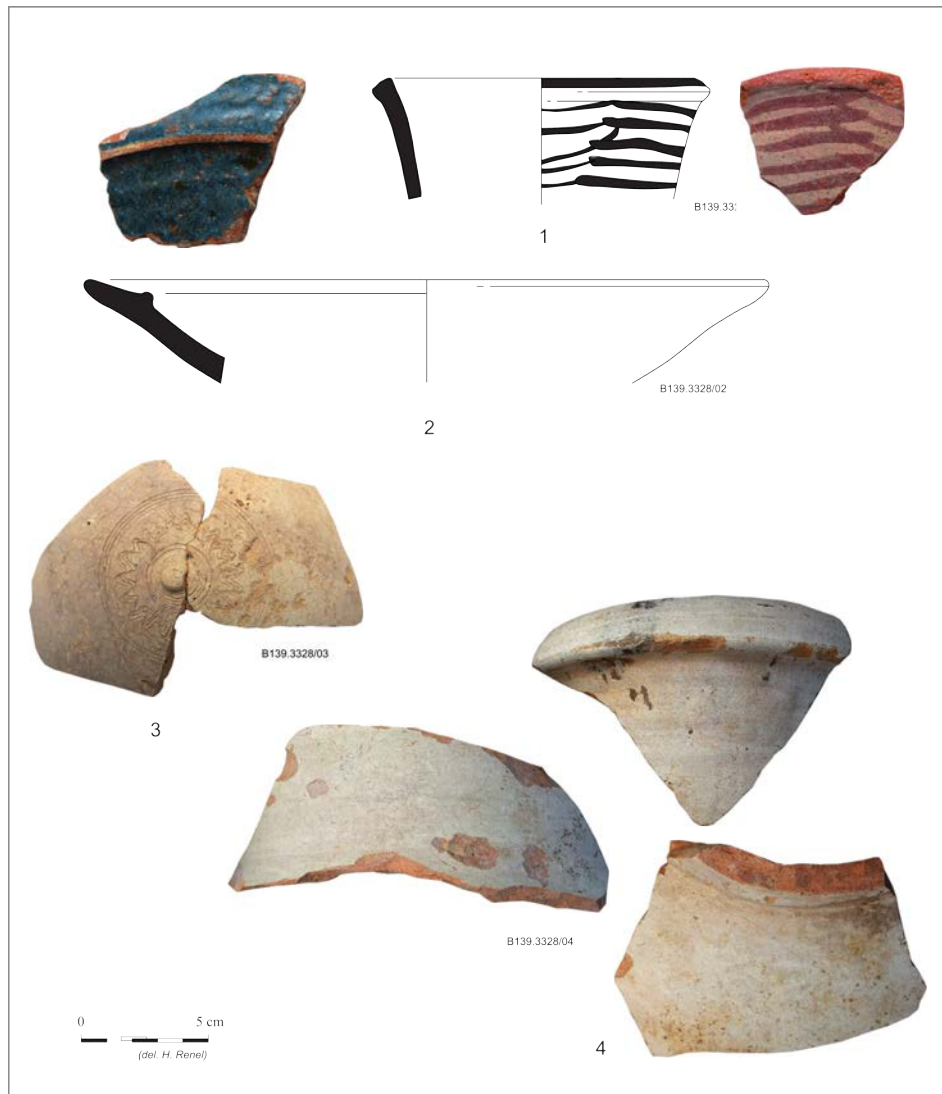
*Fig. 79 - Ceramics from B139, room B (UF3304), end of the 15th cent. - 16th cent.*

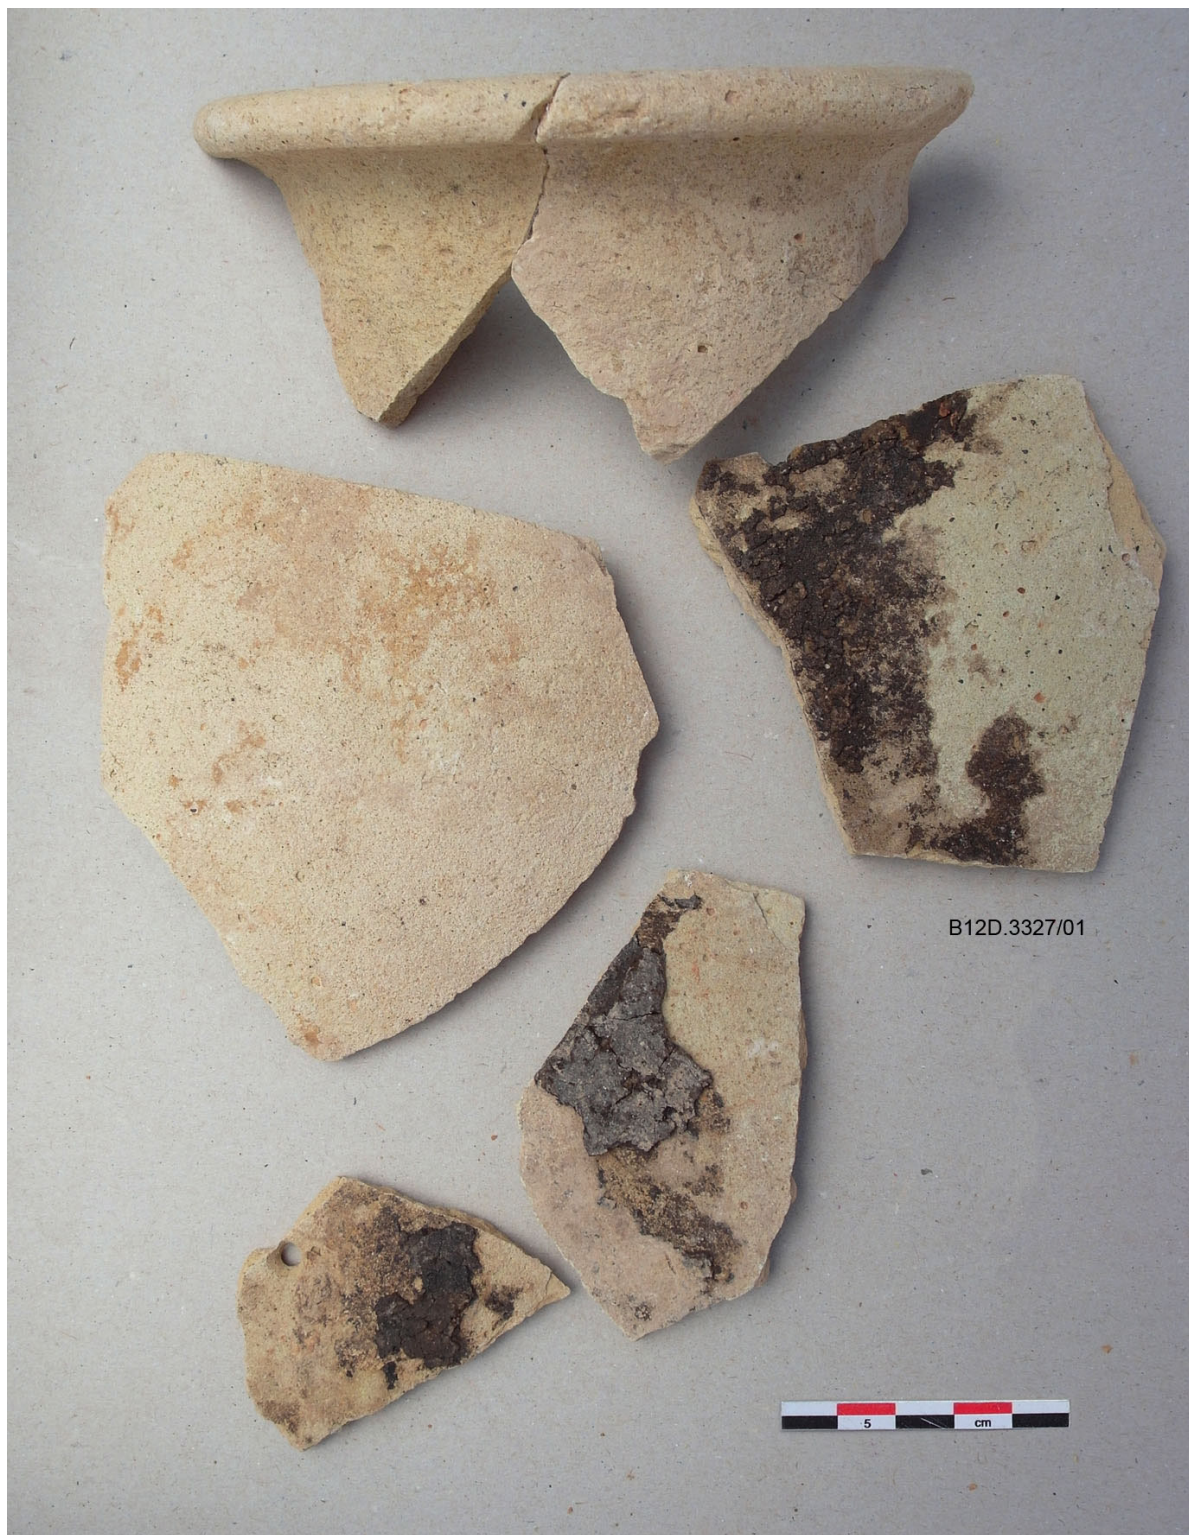
*Fig. 82 - Ceramics from the area D from the mosque (UF3327), 16th cent.*

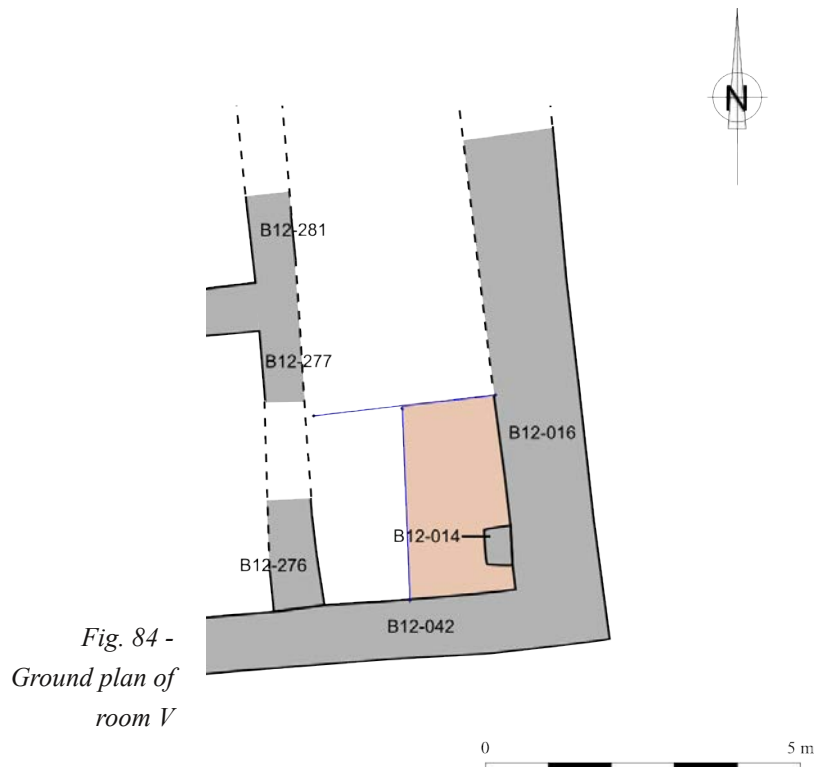
Fig. 84 -  
Ground plan of  
room V

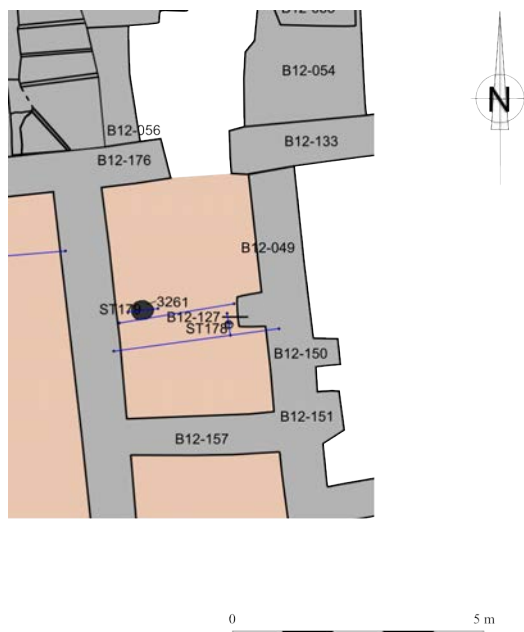
Fig. 85 - Ground plan of room G

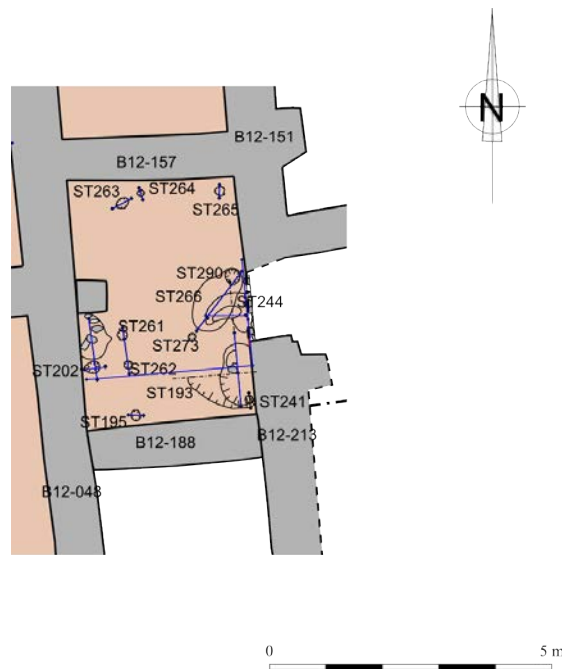
*Fig. 86 - Ground plan of room Q*

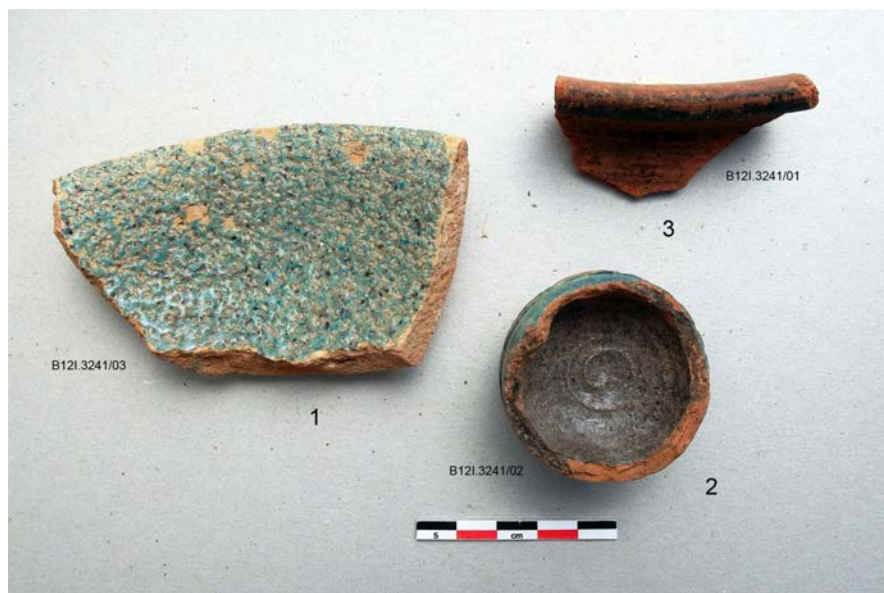
Fig. 88 - Ceramics from the area I from the mosque (UF3241), 15th cent., 1st half of the 16th cent.

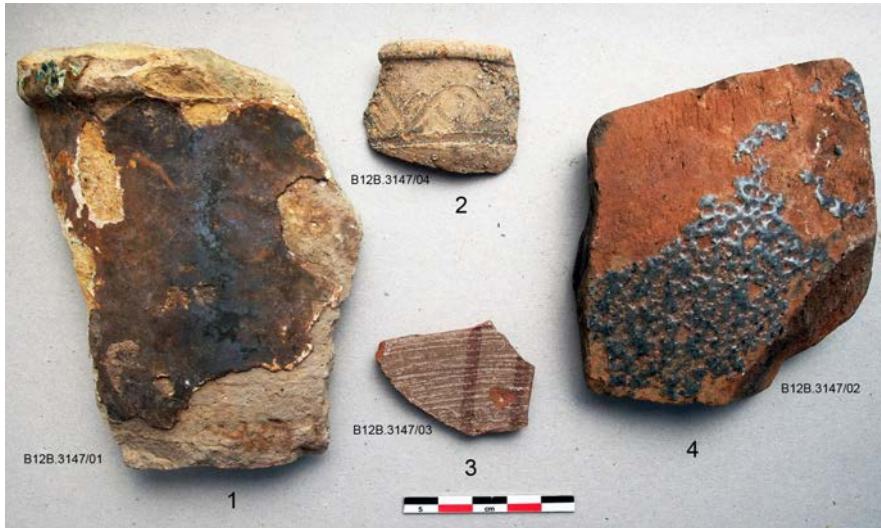
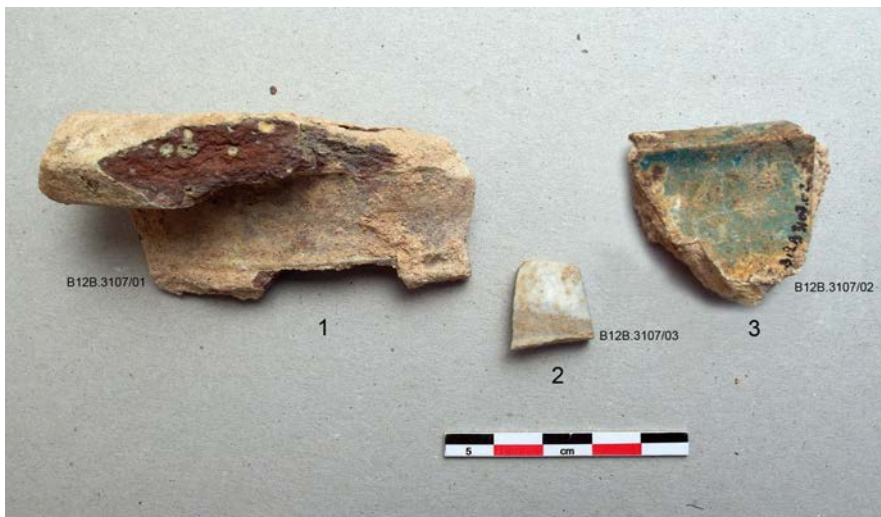
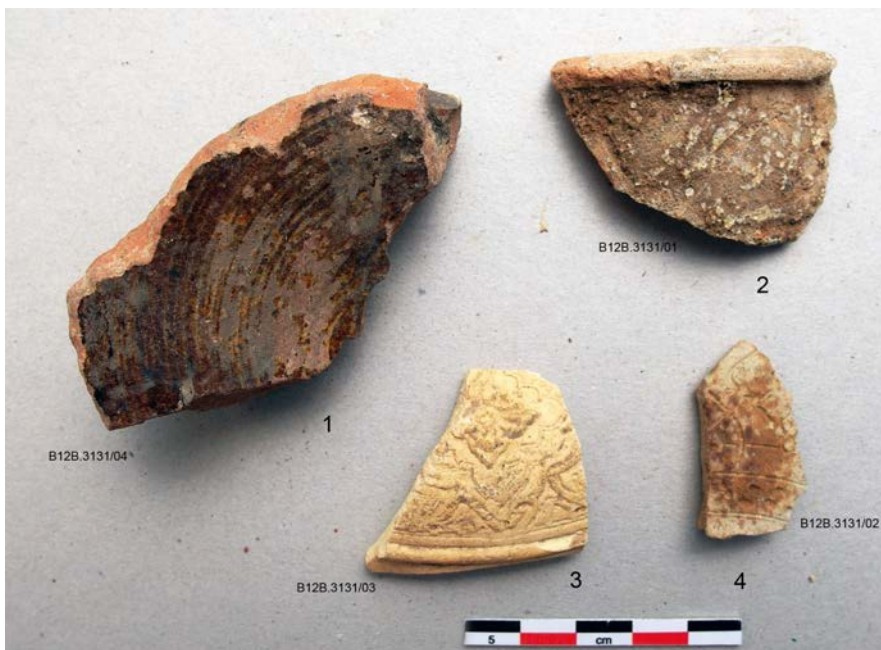
*Fig. 92 - Ceramics from the area B from the mosque (UF3147), 2nd half of the 15th cent., 1st half of the 16th cent.*

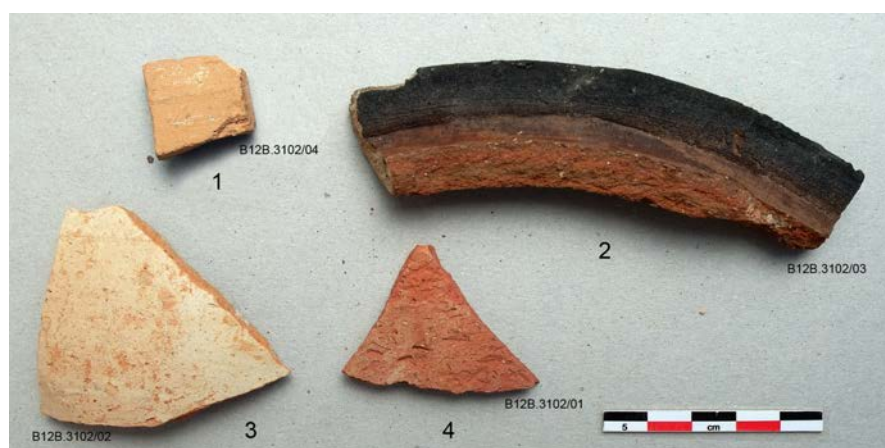
*Fig. 95 - Ceramics from the area B from the mosque (UF3102), 14th cent.*

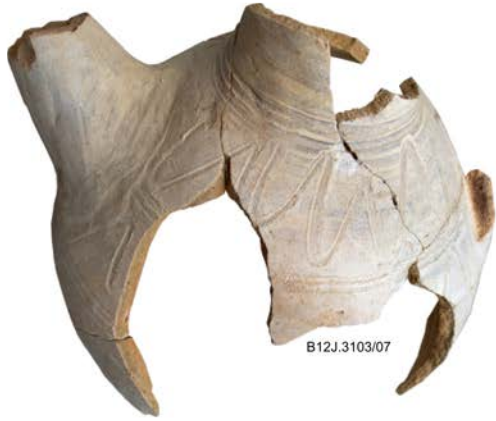
In this room occupied by the basin complex, the only layer of occupancy found is the UF3173, only made of compacted pebbles, filling the basin B12-163, which was probably used as filtrate. As this room is assumed to be a passing place which activity is related with water, it is in fact logical that traces of the first occupancy are so scarce. Ceramic study gives a dating from the second half of the 13th century to the first half of the 14th

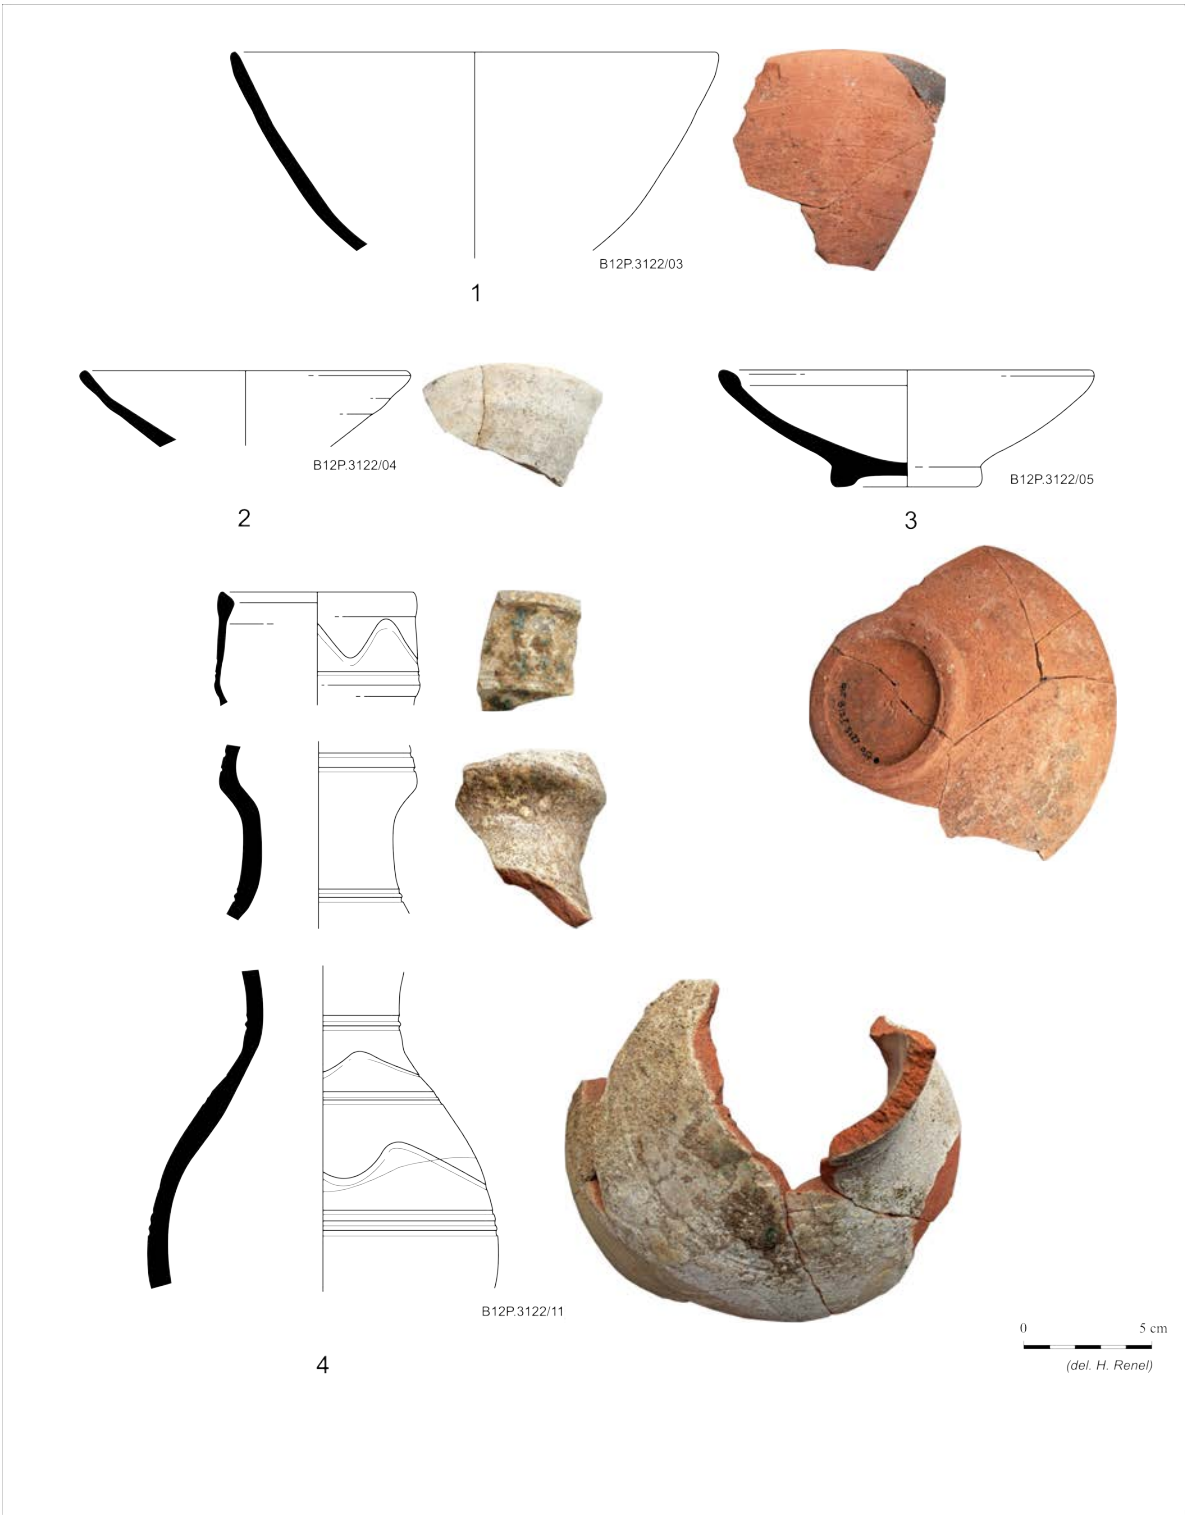
*Fig. 97 - Ceramics from the area P from the mosque (UF3122), 2nd half of the 15th cent., 1st half of the 16th cent.*

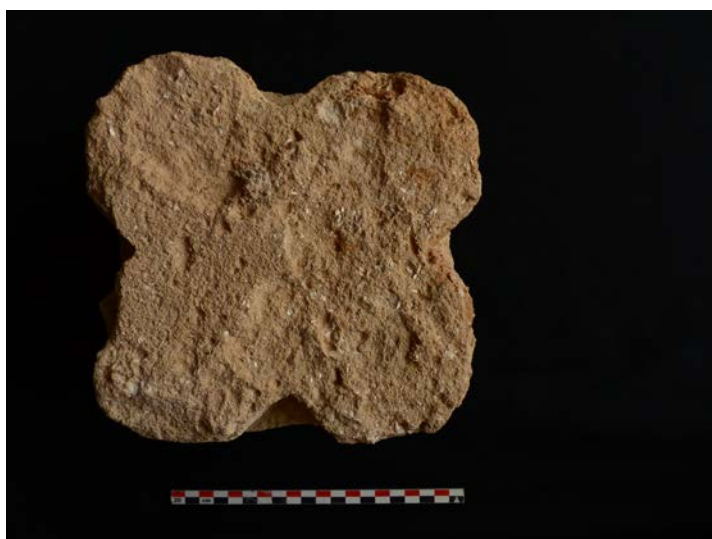
*Fig. 104 -  
Quatrefoil*

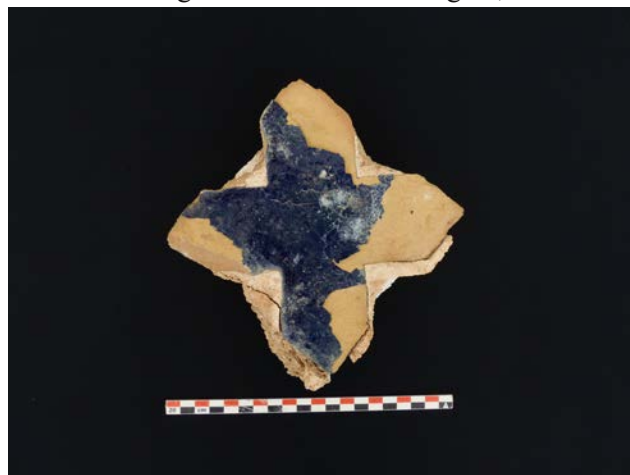
*Fig. 107 - Blue cobalt complete cross*

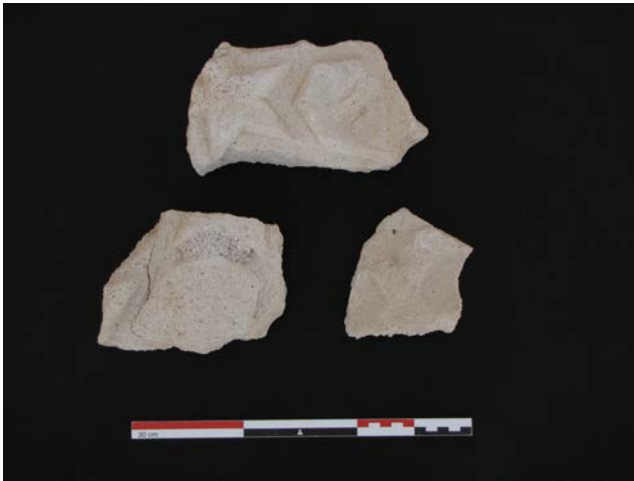
*Fig. 110 - EM 10 is a mortar mold*

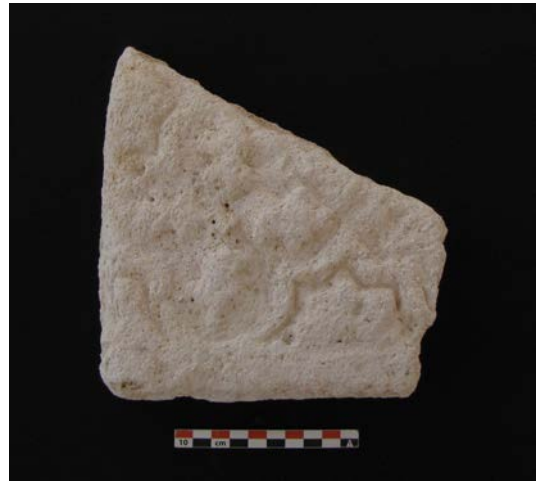
*Fig. 111 - EM 14; a mortar mold for EC 5 or EC 6*

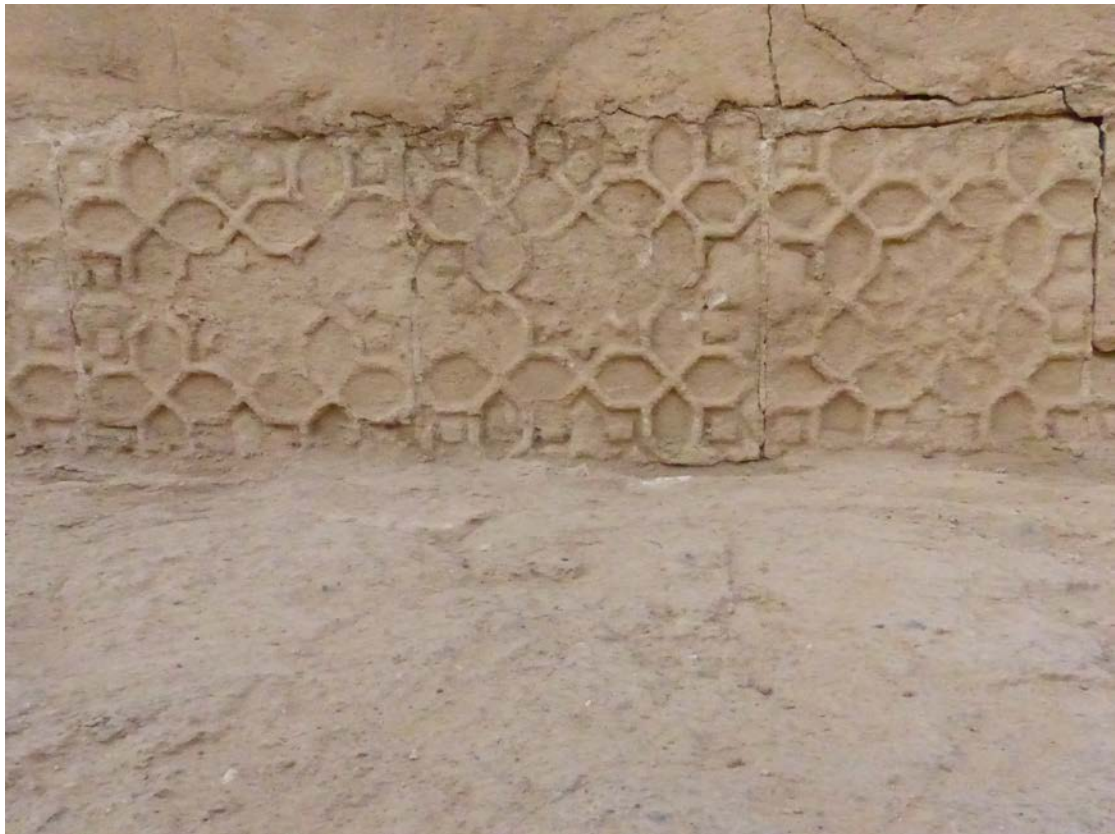
*Fig. 112 - Layout of EM 1 panels on the Minbar, see also Style L*

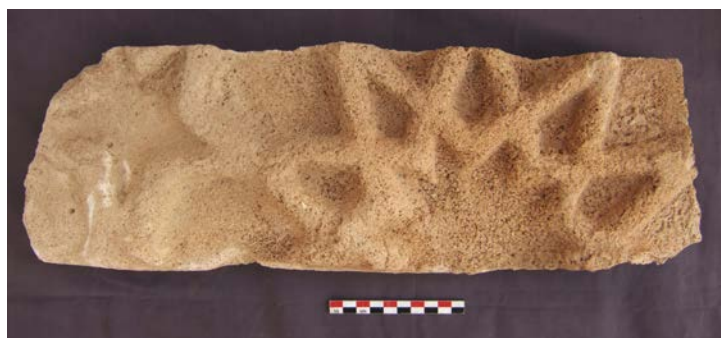
world. No complete panel has been found out yet, which does not allow to produce measurements and so, the full restitution of this panel. (fig. 113)

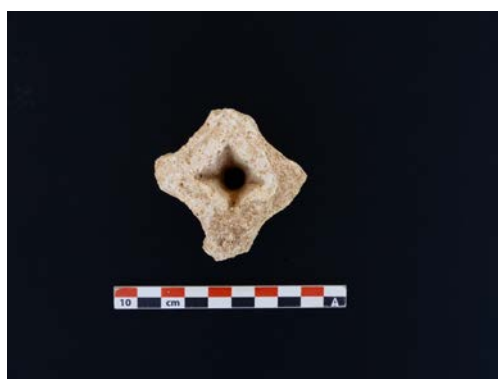
Fig. 114 - EM3 fragment,  
B95\_3525
