**HAL**  
open science

## **The Qalhât Development Project and Qalhât Project : Final report on the 2013b/2014a season**

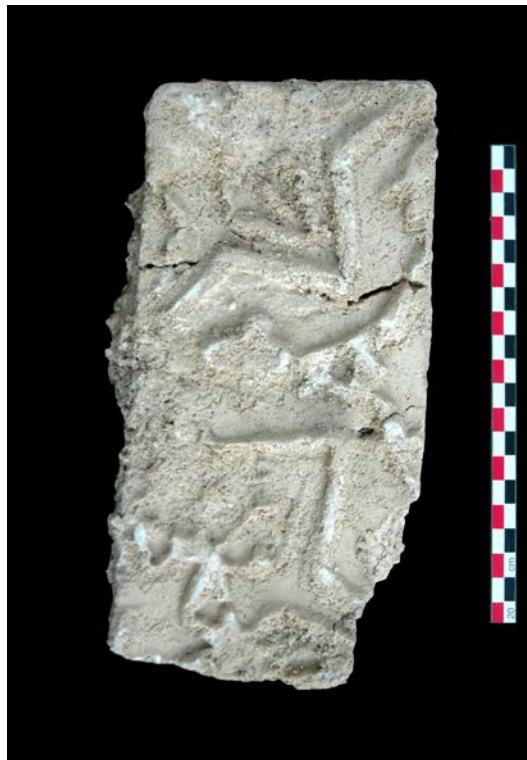
decoration. The panel is mostly rectangular with 0,44 m length and between 0,21 / 0,22 m height. (fig. 119)

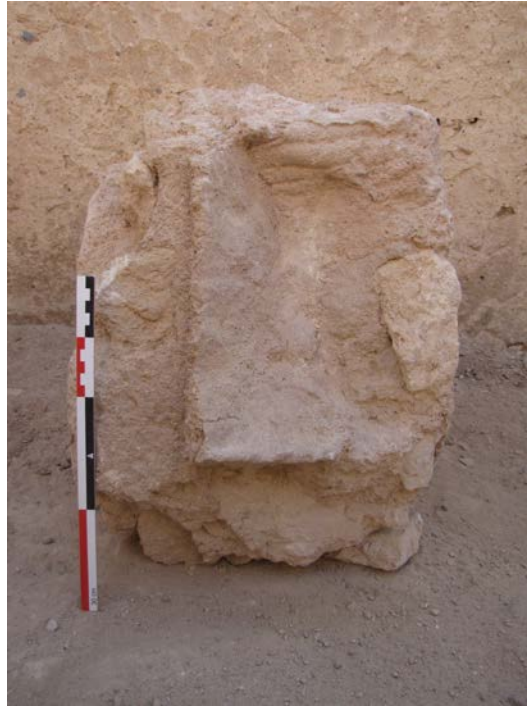
- EM 13 is a mortar element comprised in a significant architectural element which is the Muqarnas. No real decoration have been found on the mortar panels as it seems to be poorly preserved, and the full restitution is not known at this time since the Muqarnas is first an architectural element, and then a decorative one. However, it can be assumed that the panels were likely molded or carved with some designs. (fig. 120)

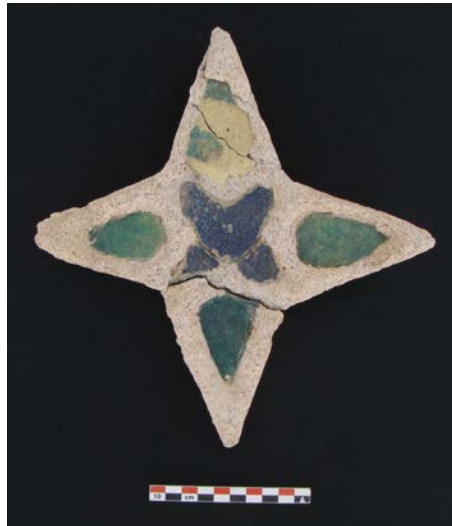
*Fig. 121 - EC2, first sub-category*

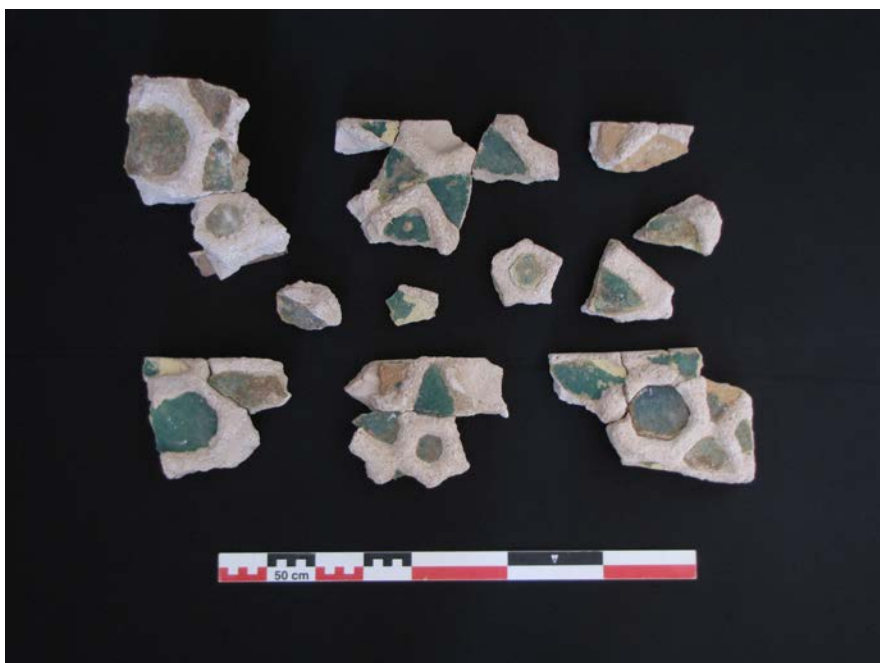
Once again, the discovered elements are too fragmented to reconstitute a full pattern, even if with some comparison, an hypothetical restitution could be possible (fig. 125).

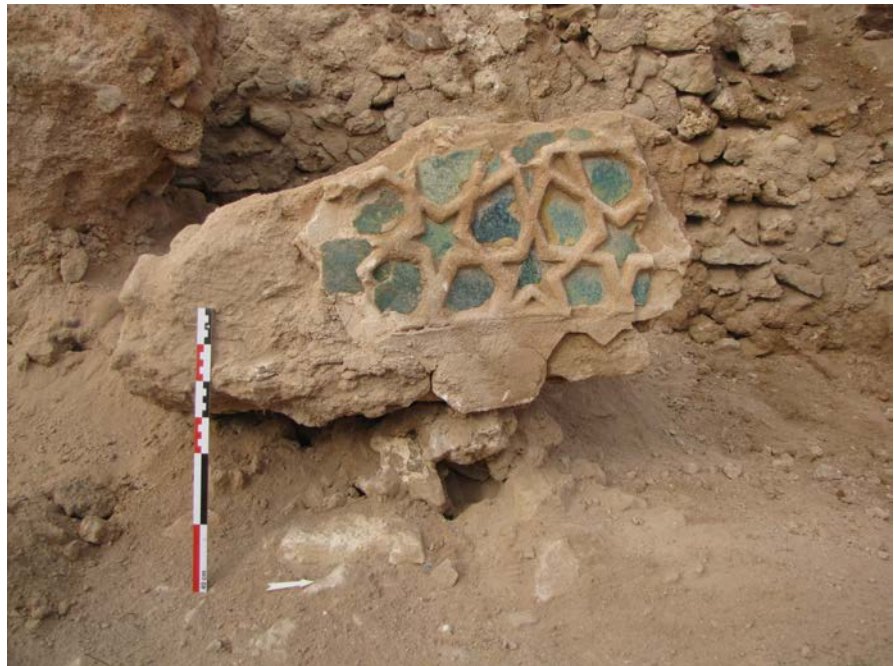
Fig. 132 - *Style G*

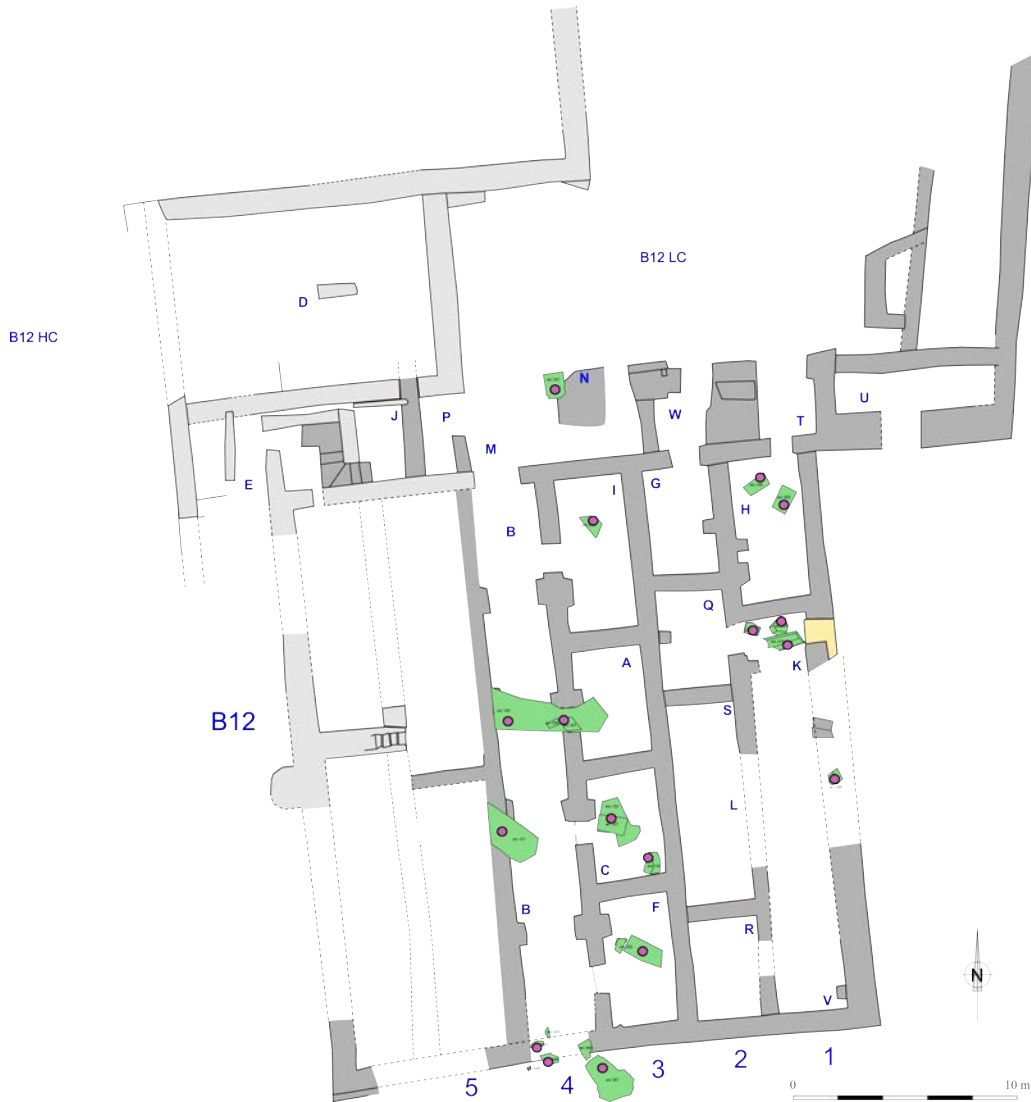
*Fig. 146 - Location of pillars elements*

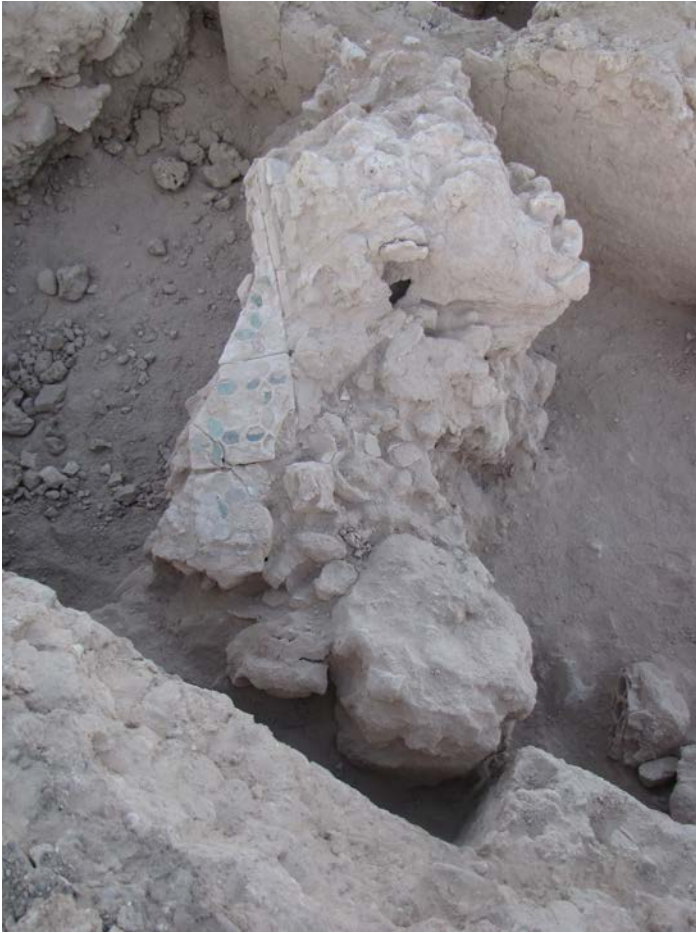
*Fig. 161 -  
IsoArc 196*

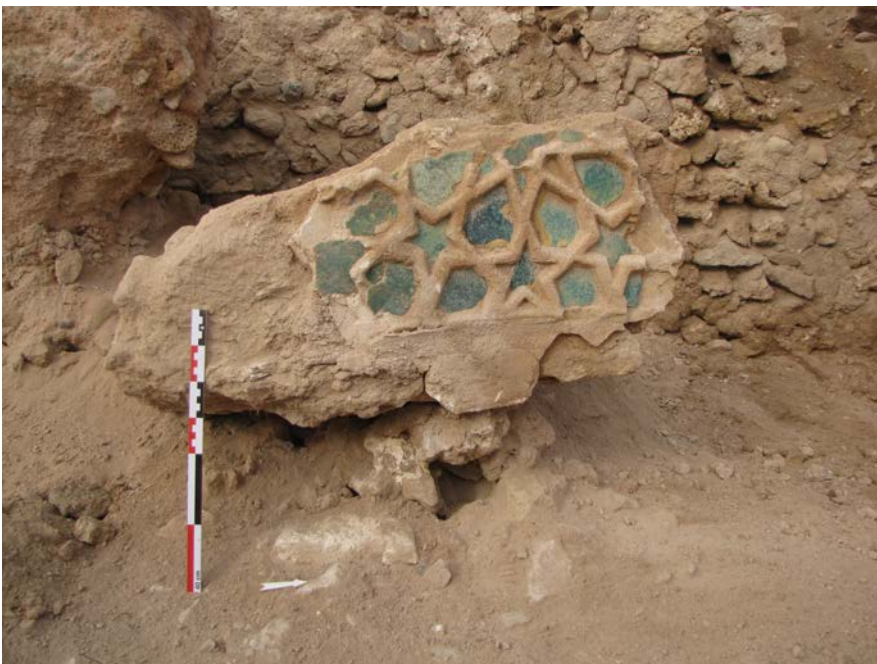
*Fig. 162 - IsoArc 130*

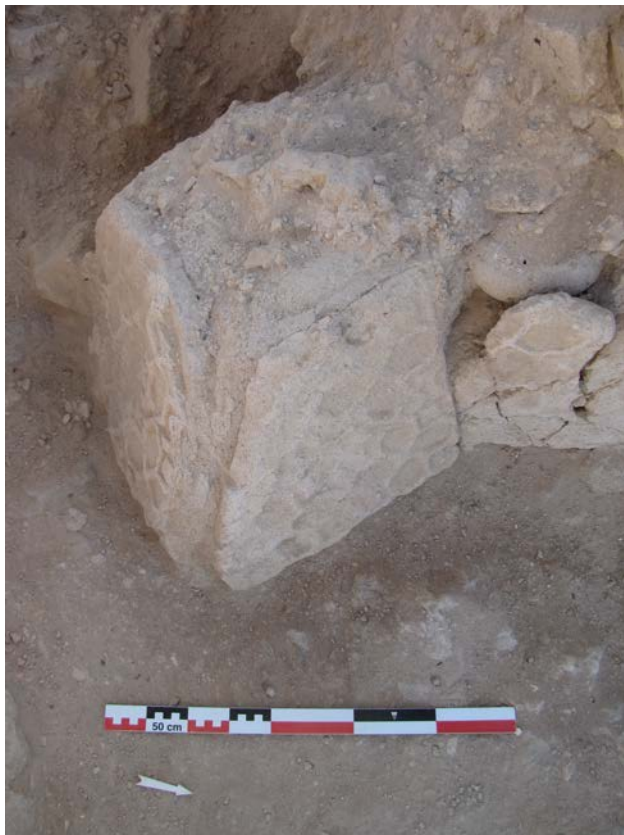
*Fig. 164 - IsoArc 335*

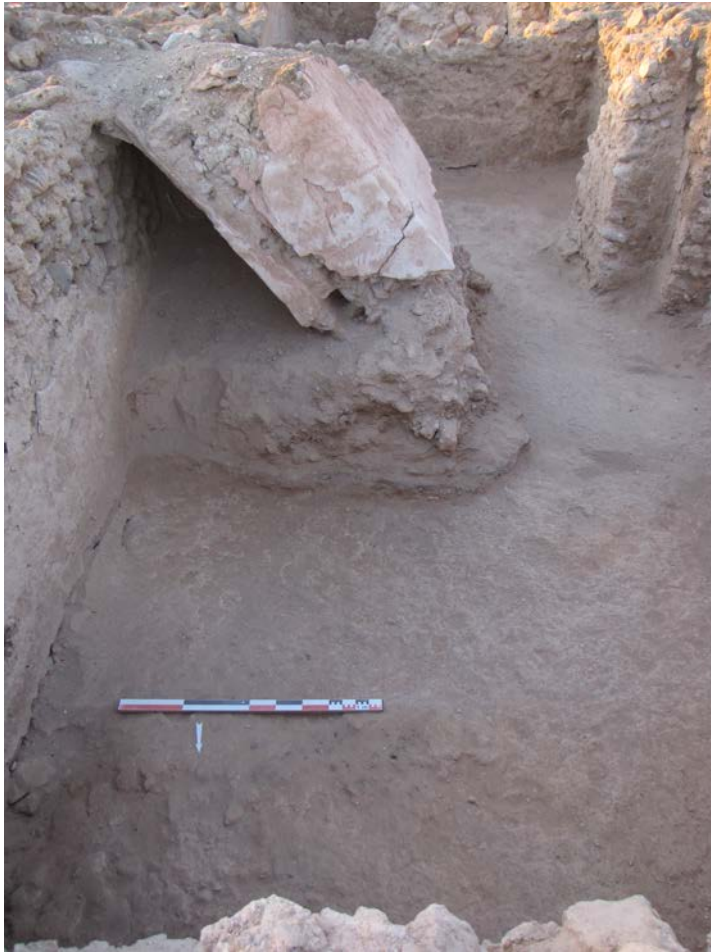
Fig. 166 - IsoArc 295

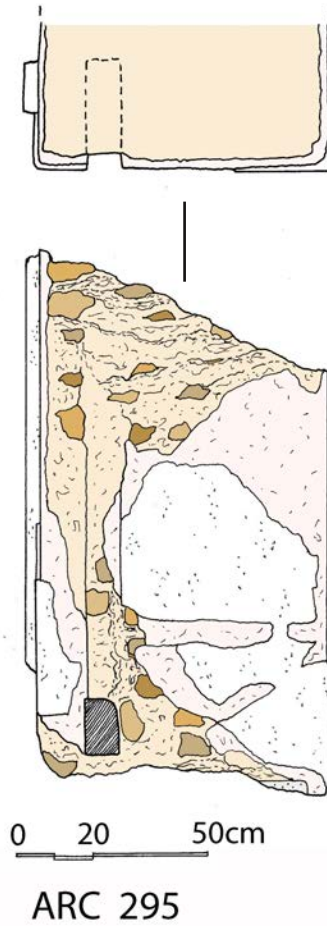
Fig. 167 - Technical drawing of IsoArc 295 (V. Bernard)

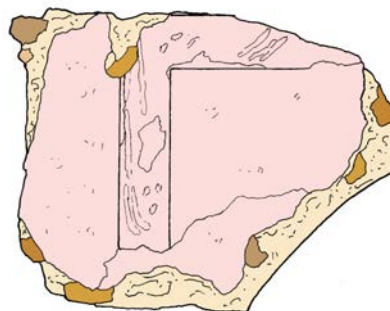
Fig. 168 - IsoArc 431 (V. Bernard)

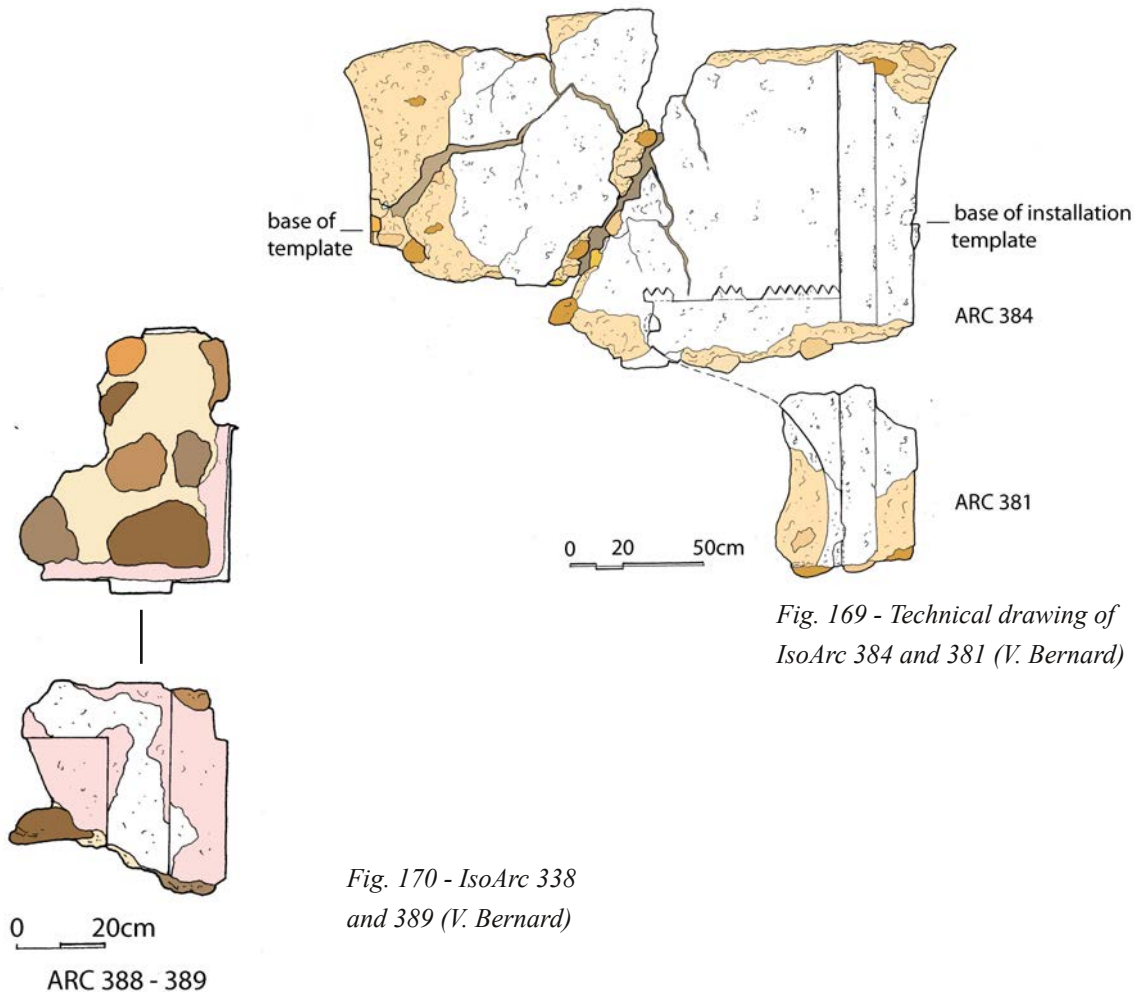
the mosque. It has to be noticed that it is quite usual to found mihrab on the outer wall, facing the courtyard, as a remind of qibla direction. By symetry, it is possible to restitute this central motive and so the width of this piece of wall : 1.98m. This decoration or mihrab was not found on IsoArc 295, meaning that there was certainly only one of them. The excavation of this area is still in progress, may be more decoration of mihrab will be found.

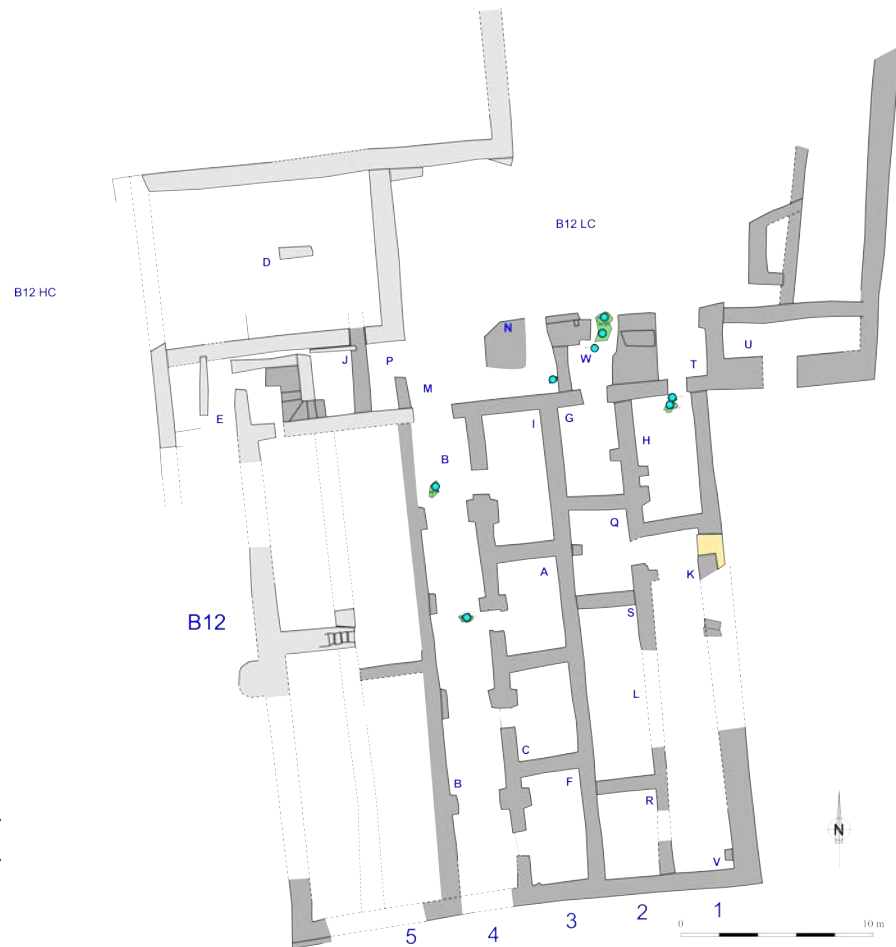
*Fig. 171 - Location of the fragments of cupolas*

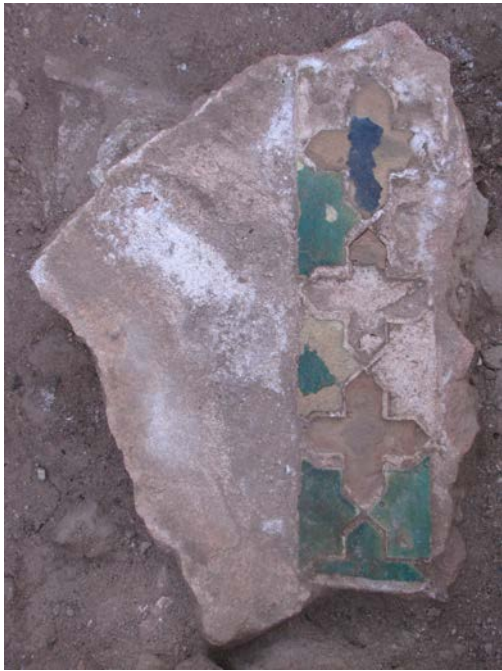
Fig. 173 - IsoArc 206

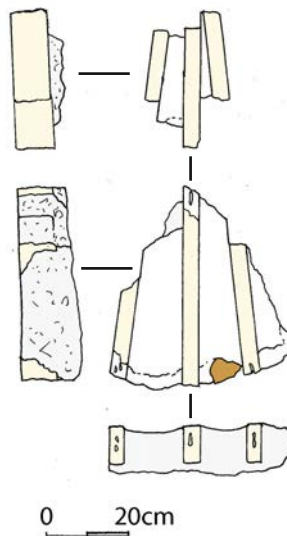
Fig. 181 - Technical drawing of a fan vault (V. Bernard)

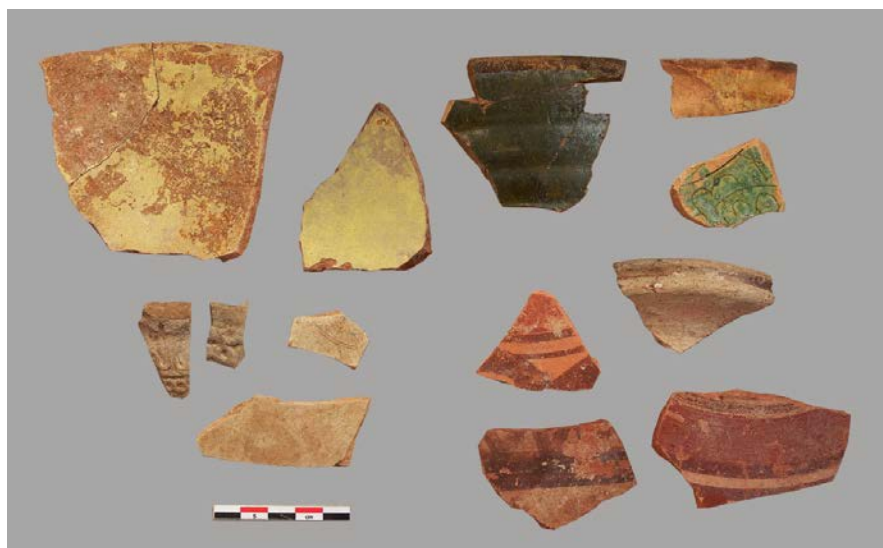
*Fig. 208 - Ceramics coming from the Uf 4020 and 4031.*
