**The Qalhât Project - Preliminary report on the second
season of excavations of the French mission
(1/11-16/12/2009)**

The Qalhât Project

Preliminary report on the second season of excavations
of the French mission
(1/11-16/12/2009)

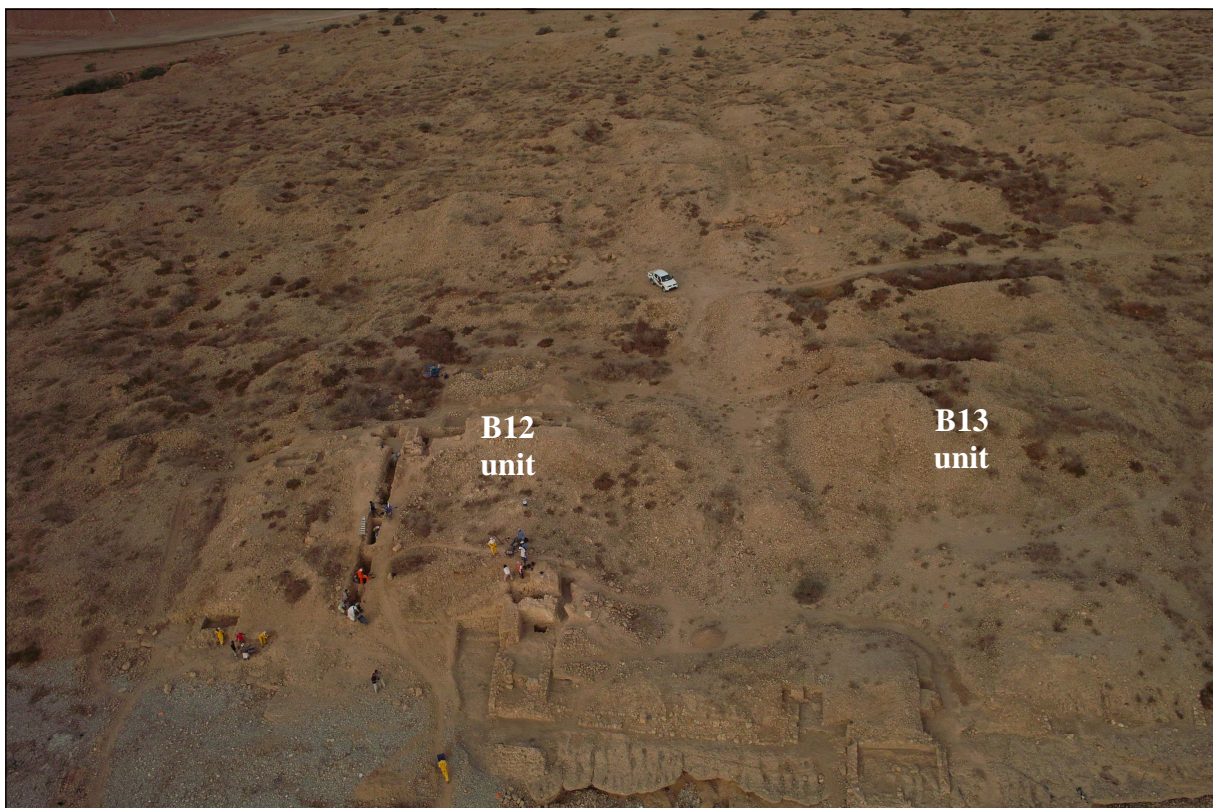
Oblique kite photograph of the B12-B13 complex

The mosque is located at the southeast corner of a wide architectural complex, measuring about 60m east-west and 80m north-south along the beach, very different from the densely built urbanism of the ancient quarter of the city all around. This complex is made of two units enclosed by surrounding walls, seemingly separated by a narrow east-west street leading from the beach to the top of the natural ridge which dominates the complex on its western side. To the south, the B12 unit includes the mosque itself in the southeast corner, an access courtyard in the northeast corner, and a large courtyard or garden in the western half of the unit, together with secondary buildings. The northern unit includes a large building to the west, and a courtyard to the east, also with secondary buildings. Some soundings were therefore also dug in these areas, in B13, to check its dating, as on the peripheral walls of the complex.

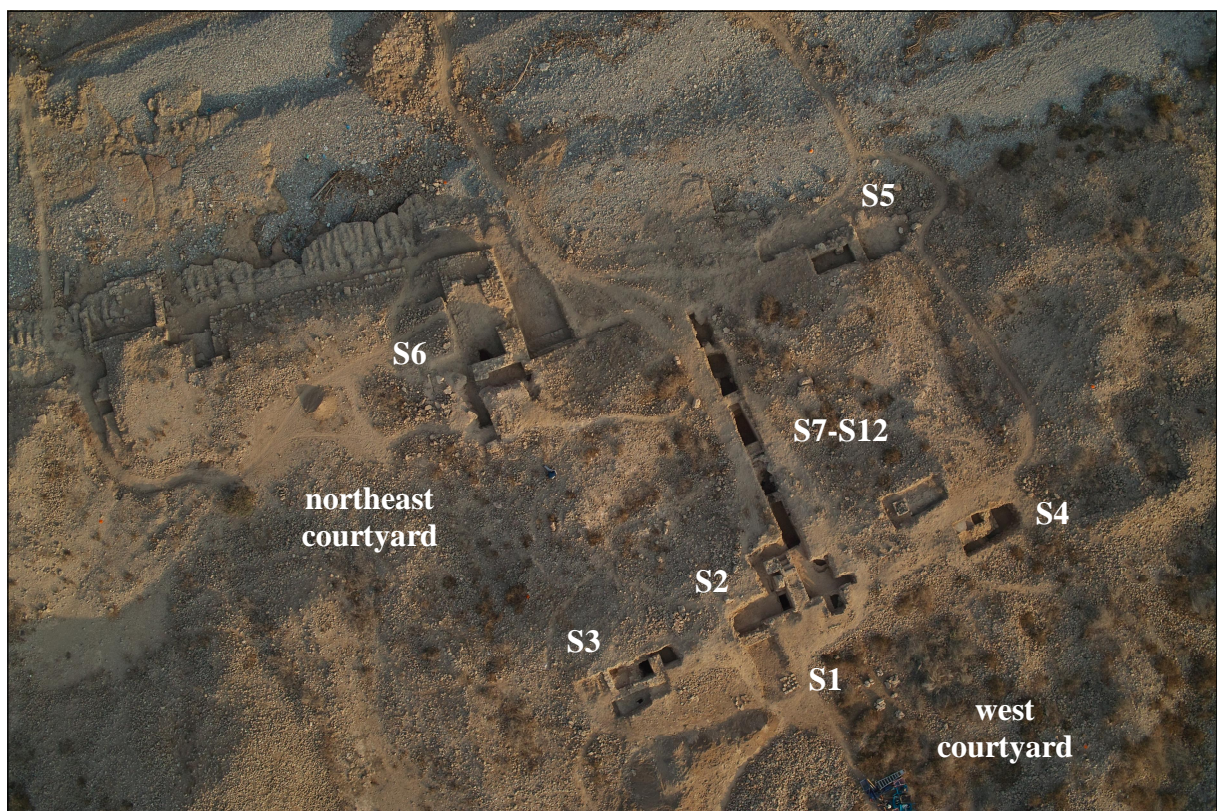
Vertical kite photograph of the mosque (B12) unit, with the location of the main soundings

Several wide soundings were dug this year in this area. Four were located in the northwest (S3), southwest (S4), southeast (S5) and northeast (S6) corners, to check the general dimensions and plan of the building, the levels of the floors inside, and the surroundings. Another one was made under the floor of the mosque, near the 2008 stratigraphical excavation on the other side of the *qibla* wall, to complete the study of the foundations (S2). And a long west-east trench, 1.5m large and 25m long, was opened across the mosque from the *mihrab* down to the sea (S7-12), to check the inside plan and the chronological evolution of the building.

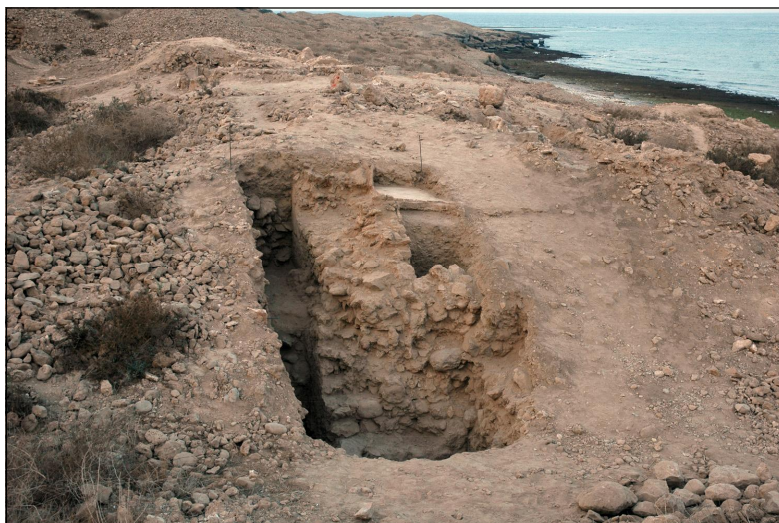
The eroded sw corner of the basement seen from the south street, with the inside white floor up.

The basement was built with surrounding walls 1.25m thick, in limestone blocks. It was founded directly on the bedrock on the eastern seaside, on top of the beach at around level $\Delta 11.00$ (S5-6). The southern wall was also founded on the bedrock, along a street climbing the slope of the substratum and leading from the beach, at level $\Delta 11.00$ (S5), to the inside of the city, with the southwest corner of the basement at level *c.* $\Delta 13.50$ (S4). In the stratigraphical sounding opened in 2008 against the outside face of the western (*qibla*) wall (S1), this basement was built from the existing surface of earlier occupation layers, at level $\Delta 14.10$, with a foundation trench about 1m deep down to level *c.* $\Delta 13.00$. In the deep sounding opened this year against the inner face (S2), the wall goes down to $\Delta 13.50$ at least. The northern side is badly known, but the base of the northwest angle was lower than level $\Delta 13.70$ (S3) and the northeast angle was based on the bedrock up the beach (S6), at around level $\Delta 11.00$ as the façade on the sea. This angle is very peculiar: a rectangular structure with thick walls, 4m wide and more than 14m long, is attached to the corner of the

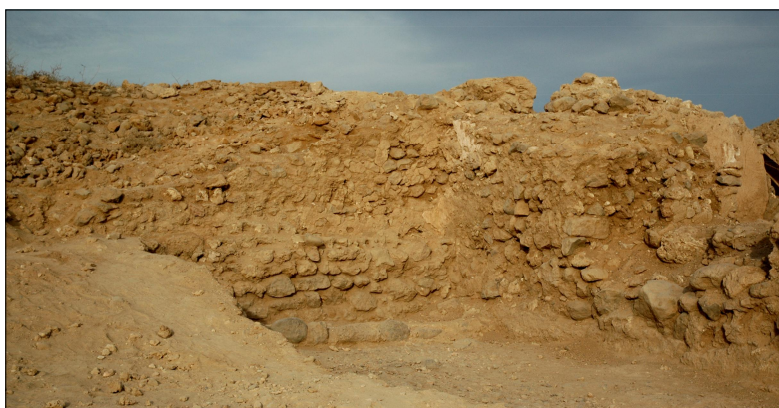
The angle of the eastern facade of the basement, on the sea, with the corner structure

basement, protruding on about 9m beyond the façade on the seaside. First a low massif was built to the east on the seaside, to level the surface of the bedrock of the beach, at about $\Delta 11.10$. On this foundation was erected a structure with a floor at around $\Delta 11.30$, accessible from the south, near the corner with the facade wall of the mosque, through a wide door 1.80m large. After some time of occupation this structure was levelled and the door blocked, to build a terrace with an earth floor based on a layer of pebbles, at level $\Delta 12.30$. In the same time a rectangular structure 3m large and more than 6m long was built against the corner of the basement. The inside was completely filled with collapsed fragments of walls and the floor could not be reached. This room had two openings, a door 1.4m wide giving access to the inside of the basement on the southern side, and a gate 2.30m wide opening northwards onto the exterior. West of this passage, a cubic masonry fills the western part of the room, maybe the base for a staircase.

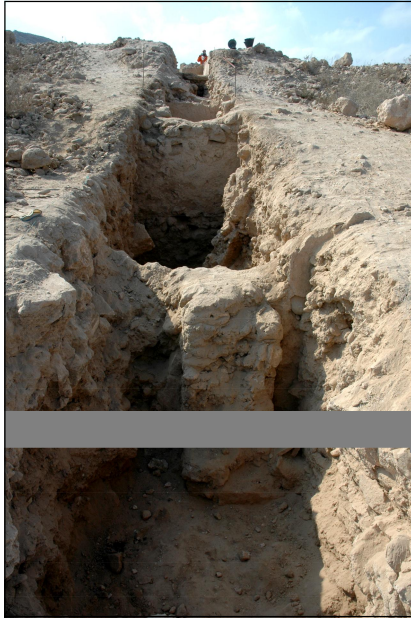
The trench, seen from the sea side

The basement was built up to level *c.* $\Delta 16.00$, thus 5m high on the seaside, and about 2/2.5m high on the inland side. Then the two western rear compartments (S7-8), which were probably too low, were filled with a backfill of good earth, when the four front ones were left empty and used as cellar rooms, most probably connected by small inside doors although none was found in the trench.

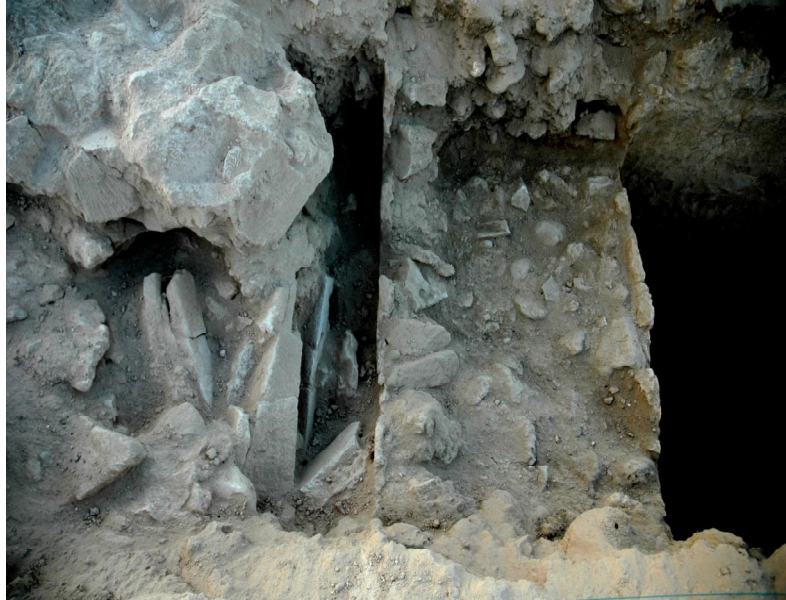
The third compartment (S9), with the collapse from the superstructures of the mosque inside the basement

The walls were coated with a strong mortar. The floors were at different levels according to the altitude of the bedrock in the compartment. The third compartment was not excavated down to the floor due to the huge amount of collapse masonry inside (S9). In the fourth compartment the floor was in strong pinkish mortar similar to the coating of the wall, at level $\Delta 13.00$ (S10). No clear floors were found in the fifth and sixth compartments where traces of an earlier occupation were discovered on the bedrock, a level of small pebbles with two post-holes and traces of an ancient wall, at level $\Delta 12.00$ in the fifth compartment (S11), at $\Delta 11.50$ in the last one (S12).

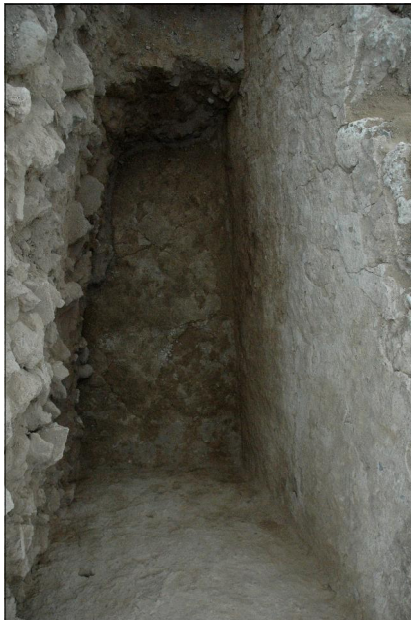
The fourth compartment (S10)

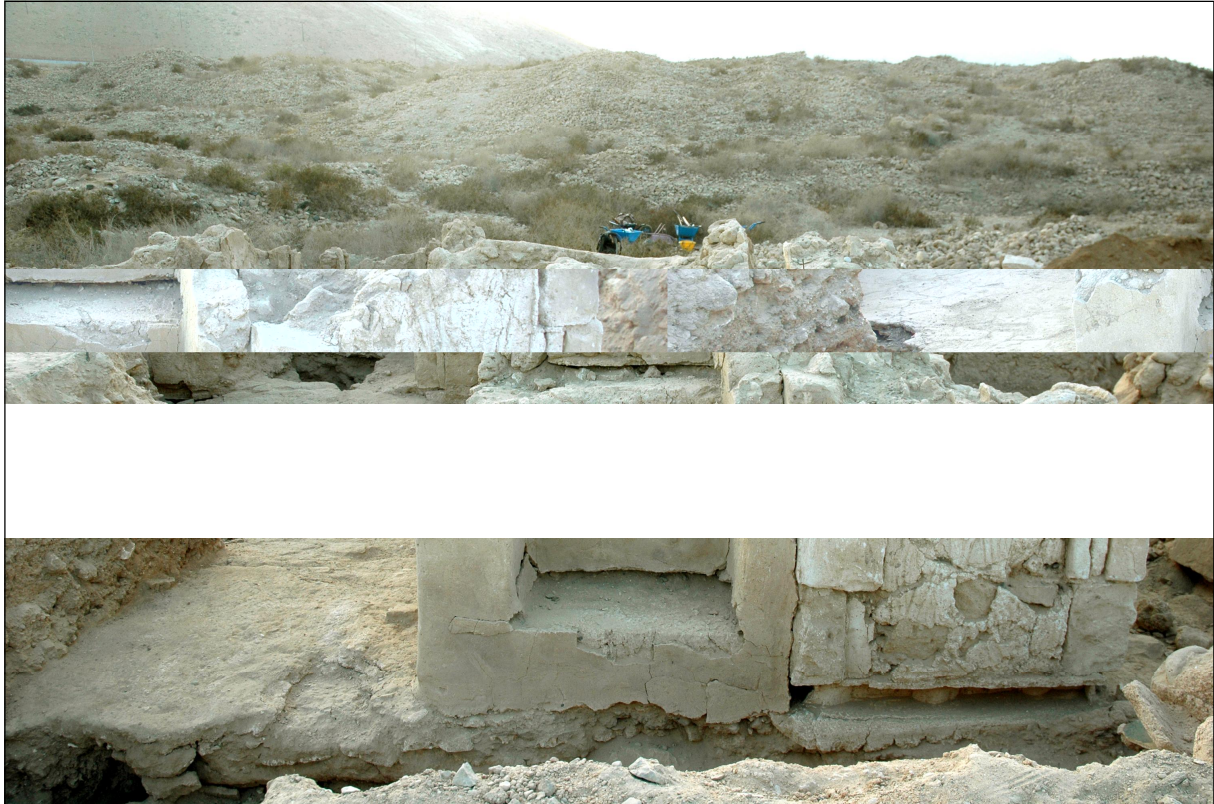
General view of the preserved part of the mosque, with the *qibla* wall and *mihrab* in the background, the *minbar* and pillar in the foreground.

The only superstructures of the mosque now preserved are the lower part of the *qibla* wall, *mihrab* and *minbar*, and the base of the pillars of the last nave, up to about 1m at maximum. The *mihrab* was located in the axis of the central nave, a niche 1.5 x 1.5m with several phases of decoration, the last one in stucco with small pilasters and recesses. A *minbar* 1.20m large and 3.8m long was at some time erected to the right of the *mihrab*, leaning against the last pillar of the central nave. This *minbar* is associated with the second floor of the mosque (S2) and the last phase of decoration in the *mihrab*, later than the original floor and the coating of the *qibla* wall, and it could have replaced an earlier structure. Four stairs are now preserved, which were protected by parapets and covered with wood planks now vanished. It probably had originally eight stairs, thus leading to a platform about 2m high.

The preserved lower part of the pillars, in the last bay, is square, 90cm on each side. It is built with square and rectangular cut limestone blocks with a vertical band in recess in its eastern front side, originally the place for a decorated panel. At the base was a deep recess surrounding the pillar and small wood beams were still preserved inside, maybe some kind of hooping to avoid destruction in case of earthquake. Fragments of octagonal and circular columns were also found in the trench and it is therefore possible that the pillars were of different shapes in each bay, or of different shape at their base and upper part.

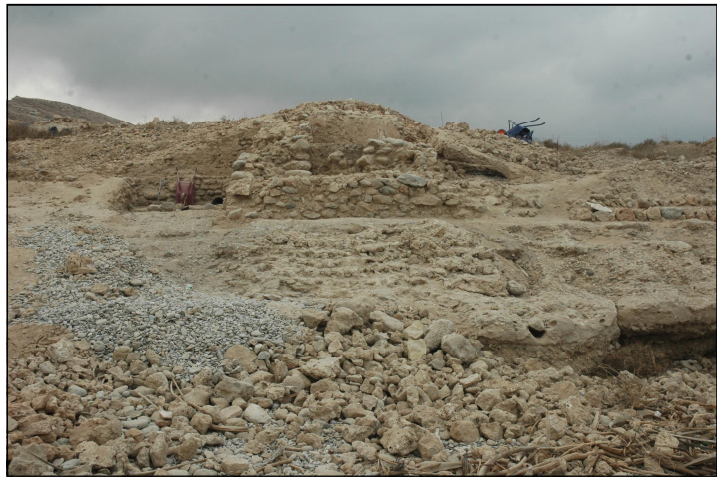
The northeast corner structure on the beach

The rectangular structure attached to the northeast corner of the basement was probably a minaret, with a staircase based on the massive masonry found in the western part of the entrance. Five crenellations were found collapsed at its foot, which were crowning the lower part of the tower, encircling the base of an upper and narrower storey. Another minaret was possibly located at the northwest corner where a square structure $???$ x $???$ m was at some time built against the northern façade of the basement. Traces of stairs were discernable inside, around a central square pillar.

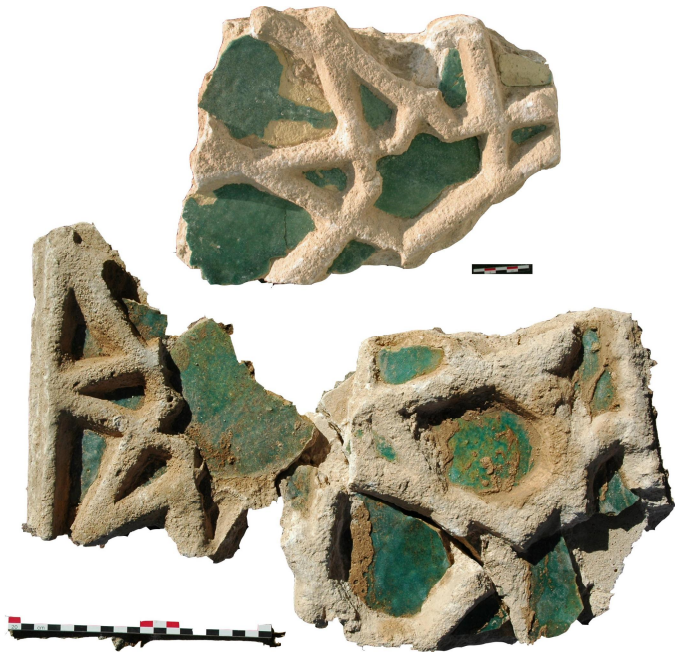
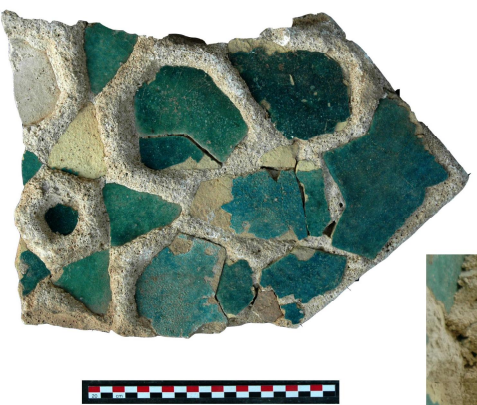
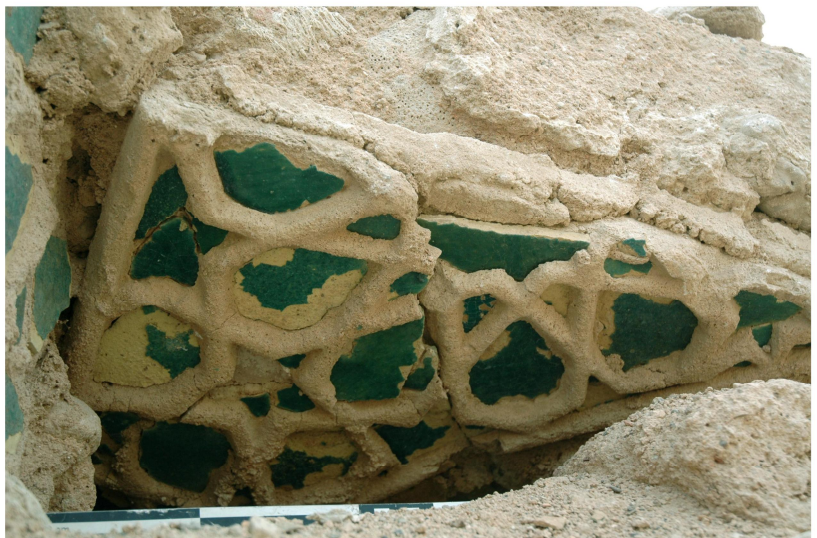
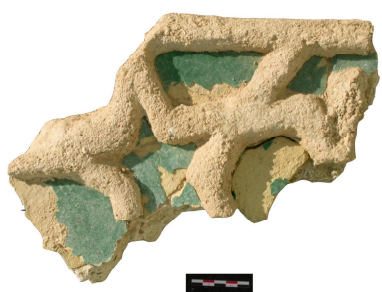
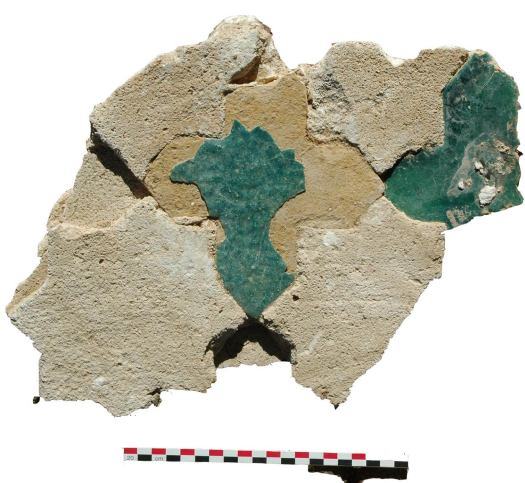
Elements of decoration from the *minbar*, the pillars and the arches

The pillars were all decorated, at least on their eastern face fronting the praying community. As for the arches, they seem to have been also highly ornamented, on all their faces. These are mostly panels with fragments of broken green star or cross tiles, inlaid in plaster and covered with thick stucco lines geometrically arranged to produce the motif of stars, with five, eight or even ten points on the corner pieces; moulds for the production of these stucco lines were even found. Or a coating of plain plaster, inlaid with complete stars and/or crosses tiles, regularly arranged on the intrados. Limestone bilobed or quadrilobed carved blocks were also found which were used in association with stars tiles. We can also mention several fragments of a large plate in Chinese blue and white porcelain inlaid in a plastered panel as decoration; they were found in the cellar room of the fourth bay.

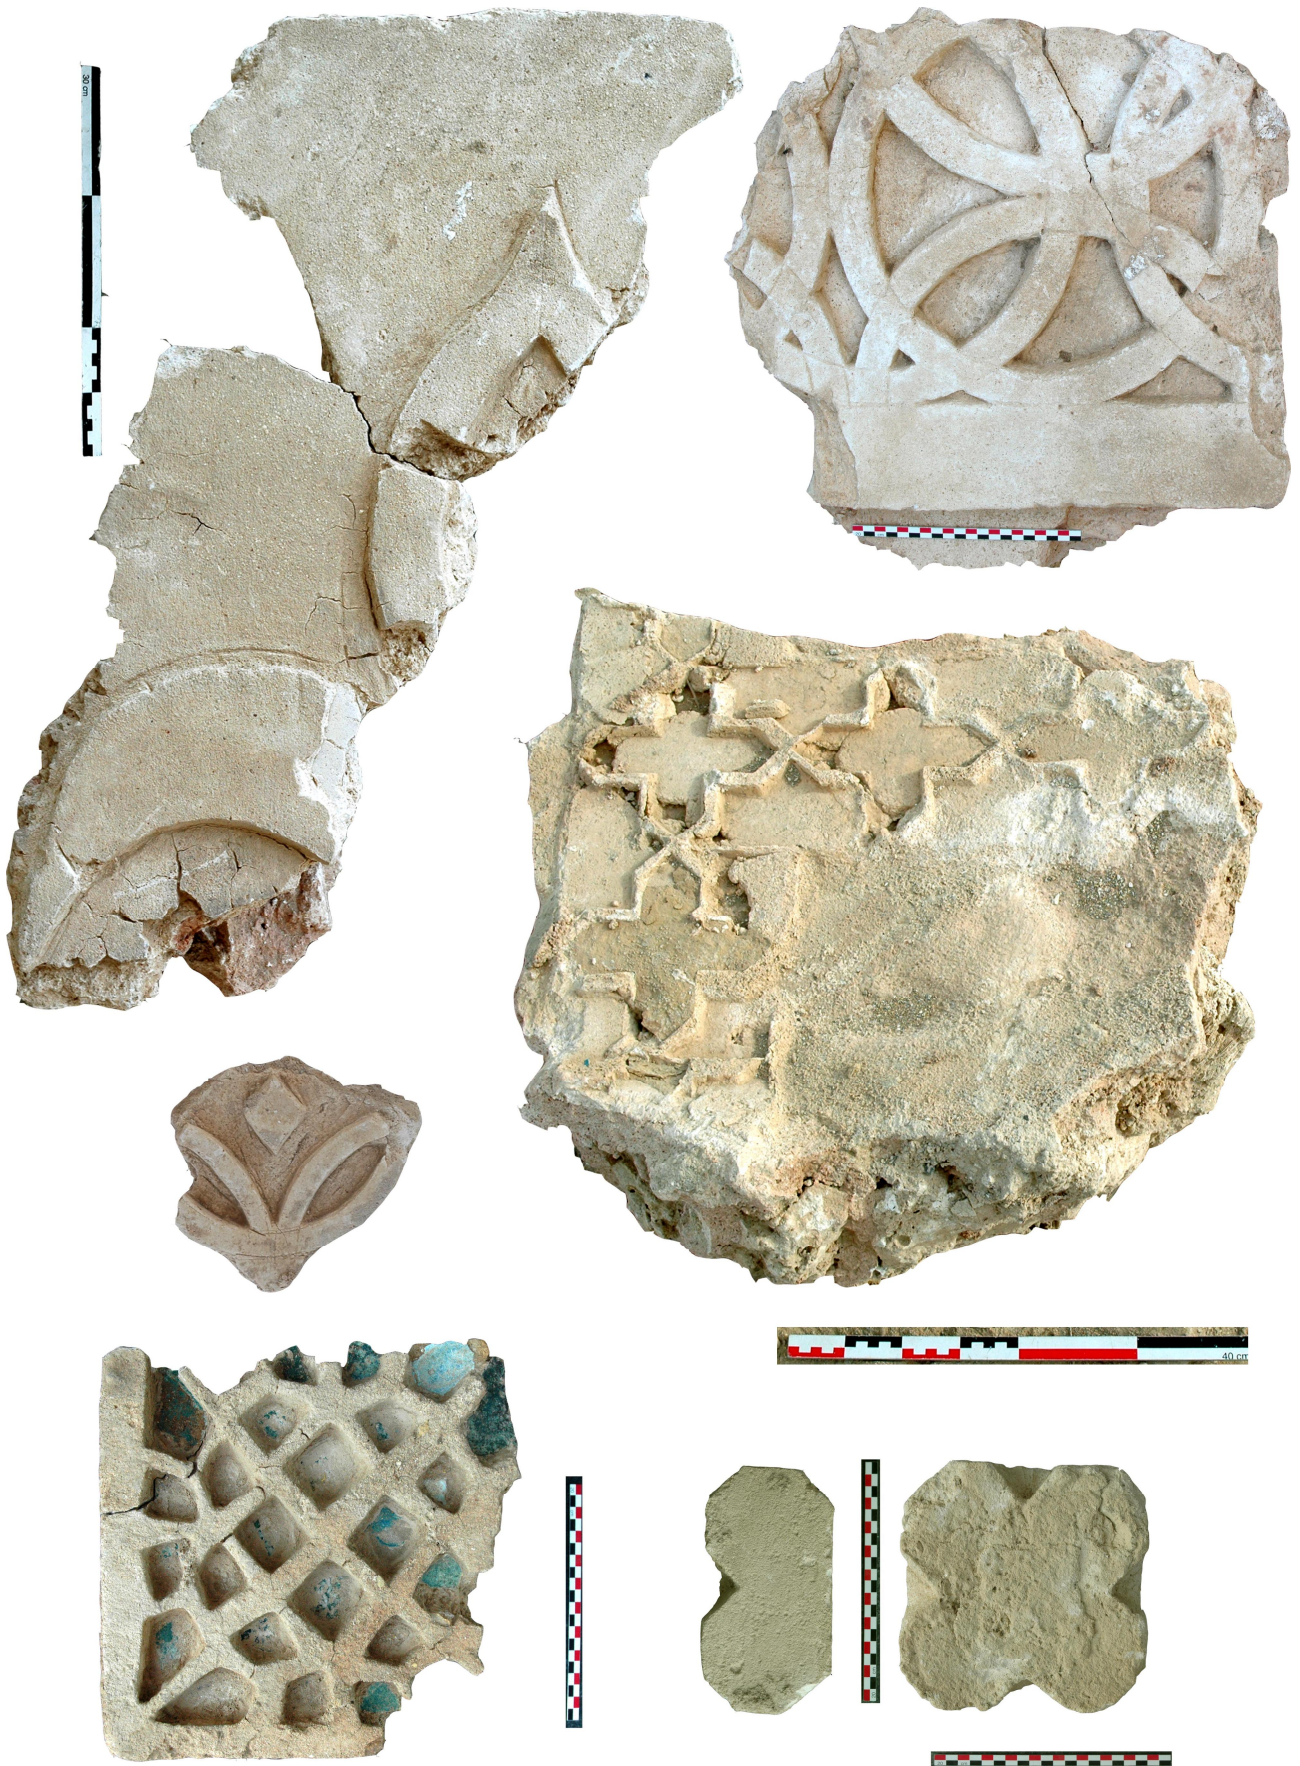
Elements of decoration from the minaret area, and varied

Massive elements of decoration were found in the sounding of the northeast corner of the mosque. Beside the crenellations already mentioned, these are two fragments of a large inscription, and several fragments of a large stucco freeze made of interlacing circles. Given the size of these motifs, they were probably located rather high, which confirms the presence of a minaret in this area.

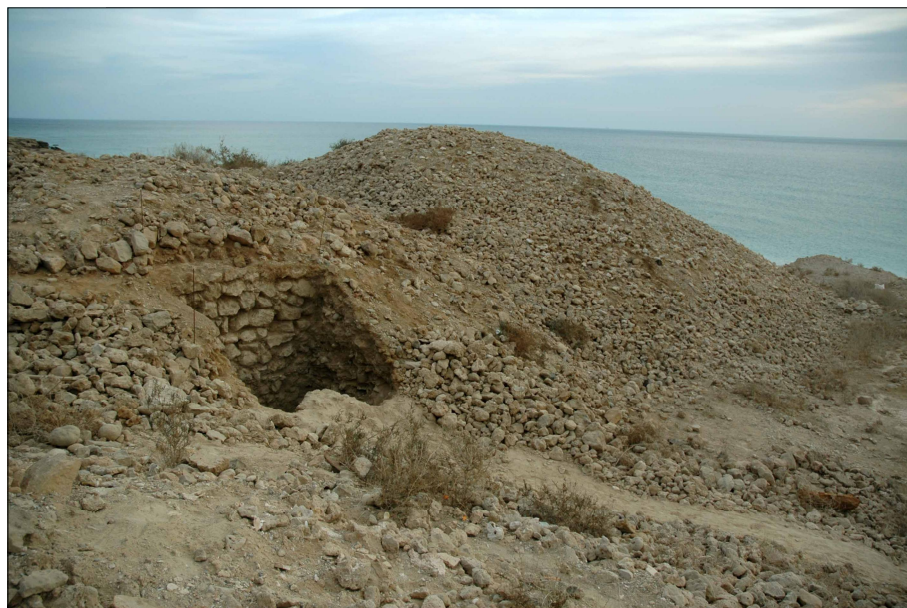
The southern wall of B13

A sounding 1.5m large was open this year against this wall to get preliminary information on the function and dating of the building, as excavations are planned there for the 2010 season. The wall is built with large limestone blocks, and preserved up to about 3m (base at Δ ???). It was certainly a very impressive construction, most probably with an official function.

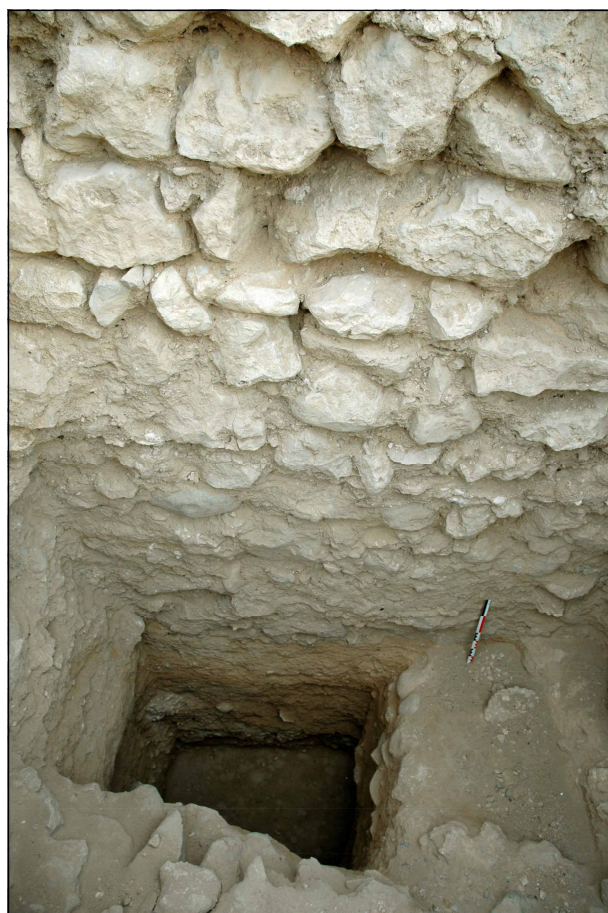
The deep sounding against the southern facade, showing the layers under the base of the wall

The base of the wall lies on a thick layer of compacted light brown clay with small gravels, with some intermediary lens of ashes, 35cm thick. Under is an occupation layer with ashes, some charcoal, and gravels, 15cm thick. Then is another layer of compacted clay, associated with a small pit with a filling of small pebbles near the northern section of the sounding. This in turn lies on a thick level of medium pebbles, which becomes more and more compacted as excavation goes down, with no human traces. Although this is probably not the bedrock proper, it is a natural deposit, prior to the foundation of the city, maybe the bed of a small wâdî. Excavations were therefore stopped at level Δ ???.

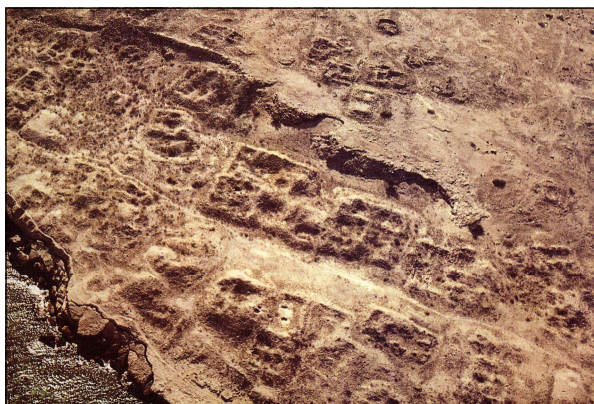
Kite photograph of the area of B16 and B38

The surface study and the clearing of the lines of walls visible on the ground show that the building actually extends on 31m north-south along the street in front of the square, and on 36m east-west from the street to the foot of the ridge, an overall surface of more than 1110m². Although the outside walls are rather clear, with a thickness of about 1m, the inside walls are hardly visible, showing only as elongated heaps of fallen stones, sometimes peaking at more than 3.50m above the surrounding surface. The general plan is therefore difficult to interpret, the southeast quadrant seemingly a built area, the southwest quadrant maybe a courtyard with peripheral rooms, and the northwest and northeast quadrants possibly two courtyards.

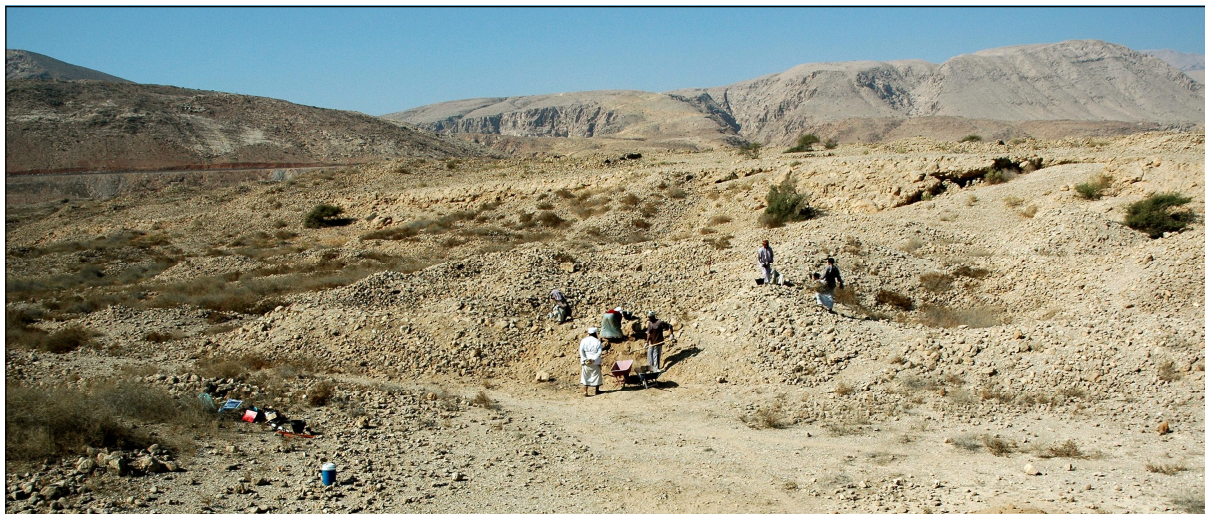
General view of B16 from the square

Building B16 is located west of the street at a place where this street widens to make a rectangular square c. 16m large and 55m long. From kite photos it looked as a nearly square construction, about 1000m², divided in what seemed to be four different quadrants, and connected to building B17 to the north by a structure alongside the street (see 2008 report).

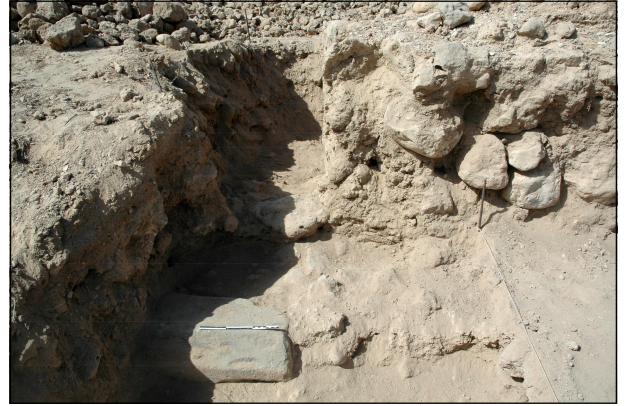
The street sounding, phase II

Along the street, the eastern facade of the southeast quadrant of building B16 was clearly visible, with a door 2m wide located slightly north of the axis of this quarter, the threshold at level D10.80. A small trench 1.50m large and 2.50m wide was opened perpendicular to this wall, including half of the doorway.

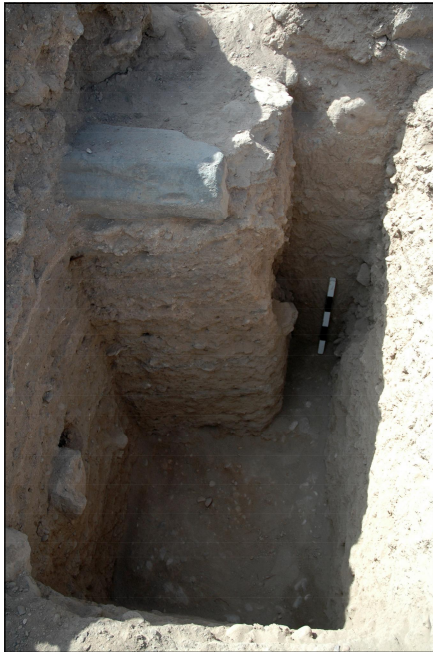
The street sounding, phase I

Under the surface collapse, a large parallelepipedic grey stone was found in front of the door (D10.67), used as a step to connect the threshold to the level of the street outside (D10.40), a very compact circulation level, beige in colour. Under it, several layers of powdering earth from grey to beige with some ashes and few charcoals are superposed on a height of about 50cm. Under is a great brown earthy level about 1m thick, which contains numerous organic remains, degraded greenish and sticking to the surface of the ceramic material. All these layers lean against the façade of an earlier wall, phase I, located just under the upper one with nearly no difference in the façade except that it is here covered with a strong coating showing finger prints. This wall was built directly on the bed-rock, here a very strong pudding of medium pebbles in a strong mortar, the base of the wall coating leaking on the earlier layer of the street just above it, at level D9.10.

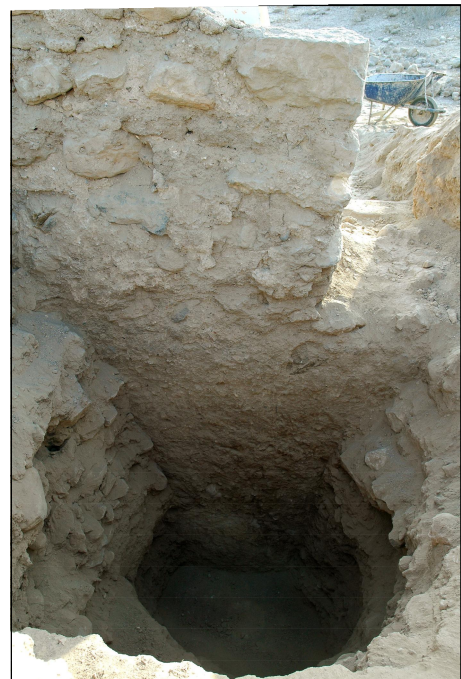
The entrance sounding, phases I-II

The street sounding was extended inside the building on the other side of the wall which is about 1m thick, in an area which was therefore the entrance to B16 (sounding 1,50 x 1,50m). The top level is a loose layer of demolition with a lot of stones in a soft powdery earth. It lies on a homogeneous layer of earth, rather compact with few charcoals and ash remains, at to the level of the threshold of the door. No built mortar floor was found in this area, which could therefore be a small courtyard rather than a room.

Under this later occupation phase, another layer of fallen stones was found, many coral blocks and few pebbles in a loose earth, about 60cm thick. Below is a meter thick layer of occupation/accumulation, with powdering earth, gravels, pebbles, bones and other few organic elements and remains. It lies on a floor located at level D 9.07 which is connected with the base of the wall of phase I, here also with a strong coating. To the contrary of phase II, no doorway was found in this early wall. Just under the floor, about level D9.00, the bedrock is similar than in the street sounding.

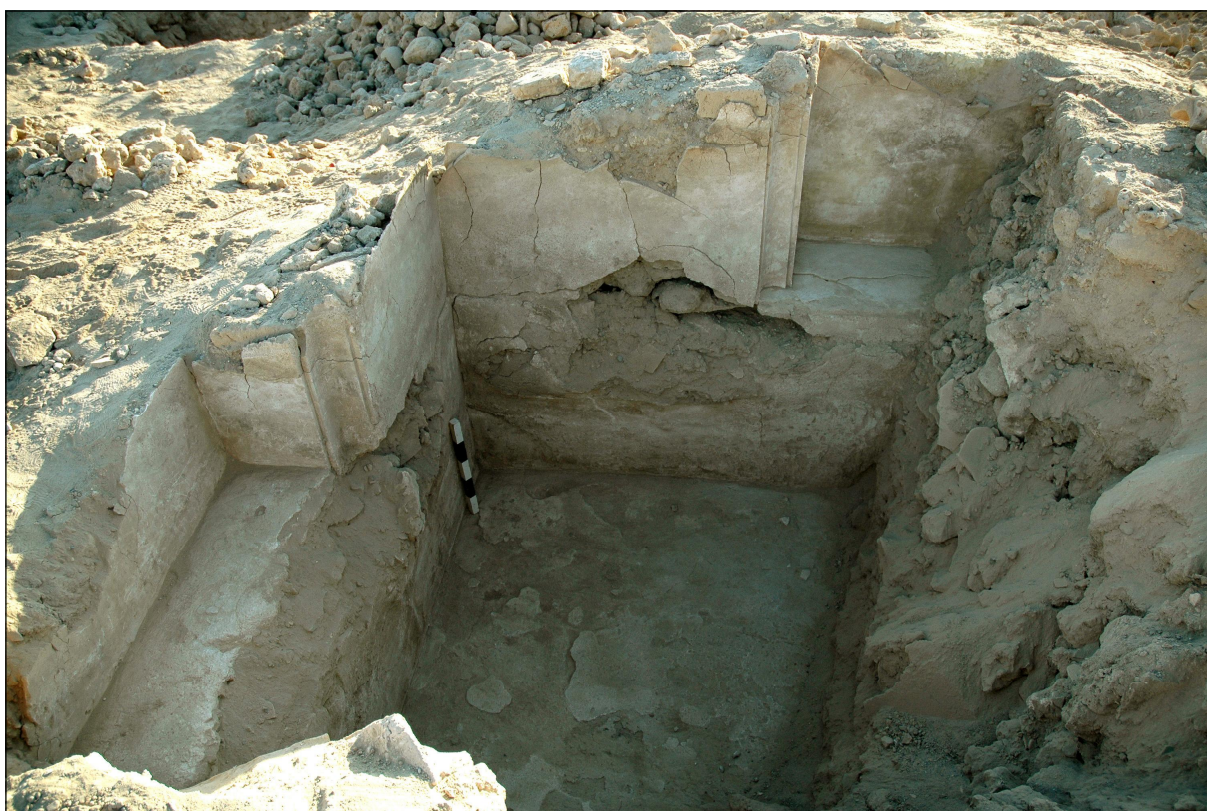
The main room, with its plastered floor and niches, phase II

Beside the outside walls, the only clear traces of construction appearing on the surface of B16 were several lines of thick strong plaster forming niches and recesses, slightly to the southwest of the entrance. A sounding and surface clearing eventually indicate that the centre of the southeast quadrant was occupied, during the later occupation phase, by a large rectangular room, 12.5m long east-west and 3.7m large north-south. This room is entirely decorated with niches 1.1m wide and 0.4m deep with concave corners, creating a regular plan with one niche in the middle of each extremity of the room and probably four niches in the lateral walls. Around the middle of the room, a deep depression in the layer of collapse was surrounded by large fragments of fallen masonry, partly curving, which are probably part of arches. It is therefore possible that the central part of the room was covered with special roofing, maybe a *qubba*.

The sounding (2.20x2.20m) was open in the northeast corner of the room, where the plaster was well preserved up to the surface. The top layer is a level of collapse about 1.20m thick (D12.70 > D11.45) made of many stones, coral blocks, mortar and numerous fragments of plaster coating, with few ceramic sherds, in a powdering earth; the base of the niches appear at layer c. D11.95, about 75cm under surface. Under this collapse a rather homogeneous layer of earth was found, with some charcoal and plaster fragments, c. 50cm thick. It rests on the floor of the room, located at level D11.00, an altitude similar to the one of the threshold of the doorway to B16 and the floors of phase II in the street and entrance soundings. Here this floor is an extremely strong white plaster, ca 5cm thick, lying on a preparation layer of small gravels and mortar, altogether ca 20cm thick. These floor layers are leaning against the base of the coating of the walls which were therefore entirely plastered and completed before starting the construction of the floor, the best technique to build a beautiful clean and even surface. The lower part of the walls, under the plaster and floor, is only covered with mortar coating and no niches are visible; it is associated with a 30cm thick layer of earth with stones, few pebbles and coral blocks and a lot of ceramic sherds, bones and fish remains, dating back to the period of construction of the room. This layer lies on a very compacted construction level with pebbles in a dumped earth, which is associated with the base of the walls, at D10.45.

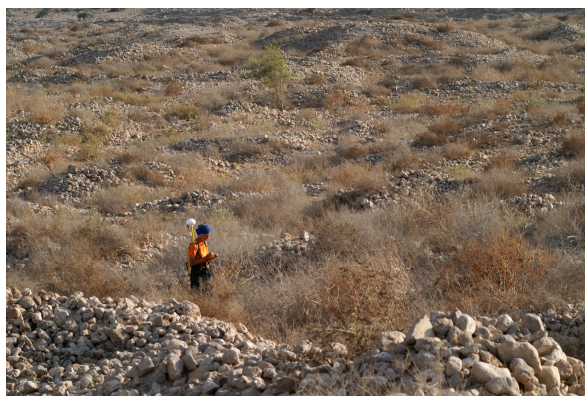
DGPS recording in a complex zone

Last year, a digital elevation model (DEM) of the ancient city of Qalhât and its surroundings has been built from topographic points acquired with a DGPS (see 2008 report). The aim of the 2009 mission (25 November to 10 December) was to achieve the map of the city itself: districts, streets, squares and when possible, buildings. The main problem we had to resolve, is that some districts are quite simple to understand – it is possible to delineate buildings, even sometimes rooms in the buildings – as others are far more complex – only streets and blocs of buildings can be identified. Therefore, we had to be pragmatic: use all the information of all types we have, and adapt the method of recording to the field complexity. We so use a DGPS to record the archaeological remains when it was possible, in the South district or in the North-East district for example; in other areas, we first identify main streets and buildings (or blocs of buildings) on aerial photography, we digitized it with GIS software, then transfer it to the GPS receiver, and finally control the photointerpretation on the field.

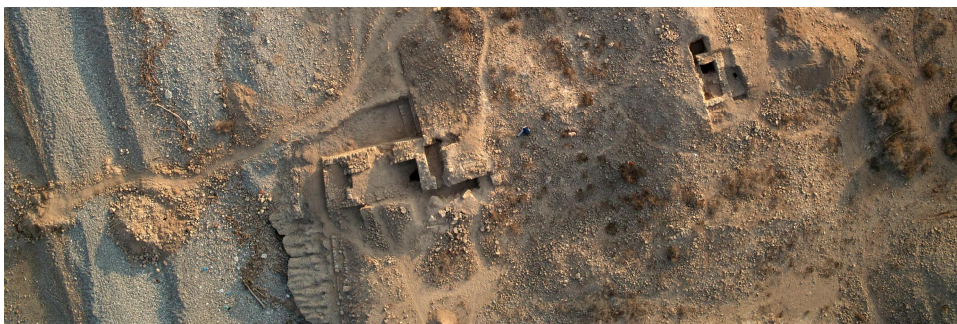
Vertical kite view of the mosque

We also use a kite with a camera and a remote video control to make our own aerial photography, both vertical and oblique. We previously recorded some painted ground control points with DGPS in order to georeference the vertical shots. This layer in the GIS, completed with oblique views, will be a great help to distinguish afterwards, with a better accuracy, the buildings in complex zones.

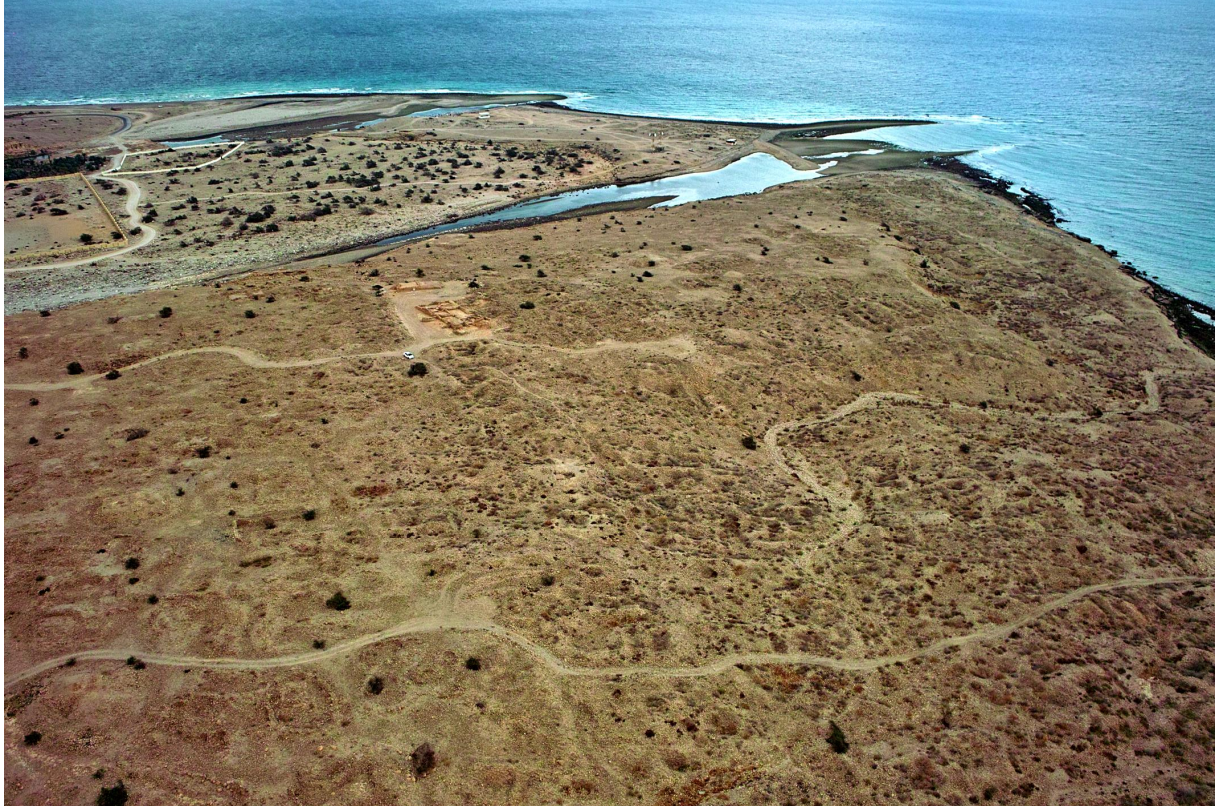
Oblique view of the northern part of the site. In the background, the 2008 French excavations in the northwest quarter of the city (B19 and B21)
