**The Qalhât Project - Preliminary report on the third  
season of excavations of the French mission  
(30/10-17/12/2010)**

# The Qalhât Project

Preliminary report on the third season of excavations  
of the French mission  
(30/10 -17/12/2010)

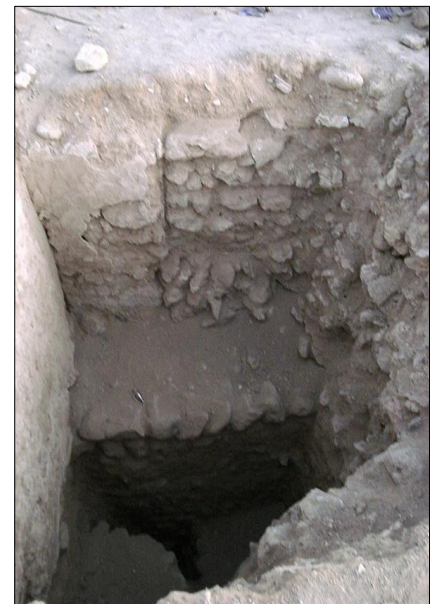
*Sounding S4A, seen from south, with the courtyard to the left*

Two other deep soundings were dug in the middle of the building, one inside the courtyard against its eastern wall, the other on the other side of this wall in the eastern wing of the construction (altogether 4.80 x 2.20m). The sounding in the courtyard (S4B) reached the bedrock 4.60m down the surface, at  $\Delta 12.90$ . The sounding inside (S4A) stopped at  $\Delta 14.60$  as many walls in this sounding progressively reduced the size of the excavation. Three main architectural phases were registered in this area.

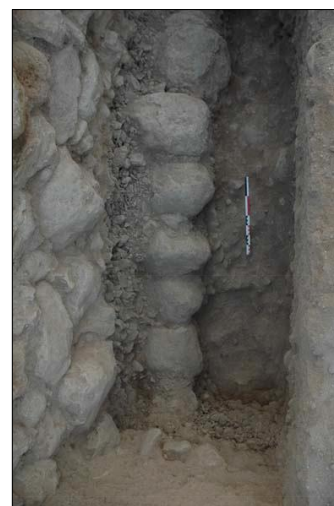
*Southern face of wall B7, from top*

The sounding opened against the southern face of the southern wall B7 therefore proved that this wall was built in one single architectural phase on its whole length. The reason of the irregularity observed in the south face could be found in the irregular profile of the bedrock (as this natural “basin” also justify the upper hole and its filling by Uf 918). This bedrock was first covered with a thin occupation layer prior to the wall B7 which was built just on top of this layer. First is a single row of large pebbles bounded with grey mortar, covered by a thick layer of gravels, both acting as a foundation on top of which the fortification itself was then erected, 2.10m large, with faces in large stones bounded with a grey mortar or clay and a filling seemingly also in big stones. Its maximum height is 1.50m and it is still possible to observe on top the presence of a narrower wall (80cm) as a parapet for a walkway. The ceramic material associated with the wall is rather poor, but contains several ancient wares as Iranian sgraffiatos of the 12-13<sup>th</sup> centuries and Yemeni mustard ware of the 13-14<sup>th</sup> centuries. As in the sounding opened in 2008 at the northern gate B38, this seems to confirm the notation of Ibn al-Mujawir saying that the fortifications of Qalhât were built in 1217/18.

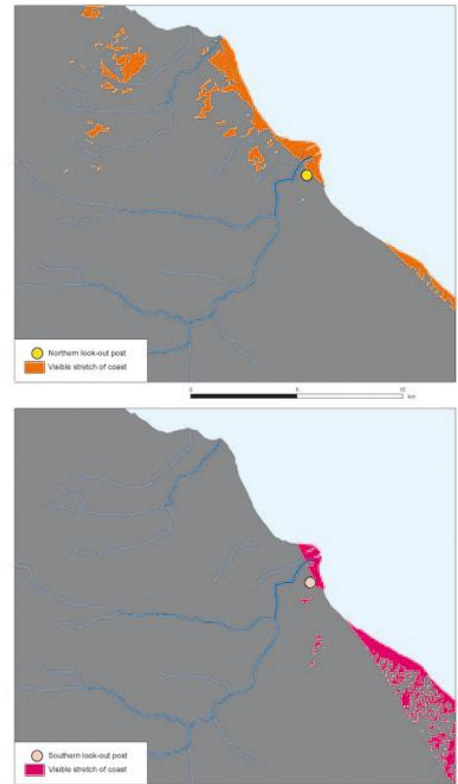
*Stretches of coast visible from the northern (up) and southern (down) look-out posts (Topographical Project)*

The ramp is rather wide, up to about 4m at some points. It ends with a long straight section leading northwards up to a rather flat area where is located a small cistern, 3.45 x 2.30m. Its depth could no be checked. The tank is limited by narrow walls 35cm wide which are preserved up to 55cm higher than the highest surrounding surface. Rain water could be supplied by a rocky area gently sloping from the north-west down to the western wall of the structure and an overflow is situated on the northern wall. Some 200m south of the cistern on the edge of the plateau is a group of three structures including a small terrace with peripheral walls in blocks and a filling of large stone chips, a small mosque and a small building. From this position, the view extends on Qalhât, on the sea, and on the northern coastal plain as far as 7.5km. 300m further south, on the other side of a shallow thalweg, a wide rectangular structure is standing on the edge of the plateau, from where the view extends southwards as far as Sur. Each post was visible from the other, both were visible from Qalhât, and this installation therefore allowed a complete scrutiny of the sea, of the roads south and north, and an immediate warning of the city in case of approaching boat or of danger.

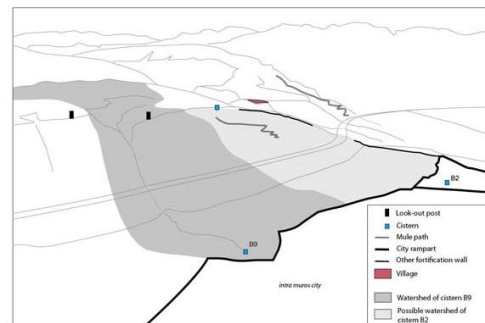
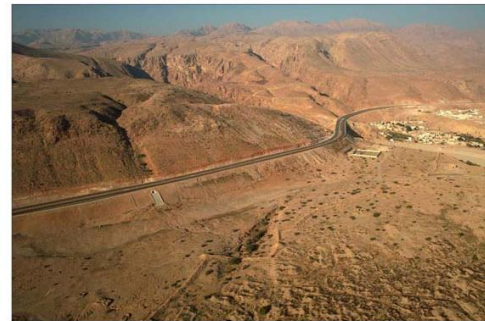
Watersheds of cisterns B2 and B9  
(Topographical project)

Also Miles described this cistern as being located in a water course, and therefore catching rainwater directly, nothing is now visible on the surface of such a watercourse. The cistern is furthermore built inside the *intra-muros* area, very near to the city walls and it could certainly not be supplied directly, by a wâdî or seasonal flooding on the surface. The only possibility should be that the water from the mountain and the area west of the fortification was channelled by low walls in the direction of the gate in the fortification, and from there to the cistern. No trace of such landscaping was found by the Topographical Project but all this area was strongly altered, by the construction of the modern track, of the electric transformer, and now by the highway embankment. It is anyway probable that the cistern was mostly filled manually, probably with water carried up from wells inside the wâdî bed, maybe by donkeys. In these conditions it is no very clear why the tank had to be so big, as water could never be renewed completely and stagnant water quickly becomes unfit for human consumption. The way water was drawn from inside is also unclear, as no trace of a staircase or similar structure is now preserved. Located as it is near the Bibi Maryam mausoleum and at the edge of the main track connecting Sûr to the northern coastal plain and the cities of Tiwi and Qurayyat, this cistern could have been used by the inhabitants of the city as by visitors and travellers, although these ones could find easy access to water in the outside cistern B9 southwards, at least during the rainy season, or in the wells in the wâdî northwards.

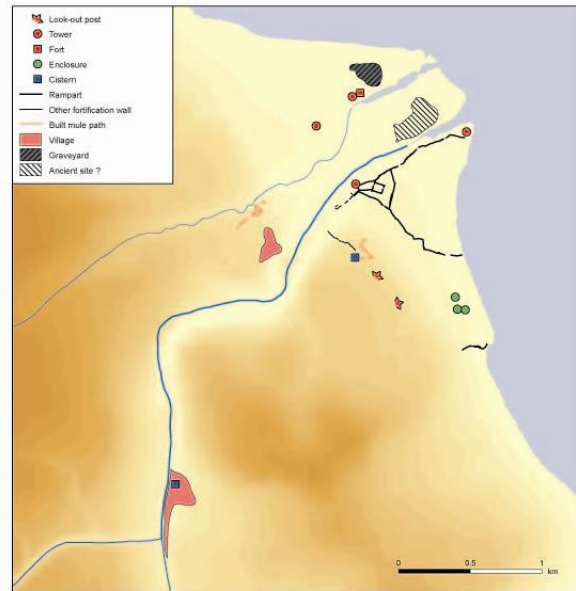
*Location of extra-muros areas and structures studied by the Topographical Project.*
