## **The Qalhât Project - Preliminary report on the third season of excavations of the French mission (30/10-17/12/2010)**

# The Qalhât Project

Preliminary report on the third season of excavations  
of the French mission  
(30/10 -17/12/2010)

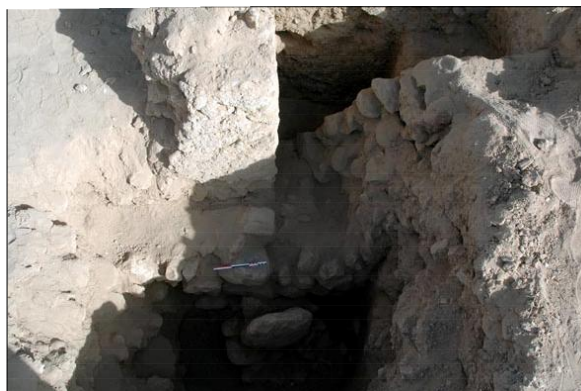
*The entrance to the passageway*

This passageway is 4m large and 13m long. On the city side it starts from the street running along the western limit of the B12-B13 complex, around level  $\Delta$  17.30. The passage was at a time reduced to 2.60m with the construction of a buttress against the southern corner and it was maybe preceded by a porch or some advanced structure as the start of a narrow wall projecting into the street is visible in the sounding. A strange fitting is located against the northern corner, opposite the buttress : it is a regular almond-shaped stone 50cm high, standing vertically with a blocking of small blocks, as a landmark.

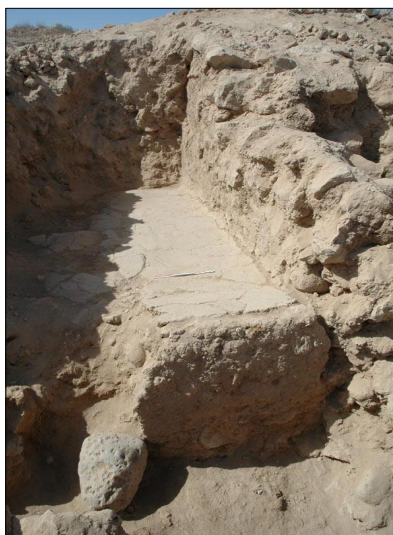
*Northern platform near the door of*

In its last stage the passageway was made of a central narrow ramp, not more than 1.50m wide, bordered by two sidewalks. The ramp was sloping down to the level of the courtyard, around  $\Delta$  15.00 probably, when the sidewalks were made of two long horizontal plastered platforms separated by a step around 90cm high ( $\Delta$  17.10 and 16.20). The step is situated 8.30m from the entrance, 1m before a door in the northern wall leading inside B13 (see *infra*). Several fragments of a pillar with mouldings and wood strapping against earthquake were found there, in a position indicating that it was probably standing in the corner of the step and the door. Fragments of wooden beams were also found. Although two downspouts are visible on the walls, which seems to indicate that we are here in an open area, it is therefore also possible that this passage was a covered hallway.

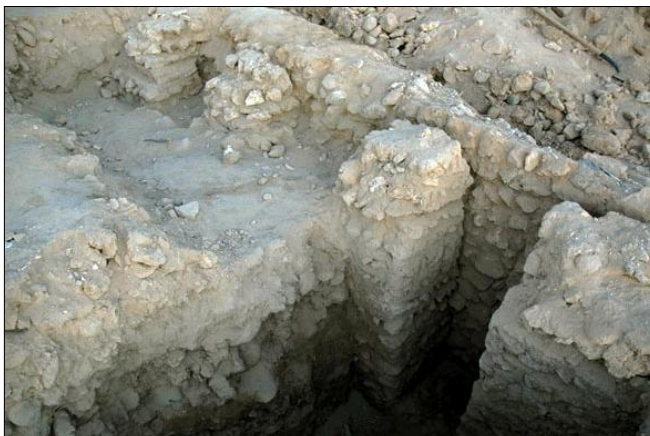
*Structure B95, with the line of pillars against the northern wall*

To the south of the passageway, in the north-western corner of the western courtyard is an elongated structure 13 x 5.50m. The surface clearing and a deep sounding 8 x 1.50m showed that this was probably made of a single wide room, 11.50m long and 3.70m wide. Its southern wall, against the courtyard, is 1m thick when the northern one, against the passageway, is 70cm thick. A line of rectangular pillars, 60 x 80cm, was built against the plaster of this wall, 60cm apart, reducing the width of the room to 3.10m. Five of them were cleared, three more can be restored, and their function is unclear. The floor of this room is at level  $\Delta$  16.08, associated with the base of the pillars which are preserved, as the walls, more than 2m high. This altitude corresponds to the level of the platform of the passageway on the other side of the wall and it is thus probable that this platform was turning round the eastern extremity of the structure and that the access to the room was located in this area, directly from the mosque courtyard. The function of this structure is unclear but it was therefore clearly connected with the mosque activities, maybe a madrasa.

Two deep soundings were dug in connection with this structure, one under the floor of the room, the other against the outside face of the wall in the passageway. The northern wall of B95 is founded at around level  $\Delta$  15.00, and it was associated in its first architectural phase, before the construction of the floor and pillars, with a perpendicular wall running north-south.

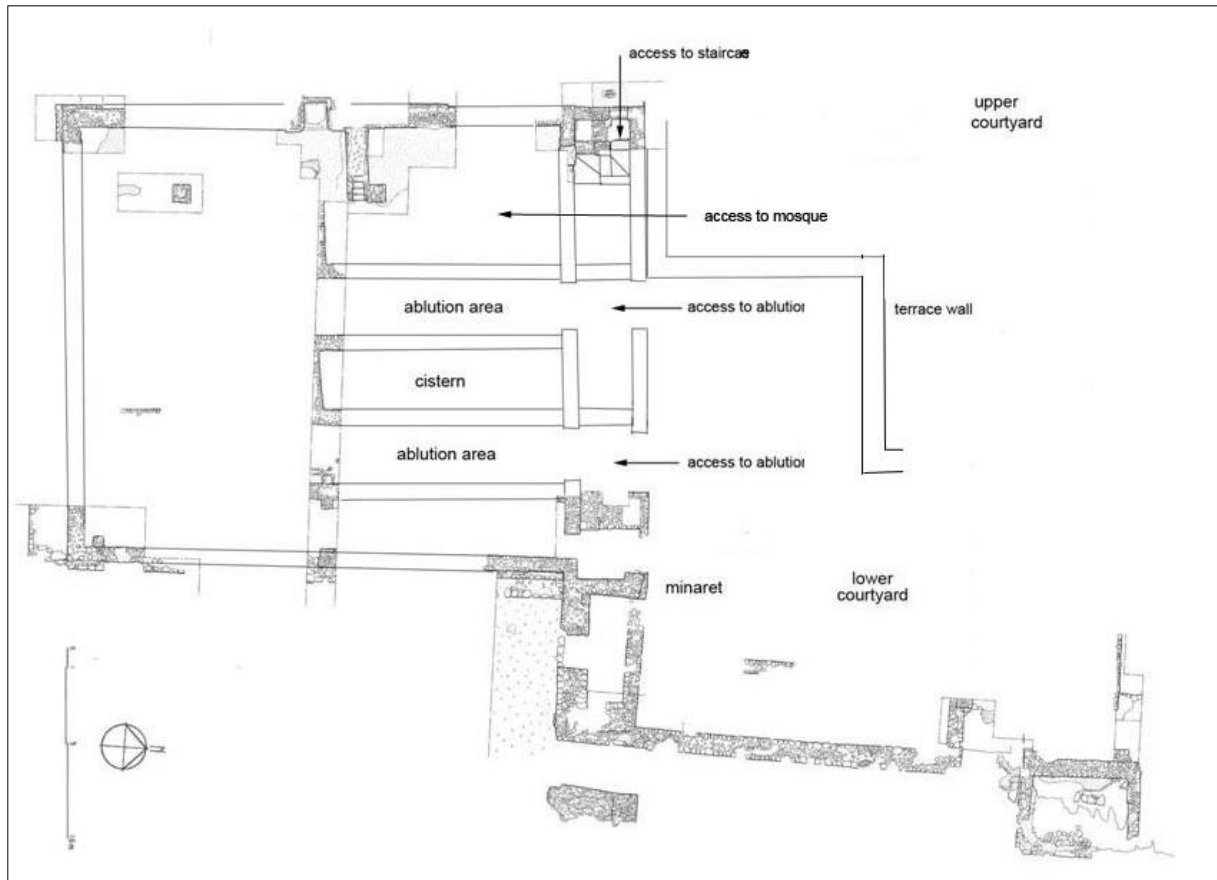
*Schematic plan of B12 showing the upper and lower courtyards, the northern wing, cistern and ablution facilities, the north-east minaret and north-west staircase, the possible access to the mosque..*

Excavations in the area between B12 and B13 lead to the discovery of a massive terrace wall, 1.10m thick, built in large limestone blocks, pebbles and fragments of pounding bedrock. This wall was founded on the bedrock and was acting as a retaining wall for a backfill which was deposited here to level the surface of earlier occupations at the time of the building of the first mosque around 1300, then for a second backfill of good earth which was possibly brought to create a garden in the 14th or 15th century. The northern extremity was not excavated, located under the bulldozer track, but there was probably here a ramp or a staircase connecting the two courtyards. As a matter of fact, this ramp should have been located in direct line between the . Southwards the wall makes a double angle to create a low square area against the northern extension of the mosque (see infra), which is now buried under masses of collapse and was not excavated. It is therefore impossible to say whether this area was open air or covered with a roof resting on pillars or columns.

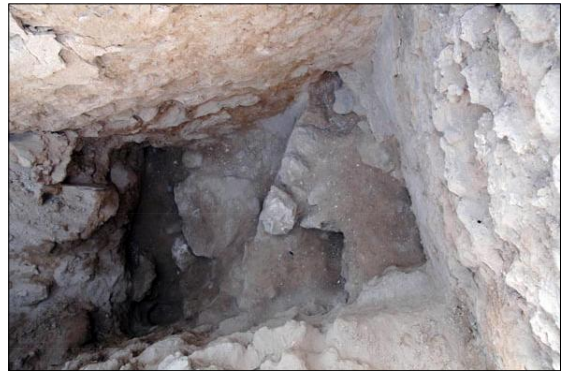
*The staircase*

The function of the small square structure located against the north-western corner of the mosque was also deciphered. As a matter of fact, it is a stairwell for a spiral staircase accessible

through a door from the upper courtyard. To the right of the door, two steps lead to a narrow opening in the northern wall of the mosque, near the corner with the *qibla* wall, which was probably a private access for important personalities, maybe the ones living in the large building B13 nearby (see *infra*). In front of the door is the start of a stair leading down to the westernmost room of the northern wing. Six steps, average 35cm high each, were excavated, which are mostly built on a very loose filling and are sometimes hardly visible now except for traces of plaster on the wall. Holes for small beams in the facade of the basement wall and on the side of the 6th step indicate that there was a door at that place, but the staircase is still going down after the door. Unfortunately excavation was not extended in this direction given the huge thickness of the collapse and the final aim of the western room of the northern wing is unknown maybe a private ablution area or some other special function.

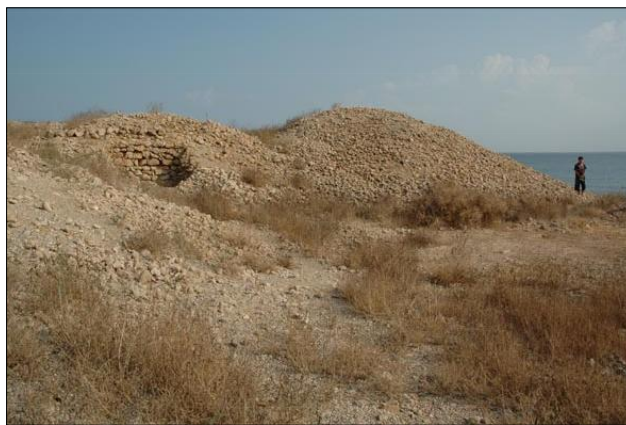
*Ruins of B13 seen from the courtyard of the great mosque*

The walls are hidden beneath huge heaps of stones and it was not possible to draw a complete plan of the structure. It is a rectangular edifice approximately 26 x 30m, with several rooms around a central courtyard and probably several storeys high. The layout is not perfectly orthogonal, the western wall being in two halves making a strong angle, maybe to fit with the topography of the ground which shows several natural ridges in this area. The main entrance was probably located on that side, in the angle at the junction of the two parts of the wall, limited to the south by a projecting structure whose shape and function is not established. A secondary gate was leading south to the mosque courtyard. The outside walls are 90cm thick. They are preserved on more than 3m high and a tall ruin at the south-eastern corner, maybe a tower, is still dominating the surface from more than 4.50m. The excavations proved that B13 was erected about the same period as the great mosque, around the second half or end of the 13th century, and that it underwent a heavy occupation with at least three main architectural phases, each of them with several sub-phases. A complete study would need a large investment in time and money, including the use of a mechanical shovel especially as the evacuation of the rubbish is rather difficult. Furthermore B13 seems to have been strongly weakened, possibly by an earthquake, and deep excavations here are rather dangerous.

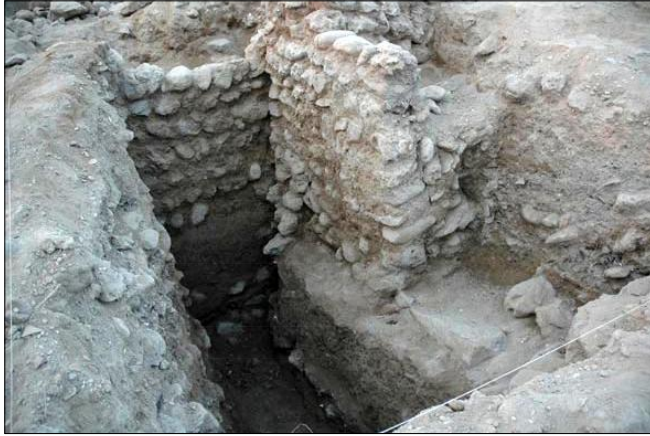
*Sounding S2, seen from north*

S2 (2 x 3m) is located against the outside façade of the northern wall of B13, rather symmetrical to S1, and produced similar information. The base of the outside wall is here at  $\Delta 14.20$ , resting on a strong foundation cut in previous layers down to  $\Delta 13.30$ , nearly 4m under the surface when excavation was stopped due to the danger of stones falling from the section. As in S1, levels prior to the construction of B13 yielded sgraffiato ceramics and some mustard ware and can be dated to the second half of the 13th. The occupation levels associated with

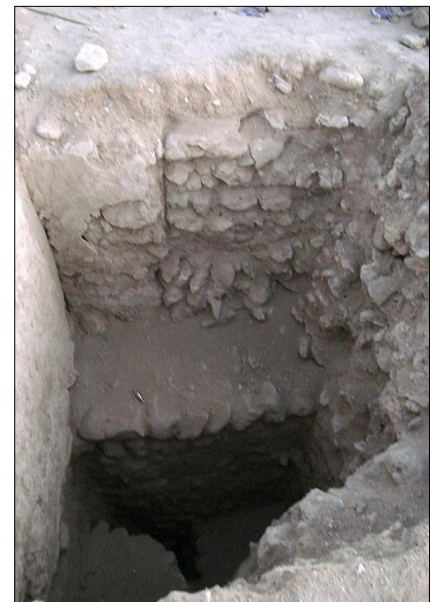
*Sounding S4A, seen from south, with the courtyard to the left*

Two other deep soundings were dug in the middle of the building, one inside the courtyard against its eastern wall, the other on the other side of this wall in the eastern wing of the construction (altogether 4.80 x 2.20m). The sounding in the courtyard (S4B) reached the bedrock 4.60m down the surface, at  $\Delta 12.90$ . The sounding inside (S4A) stopped at  $\Delta 14.60$  as many walls in this sounding progressively reduced the size of the excavation. Three main architectural phases were registered in this area.

Two layers of earth with traces of occupation, altogether 1.20m thick, are found under the first construction in sounding S4B; diagnostic ceramic was limited and dated to the 12th-13th centuries. These pre-B13 layers are surmounted by a wall starting at  $\Delta 14.20$ , bordering the courtyard to the east and probably associated with an inside parallel wall visible in S4A at the same altitude. Two layers of occupation were registered during this period in the courtyard, the last one being a rubbish dump which seems dated to the 14th century according to the preliminary study of the ceramic.

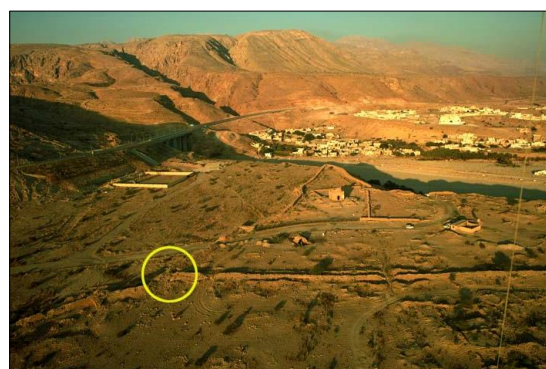
*The western corner of the city, with location of the soundings*

The aim of the soundings open in the area of the junction of B6-B7 (Dir. T. Creissen) was therefore to check the relative chronology of these two walls.

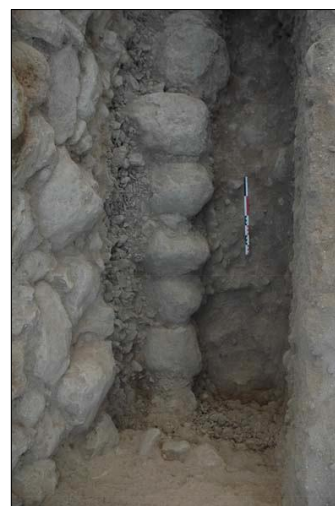
*Southern face of wall B7, from top*

The sounding opened against the southern face of the southern wall B7 therefore proved that this wall was built in one single architectural phase on its whole length. The reason of the irregularity observed in the south face could be found in the irregular profile of the bedrock (as this natural “basin” also justify the upper hole and its filling by Uf 918). This bedrock was first covered with a thin occupation layer prior to the wall B7 which was built just on top of this layer. First is a single row of large pebbles bounded with grey mortar, covered by a thick layer of gravels, both acting as a foundation on top of which the fortification itself was then erected, 2.10m large, with faces in large stones bounded with a grey mortar or clay and a filling seemingly also in big stones. Its maximum height is 1.50m and it is still possible to observe on top the presence of a narrower wall (80cm) as a parapet for a walkway. The ceramic material associated with the wall is rather poor, but contains several ancient wares as Iranian sgraffiatos of the 12-13<sup>th</sup> centuries and Yemeni mustard ware of the 13-14<sup>th</sup> centuries. As in the sounding opened in 2008 at the northern gate B38, this seems to confirm the notation of Ibn al-Mujawir saying that the fortifications of Qalhât were built in 1217/18.

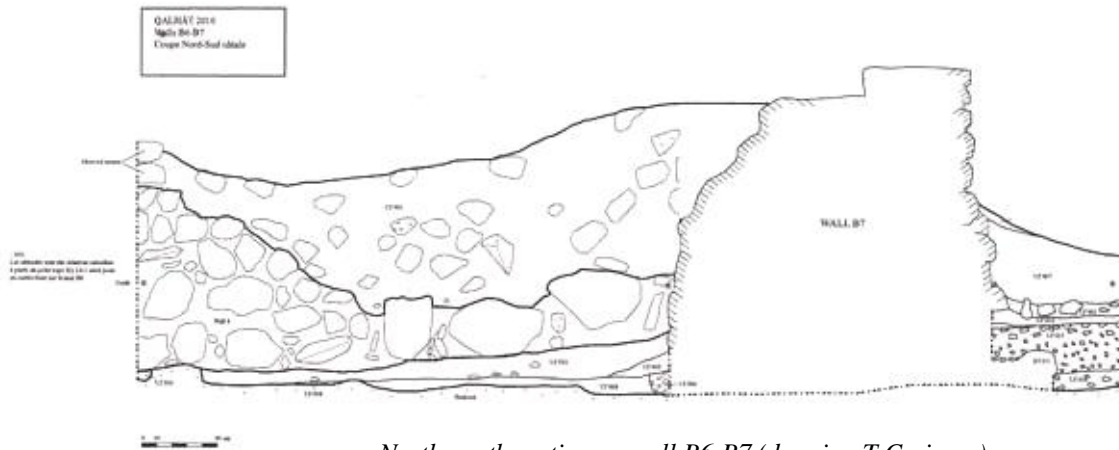
North-south section on wall B6-B7 (drawing T. Creissen)

Under the former layer, Uf 914/920 is a very localized occupation layer with many sherds resting on ashes mixed with gravels. Just under, Uf 915 is quite thick – *ca.* 60 cm maximum - and contains mostly gravels mixed with little earth. Few pottery sherds could be associated with it. This gravel level continues below the wall B7 and it covers a row of big stones (B7-F1) lined up in front of the southern face of that wall. Those stones are big pebbles bounded with some kind of grey clay mortar.

Under the stones and under Uf 915 there is a layer (Uf 916) made of chestnut earth including many pebbles (the bigger ones *ca.* 10 x 10 cm). It is quite hard and few pottery sherds were found in the limited part excavated.

The cleaning of the faces of both walls and the analysis of the stratigraphy therefore reveal that wall B6 lean on wall B7 and is clearly later. In the lower part, some big stones were used for B6, and few small ones were added to fill the gap in the junction with B7. According to the stratigraphy, the older layer is Uf 908 which covered the bedrock. It has then the same stratigraphical position as Uf 916 observed in the other sounding south of B7, but it is much harder and have a different color.

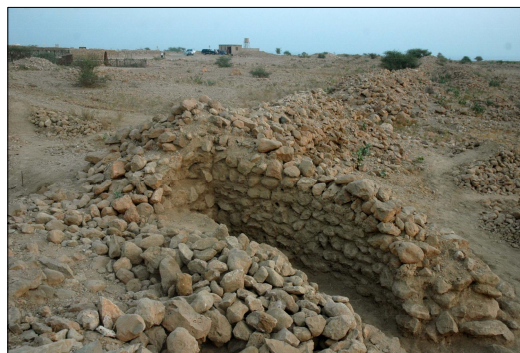
*The angle of B6 and B7, with the curved structure B6-F1*

B6 is approximately 2m50 wide. The highest preserved part are *ca.* 1m20, but the wall was certainly higher. It is made of big stones bounded with a yellowish clay in the part that have been cleared. On the eastern side of wall B6 remains of an east-west wall were visible (B6-F1). Part of it has been cleaned after moving the collapse layer (UF 911). This wall is curved towards the east, but it was not possible to observe all its southern parts, so its general layout is still not known. Yet, it probably correspond to a semi-circular structure (a tower ?). This wall lean on B6, but we can assume that he belongs to the same building phase. It is *ca.* 1m20 wide. Big stones are used for the faces as same as for the filling, and bigger ones are present in the curved part.

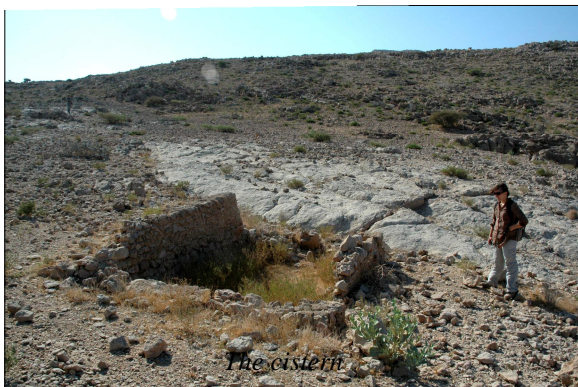
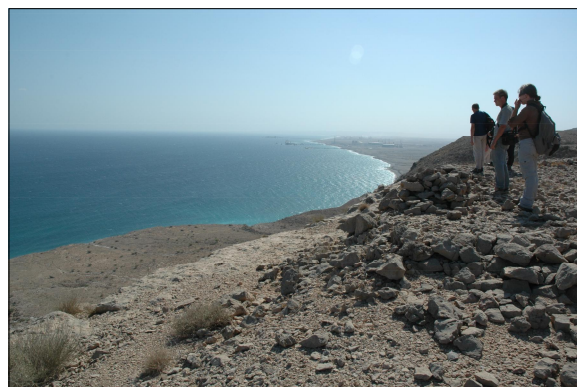
*The southern look-out post*

The ramp is rather wide, up to about 4m at some points. It ends with a long straight section leading northwards up to a rather flat area where is located a small cistern, 3.45 x 2.30m. Its depth could no be checked. The tank is limited by narrow walls 35cm wide which are preserved up to 55cm higher than the highest surrounding surface. Rain water could be supplied by a rocky area gently sloping from the north-west down to the western wall of the structure and an overflow is situated on the northern wall. Some 200m south of the cistern on the edge of the plateau is a group of three structures including a small terrace with peripheral walls in blocks and a filling of large stone chips, a small mosque and a small building. From this position, the view extends on Qalhât, on the sea, and on the northern coastal plain as far as 7.5km. 300m further south, on the other side of a shallow thalweg, a wide rectangular structure is standing on the edge of the plateau, from where the view extends southwards as far as Sur. Each post was visible from the other, both were visible from Qalhât, and this installation therefore allowed a complete scrutiny of the sea, of the roads south and north, and an immediate warning of the city in case of approaching boat or of danger.

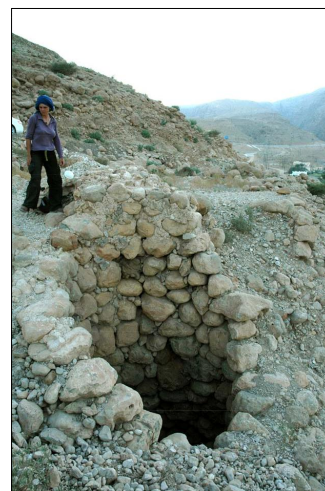
*The well near the hammâm*

Two wells are located near the main northern gate, in the area of the hammam. They are situated at the border of the natural intermediary terrace and also their edge is rather high up the wâdî bed, they are probably mostly built up against the terrace rather than dug inside it. The well nearest to the hammam is about 2m in diameter, built in boulders about 30cm wide and 50cm long. It is now empty on about 15m a very impressive structure. The second well is located further down on the slope. It measures about 1.90m in diameter, is built with smaller boulders, and it is now completely filled up.

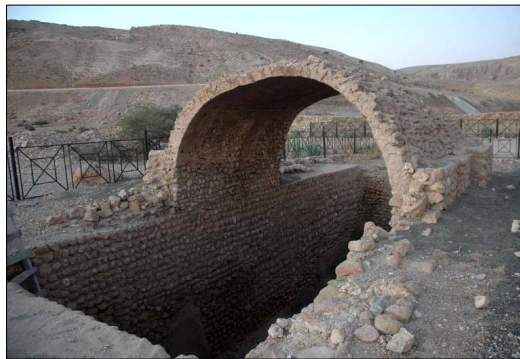
The upper part of the cistern is covered with an arched roof emerging from the surface, which is now partly destroyed also it seemed in a better condition on rather recent photos. This roof is made of sections of barrel or elliptical vaults (two are preserved, and part of a third one also) alternating with arches of the same form (two and half are preserved). For these superstructures, small coral blocks bounded with pinkish mortar are used. What seems to be equivalent of wood board traces could be seen in the intrados of some of the vaults. In both sides, the lower part of this roof is buttressed by a wall made of pebbles which is ca. 70 cm large and 70 cm high in the south. In the northern side, this wall is irregular and the eastern part is thinner : it is only 40 cm thick. Those walls are larger at the bottom than at the top and they have a slopy section. This particular profile was done to receive the lower parts of both vaults and arches. Those buttress-walls have been mostly restored recently.

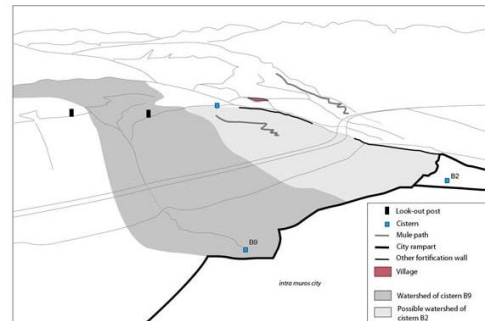
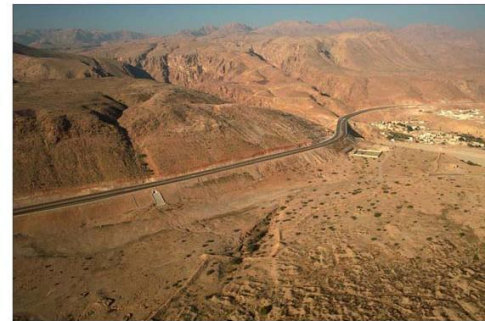
Watersheds of cisterns B2 and B9  
(Topographical project)

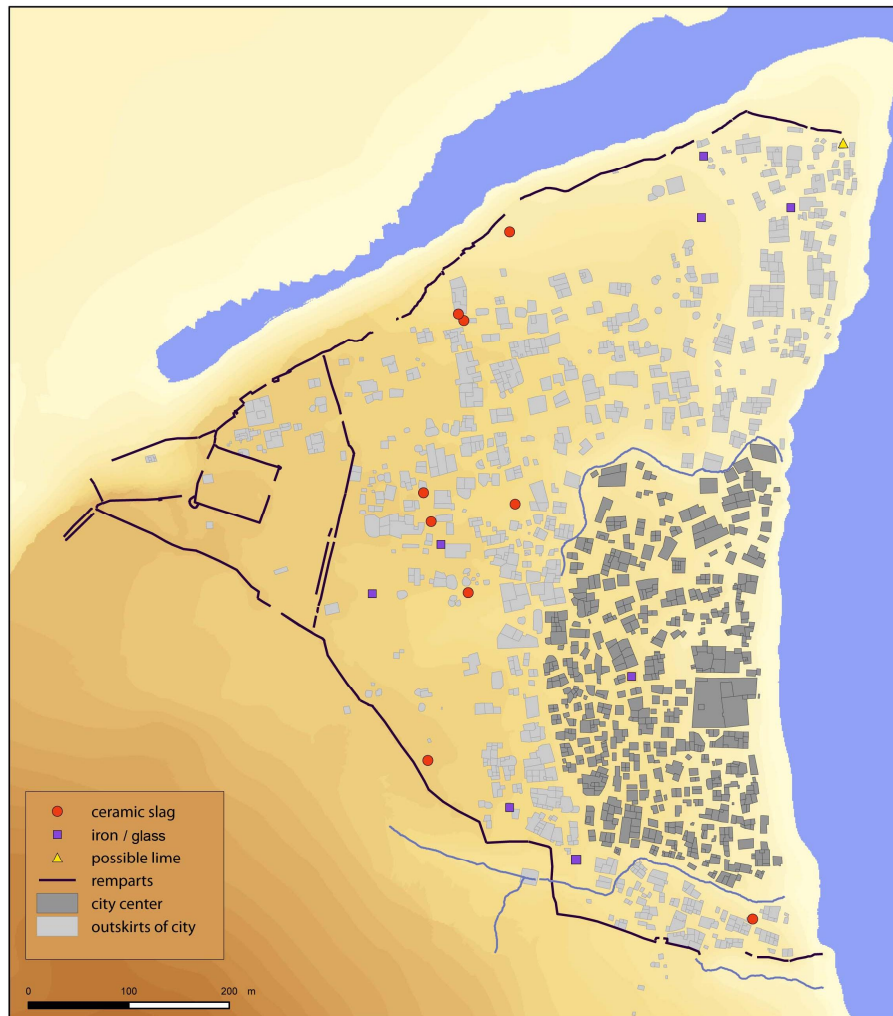
*Location of ceramics (red) iron (purple) and lime (yellow) possible production areas*

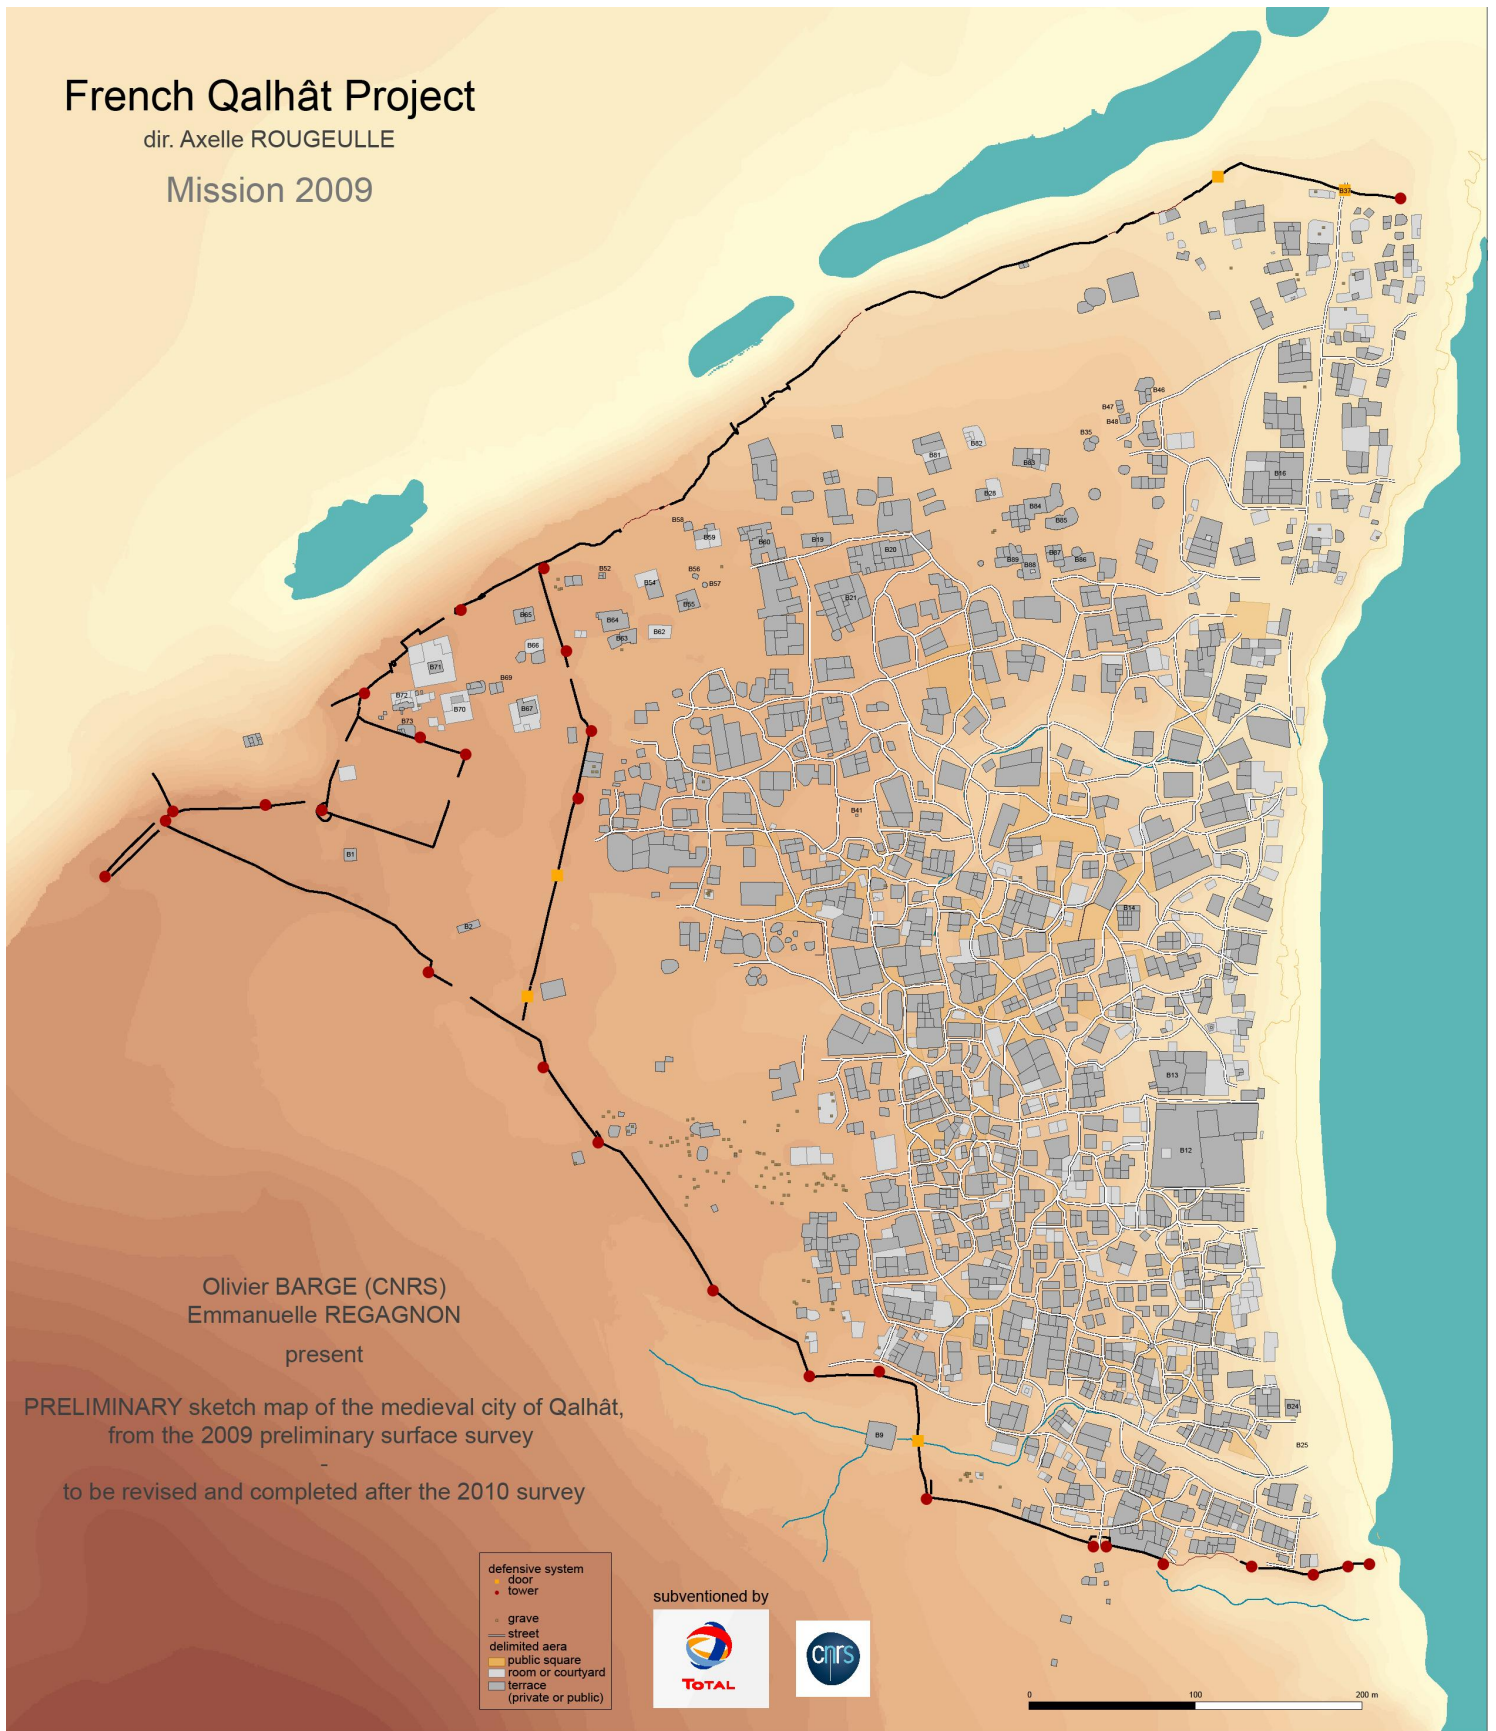
*Preliminary map of the medieval city of Qalhât according to the 2009 survey of the Topographical Project*
