The Qalhât Project - Preliminary report on the fourth season of excavations of the French mission (25/10-12/12/2011)

Preliminary report on the fourth season of excavations
of the French mission
(25/10 -12/12/2011)

Axelle Rougeulle
(Cnrs, Umr 8167)

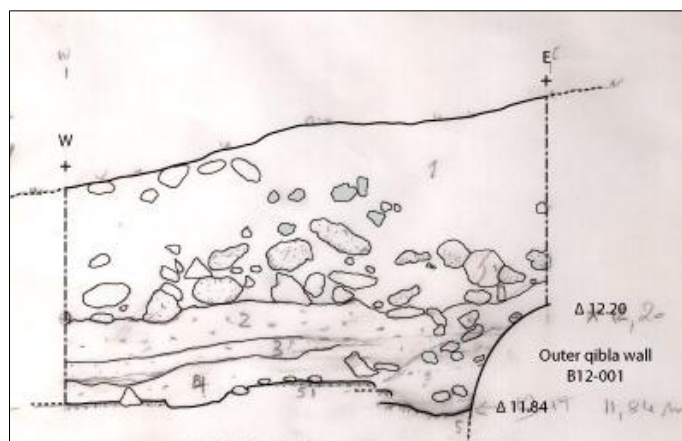
A burnt layer was located throughout the trench, indicating a time of great fire (**fig. B12_S22/3 Northern section of S22**). This layer might verify the destruction by the Portuguese in early 16th century. Beneath this burning event, we located not one floor, but three. The earlier mentioned floor is the first, i.e. the upper most. It is very strong, fixed with burnt lime inclusions in the plaster. Under this there is an older floor level that is even possibly harder than the first. Again we deal with a lime fixed mortar floor. Here we find inclusions of small pebbles and it is laid on a layer of pebbles, which measures 3-4 cm. Patches of floor is occasionally located between the two floors. This might well be reparation or renovation whenever the second floor was broken. The foundation of the floors (radier) is made of 3-5cm sized stones.

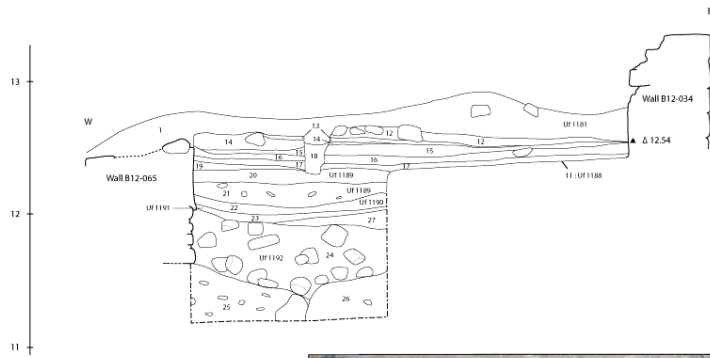
In the northern section (**fig. B12_S25-4 Northern section of sounding S25**), this ashy layer is covering a thin layer of brown beaten earth leaning on another one filled with charcoal : all of them has been gathered into Uf 1182. They are cut by a pit only seen on the section, so its original extension is impossible to reconstitute. It might have been a posthole. Under Uf 1182 is a flat and quite thin – 10 cm maximum – level mostly made of small pebbles that could have been a floor. Its leaning on what looks like a beaten earth floor including few sherds on its surface, itself toping another thin layer of pebbles. Under that later, located in the western part, is a dark brown layer including remains of decomposed wood. All of these layers have been gathered in Uf 1183. They are leaning on a hard grey cement floor, which is only situated in the eastern part of the sounding (Uf 1188, **fig. B12_S25/5 General view of the basins**) where it is covering all the width of the sounding at ca. 12m 40 maximum (but at only ca. 12m 25 in the west, since it is quite sloppy). In the south section, it is covered by layers slightly different from the above-mentioned ones (**fig. B12_S25/6 South section of S25**). First, there is a layer of small pebbles

of the supposed post-hole described in the north section. If the northern wall is largely destroyed, it has been possible to explore its lower part since the cement floor Uf 1188 is not present in this part of the sounding. Its foundation starts from approximately 11m 70, *i. e.* the same height as the ones belonging to wall B12-065. Beyond the floor level, the faces of these two walls are covered with a grey coating for *ca.* 30 cm from the height of 12m 05 (see *supra* **fig. B12_S25/5**).

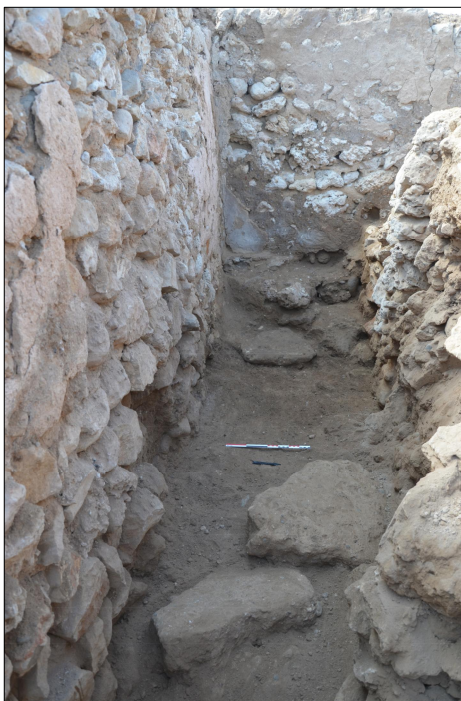
At the bottom of that layer, two big pieces of a very thick mortar floor were found (**fig. B12_S15/4 fragments of mortar floor down the collapse layer**). Under Uf 1165, 1169 make a slope towards east (ca. 10m 20 for the apparition level in the west, ca. 9M 60 in the east) and is much thicker in that direction (ca. 5cm against 20cm). It is made of very soft brown sediment including some sherds and, also, a mould for stucco decoration. Covered by this layer, Uf 1171 is made of very soft white-grey sediment, and is also very sloppy. It is about 30cm wide in the central part, but only 10cm in the east, where it became flat. A lot of charcoals are included in that layer, as well as many fish bones, ceramics sherds and few bronze objects, among which five coins. Half a grindstone was also found.

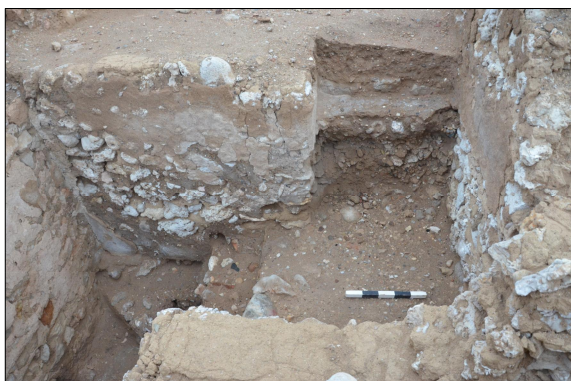
tem was already observed for the stairs discovered in 2010 along the wall B12-033 (**fig. B12_S15/6 details of upper steps showing traces of beams**).

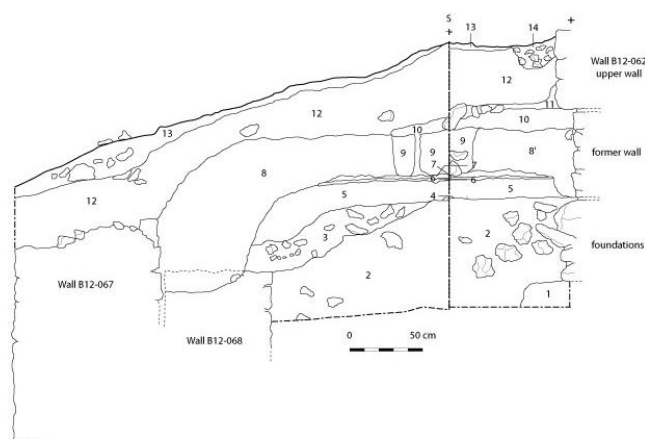
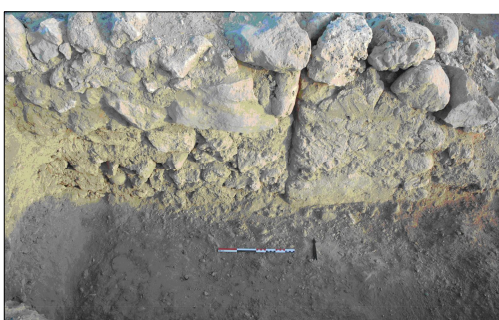
The enlargement of the sounding towards the west allowed us to study the wall B12-062 for almost 3 meters long. This wall appears to have been built in at least three different phases (**fig. B12_S21/3 south and west sections of S21W**) from the surface, and starting from the west corner, three rows of quite big stones (that are also visible in Sounding 23) lean on an anterior phase of the same wall, less wide and made of smaller nodules, mainly coral blocks (average 10-15 centimeters). This former wall surmounts a 50 centimeters layer of very coarse foundation.

At 1 meter, a massive coated pillar (ca. 70-80 centimeters wide) stands on top of the same type of rough stone foundation (both foundations might be contemporary as they look very similar), and seems to join together several structures, raising the question of its dating in the chronology of the different walls (**fig. B21_S21/4 Wall B12-062 before foundations and B12-068 had been uncovered: upper wall, former wall and plastered pillar**)

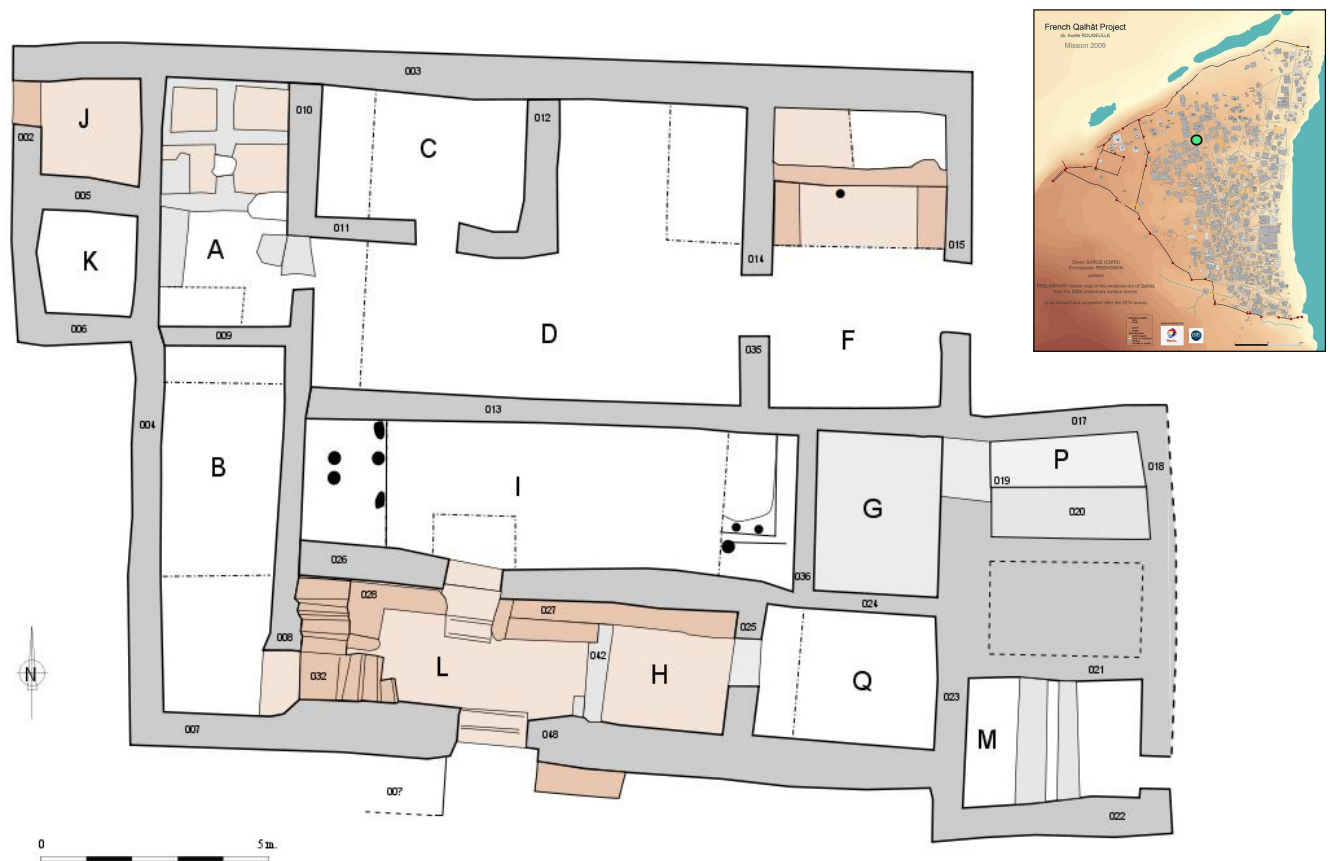
deeper than expected, only some parts of the rooms were completely excavated, but the plan of the house was nearly entirely cleared (**fig. B94/3 Plan of B94**). The building is in fact composed of two separate units, north and south with no connection visible, at least in its last stage.

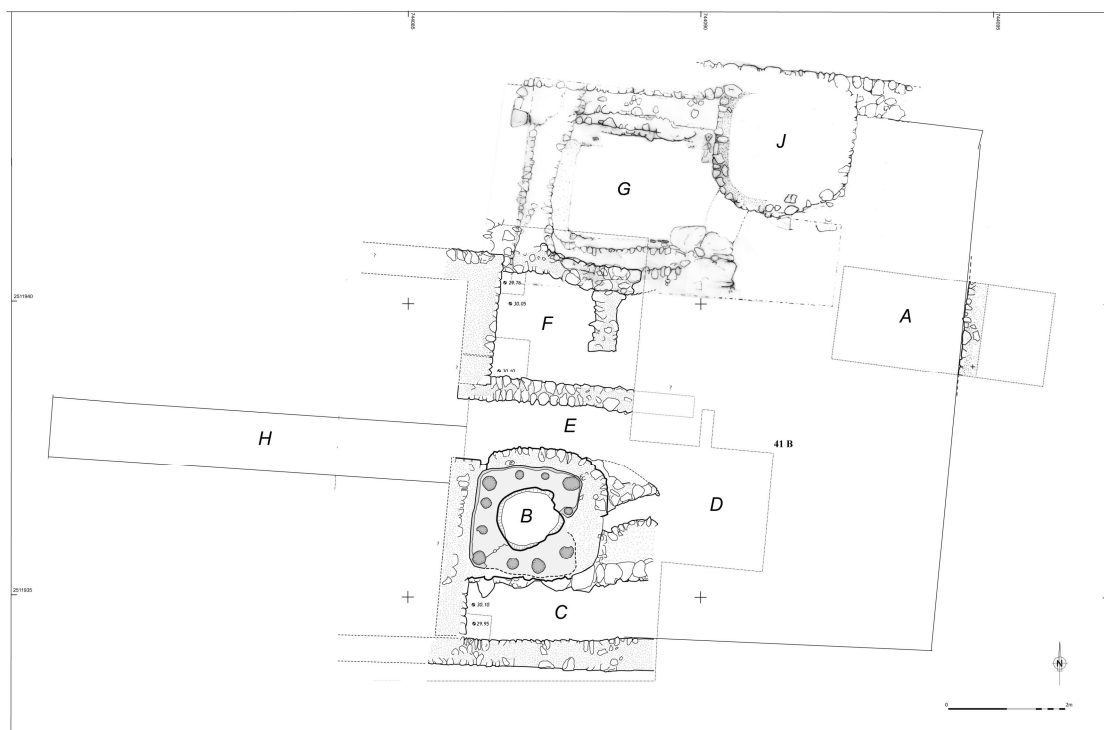
Excavations in the kiln area B41 were therefore resumed this year and two more kilns were discovered (**fig. B41/1 General view of kilns B41G and J; fig. B41/2 Preliminary plan of 2008 and 2011 excavations at B41;**)
