**The Qalhât Project - Preliminary report on the fourth
season of excavations of the French mission
(25/10-12/12/2011)**

The Qalhât Project

Preliminary report on the fourth season of excavations
of the French mission
(25/10 -12/12/2011)

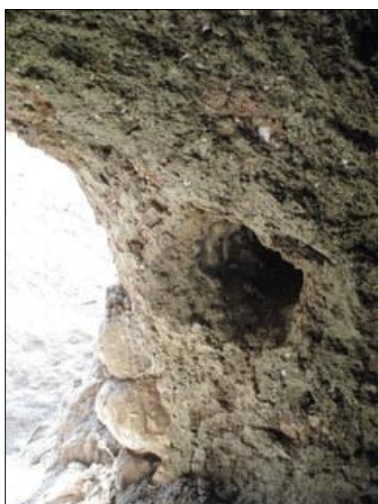
The interior of this kiln is completely covered with light green slag on all walls around and the roof alike. Actually it has three layers of slag. The roof construction of this 3:rd kiln is by 15 ventilations holes (B41/6 Ventilation hole in B41J) varying in size, but no big hole is found in the middle, as the first kiln from 2008 has. This third kiln is the combustion chamber of a furnace. The roof of the combustion chamber is accordingly the floor were the ceramic pot would have been piled and here we have a wall thickness of 24 cm. This wall is coated in yellow clay, which is the colour the local earth receives by heating.
