**The Qalhât Project - Preliminary report on the fourth
season of excavations of the French mission
(25/10-12/12/2011)**

The Qalhât Project

Preliminary report on the fourth season of excavations
of the French mission
(25/10 -12/12/2011)

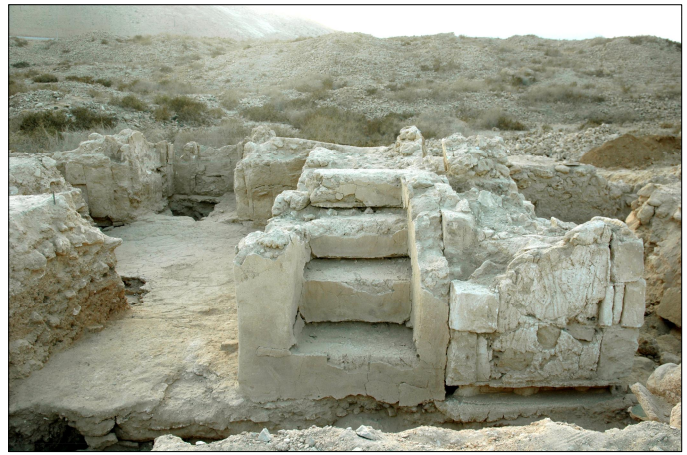
supposed to be the qibla wall brought to light the complete stratigraphy of the area (S1) and lead to the discovery of the mihrab, the minbar and a pillar (S2), which allowed the clear identification of B12 with the great mosque of Qalhât (fig. 1 photo mihrab/minbar, 2008). Other soundings opened in 2009 in the four corners (S3-S6), together with a long axial trench from mihrab to sea (S7-S12), brought information about the plan, elevation and additional details on the chronology of this mosque. Finally, further excavations were held in 2010 in the surroundings, the northern wing (S15), the wall between the two courtyards (S13-S14), the surrounding wall of the unit (S16), the main entrance (S17-19), and an associated structure (S20).

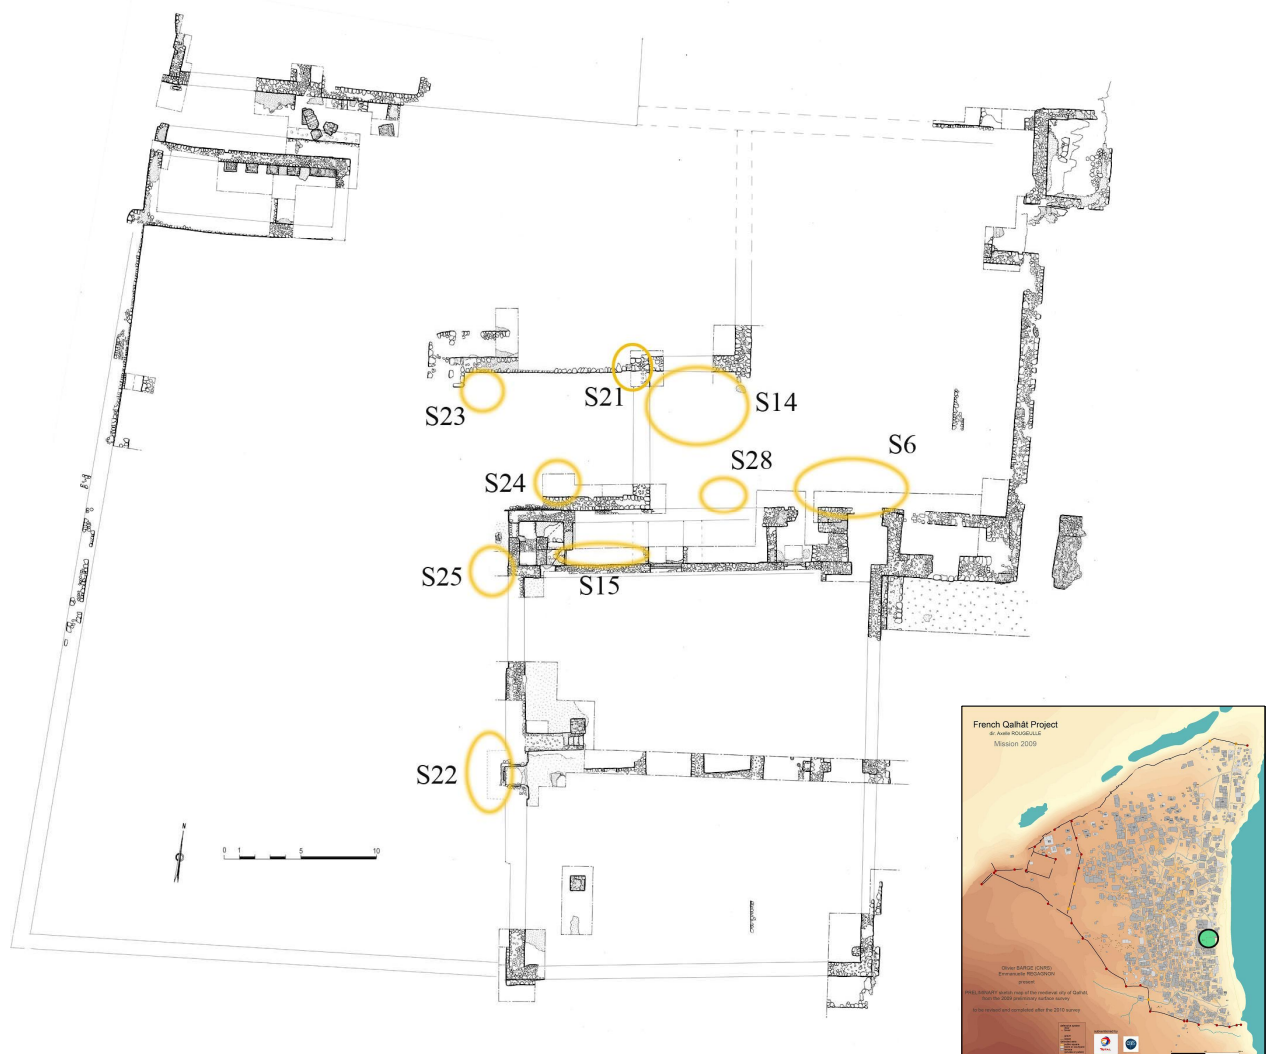
A lecture about the mosque was given last July at the Seminar for Arabian Studies at the British Museum in London and an article is now on press (A. Rougeulle, V. Bernard & T. Creissen, “The Great Mosque of Qalhât rediscovered. Main results of the 2009-2010 excavations at Qalhât, Oman”, *Proceedings of the Seminar for Arabian Studies* 42, 2012). The detailed final publication is currently under progress and questions are still arising. As a matter of fact this building is extremely complicated, with several storeys, huge collapse layers and a complex chronological evolution, and it will not be fully understood without extensive excavations and clearing. Ten additional soundings were nevertheless opened, or enlarged, this year in the northern wing and courtyards (S14-15, 21-28) to try answering the main pending questions (fig. 2 plan of the mosque and location of the 2011 soundings).

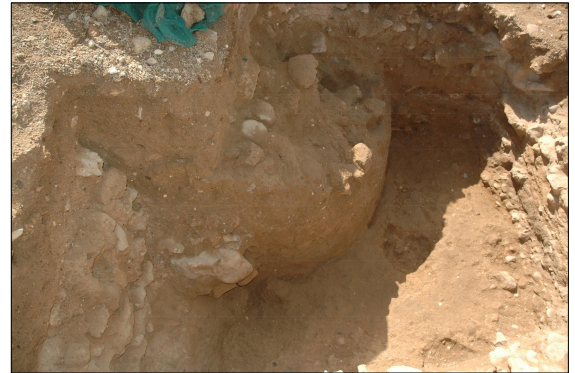
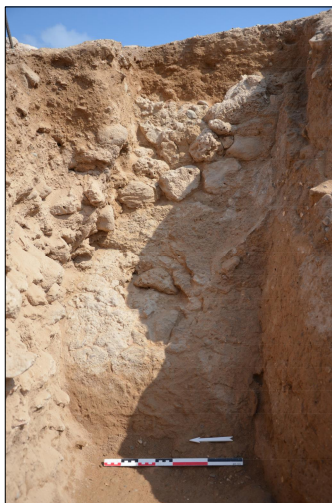
The base of the outer wall construction for the mihrab niche is covered with very thick plaster. This smoothing plaster coats the complete wall, as were it is still standing. The external mihrab outline is square-like with rounded corners (fig. B12_S22/1 The mihrab from outside). This wall construction connects to a floor, which circumvents the complete base. Most of the floor is intact to a distance of some 10-15 cm away from the wall construction of the outer mihrab base, but occasionally it is broken just at the encounter of the two. The northern and western wall is excavated in 2011 and the mihrab niche itself in 2008. To the north, the qibla wall is connected to the outer wall construction of the mihrab base. This qibla wall was partly investigated further north in 2008 (UF 367, 374). The base of this wall is very similar to the base of the mihrab wall; very solid with a smoothing grey plaster coating. On this wall, we find two phases, where the first has thick plaster smoothing the face, just like the mihrab wall. This phase is curving inward itself, few decimetres up, creating a wall base of dignifying width. This phase also connects to the above mentioned floor, accordingly is linked to the mihrab base.

Onto this original smoothed wall construction a second layer of stones was at some point added (fig. B12_S22/2 Original qibla wall before restoration). Though, this time the face is not smoothed with plaster. The second phase holds strong plaster inside and in between stones, but does in this trench not coat the entire wall as the case is on the base. Moreover, the second phase does not connect to the mihrab wall, contrary to the first. This does however not imply that the second phase is of exceedingly later construction. Rather, the impression is it is added contemporary to the first, but with another batch of plaster; the two plasters drying with some time difference. In the excavation of 2008, further to the north this second phase is though covered with plaster; why we can assume the case was along the entire wall. The lack of plaster in the connection to the mihrab wall base must thus be explained with erosion by wind and water.

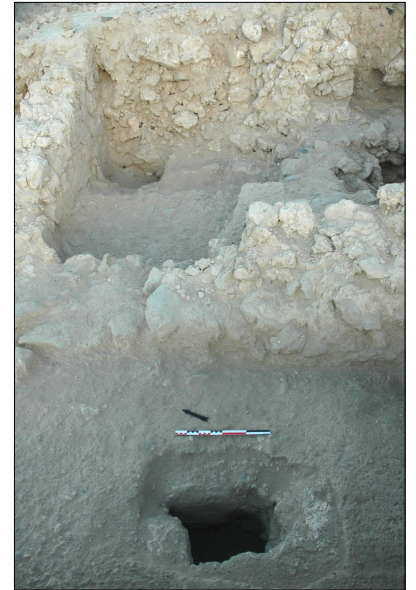
In 2009, excavations had revealed the existence of several structures located around the north-west corner of the mosque. One is linked to the staircase located at the western extremity of the northern wing. The upper part of that staircase starts from a room which was partly circumscribed by walls B12-037 (north) and B12-031 (west). In wall B12-031, a door is open, at the bottom of which a threshold was found (B12-034). West from that wall, different floors were partly excavated. They are linked with another wall further north (B12-038, not exactly in the same alignment as B12-037). Just beyond the collapse was a layer of small pebbles (Uf 650/670) which is leaning on a white plastered floor (Uf 651). This one is cut by a small pit linked to a small channel running below the floor, which was just partly unearthed (Uf 652, 654, **fig. B12_S25/1 Pit and channel outside the threshold leading to the staircase of the north wing**).

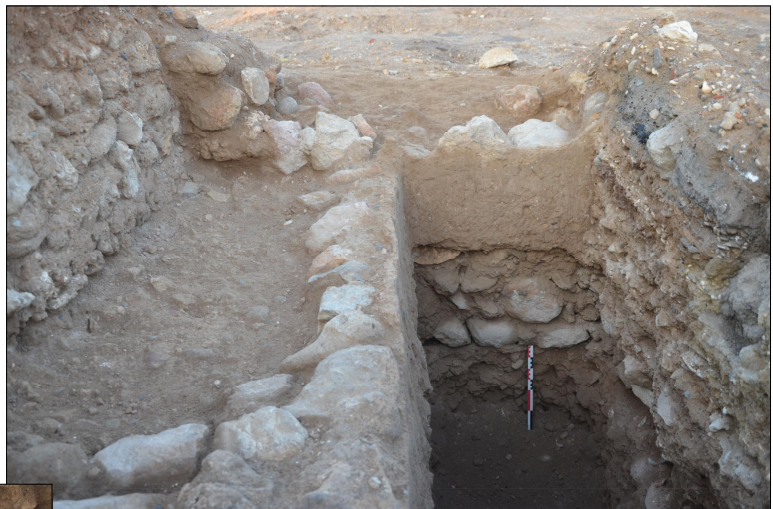
From ca. 13m 50, the surface was covered by a collapse layer including some stones and coral blocs in a brownish earth (Uf 1181). It has an east-west slope. About 3m 20 west from B12-031, this layer covered another wall, parallel to it : B12-065 (**fig. B12_S25/2 Wall B12-065**). It is made of big stones linked with earth. The inner face is partly covered by a grey coating. This wall is 80 cm wide and, including its

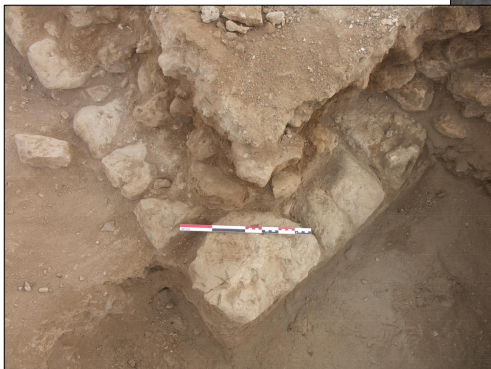
foundation, it is preserved for ca. 1 m high. About 1m50 west of the sounding, this wall is turning toward the east and it is linked to a west-east wall (B12-072) which belongs to the same room (sounding 27, **fig. B12_S25/3 Corner of walls B12-065 and B12-072**). The collapse layer is also lying on a thin ashy layer which is a little thicker in the north. It could be associated with a pocket of ashes that can be seen in the southern section.

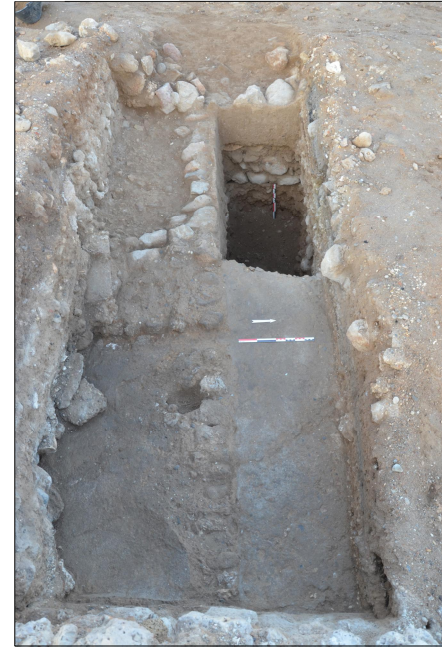
In the northern section (**fig. B12_S25-4 Northern section of sounding S25**), this ashy layer is covering a thin layer of brown beaten earth leaning on another one filled with charcoal : all of them has been gathered into Uf 1182. They are cut by a pit only seen on the section, so its original extension is impossible to reconstitute. It might have been a posthole. Under Uf 1182 is a flat and quite thin – 10 cm maximum – level mostly made of small pebbles that could have been a floor. Its leaning on what looks like a beaten earth floor including few sherds on its surface, itself topping another thin layer of pebbles. Under that later, located in the western part, is a dark brown layer including remains of decomposed wood. All of these layers have been gathered in Uf 1183. They are leaning on a hard grey cement floor, which is only situated in the eastern part of the sounding (Uf 1188, **fig. B12_S25/5 General view of the basins**) where it is covering all the width of the sounding at ca. 12m 40 maximum (but at only ca. 12m 25 in the west, since it is quite sloppy). In the south section, it is covered by layers slightly different from the above-mentioned ones (**fig. B12_S25/6 South section of S25**). First, there is a layer of small pebbles

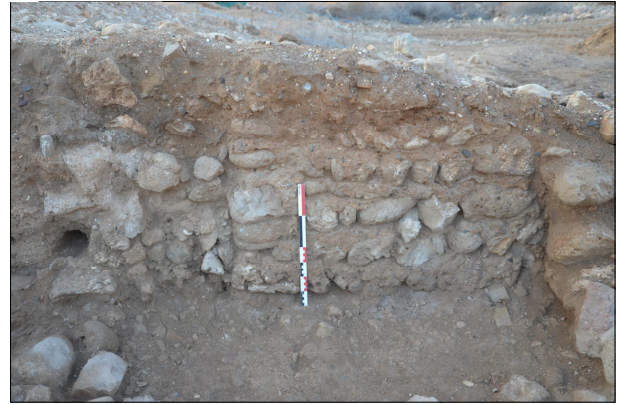
mentioned edge. These walls were linked with another one, running north-south just above the stair, which can be seen in the section. All these walls associated with the western one of the room circumscribe a kind of compartment that was originally filled by earth and stones without any mortar. Some specific features of that construction should be mentioned. In the south section, there is a gap between its east-west wall and the north-south one (**fig. B12_S25/7 Details of structure in the corner of the basins' room**). This "hole" is more or less in front

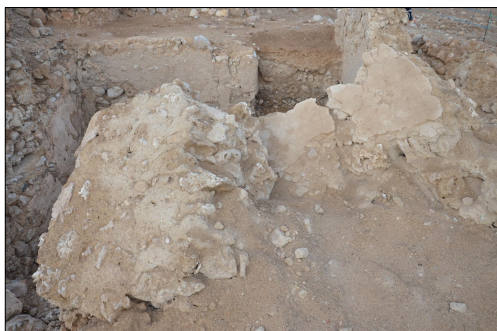
upper part, the sediment is quite soft. A big piece of masonry was removed from it (fig. B12_S15/2 fragment of masonry on top of the collapse layer up the staircase). It is about 1m10 long for 90 cm large and 52 cm wide. It is made of coral blocs and strong greyish mortar, and a white coating covered the four sides. A piece of the same masonry has been kept further east, and another one

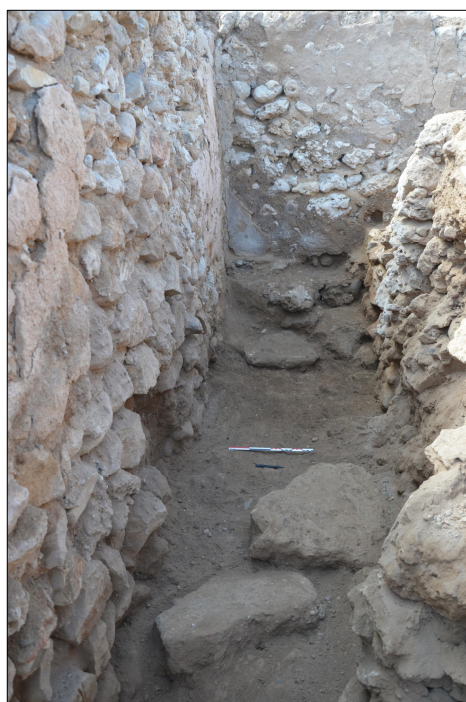
At the bottom of that layer, two big pieces of a very thick mortar floor were found (**fig. B12_S15/4 fragments of mortar floor down the collapse layer**).

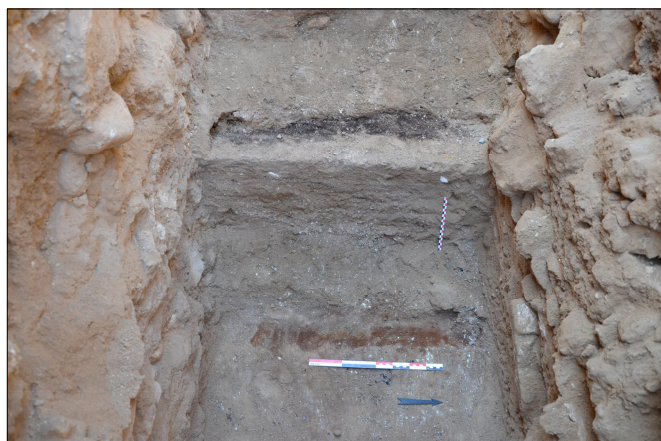
It is made of stones or coral blocs and a strong mortar. Few parts of a grey coating are preserved. The end of the stair was provided with a piece of wood, whose print is still visible even if the wood itself is completely rotten: all that remain was a hard brown and moist dust (**fig. B12_S15/5 details of lower steps showing remains of rotten wood**). This piece of wood was stuck in the northern wall of the mosque, where a hole was made for that purpose: the same sys-

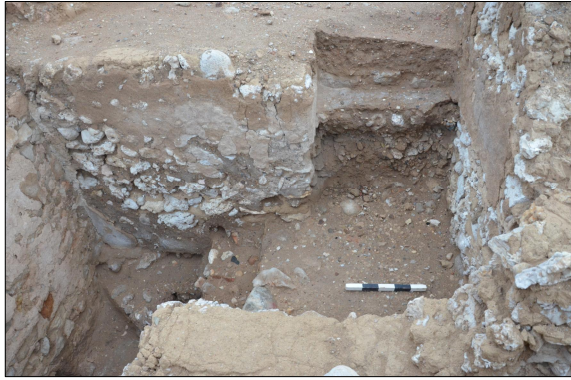
tem was already observed for the stairs discovered in 2010 along the wall B12-033 (**fig. B12_S15/6 details of upper steps showing traces of beams**).

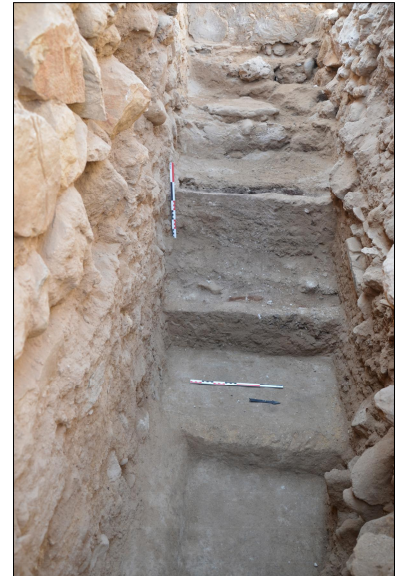
ca. 40 cm long. The two last steps are much lower (**fig. B12_S15/7 the staircase seen from down**): only ca. 15 cm for both of them. The first one is about 70 cm large. They are completely covered with a strong grey coating very well preserved (Uf 1199), and no pieces of wood were attached to them. At the bottom of the last step, the grey coating could have been the floor of the room were this staircase was leading (at ca. 9m 40) as well as the upper part of another stair. Here, the northern wall of the mosque become larger, the upper part of this enlargement curved on the top. The same kind of building process has been observed in the qibla, but one can also think that this peculiar shape belong to a landing: the stairway might have turned towards the north in that part.

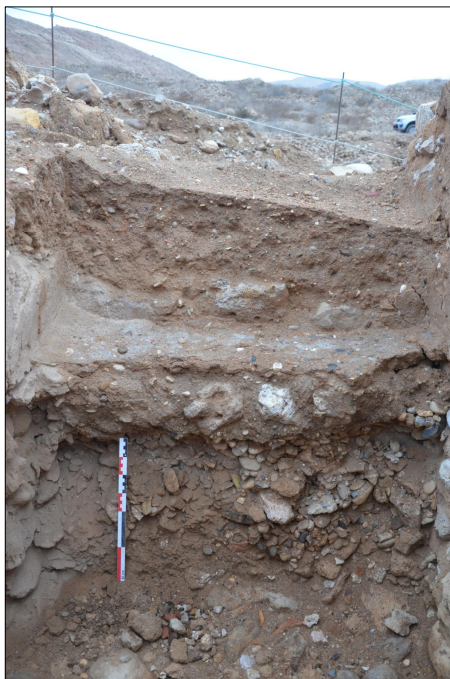
Outside the trench itself, the earlier layer excavate this year is located beyond the first step of this stairway. It is mostly made of pebble mixed with many sherds and bones, and was certainly used as a backfill for the construction of this part of the building (Uf 1155, **fig. B12_S15/8 the backfill for the construction of the upper step**).

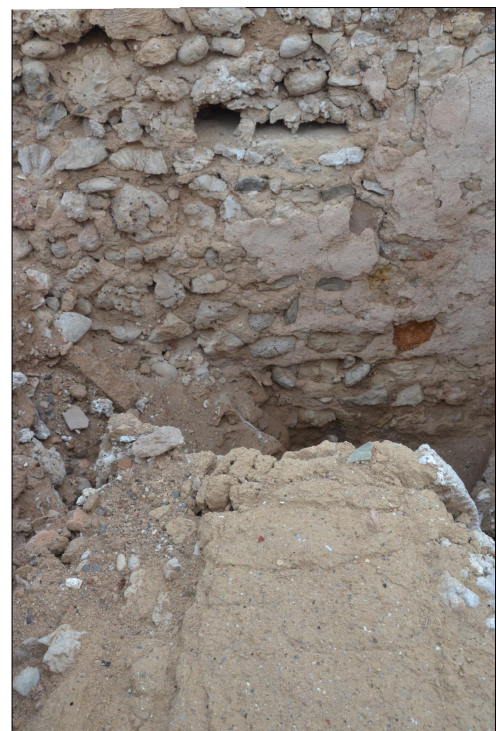
step built at the bottom of it. This kind of print is only 1m 20 long, and further north the wall is higher: one can assume that, originally, this was the case everywhere, even above this flat area. In front of that print, at the same height, they are three flat holes into the northern wall of the mosque (**fig. B12_S15/9 location of beams, probably for a door, above the third step**).

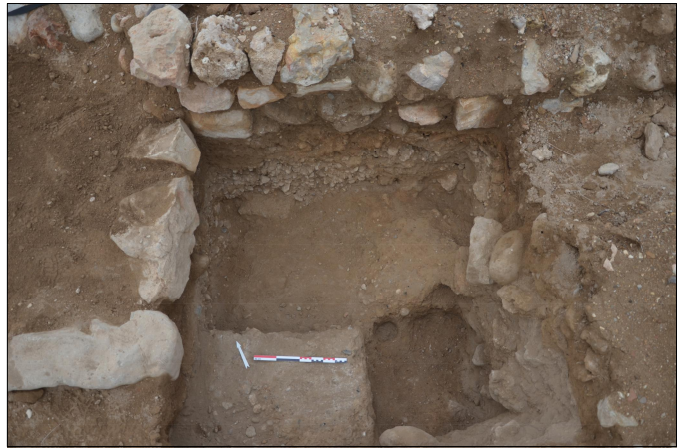
The wall B12-062 is directed west/east. It is parallel to the wall of terrace B12-037 in approximately 8m in the North (**fig. B12_S23/2 Wall B12_062**). At the level of the sounding 23 only ones three wall sill plate are still existing. They consist of limestone and pebbles of a module going of 0,20m to 0,30m bound with some mortar of orange earth. This wall is built on the arase of the pillar of the phase 2 and that of the low wall of the phase 3. It is however wider than both elements of the previous phase what explains the projection observed during the excavation. The height of the foundations of this wall is 11,25m. The upper layer of the sounding 23 corresponds in priori to the destruction of the wall of terrace B12-062. At the end the sounding 23 shows the layers of occupation of the phases 3 and 4 disappeared in this place but could remain somewhere else.

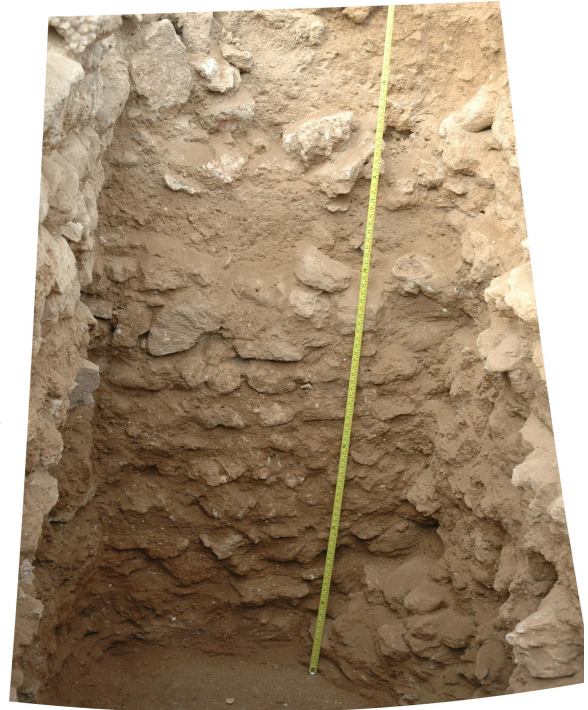
Both walls (B12-061 and B12-066) are directed the North / South (**fig. B12_S24/1 View of wall B12-065**). They are parallel and spaced out of 3m. The level of the arases is respectively 11,22m et 11,48m. Both are built with limestone and of the coral arranged in rather irregular wall sill plate of a height of 0,15 m on average. Stones are bound with a mortar of very crisp brown earth. No filler was observed on these walls. The layer of associated occupation has these walls (UF 1304) consists of hard-packed surface with numerous inclusions of coal, ashes and limestone. Its level of apparition is 9,95m. The superior layer is a powdery brown layer of soil which could be interpreted as some decomposed wood. In that case he could involve a collapsed floor. The discovery of wide pieces of ground in mortar in this layer would suppose the presence of a screed put on the floor.

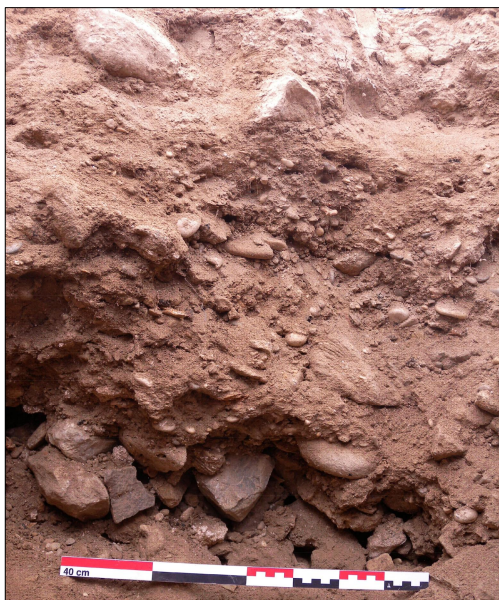
Beneath Uf 1154, 1303 came a hard brownish surface (Uf 1166), without any inclusions, which we first thought was a surface that had been exposed out in the open, and left uncovered. Finally, we came to the conclusion that it was rather some mortar dripping off the wall for it slips from it, curves and gets flat. This surface covered a very compact and homogeneous earthy heap that is hardly understandable, for it does not look like a backfill layer and has more or less no stones or pebbles in it. Quite the opposite but next to it and under Uf 1153 was Uf 1167, exclusively made of medium-sized stones, with no soil in between but gaps, and therefore considered as part of the filling phase (**fig. B12_S21/2 North section of S21N**).

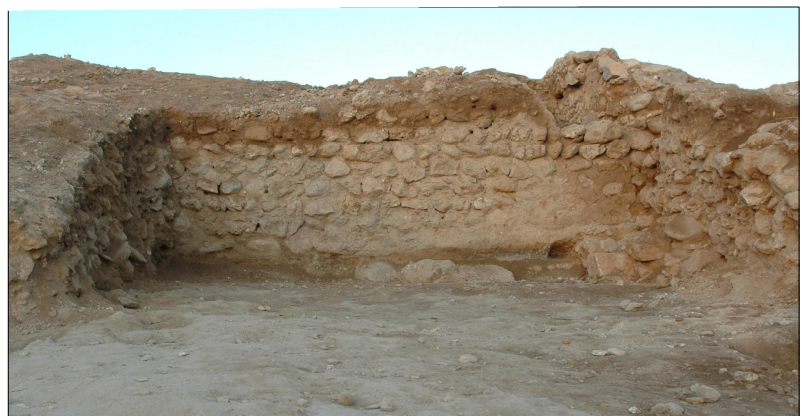
The first sounding S14 had been opened in 2010 against this wall, in the corner with wall (B12-063). This year it was extended to most of the lower courtyard. This work was made possible by the intervention of a bulldozer during one day. It consists to clean the area of the sounding of the surface layer and a high filling of stones measuring about 2m. This refill had been dated by the ceramic around the XVIth century which is the abandonment of Qalhât. After this primarily work we clean the wall, it's well preserved with seven rows of middle round stones, we actually clean some earth mortar still on its northern part (**Fig. B12_S14/1 The retaining wall seen from the low courtyard**). After the cleaning of the area, a relatively flat level appears, it consists of pebbles in a light brownish earth. It appears that the wall

foundation's is constructed on this level of pebble which indicates a second construction phase. On the north western angle of the sounding, which corresponds to the crossing of the walls (B12-067 and B12-063) we find a structure which passed behind the two foundations walls. It appears to be a fire structure with two hearths superposed. The northern part is a bank of large lime stones roughly different of the walls ones. We didn't find any trace of burning on the stones which testify the fire structure apposed on the stone bank. Material from the filling of the area can be dated to the XIV-XVth centuries.

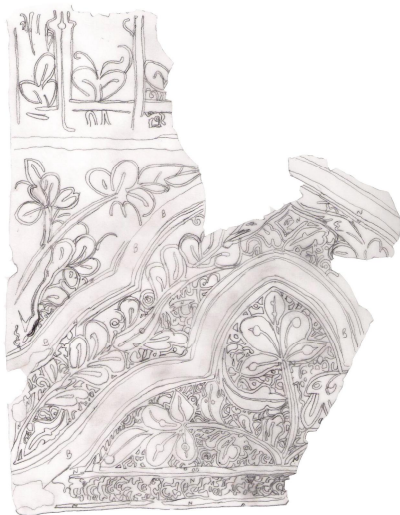
serve that the pebble stone lies on two sequences of filling. The first one is a layer of packed earth which can be used as a filling for the pebble layer, the ceramic dating is about the XIVth century. This first filling ends with a light layer of rootlet, which attest a short abandonment of the area before the levelling for the pebble. The second one is a large filling, very heterogeneous, content gravels, pebble and ceramic material. We can underline the presence of a lot of fragments of tiles belonging to the green decoration crosses of the mosque, and Kashan tiles style already known and new ones which deserve a more researches (fig. B12_S14/3 Kashan tiles from the early layer of S14).

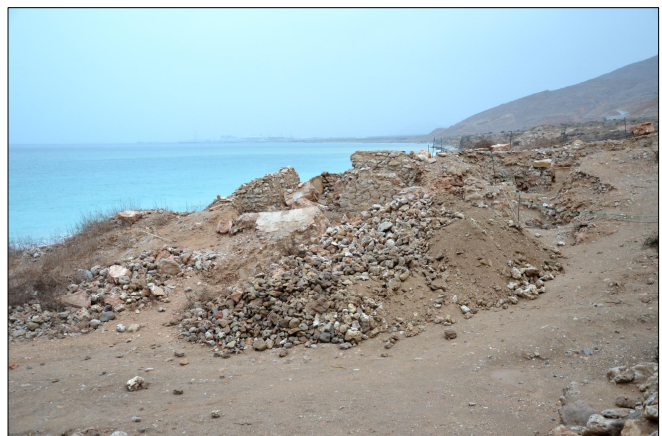
The area of the northern courtyard was covered with a huge amount of collapse masonry (B12_S26/1 The north courtyard before 2011 excavations). Following the clearing of S14 (see *supra*) these collapse layers were also removed this year against the north wing and in the area of the minaret (see *infra* S6), to obtain new information about the general set up of that part of the complex. If most of the work was done with the bulldozer, a manual sounding was also dug at the bottom of a wall discovered along the north wing after this preliminary clearing (S28).

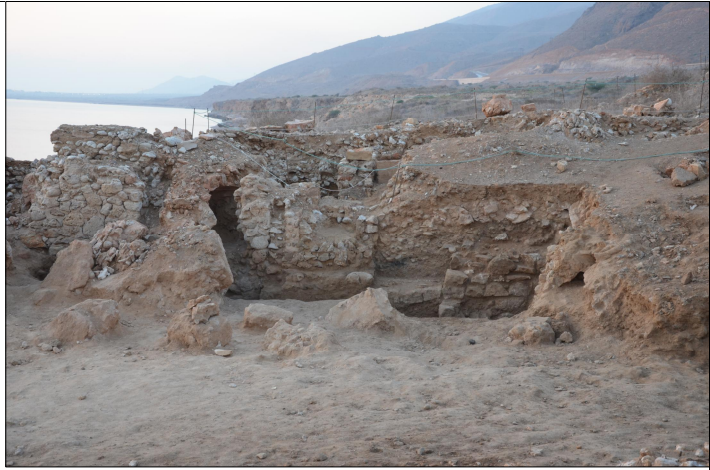
The general profile of this area is very sloppy toward the north. Its upper part is covered by a collapse layer including a white and slightly pink soft sediment made off decomposed mortar and plaster (Uf 1314). Among it are many coral blocs as well as big pieces of masonry. Some of them are still lying on the surface (fig. B12_S28/2 The area of S28 after excavations), some were destroyed and another one, now

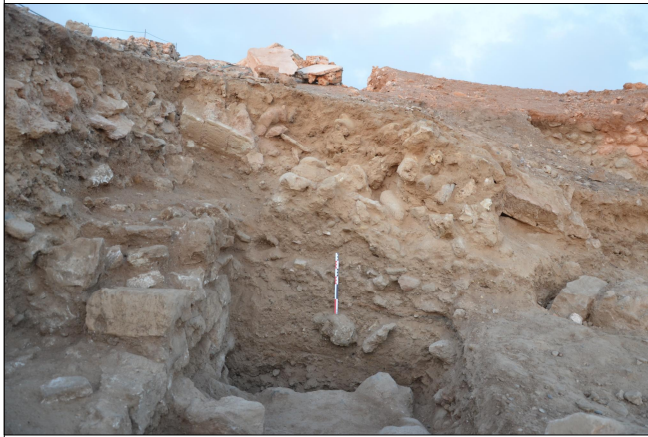
broken in two pieces, is kept in the western section (fig. B12_S28/3 Elements of the superstructure preserved in the west section of S28; fig. B12_S28/4 West section of S28). The profile of that later is rather complex. It is a half-column in the upper part,

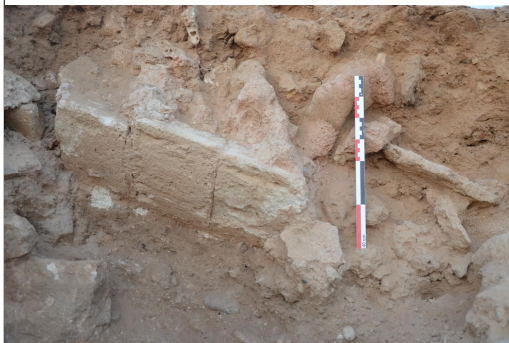
which is made of small ash-lars of sandstone (fig. B12_S28/5 Fragment of a column in the west section of S28). Further north, the second piece is polygonal, also using some cut stones, and this part is adorned

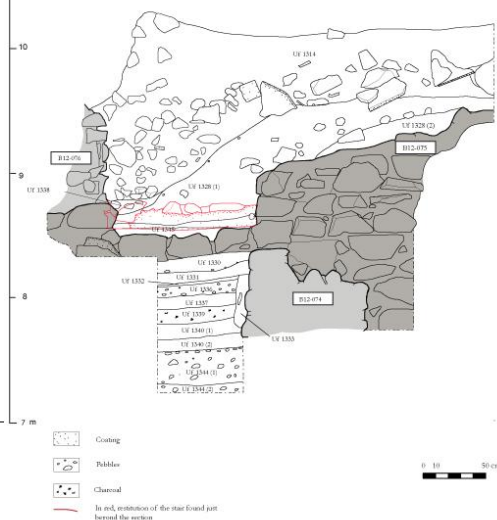
QALHÁT 2011
THE GREAT MOSQUE (B 12)
Sounding 6 and 28:
Northern and western sections

In the southern part, Uf 1314 is locally lying on a layer made of pebbles covered by a black and sandy layer which seem to have been a fireplace (Uf 1338). This is very localized (fig. B12_S28/6 South section of S28). In fact, in most of that area, Uf 1314 is covering a layer of brown earth including a lot of pebbles and also some stones or coral blocs (Uf 1328). This layer has the same sloppy pro-

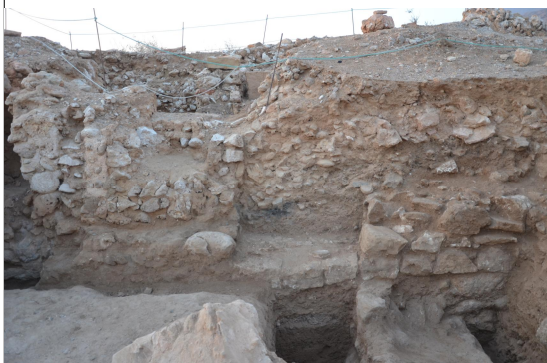
In the south, Uf 1328 is directly lying on walls or related structure. For instance, it's the case for the wall B12-075 as well as for the threshold associated with it (**fig. B12_S28/7 Wall B12-075 and its threshold**). This wall is running east-west, but it has not the same alignment as neither wall B12-058 nor wall B12-037, both discovered last year further west. It is at least 90 cm large, and about five meters of its length has been unearthed. This wall is mostly made of stones, among which are many white sandstones blocs : this kind of construction was not previously observed in

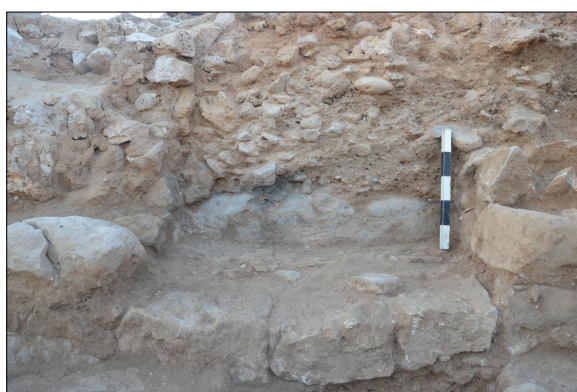
the mosque area. The threshold related to that wall belong to an entrance which is 1m 10 wide (the fireplace Uf 1338 above-mentioned is located in that area) . It is provided with at least one step covered with a grey coating, which is more or less 25 cm high (**fig. B12_S26/8 The threshold in wall B12-075**). The upper part of that wall is not regular: part of it has of course disappeared because of the collapse. In the west, this wall reaches the height of ca. 9m50, whereas in the east, after the threshold, it is not preserved beyond ca. 8m60. In fact, in that area this wall is topped by a second

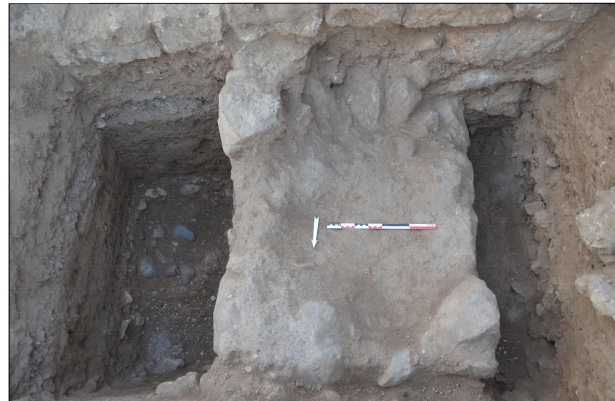
Uf 1352 is covering a wall, B12-074, which is about one meter large and run toward the north (**fig. B12_S28/10 Perpendicular wall B12-074**). The highest part preserved is at *ca.* 8m 35. This wall is linked with B12-075, but part of its upper stones have been dismantled: there's now a hole were these stones were originally joining B12-075. On the east, two layers are now leaning on the face of B12-074, Uf 1330 and 1331. Both of them are made of brown sediment including small pebbles, which are much more numerous in the first one. The threshold of B12-075 seems to rest on B12-075. On the west, the face of wall B12-074 is completely covered by a very hard layer made of brown clay including bones, glass and quite many ceramic sherds (Uf 1329), which reach the height of *ca.* 8m 50. A posthole, about 10 cm large and 50cm deep, has been dug in that layer (Uf 1354). Just under Uf 1329, Uf 1341 present the same kind of sediment, but mixed with many stones of a very irregular shape. Some of them are yellow, other red or almost purple, and all are including gypsum.

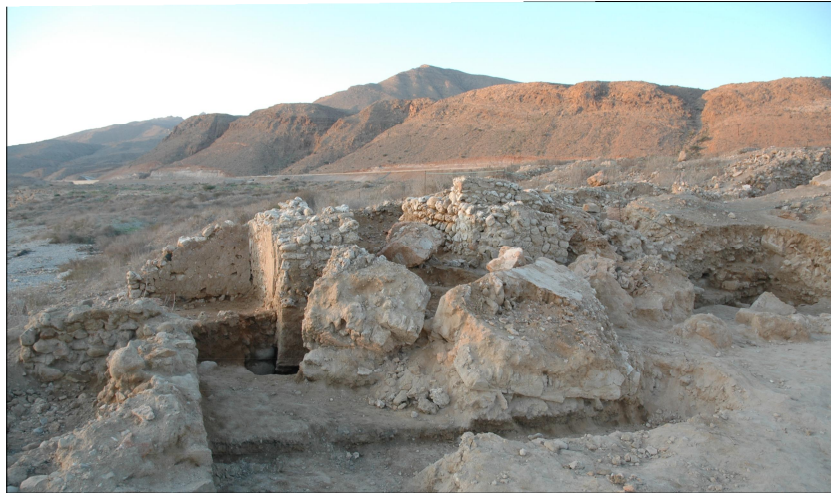
of collapsed masonry which were left in situ, lying on the floor (fig. B12_S6/1). These clearings confirmed that the minaret had a square shape of about 4.5 x 4.5 m and that it was in the line of the northern wing, at the north-east angle of the basement of the mosque.

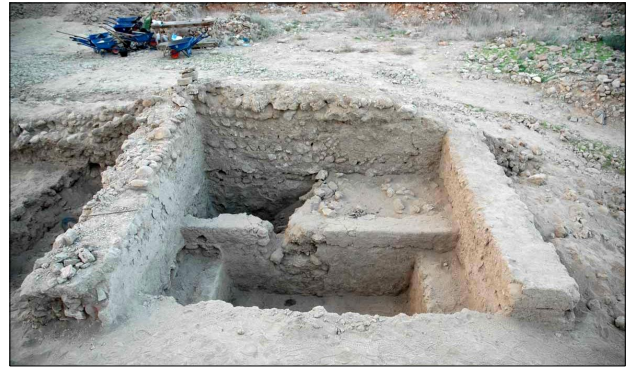
At the foot of the wall of the possible cistern, 1.40m far from the west wall of the entrance, we discovered a post-hole 15cm deep and 20cm in diameter. If the structure was really a cistern, this post-hole could have been used as part of a system to take water (fig. **B94/4 The entrance of the north house, with the possible cistern**).

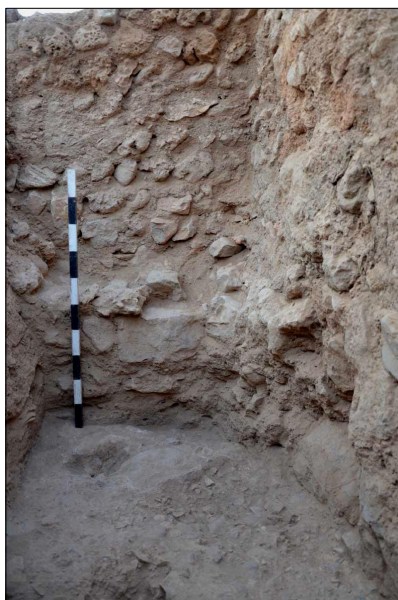
(north), B94-010 and B94-008 on either side of the western entrance leading to room A, and, finally, B94-013 (south) (fig. **B94/6 East section of soundings B94D/1 and B94C**).

*Stratigraphy (see supra **fig. B94-6**)*

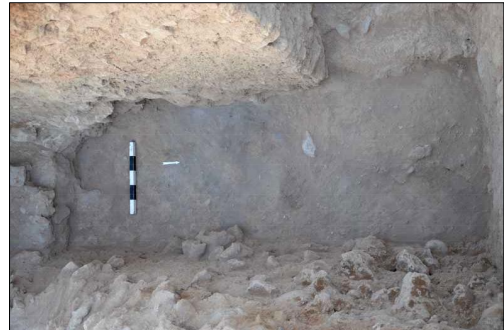
Structure B94-041). It seem to include a former structure located in that corner of room C, with stones embedded in a white mortar (it appear at the same height as B94-041). Under Uf 1439, Uf 1468 is a localized layer of very hard clay including small gravels and few ceramic sherds. It has a north-south slope. This layer is divided in two parts in the section. It has been partly dug as Uf 1467, and its original development toward the west is not known. Below, Uf 1461 is mixing stones, coral blocs and few pieces of mortar in an heterogeneous brown-grey sediment. Its southern part is much more sandy, but it could be associated with the same layer. Located under Uf 1461 and Uf 1468, Uf 1485 as the profile of small heap leaning on the above-mentioned “bench”. It is very sloppy toward the north. This layer is made of compact clay and has been observed only in the section (it was dug as Uf 1467) : its primary extension remain unknown. Under Uf 1485 and Uf 1461, there is a very heterogeneous layer mixing a brownish sandy part (near the access to room A) with others much more clayish. It is about five to ten centimeter thick (Uf 1474, **fig. B94/8 Sounding B94D/2**). In the southern part, the sediment is much more sandy (Uf 1469).

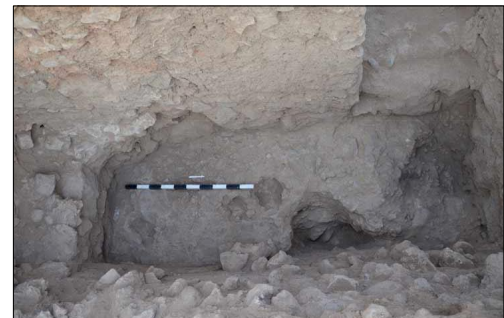
Below, at ca. 29m 70, Uf 1477 is a beaten earth floor, very soft, made of an homogeneous brown earth including some sherds – part of them leaning on the surface –, as well as pieces of an iron chain. This layer is leaning on all the wall surrounding the sounding - including the threshold of the access leading to room A – but it is going under the “bench” B94-041. Under that floor, Uf 1479 is much more heterogeneous. It is made of a brown earth including pockets of a grey or orange clayish mortar/coating in the northern part and it is leaning on the walls. In the southern half of the sounding, Uf 1479 is directly topping the bedrock. But in the other part, there is a thin and fatty layer of dark brown or grey sediment which is thicker in the west (Uf 1481, ca. 2/4cm), which is passing under wall B94-011. It is topping the bedrock except in the middle of the sounding. Here, there are some depressions in that bedrock which are filled by small gravels – not that many – and a brownish earth (**fig. B94/9 Sounding B94D/1 bedrock**). This backfill contain some pottery sherds.

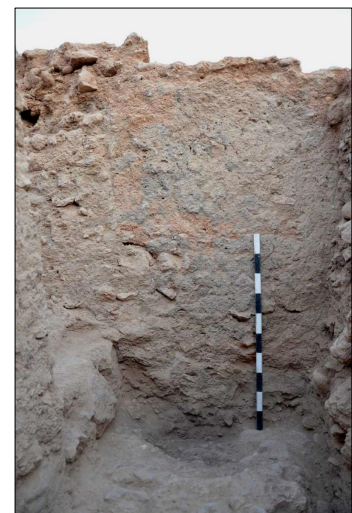
Thanks to that deep sounding, it is possible to describe more accurately some of the walls. B94-010 and B94-011 have been briefly describe above (*see sounding C/1*). The former one finished in that area in the place of the entrance to room A were a threshold made of big stones is still in place (**fig. B94/10 Threshold in wall B94-010**). At the bottom, the wall is wider, with some kind of thickening toward the east. The masonry is made of medium sized stones and small coral blocs bonded with a light brown mortar. The wall B94-011 is leaning on both this wall and its thickening. The southern face is completely covered by a coating made of clay mixed with ashes : it is partly orange, partly grey. The wall B94-008 is rather similar to wall B94-010 : big stones in the lower part, medium sized ones and coral blocs in the upper one. At the bottom, there is a huge and irregular stone that is probably an unmoved part of the bedrock included in the masonry.

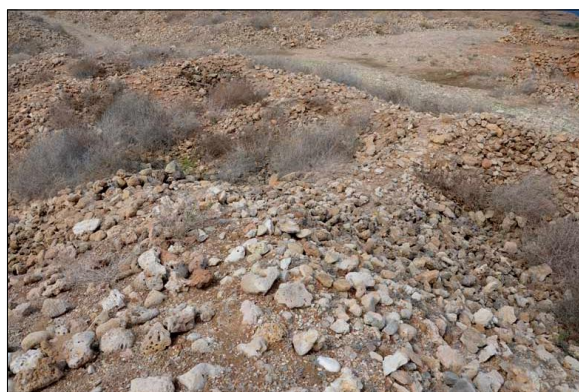
In the north-west corner of the supposed courtyard (*room D*), the relief was quite hilly (**fig. B94-11**). A quick surface cleaning (Uf 1400) has revealed that a room was located here. A deep sounding was open in its western part while the all area was cleaned to understand the global set up of that part of the building.

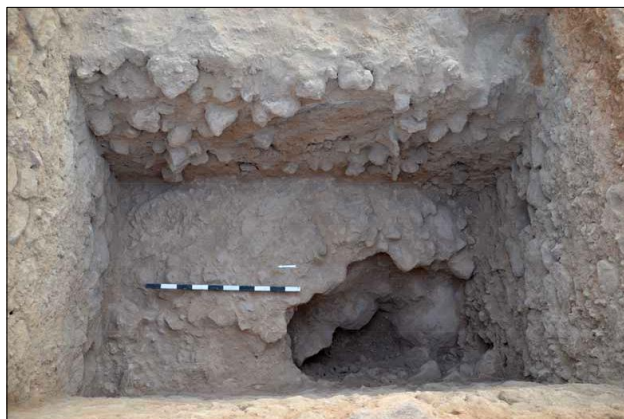
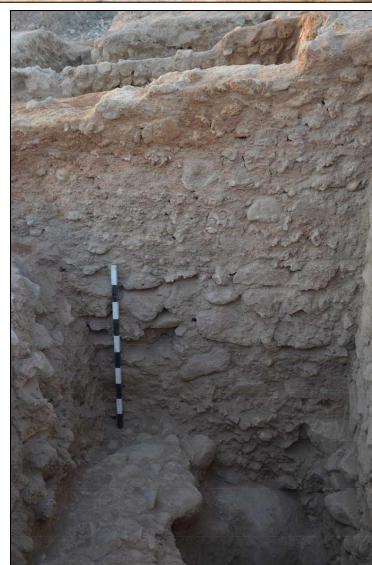
Below them, Uf 1426 is an homogeneous floor made of beaten earth. It is made of a very soft and light brown sediment including few small pebbles. Some sherds cover its surface, as well as part of undefined iron piece. In the northern part of the sounding, this floor is directly covering the bedrock (at ca. 29 m 60 maximum). Nonetheless, further south, this one is characterized by the presence of a deep – but natural – depression (**fig. B94/12 The bedrock in room B94D**). In its upper part, it is filled by a layer including many small pebbles/gravel and few medium sized stones. There are also a lot of pottery sherds as well as some coins and half part of a cornelian (?) ring. All of them are mixed with a brown and soft earth. Just above, Uf 1444 also contain a lot of ceramic associated with small fragments of limestone mixed with a brown and compact earth. Both wall 010 and wall 011 seem to be built directly above this backfill (**fig. B94/13 Corner of walls B94-10 and 11**). Apart from the sounding, the Uf 1407/1413 was also removed from all the area of room C in the aim to see all its wall and the entrance, which is located in the south (**fig. 36**). The upper part of the eastern wall has been completely cleaned (B94-012).

The construction seems to be rather homogeneous, even if only the walls B94-003 et B94-010 are clearly linked (**fig. 37**). B94-012 is leaning on B94-003, whereas B 94-011 is leaning on B94-010 (its relation with B94-012 is yet not clear). These wall were partly built directly above the bedrock, partly upon a backfill which was certainly brought here just before the construction (**fig. 34 and 35**). According to the ceramic, this backfill seem to date from the first half of the fourteenth century. Above this filled depression, the wall B94-010 is mostly made of big stones set in irregular rows. Medium sized stones are still used for the middle part of this wall, whereas the upper one is almost only made of small coral blocs bonded in an orange mortar. This wall is about 60 cm large and more than 2m of its height is preserved. Wall B12-011 is also partly built above the backfill. It is only about 50 cm large, and reach the same level as the former one. Few big stones are used in the lower part, coral blocs in the upper one. It is provided by an entrance 90 cm wide. The northern wall (B94-003), almost 1m large, is all made of big stones and the lower part and coral blocs for the upper one. Just part of the eastern wall (B94-012) was unearthed. It is about 85cm thick. All these walls circumscribe a room measuring approximately 12 m² (2m 70 x 4m 50).

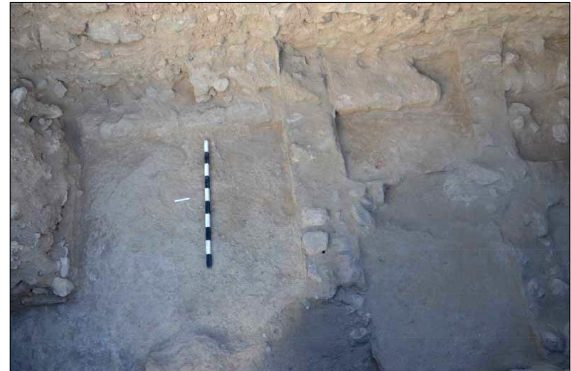
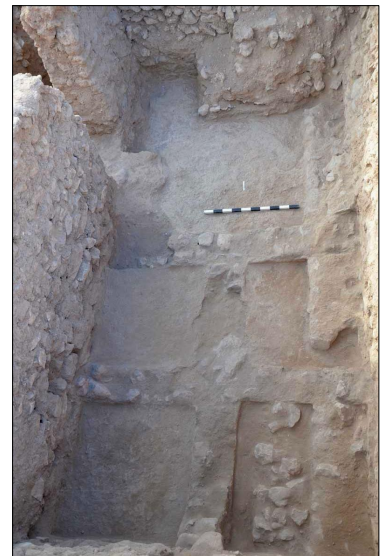
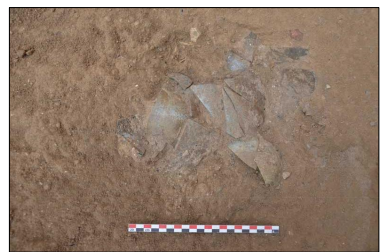
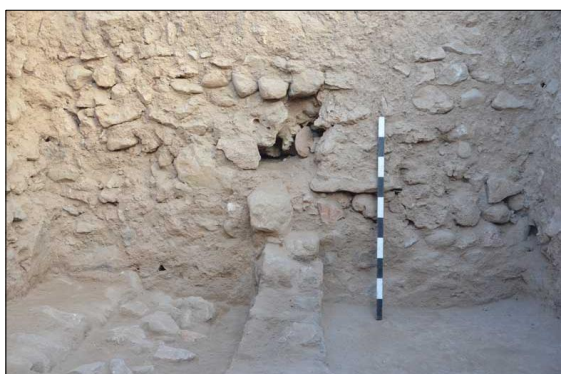
The upper part is covered by a layer mixing stones, coral blocs, gravel and earth which partly covered the top of the walls (Uf 1400). Just beyond, Uf 1409 is made of a soft earth including many stones and coral blocs as well as pieces of mortar. The next layer, Uf 1411, contain few stones/coral blocs, in earthy sediment including small pebbles. It is quite hard. Many pieces of what seem to be flat vegetal and very light remains – maybe palm bark – are included in it. This layer is quite thick (ca. 80 cm). Just under, there is a layer mostly consisting of stones, which in fact was mostly observed in the section. It has been considered as part of Uf 1414, even if this one is a layer mostly made of a very soft earth including sand and many very little white inclusions. This is probably a beaten earth floor. In the south-east corner, between Uf 1411 and 1414, there is layer containing many ashes and pieces of ceramic (Uf 1488). In that same area, Uf 1411 is topping a kind of heap made of very hard orange clay (Uf 1497) leaning on the threshold separating this room from the courtyard. This heap is covered by a layer of soft earth mixed with sand which is the same as Uf 1414. Under the layer of stones, there is a low bench abutting the western wall (B94-029, fig. **B94/14**). Below the heap and the supposed floor, the next layer is made of a soft and dark brown earth (Uf 1419). It covered a brown-grey cement floor (Uf 1428). During the exploration of the northern part of the sounding, some specific structures linked to that floor were discovered (B94-034). They consist of four “basins” separated by largely destroyed edges (fig. **B94/15 The basins**). All of them were covered by the above-mentioned Uf 1419. We have decided to create separated Uf number for the northernmost basins, hoping that their filling might help to understand their function. Uf 1493 is located in the north-east basin. There was a big piece of a glass bottle crashed in that layer, just above an half-frog (fig. **B94-16 Glass bottle**). Uf 1496 fill the western basin. It includes many stones.

All these structure are covered by a strong grey cement which, originally, go back up the edges. Some coating is still visible up to ca 50 up the floor level at the bottom of wall B94-007. The central edge is linked with wall B12-003 and, according to what remain, it was probably about 60 cm high originally (fig. **B94-17 Wall B94-007**). This edge is ca. 30 cm

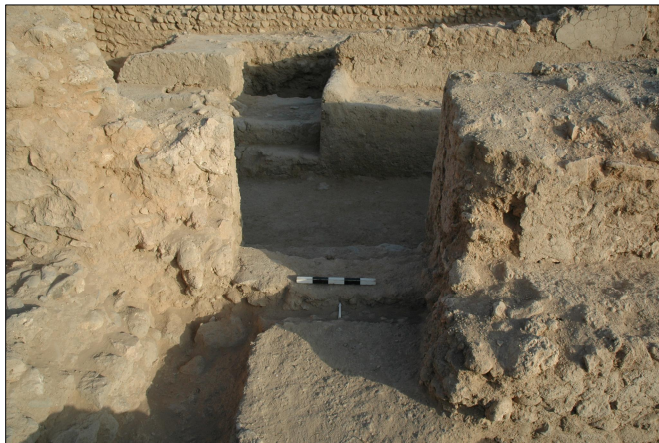
From the outside (**fig. B94-19 Door and structure 045, 046 (doorstep) and 047 from the outside**), the entrance area showed two structures, one on each side of the door. To the east, a 70 cm high wall seat (structure 047) lay along wall 048, starting from the doorstep. Its eastern extremity is unknown but a stone collapse had damaged the top of it, about 3m east of the door. This wall seat was built against wall 048 and was totally covered with hard gray plaster.

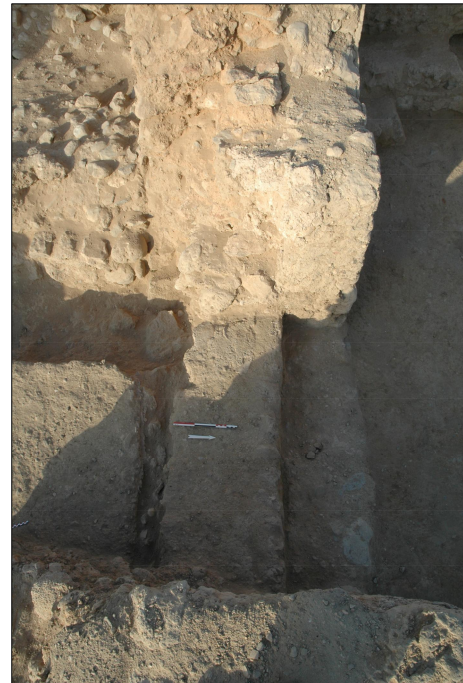
To the exterior, the last street level had been found a few centimeters below the upper step, that is to say that people had to get down to enter the B94 house. But the upper step and the street level were not found in connection: a 15 cm gap had been observed together with very faded wood remains. We presume thus that a wooden beam was set up between the two walls, parallel to the steps. Moreover, a post also seems to have been erected on the south facing side of wall 048, just before the door opening. This speaks in some kind of wooden gate or any closing system's favour (**fig. B94-18 Structure 046 from top: (from south to north) street level, wooden beam traces, steps and entrance hall**).

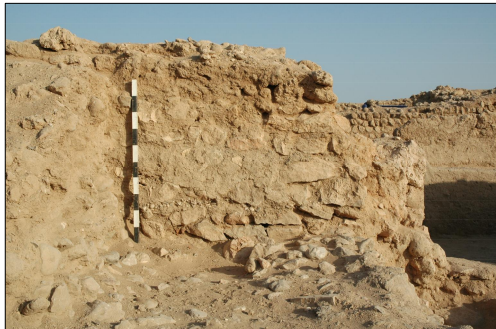
On the other side of the door, wall 007 was preceded by a stone structure (B94-045) that is hardly understandable and would deserve further excavations. It consists in two rows of medium to

big sized stones running north-south along ca. 1m. It has been only uncovered on its east side, that showed remains of a rather soft gray-ochre coating with small gravels inclusions. Those stones lay on Uf 1525 already mentioned and were apparently leaning against wall 007, as far as we could observe it. Above the two lower rows came 3 to 4 more rows, made of smaller nodules (B94/21-22).

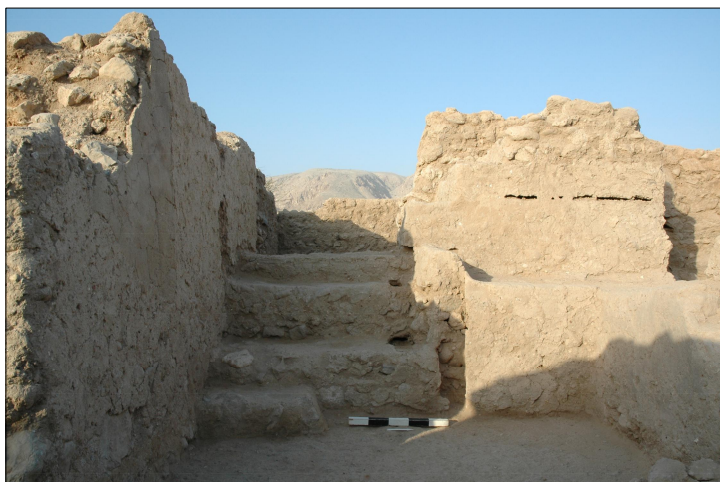
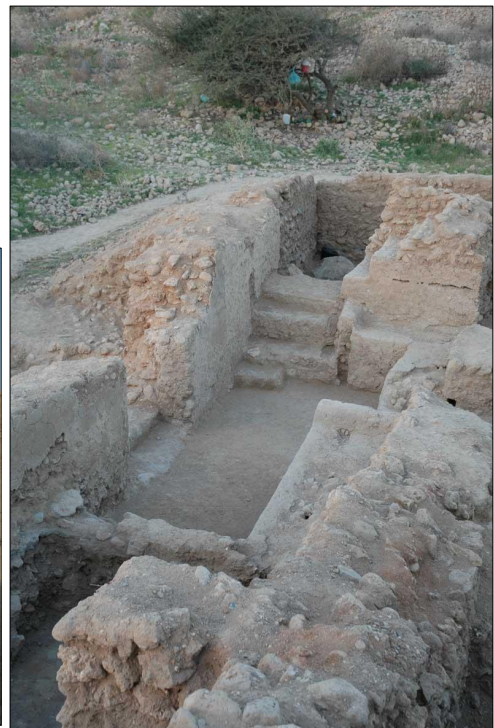
Once the gate of the southern house passed, we arrive in an entrance room (B94L/H) which was furnished with several benches of different width and height (fig. B94/23-24 The entrance to the house and the staircase). To the left hand side (west) was situated a staircase leading to the first floor, with an intermediary platform giving access to the door of room B94B (see *infra*). The walls, floor, benches and stairs were all covered with a strong plaster. To the right (east) hand side, a door was leading to a room (B94Q which was not excavated. And in front of the entrance was an other door leading to what seems to be the courtyard of the house, B94I (see *infra*)

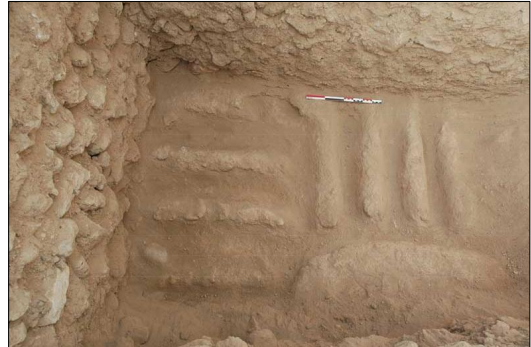
The northern back part of the space was occupied by a madbasa, a typical Omani structure to produce date honey (dibs) (**fig B94-25**). The shape seems rather complicated but only a small part of the structure was cleared and its exact dimensions and layout are unknown. It is therefore difficult to know if this madbasa was for domestic consumption only or if it was also for selling. A layer of squatter reoccupation was found on top of this structure, with ashes, charcoal, bones, shells, and ceramics.
