**The Qalhât Project - Preliminary report on the fourth
season of excavations of the French mission
(25/10-12/12/2011)**

The Qalhât Project

Preliminary report on the fourth season of excavations
of the French mission
(25/10 -12/12/2011)

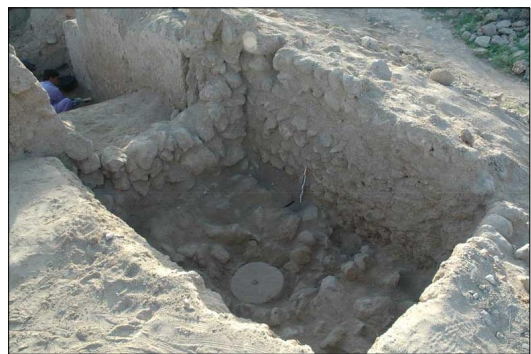
Excavations in the southern front side of the room, in front of the door, brought interesting information about the chronology of the house. As a matter of fact, it appeared that the wall between the entrance and the room was based on an earlier wall built in large coral blocs, which was associated with a strong mortar floor and several thin layers of occupation. This is one of the rare clues that this area was occupied before house B94. The walls of the house itself were built above the previous wall and occupation layers. They are associated with a level with many stones, including two complete grinding stones (**fig. B94/26 occupation of room B94B in the second phase**), which is at the same altitude than the madbasa in the opposite part of the room.

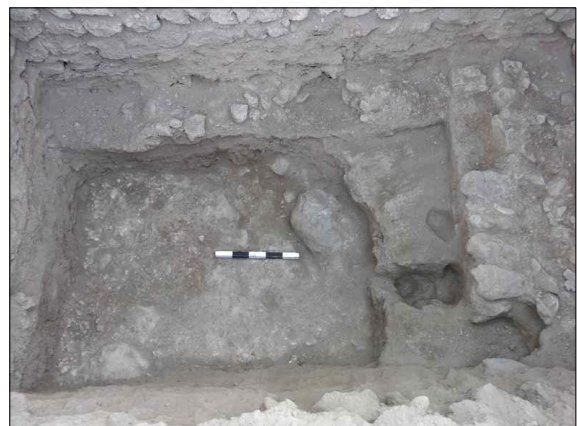
The sounding 1 made in the courtyard is situated in its eastern extremity, against the wall B94-036. It measures 1,70m of width on 4,50m of length. Two phases of occupation were registered.

The earlier level is made of an occupation layer on the bedrock (UF 1445) made of a rather fine brown earth. It was observed that this layer goes under the north wall of the room I (B94-013). This last one thus takes place after this layer of occupation.

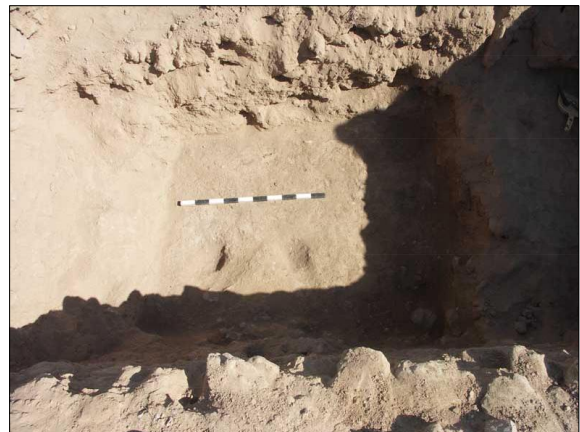
The sounding 2/1 is situated on the in the western extremity of the courtyard, along the wall B94-008. This sounding has for dimensions 1,80m of width and 2,80m of length. Two phases were also determined in this place.

The first phase is composed of a posthole only. Its diameter is 0,20m and its depth 0,15m. It probably belongs to a structure situated beyond the sounding. The phase 2 corresponds to the construction and occupation of the room I (B94-008, 013, 026 and 036). The level of the floor associated to this phase 2 is in hard-packed surface. Its altitude is at 29.40 and its thickness is of 10cm. Two post holes are associated to it. They are situated in the north half of the sounding, distant one of the other of 0,30m and making a north / south directed line. Their diameter is of 20cm and 15cm, their depth is of 15cm. Thick under the layer of collapse.

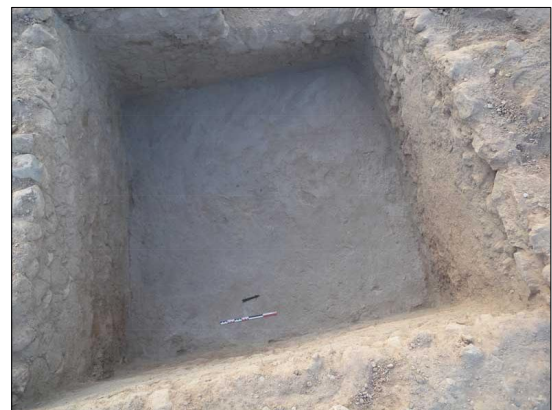
During the excavation of J, a section had been done over the external wall of the room, down to the bedrock to have a stratigraphical sequence of the street connection with the house. This external sounding allows us to say that the street level consists more or less of the bedrock. We can distinguish a small occupation earthy layer on the top of it, containing small pebbles, charcoal and ceramic sherds (UF1448) [see picture: phase 1]. Above it there is three fillings corresponding to the abandonment of the house [phase2], the collapse of the building [phase4] and to the abandonment of the site [phase5].

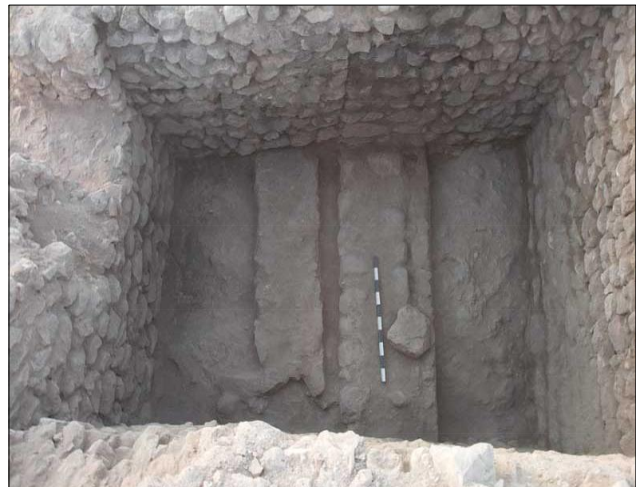
Wall B94-039 and B94-040 are parallel and spaced out of 0,20m. They are both directly built on the bedrock and their arase is at a height of 28.96. A backfill (UF 1492) was then settled to level the ground. It consists of very dry and compact orange-coloured, clayey sediment mixed with small pebbles. This backfill was observed in the East and on the West of both walls. It would seem that it also served as a floor because the layer (UF 1489) is above directly put at a height of 28,87m. It consists of one earth furnishes and sooty on a thickness of 0,05m. This layer seems to correspond to the occupation of the phase 1. It was not observed east of the wall B94-040. The inside of the building of the phase 1 would be on the West of the wall B94-039. Of more this last one is coated on its western facing.

The construction line observed in the masonry of the south wall of phase 2 allows to say that the wall B94-039 had a rise of at least 2m while there is no element to estimate the minimal rise of the wall B94-040. A hardened level recovered the wall B94-040 what implies the abandonment of this masonry before the construction of the room M. The walls, the backfill and the layer of occupation lay under the foundations of the walls of the room M which proves their anteriority (cf figure).

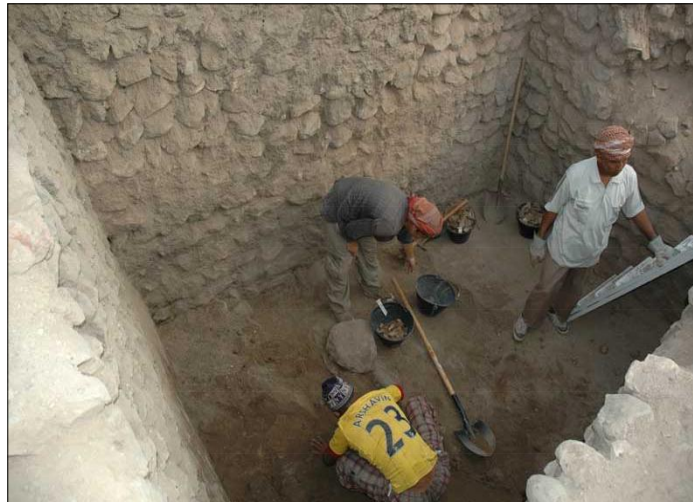
The wall B94-022 presents an abnormality in its construction. As a matter of fact, a blow of sabre was observed on all the height of the elevation, at approximately 2m of distance of the western wall and 1,60m of the east wall. This abnormality is also visible on the plan, as it appears clearly that the wall B94-022 widens at the level of this line in the masonry.

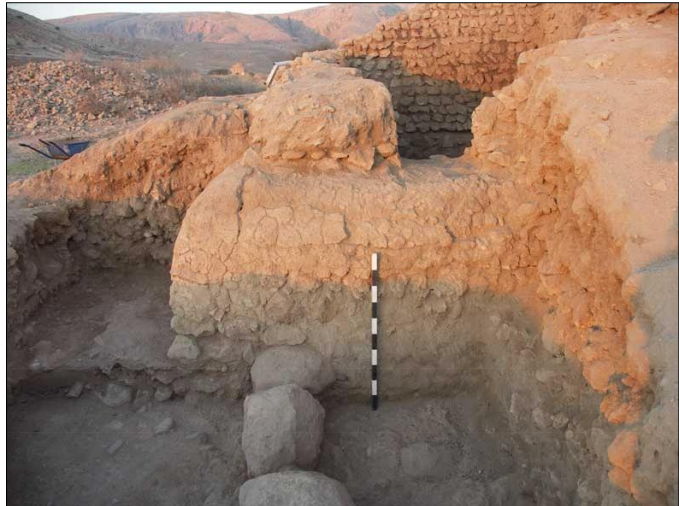
The southeast outside angle of the house presents a base (cf photo), it is built in an arc in the summit then in vertical rise for them 0,80m of the base. The sounding made in this place allowed of observed that the construction was put on the the layer of leveling (UF 1436), after a level of circulation, a caillouti of small pebbles (UF 1435) was installed. Walls B94-022 and B94-018 are built in the same time that this basement. The ground level (UF 1455) have an appreciably same level (29,06m) that the outside ground (UF 1435). The height of the base is of 1,20m between the outside level of circulation and the base of the wall B94-022. It is to note that the base is built on a line of three very big limestone blocs (UF 1421) directed est/west. It is possible that this line corresponds to an outside arrangement in connection with the phase 1 of the house.

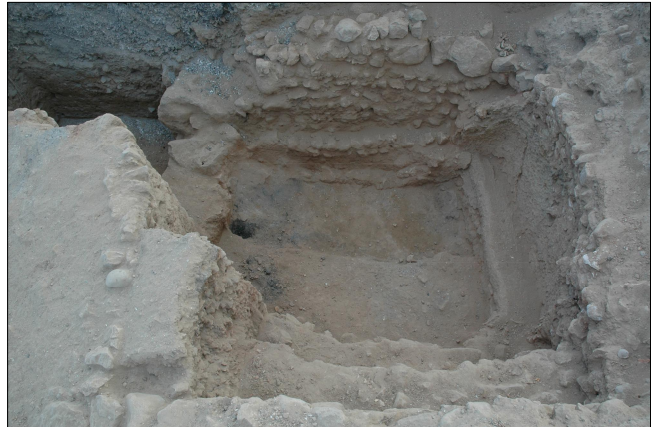
The interior size of the second kiln measures 205 x 135 cm and at floor level the 2:nd kiln gives the impression of being square (fig. B41/3 Kiln B41G). If this is the case at roof level is unfortunately not to be known. The exterior of this kiln measures 300 x 300 cm approximately.

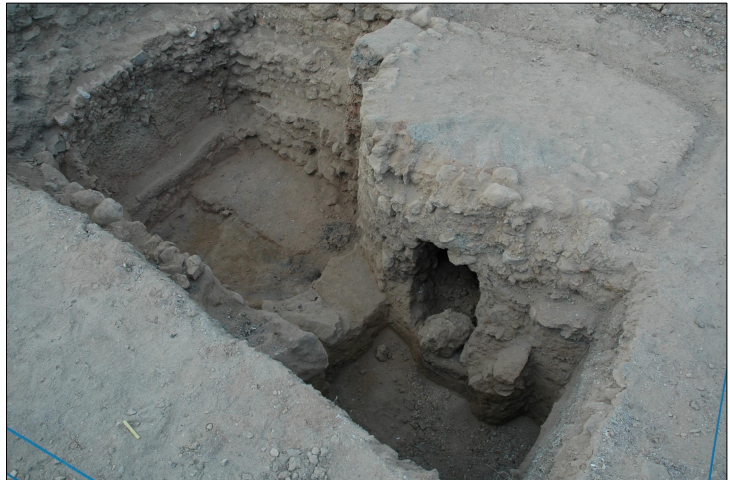
The interior of the kiln at door level is 126 x 128 cm. The exterior of this kiln measures 190 x 210 cm and it rises today 150 high, were the bottom stones are large (20 x 25) and the upper stones minor (12 x 12) (fig. B41/5 Kiln B41J built in the ruins of B41G). The entrance measures 50 cm in depths and the stones here measure on an average of 12 x 9 cm in size. Beneath the entrance there are two layers of burnt ash and clay (black and red). As we find these layers under the contemporary door, we know the kiln was closed at the time of firing.

The interior of this kiln is completely covered with light green slag on all walls around and the roof alike. Actually it has three layers of slag. The roof construction of this 3:rd kiln is by 15 ventilations holes (B41/6 Ventilation hole in B41J) varying in size, but no big hole is found in the middle, as the first kiln from 2008 has. This third kiln is the combustion chamber of a furnace. The roof of the combustion chamber is accordingly the floor were the ceramic pot would have been piled and here we have a wall thickness of 24 cm. This wall is coated in yellow clay, which is the colour the local earth receives by heating.

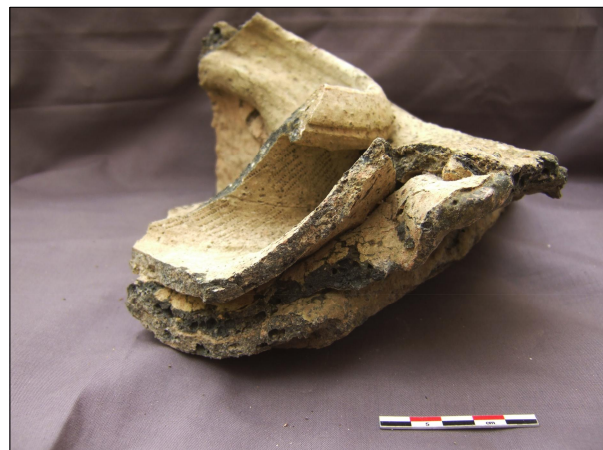
Aside from ceramics we have a lot of waster found in the collapsed layers while excavating kiln B41G. Wasters are ceramic objects which were overheated in their burning process, making them collapse and sometimes fuse with other matters (**fig.B41/7 Waster of a pseudo-textile jar**). They are light green in colour, somewhat less bright than the slag. This waster alike the slag in the collapse layers, must have come from another kiln, more precisely from kiln B41J found in this area. Hence the second was used as a trash area for the third. This came to our knowledge when we realized the third kiln was later than the second.

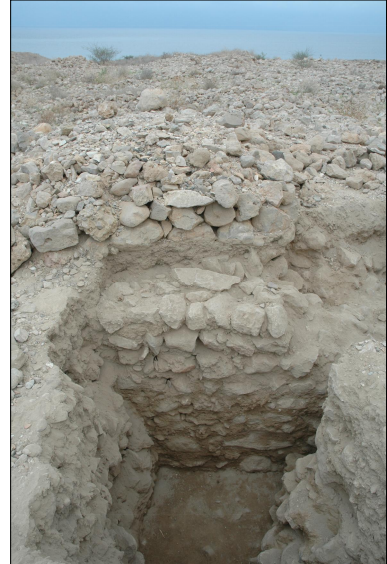
S3: West of the grave, trench with wall running north, although this north wall could not be located in the northern trench, S2, as would be expected (**B41/9 Sounding B101_S3**). The wall segment that is located stands with 8 rows of stones and two stones wide. The wall is found in a level lower than the grave, and it does not run parallel to the gable of the grave, hence we can assume the wall has no connection to the grave. Instead, we know that this wall does not stand upon the bedrock. There is a layer of pebbles in between the lowest row of stones in the wall and the bedrock. Mortar is stuck between the stones, a mortar of reddish-brown colour with white burnt lime inclusion.
