The Qalhât Project - Preliminary report on the fourth season of excavations of the French mission (25/10-12/12/2011)

The Qalhât Project

Preliminary report on the fourth season of excavations
of the French mission
(25/10 -12/12/2011)

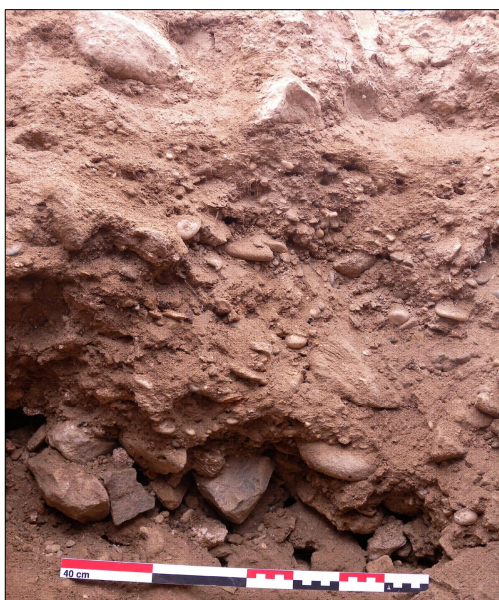
Beneath Uf 1154, 1303 came a hard brownish surface (Uf 1166), without any inclusions, which we first thought was a surface that had been exposed out in the open, and left uncovered. Finally, we came to the conclusion that it was rather some mortar dripping off the wall for it slips from it, curves and gets flat. This surface covered a very compact and homogeneous earthy heap that is hardly understandable, for it does not look like a backfill layer and has more or less no stones or pebbles in it. Quite the opposite but next to it and under Uf 1153 was Uf 1167, exclusively made of medium-sized stones, with no soil in between but gaps, and therefore considered as part of the filling phase (**fig. B12_S21/2 North section of S21N**).

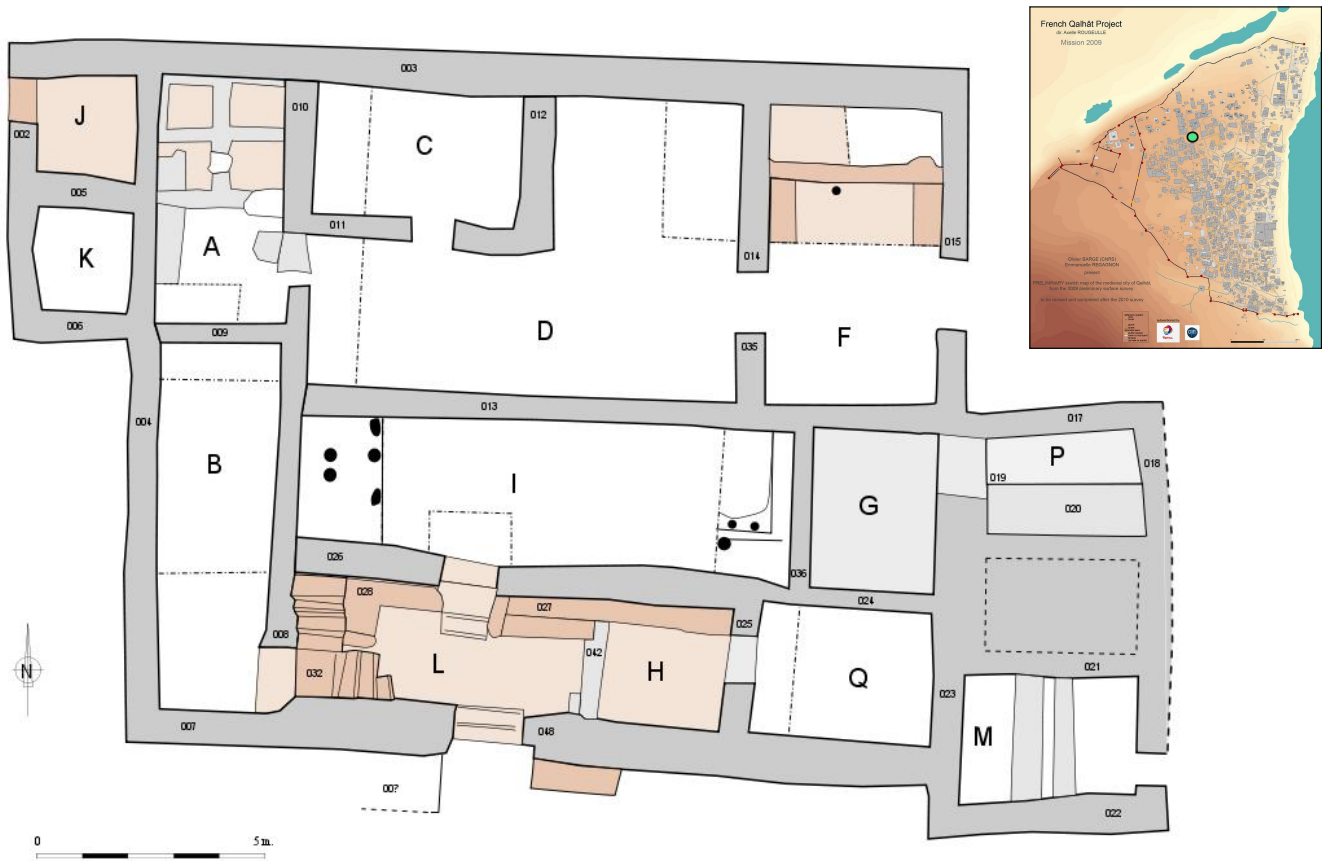
deeper than expected, only some parts of the rooms were completely excavated, but the plan of the house was nearly entirely cleared (fig. B94/3 Plan of B94). The building is in fact composed of two separate units, north and south with no connection visible, at least in its last stage.

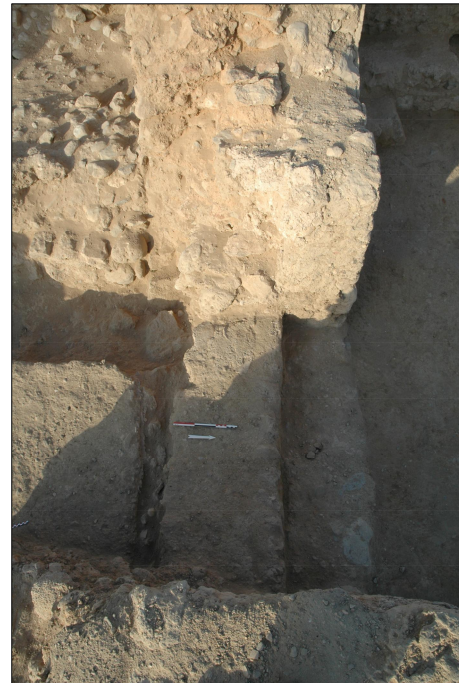
From the outside (fig. B94-19 Door and structure 045, 046 (doorstep) and 047 from the outside), the entrance area showed two structures, one on each side of the door. To the east, a 70 cm high wall seat (structure 047) lay along wall 048, starting from the doorstep. Its eastern extremity is unknown but a stone collapse had damaged the top of it, about 3m east of the door. This wall seat was built against wall 048 and was totally covered with hard gray plaster.
