**Figure 5.** The shipwreck of Phanagoria with the ballast and the location of the finds (drawing P. Poveda, CNRS/CCJ).

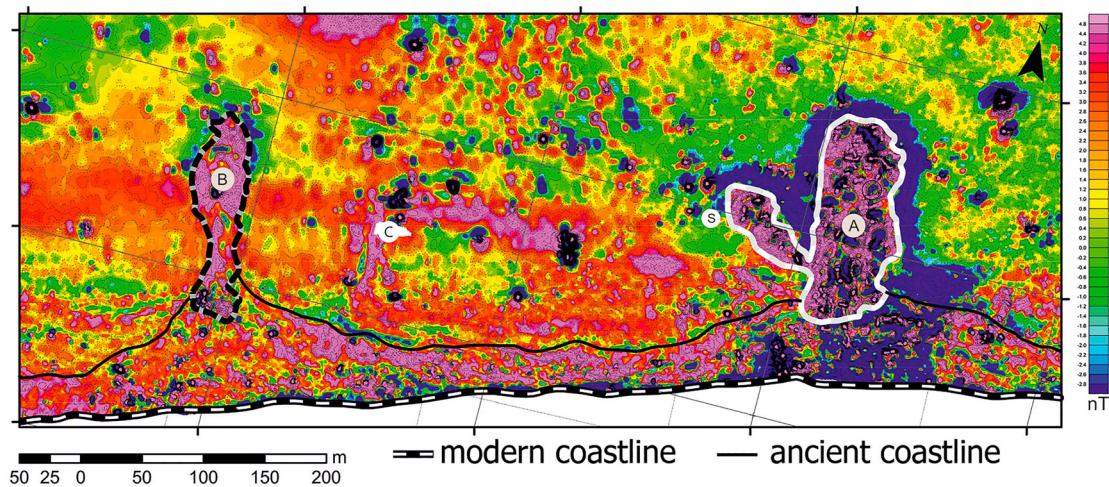
**Figure 2.** Geophysical survey of the submerged zone in front of the ancient city of Phanagoria: A) eastern pier and the adjacent stone embankment (5th–4th c. BCE); B) western pier (dating unknown); C. Roman structure; S. the shipwreck (map A. Luchnikov).

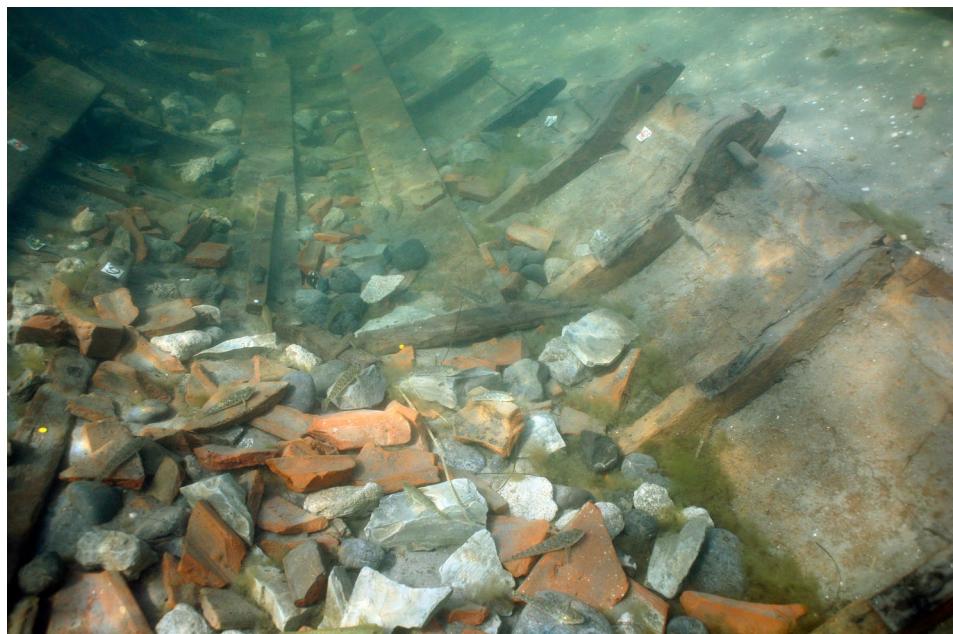
**Figure 3.** View from the NE of the layer of stones and fragments of roof tiles covering the bottom of the ship and the port side (photo S.V. Olkhovskiy, IA RAS).

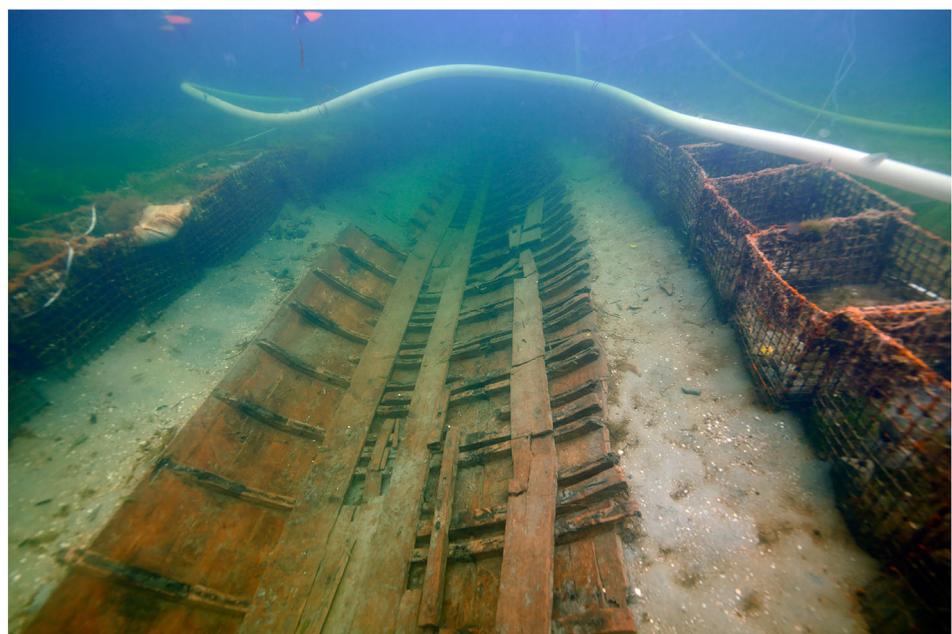
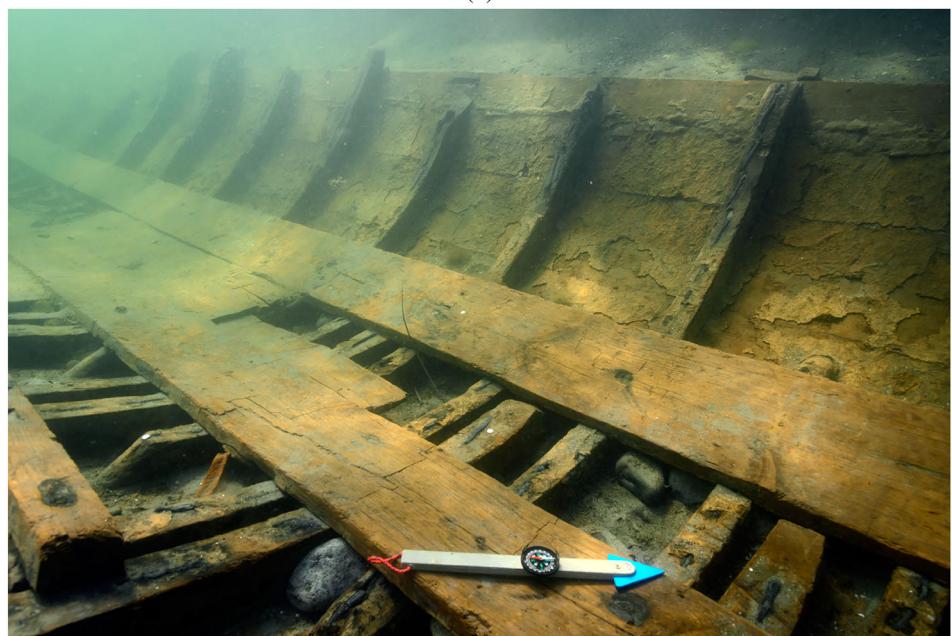
**Figure 6.** The shipwreck without its ballast: a) view from SW; b) detailed view of the port side from the SE (photos S.V. Olkhovskiy, IA RAS).

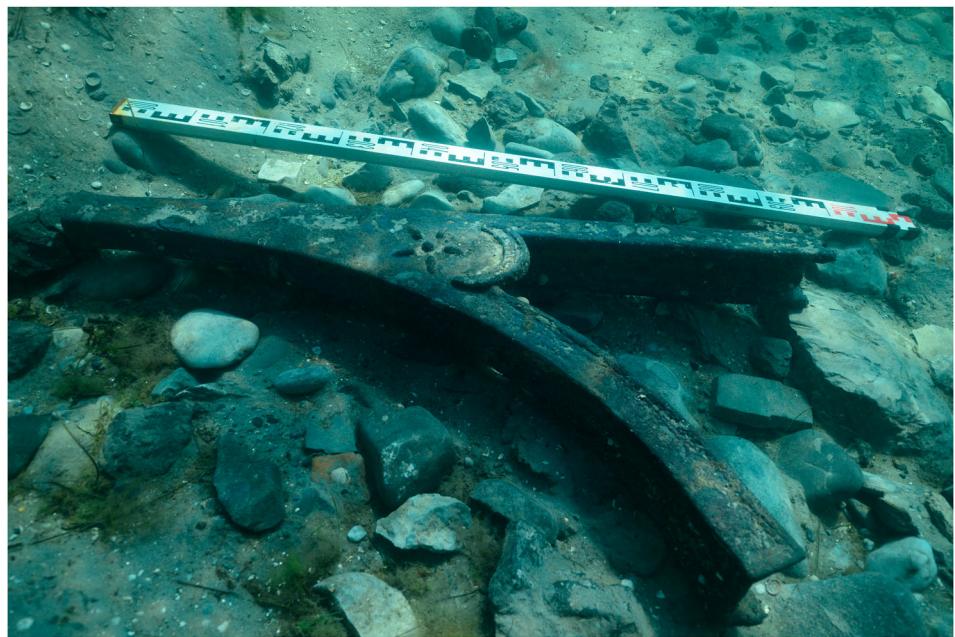
**Figure 7.** The bronze casing of the ship of Phanagoria (photo S.V. Olkhovskiy, IA RAS).

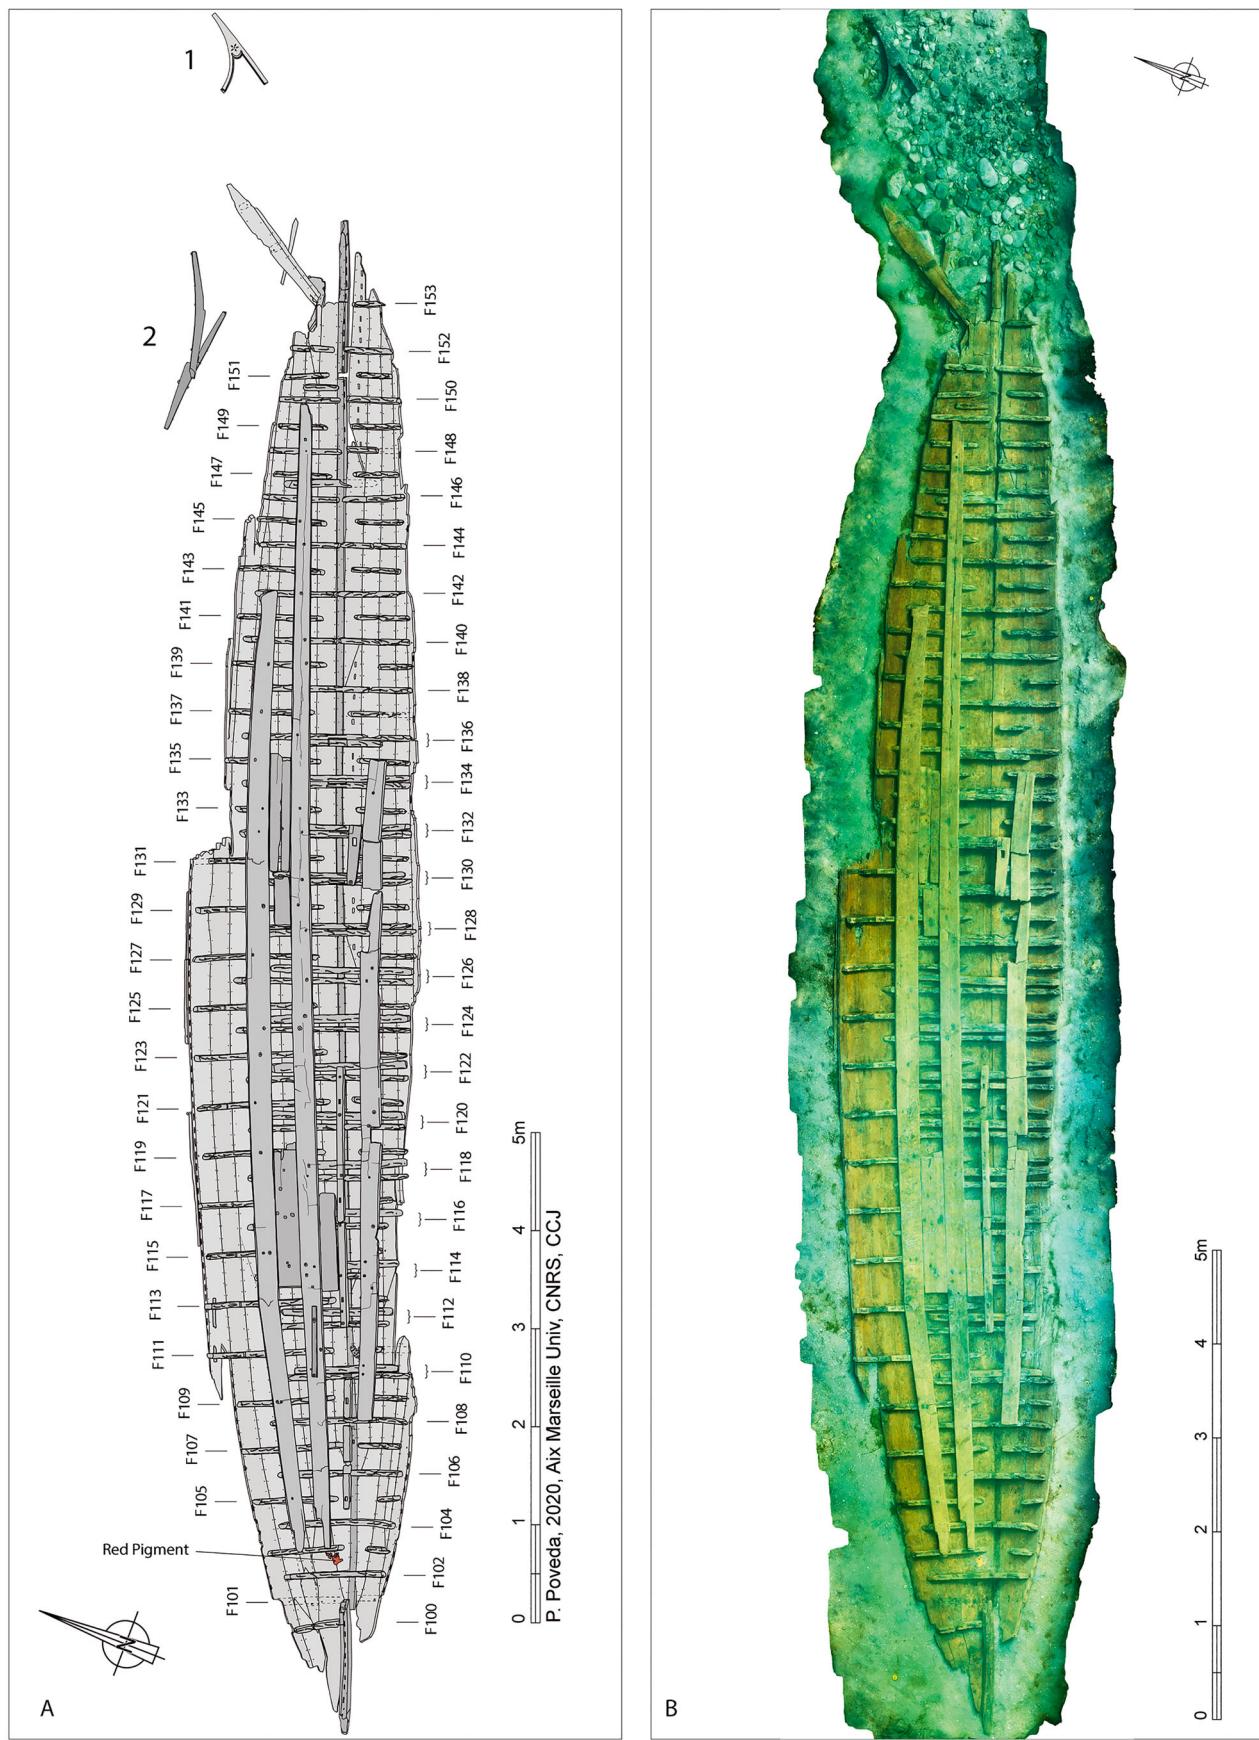
**Figure 10.** a) Plan of the Phanagoria shipwreck: 1) ram; 2) *proembolion* (drawing P. Poveda, CCJ/CNRS); b) the Phanagoria shipwreck after removal of the ballast (orthoimage M. Zhukovsky).

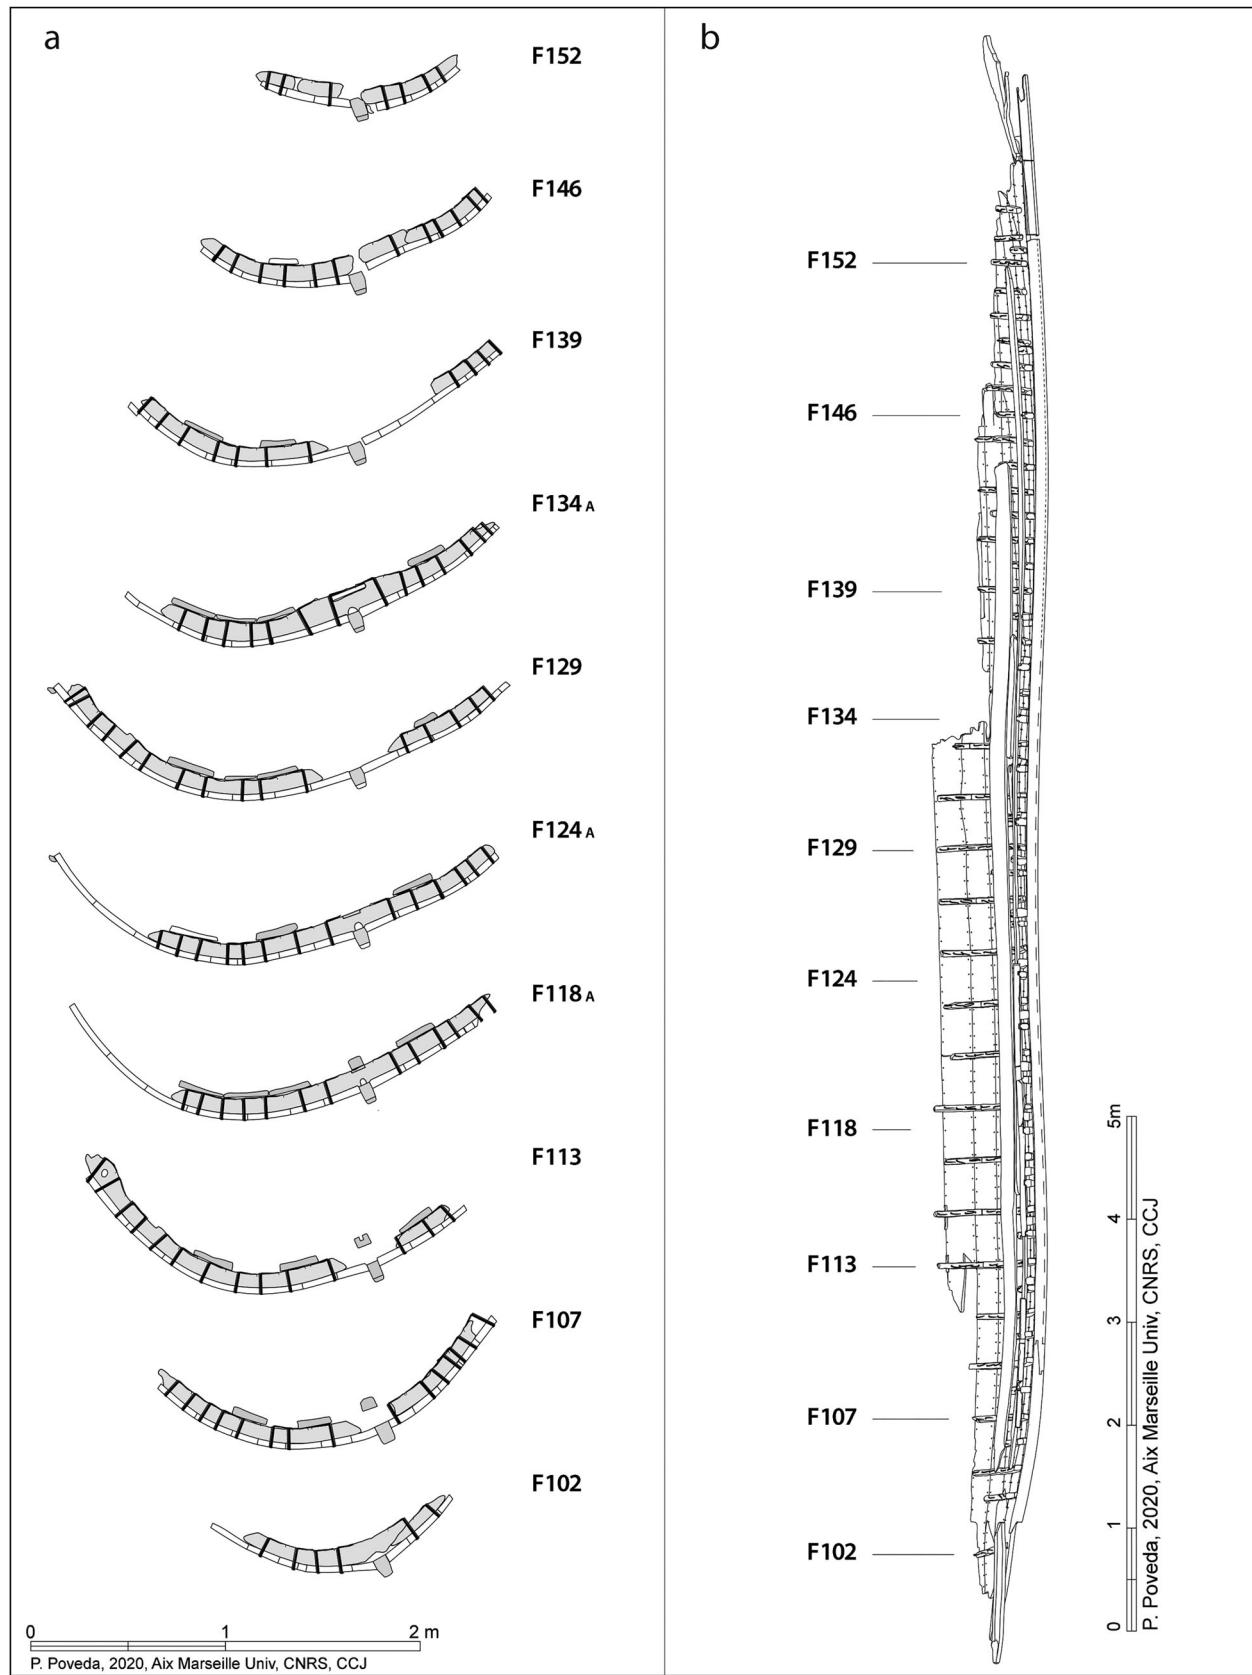
**Figure 11.** The Phanagoria shipwreck: a) cross sections; b) longitudinal section (drawing P. Poveda CCJ/CNRS).

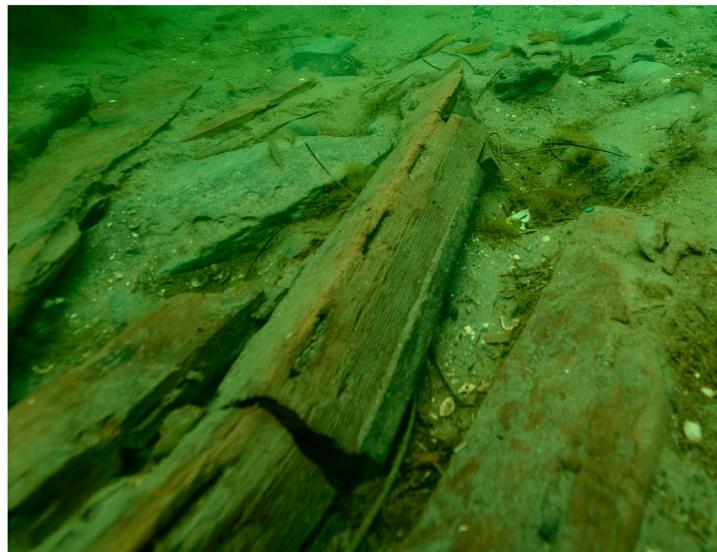
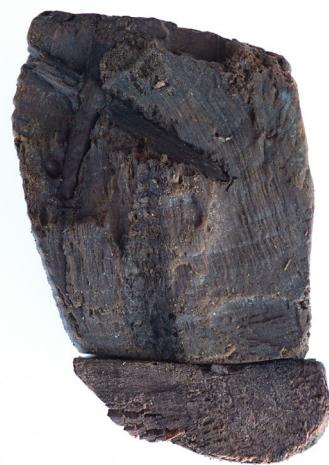
**Figure 12.** The keel: a) view of the fore part (photo S.V. Olkhovskiy, IA RAS); b) section of the keel and its false keel (photo P. Poveda CNRS/CCJ).

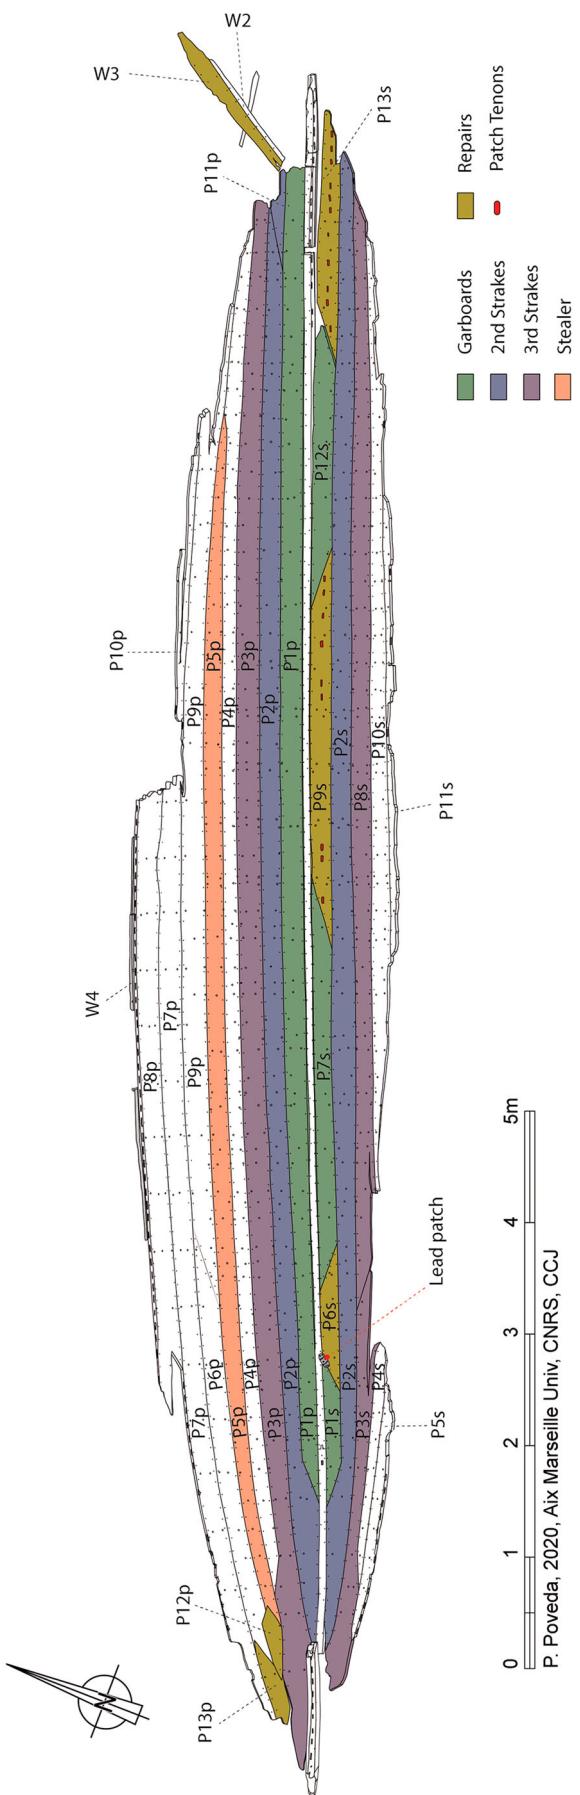
**Figure 13.** The planking plan (drawing P. Poveda CCJ/CNRS).

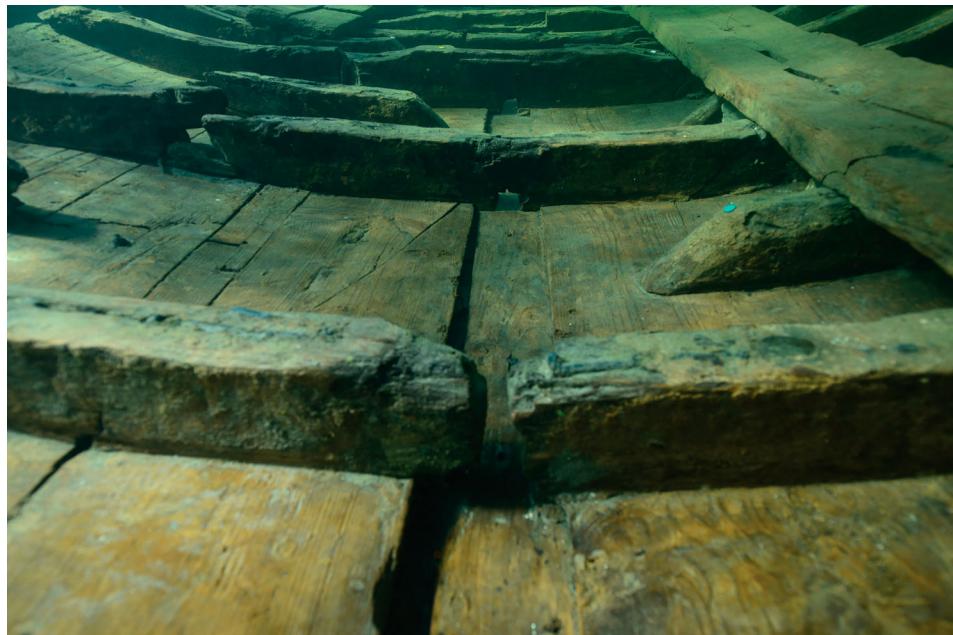
**Figure 14.** The bottom of the shipwreck (photo S.V. Olkhovskiy, IA RAS).

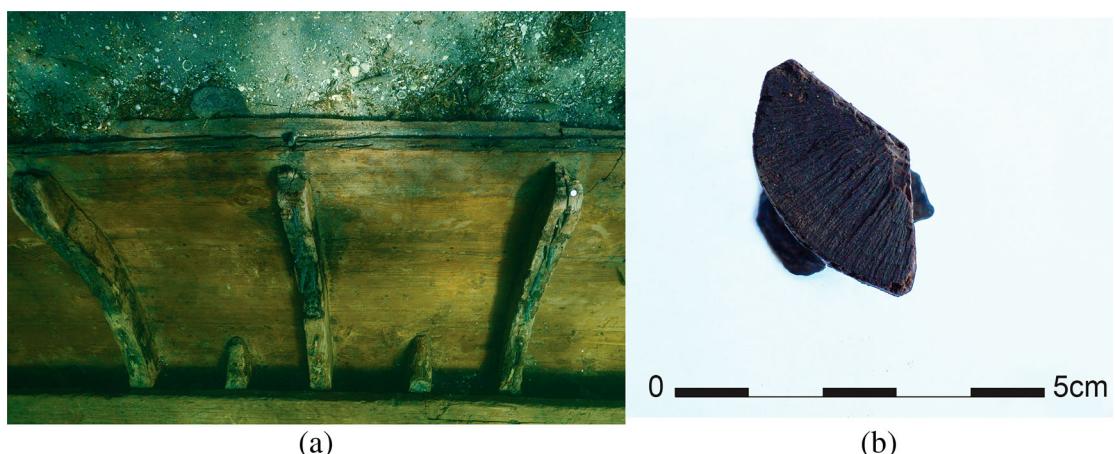
**Figure 15.** The rail timber W4: a) view *in situ* (photo S.V. Olkhovskiy, IA RAS); b) section view. Note the nail connecting the timber to the planking (photo P. Poveda, CCJ/CNRS).

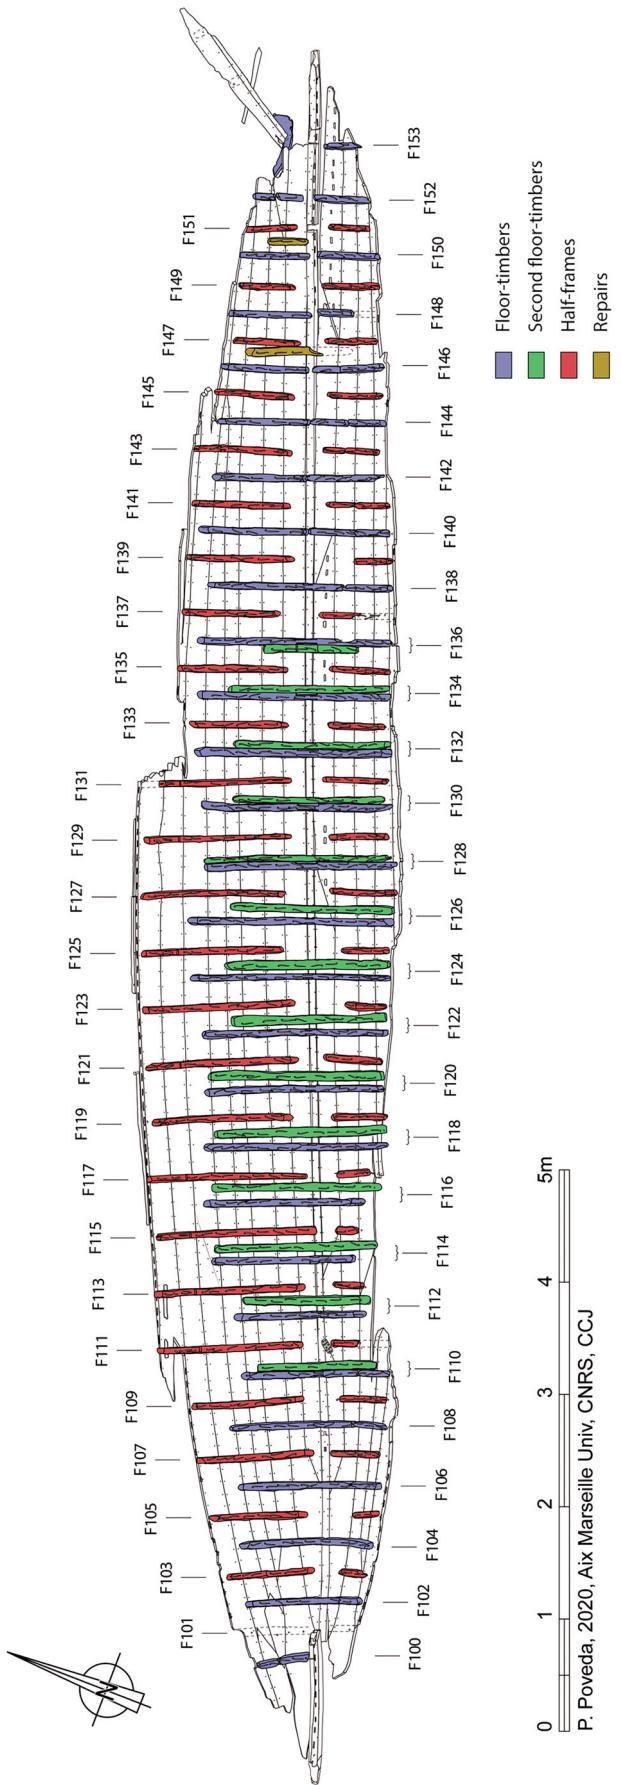
**Figure 16.** Frame plan (drawing P. Poveda CCJ/CNRS).

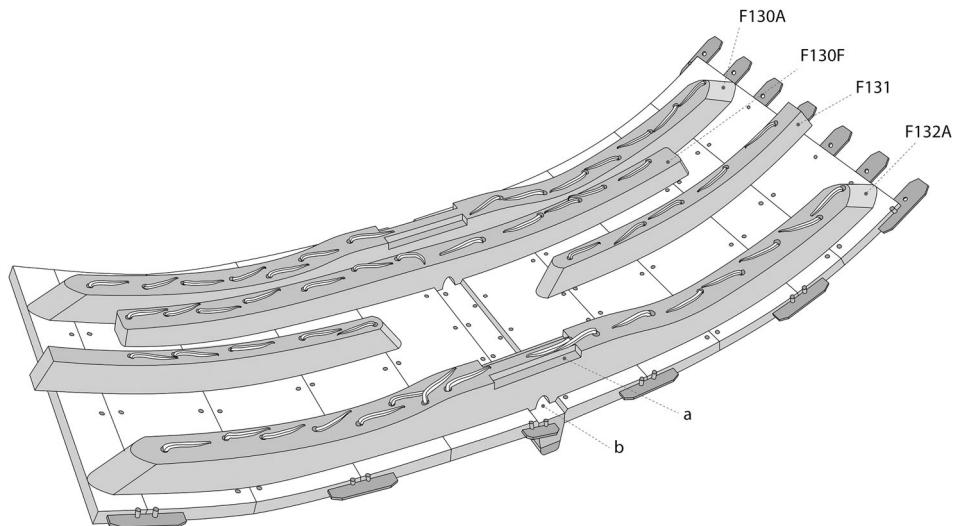
**Figure 17.** Framing pattern: a) recesses for the mast-step; b) limber-hole (drawing P. Poveda CCJ/CNRS).

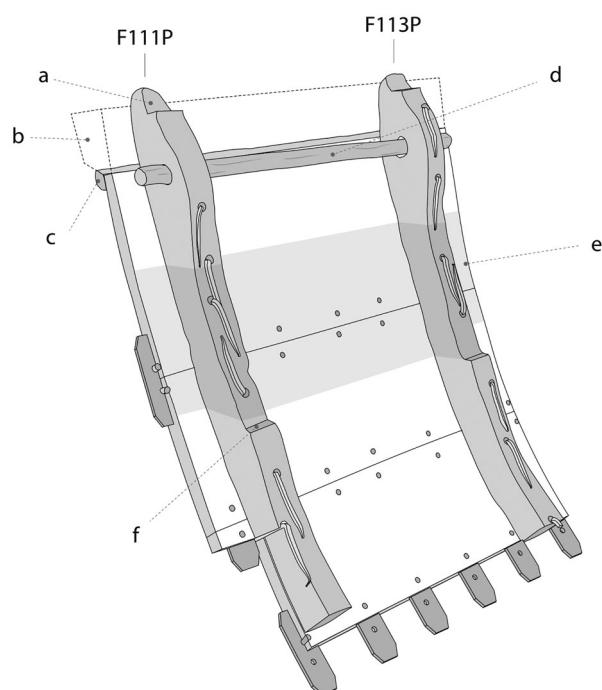
**Figure 18.** The upper part of the port side between frames F111P and F113P: a) notch; b) reconstructed wale (ninth strake); c) slender timber W4; d) cleat; e) dark trace on the pitch; f) recess supporting a stringer (drawing P. Poveda CCJ/CNRS).

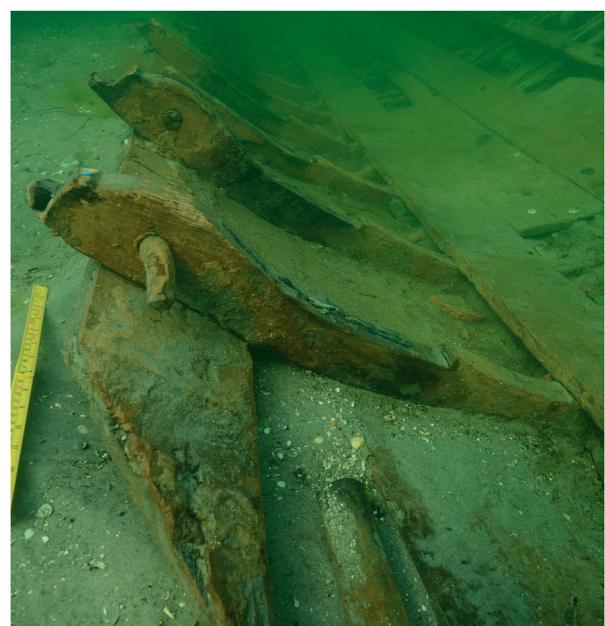
**Figure 19.** The upper part of the port side between frames F111P and F113P (photo S.V. Olkhovskiy, IA RAS).

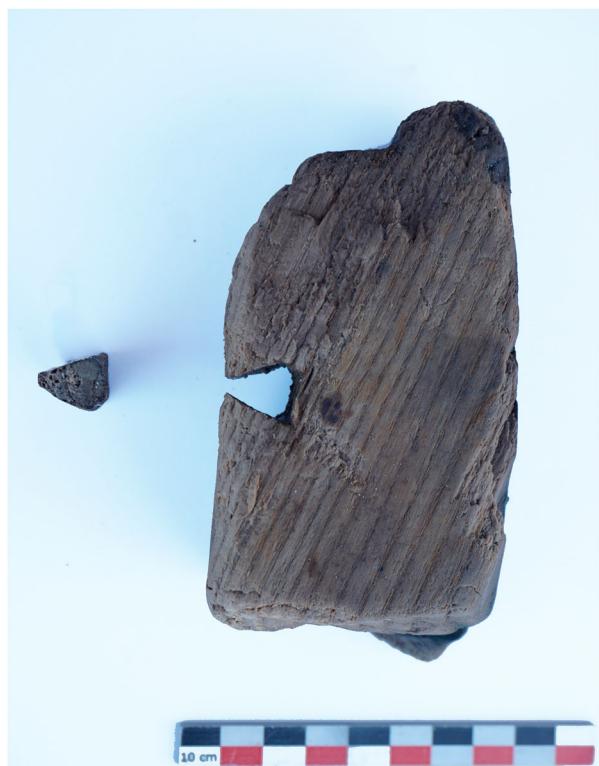
**Figure 20.** Fragment of the upper extremity of frame F117P with the wedge (photo P. Poveda CNRS/CCJ).

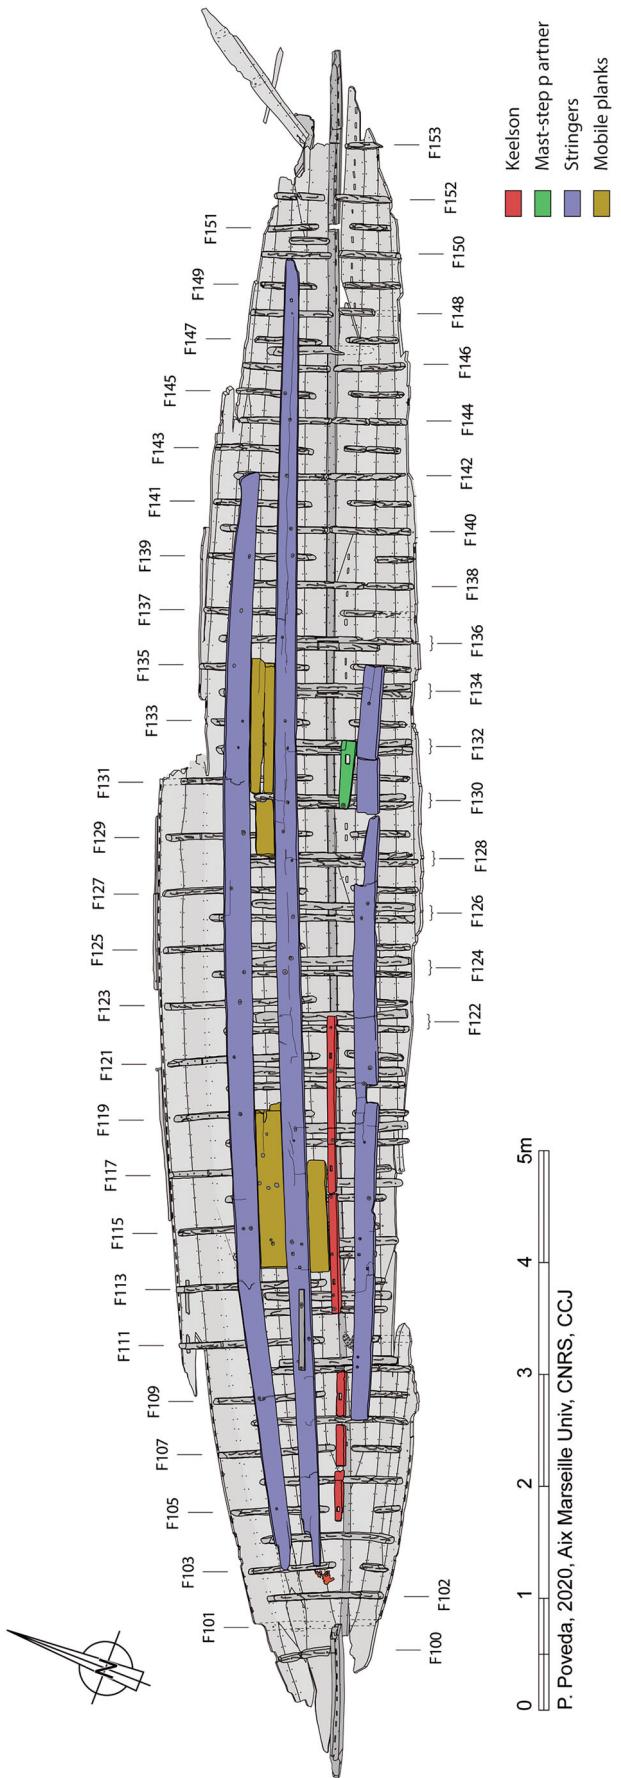
**Figure 21.** Plan of the internal longitudinal components (drawing P. Poveda CCJ/CNRS).

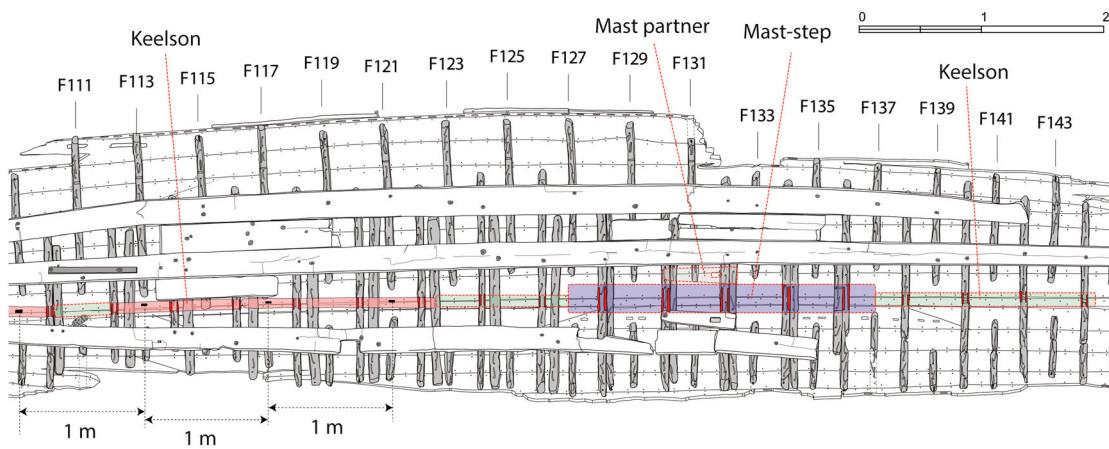
**Figure 22.** The position of the recesses on the top of the frames (red), the reconstructed mast-step (violet), reconstructed parts of the keelsons (green), conserved keelson on the stern (rose) with the four mortises for stanchions (black) (drawing P. Poveda CNRS/CCJ).

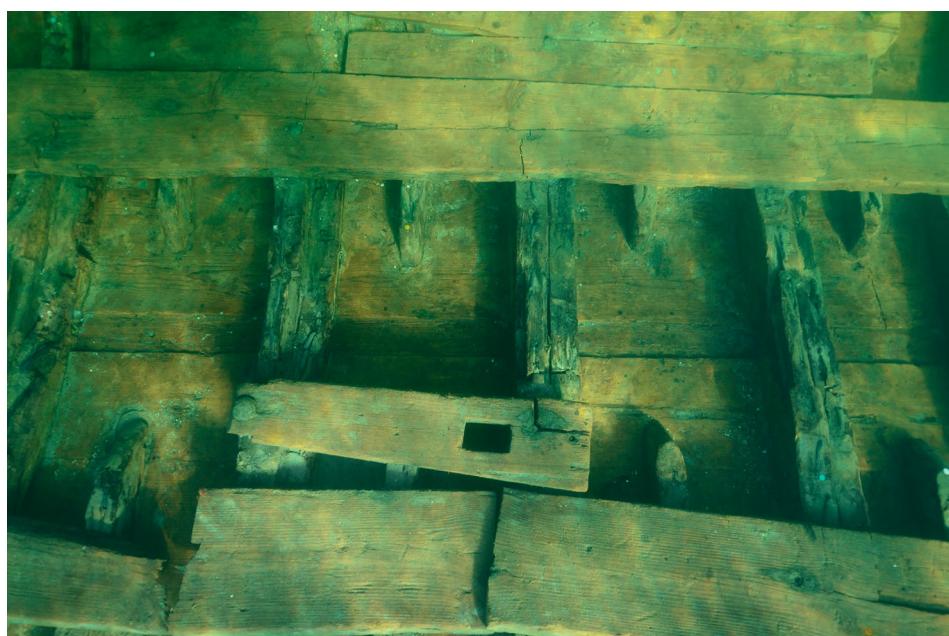
**Figure 23.** The starboard mast partner (photo S.V. Olkhovkiy, IA RAS).

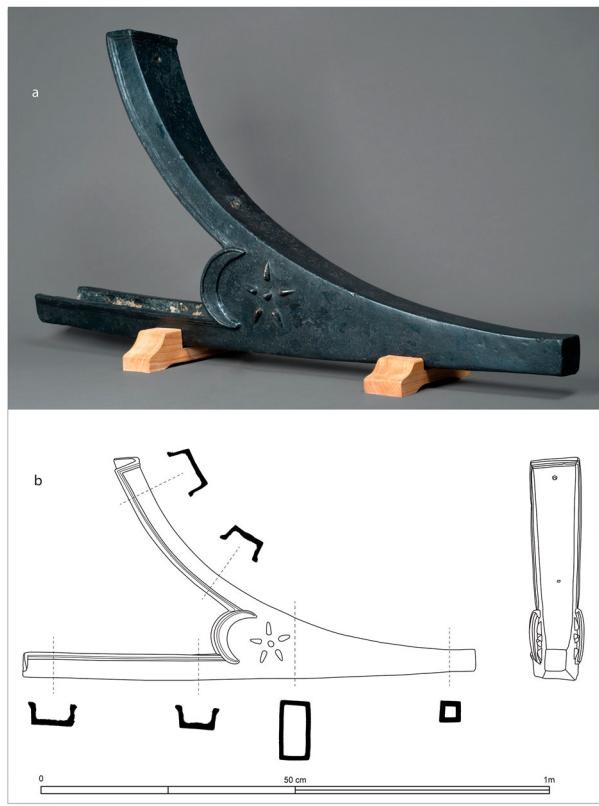
Fig. 24

**Figure 24.** The ram (a) photo IA RAS; b) drawing P. Poveda CNRS/CCJ).

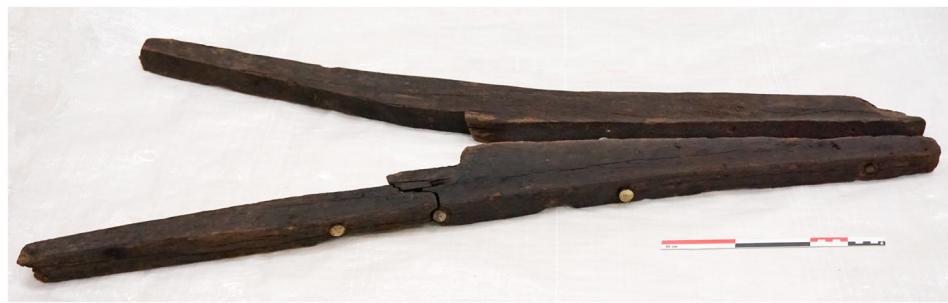
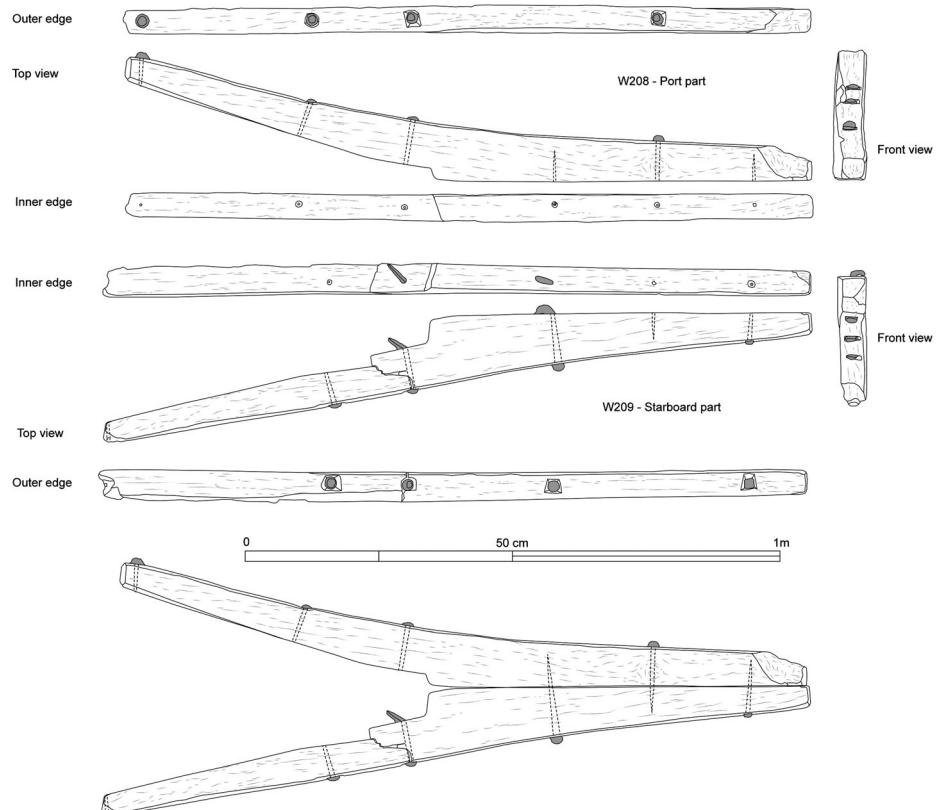
**Figure 25.** The fore-ram or *proembolion* (photo and drawing P. Poveda CNS/CCJ).

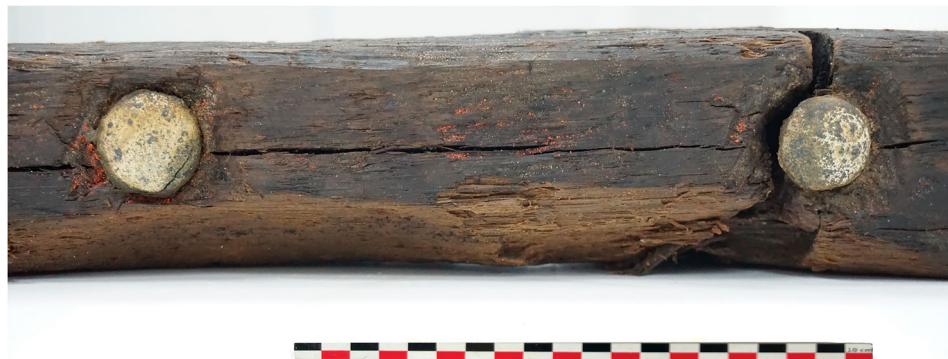
**Figure 26.** The recesses for the nails in one of the timbers of the fore-ram or *proembolion*. Note the traces of red pigment (photo P. Poveda CNS/CCJ).

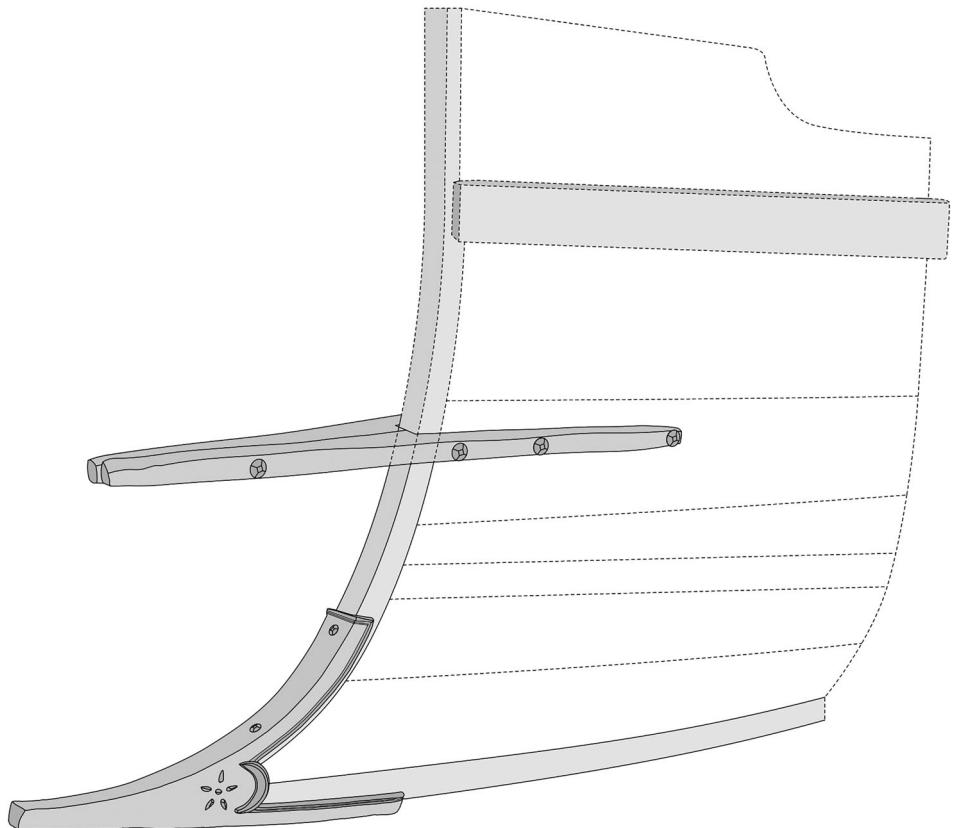
**Figure 27.** Hypothetical reconstruction of the position of the fore-ram in the bow (drawing P. Poveda CNS/CCJ).

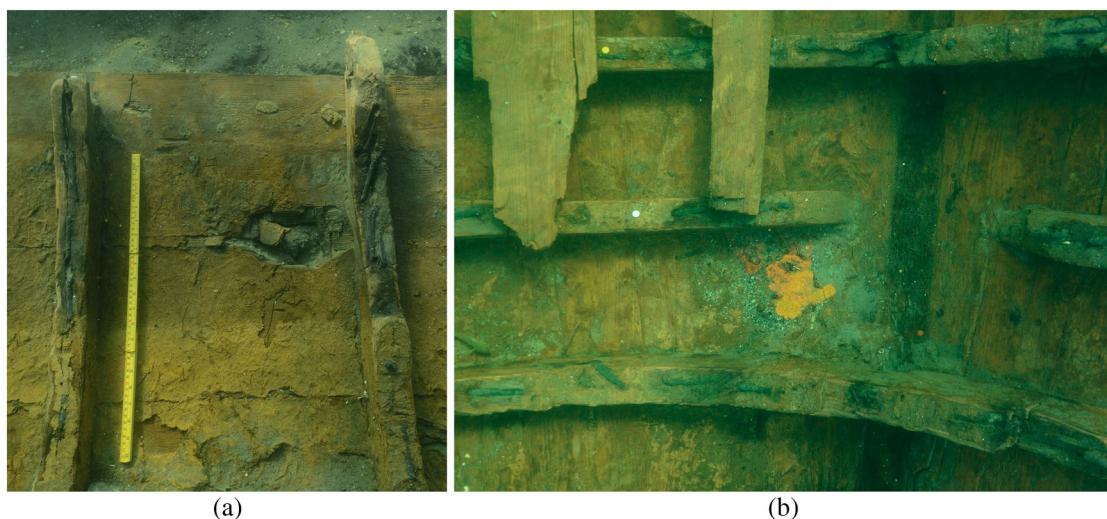
**Figure 28.** a) The port side covered with pitch. Note the different colouring of the pitch: the exposed parts are yellowish, while the parts that were hidden under the stringer are darker (photo S.V. Olkhovskiy, IA RAS); b) Small pile of a red substance inside the hull between frames F102 and F103, in the aft part of the ship (photo S.V. Olkhovskiy, IA RAS).

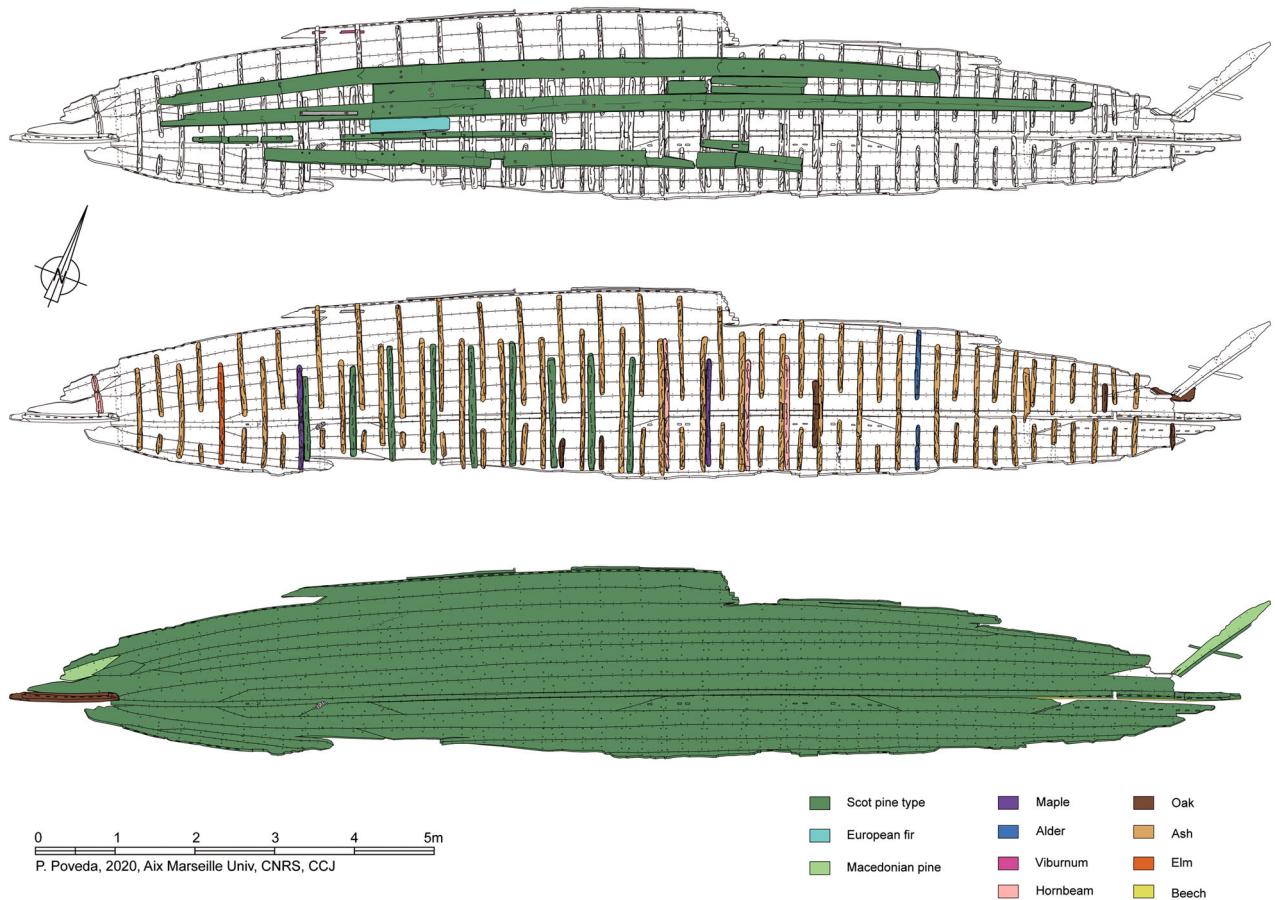
**Figure 29.** Distribution of wood species (identification C. Cenzon-Salvayre, drawing P. Poveda CNRS/CCJ).
