Eastern Jarash Project: 2022 Final Report

EASTERN JARASH PROJECT

2022 FINAL REPORT

I. Framework of the project, objectives & first results

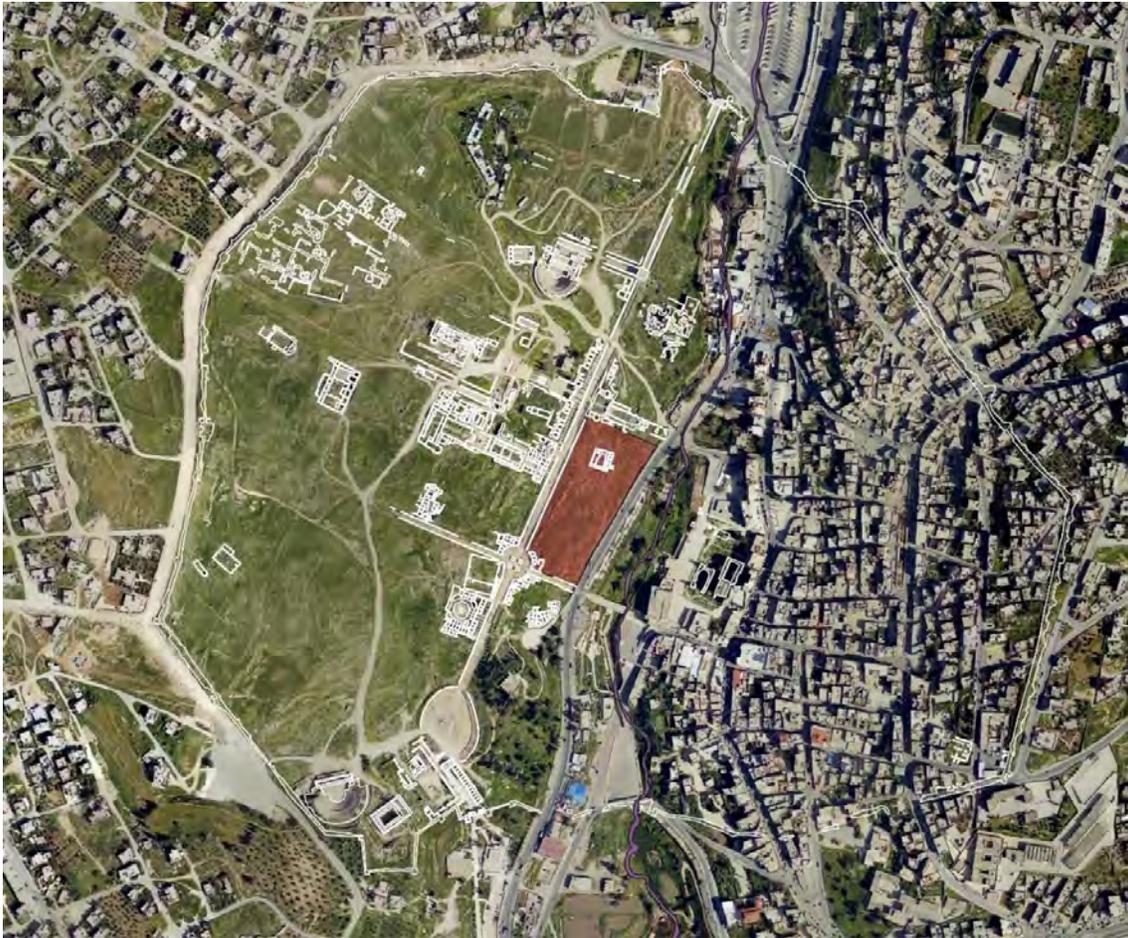
Fig. I.3. Map of the main buildings in Jarash in 2015 on an orthophoto produced by RGJC and depicting in pink the study area of the Eastern Jarash Project (G. Pontitcelli, 2022). To the north is building A, previously excavated by the DoA and studied in 2022 by the EJP.

traffic axes of the city in Umayyad times, on the south and north by the decumani, and on the east by the Chrysorhoas River (fig. 1). Italian excavations (2002-2009) attest to a well-preserved Umayyad occupation probably characterized by commercial and artisanal facilities. In addition, DoA excavations have uncovered a large building, likely a Byzantine building transformed in the Umayyad period, which has been unpublished and poorly documented and whose function remains unclear. A reoccupied Roman portico corner, possibly from the Umayyad period, has also been interpreted as a neighborhood mosque by a DoA architect but very sketchily published.

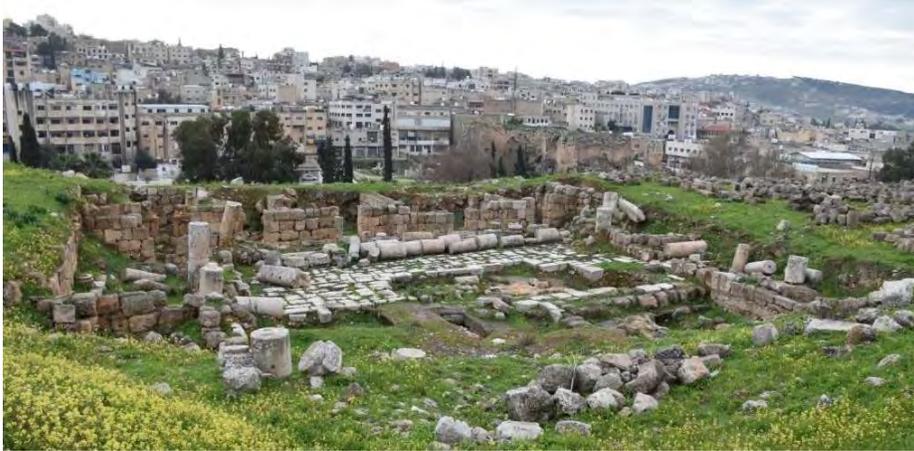
Fig. I.4. Building A at the beginning of the campaign, before excavation and cleaning.

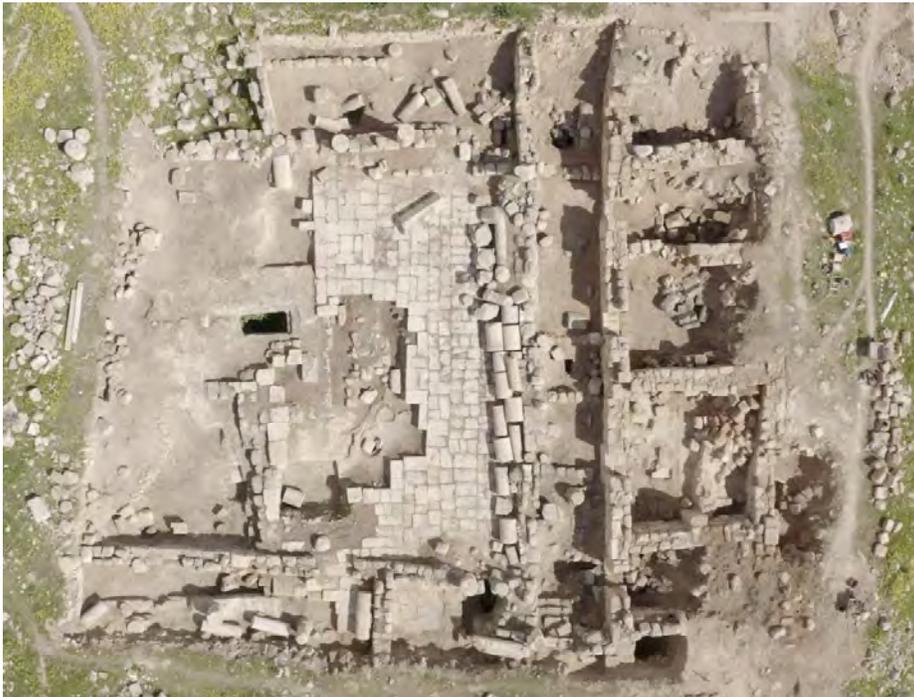
Fig. I.5. Aerial view of building A during the excavation.

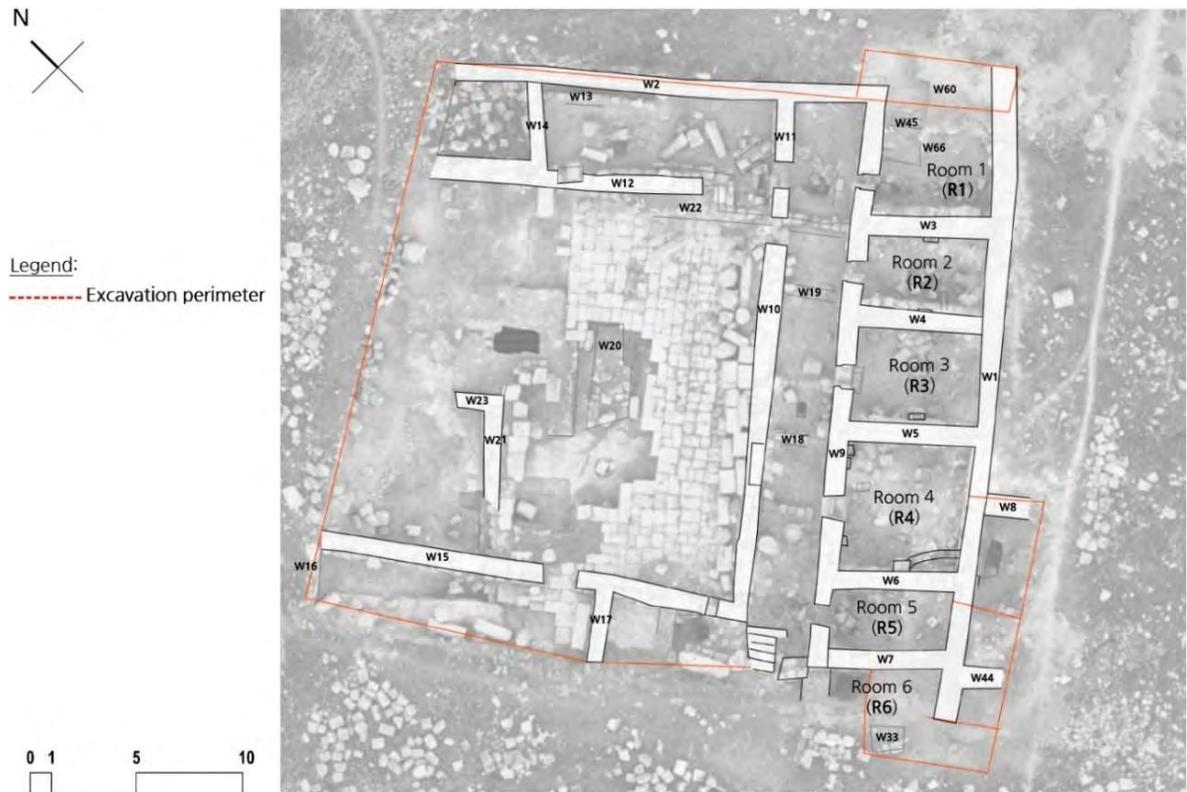
Fig. I.7. First draft of the ground plan with rooms' and walls' numbers.

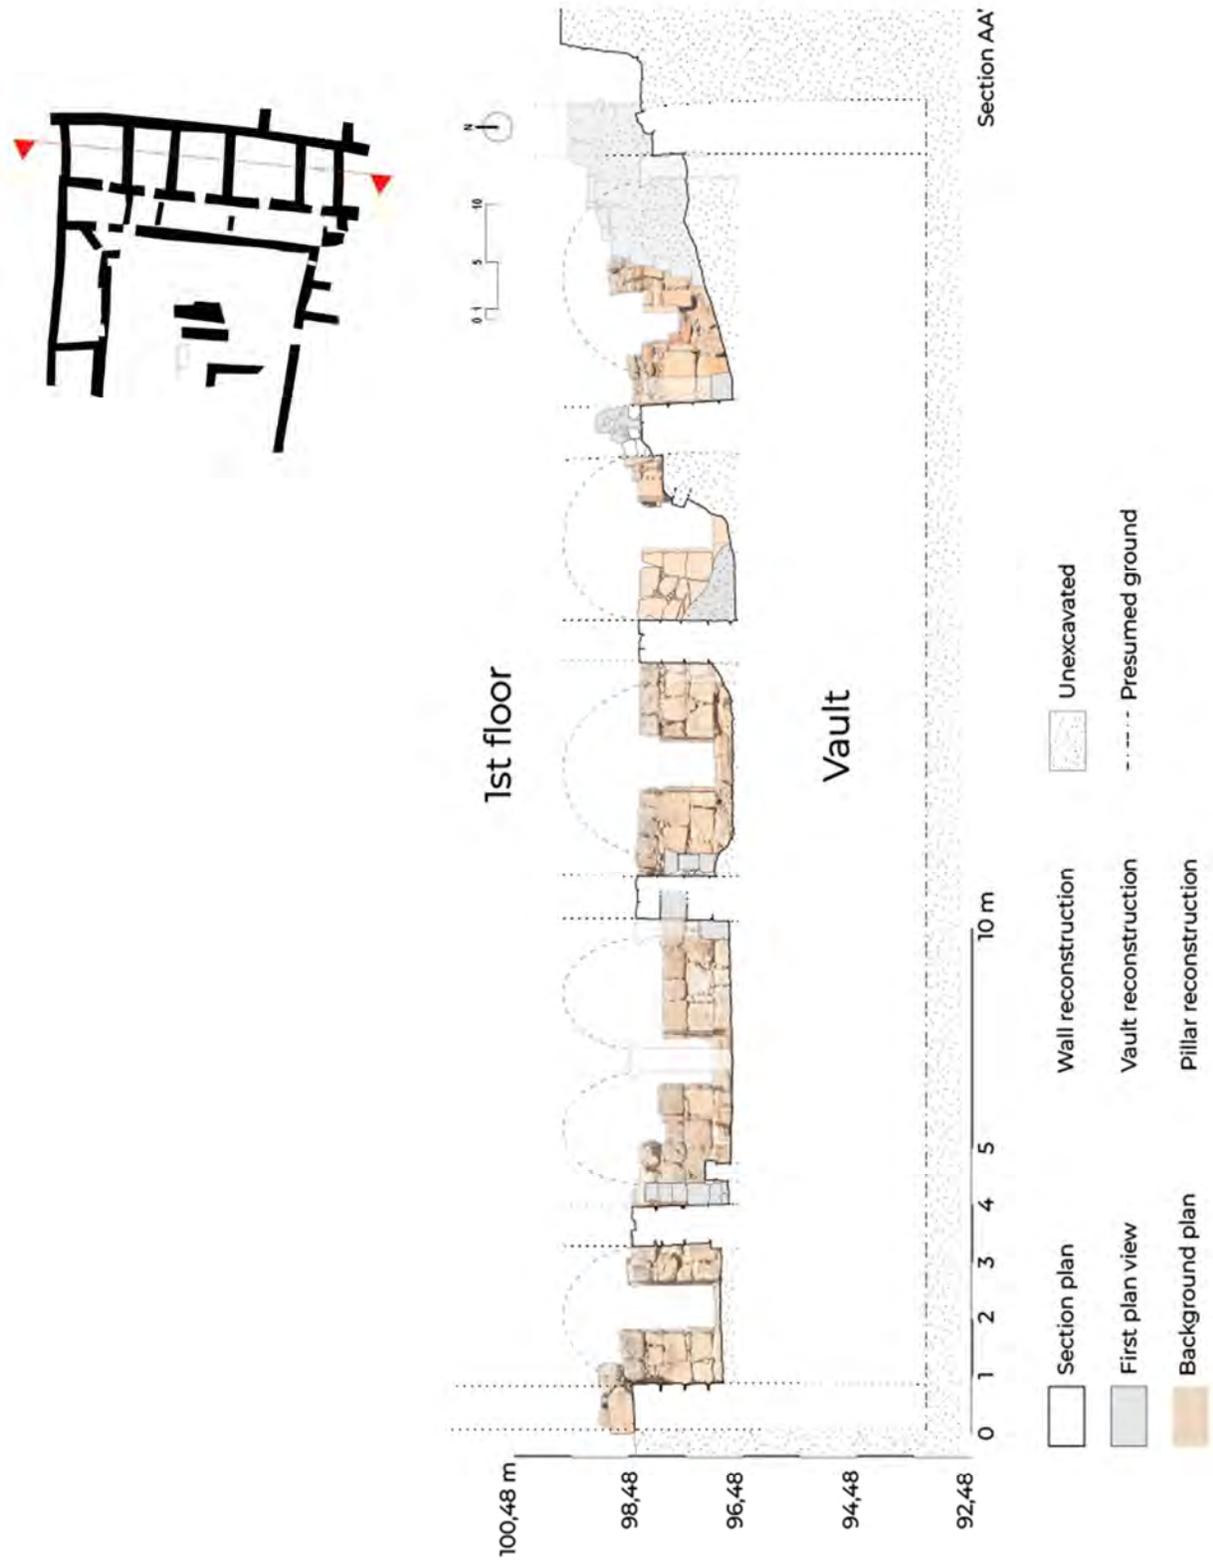
Fig. I.8. N/S architectural section of the eastern wing, with restitution of the vault and its floor (arch. Emmanuelle Devaux and Arthur Moumneh).

According to the discoveries made in rooms R4 and R5, a **storey** can be restored: it was supported by longitudinal vaults, resting on pillars or corbelled imposts that are still partially visible. It is not possible to understand yet why rooms show pillars and other imposts. The collapse layers (SU26, 27, 39, 52 in room R4) of the storey included numerous rough stone tesserae (white, brown, and red) and painted coating fragments suggesting that the walls of the upper storey were protected and decorated with painted plaster while the floor was adorned by a mosaic pavement, at least at the level of room R4. The walls of the upper storey were uncoated and its floor is made of beaten earth, at least in rooms R4 (SU56) and R5 (SU69). The storey was probably accessible through a flight of stairs still visible in the southeastern corner of the portico. It was excavated by the previous team. It currently consists of 5 steps and measures 1.80 m. At its base, it is 1.70 m large but 1.10 large at its summit. The steps are 0.35 m deep.

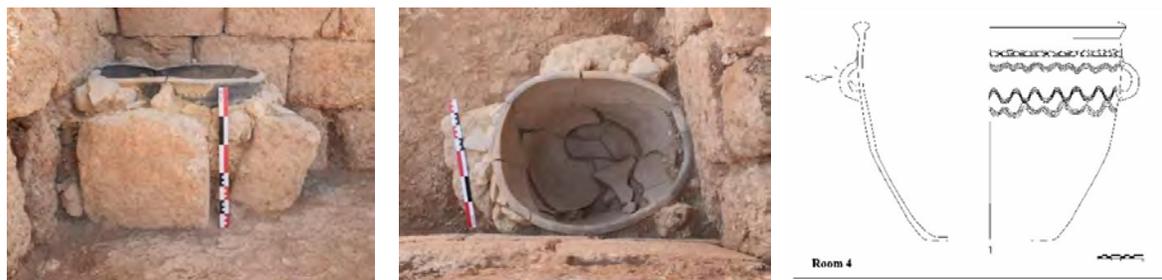
Fig. I.9. Complete bowl (Jerash Light Grey Handmade Ware) placed in a stone massif at the northeast corner of room R4.

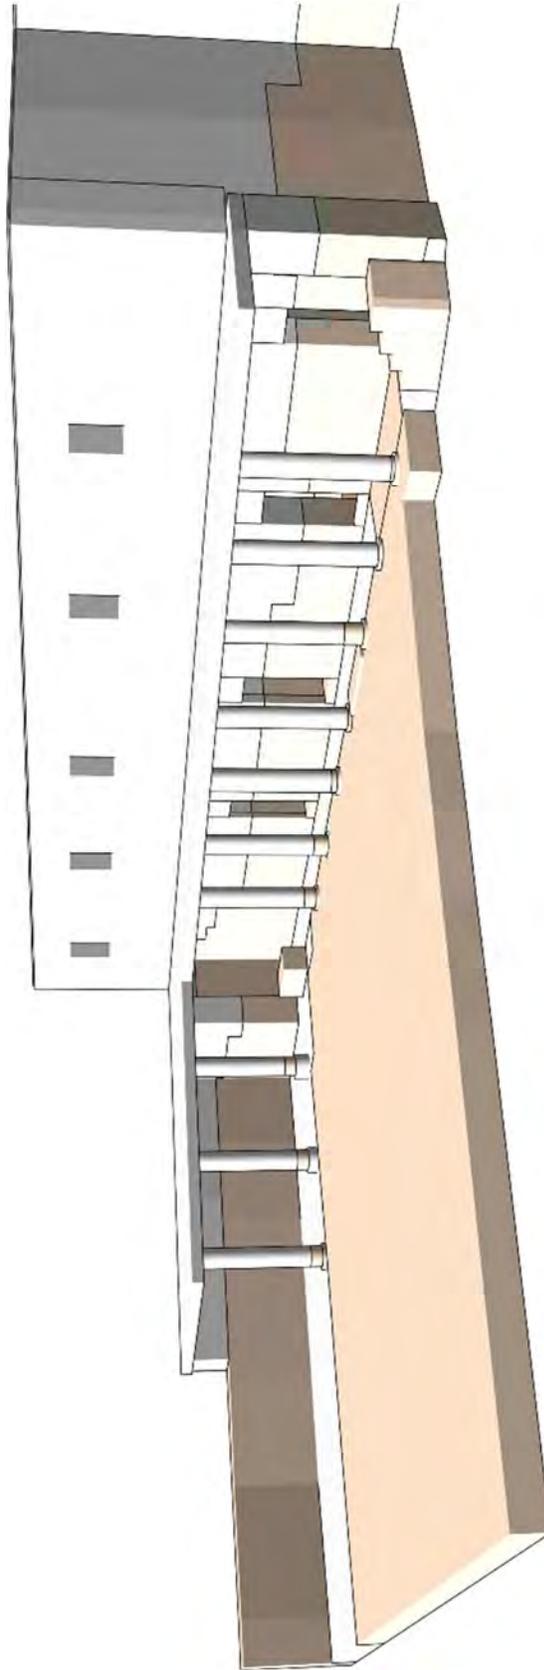
Fig. I.13. First proposal for a 3D restitution of building A in its last phase of occupation, prior to the earthquake of 749, work in progress (Arthur Moumneh).

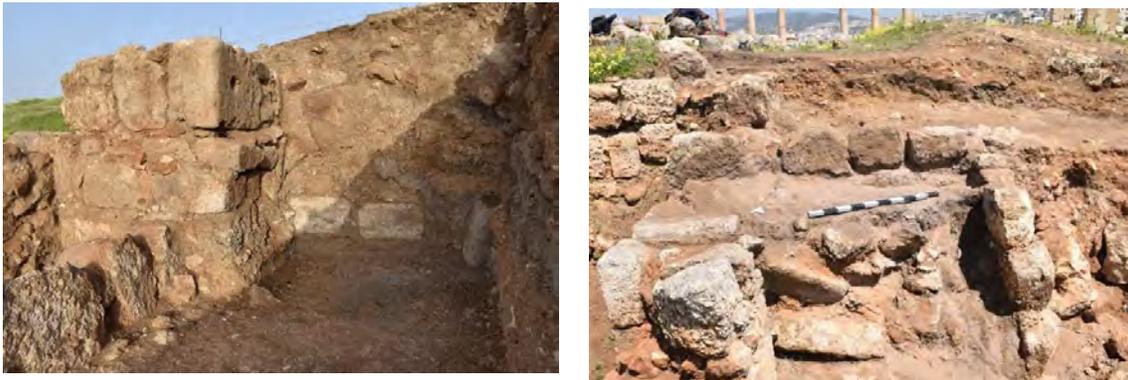
Fig. I.14. Later occupation of the northeastern area of building A, after the earthquake of 749: to the left, the corner W67 between walls W9 and W2 (phase 5), and to the right, the ashy layer (41) of a fireplace at the foot of two walls.

Phase 6. The area was then scarcely occupied in a period that could not be yet defined (Ottoman? Modern?). It is attested in the northeastern area by a fireplace (41) located between two more recent walls: the northern wall W45 is preserved for 1.80 m and the eastern wall W66 for 1.10 m. The structure was badly destroyed by previous excavations and not documented. Dating back to the same phase, or the previous one (phase 5) is a double-facing wall discovered in the southeastern area (W33, 1.5 m long).

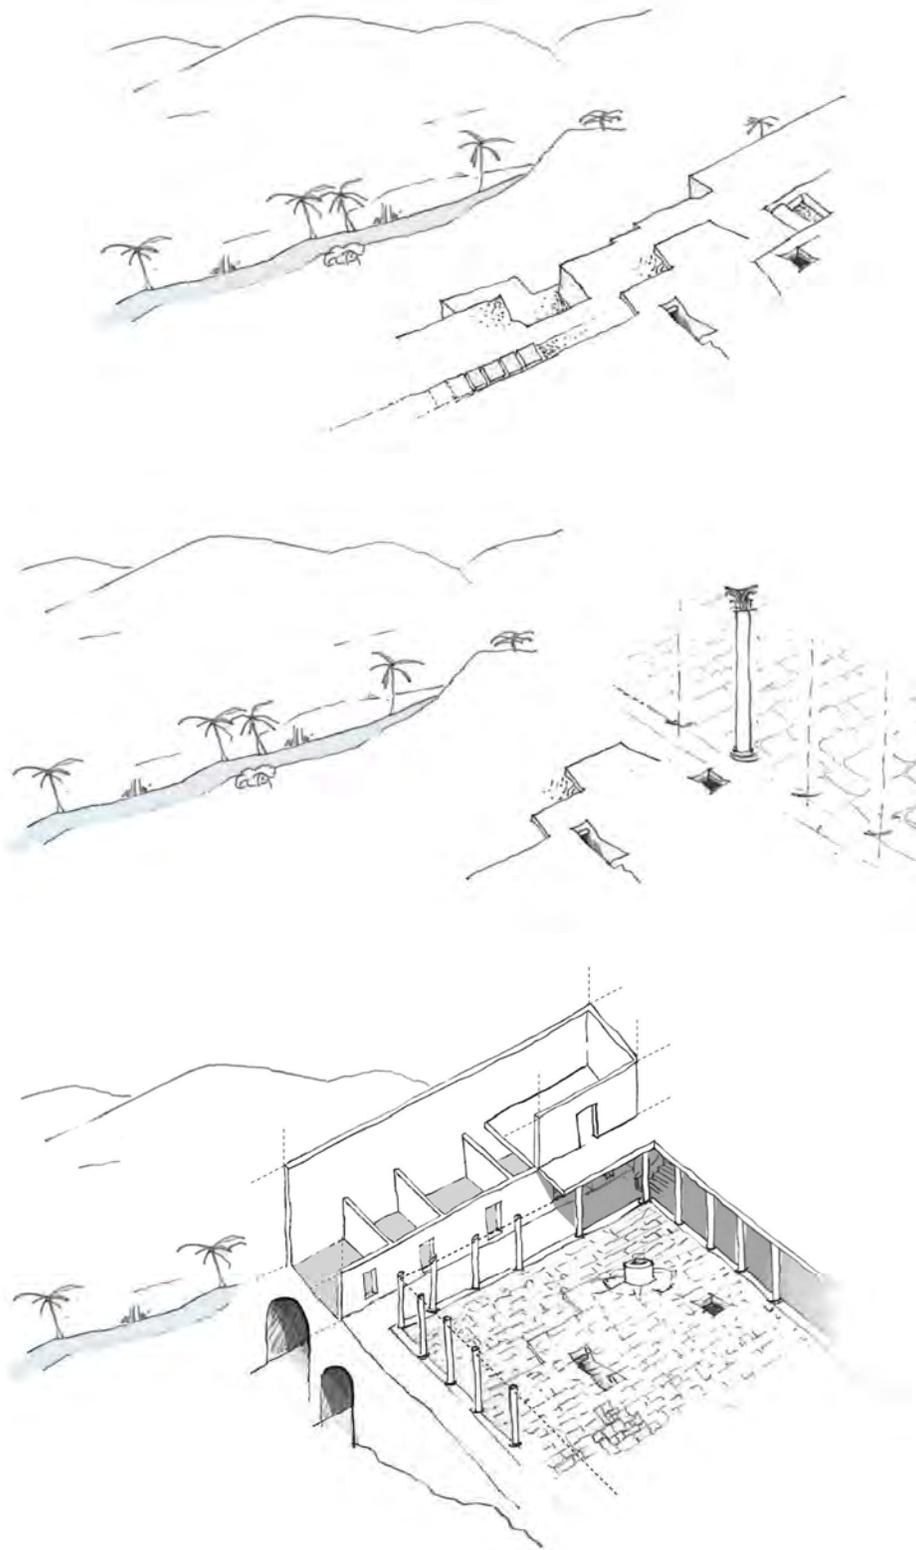
Fig. I.15. Tentative restitutions for phase 1 (quarry), phase 2 (colonnade?), and phase 3 (courtyard building A) drawn by arch. Stéphanie Cunin.

Phase 3. This corresponds to the construction of the large courtyard building A. Because it was mainly excavated by the previous team, we do not have yet any dating elements in stratigraphy. However, Roman architectural elements (capitals, bases, drums) were reused in the construction. The paving of the courtyard seems characteristic of the Byzantine period: the slabs were recuperated blocks, re-cut, and sawn. A hydraulic sawmill from the 6th century was found nearby, on the other side of the cardo, restored and published by the MAFJ (Seignes & Morin 2007).

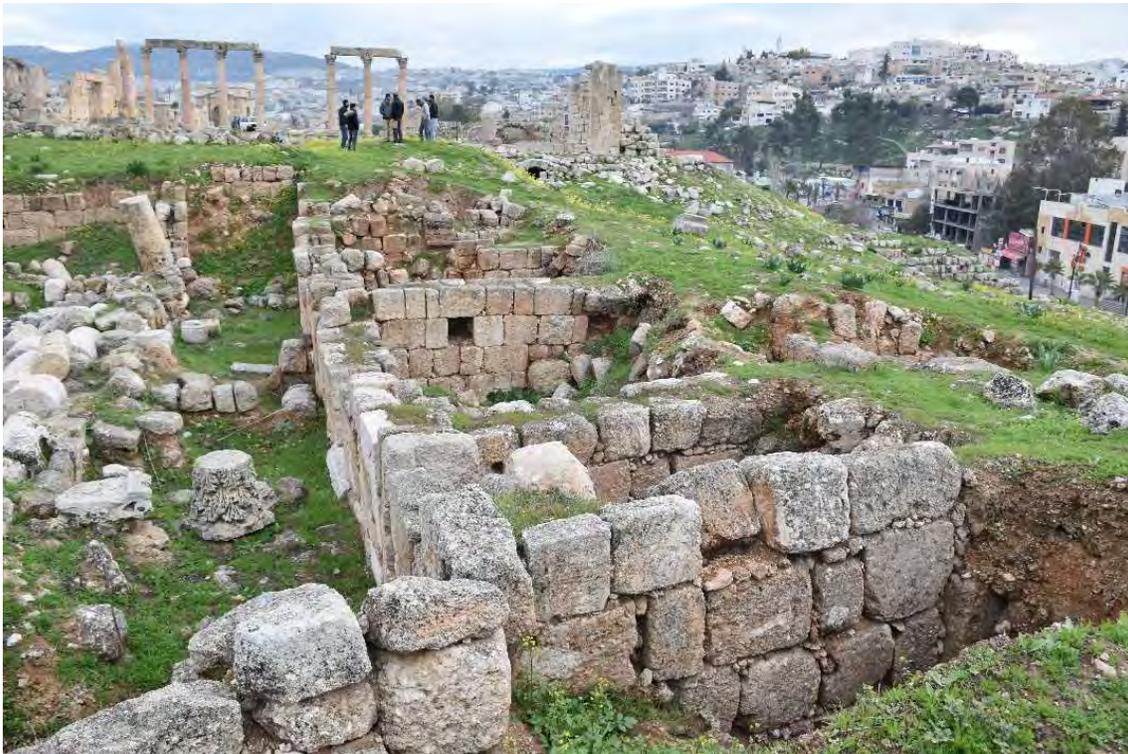
Fig. II.1. The eastern wing of building A, before 2022 excavation, view from the south.

Even though the eastern and northern wings of building A were almost completely excavated by the Department of Antiquities (DoA), the location of the northeastern corner of building A (fig. II.1), located in front of the Roman Nymphaeum, east to the *cardo*, was still unearthed. The aim of the excavation in area 1 was to locate and characterize this specific corner to better understand the architecture of building A, and to discover the limits of room R1. Furthermore, this sounding was implemented to collect data about the stratigraphy of the area, inside and outside the building, since no documentation from the previous excavators was available. Sounding 3 (6.65 m E/W and 4.70 m N/S) in area 1, in the northern section of Room R1, was identified as part of the Eastern Jarash Project 2022 excavation. The purpose of this sounding was to determine the stratigraphy, phases, and structural constraints in this area of the building.

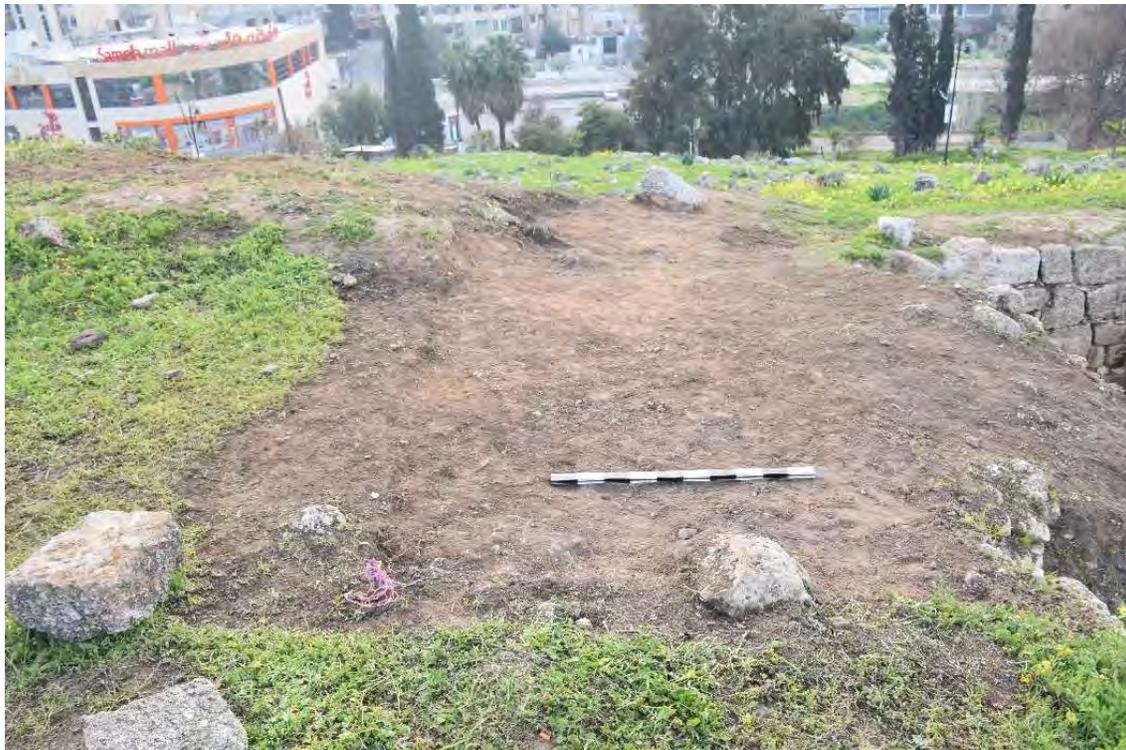
Fig. II.2. Northern part of building A, area 1, as well as sounding 3, before excavation, view from the west.

The excavation began following the clearing of sounding 3 (fig. II.2), particularly the northern portion of area 1. The upper part is probably a modern dump originating from the rubble from the previous excavation undertaken in 2001. The exterior of the building was excavated and a sounding of 6.65 m E/W and 0.80-0.65 m N/S was implemented near the outer face of northern wall (W2). Additionally, sounding 3 was set up in the northern portion of room R1 since different phases and contexts were visible in section 1 in the middle of room R1. The southern part of room R1 was previously excavated and the only remaining archaeological contexts were located along the northern wall and the eastern wall.

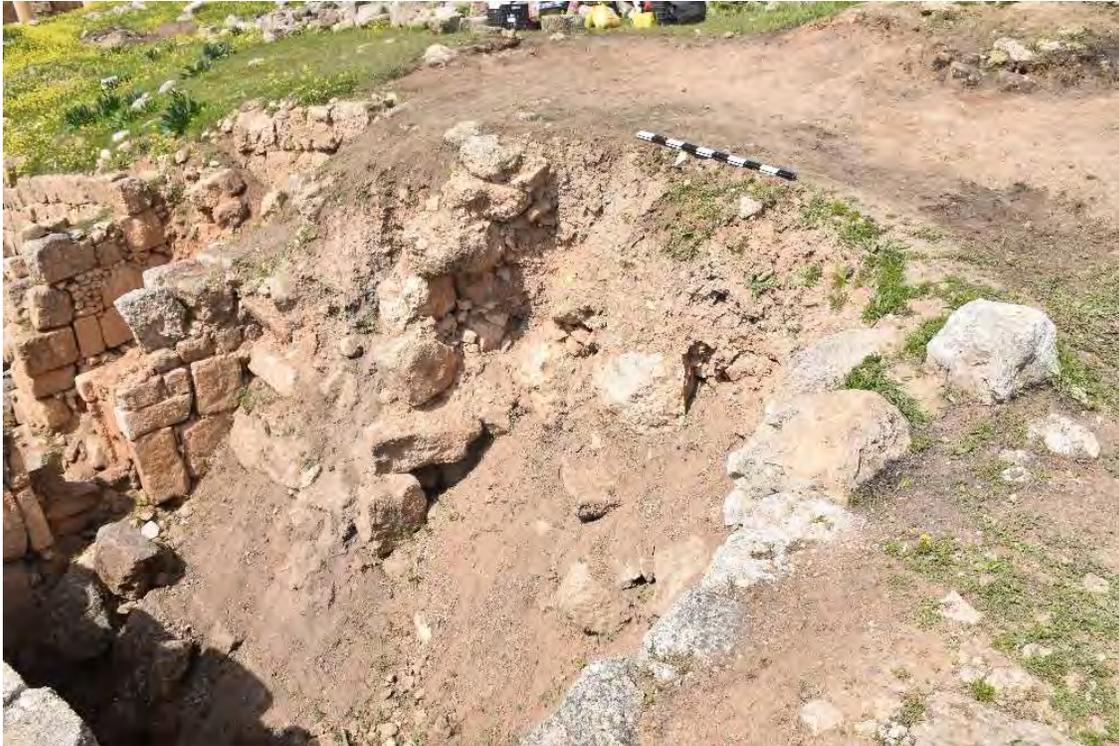
Fig. II.3. Baulk from previous excavation, before cleaning, view from the southeast.

Five different phases were identified in the E/W sloping section of sounding 3 (fig. II.3, see section 2).

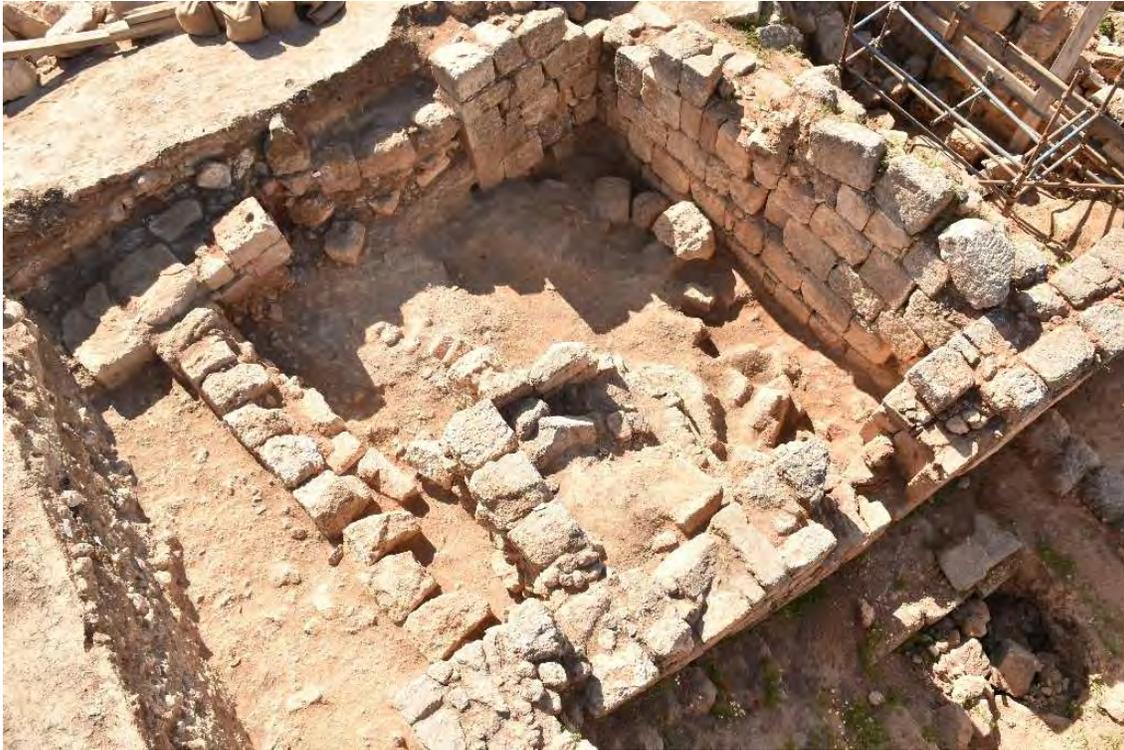
Fig. II.21: Zenithal view from the sounding 3 in area 1 and room 1 to the right, at the end of the excavation

The excavation of the northeastern corner, unearthed during the previous excavation by the DoA, did not reach the circulation floor of room R1 but probably its northern limit, corresponding to wall W60 (fig. II.21). The latter wall does not correspond to the extension of W2 to the east but is, in fact, a completely other built wall that follows the same E/W axis. Even though W1 and W60 form the eastern corner of room R1, both do not constitute the eastern edge of the whole building since wall W1 still extends further east. Room R1 is almost square-shaped (4.70 x 4.62 m). It is one of the largest rooms of the eastern wings of the building, and just a bit smaller than room R4. At one phase, this room possessed two doors, a small one (0.55 m) in its western wall (W9) and a larger one (2.20 m) in its eastern wall (W1). It is still too early to hypothesize over the original phase of the building since the connection between W1 and W60 and not yet been established with the western wall of the room (W9) and the link with the eastern wall (W1) still needs to be confirmed.

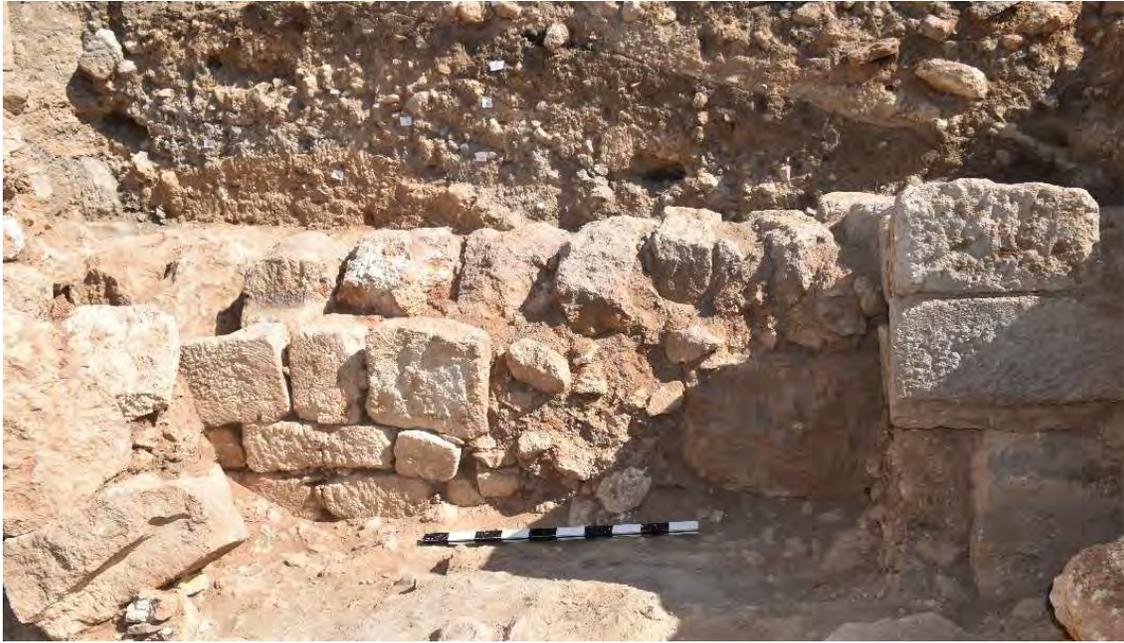
Fig. II.16. Northern wall (W60) of room R1.

Under collapse layer (59), northern wall (W60) of room R1 was unearthed. E/W oriented, it was excavated over 4.12 in length (fig. II.16) and 0.45 in width. It is preserved over 1.43 to 1.55 m in height (top level: 98.49 m to 96.95 m) and five courses of carved limestones were visible. The fifth one was unstable and preserved only in the southern part of the wall. The stones were numbered and then dismantled. The shape of the fifth and fourth courses are different from the three lower courses; the module of the blocks is larger and the faces are roughly carved. However, they are connected to each other by the same reddish mortar. The stones of the upper course are larger than the lower ones: the stones of the upper course are 0.70 x 0.50 x 0.45 m, of the middle course 0.45 x 0.40 m, and of the lower course 0.20 x 0.12 m.

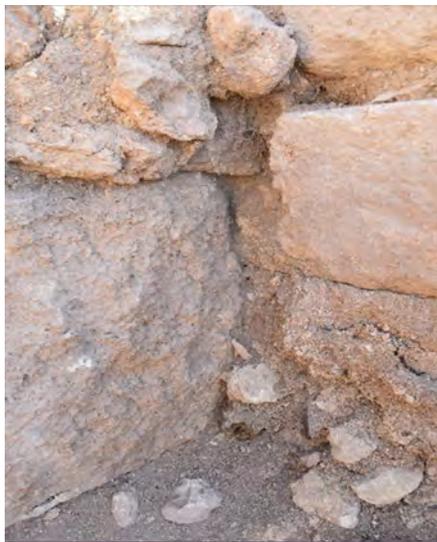
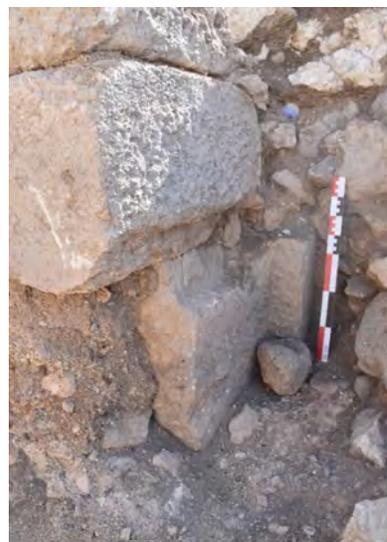
Fig. II.17-18. To the left: huge stone that linked wall W60 to wall W1; to the right: door features with a stone with a jamb rabbet and what could be a socket.

Furthermore, W60 seems to be linked with W1 in the east corner through a huge block (0.50 x 0.70 m) that seems to be imbedded inside wall W1 (fig. II.17). Nevertheless, it is unknown if they have the same foundation since the area was not excavated till the circulation level. The western part of wall W60 extends under W67 and reaches wall W9 as evidenced by a stone of W60 going below W67. In its current state, it is impossible to know if W60 and W9 were linked or not.

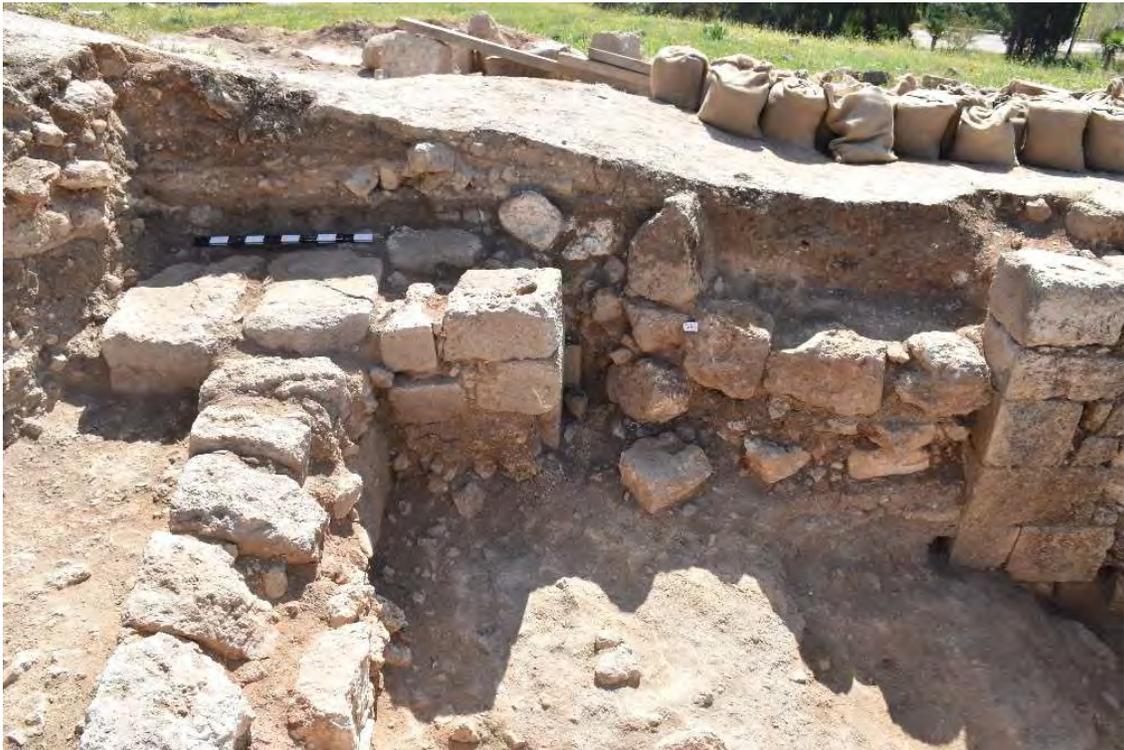
Fig. II.19: Wall W1 continuing to the north and door of building A. W65 that was later added to condemn the passage.

In addition, in the northeast corner of sounding 3 the northern extension of wall W1 appeared (fig. II.19). Wall W1 was excavated on an extent of 2.15 m N/S. It is between 0.60-0.96-1.20 m wide. The wall was excavated on a high of 6 courses in the southern part and 3 courses in the northern part (top level 97.13-98.37 m). In the northern doorjamb, the lower internal course of the northern wall is missing and sediment was discovered under the second course. A large door (2.20 m) is located in the middle of wall W1. A door jamb rabbet is preserved on the outer facing of the wall (fig. II.18). At its foot was preserved what is probably a circular stone socket (0.07 x 0.10 m) for the door (45) (fig. II.18). It is not certain if the threshold of the door could be deeper or at floor level since it is covered by the door rabbet. Finally, this wall extends north, under the baulk of sounding 3 and it is not possible yet to know where the northeastern corner of the building is located.

It should be noted that walls W60 and W1 present different types of construction (fig. II.19). The southern portion of W1 is built in larger and better cut stones than W60. It is difficult to know if this difference is related to different stages of construction. The southern portion foundation has not been fully excavated yet. Even if the two walls seem to be linked by

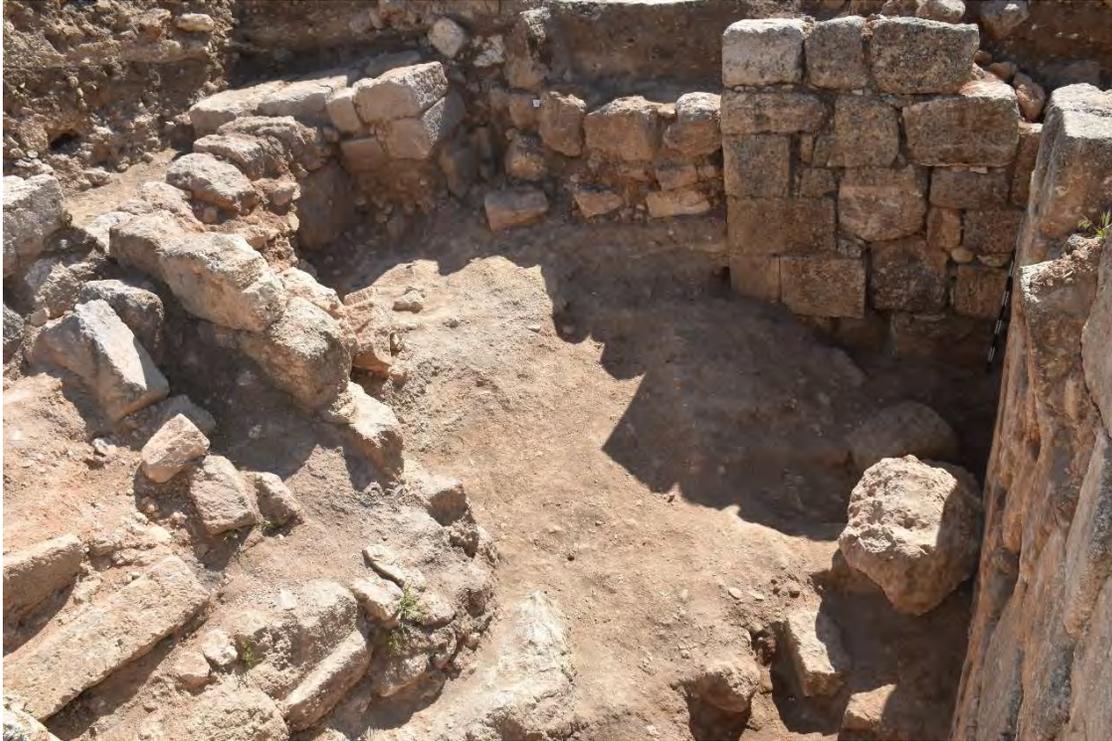
Fig. II.20: Inside room 1, view from the southwest, with wall W1 and its door in the background, and wall W66 to the left.

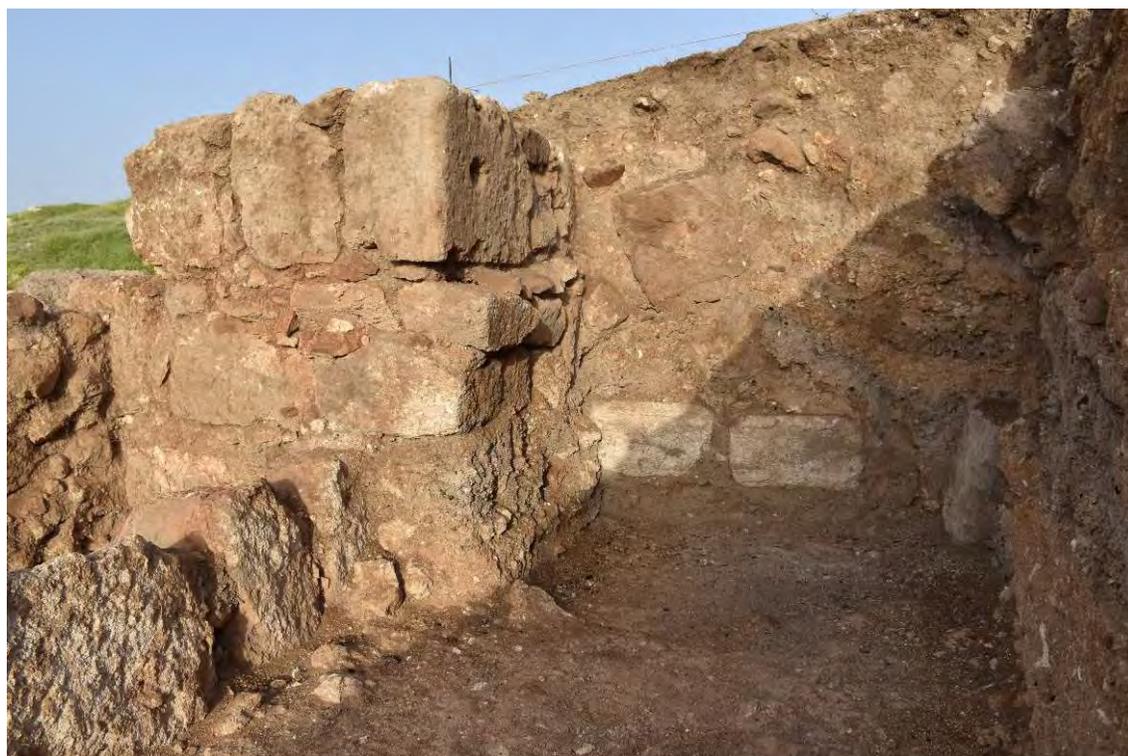
Fig. II.13: Wall W67 on top of layers 49 and 58 and wall W60 (view from the east).

Upper than the collapse layers were discovered the corner of two walls (W67), at the northwest of sounding 3. The eastern wall is 1.10 m long, 0.90 m wide and N/S orientated while the northern wall is 1.20 m long, 0.75 m wide and E/W orientated. The corner of W67 is 0.85 m high (top level: 99.39-98.52 m) (fig. II.13). The corner (W67) was built above layer 49 and layer 58 at the north and northeast. The eastern wall is built above W9, the western wall of the eastern wing of building A and the northern wall on W60, the northern wall of building A. It was built of two courses of semi-dressed limestone with chinking stones between them that were added to the earlier walls, probably partially collapsed. In addition, it was clear that corner W67 was built against and above wall W9. The fact that the corner was built above W60, SU59, and SU58 shows that it is not a part of the original building composed of walls W9 and W2. The eastern wall of the corner is also going more to the north than what seems to be the northern end of wall W9. It was probably built to link walls W60, W2, and W9 after the destruction of the supposed corner of building A. It is probably the corner of a new construction, built on building A and reusing some part of the wall that was still up.

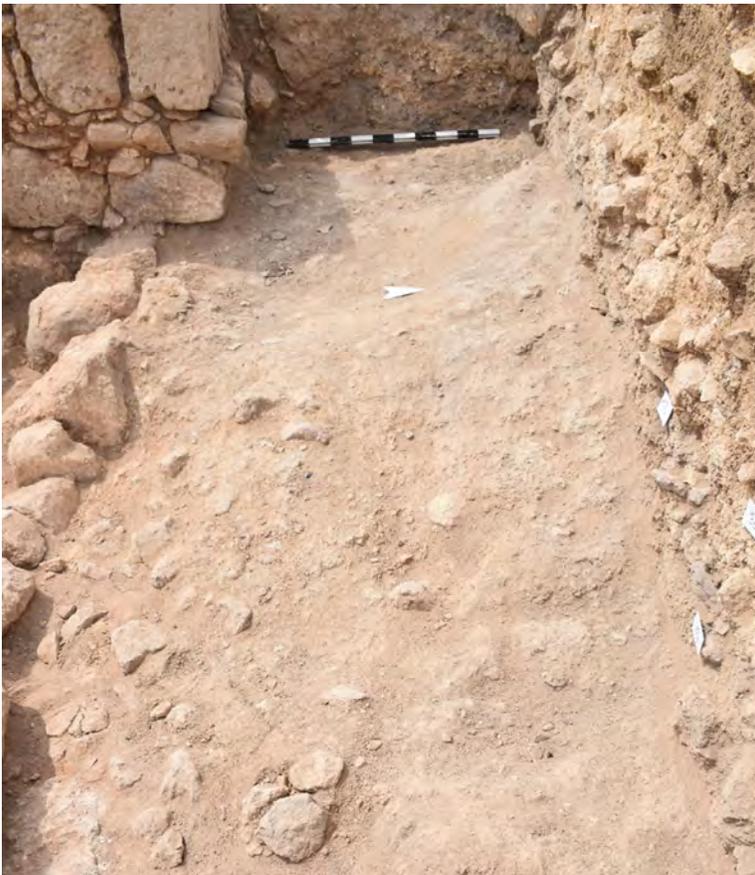
Fig. II.12. Layer 49 in sounding 3.

On the collapse SU53 were discovered two layers, SU49 and SU58. Both layers 49 and 58 were mixed alternately in the western part of sounding 3 in an unusual way, and then re-appeared at different levels and under the wall W67. Perhaps the reason for the mixing of these two layers (49, 58) was the existence of the huge stones inside layer 46, which affected the deposition of those two layers. Below layer 46, at the northwest of sounding 3, was discovered the layer 49 (fig. II.12). It was composed of pottery, charcoal, and stones and they looked like remnants of human occupation.

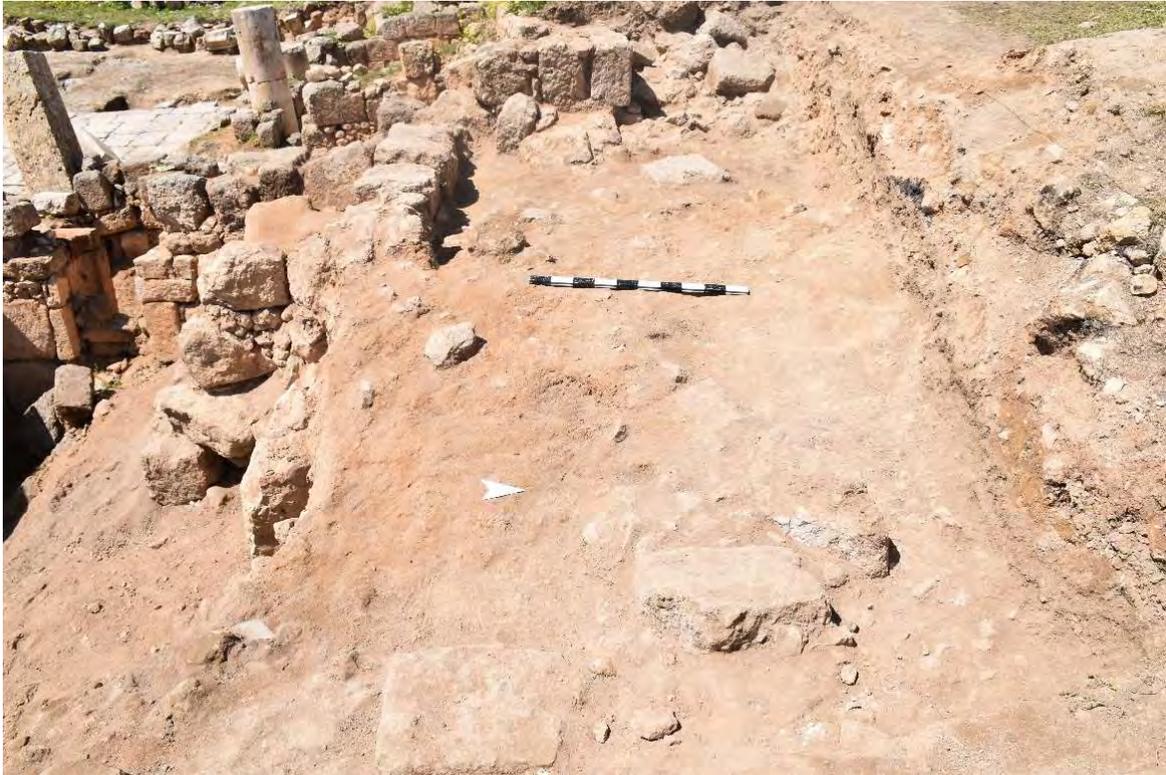
Fig. II.11: Dump layer 46 in sounding 3: to the west, the stone could have collapsed from the corner of W67.

Above layers 49 and 58, against wall W67 and below layers 36 and 40, one layer (SU46) covers almost all the area of the sounding 3 (6.65 m E/W, 4.70 m S/N). It is circa 0.40 m thick (top level: 98.90 to 98.10 m with a slope from the west to the east). It is a compact to loose reddish-brown layer composed of deposits, cobbles, and huge stones (fig. II.11) and was probably a dump layer with a lot of stones at the N-W of sounding 3. Those stones probably came from wall W67. It would explain why it was thicker and higher in the northeast of sounding 3, close to wall W67.

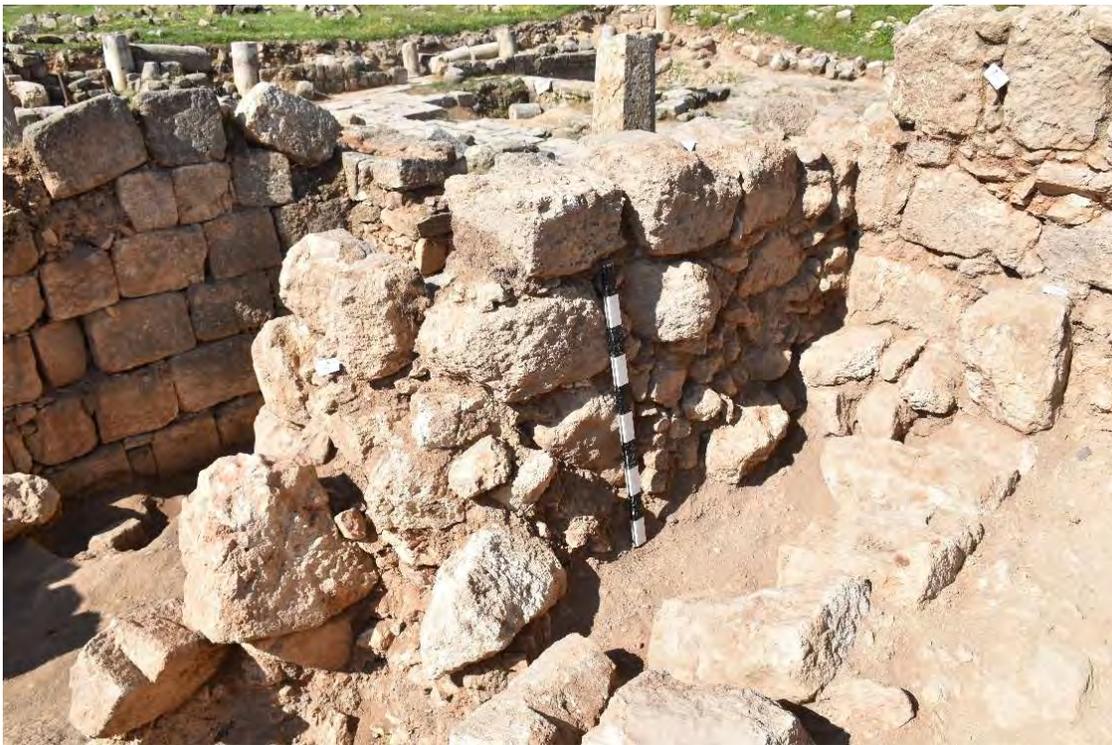
Fig. II.8: Corner between walls W45 to the right and W66 to the left, view from the northeast.

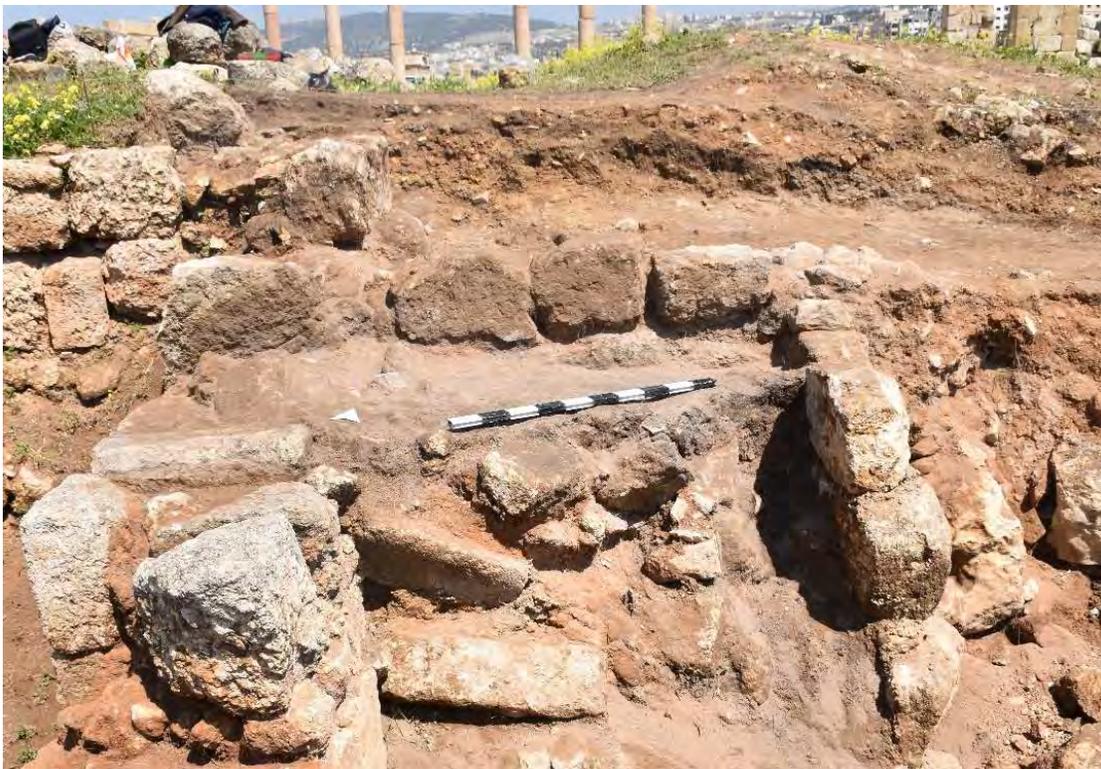
Fig. II.9: Burnt layer (41) in sounding 3

Inside the structure, or the room that walls W66 and W45 are forming, a fireplace, or a similar structure, was discovered. A burned layer (SU41) abuts against the southern facing of wall W45 and the western facing of wall W66 and covers wall W9 (fig. II.9) up to the base of the lower course of walls W45 and W66. Layer 41 is composed of ash, pottery, and small bricks from a tannur and is probably related to a fireplace. The dimension of the layer is 2.00 m E/W and 1.10-0.40 m N/S, with a height of 0.13-0.20 m (level: 95.81-95.55 m). Its color is dark grayish and its compaction is very loose.

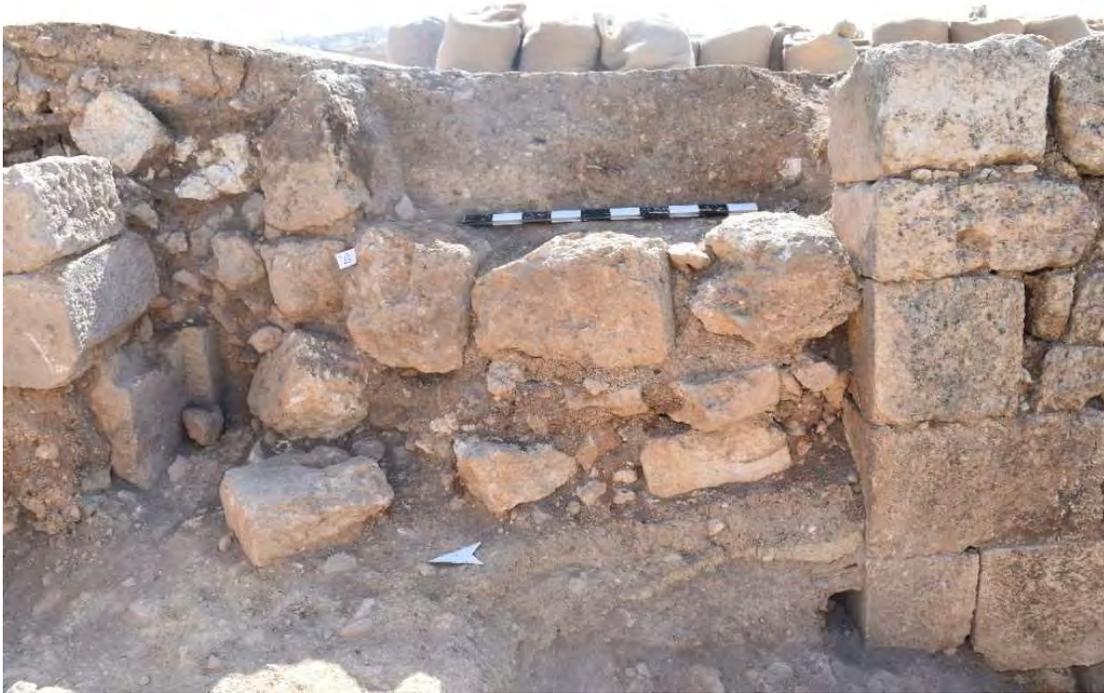
Fig. II.10: Door 65, the original door of wall W1, in the eastern wall of building A.
