Eastern Jarash Project: 2022 Final Report

EASTERN JARASH PROJECT

2022 FINAL REPORT

I. Framework of the project, objectives & first results

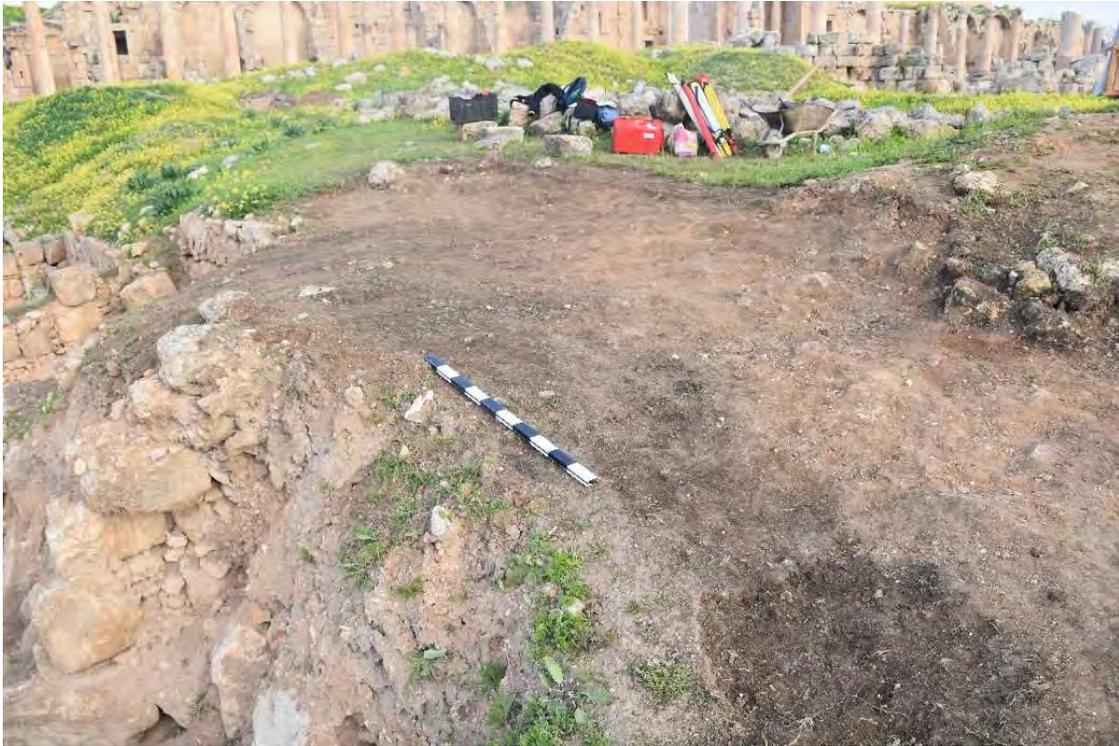
Fig. II.4. Layer 28 in sounding 3.

Upper layer 28 covered the entirety of sounding 3 (fig. II.4). It is a grayish-brown compact to loose layer, composed of cobbles, pottery, mixed deposits, and modern objects (length: E/W 6.65, S/N 4.70, width: 0.38 m, alt. 99.77 to 98.42 m).

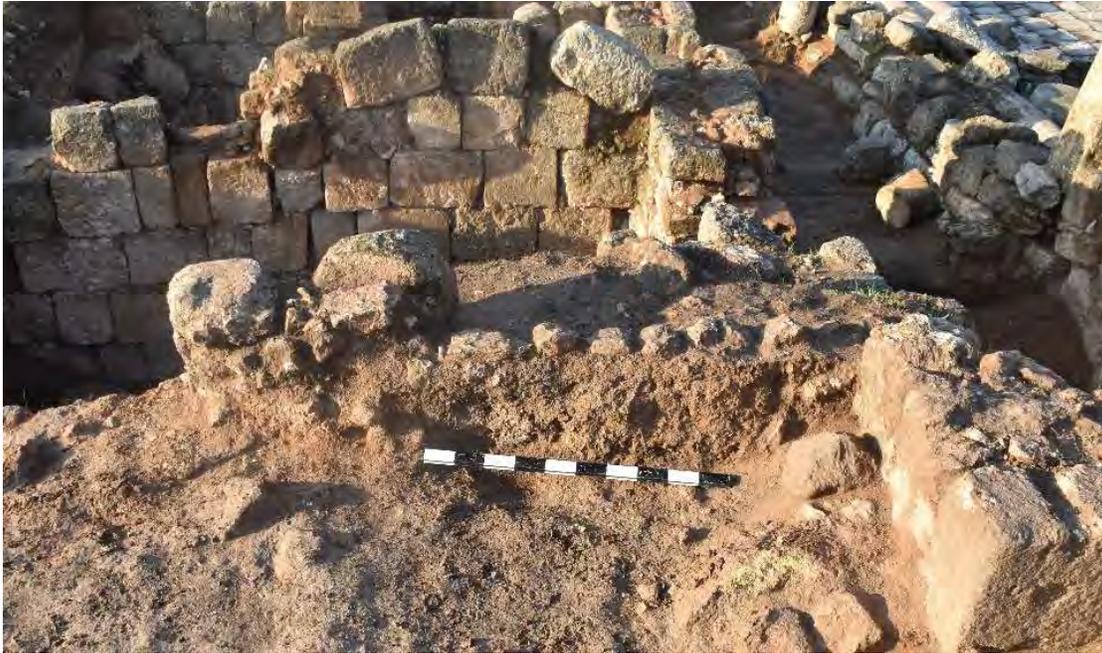
Fig. II.5: Wall W34 and layer 35 in sounding 3.

Under layer 28, wall W34 was discovered, built on top of layer 36 and wall W66. This simple wall was built of one limestone course of different sized blocks (fig. II.5), ranging from large to small, which were arranged in a straight row with an E/W orientation (dimension of 1.70 x 0.70-0.10 x 0.45 m, and level of 99.53 to 99.12 m). Four stones were set to form a double facing wall while the other medium to small seven blocks formed a simple stone lining. Furthermore, it had no base or foundation. However, the function of this wall and its connection to its surroundings is unclear; it might belong to a modern occupation phase or the stones could have been placed by previous excavators to delimit their digging area.

In the south and against W34, layer 35 was discovered, on an extension of 2.20 m E/W, 1.10 m N/S, and a width of 0.40 m (level: 97.59 to 97.19 m). This layer is probably an extension of layer 28. However, it is composed of dark grayish brown sandy compact to loose sediment and includes a few of pottery and cobbles, as well as modern objects (fig. 5). Layer 35 was distinguished from layer 28 because there is no real connection between them. They are separated by walls W45 and W34.

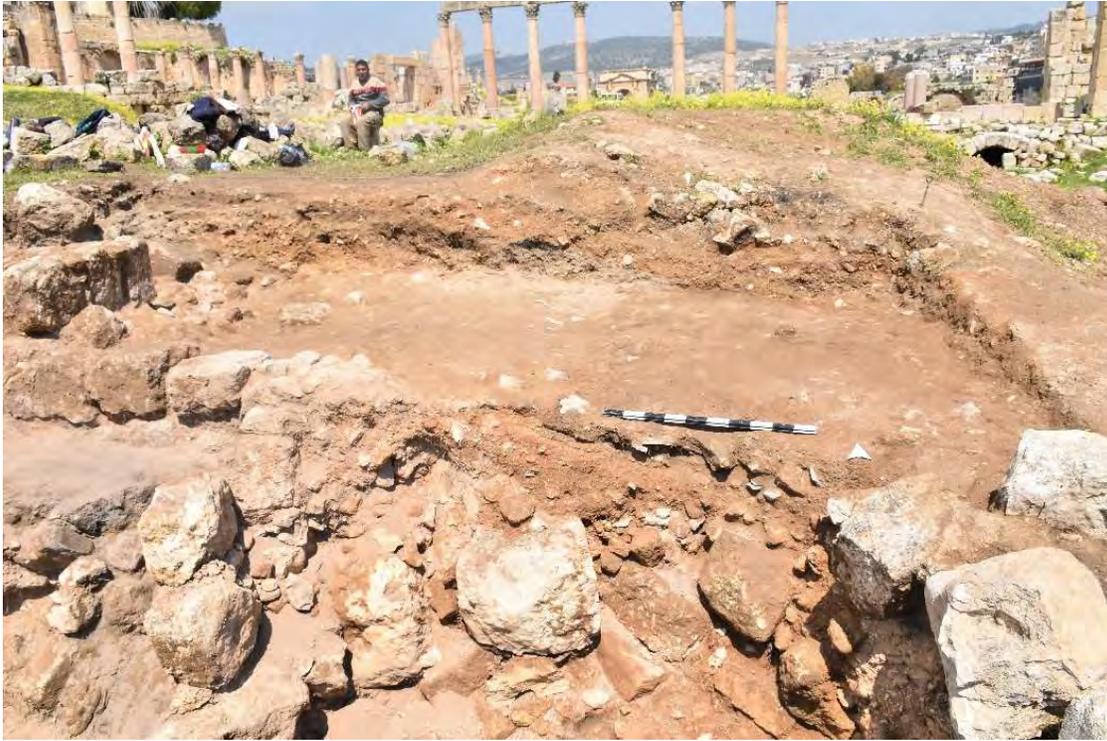
Fig. II.6: Layer 36, from the section, we note how layer 36 is the extension of layer 28, located above it.

Moreover, below layer 35 and wall W34, compact to loose grayish-brown layer 36 was found (fig. II.6). This layer is the extension of layer 28; same composition but with more pottery and cobbles to the east corner of sounding 3. It covered the entirety of sounding 3 (E/W 6.65 m, N/S 4.70 m, width 0.38 m, and level 99.50 to 98.12 m).

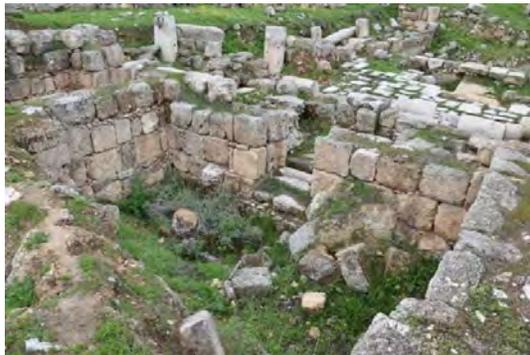
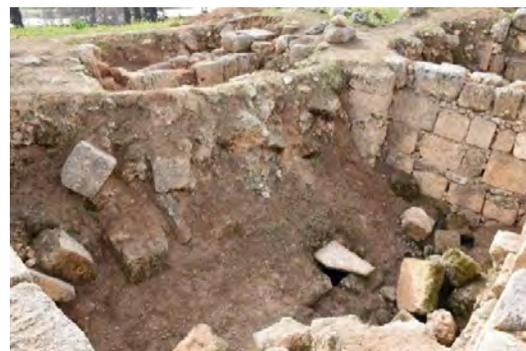
Fig III.1. Room R4 before excavation, view from the northeast (to the left) and baulk from the 2001 excavations after surface cleaning (to the right).

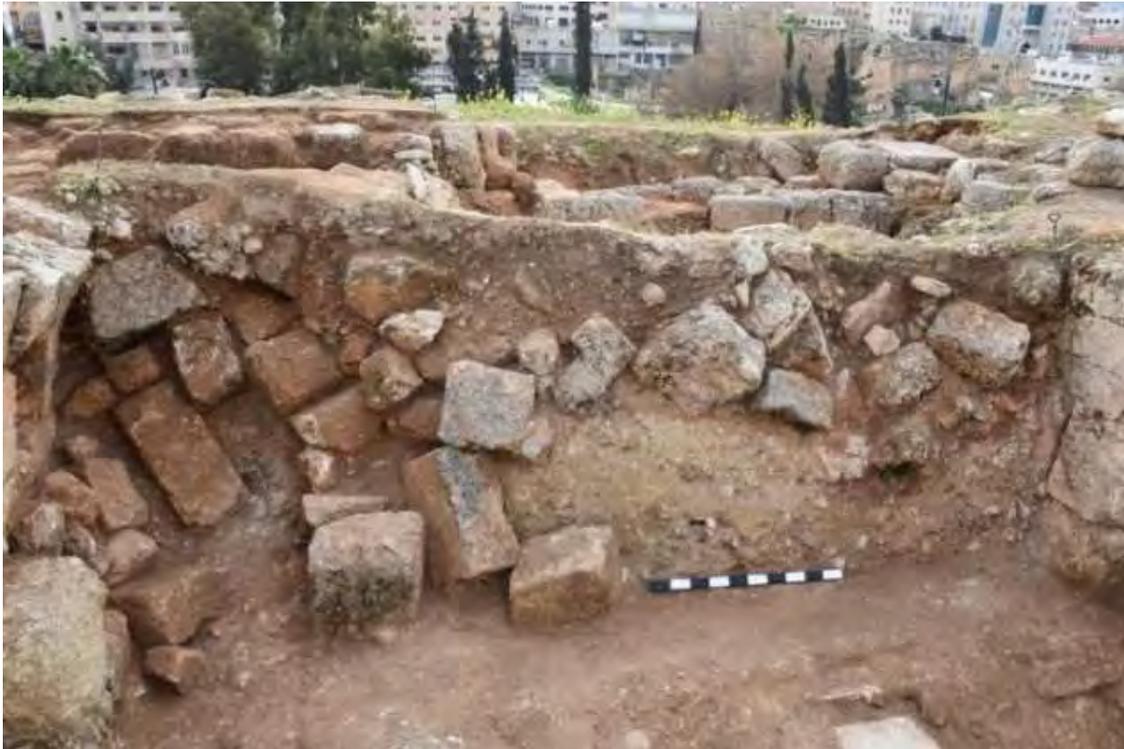
Fig. III.2. Bank from the 2001 excavations, remaining in room R4, after surface cleaning (to the left) and before drawing (to the right).

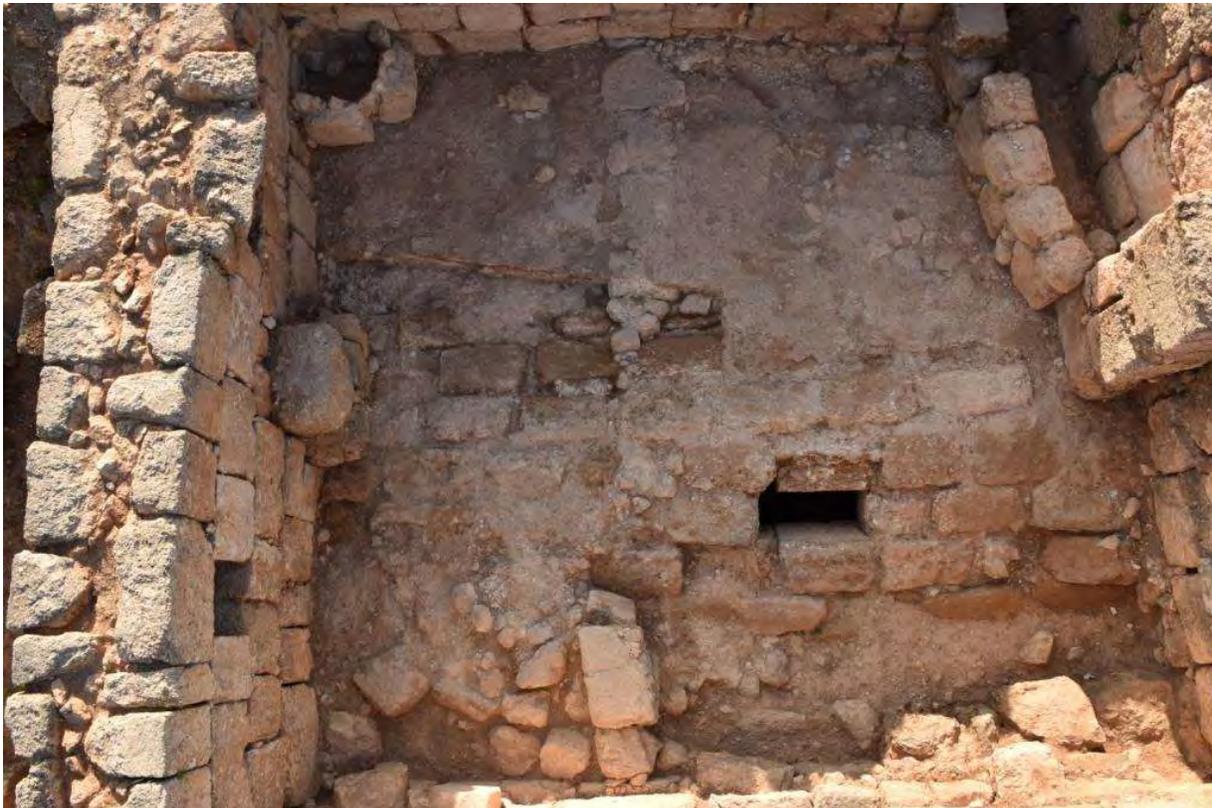
Fig. III.3. Zenital view of room 4 at the end of the 2022 excavations.

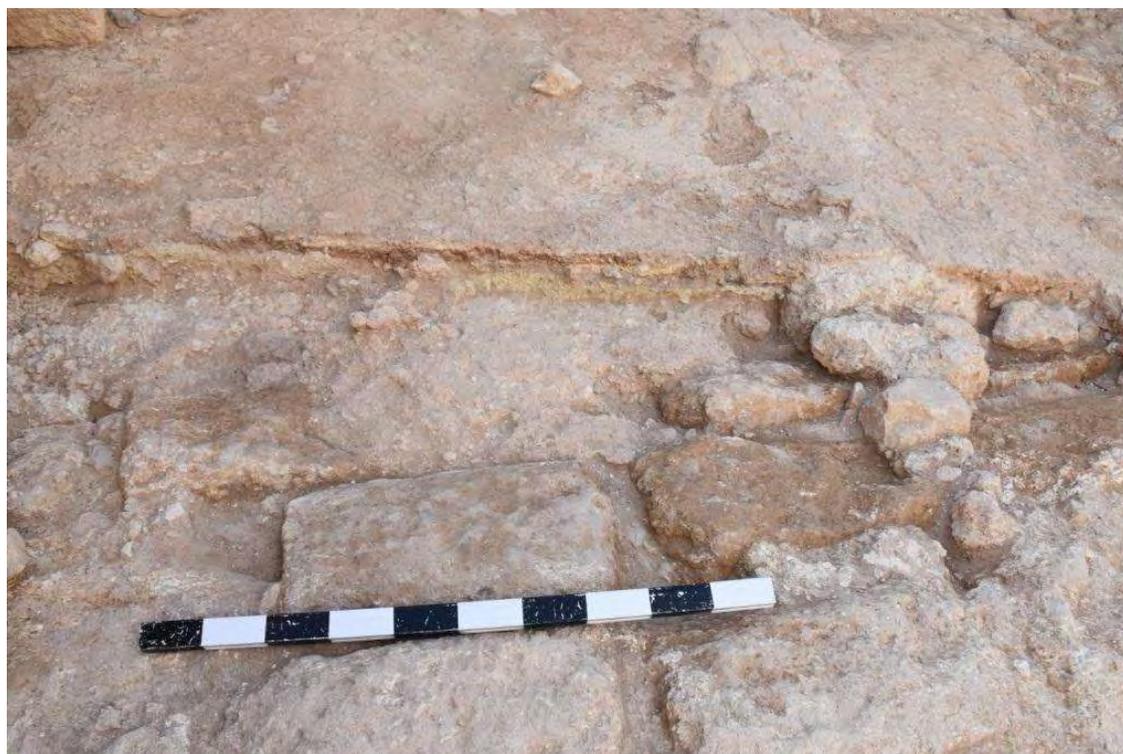
Fig. III.4. Earthen floor 56 consisting of numerous soils beaten on the vault's summit, view from the west.

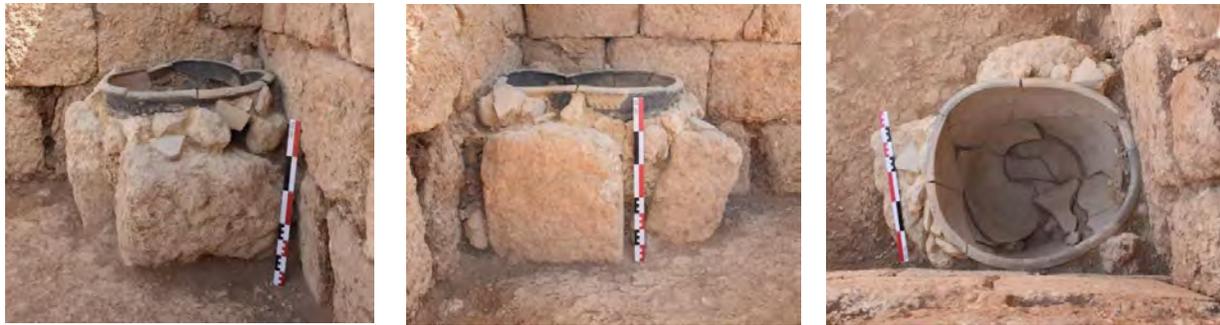
Fig. III.6. The basin in a stone structure (ST77) in the northeastern corner of room R4: a water trough?

In the northwestern corner of room R4, structure ST77 is composed of a large pottery basin held by stones (fig. III.6): the basin is placed, strictly in the corner, against eastern wall W1 and northern wall W5, and one stone was placed in the south, and another to the west to hold it. Small stones and sherds were wedged between the sides of the basin and the stones and walls to keep it in place (fig. III.6). Even broken, the basin is nevertheless complete. At the time of discovery, it was 0.54-0.60 m diam. and c. 0.40 m deep (level of the base 96.51 m; top level of the lip 96.92 m). The basin is a type of Umayyad basin in black fabric with two handles and combed waves decoration under a triangular rim probably produced in Jarash, the Jarash Light Grey Handmade Ware (see Pappalardo's report, p. 76-83). The stone structure is between 37-45 cm high (level of southern stone 96.78 m; level of western stone 96.84 m) and square-shaped measuring 1.60 N/S x 1.35 E/W m. At the foot of the western side of structure ST77, a layer of preserved manure was also found. It measures 1.58 m E/W and 1 m N/S (fig. III.6). Its extension to the west is unknown since it was excavated by the previous team. The layer is 0.14 m thick (top level 96.43 m; bottom level 96.49 m). It comes against the western side of the structure ST77 and wall W5 and lies on floor 56. This layer (SU55) is characterized by light brown sediment very thin, loose, soft, and almost without inclusion. Its texture is symptomatic of the manure and it would indicate that animals would have used this room, in particular the basin, maybe as a water trough.

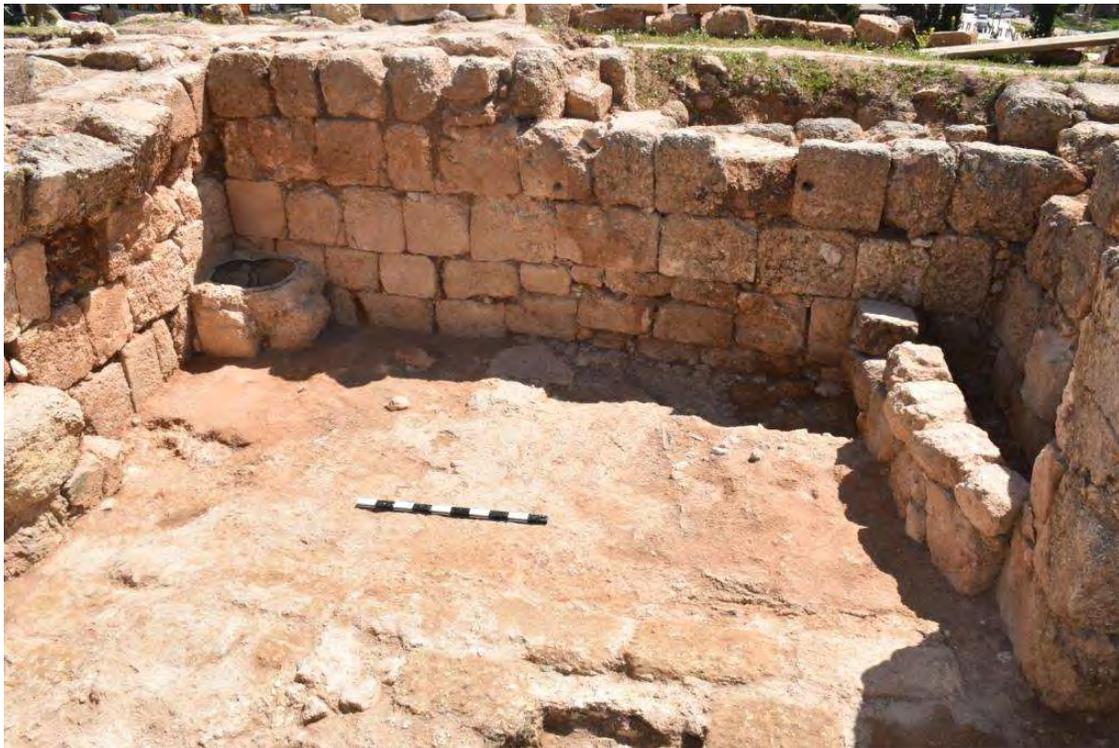
Fig. III.7. Room R5 with burned manure (SU55) at the foot of structure ST77, and another layer that could be manure (SU54) at the foot of ST78, on earthen floor 56.

In the southeast corner of room R4, structure ST78 is composed of a low wall that closes an area of c. 0.5 m wide between it and southern wall W6 (fig. III.7). The wall, 2 m long and 0.3 m wide, is built by a simple row of large rubble stones. It is preserved over two courses. It abuts the eastern wall W1 and the southern pillar (ST?). Holes in the wall could have been pierced to place wooden equipment for a trough. Rope holes to tether animals. Holes were also pierced in the corners of the southern pillar to tie animals using ropes (fig. III.7). Along the structure, a layer of loose granular brown sediment with small gravel was preserved. Its texture is different from the manure deposit (SU54).

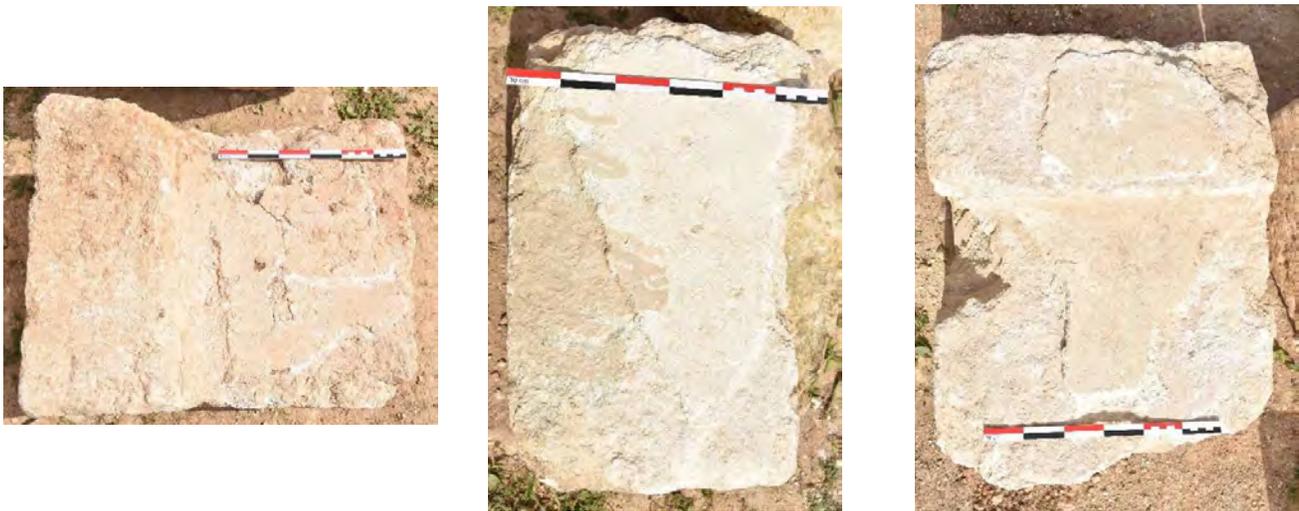
Fig. III.8. Coated stones discovered in the walls' collapse inside room 4.

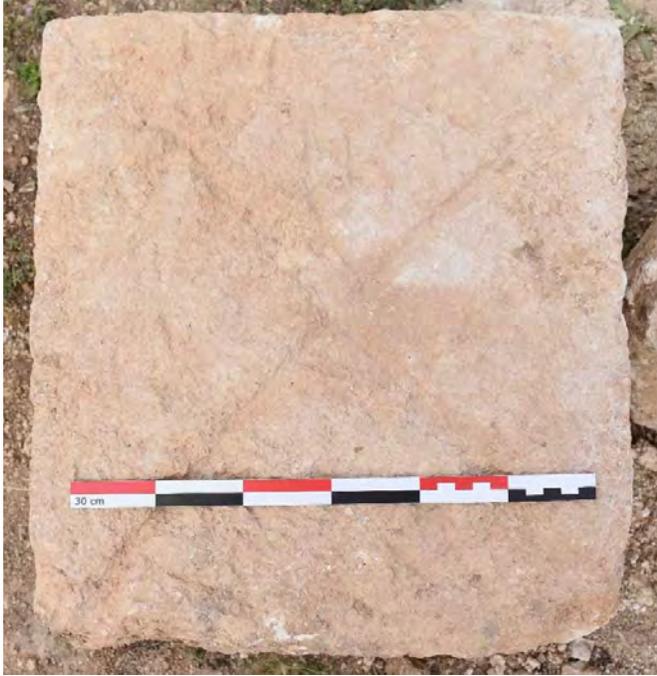
Fig. III.9. Carved stones discovered in the walls' collapse inside room 4.

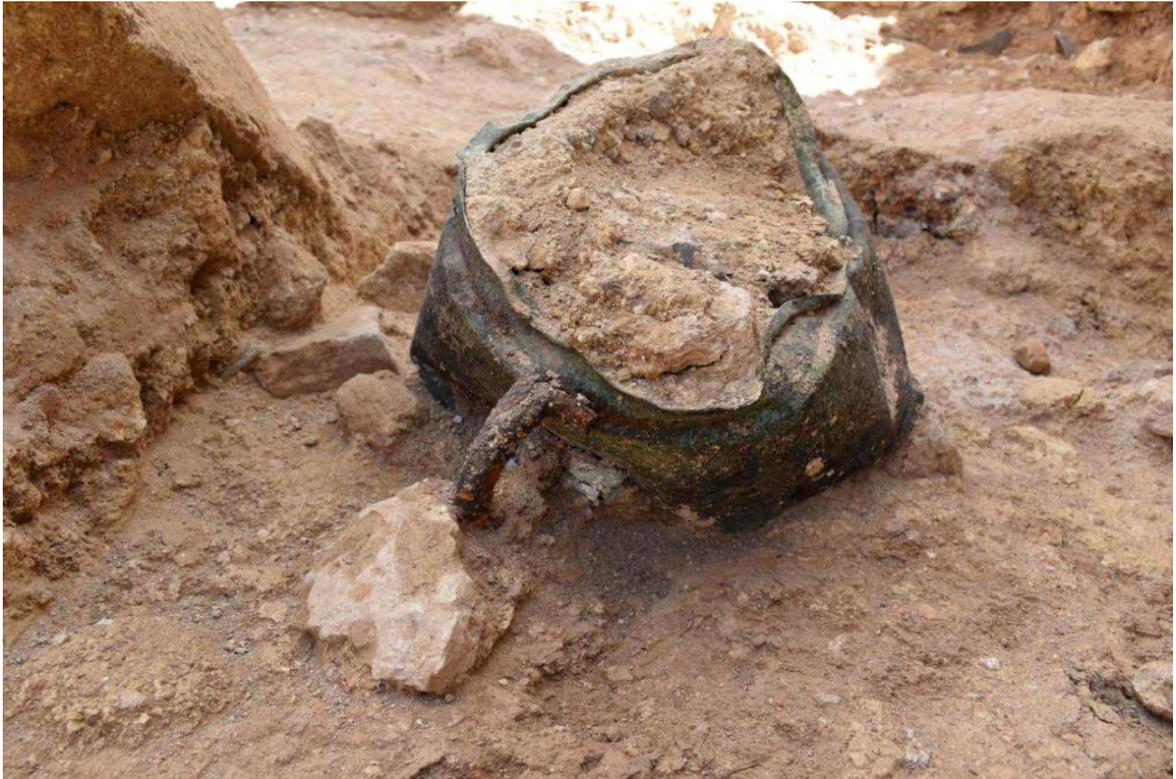
Fig. IV.3. Copper pot (number EJP22-A-065) laying on floor SU69 of room R5.

An earth floor SU69 (top level: 96.77 m) was unearthed in room R5 directly under the collapse layer SU62. But as the time of the project was limited, the removal of the whole SU62 was not possible and only a small part of the floor has been uncovered yet (E/W1.20 N/S 0.90 m), where a copper pot was discovered (object number EJP22-A-65) in the southwestern corner of sounding 4C, approximatively in the middle of the southern part of the room. It was discovered in the last days of the campaign, during the excavation of collapse SU62. The decision was made to excavate around it to be able to remove it as a block to avoid looting and this is why the earthen floor of room R5 was only reached in this part of the sounding. It seems that the copper pot was set on the floor when the collapse happened. One of the stones fell on it and it got bent. It may have allowed sediment to go beneath the pot. The copper pot has been removed with its filing, to be analyzed. The earthen floor was a fine brown compact sediment, probably very similar to the earthen floor found in R4 (see in this report). It was not excavated. In the part of the room

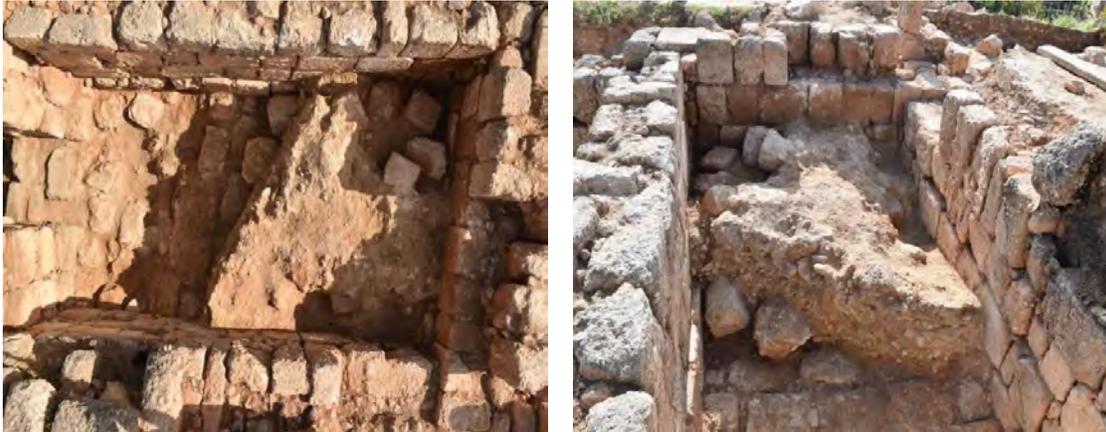
Fig. IV.4. First collapsed layer SU62 inside room R5.

Above SU50, another collapse layer was excavated, SU62. It is a heterogeneous layer mixed of stones, that probably collapsed from surrounding walls, and mixed-colored sediment, mainly yellowish, but also reddish and orangish. The stones are of various sizes. This stratigraphic unit was higher in the middle and sloped down towards the edges near the walls. This hill shape is probably related to the collapse of the walls and the floor of the upper storey that mainly fell in the middle of the room. The frequency of artifacts in this layer was very high, especially when it comes to pottery. Their positioning in the layer suggests that it probably fell from the upper storey at the time of collapse. That room probably was used as a kitchen or a kind of storage room. From the preliminary analysis at the site, most of the pottery from this layer seems to be from the early

Islamic period. In addition to the pottery, there was also a lot of metal, colored plaster, and some kind of carbonized material which might be carbonized leather. This layer was excavated on c. 2.60 x 2.60 m. It was most probably covering all of room R5, but half of it disappeared during the excavation of the western part of the room by the previous team.

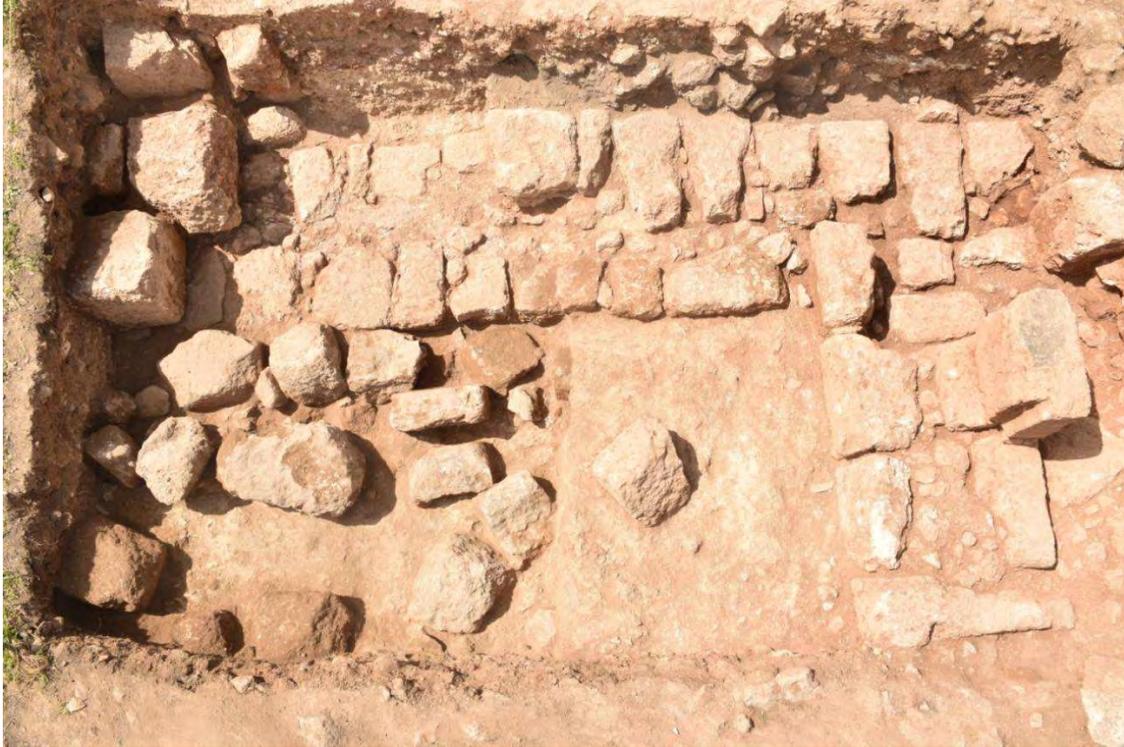
Fig. IV.5. Walls W1 and W44 and layer SU51 partially excavated and the upper part of the collapse, located in the external part of the building at the eastern side of building A.

SU51 is the first deposit covering the collapse of the earthquake. It covers most of sounding 4A. It is a mixed dark brownish layer with frequent yellowish patches. It includes different-sized stones including structural wall stones, that have collapsed before or at the same time as the deposition of the layer. The yellowish patches in it might have occurred from the decomposition of plaster or mortar fragments that later got mixed with sediment. This layer was not fully excavated since the aim was to check the extension of wall W1. A small part of this layer was excavated in sounding 4B. As wall W1 appeared with its collapsed blocks next to it, from the eastern side, the decision was to stop the excavation at this level and move to excavate other parts of the sounding; we note that the sediment got more yellowish at this level. This layer may still be extending further below the excavated level. The presence of this yellowish color in the deposit might have been the result of the decomposition of plaster and mortar fragments that were trapped under the sediment of the layer above. To be on the safe side, the layer got a new stratigraphic unit number SU68, since it was not fully excavated. The frequency of the artifacts was also low in

layer SU51. The dimensions of this layer were around 3 x 1.5 m (top level 98.69 m). It is also located under SU42. After its removal in sounding 4B, the rest of wall W1 was uncovered.

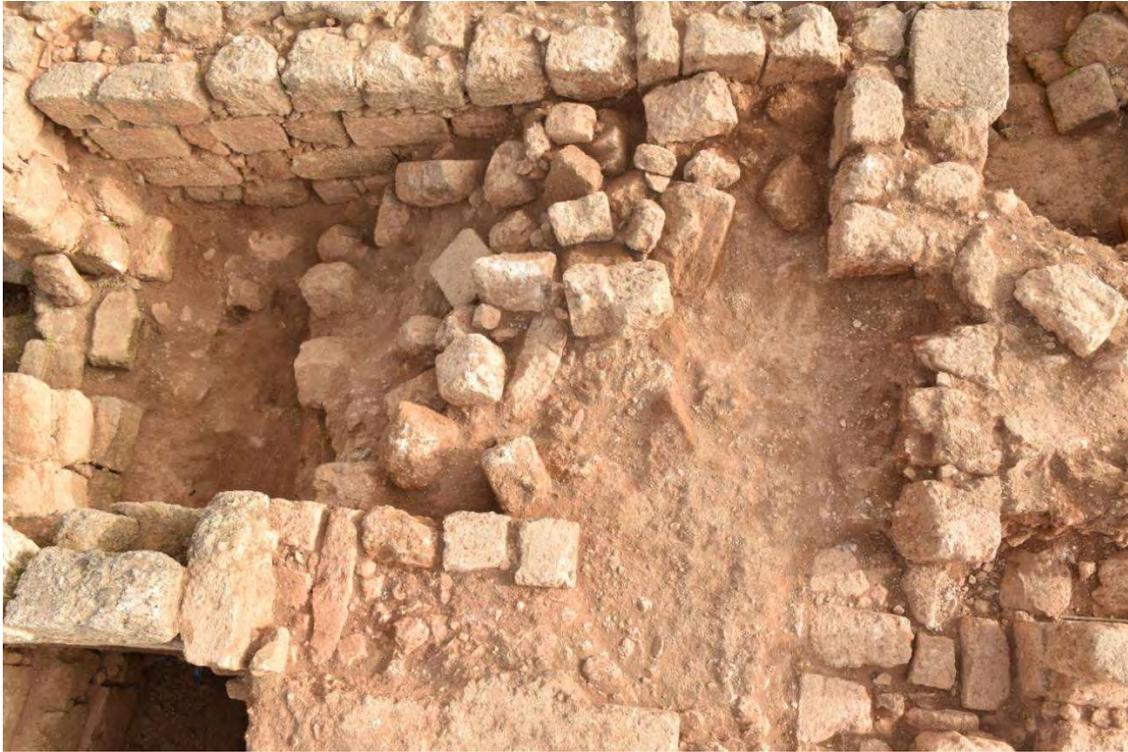
Fig IV.6. General view of the reddish compact layer (SU42) covering the upper part of the collapse, before excavation in room 5.

SU42 was a compact reddish layer with brownish patches. It seems to be covering most of sounding 4 except the southeastern part of the sounding. It was found in sounding 4A and 4C (see section 6) and we can suppose that it is also running inside room R6. Stones of all size were found inside the layer; it is probable that these stones belong to the phase of the collapse of the building since the main layer of collapsed blocks is just situated on top of it, which makes it a filling deposit. It is a very thick layer (around 0.5 m in sounding 4C) that thins down towards sounding 4A (around 0.10-0.15 m). The frequency of artifacts is very low as well. It is located under SU43, SU37, SU32 and SU31, and above SU51 and SU62. It covers walls W1 and W76. Only a small part of SU42 appears in the drawing of section (section 6).

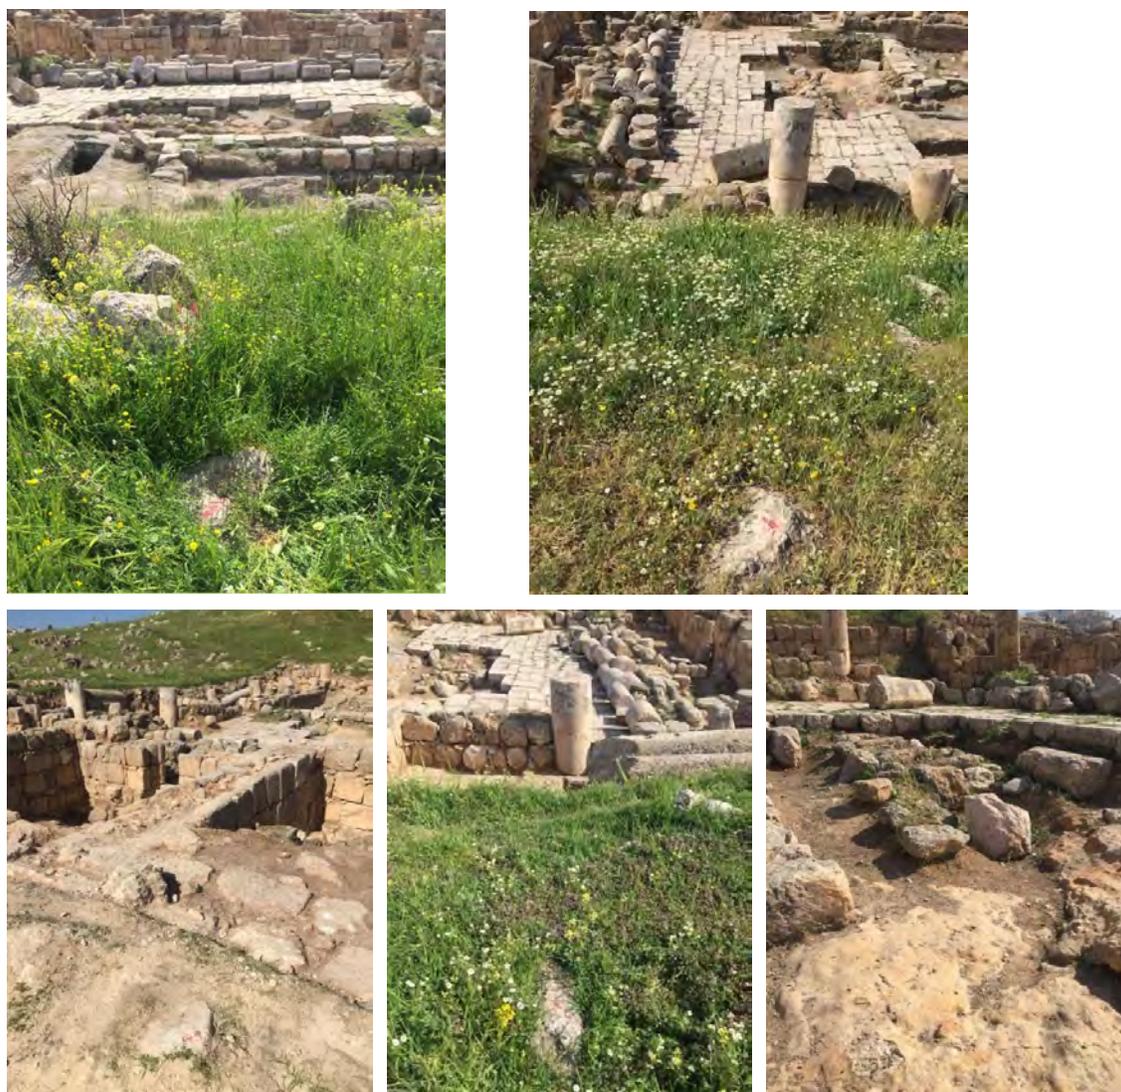
Fig. VI.1. The 5 points (S1-S5) of the local system.

Point ID	X	Y	Z
SDoA	942.724	1062.889	125.708
S0	966.673	914.937	104.128
S1	977.888	938.928	99.297
S2	997.535	956.146	100.087
S3	1010.257	940.153	98.524
S4	995.571	925.739	98.970
S5	991.971	937.799	96.368

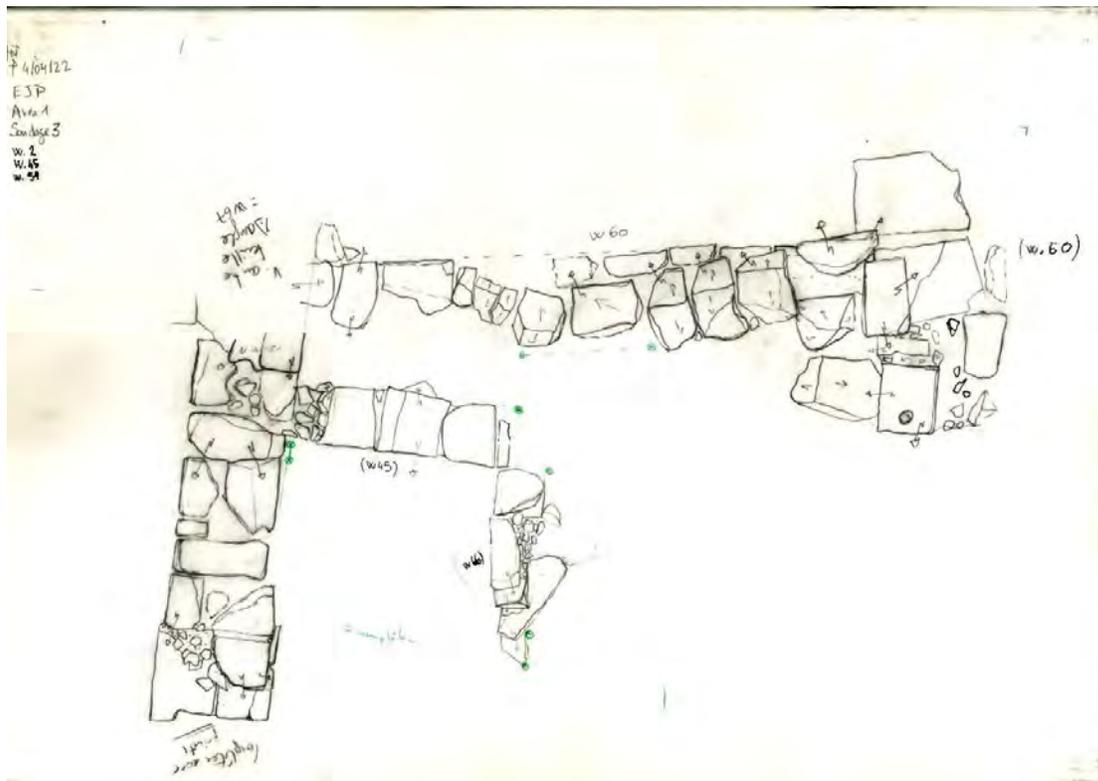
Fig. VI.2. Example of a “stone by stone” design made during the 2022 campaign.

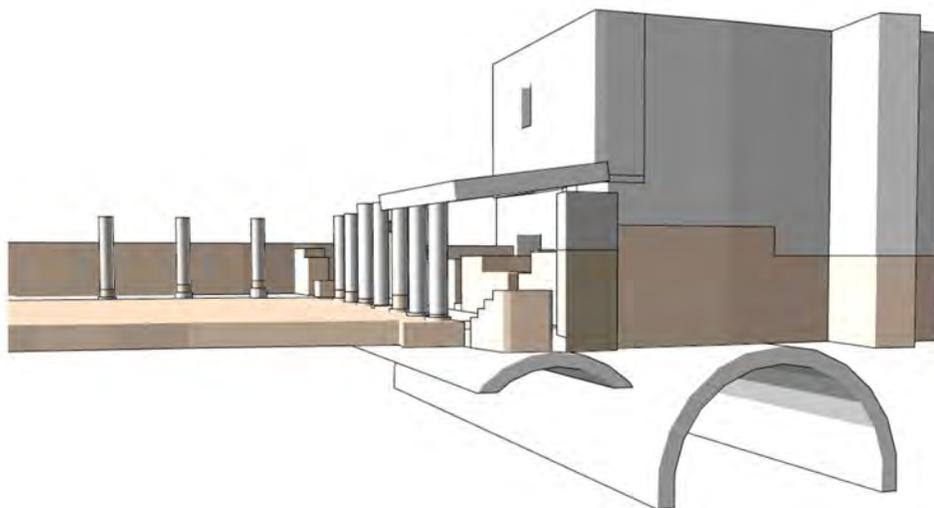
Fig. VI.3: Partial restitution of the retaining vaults

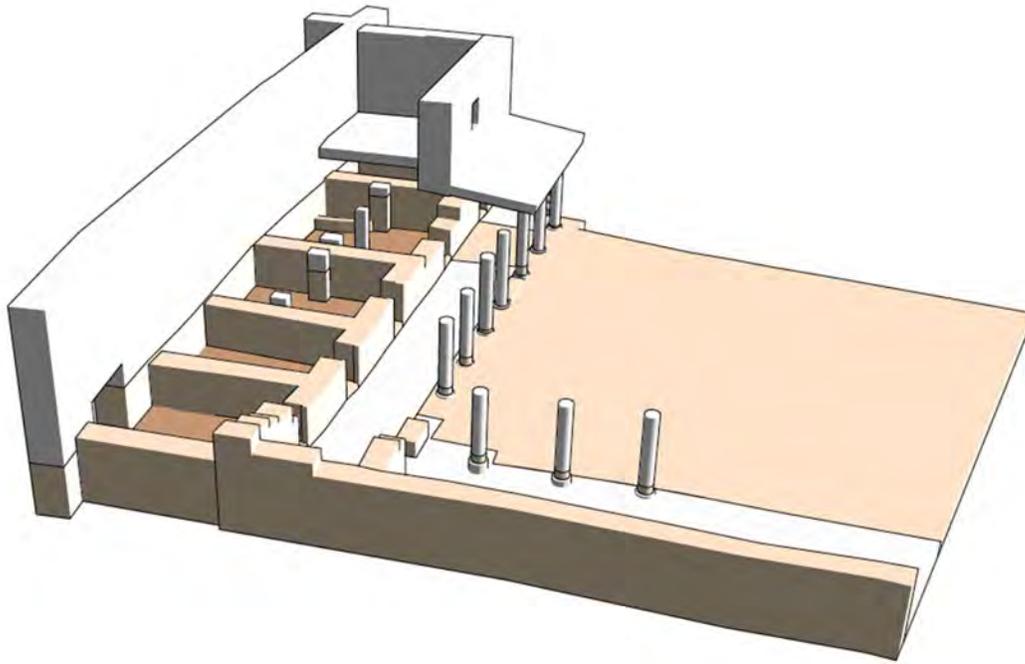
Fig. VI.4: Partial restitution of the building and the portico

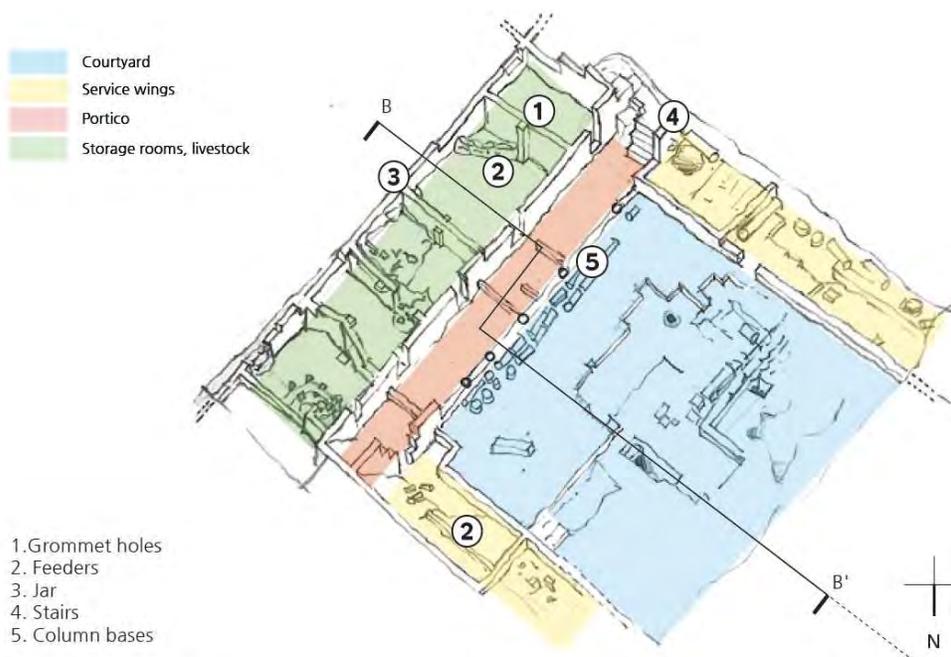
Fig. VII.1. Functional distribution of building A

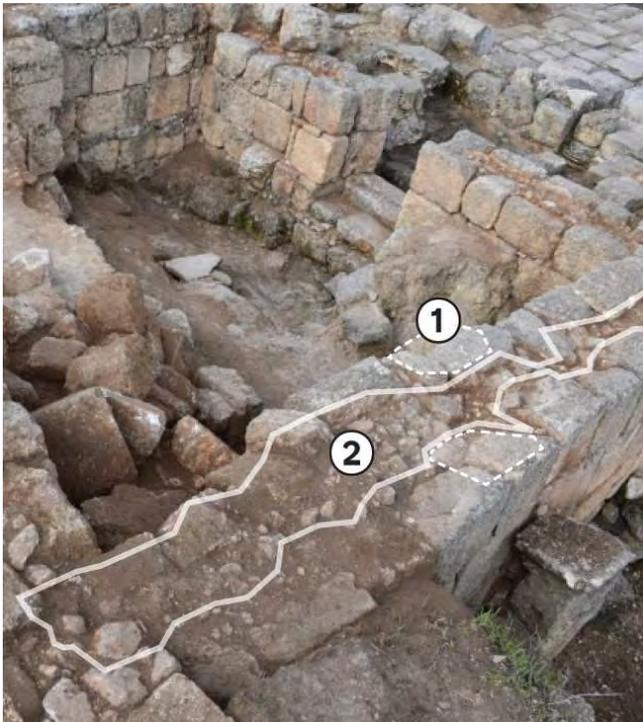
Fig. VII.2. Example of masonry implementation (wall W3)

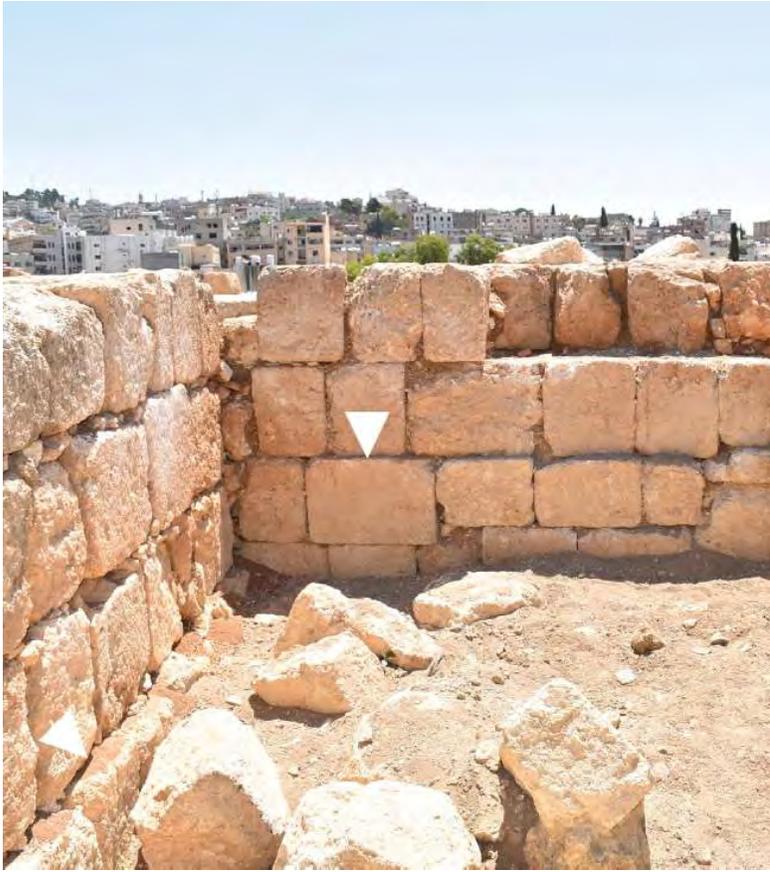
Fig. VII.3. Protruding block in the eastern and northern walls (W1, W6) of room R5

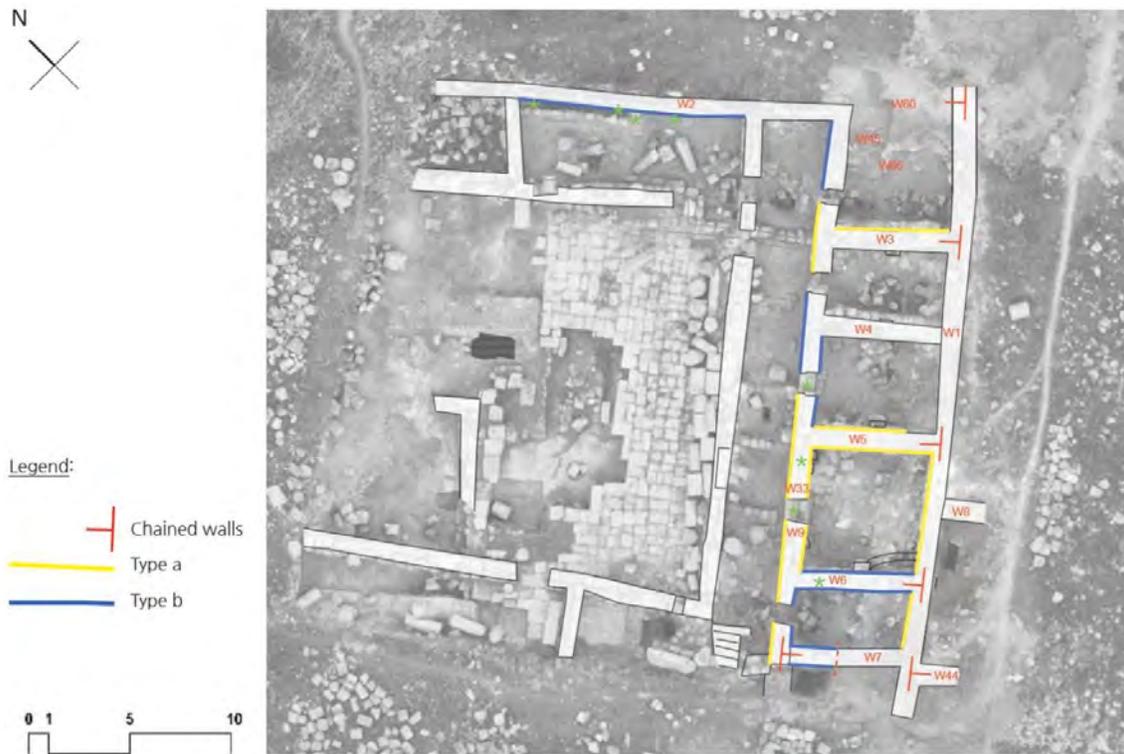
Fig. VII.4. Distribution of wall types

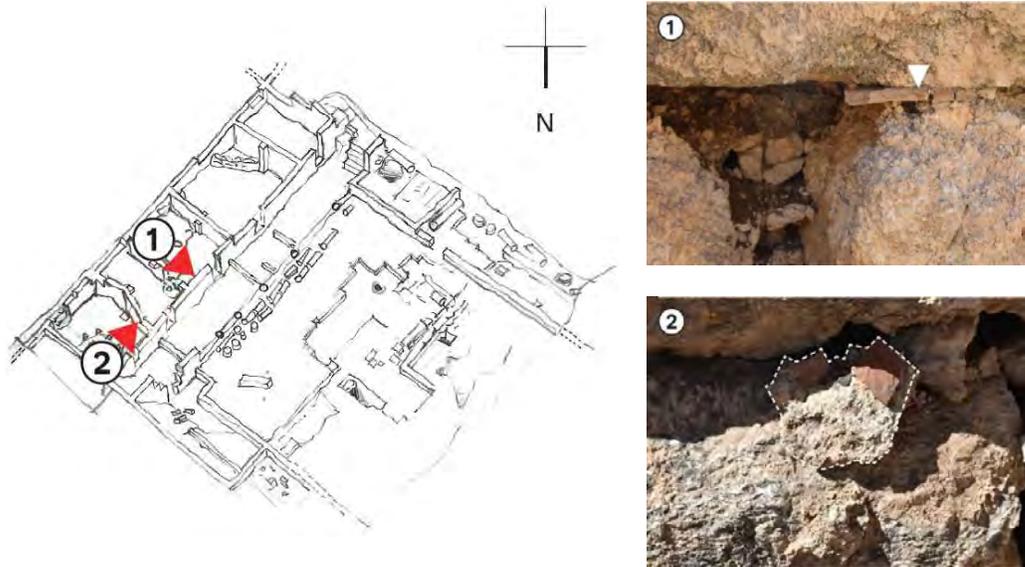
Fig. VII.6. Location of visible mortars (to the left); earthen mortar with pieces of ceramic sherds in wall W9 (to the up-right); lime mortar with ceramic pieces on the surface, tiles, coal and egg shells wall W3 (to the bottom-right).

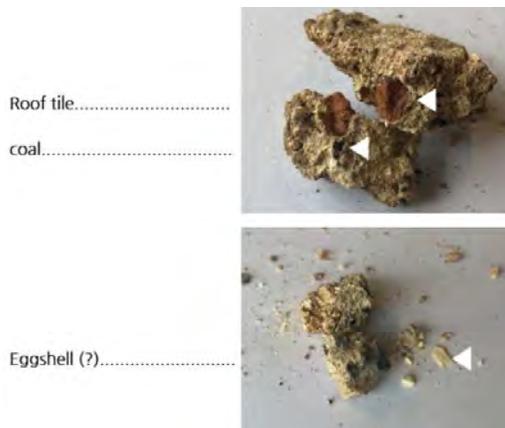
Fig. VII.7. Mortar details of samples from the wall W3

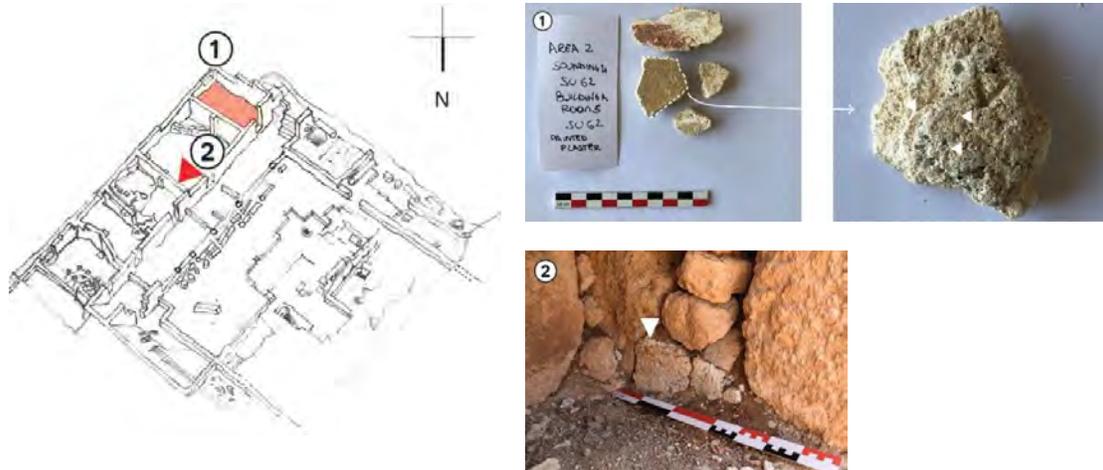
Fig. VII.8. Location of visible plasters (to the left), fragments of smoothed and painted lime plaster and reverse side of the plaster fragment (to the up-right); lime plaster in place in the northern niche of the room R4 (to the bottom-right).

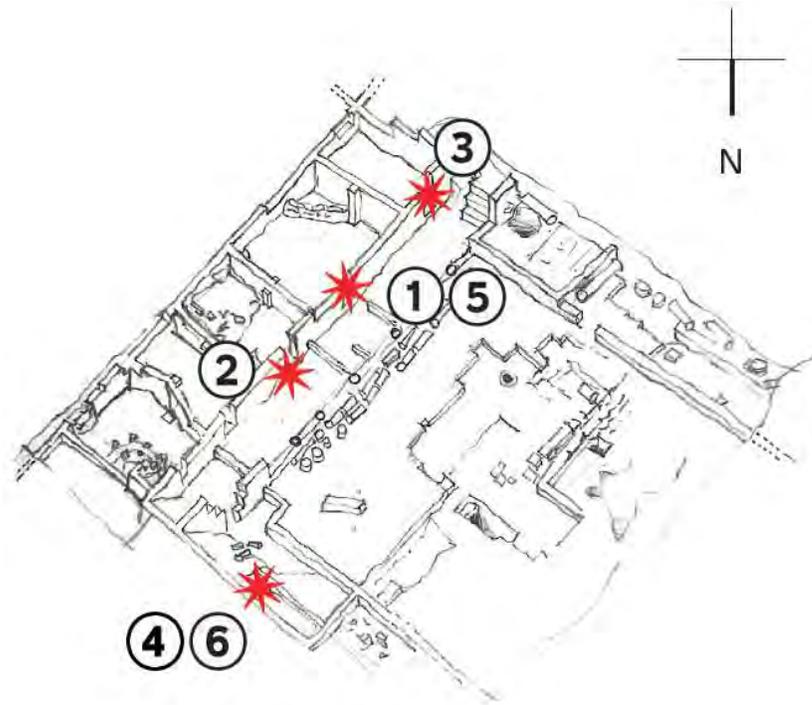
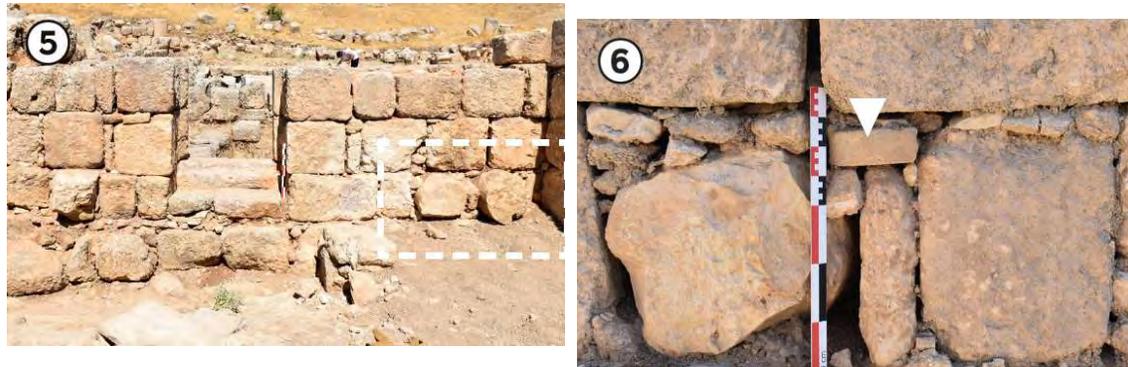
Fig. VII.9. Visible re-uses: 1) Cornice reused as a threshold in wall W9 (room R4); 2) Cornice reused as a threshold of room R3's door, in wall W9; 3) Cornice (?) reused in the masonry pattern of wall W6 (room R5); 4) Bonding column reused as masonry ties wall W2; 5) Bonding column in wall W9 (room R4); 6) Terracotta brick from a hypocaust pile reused as a seat adjustment element wall W2.
