Eastern Jarash Project: 2022 Final Report

EASTERN JARASH PROJECT

2022 FINAL REPORT

I. Framework of the project, objectives & first results

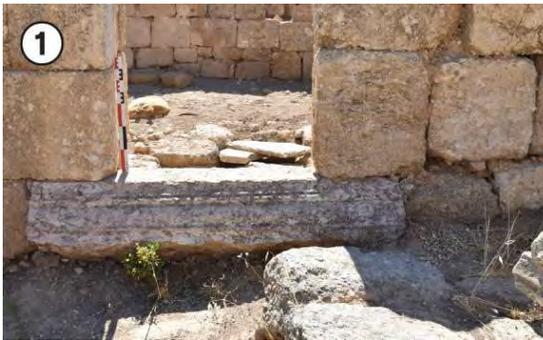
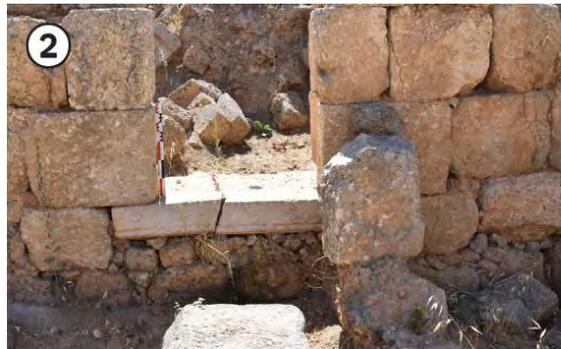
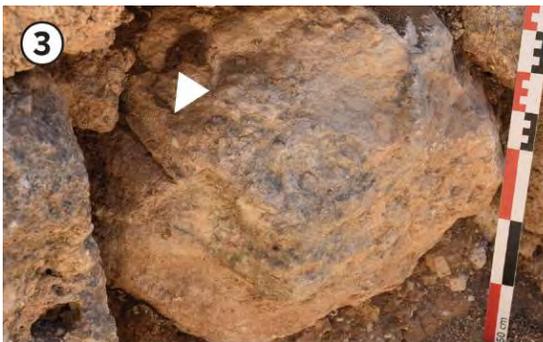
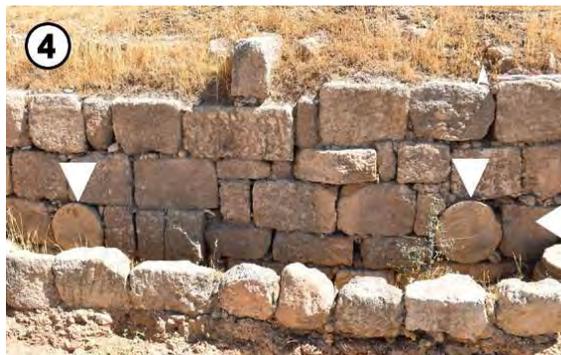
Fig. VII.9. Visible re-uses: 1) Cornice reused as a threshold in wall W9 (room R4); 2) Cornice reused as a threshold of room R3's door, in wall W9; 3) Cornice (?) reused in the masonry pattern of wall W6 (room R5); 4) Bonding column reused as masonry ties wall W2; 5) Bonding column in wall W9 (room R4); 6) Terracotta brick from a hypocaust pile reused as a seat adjustment element wall W2.

It is difficult to know whether the large blocks used in the majority of the masonry of building A are reused blocks. Nevertheless, the identifiable re-used architectural elements are abundant (Fig. VII.9) and can be classified into three categories: entablature elements, column elements, and masonry modules. Entablature elements were reused for the thresholds in rooms R4 and R3, therefore it is easy to imagine linear cornices cut into blocks to form a monolithic threshold with modenature. The drums of columns, which were easily identifiable on the elevations, were used to chain the masonry. Other elements were also reused, particularly in mixed masonry with cobbled courses. Brick modules were often used as spacers between the stone blocks, or terracotta fragments were used as a mixture in the mortar.

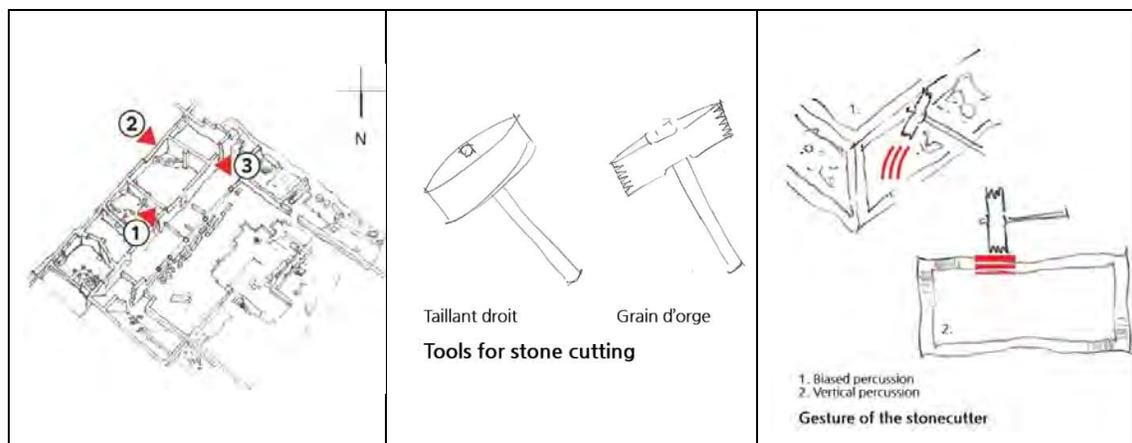
Fig. VII.10. Location of visible tool marks (to the left); Tools for stones cutting (in the middle); Gesture of the stonecutter (to the right).

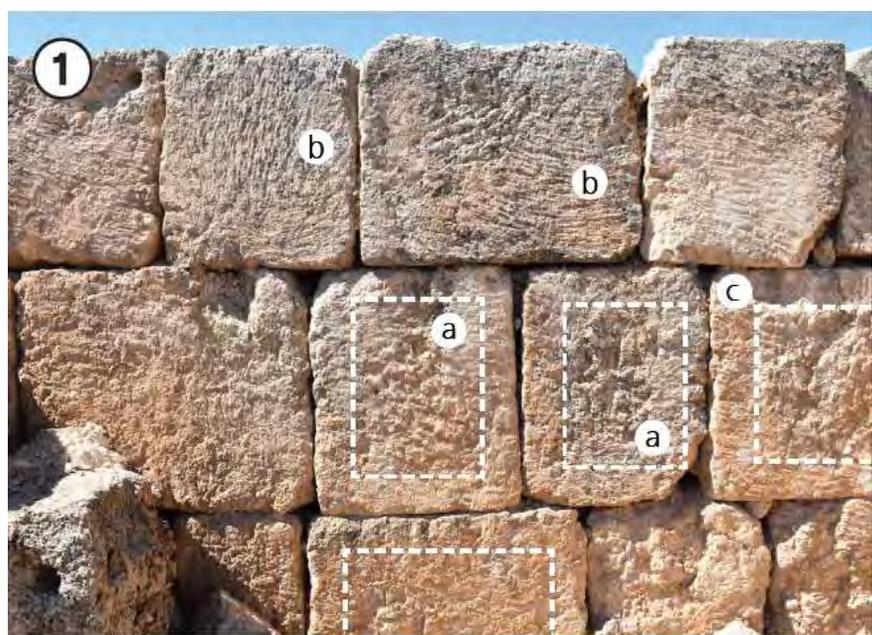
Fig. VII.11. Different techniques on wall W5 (room R3): a. Facings erected with a pickaxe, b. Facings erected with a straight edge, c. Peripheral chiselling.

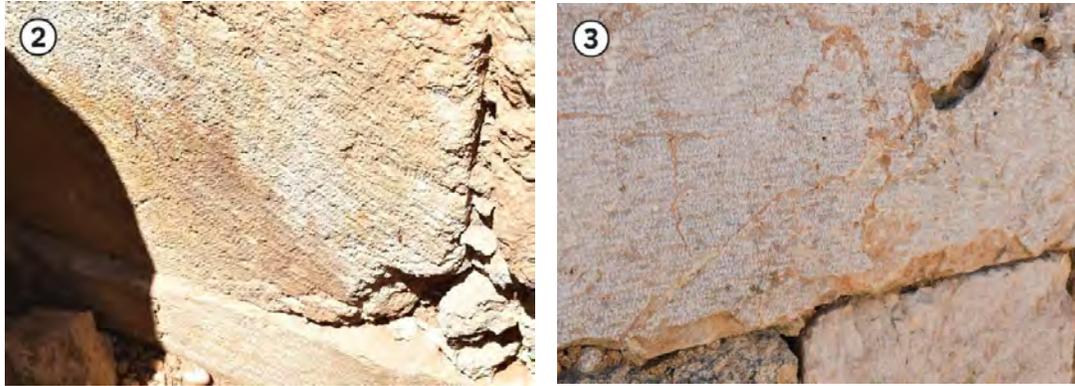
Fig. VII.12. Wall W9 (room R5): the “*marteau grain d’orge*” (serrated) used in biased percussion (to the left) and in vertical percussion (to the right).

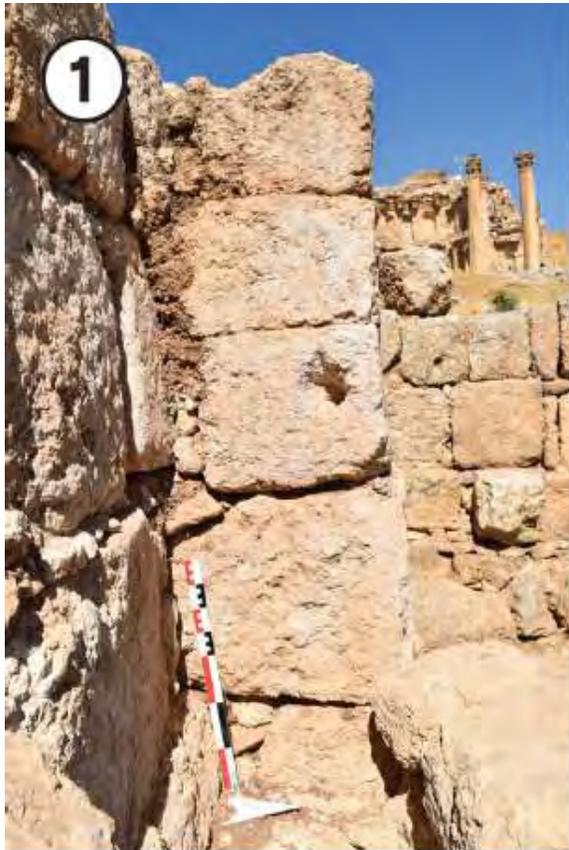
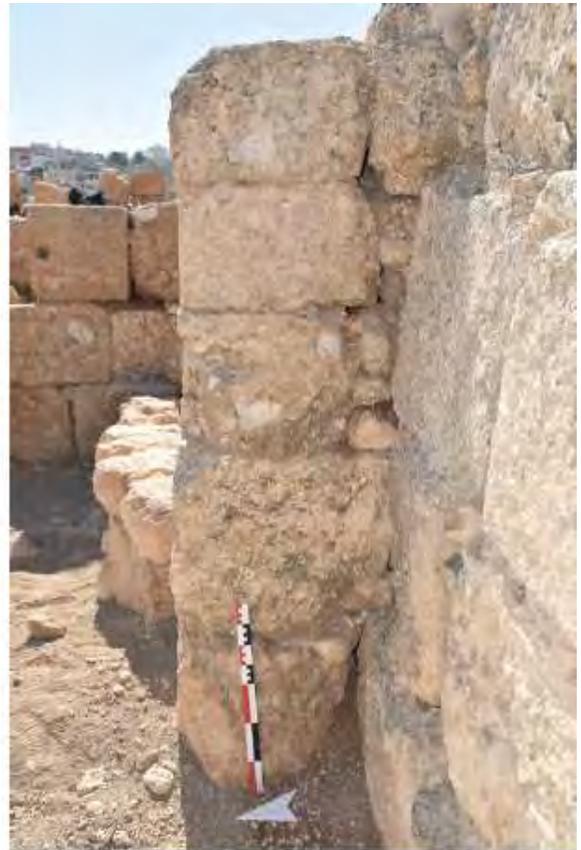
Fig. VII.13. East and west elevation of the south pillar of room R4.

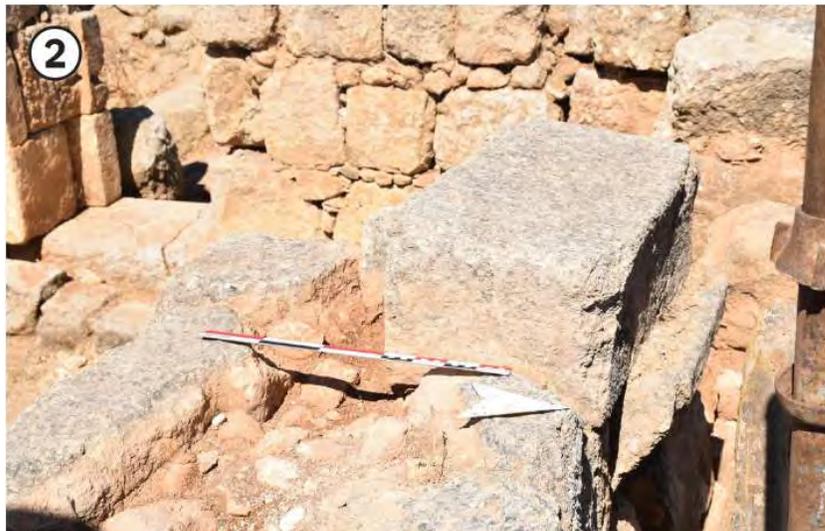
Fig. VII.14. First starting blocks of the arch in room R2.

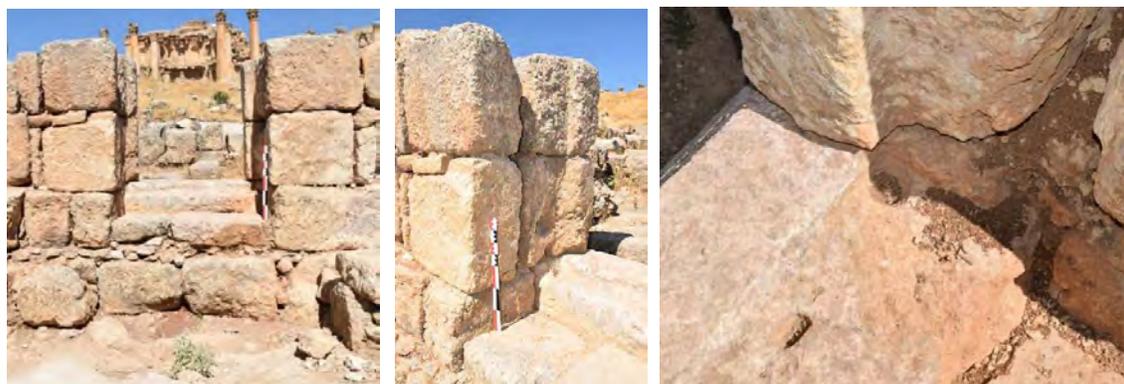
Fig. VII.15. To the left, elevation of the access bay in room R4; in the middle, the door rabbet in room R4; to the right, door sockets.

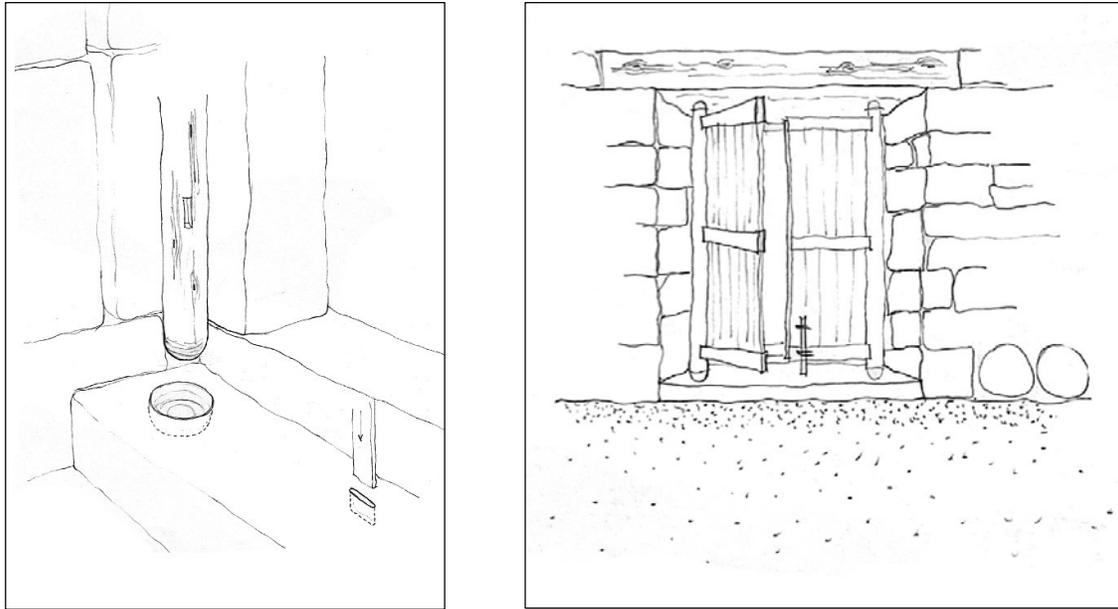
Fig. VII.16. To the left, door details: stone threshold with a doorsocket, a pivot of a wooden door leaf, and the cavity for door block (?); to the right, hypothesis for the return of a two-leaf closing mechanism

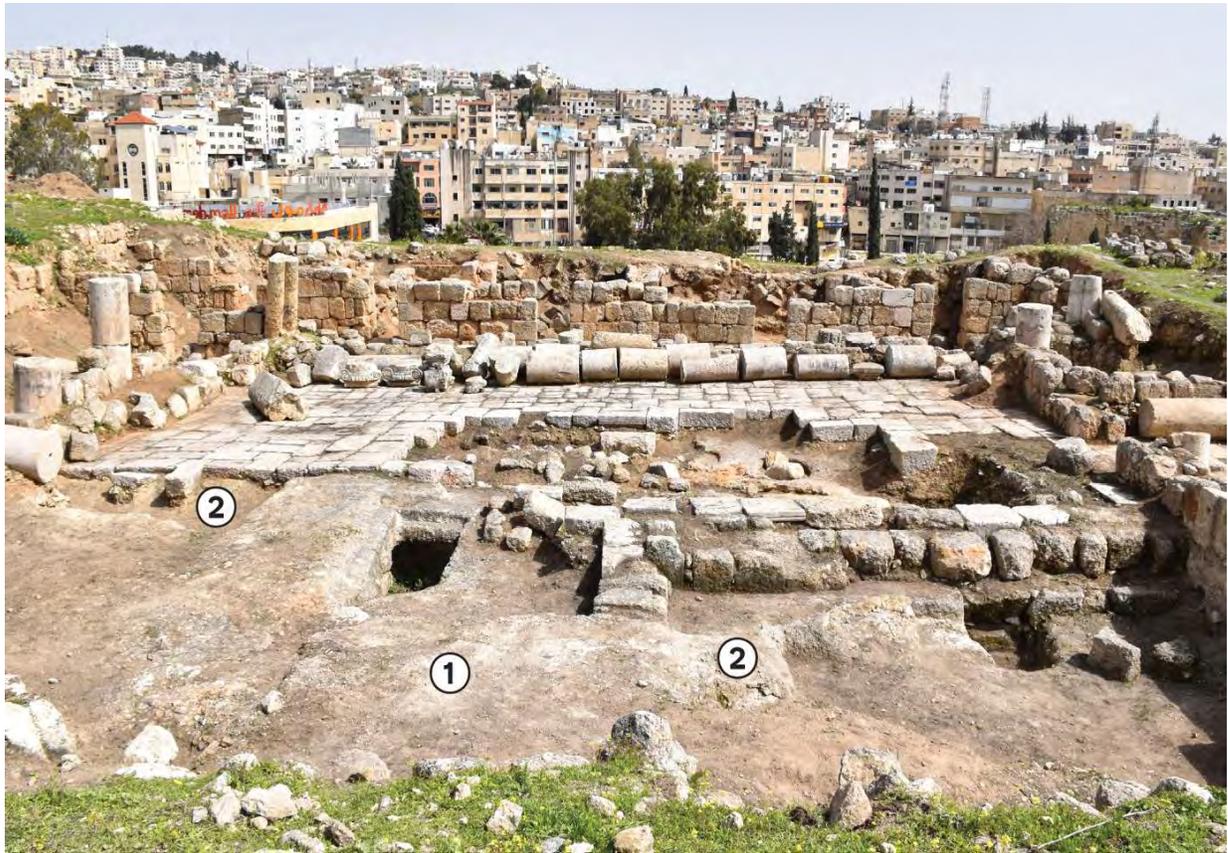
Fig. VII.17. Courtyard of building A and western part using the substratum: 1) rocky outcrop, 2) traces of exploitation - quarry (?).

The western half of the courtyard floor is composed of a rocky outcrop where various traces of exploitation and domestic installations (cavity, cistern) are visible (Fig. VII.17). The soil of the Jerash region is made up of sedimentary deposits from the Cretaceous era (ABABSA 2013). The town is built on layers of various nature (sandstone, limestone, marl, clayey sand) which overlap and are outcropping in many places. On the ground of the courtyard of building A, more or less regular orthogonal cuts and pockets reveal the surface exploitation of the rock. Outcrops of this type provided a local and cheap material from the earliest buildings of the 7th/6th centuries BC until the city was abandoned. The quality of the quarried rock varies considerably (SEIGNE 2000). It is conceivable that it was the poor quality of the rock or the central position of the quarry in the town that led to the abandonment of quarrying at this location as the town expanded.

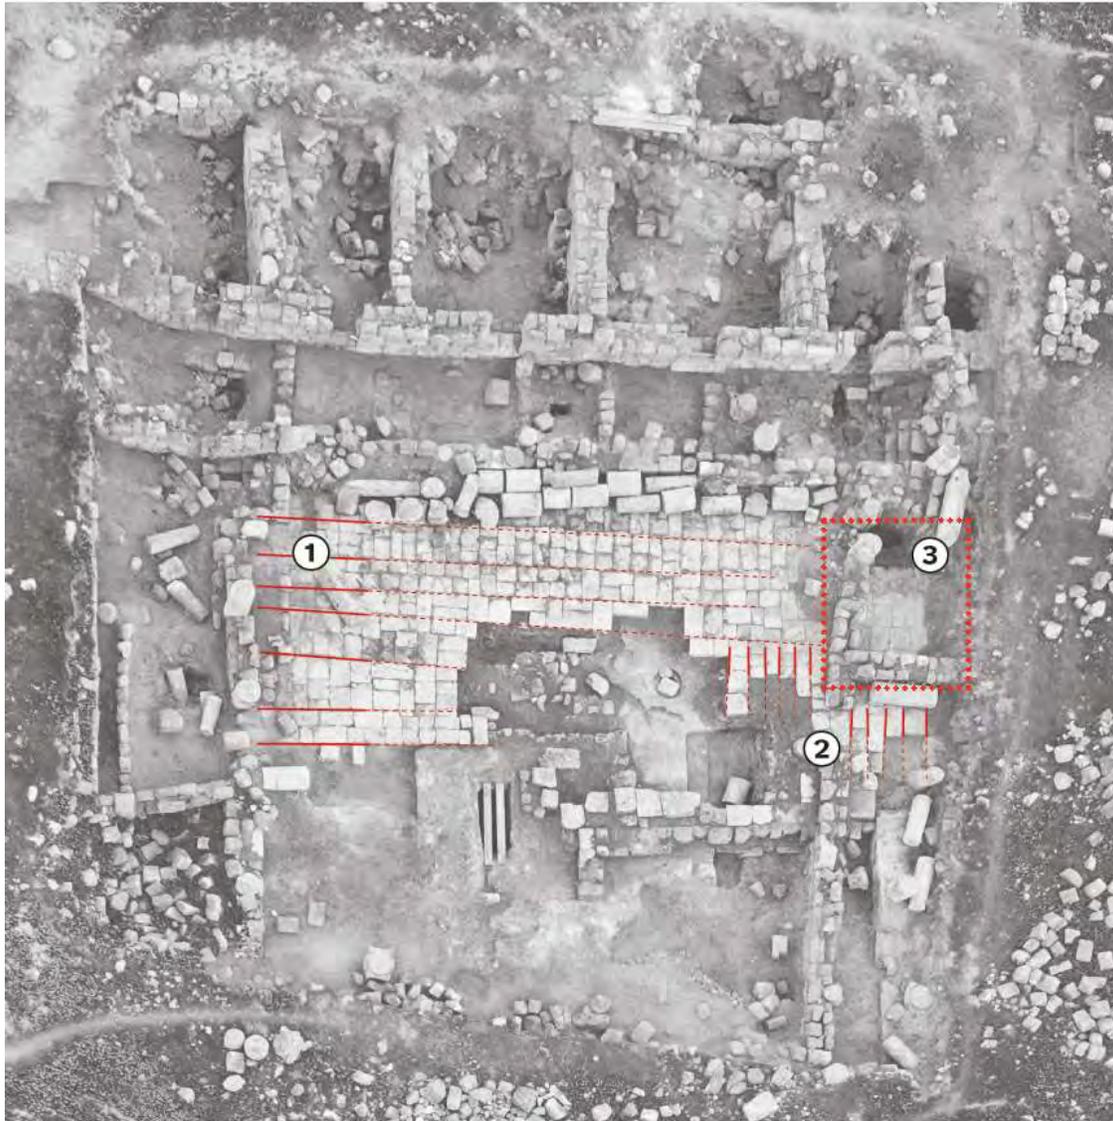
Fig. VII.18. Location of the three paved areas and hypothesis on the direction or phase of laying.

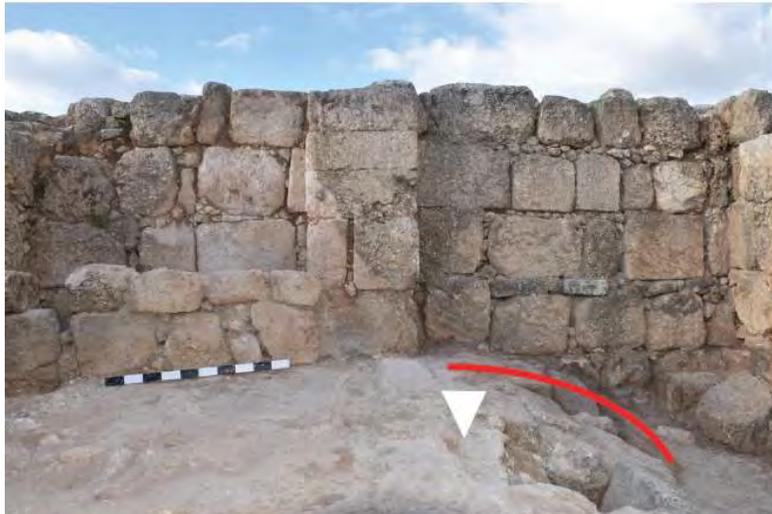
Fig. VII.19. Support by retaining vault (room R4).

The structures in place allow us to reconstruct the configuration of the ground and show how building A fits into the natural slope of the wadi. Two retaining vaults, one under the five adjacent rooms and the other under the east wing of the portico, make up for the required level created by the artificial terrace built over the old quarry (Fig. VII.19). A superposition of layers of different nature levels the ground on the extrados of the vaults. At the level of the vault joints, where the leveling layers are the thickest, an inverted dry-stone wall was built at the base to support the wall and doorway of room R4 (Fig. VII.20). The sample section taken from the floor shows a

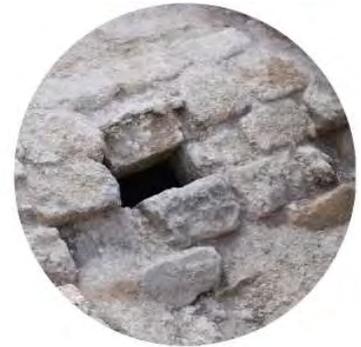
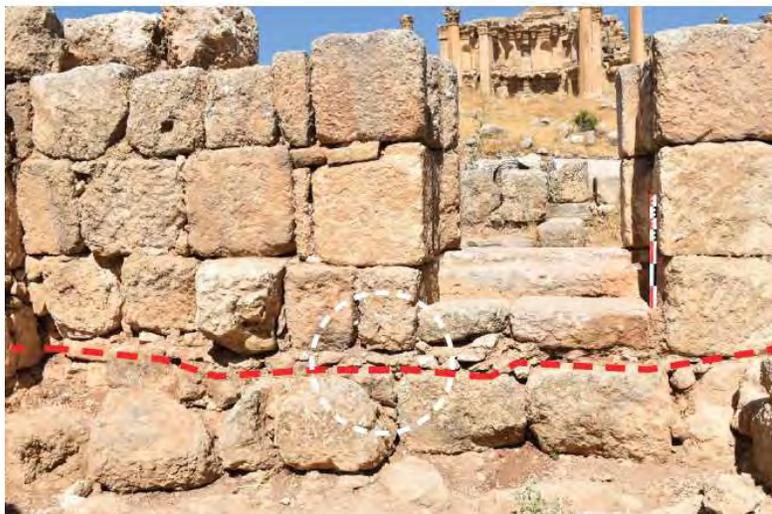
Fig. VII.20. Levelling made of pebbles (room R4).

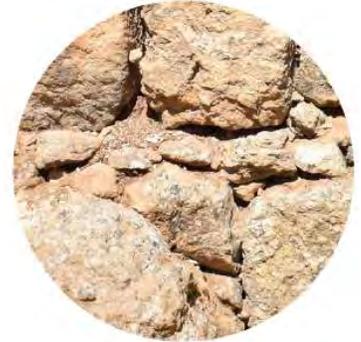
Fig. VII.21. Coating with clay; gravel, sand; rammed earth (room R4).

3-layer composition (4): a layer of clay, a layer of gravel/sand, and a layer of ochre tile mortar (Fig. VII.21). This type of covering, with its smooth appearance, constituted a relatively impermeable layer facilitating the maintenance of the stables.

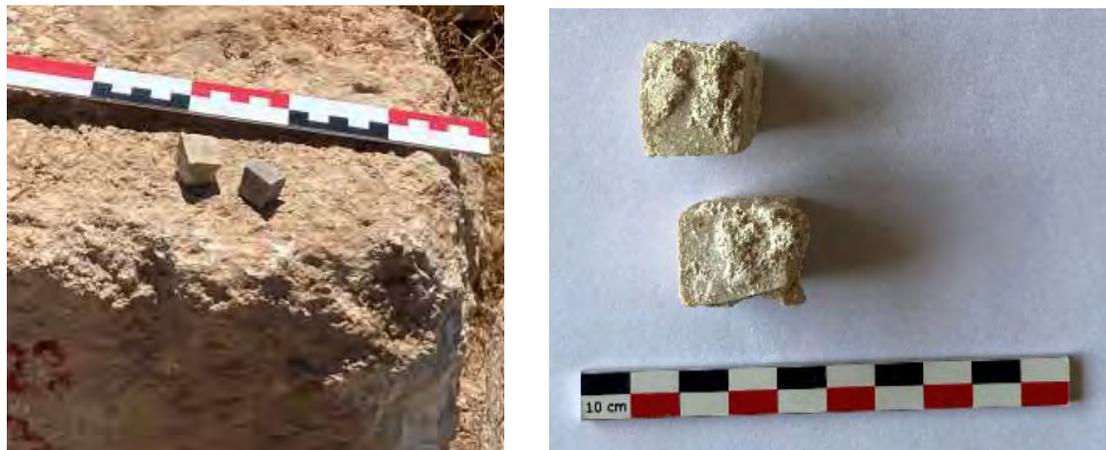
Fig. VII.22. Brown and white tesserae (to the left) and lime mortar on the reverse side of the tesserae (to the right).

Given the number of tesserae found in the collapse of the upper level in room R4 (Fig. VII.22), it is highly plausible that the upper floors were covered, at least in part, with mosaics.
