# Methods for Rock-hewn Worksite Analysis: The Church of Göreme n° 4b (Cappadocia): A Case Study

Anaïs Lamesa

Anaïs Lamesa. Methods for Rock-hewn Worksite Analysis: The Church of Göreme n° 4b (Cappadocia): A Case Study. *Anatolia antiqua = Eski anadolu*, 2020, XXVIII, pp.23-45. 10.4000/anatoliaantiqua.1308 . halshs-04407944v2

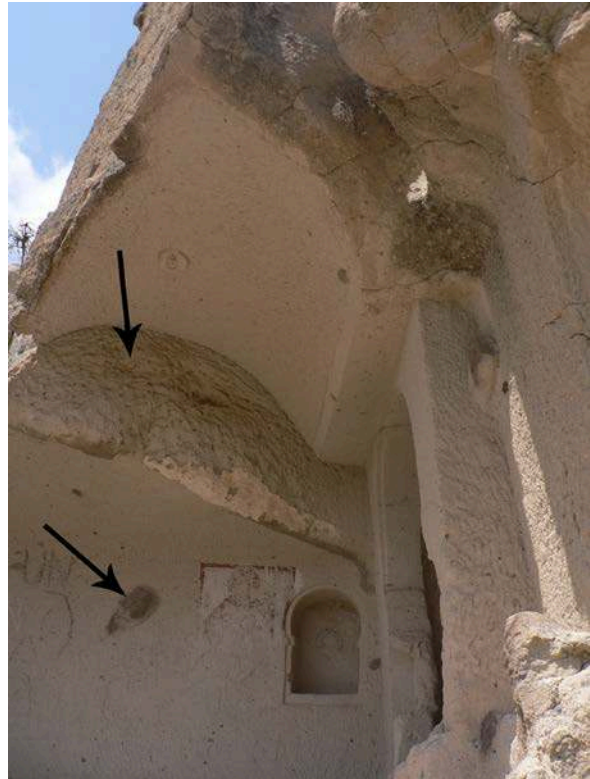
**Fig. 1** Two inclusions of decimetric and metric scale, the church Göreme n°4b (A. Lamesa).

Many pyroclasts, dark and of centimetric scale, can be seen on the church walls. Three are particularly remarkable: the first inclusion, of decimetric scale, can be seen on the nave's north wall. The second and third inclusions, both of metric scale, are in the nave, near the vault and pew respectively. As we will see, all three inclusions had an impact during the excavation (Fig. 1).

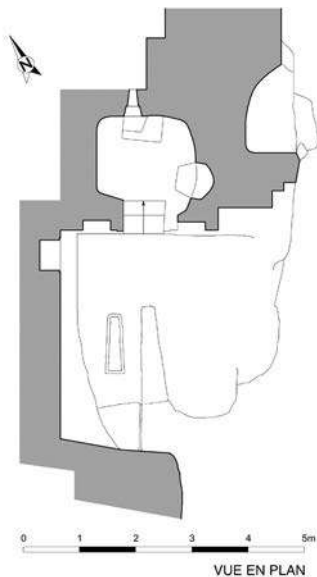
**Fig. 2** Plan of the church  
Göreme n°4b  
(A. Lamesa and V. Dubois).

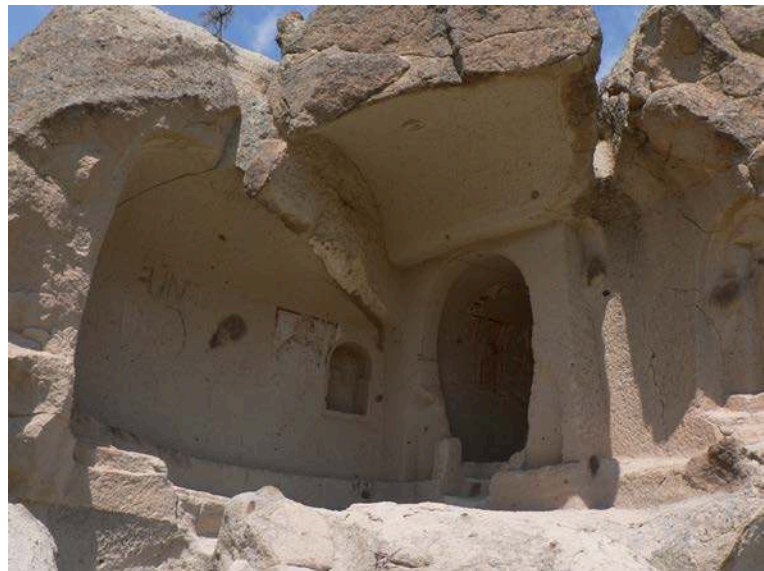
**Fig. 3** Details of the different elements composing the nave  
(A. Lamesa).

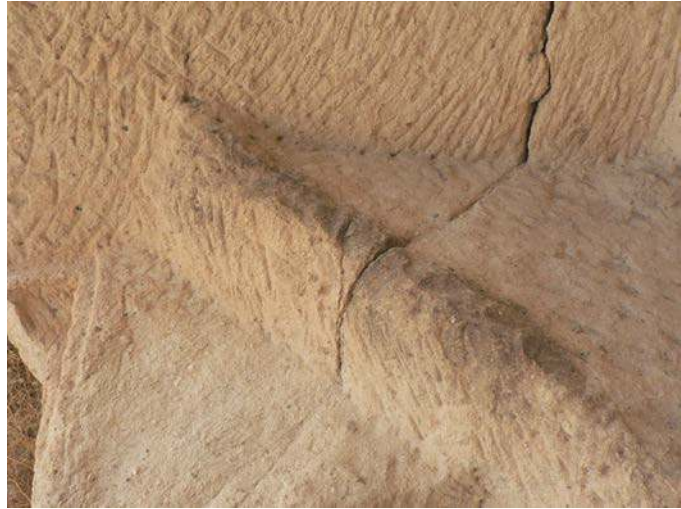
**Fig. 4** Bench's irregularity to the northwest part of the nave with sledgehammer impacts (A. Lamesa).

The rock's heterogeneous nature altered the course of the construction process and considerably modified the church's final shape. A simple observation of the nave confirms this. The monument has a transversal nave (Fig. 2), but the shape of its vault is unusual. On the south side,<sup>6</sup> a very regular barrel vault suddenly stops giving way to a kind of flat ceiling on the north side. In this part of the roof, delimitation with the walls of the nave is not clearly defined (Fig. 3).<sup>7</sup> The presence of the first metric scaled inclusion explains this interruption. Similarly, a bench runs along the northern and eastern walls. This bench is of irregular aspect and widens towards the northwest of the nave. Coincidentally, we find the second metric inclusion of hard stone (Fig. 4) near this irregularity.

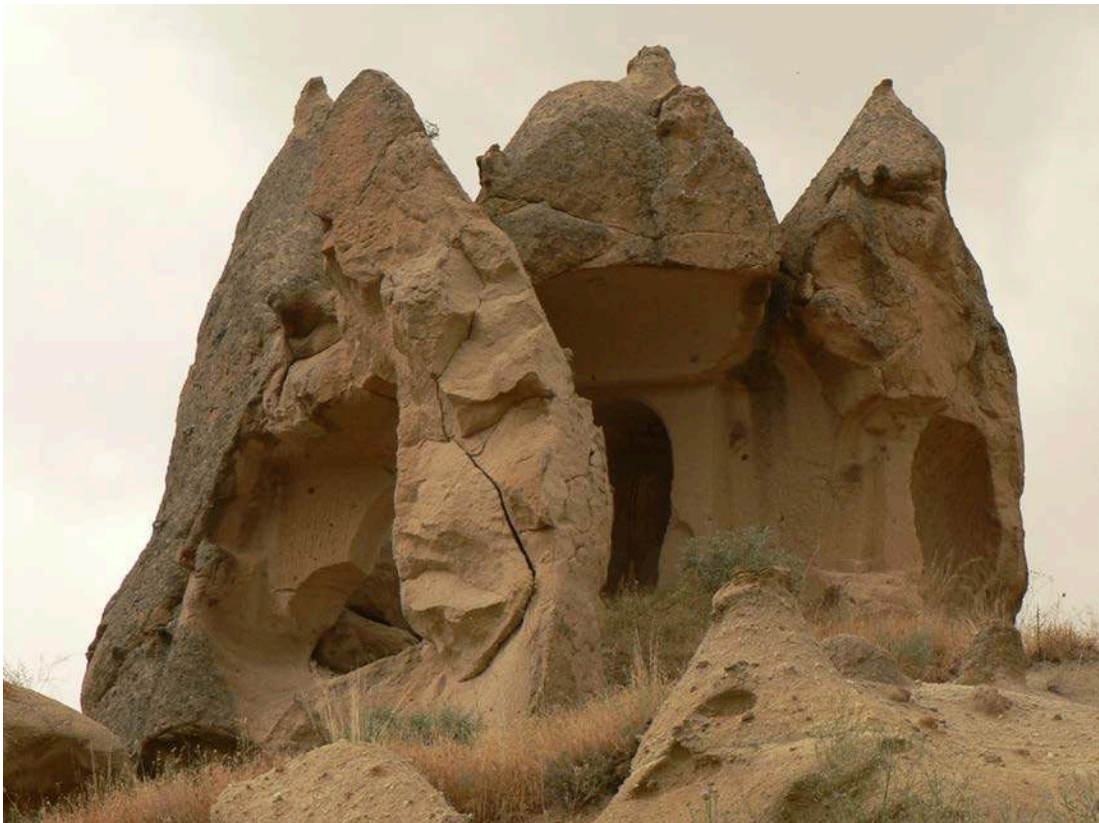
**Fig. 5** View of the church Göreme n°4b and its supposed entrance (A. Lamesa).

The presence of rooms under the church could indicate that steps used to lead to a now destroyed doorway in front of the present monument (Fig. 5).<sup>8</sup> The nave is in an awful state

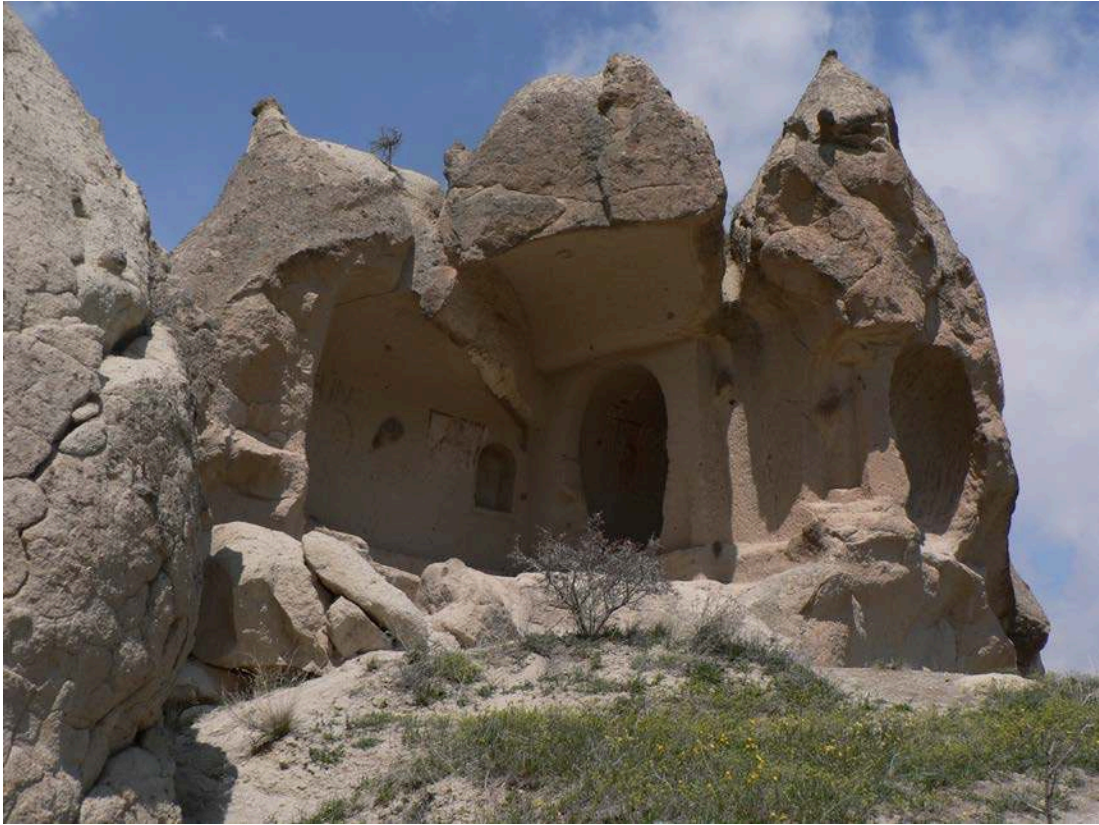
**Fig. 6**  
The apse and the southeast room of the church Göreme n°4b's nave (A. Lamesa).

of conservation and has been completely gutted. Part of its western wall and the whole of its southern wall have fallen into the valley down below (Fig. 6). Three alcoves were carved into the nave. The first one is on the north wall, at man's height. It is wide and flat-bottomed. The other two alcoves were excavated at the bottom of the eastern wall. Their bottoms are curved and they have been identified as seats (Fig. 7) (Jolivet-Lévy, 1991, p. 90). A panel near the flat-bottomed niche on the northern wall adorns a painting depicting a holy warrior. Its execution has been dated to the 11<sup>th</sup> century (Jolivet-Lévy, 1991, p. 90).

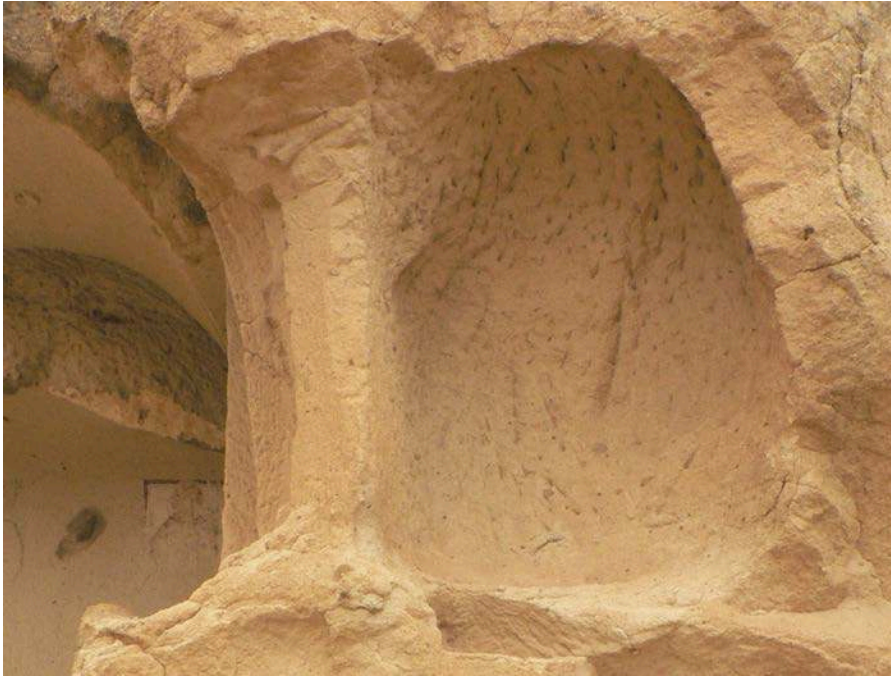
**Fig. 8**  
View of the unfinished room in the south part of the church (A. Lamesa).

At the southern end of what remains of the nave, an irregular room, collapsed on its southern half, opens to the east. It has never been noticed before – yet it seems essential to the understanding of the church's architectural organisation and its initial projected design (Fig. 8).

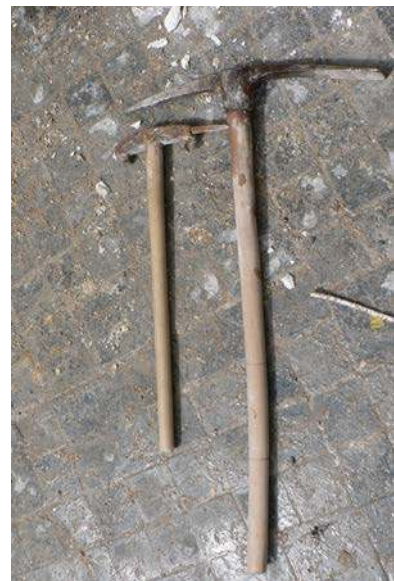
**Fig. 10** A long-handled pick and a short-handled pick held by stonemason K. Manap (A. Lamesa).

The predominant tool marks on the church's wall originate from a tool with a short handle (Fig. 10).<sup>9</sup> The grooves they typically leave behind are narrow, short, and evenly spaced. They form a distinctive radial and slanted cut, a feature of the short-handled pick. This cutting process is used to straighten up walls. The series of the longitudinal impacts forms an arc. The stonemason operates in profile, and the marks result from the movement of his tool. This cutting is carried out voluntarily for functional or aesthetic purposes.

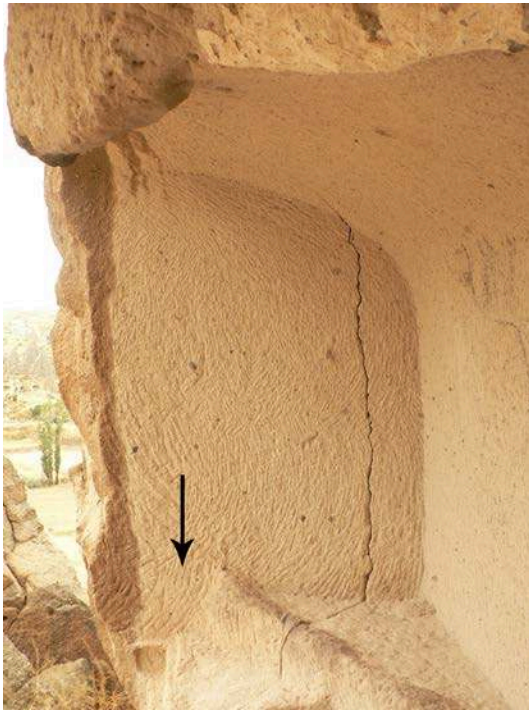
**Fig. 11** Long-handled picks' impacts, west wall of the nave (A. Lamesa).

A second type of marks also result from longitudinal impacts of a thrown tool, a long-handled pick<sup>10</sup> in this case. These differ from the short-handled pick tool marks with distinctive wide and long grooves and cuttings of various types – radial, slanted, linear – may be observed throughout the monument. For the radial type, the quarryman handles his tool parallel to the wall. The longitudinal impact series forms an arc. The quarryman operates with the bed rock he aims to remove in front of him. This cutting is often associated with linear cutting. These are the final impressions left on the rock mass by the worker. This cutting leaves round or square impacts (depending on the tool's cutting-edge wear) in vertical line patterns. Both types of cuttings can be classified as destructive.<sup>11</sup> In the church Göreme n°4b, tool marks of long-handled picks can be seen in the south-eastern hall and at the bottom of the nave's western wall (Fig. 11).

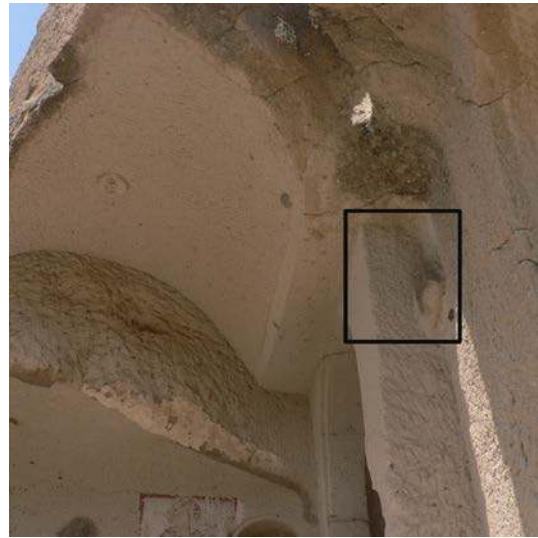
**Fig. 12** Polkas' tool marks on the relief side on the east wall of the nave (A. Lamesa).

The third type of tool marks also results from a thrown percussion tool: an axe with two cutting edges (one vertical and the other horizontal) named polka or a carving axe (Bessac, 1986, pp. 39-52, 53-59). It is not easy to distinguish these two tools by their marks. In the church Göreme no. 4b, some of these tool marks are clearly visible on the relief side of the apse frame on the nave's eastern wall (Fig. 12). The tool marks are distributed horizontally, trademarks of a polka. The chosen cutting is of the slanted type. This tool was exclusively used on the eastern parts of the nave, the cornice running along the nave, the intrados and mouldings of the triumphal arch, and the upper part (covered with paintings) of the apse (Fig. 13) to finish the flattening of the walls.

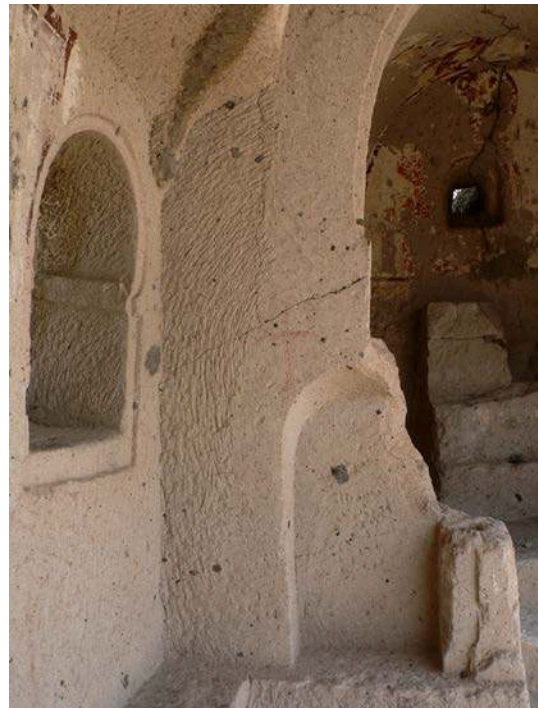
**Fig. 13** View of the east wall of the nave: junction between the short-handled picks' tool marks and the polkas' tool marks (A. Lamesa).

The second limit derives from specific tasks in the *chaîne opératoire*, the purpose of which is to precisely make tool marks disappear. An example is the fine smoothing of the walls: this technique is commonly used in Cappadocia, where the rough/smooth contrast can be played with (Fig. 16) (Lemaigre, 2010, pp. 69-72; Jolivet-Lévy 2007, pp. 52-60; Jolivet-Lévy & Lemaigre Demesnil, 2015, p. 118). This fine finishing of the walls was applied around the nave's alcoves and passages (see Fig. 13).

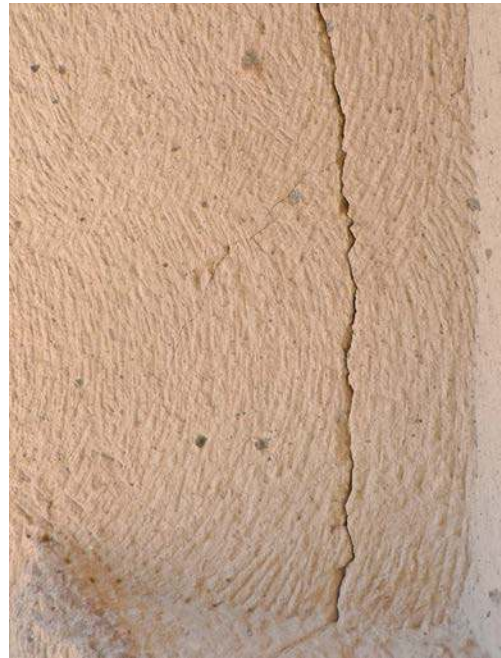
Fig. 14 West wall of the nave of the church Göreme n°4b, radial and slanted cutting by short-handled pick (A. Lamesa).

The layers' superimposition makes a hewing chronology possible: the tool marks of the long-handled pick are covered by the impacts of the short-handled pick (Fig. 14). The tool marks of the polka very clearly overlap those of the short-handled pick.

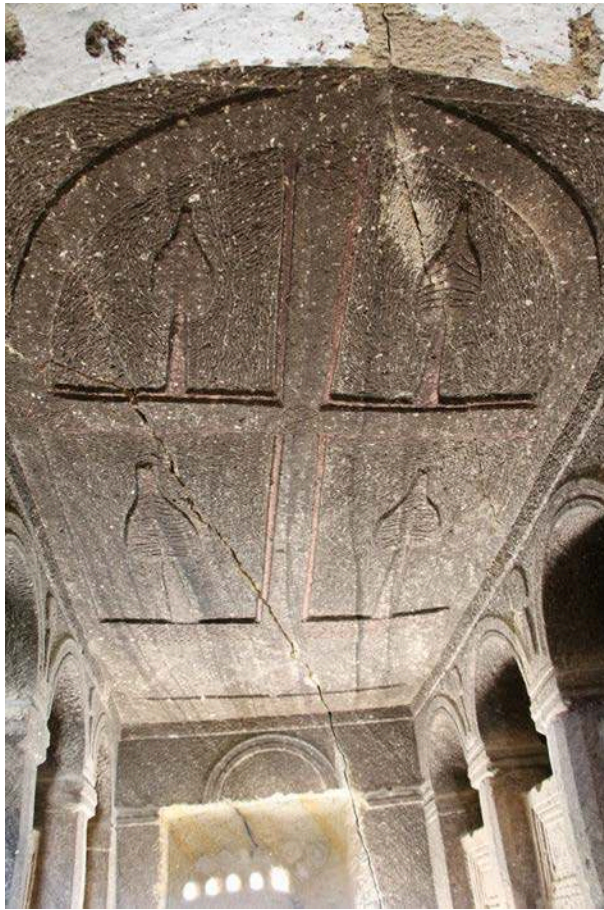
**Fig. 17**

Using a rasp or an abrasive to smooth out the moulding of the T05 DB tomb located in the Davutlu Valley Bucağı at Mazıköy (A. Lamesa).

In Cappadocia, we were able to observe some of these marks on a moulding of a monumental tomb in the Davutlu Bucağı Valley (Fig. 17) (Lamesa, 2016, p. 416). However, these finishing techniques do not seem to have been used in the case of the church Göreme n°4b. The space to be smoothed is far too large. Abrasives or rasps are typically used for mouldings and no streaks could be found.

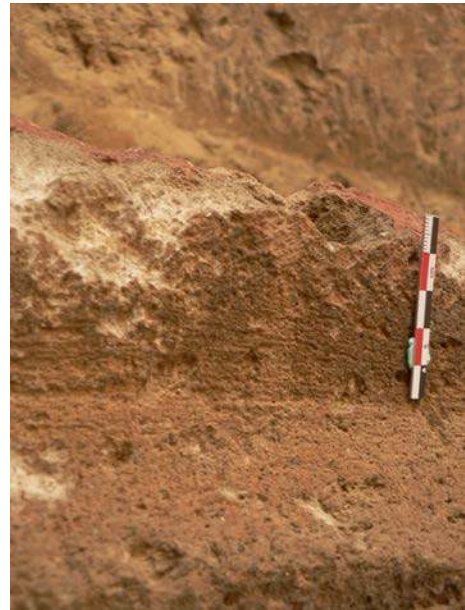
**Fig. 16**

Ceiling of the Church of St. Basil/Uçhisar n°3. Short-handled pick's tool marks highlight the smoothing of the cross (A. Lamesa).

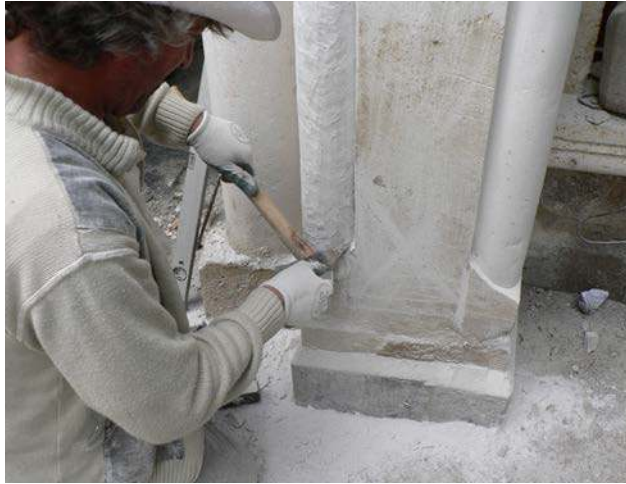
Fig. 18 K. Manap using the polka as a scraper (A. Lamesa).

We followed the stonemasons' team led by Kemal Manap. For a smooth rendering of a block used in a wall, the master/*usta* uses the blade of the straight edge as a scraper to remove the roughness left by the tool's impact (Fig. 18). He then finishes smoothing with an artificial abrasive (sandpaper). This straight-edged scraped cut can also be performed using a wide chisel with a sharp, straight edge (Bessac, 1986, p. 190, see also Lamesa, 2011, p. 185).<sup>14</sup> The resultant effect matches what could be observed on the church walls. The tool marks of the straight edge are

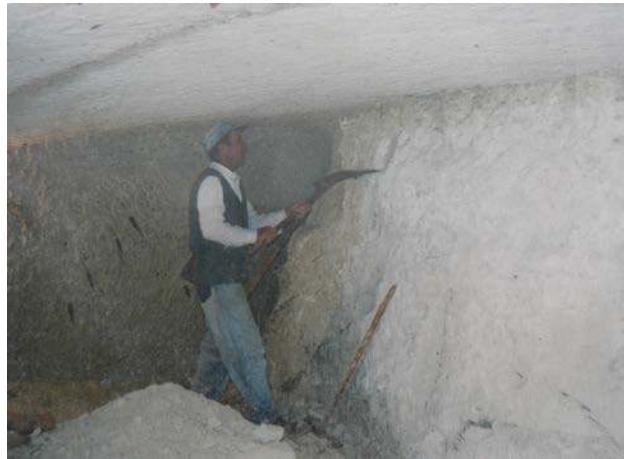
Fig. 19 1980s photograph of Mustafa Işık digging the depot near the Göreme Museum (Anonymous, given to A. Lamesa in 2008).

Thanks to the photographs published by F. Öztürk (2009, res. 17-18) or collected during interviews, we notice that (1) the rubble allowed the stone worker to climb to ceiling level. In the picture (Fig. 19), the tool marks (2) are distributed horizontally at the level of the upper part of the wall (slanted cutting) and follow an arc at the centre of the wall (radial cutting). The extremities of the room (ceiling, corners and floor) require a precise and meticulous cutting to be carried out, which is impossible with slanted and radial cutting. It appears that (3) the stonemason's work was carried out in sections, as rock reserves were gradually being removed (Öztürk, 2009, including res.17).

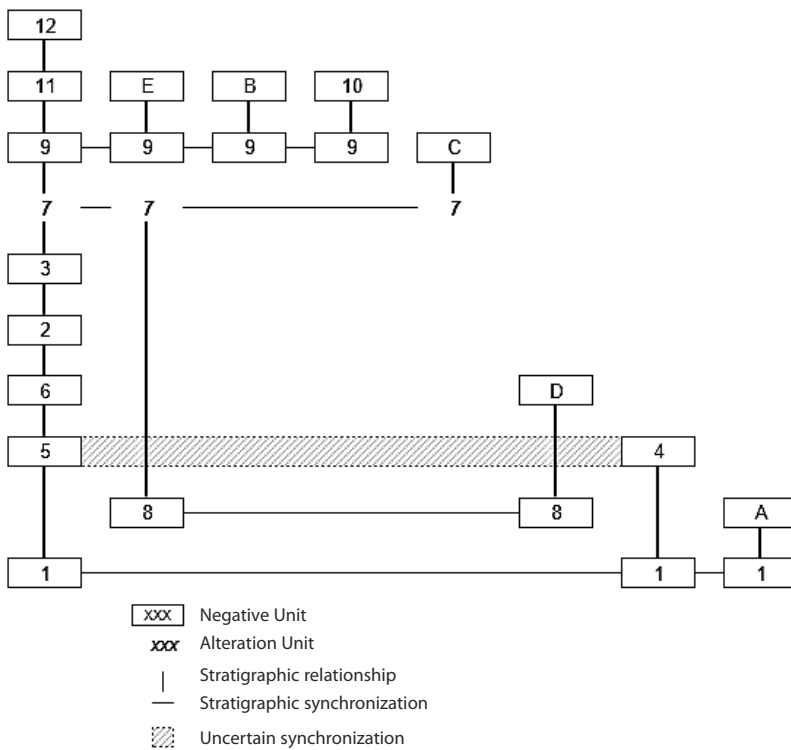
**Fig. 21**  
Harris diagram of Negative Units taken from *Le Stratifiant* software, non-phased.

By mechanically applying the Principle of Stratification of Negative Units, an automation made possible by the software *Le Stratifiant*, a striking pattern emerges. While nine phases appear on the Harris matrix, Negative Units 1 and 8 do not seem to correspond to the same period. A lost chronological relationship is therefore revealed between these two units (Fig. 21).

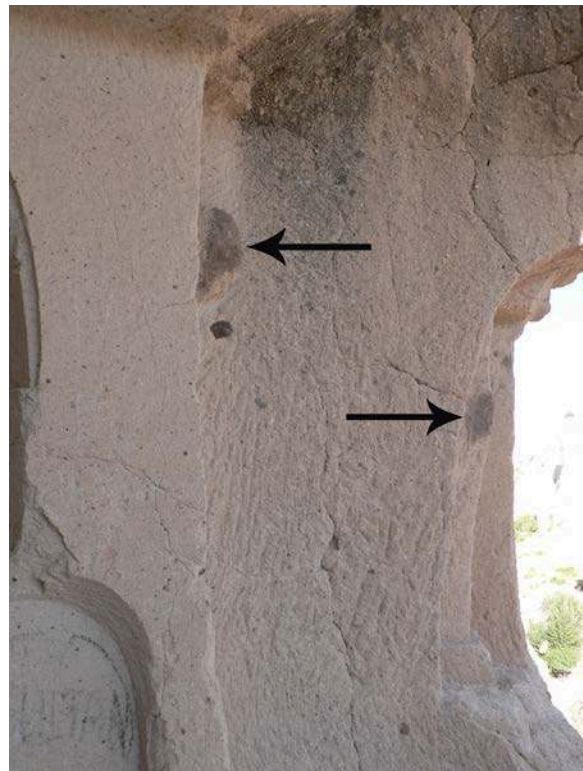
Fig. 23 Inclusions close to the southeast room's entrance (A. Lamesa).

room is made during hewing. In addition, its entrance is marked by a pediment surmounted by a rectangular corbel and is inscribed in an opening in the shape of an arc (Fig. 23). The corner of the door can also be seen. Paradoxically, we observe a destructive radial and slanted cutting and a linear cutting characteristic of the use of a long-handled pick on its interior walls. This tool and the cuttings associated with it were identified during the construction phase of the work. The workman stopped while he was obviously shaping the room. The entrance had already been regularised and was in the process of being finished. This can be seen by the levelling of the inclusion at the level of the pediment and by the partial destruction of the nearby inclusion (Fig. 23). Similarly, the mouldings surrounding the door are well done. It is impossible to define what could have been the role of this southeast room: a second apse? A *parekklesion* (annexe chapel)?
