Methods for Rock-Hewn Worksite Analysis. The Church of Göreme n°4b (Cappadocia): a Case Study¹

Anaïs LAMESA*

Some rock-hewn structures present oddities in their layout, far from the models shared by the majority of similar monuments. These particularities challenge and question the very process of their design. While a technical survey may explain part of these singular cases, a careful comparative selection of the available methods remains paramount to draw a complete picture of the progress and organisation of these peculiar worksites.

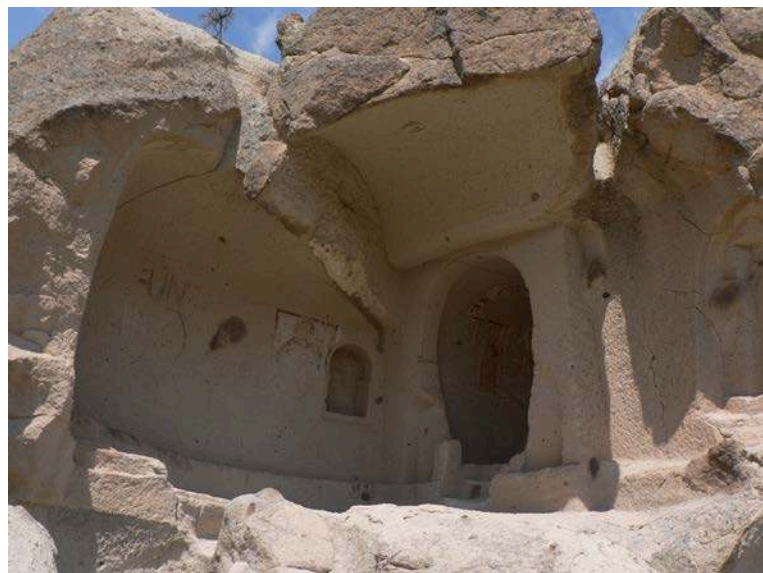
Fig. 3 Details of the different elements composing the nave (A. Lamesa).

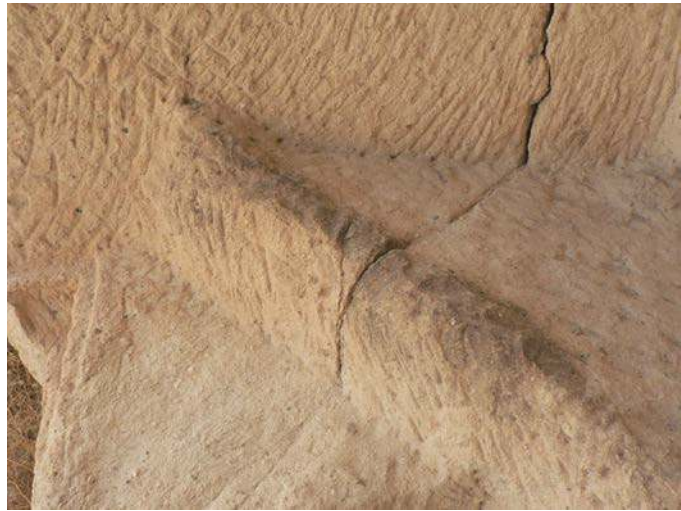
Fig. 4 Bench's irregularity to the northwest part of the nave with sledgehammer impacts (A. Lamesa).

The rock's heterogeneous nature altered the course of the construction process and considerably modified the church's final shape. A simple observation of the nave confirms this. The monument has a transversal nave (Fig. 2), but the shape of its vault is unusual. On the south side,⁶ a very regular barrel vault suddenly stops giving way to a kind of flat ceiling on the north side. In this part of the roof, delimitation with the walls of the nave is not clearly defined (Fig. 3).⁷ The presence of the first metric scaled inclusion explains this interruption. Similarly, a bench runs along the northern and eastern walls. This bench is of irregular aspect and widens towards the northwest of the nave. Coincidentally, we find the second metric inclusion of hard stone (Fig. 4) near this irregularity.

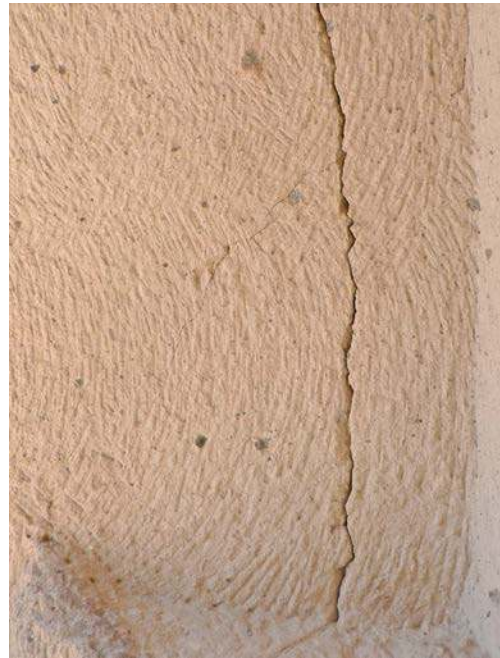
Fig. 14 West wall of the nave of the church Göreme n°4b, radial and slanted cutting by short-handled pick (A. Lamesa).

The layers' superimposition makes a hewing chronology possible: the tool marks of the long-handled pick are covered by the impacts of the short-handled pick (Fig. 14). The tool marks of the polka very clearly overlap those of the short-handled pick.

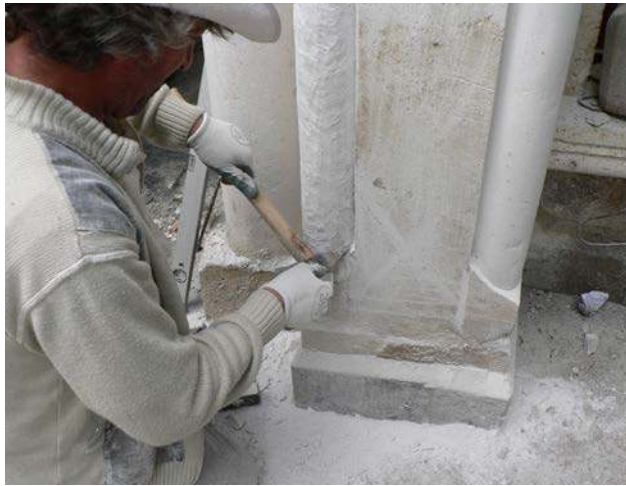
Fig. 18 K. Manap using the polka as a scraper (A. Lamesa).

We followed the stonemasons' team led by Kemal Manap. For a smooth rendering of a block used in a wall, the master/*usta* uses the blade of the straight edge as a scraper to remove the roughness left by the tool's impact (Fig. 18). He then finishes smoothing with an artificial abrasive (sandpaper). This straight-edged scraped cut can also be performed using a wide chisel with a sharp, straight edge (Bessac, 1986, p. 190, see also Lamesa, 2011, p. 185).¹⁴ The resultant effect matches what could be observed on the church walls. The tool marks of the straight edge are
