Eastern Jarash Project: 2023 Final Report

EASTERN JARASH PROJECT

2023 FINAL REPORT

Edited by **Dr. Julie Bonnéric**

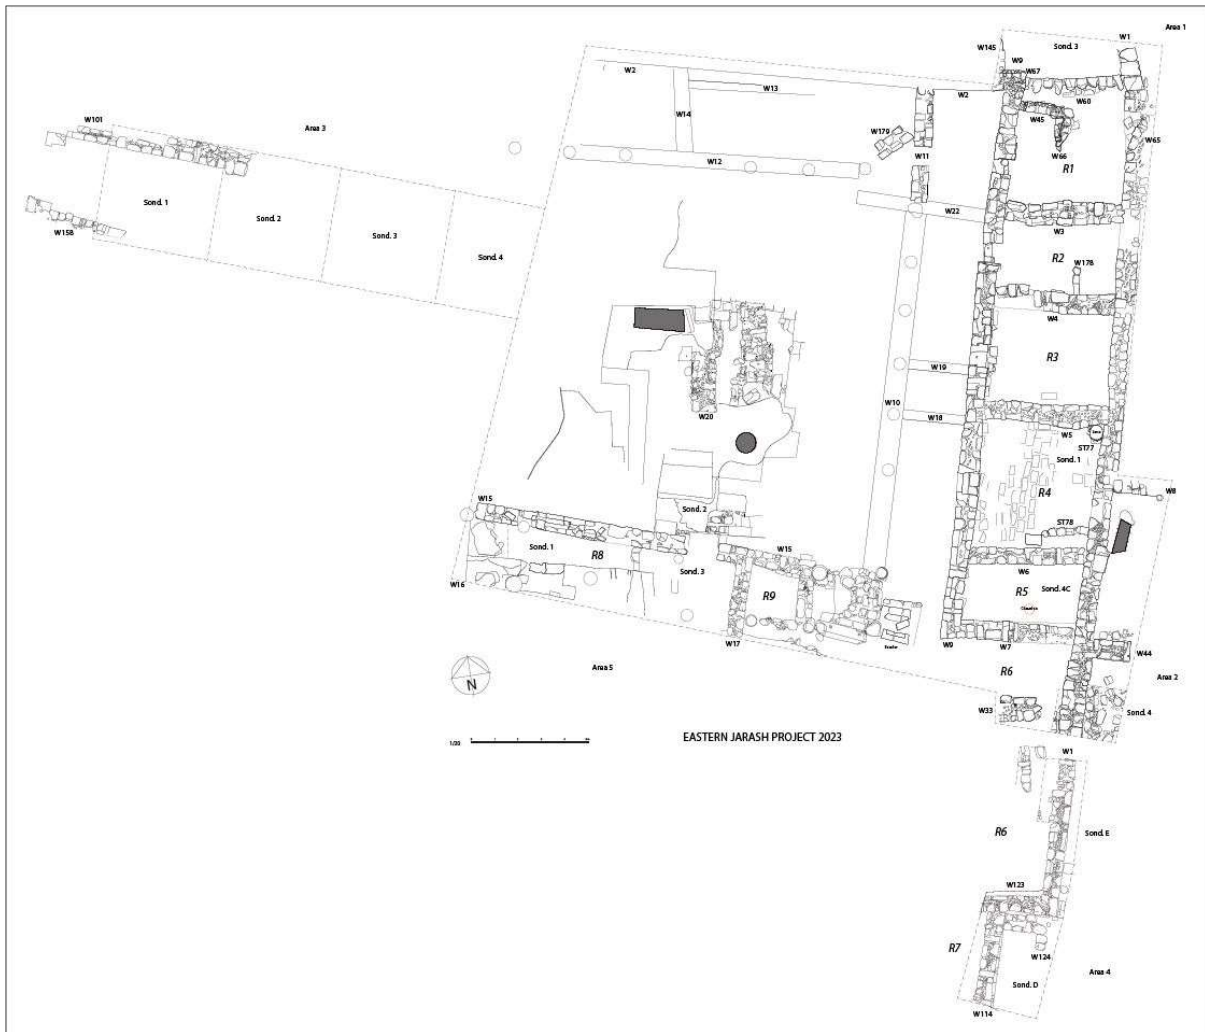
Fig. I.1. Plan of Building A or the 'House of Hearts' at the of the 2023 campaign.

The excavation carried out in 2023 modified our understanding of the layout of building A, in particular by extending its limit to the south and west and the revelation of new rooms.

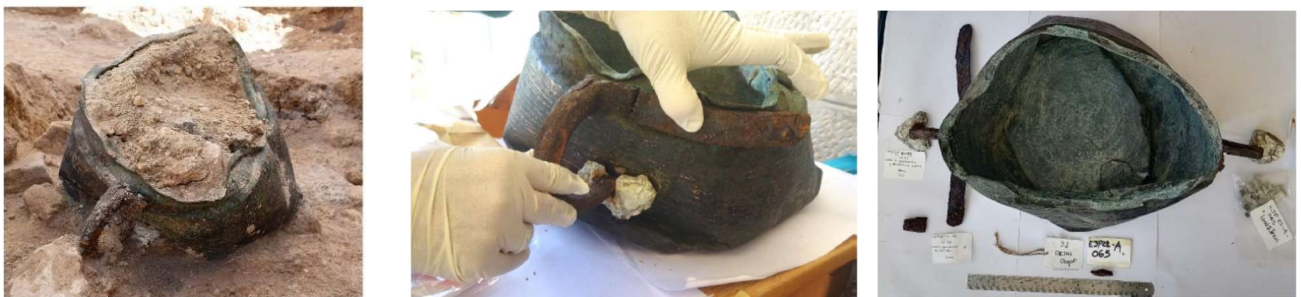
Fig. I.4. The copper alloy pot discovered on the floor of room R5 in 2022 under the 749 CE collapse: at the time of its discovery (left), during its restoration (middle) and after the restoration (right).

The diameter of the excavated big, copper-alloy pot is around 40 cm, and the maximum height is 24 cm. The shape of the pot, discovered under collapsed walls, is not regular due to the stones and debris that have fallen on it. As a result, it has folds and cracks in the rim, sides and base.

This pot was documented and then examined with a magnet to ensure no iron metal was present in the object. It was associated with a frame for the pot's rim, identified as an iron frame.

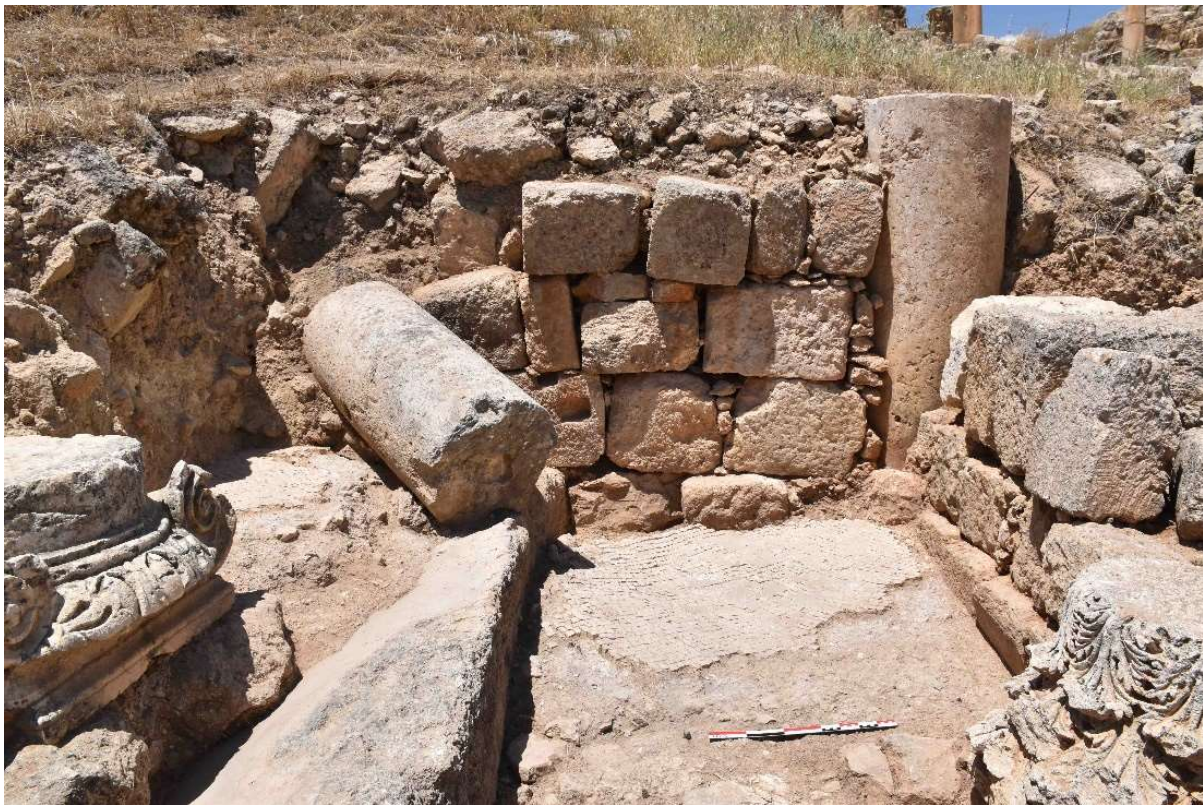
Fig. I.6. The mosaic pavement (116) built with large (2.5 × 2.5 cm) white tesserae against the late wall W15 which reduces the size of the courtyard to the southwest.

upper to the south and lower to the north. It seems that it was used for long enough to be restored with a yellow compact mortar. Unfortunately, this area was excavated in 2001 and the artifacts that may have been preserved on the floor by the collapse of the walls were removed, so it is impossible to identify its function for now. The southern part has not been excavated yet. The situation is the same for room R9. The northern portico also seems to have been reorganized into rooms with the construction of walls W12 and W14 but the rooms here do not seem to eat into the courtyard itself. This area was excavated in 2001 by the DoA, however, it should be cleaned again and studied further.

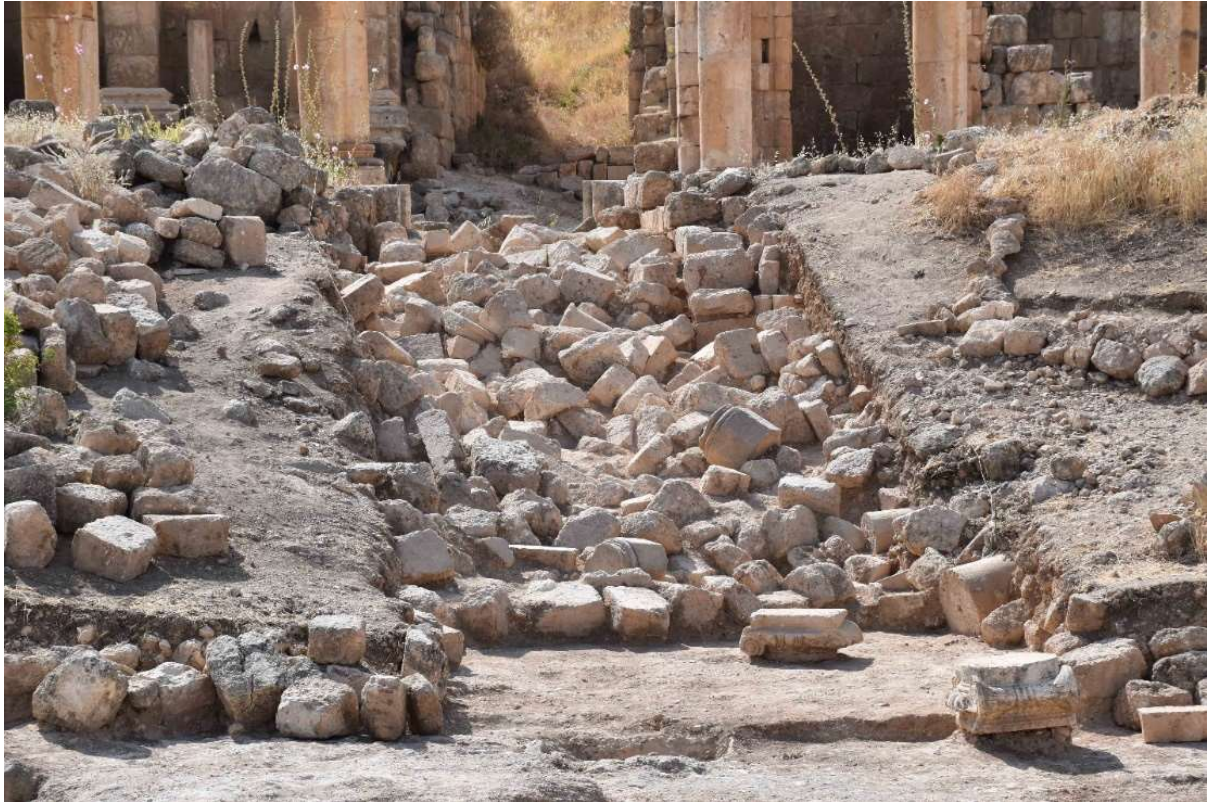
Fig. I.7. The trench opened in area 4, between a portico shop and the courtyard, and the collapse following the 749 CE earthquake.

excavation of the trench could not be completed due to the huge quantity of large blocks which needed to be removed (fig. I.7), so for the moment it is not possible to say if the two structures were separated by a wall or a street, or even joined together.

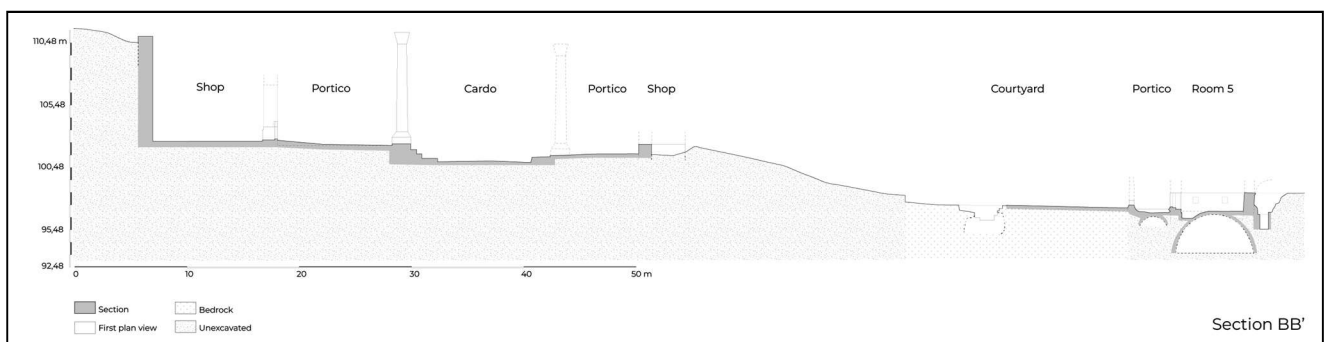
Fig. I.8. Architectural section between the Roman cardo and building A showing the area in between that was not excavated in 2001.

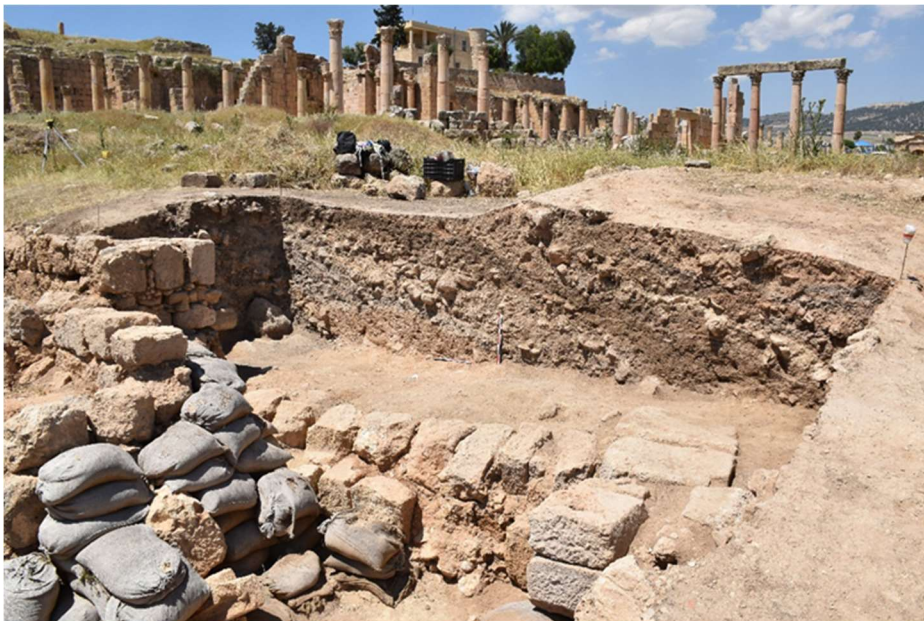
Fig. II.1. Sounding 3, the area north of room R1 at the beginning of the excavations.

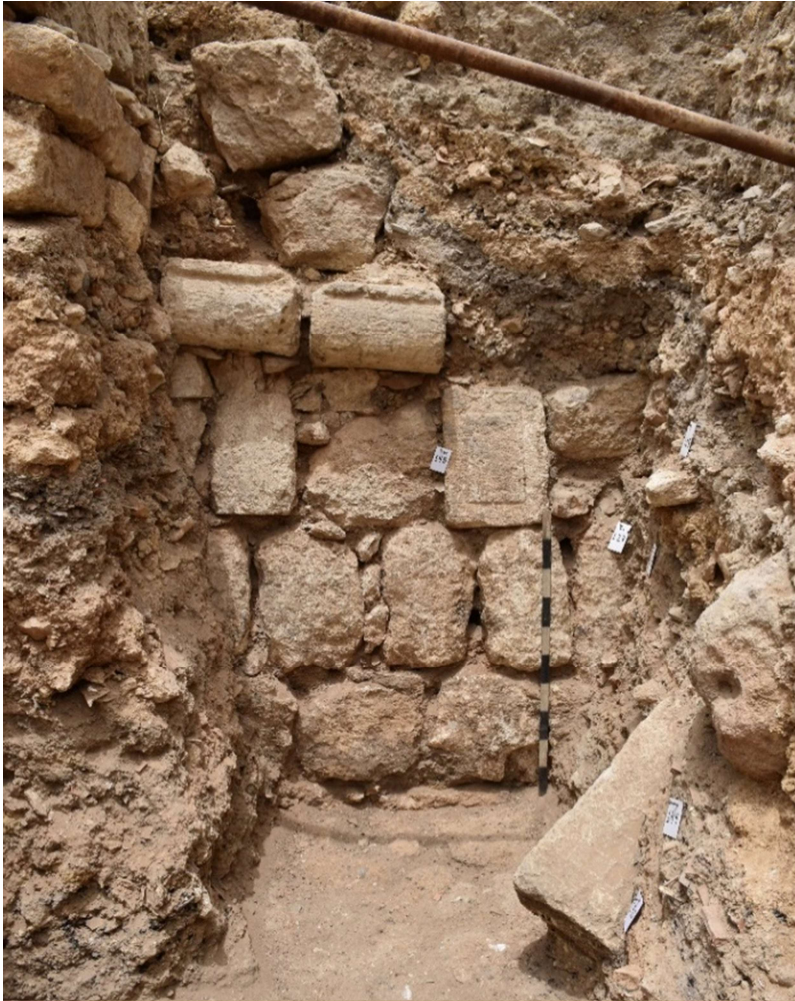
Fig. II.3. Wall W145.

between wall W145 and the rest of the building's architecture, specifically in the eastern wing. Its eastern face is not aligned with wall W9, the western wall of the eastern wing.

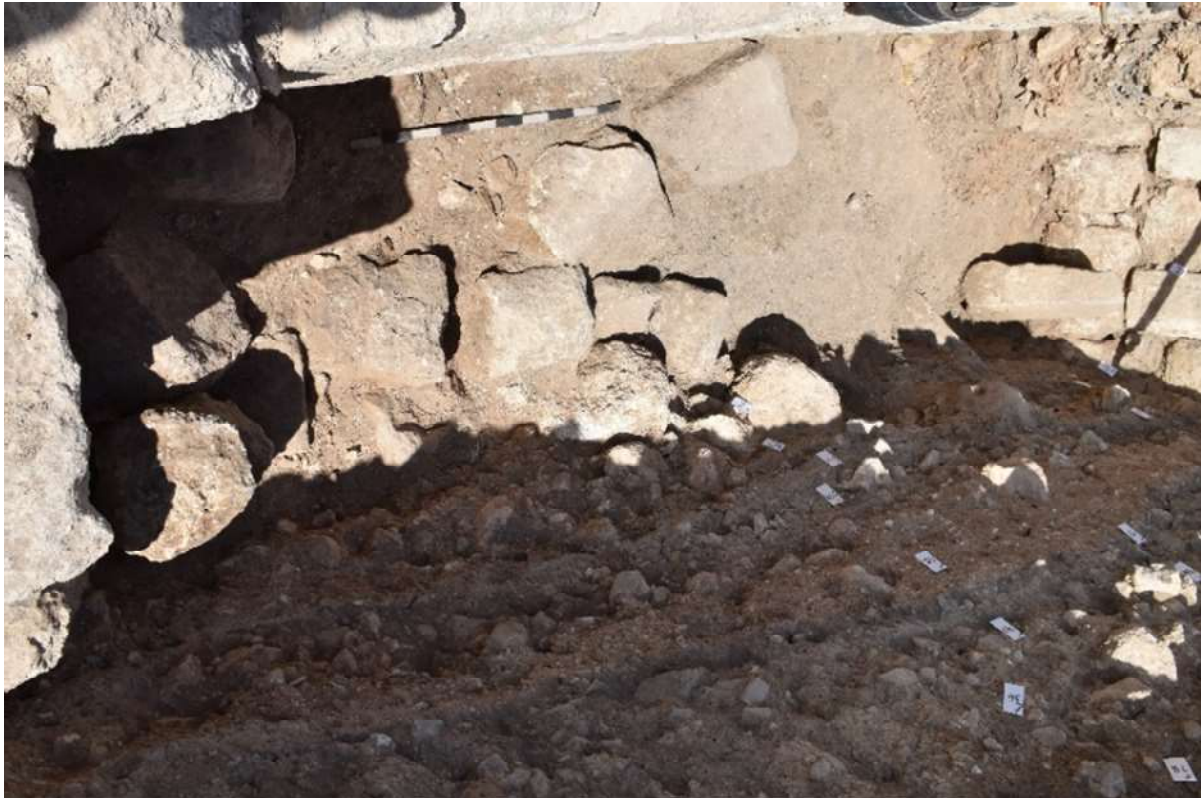
Fig. II.4. Deposit 144.

Below cut 127 and collapse 140, deposit 144 was found, between wall 145 to the west (fig. II.4), collapse 140 to the east, wall W60 to the south and L.O.E to the north. It measures 3.10 m E/W and 1.63 m N/S, and has a top level of 600.08 m and a bottom level of 599.25 m.

What differentiates this context from collapse 140 is the high frequency of material in it. Deposit 144 included a lot of material such as pottery, bones, mosaic, metal, glass, tile, marble, ceramic building material (CBM) and large carved blocks (fig. II.5) with a maximum module of 0.70 x 0.45 x 0.30 m. In addition, it included lime flecks, patches of mortar, random stones, as well as charcoal that gives this layer a gray color. We are still uncertain about the function of this deposit, located at the edge of building A. It could be a collapse, a dump or a landfill used to level the area outside building A.

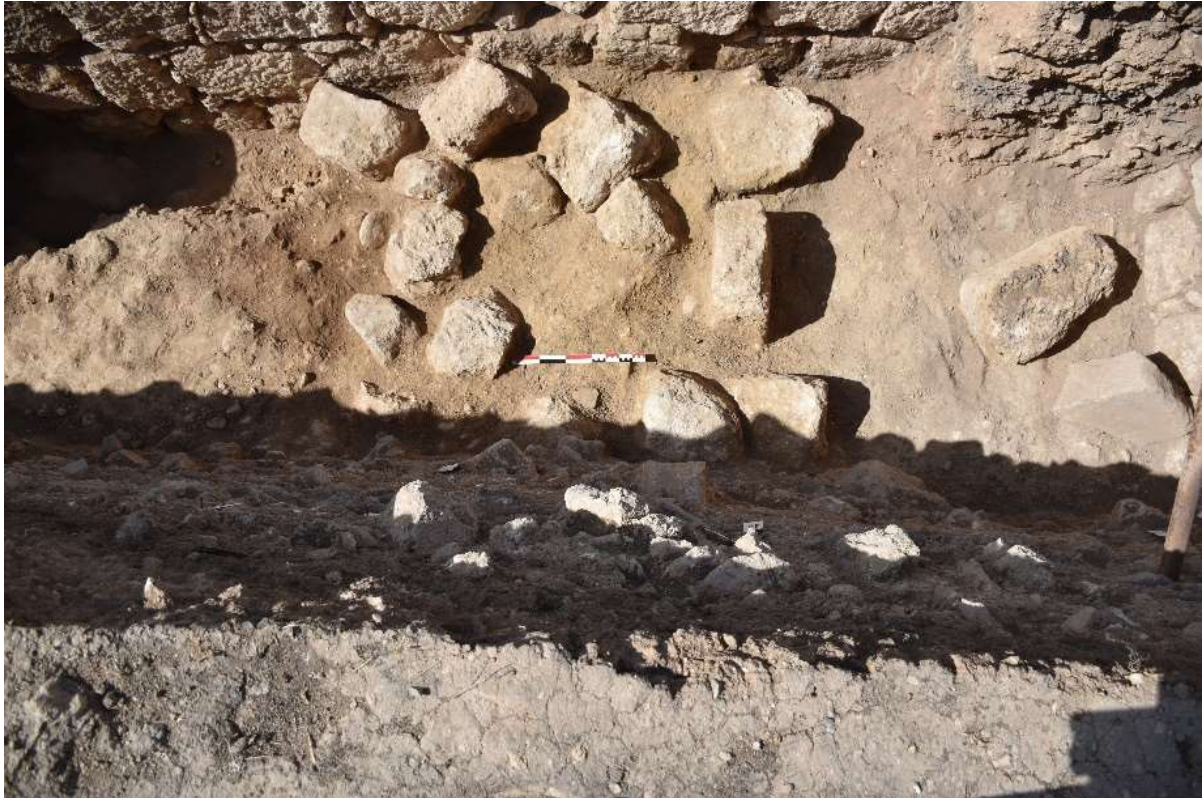
Located below deposit 144, deposit 150 has a yellowish-red hue and is very similar in composition to deposit 144. However, its compact sediment includes ash and charcoal, with an extremely high quantity of pottery, a few objects and large blocks with a maximum module of 0.70 x 0.45 x 0.30 m, giving the impression of a huge dump mixed with the collapse (fig. II.6).

It spreads between wall W145 to the west, layer 155 to the east, wall W60 to the south and L.O.E to the north. It measures 3.50 m E/W and 1.63 m N/S and has a top level of 599.57 m and a bottom level of 599.25 m.

Fig. II.6. Deposit 150.

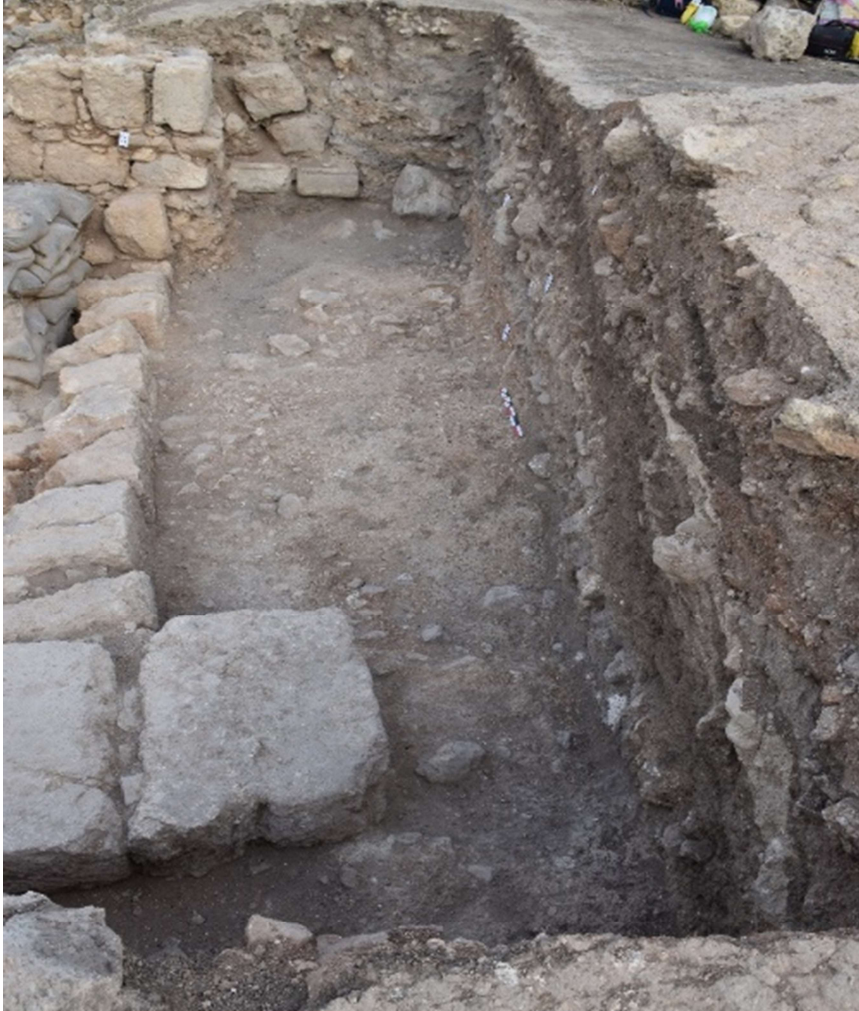
Fig. II.7. Layer 103, view from the east.

Layer 103 is a loose to compact reddish-brown sediment composed of silt and charcoal (fig. II.7). It was uncovered under layer 58⁴, above layers 122 and 105. It accumulates between wall W01 to the east, wall W60 to the south, L.O.E. to the north and measures 4.00 m E/W and 1.70 m N/S. The top level is at 601.13 m and the bottom level is at 600.83 m.

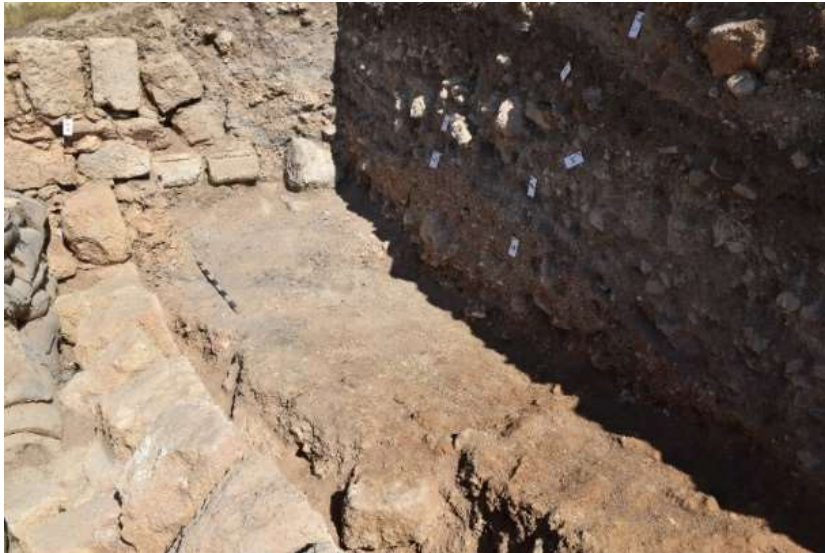
Fig. II.8. Layer 105, view from the southeast.

Below layers 58 and 103 in the NW part of sounding 3, layer 105 was unearthed. It measures 2.40 m E/W by 1.72 m N/S, with a top level of 601.23 m and a bottom level of 600.96 m. It is a gray burnt layer with black patches composed of ash including pottery, bones and glass, etc. (fig. II.8). This deposit can probably be interpreted as a dump located at the edge of building A.

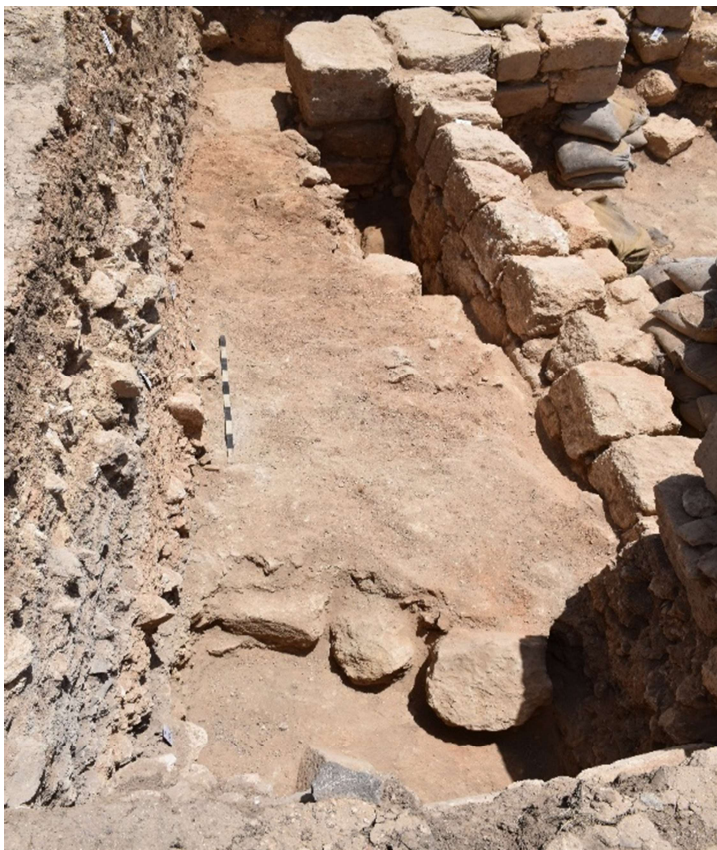
Fig. II.9. Layer 122.

Below layers 105 and 103, and above layer 135, layer 122 is another reddish-brown deposit that extends in the middle of the sounding over 2.40 m E/W and 1.72 m N/S, with a top level of 600.94 m and a bottom level of 600.60 m. This layer looks like a natural deposit composed of ash and includes a small amount of material such as pottery and bone (fig. II.9).

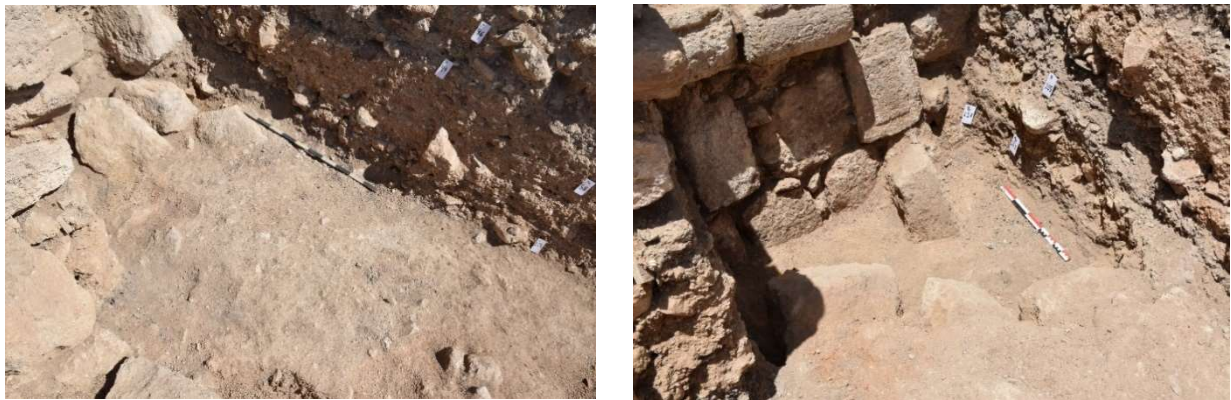
At the northwest corner of sounding 3, cut 127 and fill 121 were created by the collapsed blocks. Fill 121 was very soft and composed of large blocks, pottery and pebbles (fig. II.10). In this deposit, we note a soft residue around the blocks mixed with the rest of the sediment (top level of 600.99 m and a bottom level of 600.56 m). This soft residue is due to the erosion of the limestone blocks. Pit 127 has a trapezoidal top plan and measures 1.25 m N/S by 1.10-0.80 m E/W (fig. II.10). In addition, it was located against wall W145 to the west, L.O.E to the north and collapse 135 to the east. It had a top level of 601.13 m and a bottom level of 600.54 m.

Fig. II.10. Fill 121 on the left and cut 127 on the right.

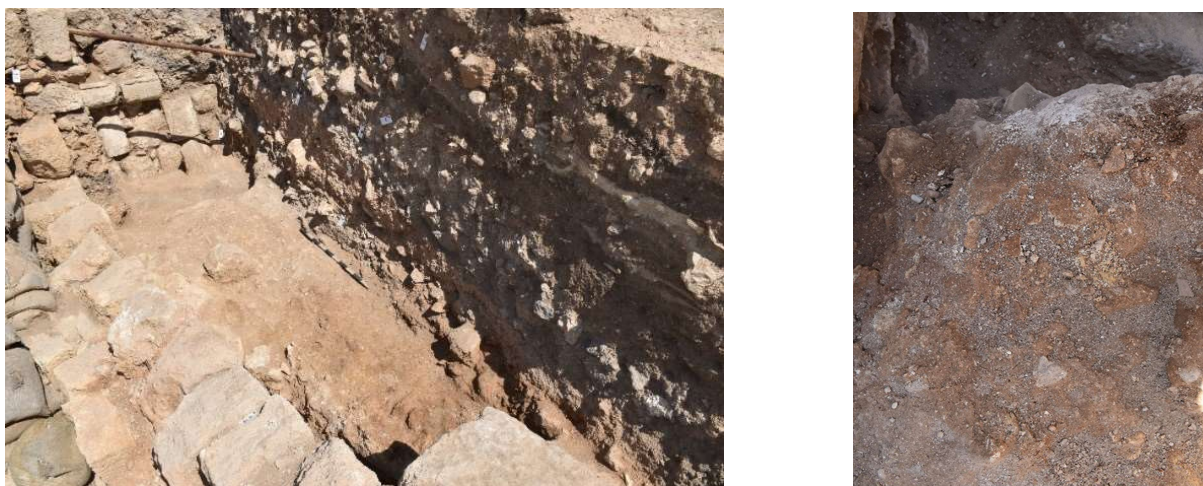
Fig. II.11. Layer 135 on the left and plaster in it on the right.

Below layer 122, layer 135 was discovered (fig. II.11) which is a soft, light yellowish-brown layer that interfaces with collapse 140 and the collapse appears inside it. Furthermore, it contains a low frequency of material however this includes pottery, bone, mortar and pieces of painted plaster that probably originated from the collapsed walls (fig. II.11). This context covers the whole surface of the excavated area and is truncated by pit 127 in its western corner. Its location is between cut 127 to the west, wall W1 to the east, wall W60 to the south and L.O.E to the north, it measures 5.20 m E/W by 1.36 m N/S, with a top level of 600.78 m and a bottom level of 600.41 m.

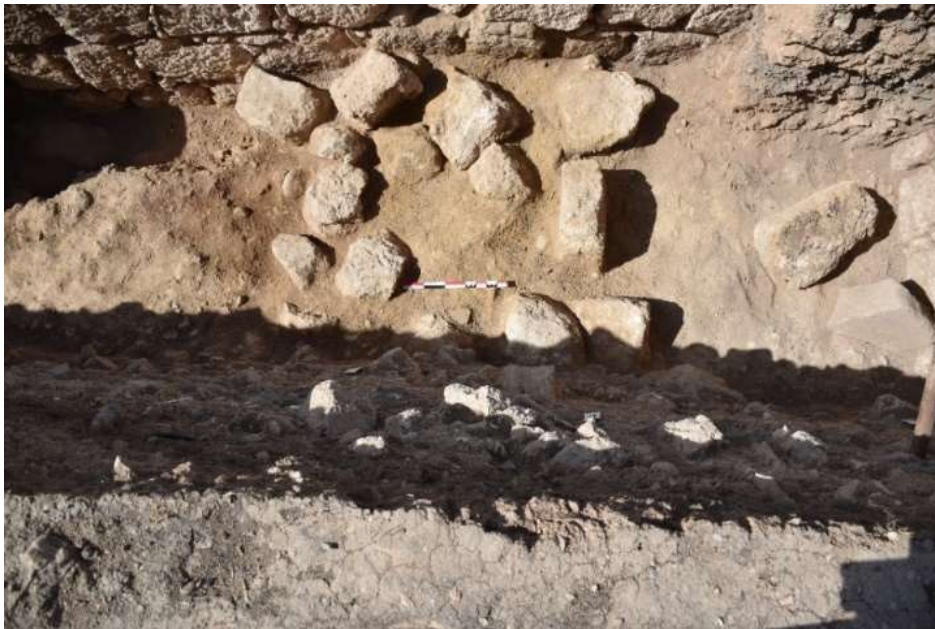
Below layer 135, collapse 140 was unearthed (fig. II.12). Collapse 140 was different in terms of color from layer 135, as it was yellowish-white and included more mortar, as well as a higher quantity of stones, the shape of which were more carved. This collapse layer was spread between layer 135 to the west, wall W1 to the east, wall W60 to the south and L.O.E to the north. It measured 5.20 m E/W and 1.63 m N/S, with a top level of 600.78 m and a bottom level of 599.69 m.

Fig. II.12. Collapse 140.

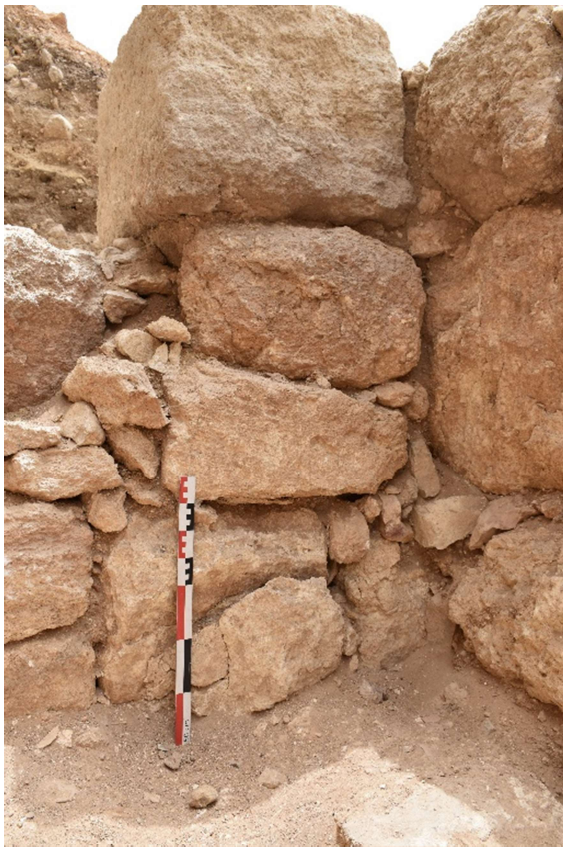
Fig. II13. Wall W1 on the right shows the shape of its construction with blocks of different modules and the use of smaller stones as filling. It also shows the connection between walls W01 and W60.

Wall W1, which intersects with wall W60 from the east, also predates the construction of building A, especially as it is linked to wall W60 (as previously mentioned in the 2022 report). However, the type of construction differs, as it was built with stones that appear to be part of the foundations of the building. Moreover, small stones were also used to fill the gaps between the blocks (fig. II.13).

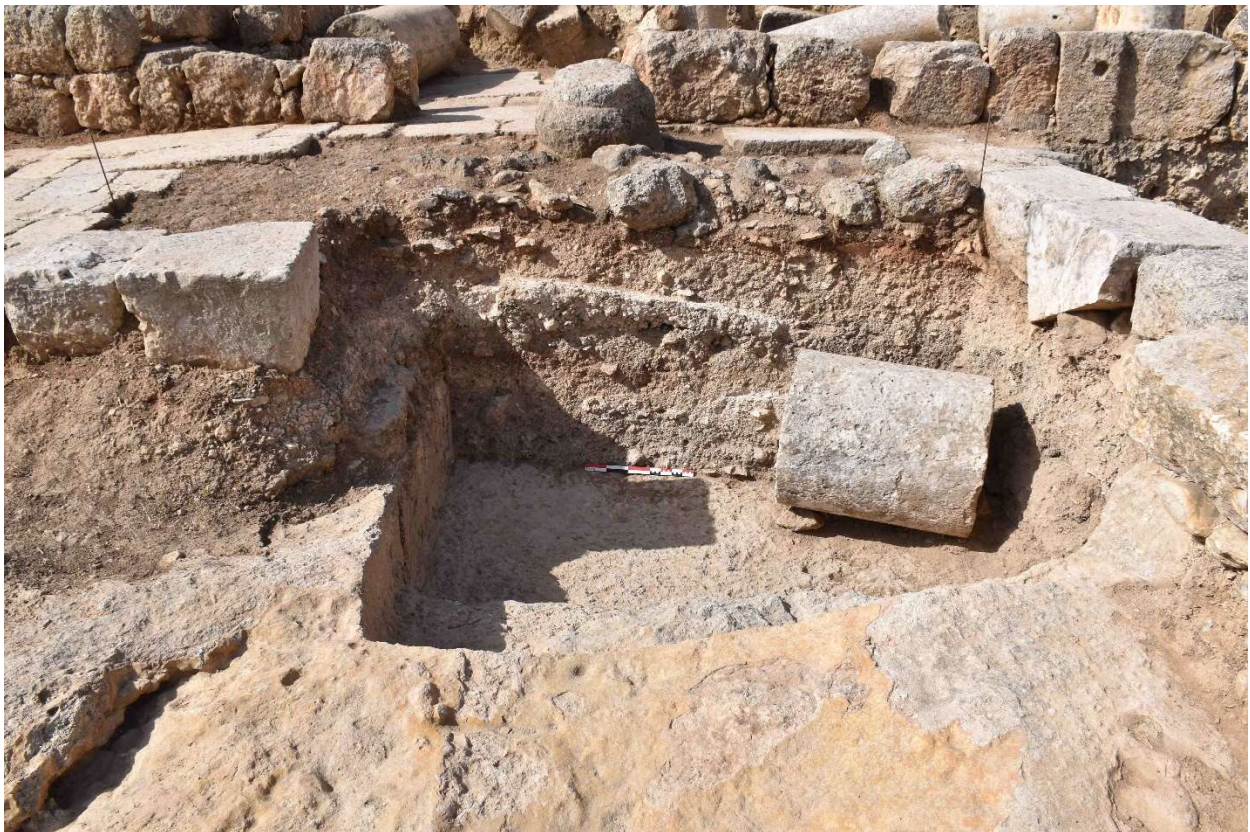
Fig. III.1. The tank and the layers that filled and covered it, as well as the courtyard pavement, view from the north.

The cuts in the bedrock were reused in at least one location. In area 5, a tank was built reusing a rock cut as one of the tank's faces (fig. III.1). This tank is located in the middle of the southern part of the courtyard but it was clearly not in use during the occupation of building A, as attested by the many layers that filled and covered it. It has not been entirely excavated yet. The northern part was excavated by the DoA in 2001 and only the baulk was straightened to be studied and drawn. Only the upper layers filling the tank have been excavated so far (in sounding 2) and the excavation of the tank needs to be completed next year. It is also covered by the later wall W21.

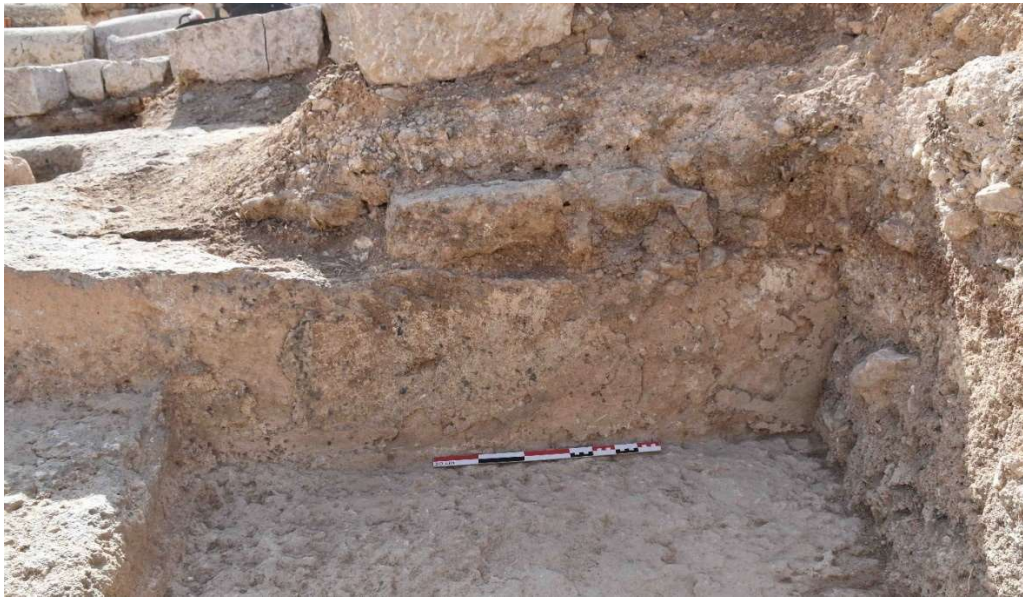
Fig. III.2. The eastern facing of the tank and its coating, view from the west.

disappeared, but no fragments have been discovered. The bottom is quite flat, with a slight slope from east to west (level to the east: 598.88 m, to the west: 598.83 m).

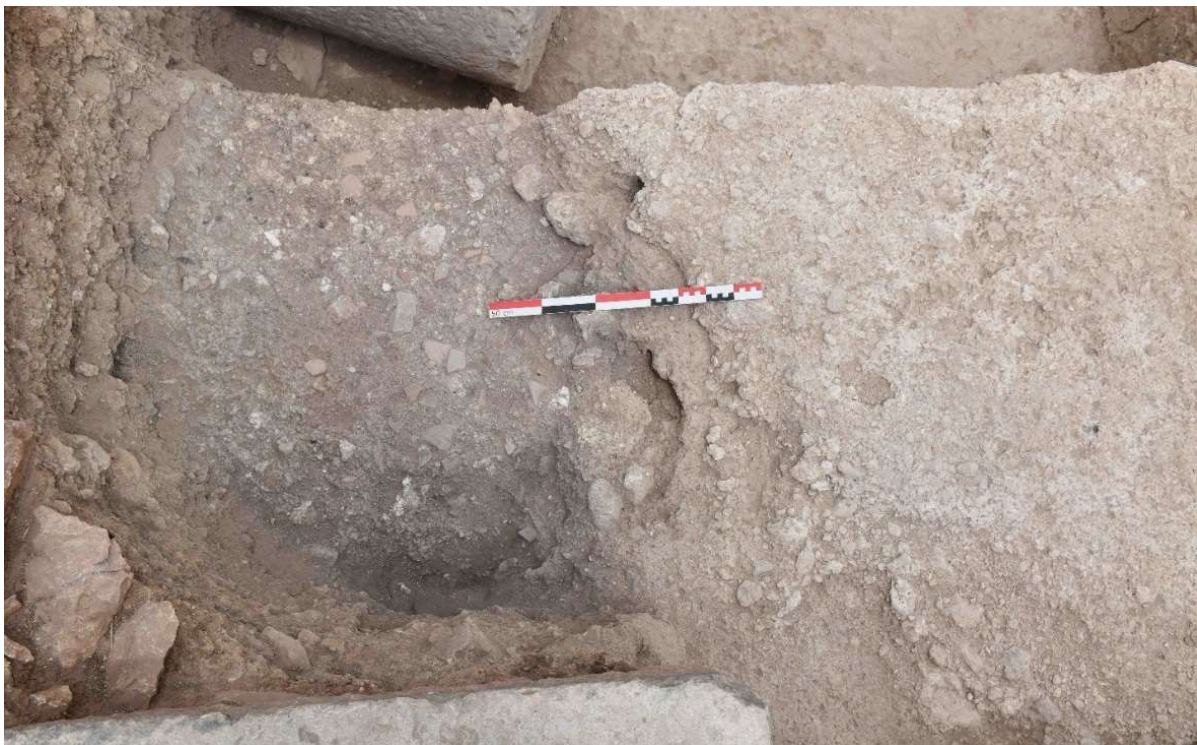
Fig. III.3. Layers 148, 149 and 156 were not excavated, zenithal view.

A thick layer (148) seems to seal the area. It is a homogenous loose white layer, composed of plaster or lime and small pebbles. The surface has been revealed but it has not been excavated yet. According to the section, it is between 6 and 26 cm thick. There is a clear slope from the east to the west (top level to the east: 599.76 m, top level to the west: 599.58 m). It covers the eastern part of the excavated area (1.5 m E/W by 2.30 m N/S). In the western part, layer 149 is against 148 and seems to continue on from it. This layer is composed of very loose black sediment containing small stones, ashes, charcoal, lime nodules and sherds. This layer is probably too loose to be a levelling deposit and more extensive excavation is needed to understand its function. Layers 148, 149 and 156 were not excavated but only cleaned on the surface.

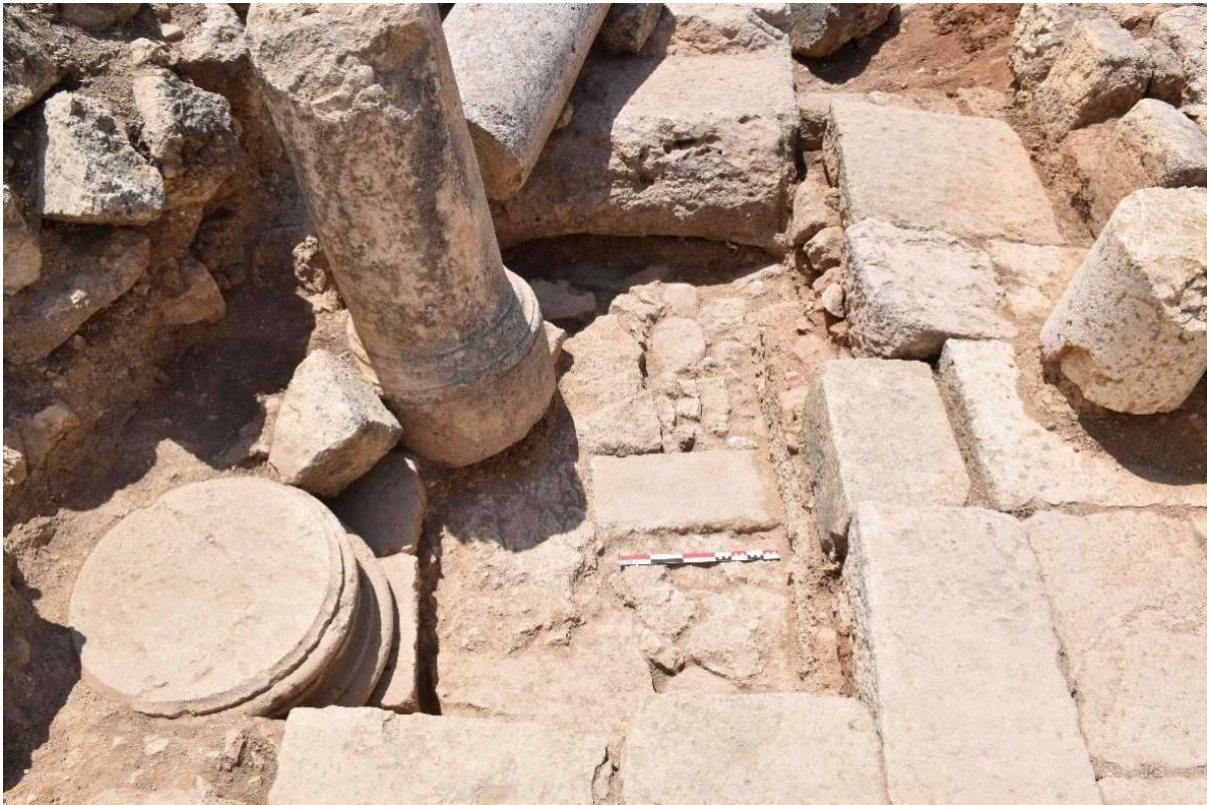
Fig. III.4. The last layer of sounding 3 with flattened large and small stones, under layer 147 and probably related to plaster layer 148, view from the east.

In sounding 3, the deeper layer that appeared is characterized by large flattened blocks and small stones (fig. III.4). It is flat but irregular. There is almost no sediment between them, at least on the visible surface. It has not been excavated nor numbered. It is almost at the same altitude (599.69 m) as the plaster layer 148 in sounding 2 and both could be related to a phase of occupation of the area. It is unclear whether the two stones visible under the colon base ST175 are built on this layer or not.

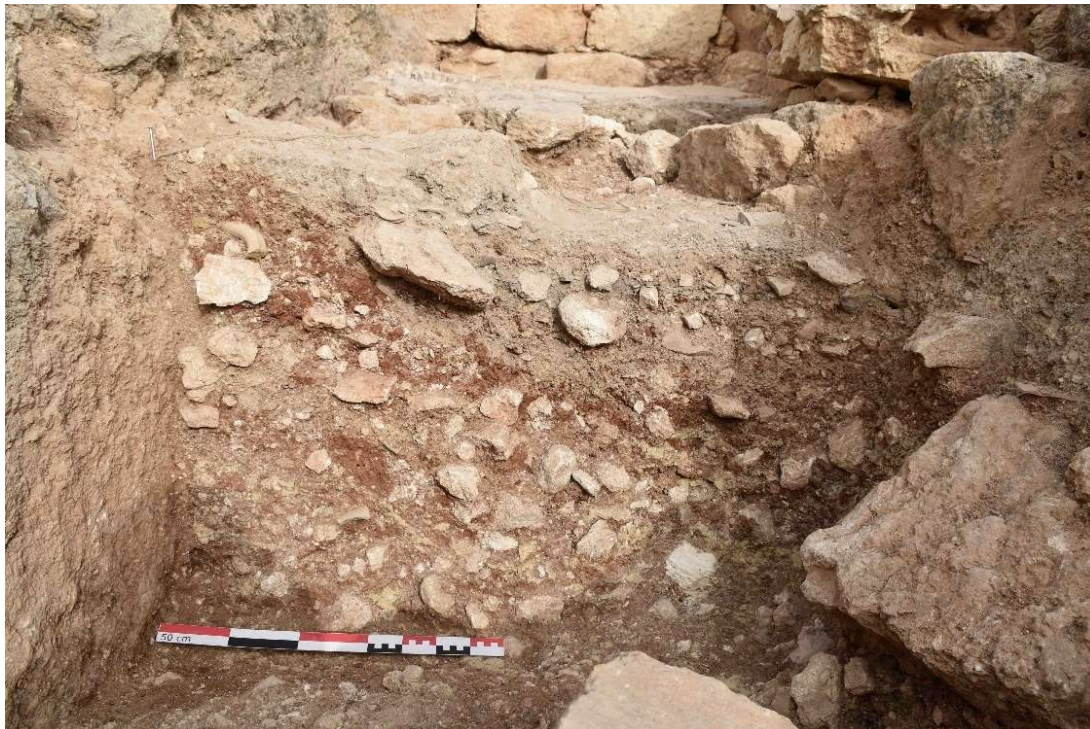
Fig. III.5. Deposits in sounding 1 to level the floor of the southwestern part of the courtyard with the bedrock floor: 136 is above 139, view from the east.

Under the mosaic pavement (116) and its two construction layers (117 and 118), which were both built in the later phase (5), appeared two layers numbered 136 and 139 (fig. III.5). The first one was a thick layer of powdery yellowish-gray sediment with small stones (between 5-19 cm), ashes, charcoal, lime nodules, many pottery sherds, bones, mosaic tesserae and glass fragments. In particular, a fragmentary bone bracelet (EJP23-A-12) was discovered in it. It was c. 30 cm deep (top level: 599.94). Under it, layer 139 is mainly composed of clayey red sediment which is compact when humid and then powdery when dry. It is heterogeneous with the presence of a green clay sediment. The limit between 136 and 139 is sometimes unclear because they can be mixed. There are sometimes red or green sediments similar to 139 in a general matrix similar to 136, in particular in the northern part of the sounding. This was at least 50 cm deep. The bottom of this layer has not been reached yet and excavation stopped at level 599.39 m. According to the stratigraphic disposition of both layers, and the fact that they mix at their northern interface, both may be deposits which were used at the same time to level the area. This deposit may be linked to the construction of wall W15, it could have provided a flat surface equivalent to the level of the pavement to the south, or later, to build wall W15. This is difficult to determine and the excavation of the remaining layers north of the wall W15, in the western part of the courtyard, may answer this question.

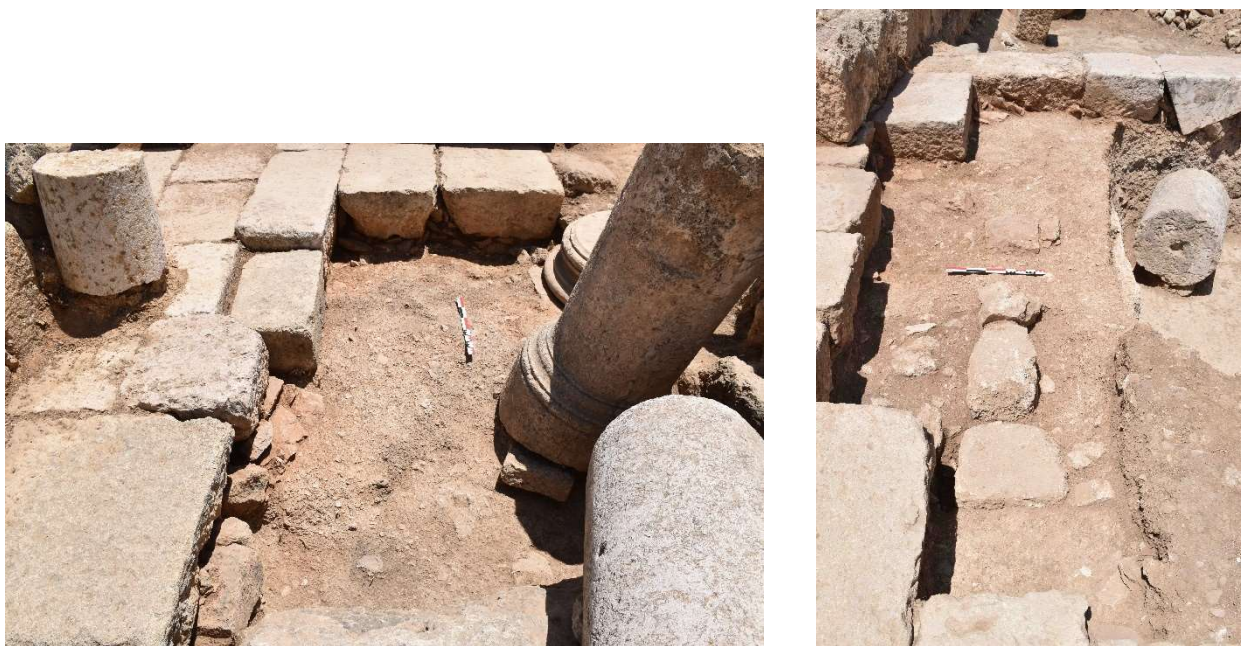
Fig. III.6. Levelling deposit prior to the building of the pavement: to the left, layer 147 in sounding 3 (view from the west); to the right, layer 138 in sounding 2 (view from the east).

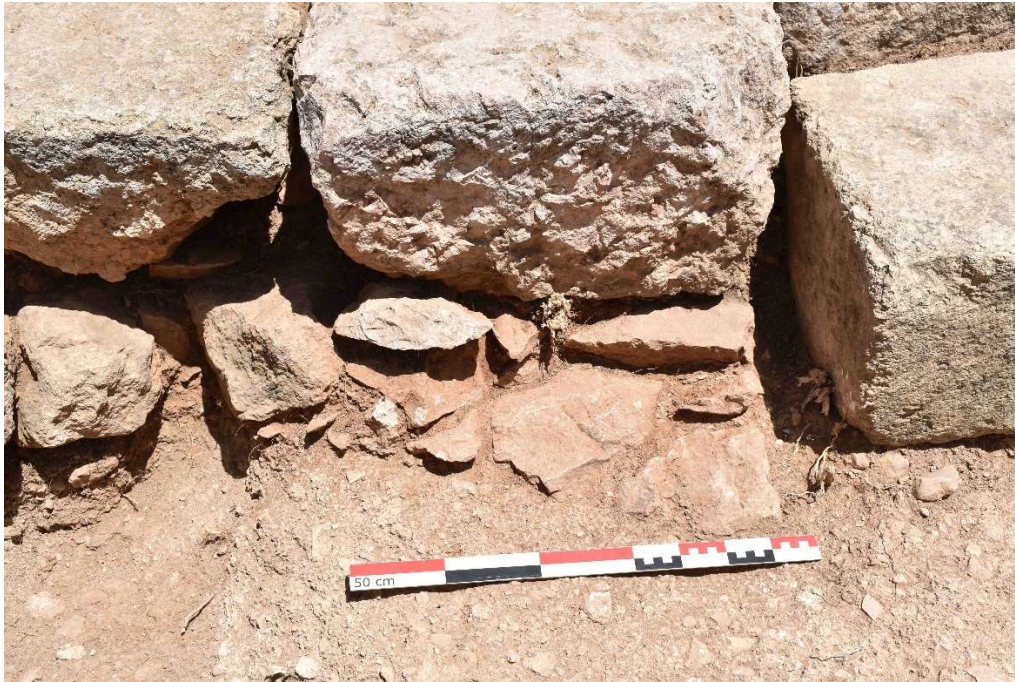
Fig. III.7. Stone layer for wedging the uneven stone pavement: detail in sounding 3, on top of levelling layer 147, view from the south.

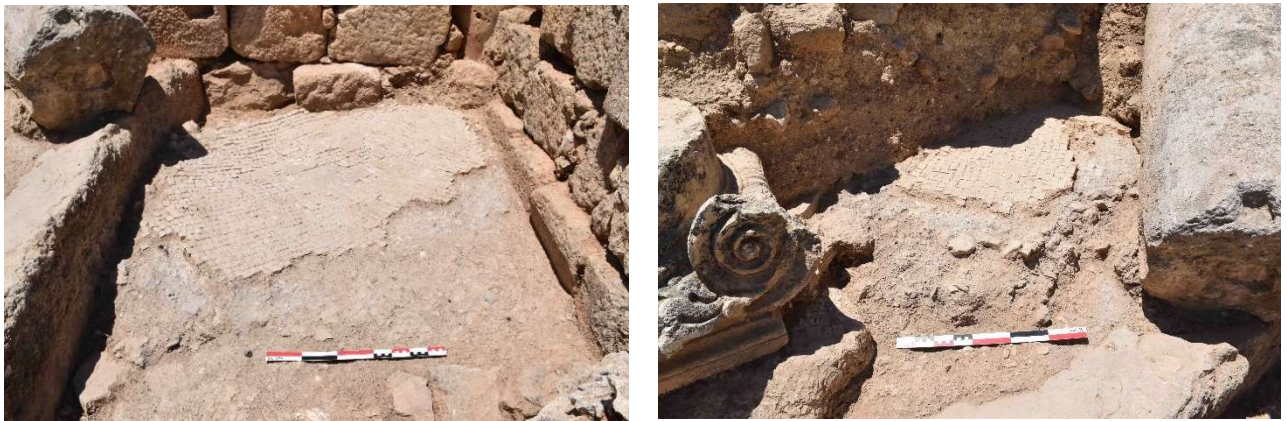
Fig. III.8. The mosaic pavement: the northern one (116, on the left, view from the east) is lower because it was built on the level of the pavement while the southern one (109, on the right, view from the northeast) was built on bedrock higher than the pavement.

The floor of room R8 seems to have been a mix of mosaic and stone pavements. The eastern part was paved reusing stone slabs from the courtyard, probably over 2.30 m N/S x 3.90 m E/W. This is most probably missing over 1.25 m N/S x 2.25 m E/S, where the sounding 3 was carried out. The western part of the room had a white mosaic floor from which

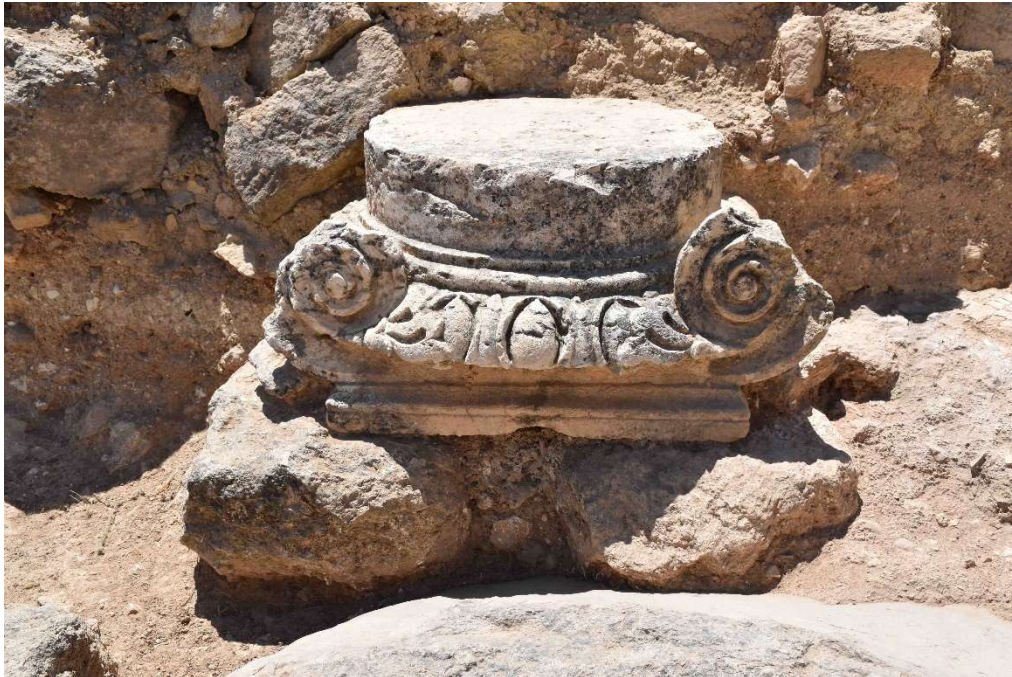
Fig. III.10. The structure ST115 consisted of an upside down Ionic capital on a stone massif, maybe a support for a column, view from the north.
