Eastern Jarash Project: 2023 Final Report

EASTERN JARASH PROJECT

2023 FINAL REPORT

Edited by **Dr. Julie Bonnéric**

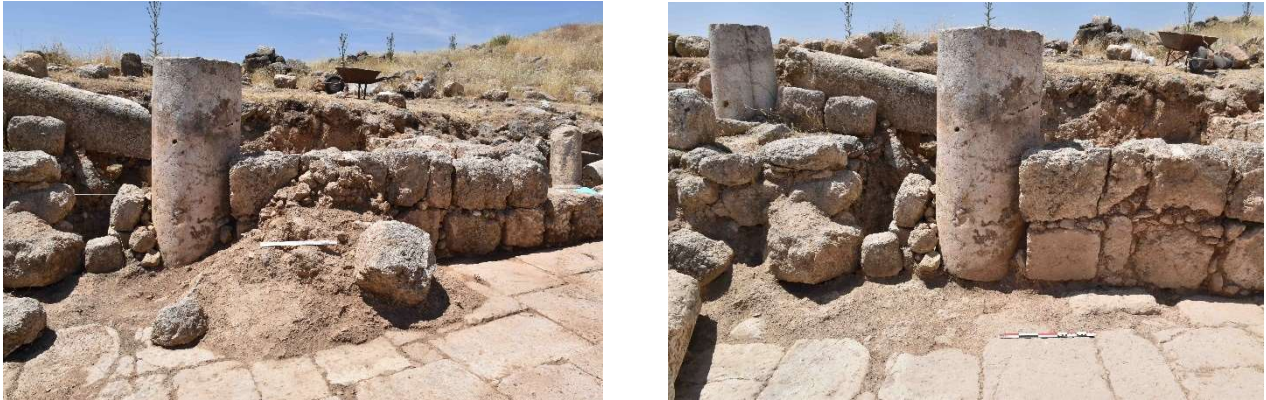
Fig. III.11. The collapse layer 137 on the courtyard pavement, against the northern facing of wall W15, the only remaining collapsed material from the 749 CE earthquake in area 5 which was not excavated in 2001. Before excavation on the left (view from north-east), after excavation on the right (view from the north).

In this area, the last phase is an abandonment phase which started with the 749 CE earthquake. It is characterized by collapse layers. Because the area has already been excavated, these layers mainly appear in the southern baulk (fig. III.9). Layer 107 is a thick layer (c. 0.90 m high) of large and middle-size stones in a loose reddish-brown sediment with gravel, pebbles and large stone blocks. It follows a slope to the east which corresponds to the middle part of the courtyard (top level max.: 602.10 m, top level min: 601.45 m). It was covered by a top soil layer (top level max.: 602.20 m, top level min: 601.56 m). Two other collapse layers were found in the baulk, at its western extremity. The first one (108) is located under 107. This is a yellowish compact sediment without any blocks, just small stones. It is quite similar to the layers of the upper floor that collapsed in room R4. It seems less pulverulent and more compact, probably because there is no wall or mosaic mortar. It is c. 25 cm thick (top level: 601.20 m). It comes up against and on the capitals of ST115. Under 108 and laying on the mosaic pavement 109, layer 106 is also a collapse layer, with more pebbles. It is 28 cm thick (top level: 600.96 m) and is only visible over 1.42 m west to ST115. Because of the collapsed drum, it was not possible to see if it runs up to wall W16.

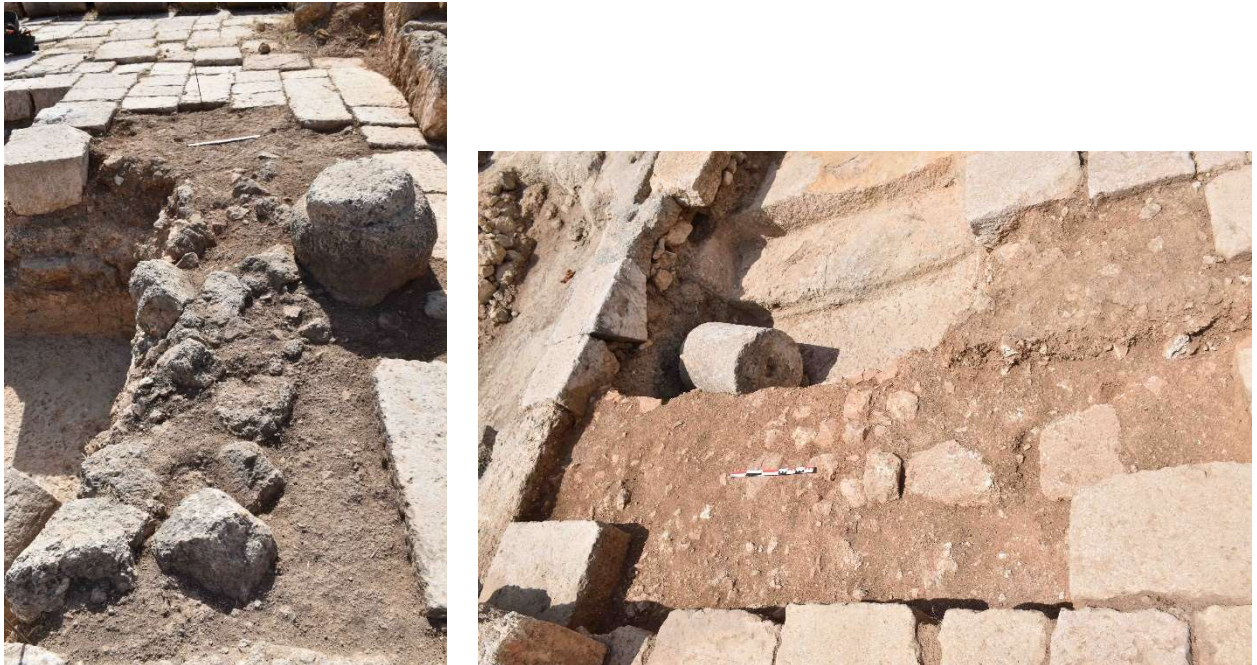
Fig. III.12. The upper layers of sounding 2: layer 128 (to the left, view from the west) above layer 134 (to the right, view from the south).

In the absence of enough pictures from the 2001 excavation, it is not easy to know whether the top layers (128 and 134) in sounding 2 are archaeological layers or not (fig. III.12). No plastic or modern elements have been found in these layers and they are visible on a picture dating from the end of the 2001 excavation. Therefore, we consider that they are archaeological layers and that the archaeologists did not remove the courtyard's stone pavement. However, they lie on layer 138, the levelling layer of the pavement. This suggests that these deposits are related to the earthquake and that the pavement was missing at the time the earthquake occurred. However, it cannot be excluded that the stone slabs were collected after the abandonment of the ruined house as the courtyard would not have been buried under a thick layer of wall stones, stories or roof debris since it was a large open-air area. Some archival pictures confirm that, at the moment of the previous excavation, the pavement in the middle of the courtyard was covered by only a relatively thin layer of earth (c. 30 cm²) and a few stones. The two remaining layers could be related to the collapse caused by the earthquake and sedimentation following the abandonment. Layer 128 is a brown sediment containing small and medium size stones. It is more or less 20 cm thick (top level: 600.26 m). It is quite possible that the upper part of this layer was removed in 2001 to level the layer with the surrounding pavement. Below 128, layer 134 is a more compact reddish-brown sediment, with stones that are smaller than those in 128. It is c. 10 cm thick and quite flat (top

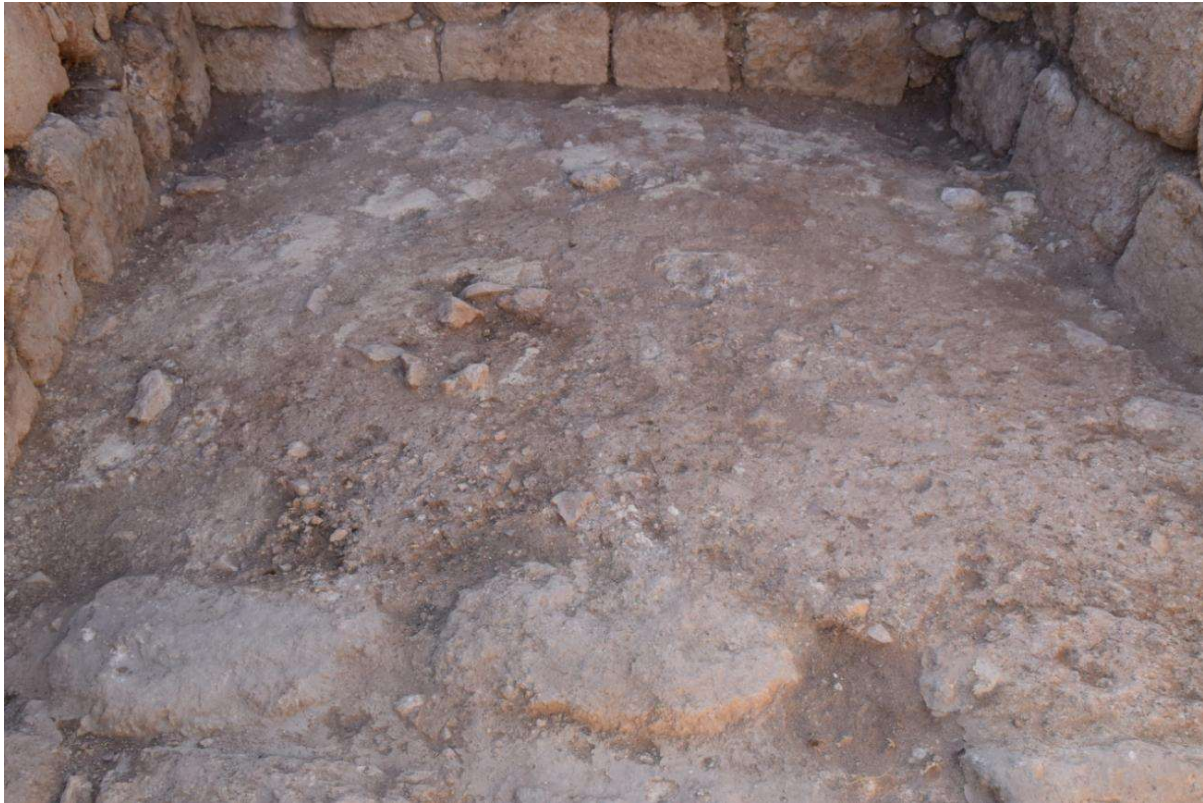
Fig. IV.1. The earthen floor SU69 in room R5, view from the west.

In room R5, directly under a collapse layer (SU62), an earth floor numbered SU69 (top level 601.07 m) appeared. It contains a fine brown sediment, including very small pieces of gravel, covered with small yellow patches of mortar from the collapse (fig. IV.1). It was placed on the vault summit. It is probably similar to the earth floor found in R4 (see the 2022 report) but in room R5 the floor has not been excavated.

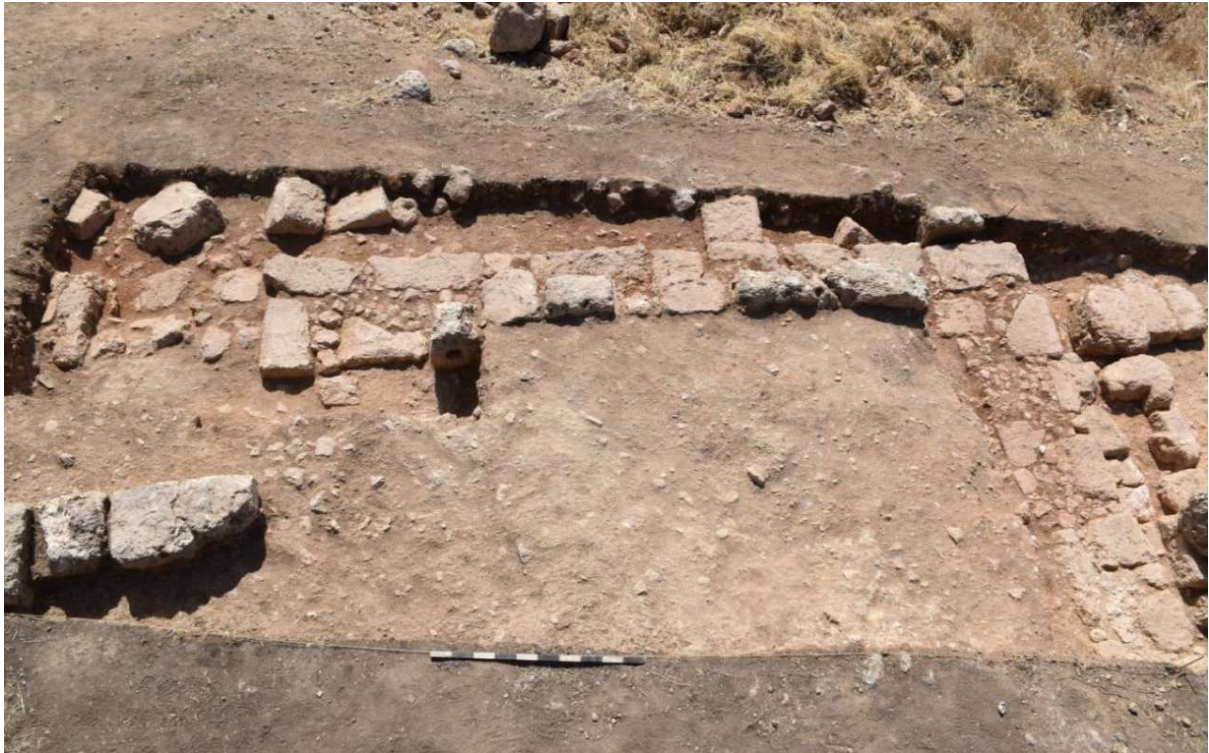
Fig. IV.3. Sounding E and the southern corner of room R6 with the linked walls W1 and W123, a door in W1, as well as SU133, SU131, SU132, SU143 and later W130.

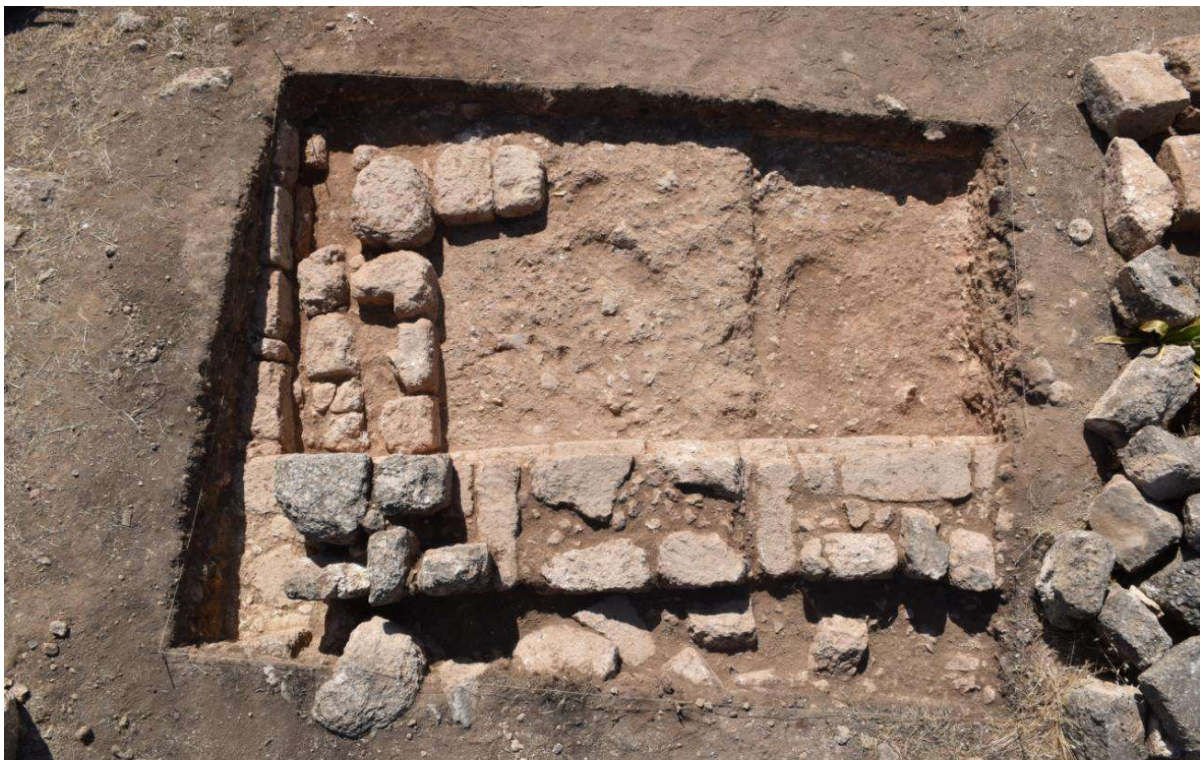
Fig. IV.4. Sounding D and the corner between W114 and W123, as well as SU113, SU125, SU126 and W124 in the outside corner.

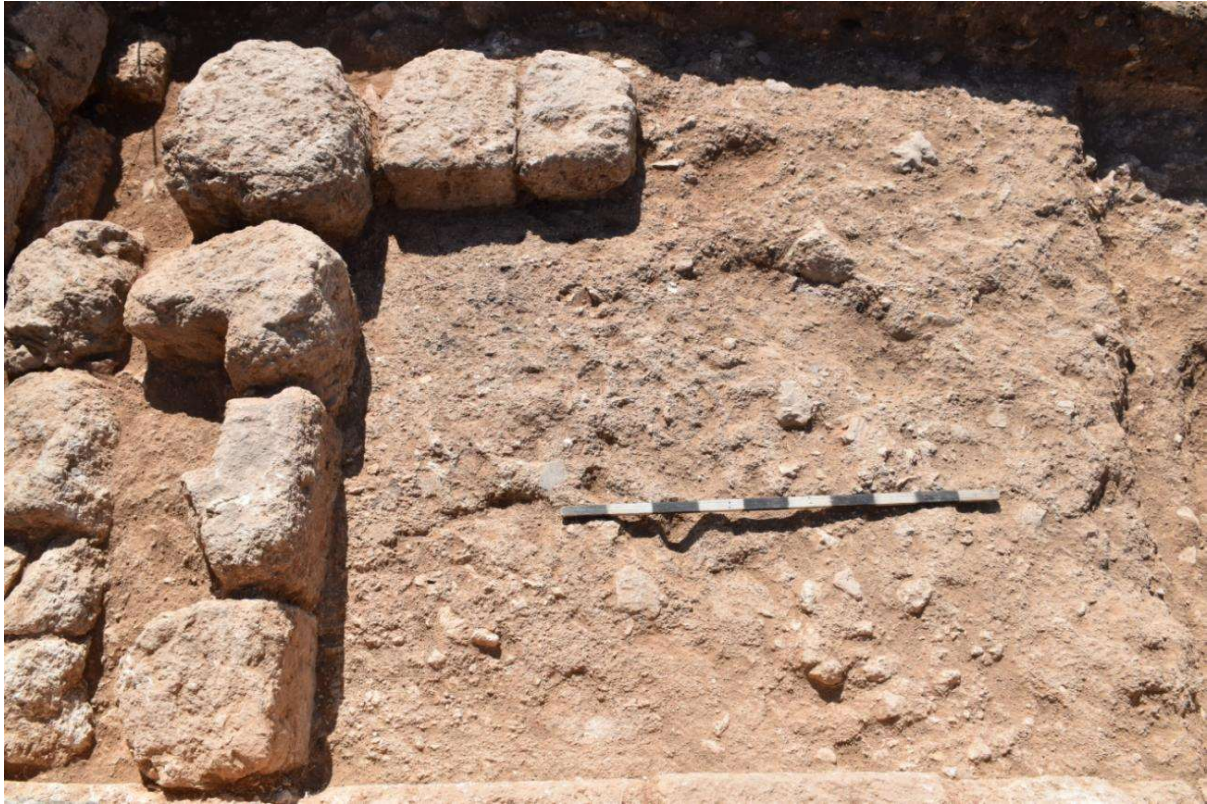
Fig. IV.5. Floor SU125 against W124.

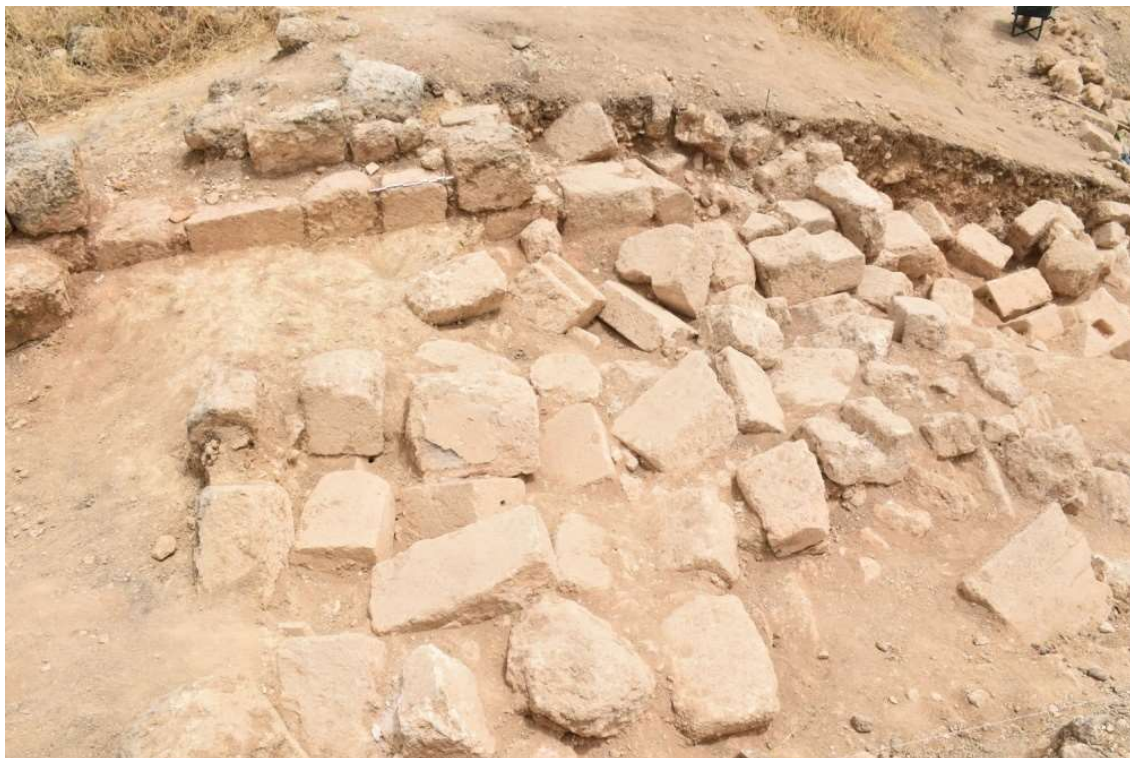
Fig. V.2. Wall W101, the northern wall of the shop and the collapse 102 in the western part of the sounding, view from the south.

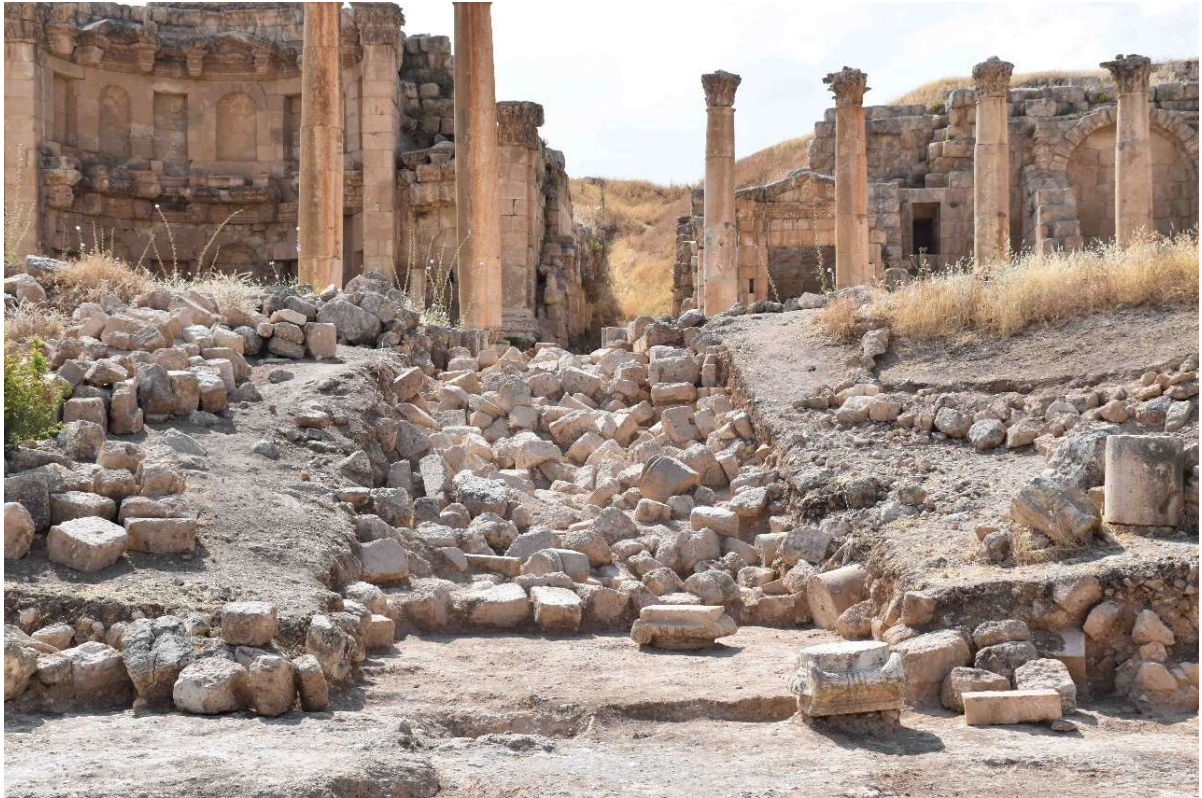
Fig. V.3. The area 3 at the end of the excavation, view from the east with collapse 102.

The second phase is characterized by a huge collapse which was most probably related to an earthquake (fig. V.3). The pottery has still to confirm this but, according to the 2022 results, it is most probable that the 749 CE earthquake destroyed area 3. The collapse layer 102 covers the whole excavated area 3 (20 x 5 m). It mainly contains large and medium carved stones in light brown sediment, which are probably related to the collapse of walls. Column capitals, drums and bases appeared in the layer, as well as rubble stones. Many finds were also found such as pottery sherds, iron nails, coins and one juglet (fig. V.4). This layer slopes towards the east (top level max to the west: 604.17 m and top level min to the east: 601.26 and bottom level max to the west 603.92 m and min to the east 600.64 m). The slope is related to the fact that the circulation level is higher in the western part (i.e. the cardo) and lower in the eastern part (i.e. the courtyard). The absence of walls in the courtyard also explains that the collapse is thinner in the eastern part of the excavation area. These stones may have been collected in this area after the earthquake occurred in 749 CE.

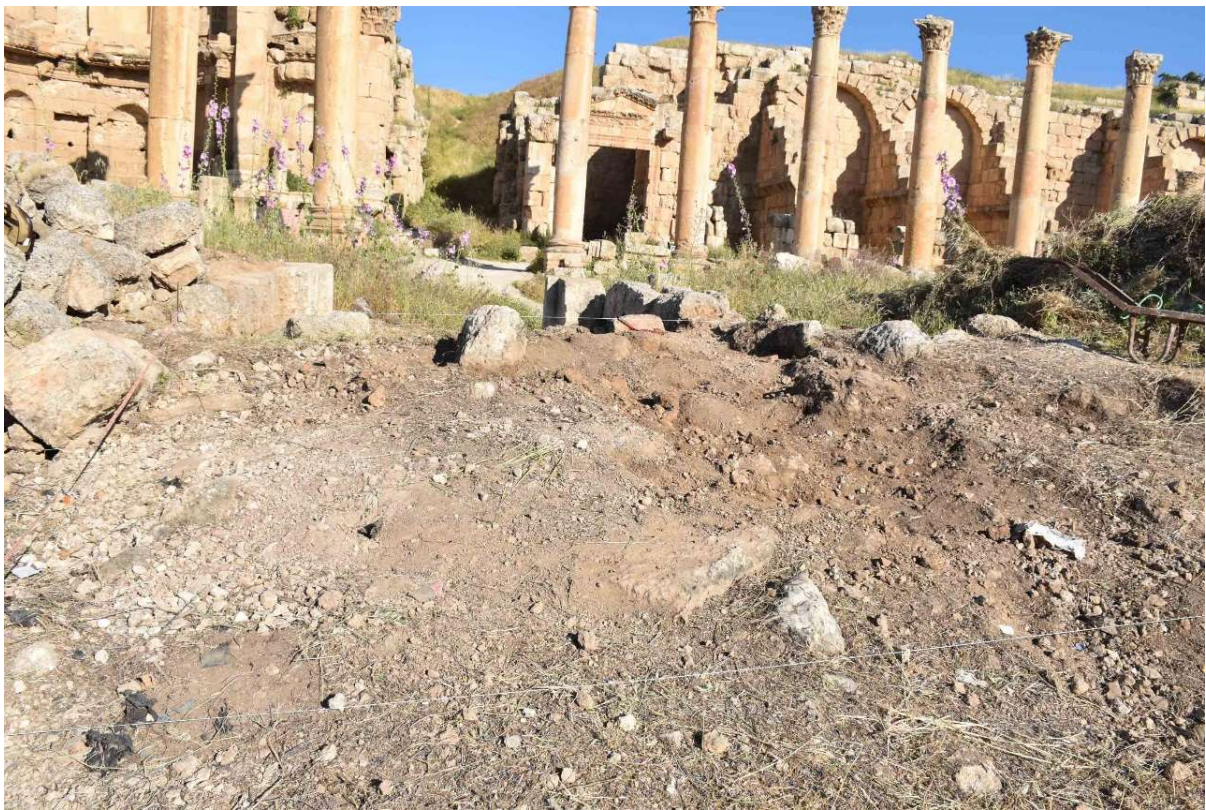
Fig. V. 5. Top soil (cxt 100) at the beginning of excavation in sounding 1, view from the east.

The collapse 102 was covered by a topsoil layer (SU100) that contained plant roots and plastic and, in addition, carved stones and some architectural elements were also found. The sediment is loose and dark gray to light gray (fig. V.5). The depth of this layer ranges from 40 cm to 70 cm (top level max.: 604.62 m and bottom level min.: 601.26 m). This layer also contains many pottery sherds, mosaic tesserae, shards of glass and slag. This layer is the result of recent sedimentation and rubbish, and could also be the filling thrown here during the excavation of the building by the DoA. It follows the slope of the collapse 102.

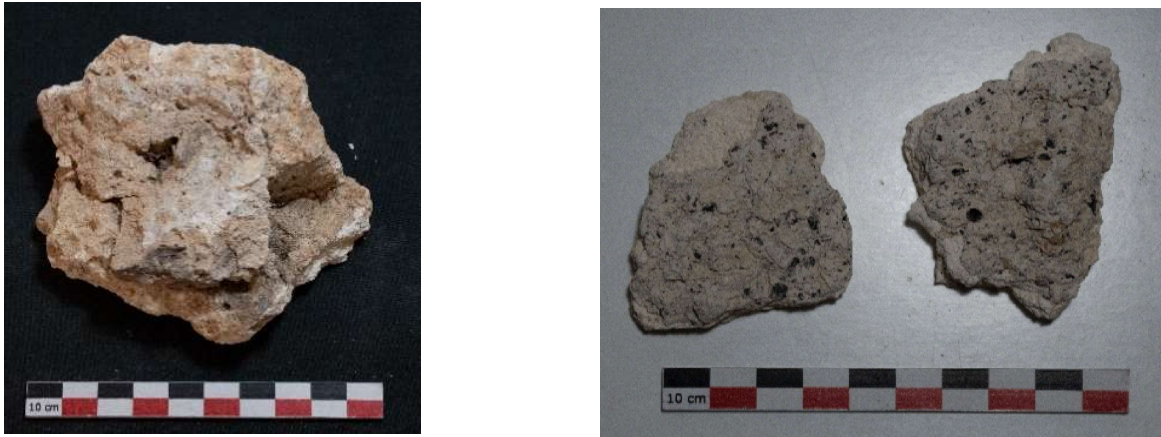
Fig. VII.5. On the left, the type of mortar in context 25 and, on the right, the mortar that was only discovered in context 62.

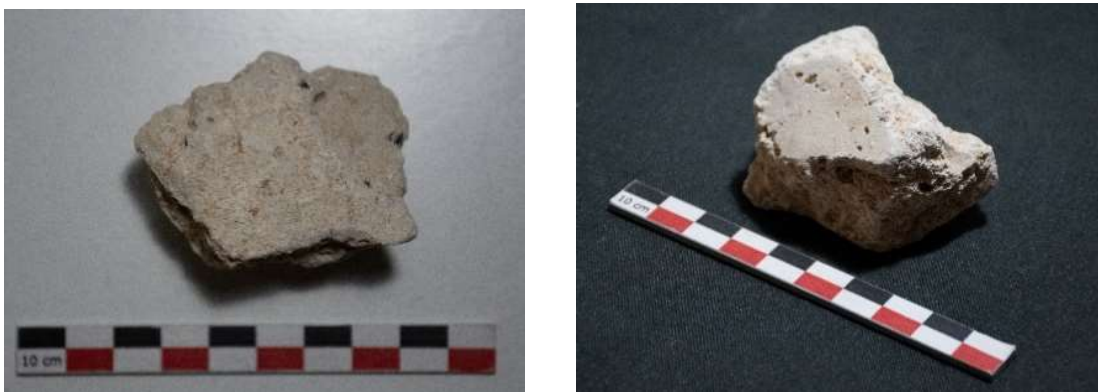
Fig. VII.6. Fragments of mortar without any traces of painted plaster were found in stratigraphic layer 52.

It should also be noted that, in context 52, certain fragments do not show any coating (fig. VII.6). They have no pigment and a particularly compact appearance. It could be hypothesized that these are stucco elements.

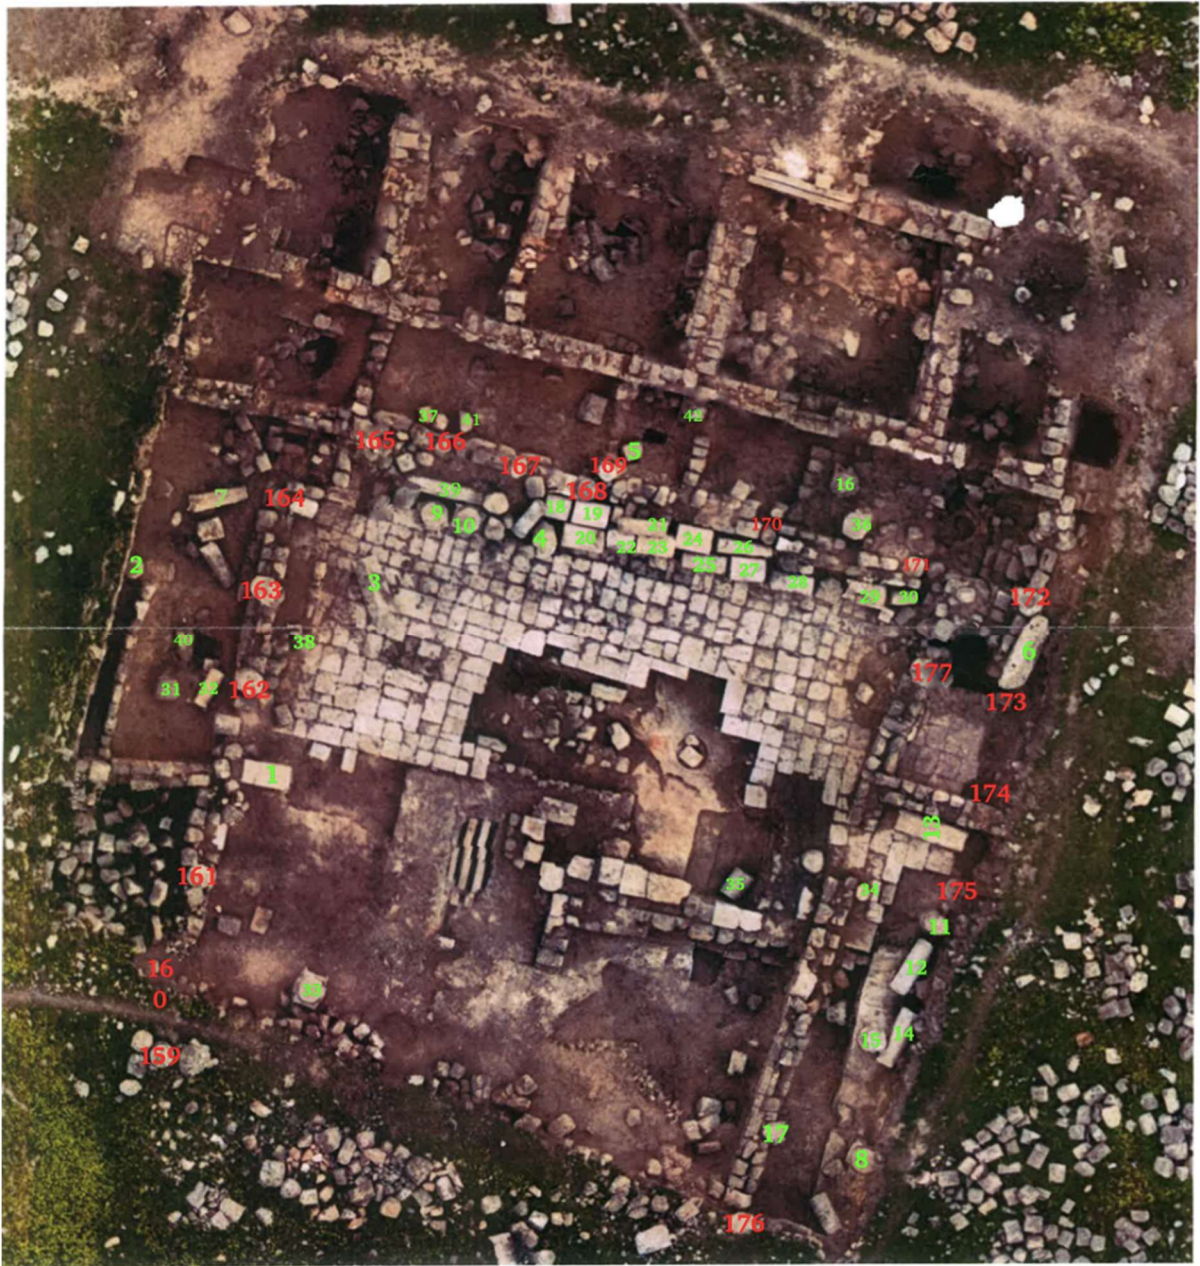
Fig. VIII.1. Orthophoto of building A with column numbers: red = structures in place, green = floating structures.

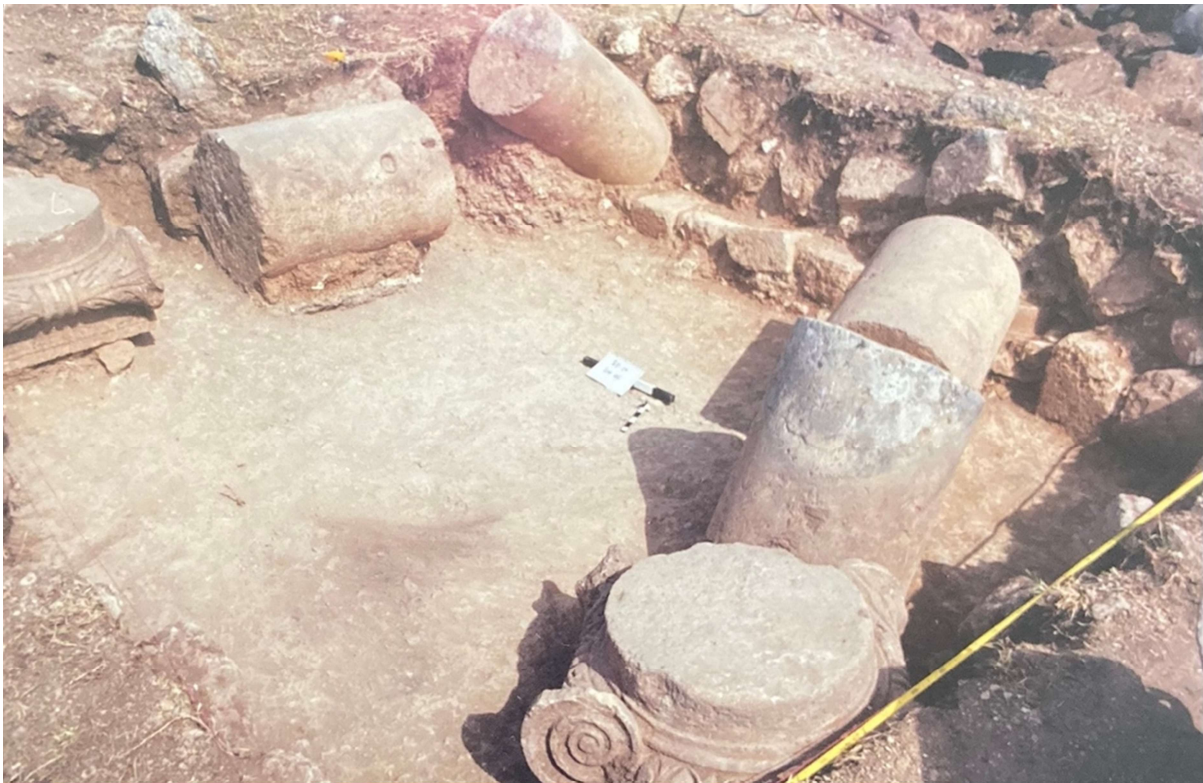
In addition, archive photographs from the 2001 excavation enable us to identify the planes on which the columns fell before they were moved (to the eastern part of the courtyard in the case of most of the drums). We can see that at least two of the columns had an inverted Ionic capital as a base, which supported at least two large diameter drums (around 65 cm).

Fig VIII.2. Archive photograph from the 2001 excavation (DoA): view of two fallen columns.

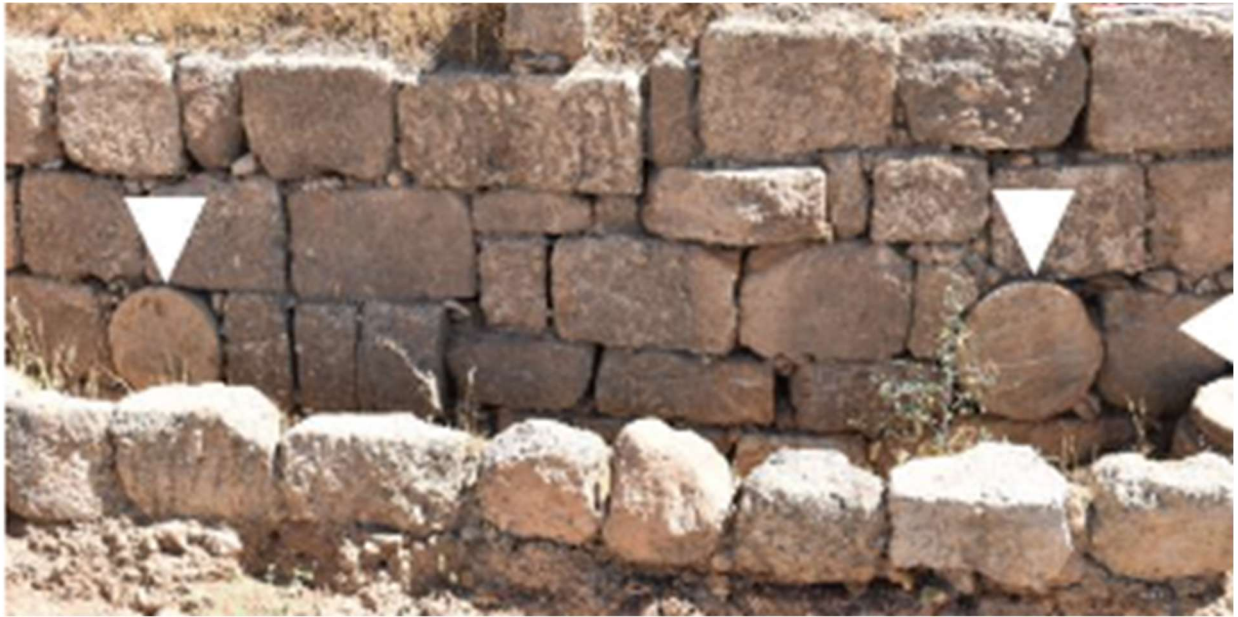
Fig. VIII.3. Drums used inside the masonry of wall W2.

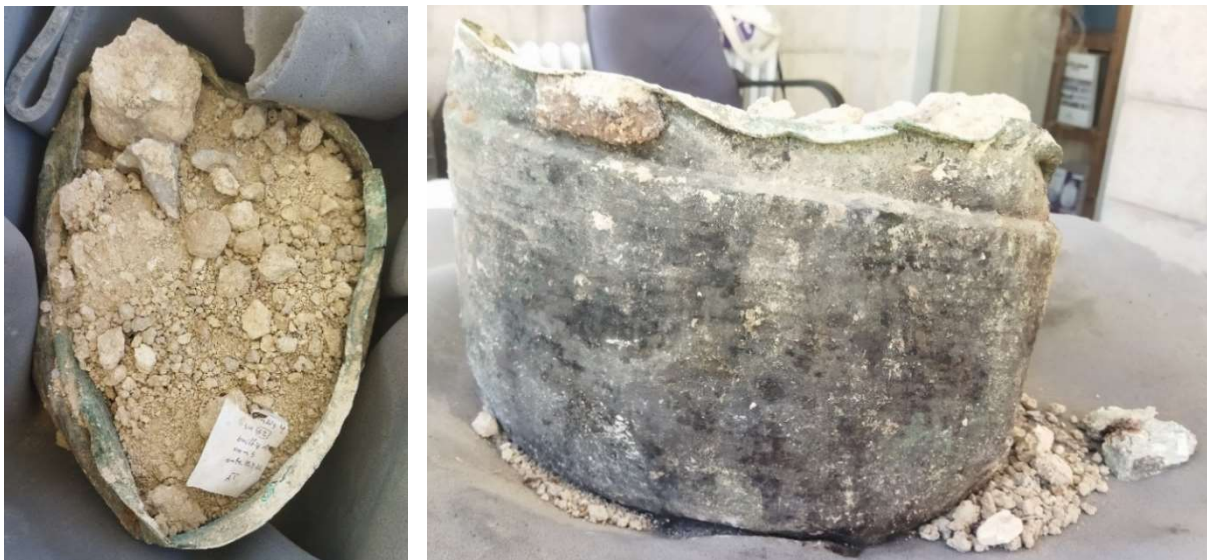
The diameter of the excavated big, copper-alloy pot is around 40 cm, and the maximum height is 24 cm. The shape of the pot, discovered under collapsed walls, is not regular due to the stones and debris that have fallen on it. As a result, it has folds and cracks in the rim, sides and base.

Fig. X.2. The shape of the pot when received for conservation treatment.

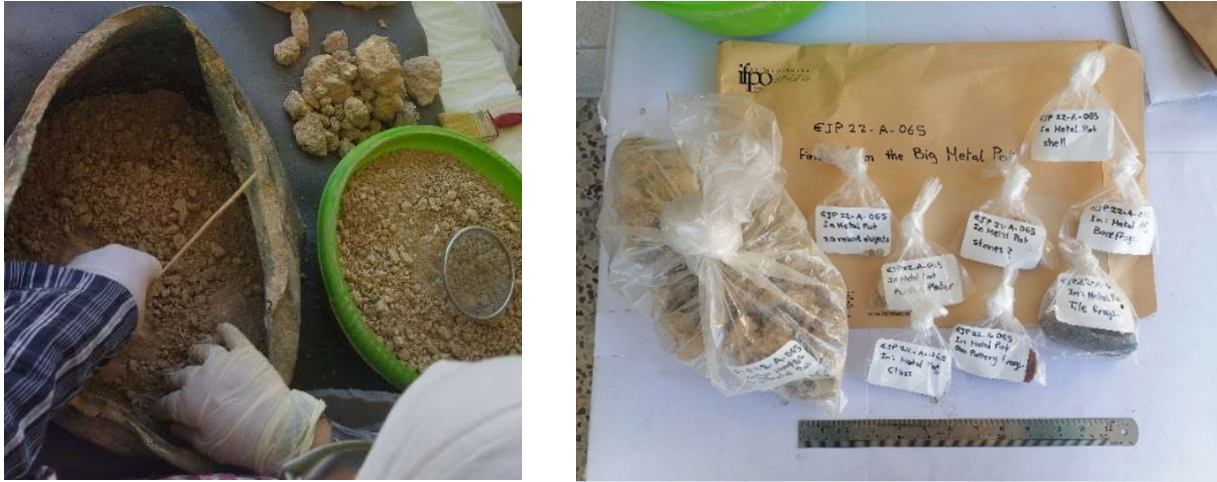
1. Cleaning the dirt inside the pot was like a mini-excavation as the sand from inside was sifted to look for small or tiny objects. The pot contained stones, mortar pieces, painted plaster, pottery, glass, shells, tiles and bone beside the debris.

Fig. X.3. Cleaning the debris inside the pot and the significant finds from the pot.

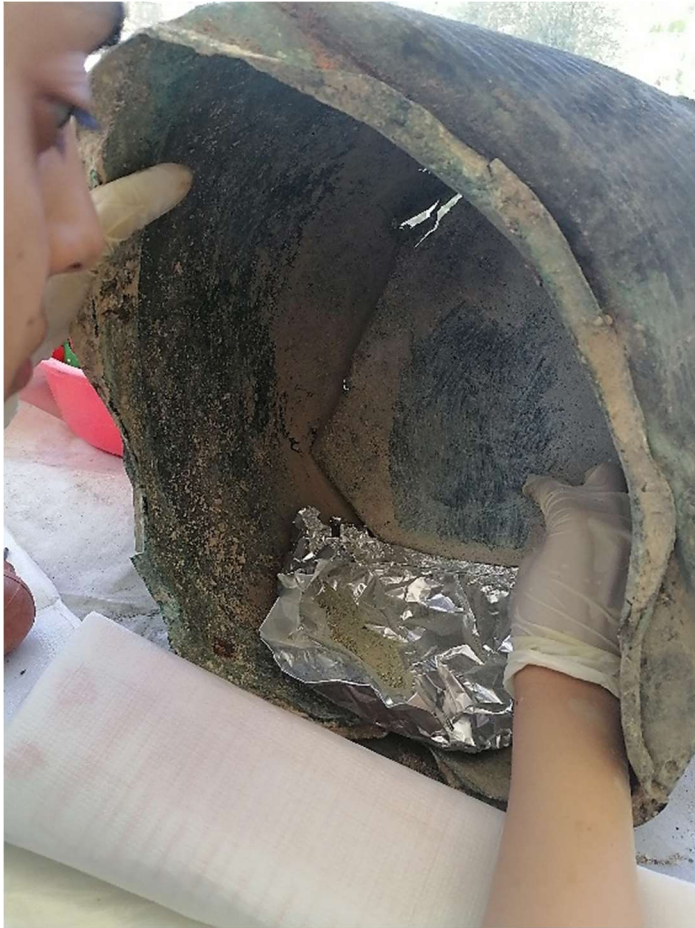
2. Cleaning the corrosion layer from inside the pot to prepare samples for analysis of the residues of this pot that could uncover its previous uses. This cleaning used only medical scalpels (mechanical cleaning).

Fig. X.4. Preparing samples from the residues and corrosion.

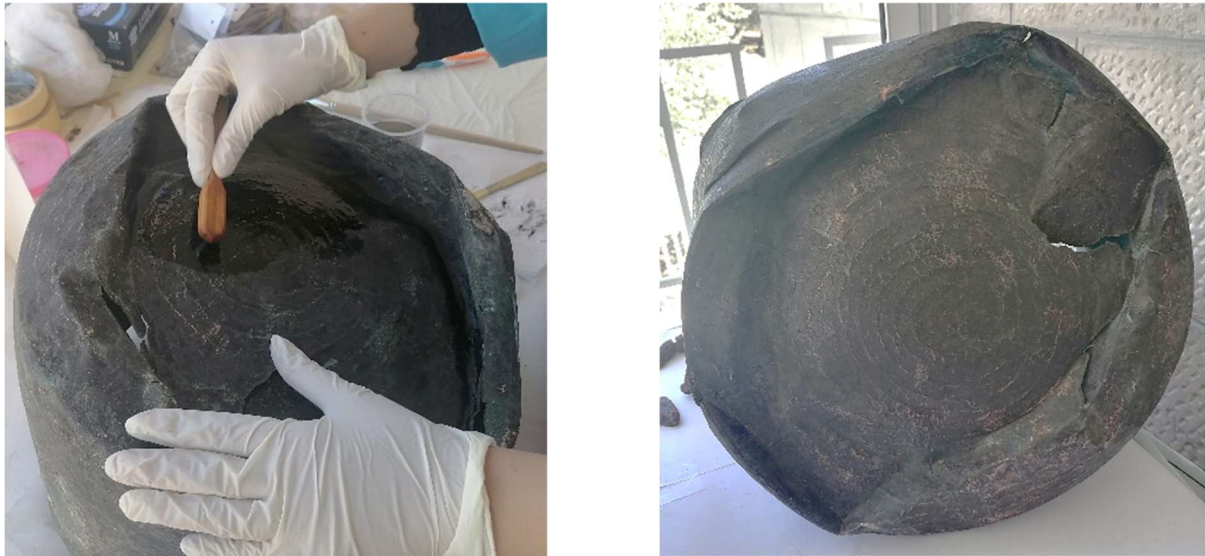
3. Cleaning the soot from the outside surface of the pot. This cleaning aimed only to remove the soot that had left traces all over the pot's surface; therefore, the cleaning did not go into deeper layers. Brushes, wooden sticks, dental tools, sponges and a solution of Formic Acid with distilled water were used to clean it. Interestingly, after this cleaning it became clear that the soot had protected the metal surface from corrosion. Once the soot layer was removed, it revealed the metal surface, which is unusual for archaeological metals. Meanwhile, the pot's surface on the

inside, the rim and the surface under the pot's lead holders and iron frame all had corrosion layers. This exciting phenomenon deserves to be researched and analyzed in the future.

Fig. X.5. Cleaning the soot layer from the pot's outside surface.

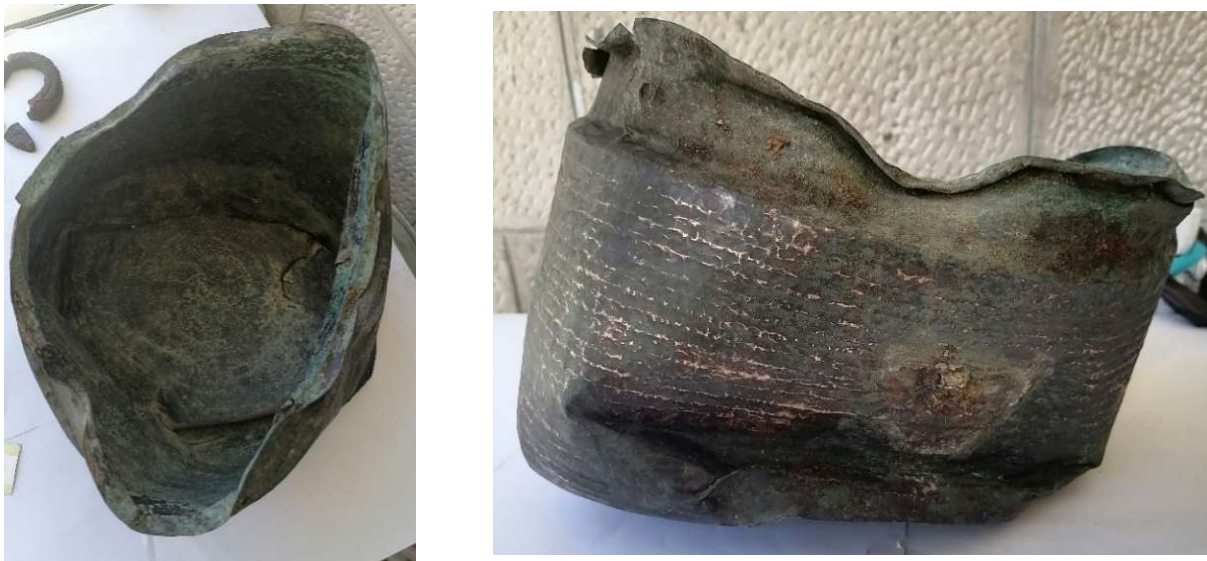
4. Chemical cleaning using Ethanol (alcohol) for all the pot's surfaces and then brushing to rinse it from any traces of dust, corrosion residues or other chemical materials.

Fig. X.6. The big pot after final cleaning.

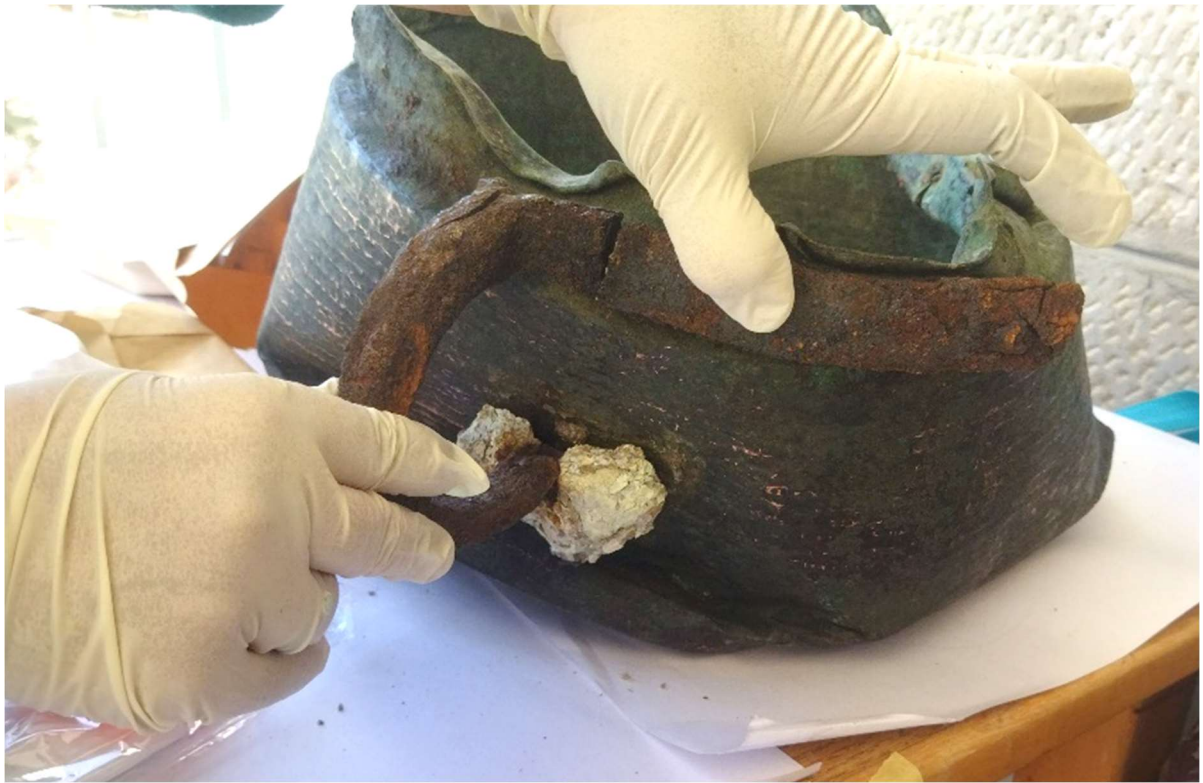
5. Joining the other fragments/objects to complete this pot. Both objects with the numbers EJP22-A-182 and EJP22-A-183 are fragments that belong to the big pot number EJP22-A-065. The object numbered EJP22-A-183 contains eleven iron frame fragments and two handles, most of which have been joined with the iron frame fragment left on the pot. One of these iron fragments was glued to the iron frame on the pot using UHU as a reversible adhesive. Paraloid B-

72 was used first, but it was not strong enough for the iron frame. Furthermore, it was found that the object numbered EJP-A-182 also belonged to this pot: a triangle lead object with a thick iron nail head, which is one of the two holders on the pot attached to the pot's iron handles.

Fig. X.7. Gluing the joining fragments to the big pot.

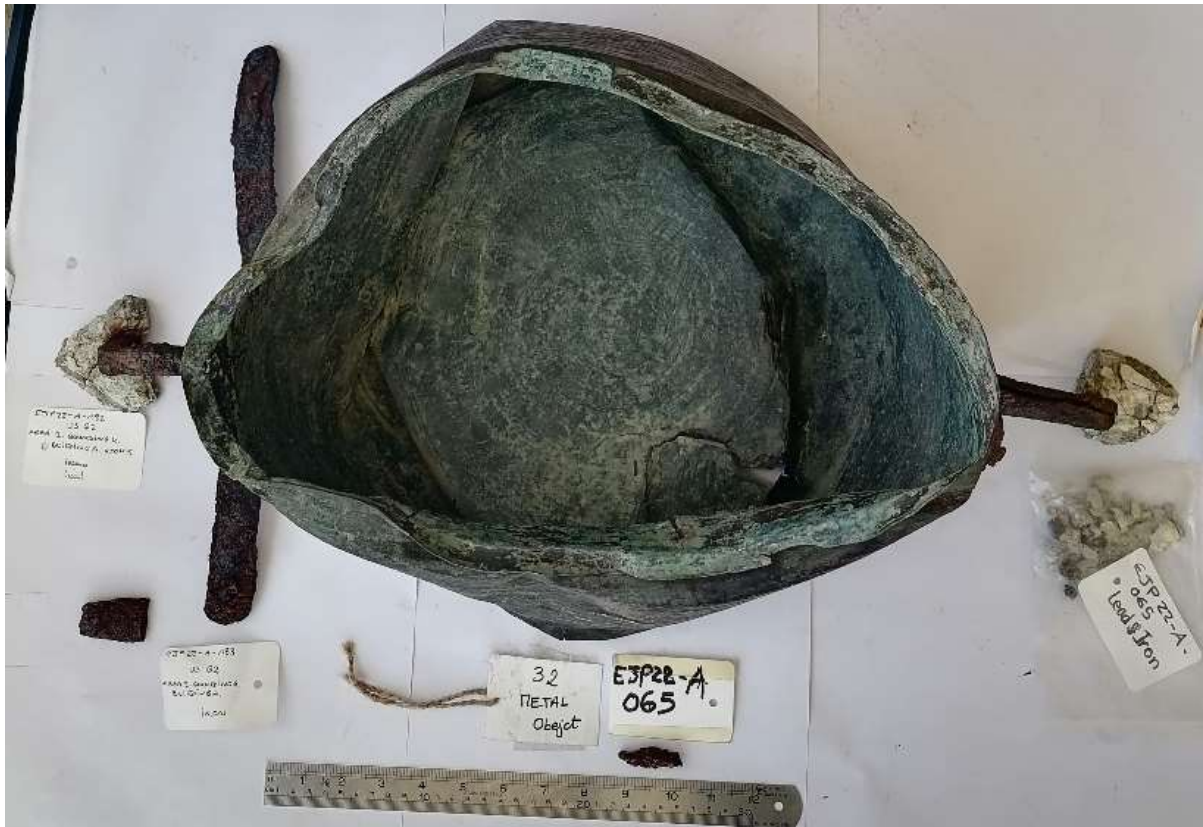
6. Later, the pot was left to dry before the final photos were taken and it was prepared for packing. Restoring this big pot requires discussion and further research. It is clear that the iron frame and handles are part of the pot and that the handle holders are made of lead metal while the pot is made from a thin layer of copper alloy that has been squashed due to heavy stones falling on it during the earthquake. As a result, gluing these heavy metals (lead and iron) to the thin copper alloy will not be enough to hold them together. The pot will need to be sufficiently supported in one place to strengthen it before it will be possible for these heavy metals to be glued or joined onto it.

Fig. X.8. The final photo of the pot with the other objects belonging to it.

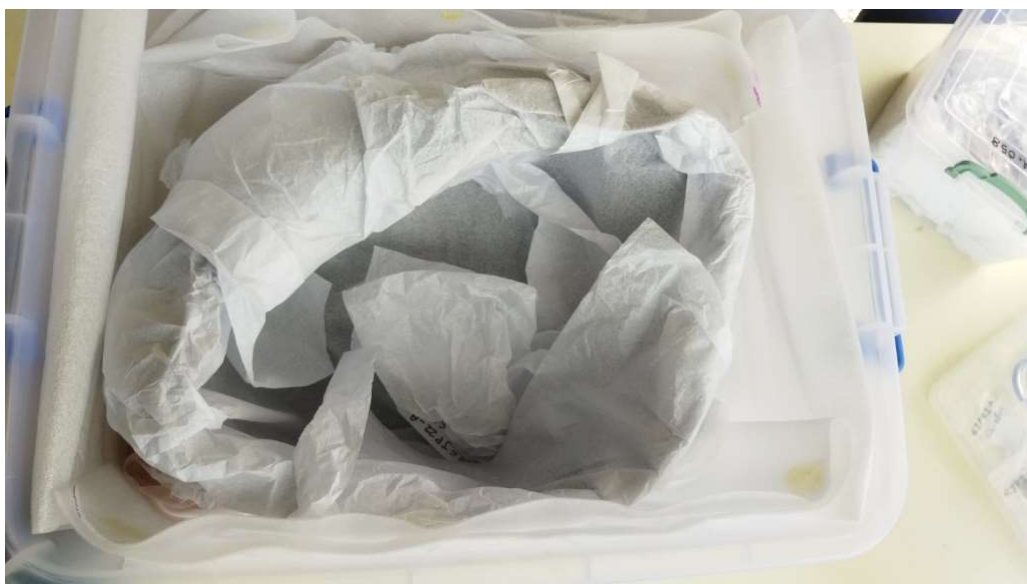
7. Packing the big pot into a separate polyethylene Tupperware box, using polyethylene sheets as cushions and wrapping the pot with acid-free tissue. The fragments that belong to this big pot were packed within the same Tupperware box in separate bags. The lead metal of both holders flaked very easily into small fragments so they were wrapped in acid-free tissue to preserve them.

Fig. X.9. The big pot wrapped with acid-free tissue in the Tupperware box.

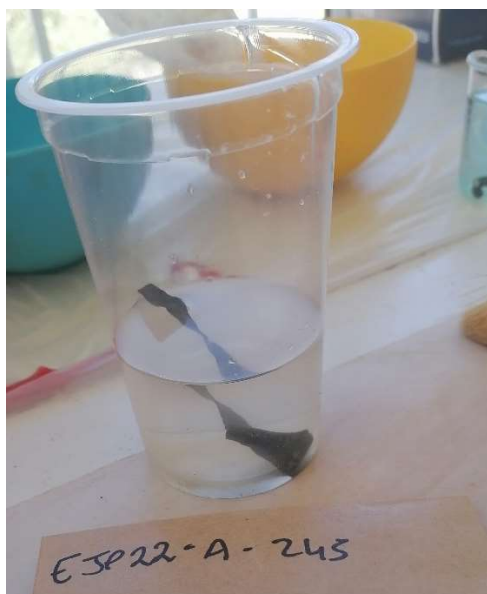
After cleaning the object, it was soaked in Ethanol (alcohol) for a few minutes and then brushed with a toothbrush to remove any residues from any cleaning materials or dust.

Fig. X.10. EJP22-A-245: this copper-alloy object was soaked in Ethanol after it was cleaned.

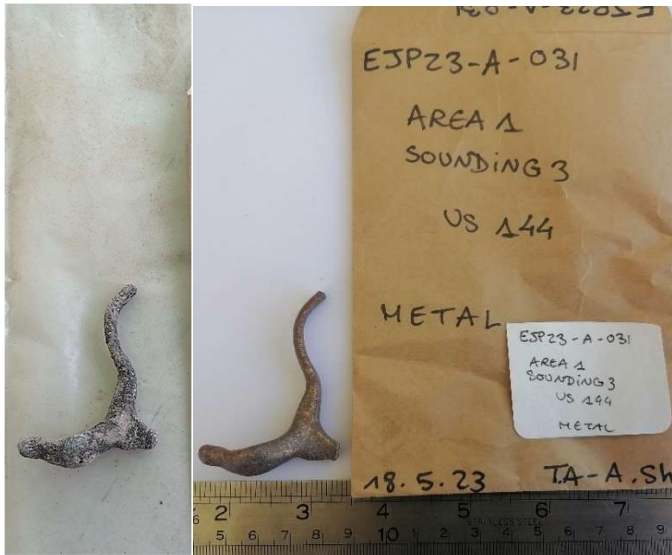
Fig. X.11. EJP23-A-031: copper-alloy lamp handle before and after cleaning.

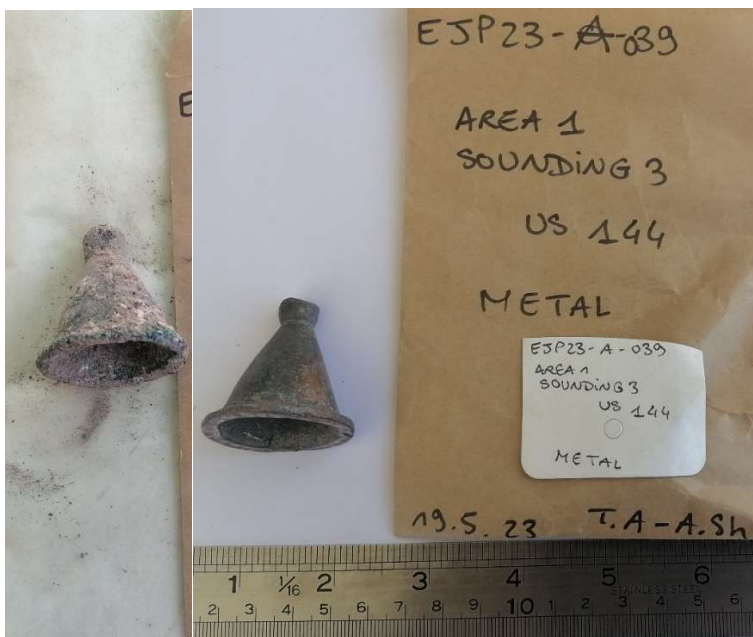
Fig. X.12. EJP23-A-039: copper alloy bell before and after cleaning.

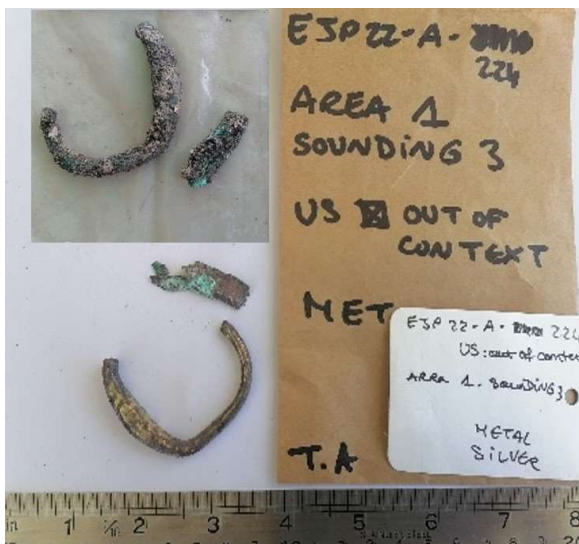
Some copper alloy objects were severely corroded; the bronze disease affecting the metal could have corroded all of the metal material. In this case, the corrosion keeps the object's shape; therefore, there is no point in cleaning these corroded objects. Even cleaning that only aims to remove dust can cause objects in this situation to break up into small flakes.

Fig. X.14. EJP22-A-224: two objects, one was cleaned but one was corroded from the inside.
