Eastern Jarash Project: 2023 Final Report

EASTERN JARASH PROJECT

2023 FINAL REPORT

Edited by **Dr. Julie Bonnéric**

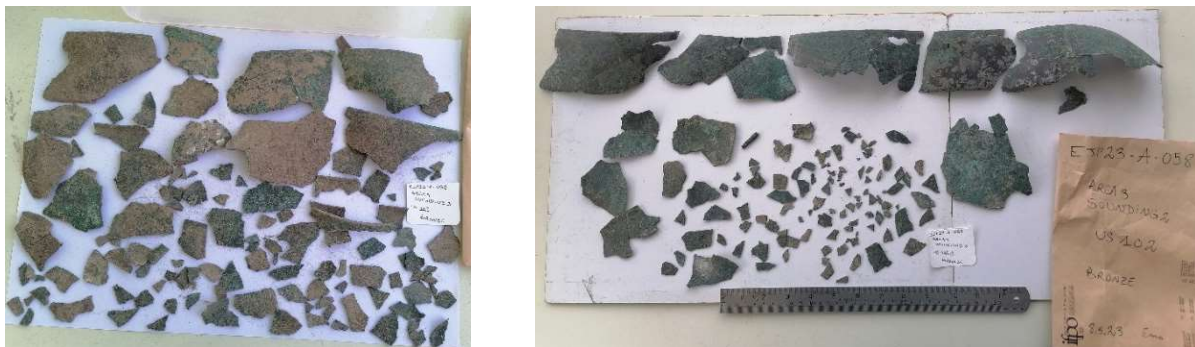
EJP23-A-058 is a small bowl, its diameter is around 25 cm and its height is around 10 cm. It is broken into more than 50 fragments. It is made of copper alloy with a fragile metal; some of the broken fragments are bent due to them having been buried under heavy stones. Looking for joins between these fragments took a long time and it may still be possible to find other bondings with more time. During this project, it appeared that these fragments originated from only one bowl, as the rim is complete. The big fragments were glued using UHU as a reversible glue to find out the shape of this bowl.

Fig. X.16. EJP23-A-058: fragments before and after the fragments were joined.

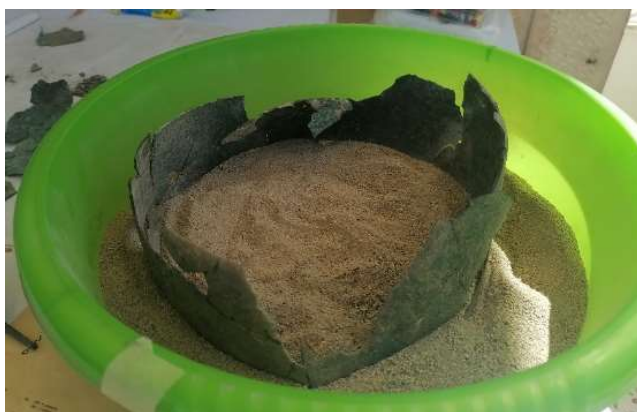
Fig. X.17. Fragments of the copper alloy bowl temporarily joined together using a sand support.

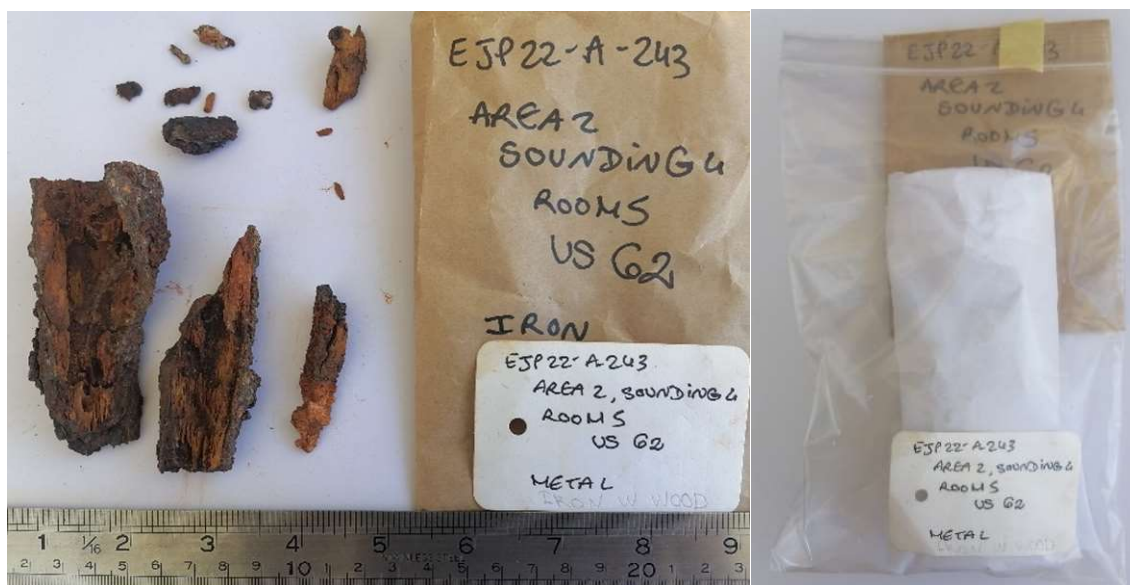
Object number EJP22-A-243 is a hollow iron object which is split into five pieces; the inside surface has wood remains. Therefore, no chemicals were added during the conservation process and this object has been wrapped with acid-free tissue to preserve the wood.

Fig. X.18. EJP22-A-243: an iron object with wooden remains wrapped with acid-free tissue for packing.

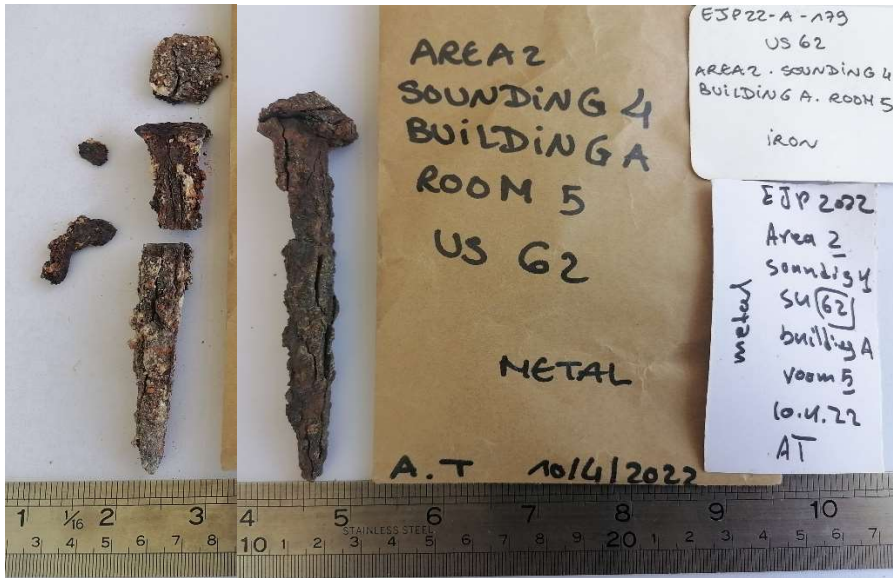
Some of the iron nails in this collection flaked during the cleaning process. Therefore, after the object was cleaned, the loose flakes were glued back to the object using UHU as a reversible adhesive. Examples of these objects are numbers EJP22-A-181 and EJP22-A-241. EJP-A-179, an iron nail, was found broken and was then glued by applying UHU.

Fig. X.19. EJP-A-179: on the left, this broken iron nail before conservation work and on the right, after it had been glued together.

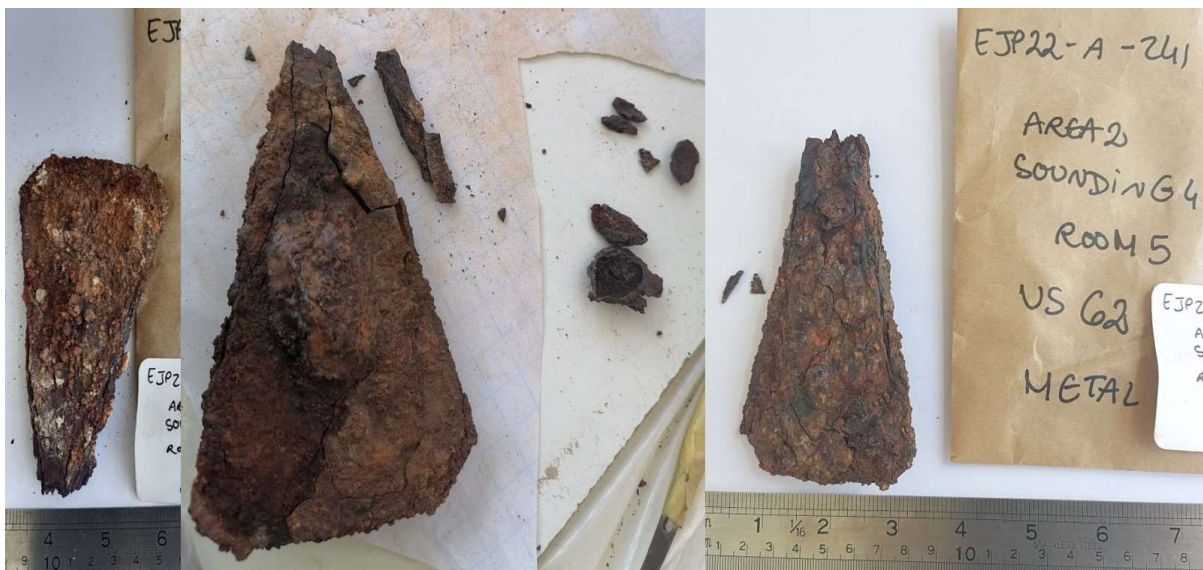
Fig. X.20. EJP-A-241: iron object before and during cleaning when some flakes came off and after treatment, all glued back together.

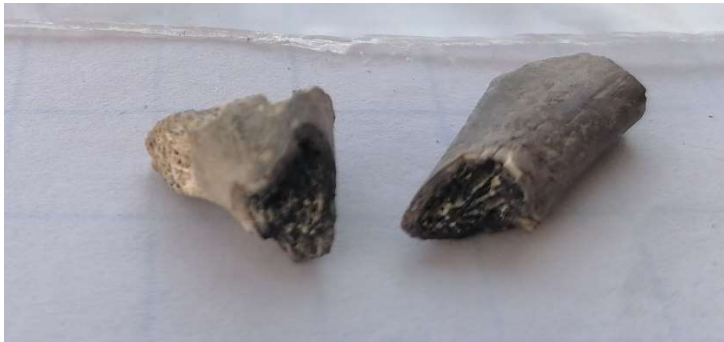
After the dust was cleaned from EJP22-A-213 it appeared that this was in fact two fragments of a broken carbonized bone. They were cleaned using Ethanol and then they were glued together using UHU.

Fig. X.21. EJP22-A-213: two fragments of carbonized bone
