The Zambratija prehistoric swen boat: recovery and new observations concerning the boat's structure

THE ZAMBRATIJA PREHISTORIC SEWN BOAT: RECOVERY AND NEW OBSERVATIONS CONCERNING THE BOAT'S STRUCTURE

A team of Croatian and French archaeologists, restorers, technicians, and divers gathered around the Archaeological Museum of Istria, the Culture and Media Ministry of the Republic of Croatia, and the Centre Camille Jullian (CNRS, Aix Marseille Université), raised the remains of the Zambratija Late Bronze Age / Early Iron Age sewn boat from the seabed of Zambratija cove in June and July of 2023. The shipwreck was comprehensively investigated in 2013 with the results presented at many exhibitions, accompanied by a catalogue, and in a specialist monograph presenting the data known at the time of publication. The recovery of the boat provided a unique opportunity to complete the analysis of this unique find. New data concerning the building methods, repairs, and the waterproofing system of the hull have been obtained as a result of the dismantling of the boat and the meticulous documentation and analysis of each timber. The entirety of the surviving structure was documented, photographe

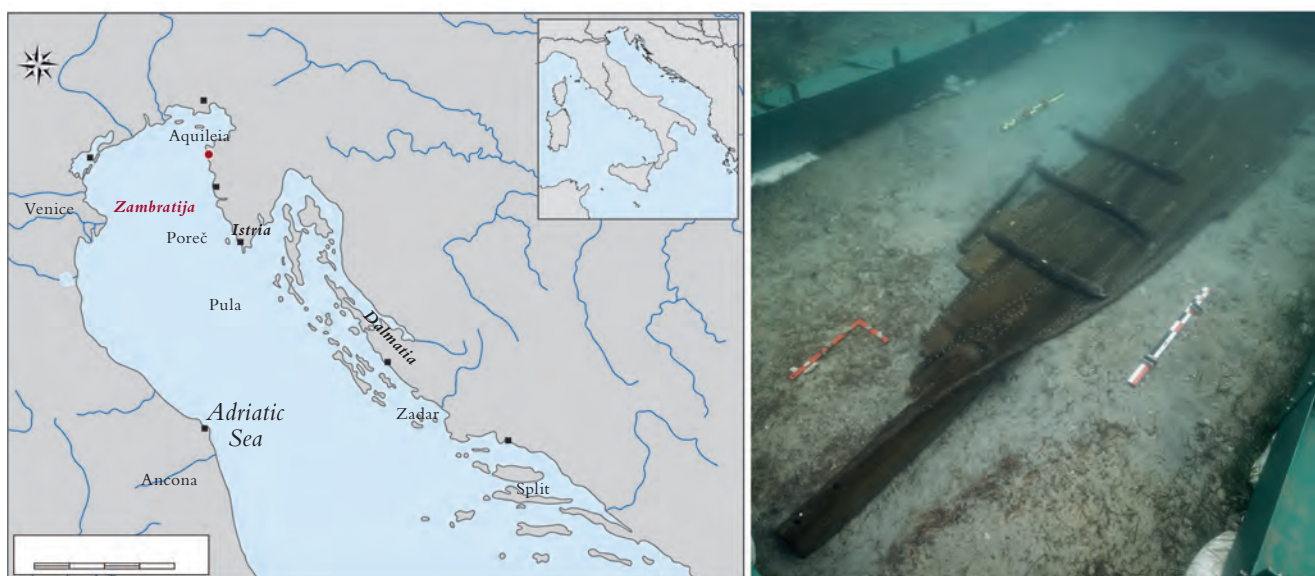
Sl. 1 Položaj lokaliteta te prapovijesni brod Zambratija tijekom istraživanja u 2013. godini (fotografija: Ph. Groscaux, CNRS/CCJ).
Fig. 1 The position of the site / the prehistoric Zambratija boat during 2013 investigative work (photo: Ph. Groscaux, CNRS/CCJ).

The Zambratija boat was discovered in 2008 in the Zambratija cove, located on northwestern coast of the Istrian peninsula. It was partially investigated in 2011, and comprehensively investigated in 2013 (Fig. 1), with the latter campaign involving the documentation of the inboard side of the boat's hull. Following the investigative work, the boat was covered with sand and secured with iron mesh (Koncani Uhač, Uhač 2019, 18–49). The AMS radiocarbon method was used to date samples taken from the boat's planks, yielding results that placed the boat in the Late Bronze / Early Iron Age in Istria (last quarter of the 12th to last quarter of the 10th c. BCE). No artefacts were identified within or around the boat's structure that would provide for a narrower dating window, and there were no indications as to whether the boat was abandoned or wrecked.

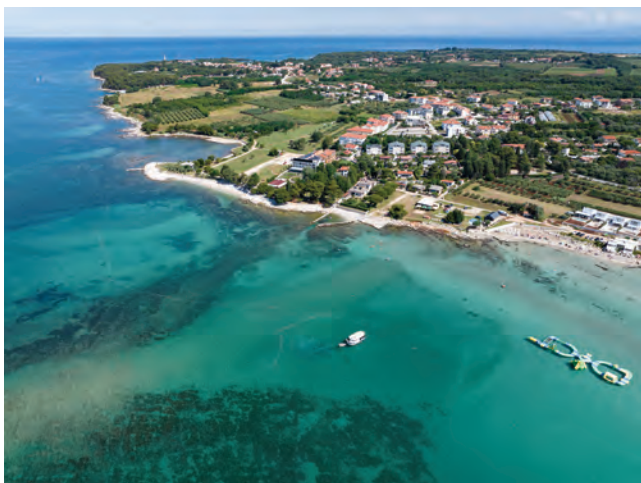
Sl. 2 Zračni snimak lokacije broda u uvali Zambratija tijekom istraživanja u 2023. godini (fotografija: Ph. Soubias).

Fig. 2 Aerial image of the boat site in Zambratija cove taken during the 2023 investigation (photo: Ph. Soubias).

Reambulacije lokaliteta prapovijesnog broda u uvali Zambratija pokazale su da se, unatoč zaštiti s mrežištem postavljenim na kraju istraživanja u 2013. godini, brodska konstrukcija nalazi u opasnosti. Naime, sve učestalije ekstremne meteorološke nepogode uzrokovale su ubrzanu eroziju morskog dna, a stihijsko sidrenje u uvali dovelo je do ugroze lokaliteta (Sl. 2).

Reconnaissance of the prehistoric boat site at the Zambratija cove showed that, notwithstanding the protective mesh installed at the close of the 2013 investigative campaign, the boat's structure remained under threat. Increasingly frequent extreme weather events were causing accelerated erosion of the seabed, while uncontrolled anchoring activity posed a direct threat to the site (Fig. 2).

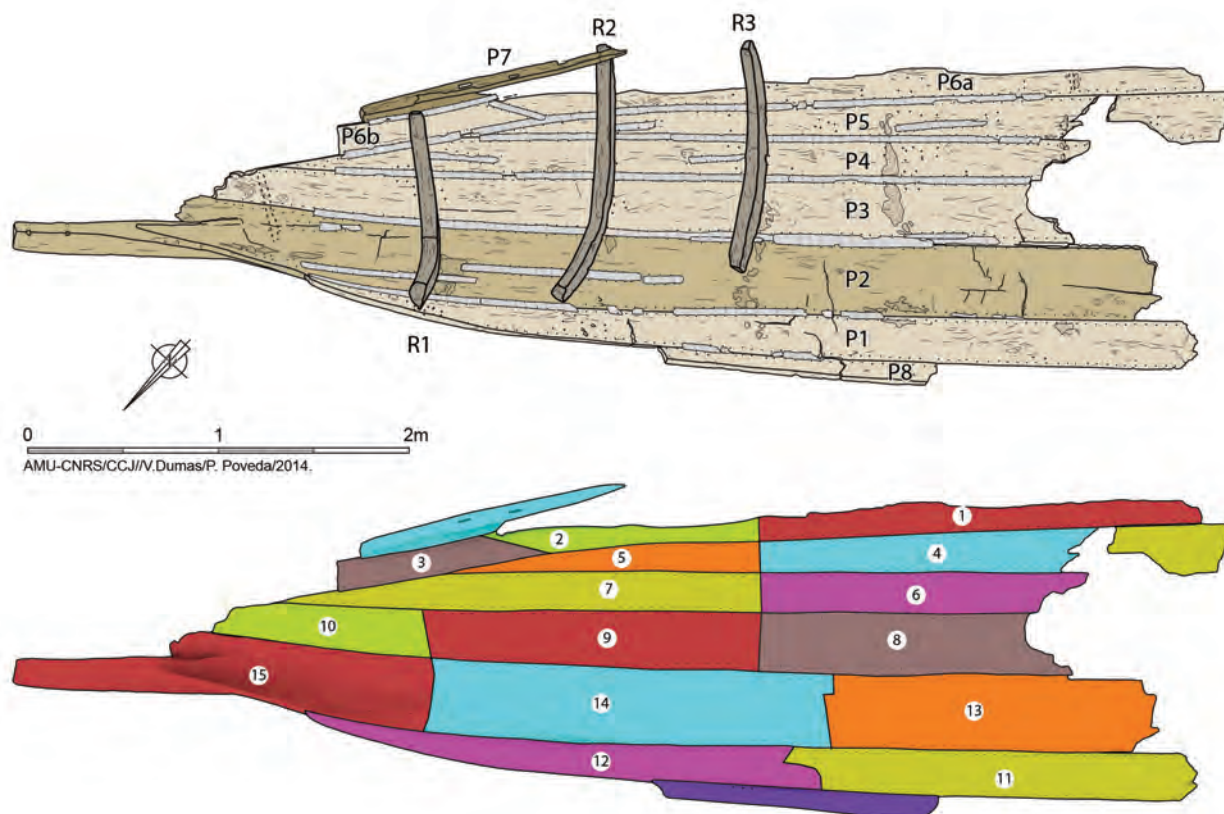
Fig. 3 Plan view of the Zambratija boat developed in 2013 (by: V. Dumas) used as the basis for the development of the dismantling plan to raise fifteen elements in chronological order (by: P. Poveda).

strakes,⁴ it was decided that the hull should be dismantled and the individual elements recovered. Three-dimensional element-specific cradles were designed for each timber based on the 2013 photogrammetric model. The raising of the boat's planking was planned as a recovery involving fifteen separate cradles based on a developed recovery workflow (Fig. 3).

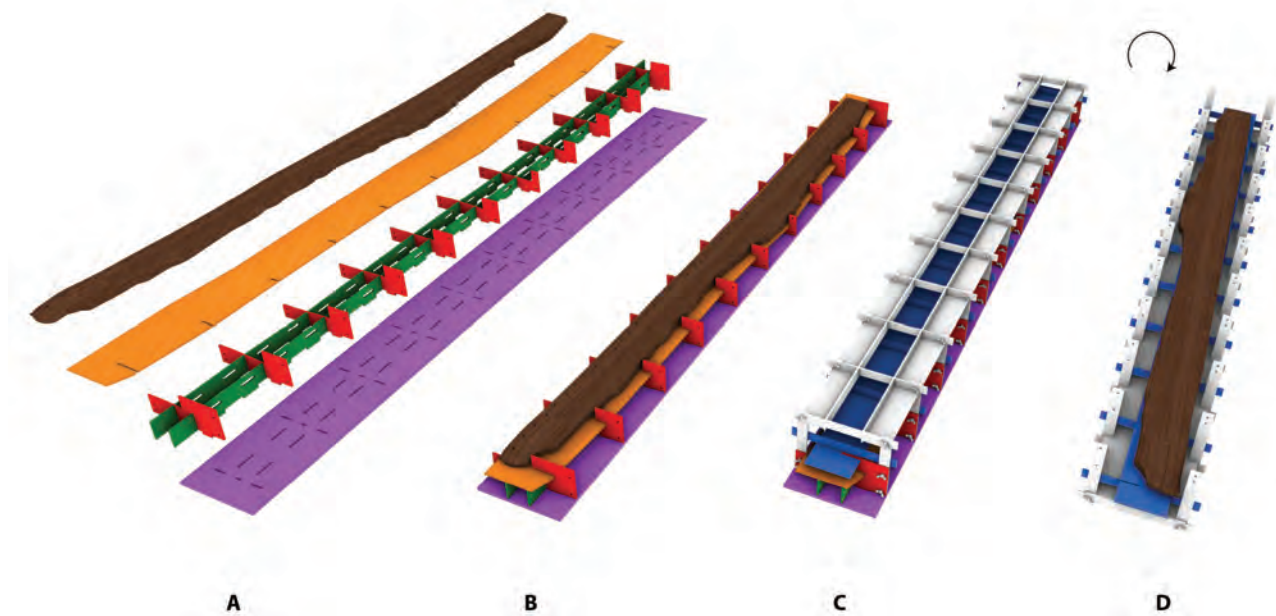
Fig. 4 Each cradle consists of longitudinal and transverse elements (green and red) held together by a base panel (purple). An upper panel (orange) is placed on top of the element and then tied to fit the correct shape before gluing (A). The cradle takes the negative shape of the plank that is raised from the seabed (brown, B). A cover (white and blue, C) is placed and affixed to the cradle with screws to allow for safe rotation of the plank (D) (by: P. Poveda).

The cradles were designed following a modular system principle, with an upper panel intended to hold a plank in place when later turning it over during the cleaning and documentation of the outboard side. This system would allow for the rotation of the boat's timbers without compromising their form (Fig. 4, Fig. 5). Half-centimetre and one-centimetre-thick PVC panels were cut using a computer numerical control (CNC) machine prior to assembly and gluing into the desired form.

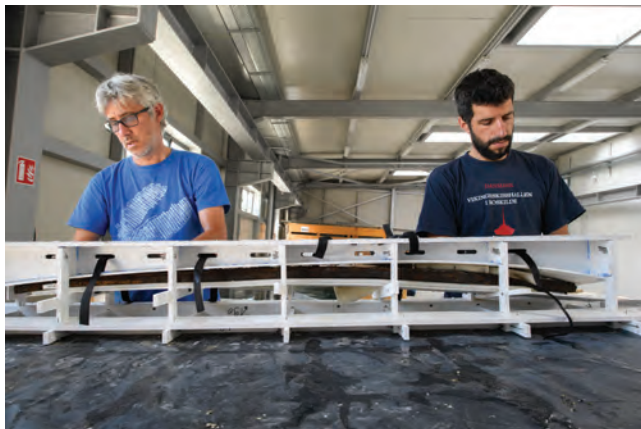
Fig. 5 A cradle with plank P6a2 turned upside down for cleaning and documentation of the outboard side of the hull planking (photo: L. Damelet).

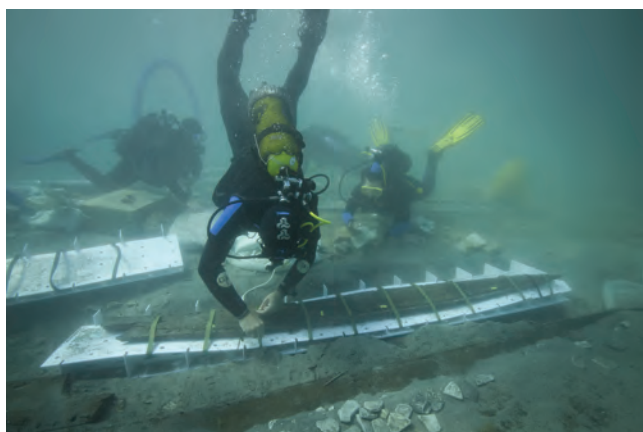
Sl. 6 Izvlačenje platice P1 (fotografija: L. Damelet).
Fig. 6 Extracting plank P1 (photo: L. Damelet).

The first step involved excavating a ditch next to a plank to receive the recovery cradle (Fig. 6), whereupon the plank to be raised and a small part of the adjacent plank were cleaned. The laths that covered the plank stitching were assigned an alphanumeric code and, following

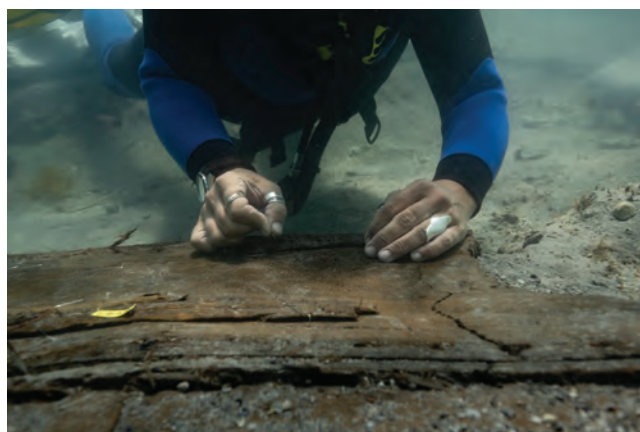
Sl. 7 Numeriranje te premještanje letvice koja se nalazila iznad šavova (fotografija: Ph. Soubias).
Fig. 7 Numbering and moving a lath set above the stitching (photo: Ph. Soubias).

photogrammetric imaging, were moved and fixed to the plank that was to be raised (Fig. 7). This photogrammetric imaging provided data on the original position of a lath, which is critical to a later restoration of the boat. The plank was then moved onto the recovery cradle and the ensemble was secured in place using Velcro straps. The element was then fixed to an aluminium ladder to prevent the cradle from warping, i.e., to prevent the timber from cracking as it was raised from the seabed (Fig. 8). Once the cradle and the timber had been raised to the surface, the unit was transferred to land by boat.

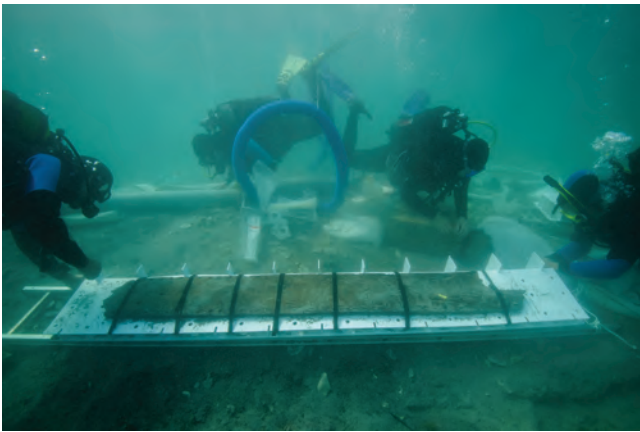
Fig. 8 A plank relocated to a cradle and fixed in place with Velcro straps (photo: L. Damelet).

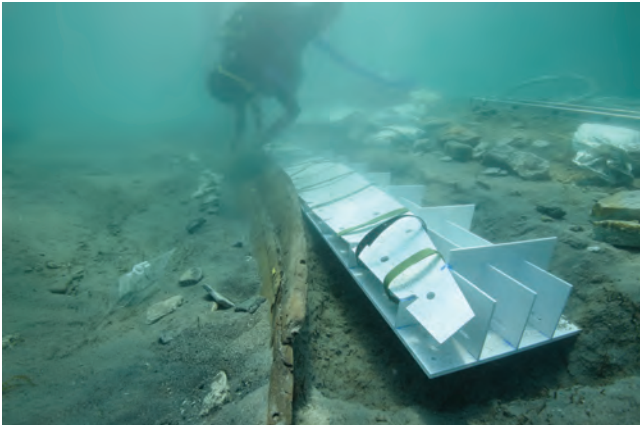
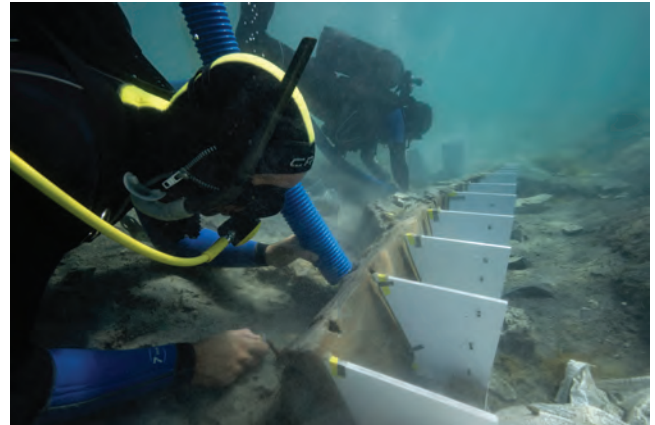
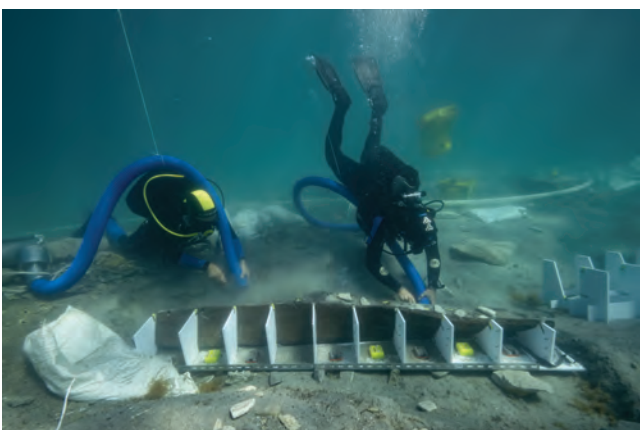
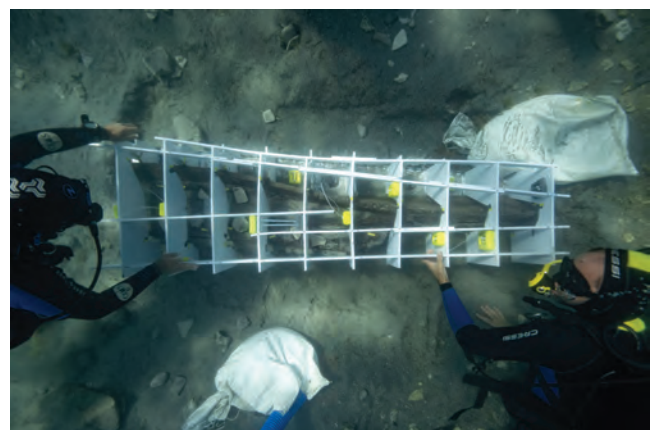
Fig. 9 a, b, c, d. The process of recovering longitudinal axial timber P2 (photo: Ph. Soubias).

A specific cradle was designed for the recovery of longitudinal axial timber P2. Given its complex shape and estimates of its weight, this recovery cradle comprises two elements, with regular insertions of support strips at its underside during excavation. The extraction of this timber was the most demanding part of the entire operation (Fig. 9 a-d).

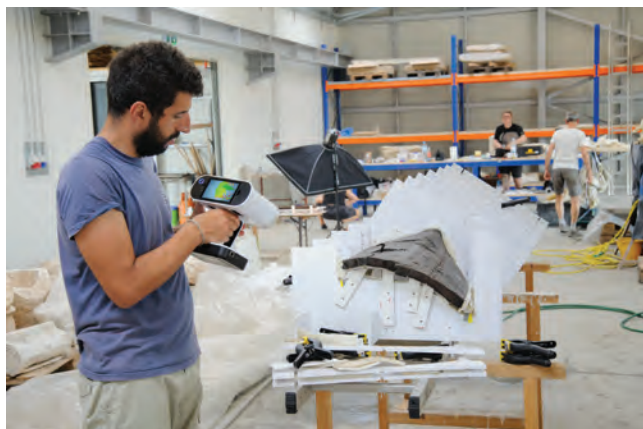
Sl. 10 Skeniranje uzdužnog osnog elementa P2 (fotografija: L. Damelet).
Fig. 10 Scanning longitudinal axial timber P2 (photo: L. Damelet).

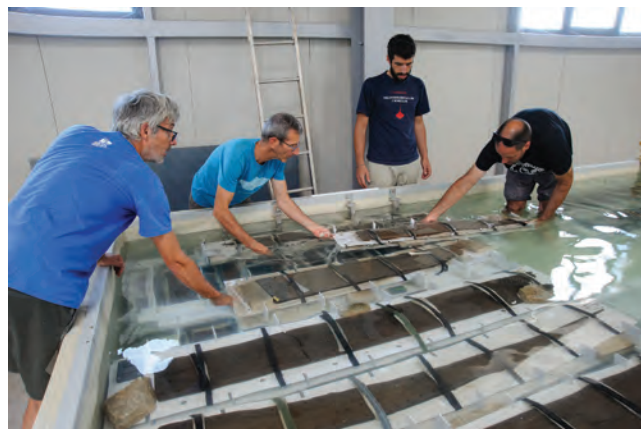
Sl. 11 Na kraju svih faza dokumentiranja i uzorkovanja elementi broda uronjeni su u desalinizacijski bazen sa slatkom vodom (fotografija: L. Damelet).
Fig. 11 Upon completion of all documentation and sampling phases the boat timbers were submerged in the freshwater desalination tank (photo: L. Damelet).

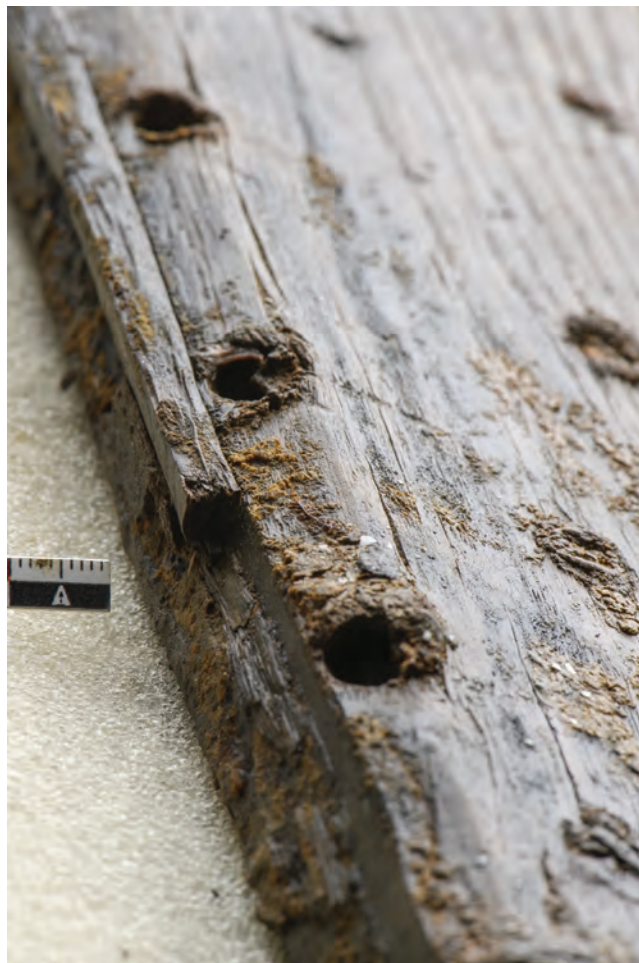
Fig. 12 Detail of the boat's planking: view of the outer edge of plank P5b with a fragment of a twig (stick) in the recessed joint (photo: L. Damelet).

The analysis of the individual boat timbers has clarified our insight into the system used to render the boat watertight. Small twigs (sticks with a 2.0-centimetre diameter) placed to the outboard side of the planking along the longitudinal recesses at the seams between strakes (Fig. 12) held in place sealant that was applied

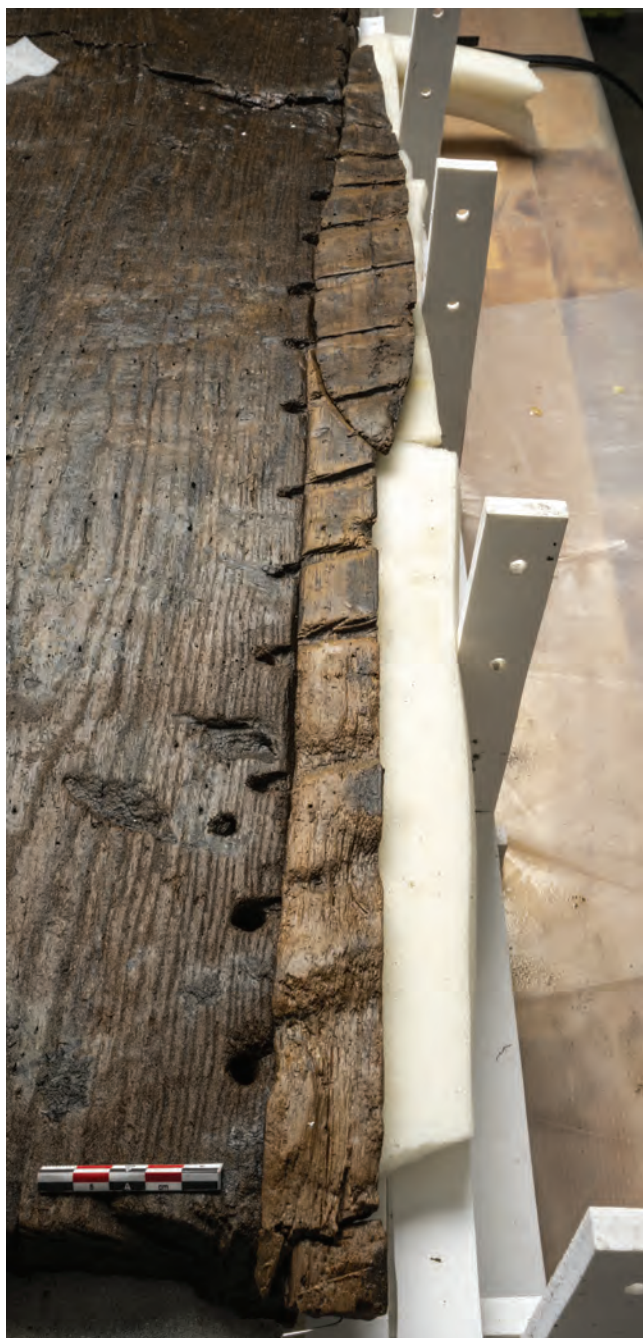
Fig. 13 Patches used to repair the seam between timbers P2 and P3 (photo: Ph. Soubias).

Our examination of the edges found that most of the hull planks have multiple channels that constitute the stitching holes, which can be associated with the original stitching assembly and later repairs. It should be noted here that the outer seam between longitudinal axial timber P2 and plank P3 was cut to allow for the insertion of two patches: one is almost flat, having a length of 76.5 centimetres, a width of 2.9 centimetres, and a thickness of 1.5 centimetres, while the other is lenticular, 49 centimetres long, five centimetres wide, and 2.2 centimetres thick. The outside surfaces of these patches also have recesses that conceal ligatures (Fig. 13).
