Azraq al-Šišan

`AYN SAWDA RESERVOIR PROJECT

Report of the fieldwork led from the 13th to the 31st of May 2014

L. Abu-Azizeh, architect, Ifpo Amman (French Institute for the near east)

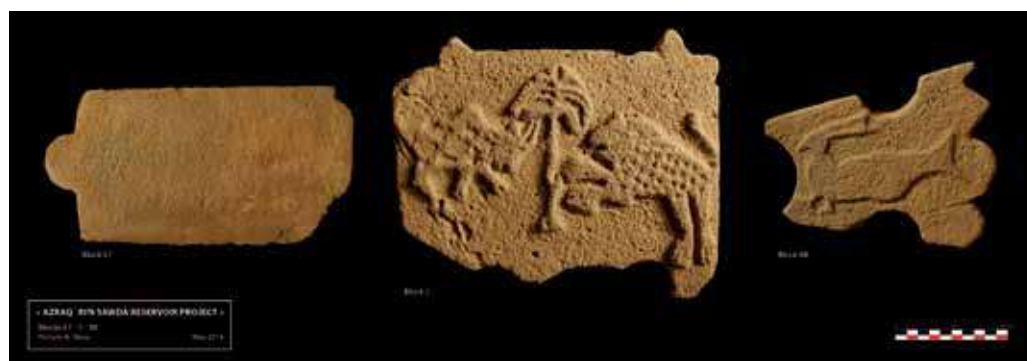
Fig.4: Example of some carved blocks uncovered in the reservoir until 2013 (AS and LAA 2014).

The carved blocks of the `Ayn Sawda reservoir, discovered between 1981 and 2013, are now shown in Qala't Azraq. Only 10 of the 106 blocks are stored in Irbid, in the Yarmouk University. The specificity of these basalt blocks is their shape, often surprising, which present tenons and mortise on one of their faces as well as on the four faces. Only 62 blocks presents a bas-reliefs drawing on their main face, representing human beings, animals and vegetation or even more complex scenes (**Fig.4**).

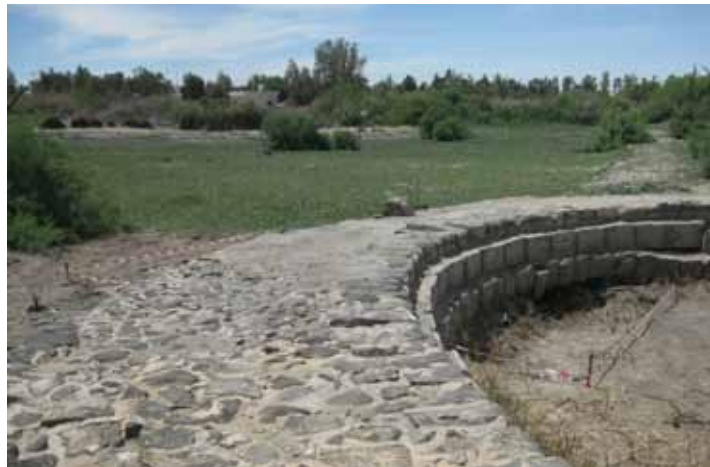
Fig.6: General view of the wall M1 in sector A. Looking to the west (BC 2014).

of the sounding was the study of the structure by observing its foundations and the archaeological layers adjoining, and the seeking of a junction with a wall located on the surface, halfway to the N/E angle of the reservoir¹¹ (**Fig.6**).

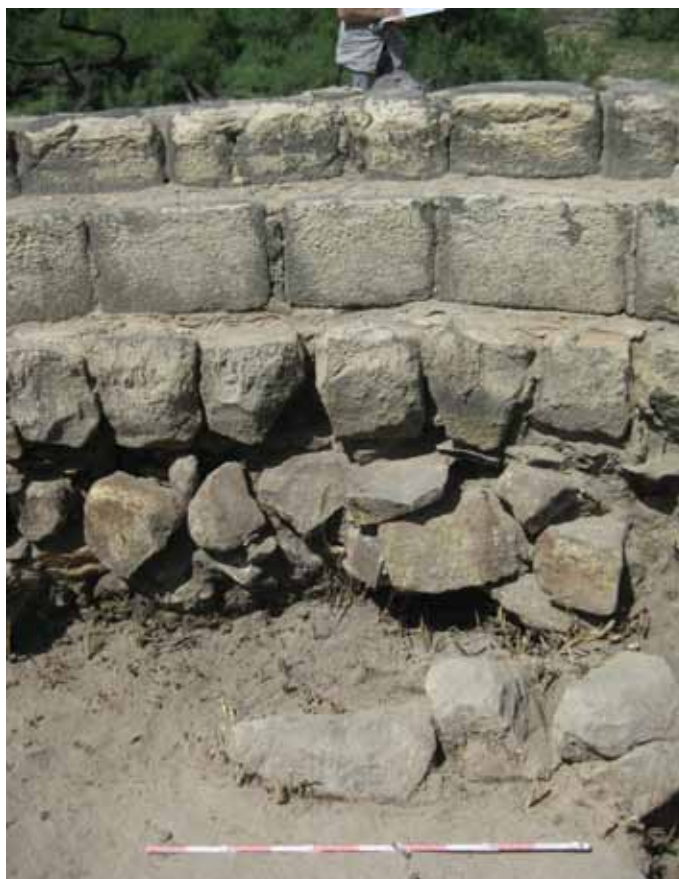
Fig.9: View of the three stone rows and the foundations of circular wall M1. Looking to the south (BC 2014).

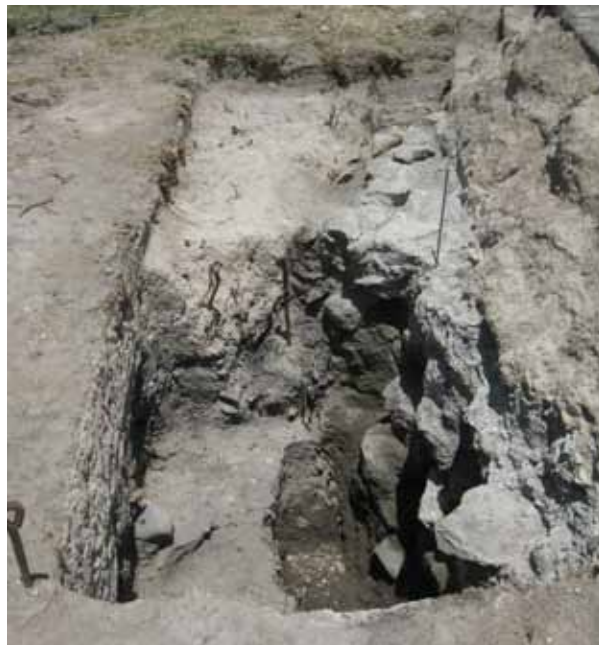
Fig.11: View of sounding A south. First plan: the deep sounding stopped by the water. On the left: the mortar glasis on the basalt rows of the exterior face of M1. Looking to the N/W (BC 2014).

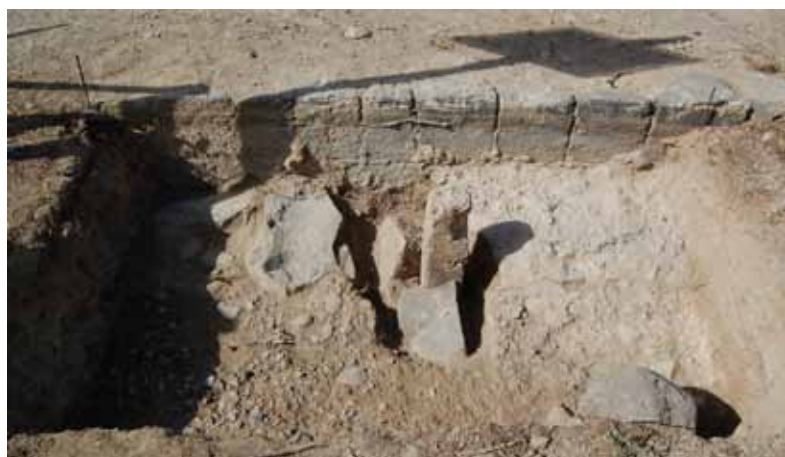
Fig.12: General view of sounding B1 after having reached the mortar glasis (JB 2014).

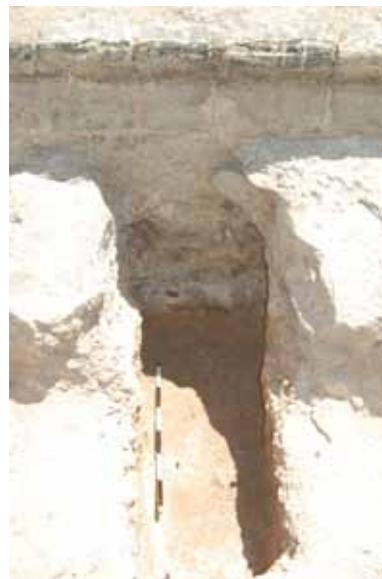
Fig.14: View of sounding B1 after having reached the foundation level (JB 2014).

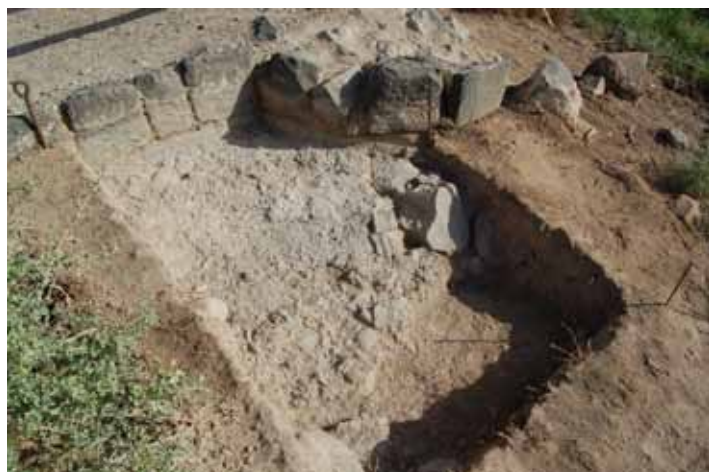
Fig.15: View of sounding B2 after having reached the mortar glacis (JB 2014).

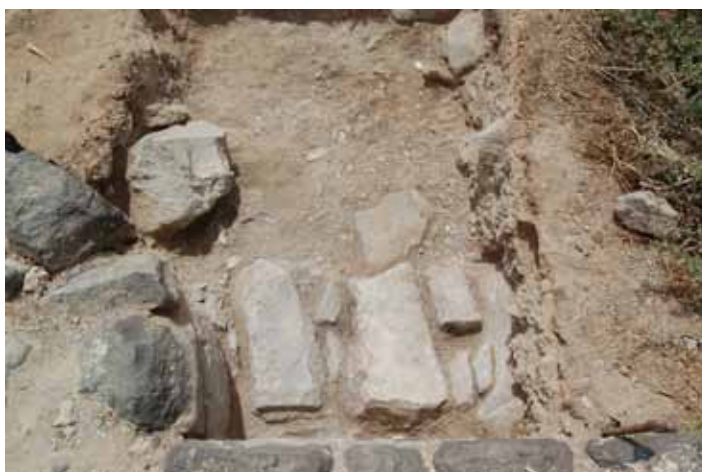
Fig.18: View of the slabs appeared under the mortar glacis in B2 (JB 2014).

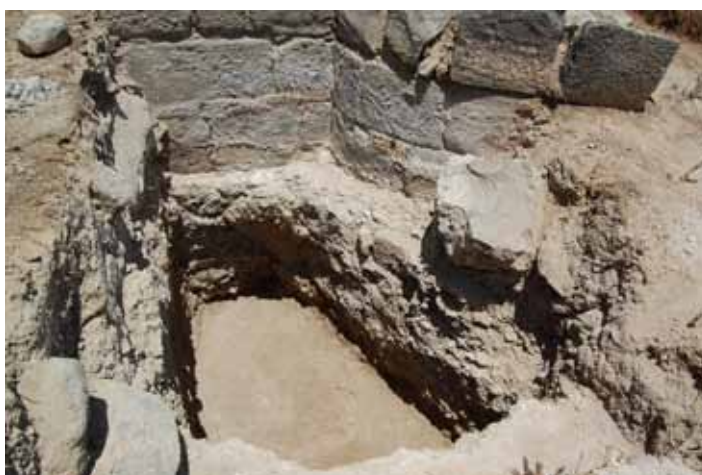
Fig.19: General view of B2 looking to the foundation system (JB 2014).

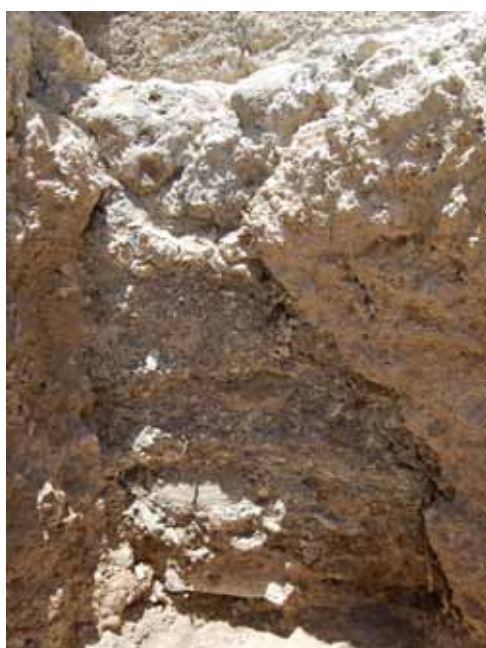
Fig.20: Detail of the foundation in B2 under wall M4 (JB 2014).

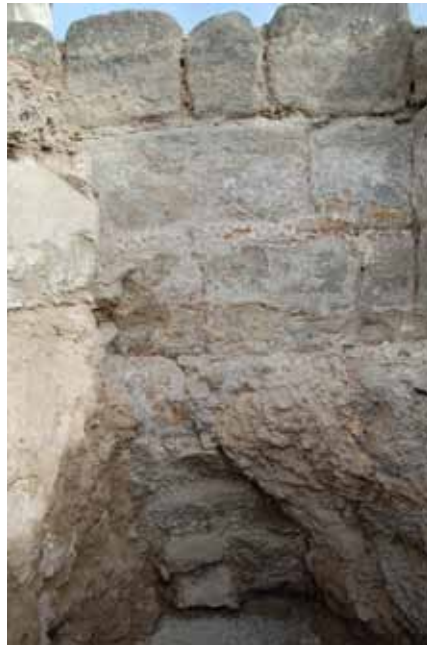
Fig.21: Detail of the foundation under wall M4 in B2 after having removed the mortar (JB 2014).

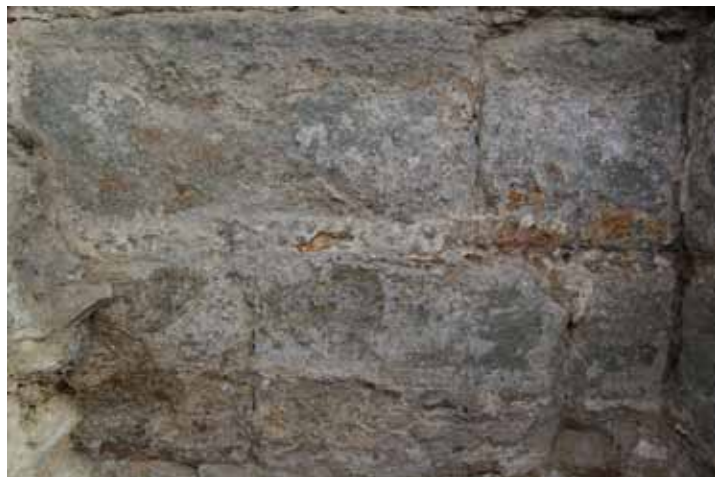
Fig.22: Detail of the overthickness joint with the basalt inclusions (JB 2014).

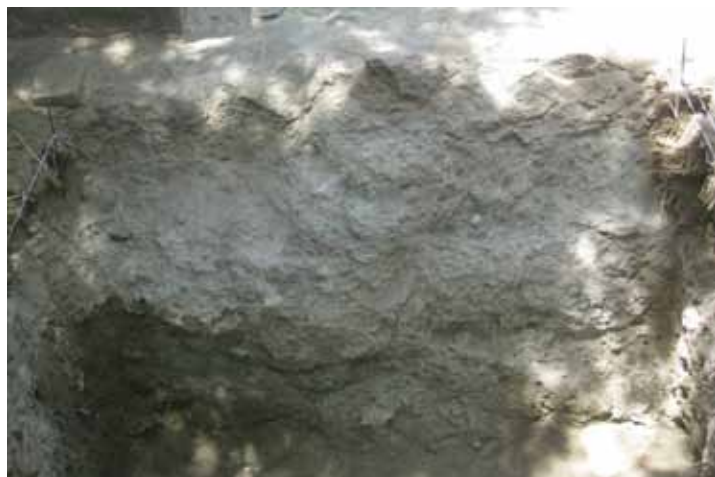
Fig.23: Mortar glais next to the basalt benches of the platform, sounding C1.
Looking to the west (BC 2014).

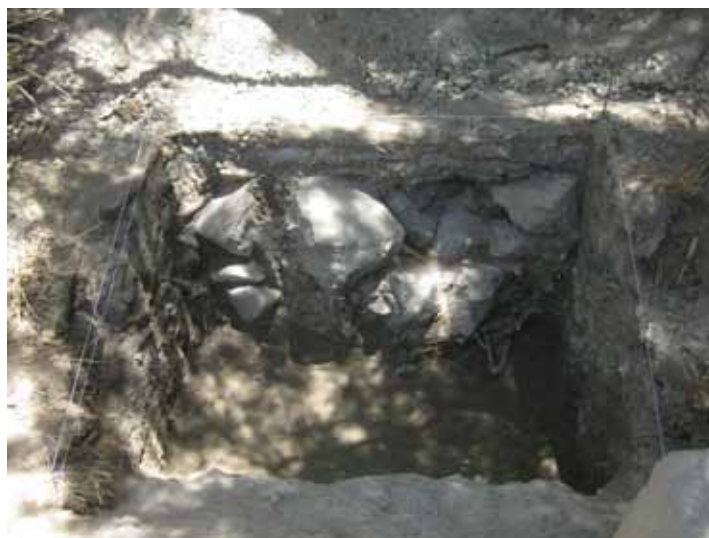
Fig.24: Basalt blocks in the east section of sounding C1 related either to a wall collapse or to the recent Reserve laying out. Looking to the east (BC 2014).

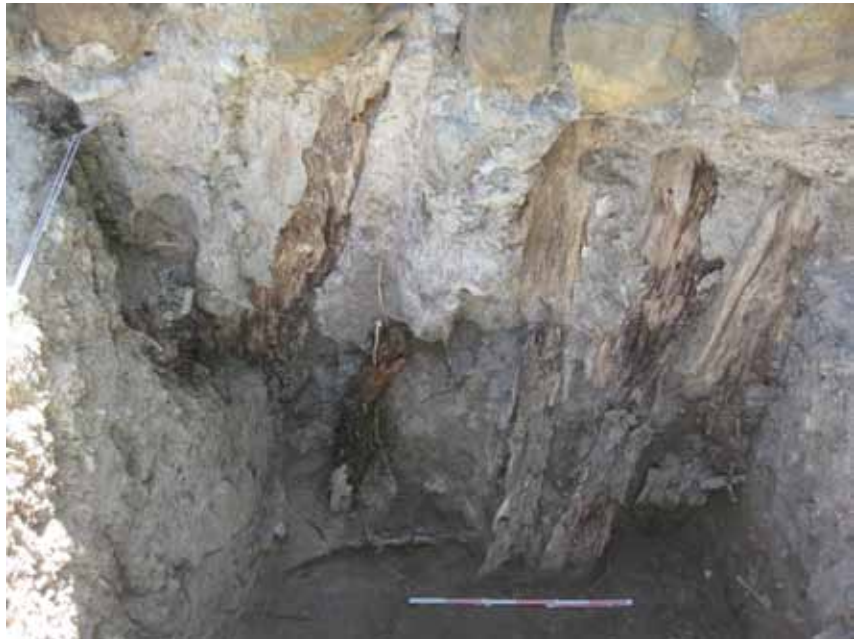
Fig.26: Wooden elements (pillars and boards) under the basalt bench of the platform, in sounding C2. Looking to the east (BC 2014).

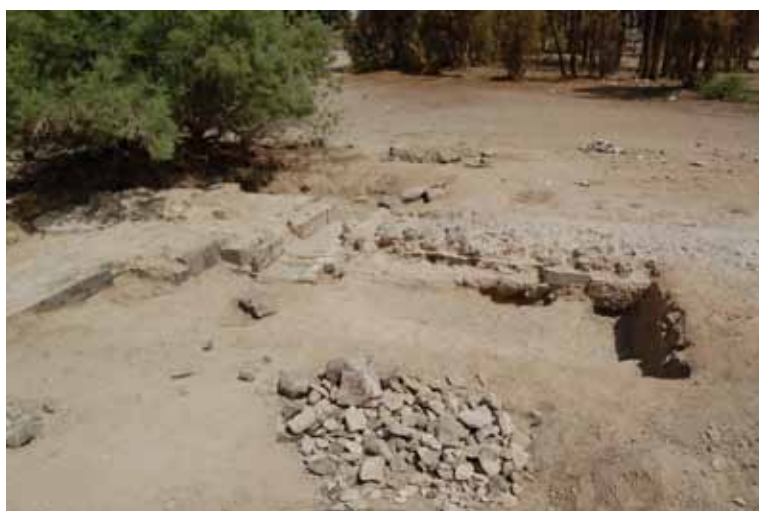
Fig.31: General view of sector D during the excavations, the channel is visible (JB 2014).

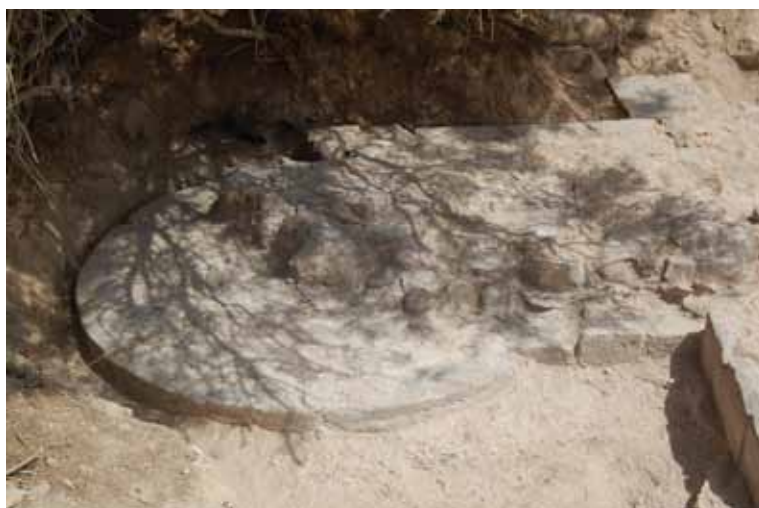
Fig.32: View of buttress 18-1, in sector D, uncovered on the west extremity of wall M3 (JB 2014).

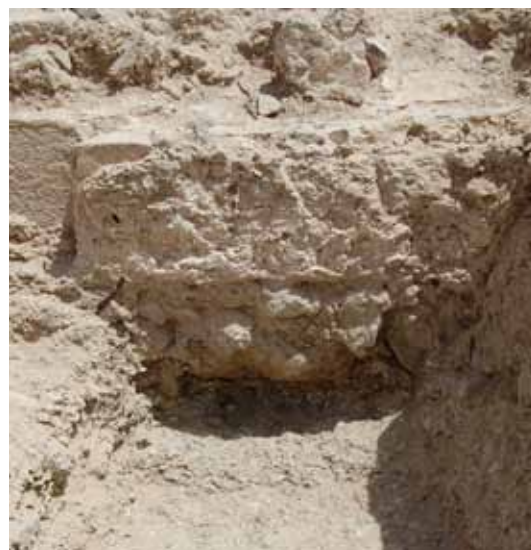
Fig.36: Detail of M3 foundation in sector D (JB 2014).

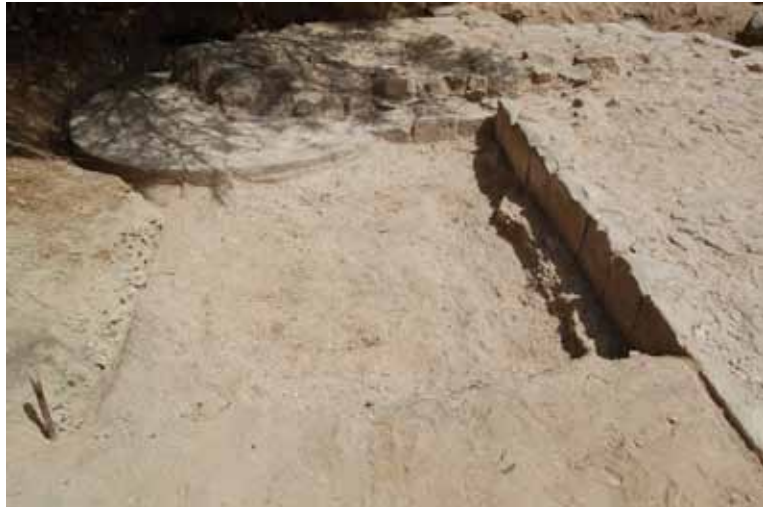
Fig.37: Detail of sounding D2 (JB 2014).

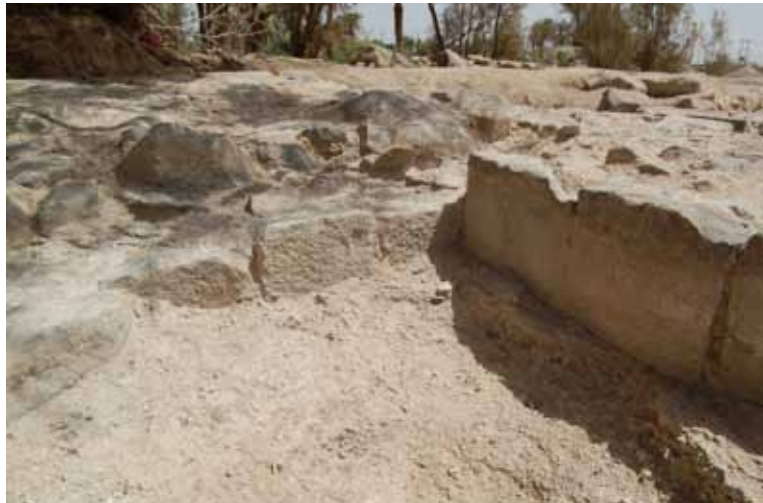
Fig.38: Detail of the connection between walls M3 (in front) and M8 (on the right) in sounding D2 (JB 2014).

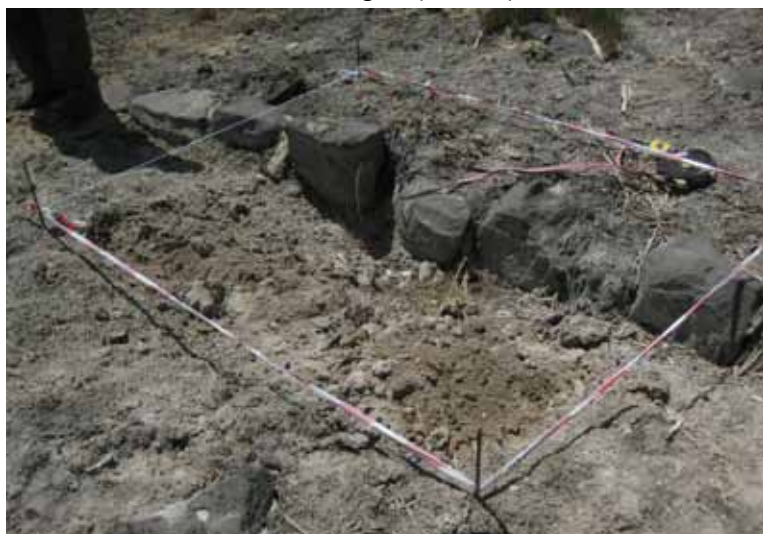
Fig.39: Location of sounding E1 on each side of the stone alignment M2, before the excavations. Looking to the S/W (BC 2014).

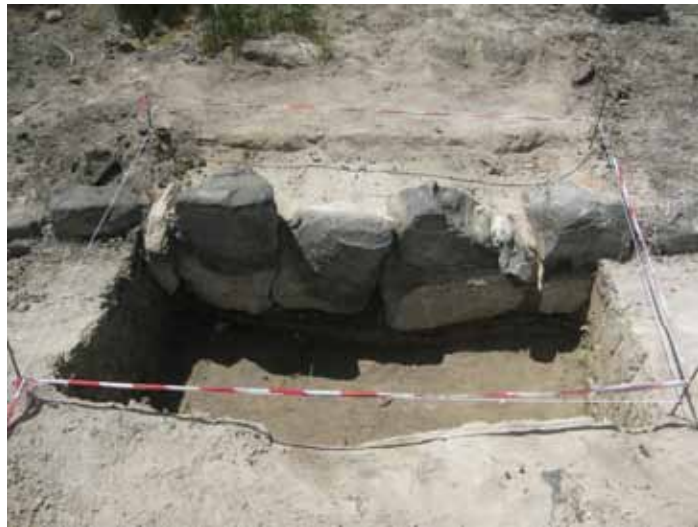
Fig.40: The stones of alignment M2 in sounding E1 (BC 2014).

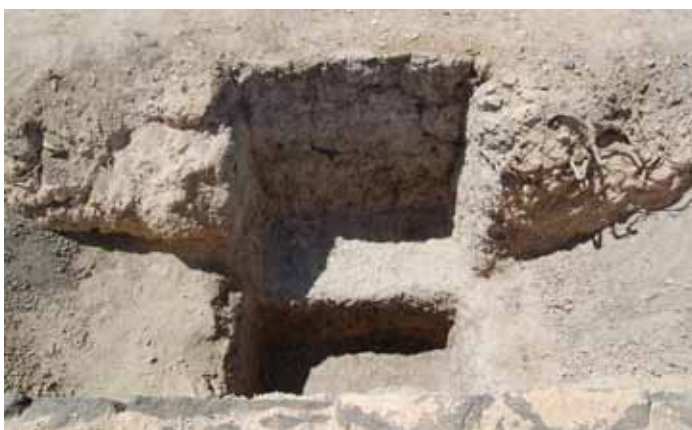
Fig.43: Detail of sounding G1, south of wall M3. Looking to the south (JB 2014).

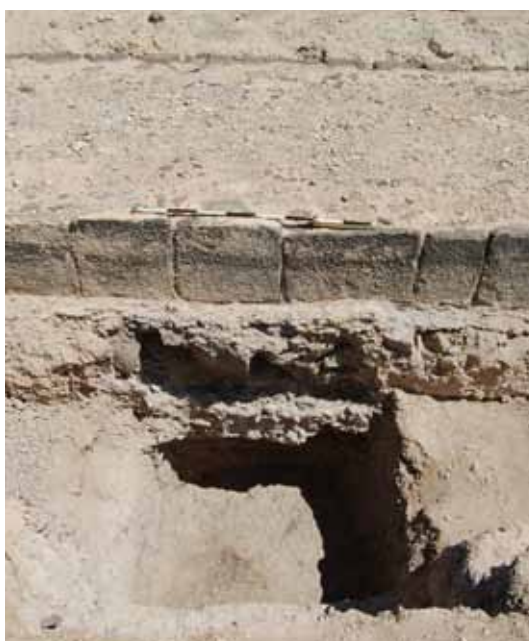
Fig.44: Detail of sounding G1, south of wall M3. Looking to the north (JB 2014).

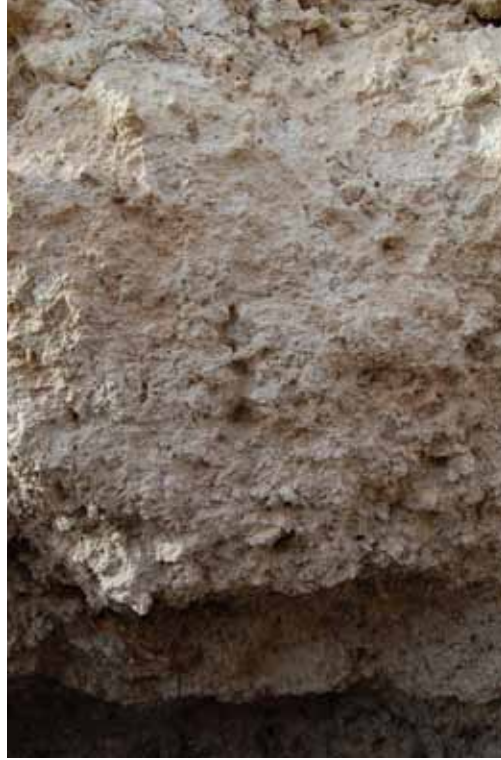
Fig.46: Detail of the mortar in sounding G2 (JB 2014).

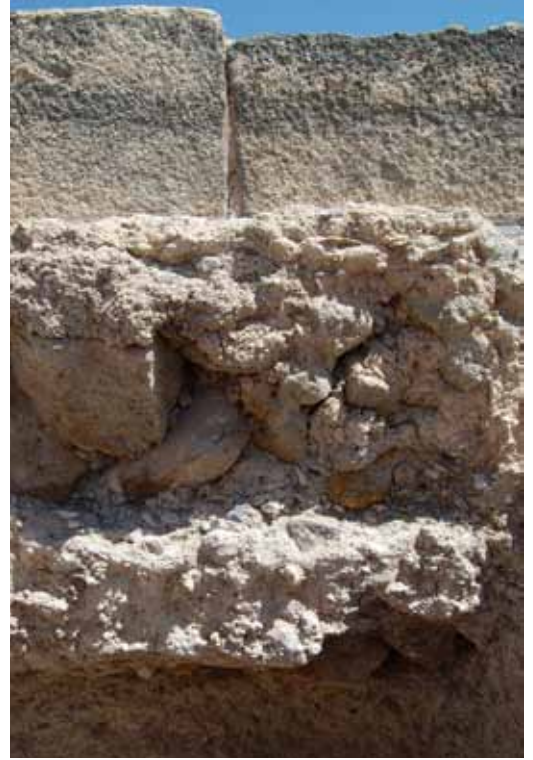
Fig.47: Detail of the different layers of the foundation in sounding G2 (JB 2014).

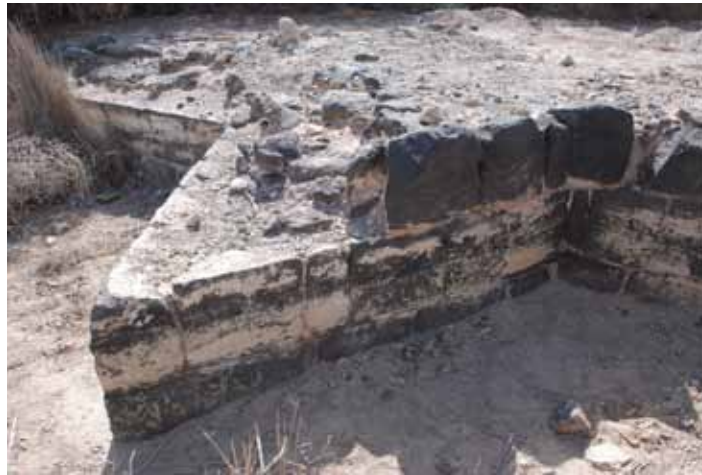
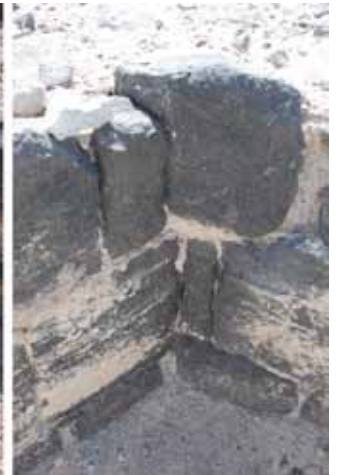
Fig.48: Detail of buttress 4-1i and its connection with wall M6 (AS 2014).

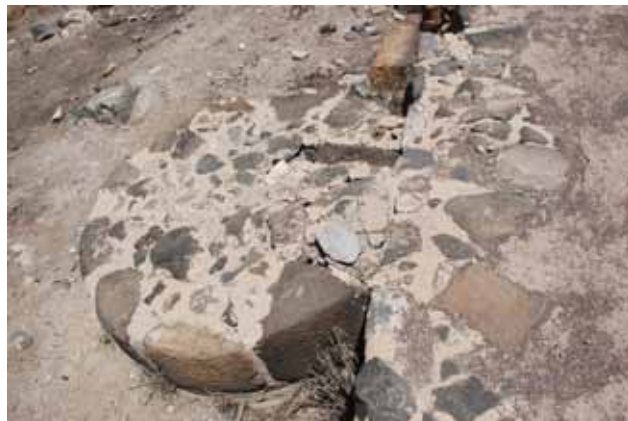
Fig.49: Detail of the restored buttress 12-4e with the continued facing of wall M3 (AS 2014).

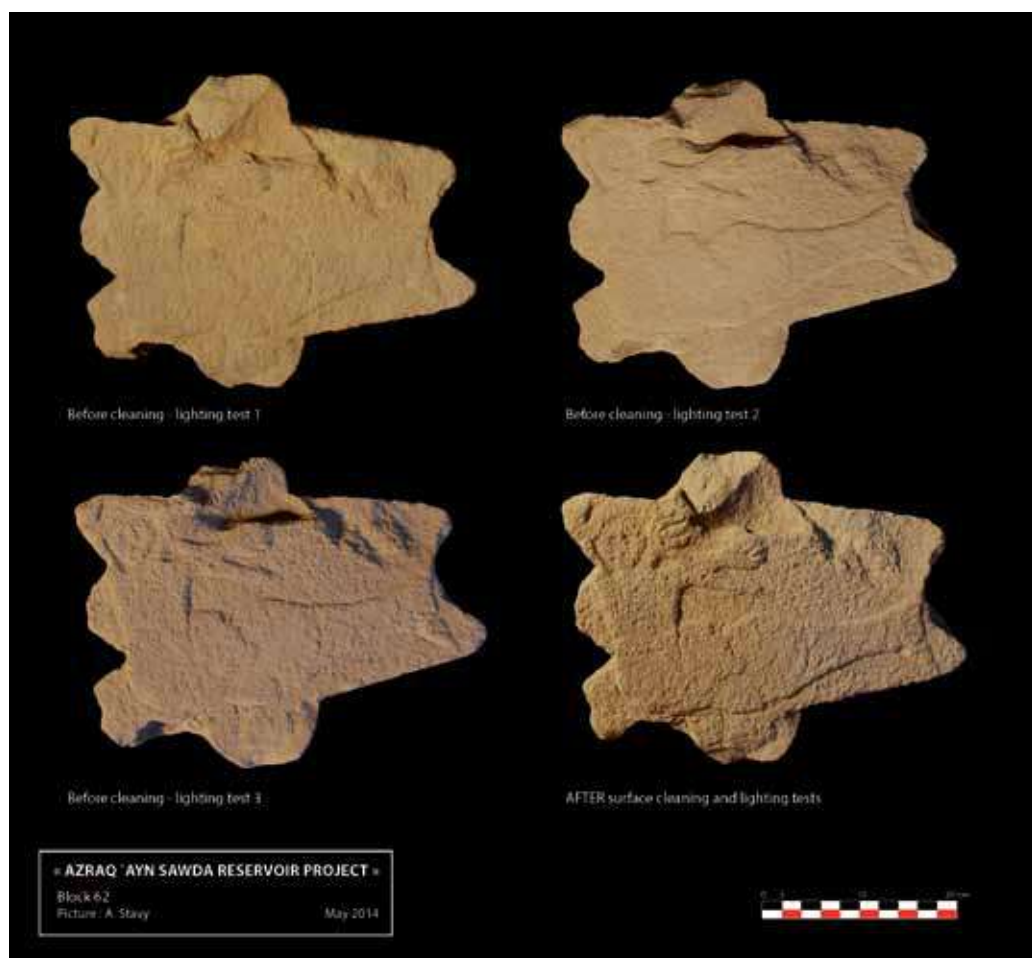
Fig.55: Methodology elements on block 62 (AS and LAA 2014).

The first phase of our work was to list the blocks stored in Qala't Azraq (cf. Appendix 2) and to photograph their main face. This step, compulsory as we didn't have these documents, constitutes the base of a database catalog that will allow us to study the block in an accurate way. The photographs have been taken with a reflex digital camera Nikon, lent by the Ifpo, and a three worksite spots installation to get a good lighting. The main conclusion of this work, and especially from the photographs, is that the blocks need a full cleaning. Indeed, the accumulation of dust in the exhibition room is very important and doesn't allow distinguishing the bas-reliefs in a correct way. For our fieldwork this year, in the frame of saving time, we proceeded to a surface cleaning with a soft brush of each block before to photograph them. It allowed us to notice that, under the dust, most of the blocks still present earth or vegetation traces giving them their brown/beige color while it is basalt blocks! Beyond the problem that it creates for the photography, it is clear that the blocks are not highlighted from a touristic point of view (**Fig.55**).

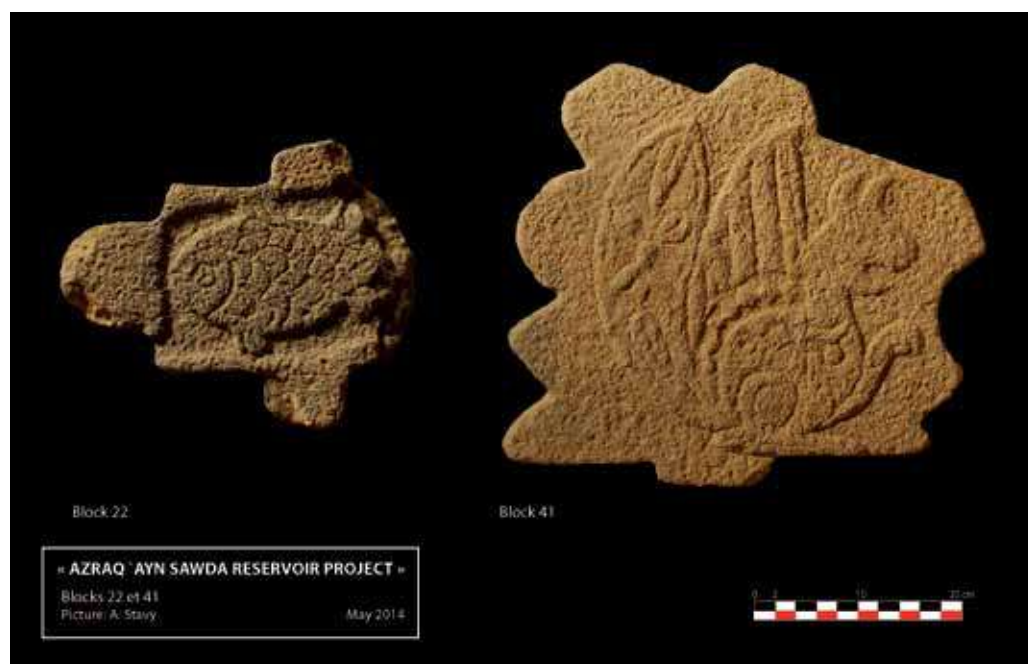
Fig.57: Blocks 22 and 41 used as test for the 3D modelling (AS and LAA 2014).

Because of time issues, we did our tests on two blocks only: the block 41 (representing a senmurv) and the block 22 (decorated with a fish) that we choose for their different stone cutting aspects (**Fig.57**).

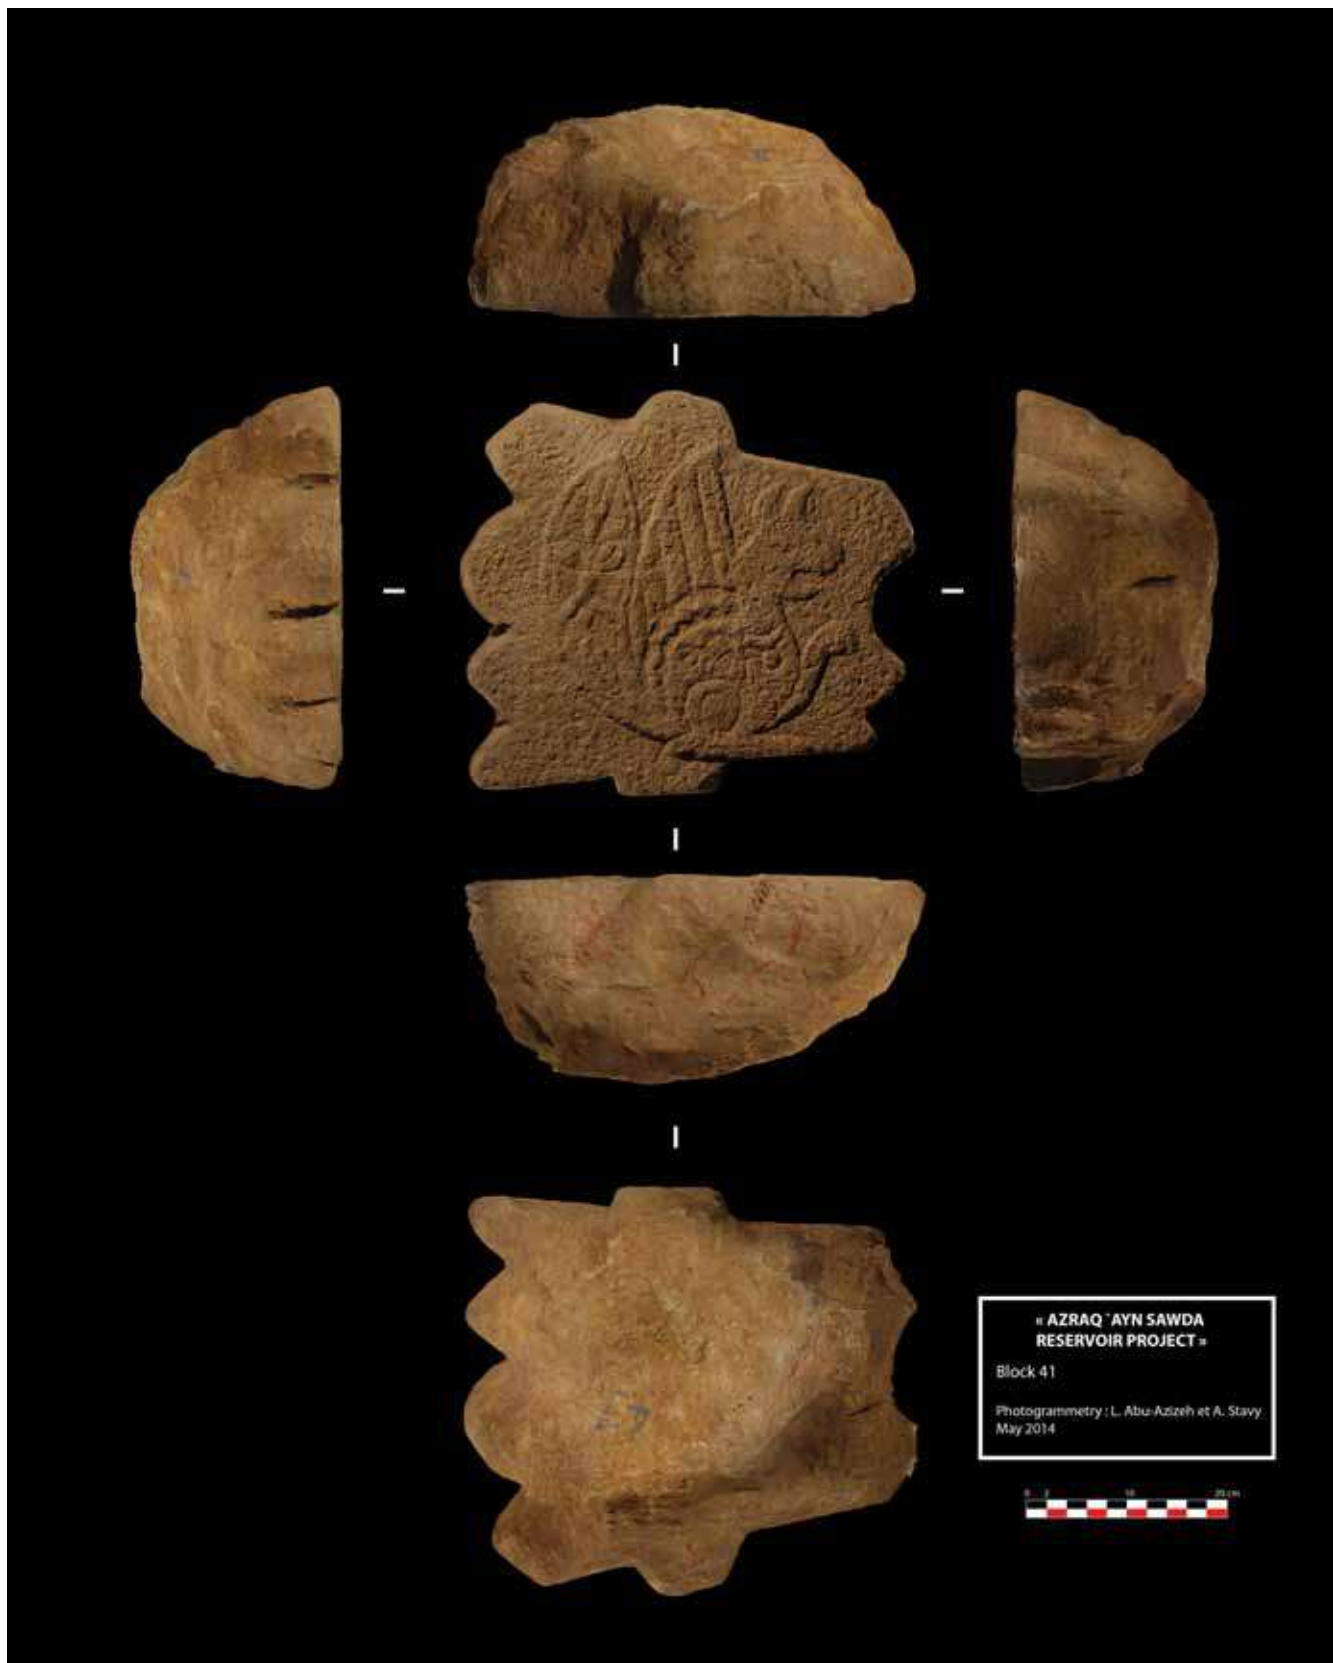
Fig.60: Block 41 orthophotos after the photogrammetry process (AS and LAA 2014).

The results are very positive as we succeed and created the 3D models of blocks 41 and 22 (**Fig.58**). We validated so the first step of the work and extract from the 3D models the orthophotos of each face (**Fig.59 and Fig.60**).
