## Azraq al-Šišan. ‘Ayn Sawda reservoir project. Report of the fieldwork led from the 13th to the 31st of May 2014

# Azraq al-Šišan

## ʿAYN SAWDA RESERVOIR PROJECT

Report of the fieldwork led from the 13<sup>th</sup> to the 31<sup>st</sup> of May 2014

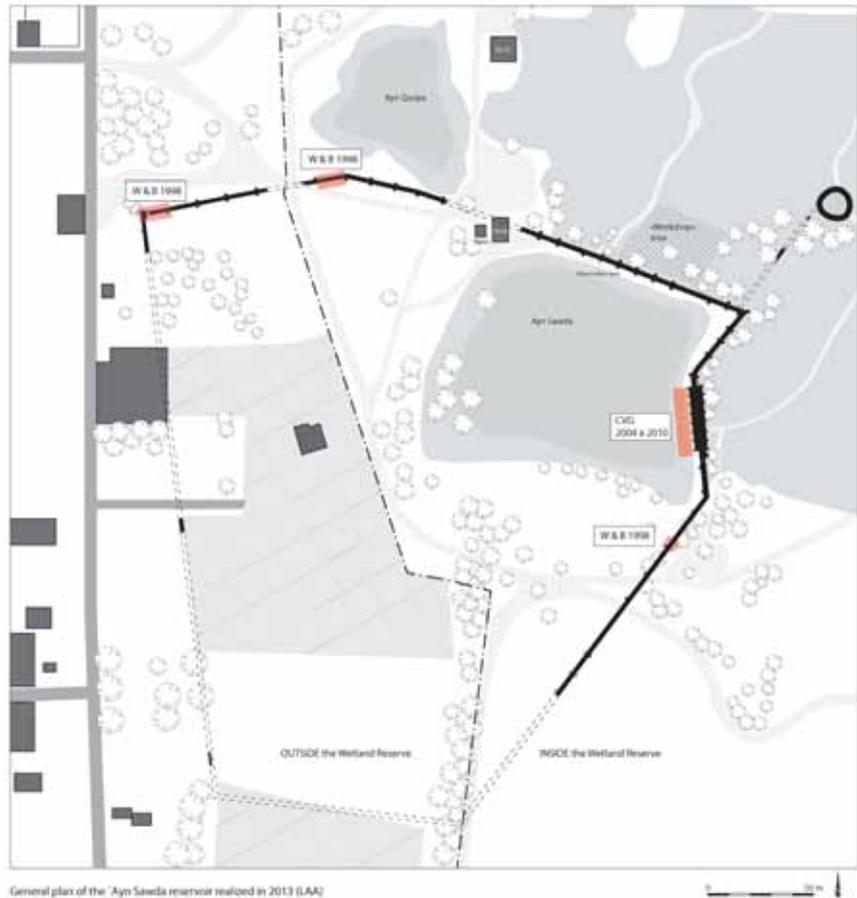
Fig.2: General plan of the reservoir indicating the former excavations project (LAA, 2013).

In 2013, during the relay mission, we have produced the first plan of the reservoir elaborated from a total station survey, a precise and accurate plan of the structures (**Fig.2**). Nevertheless, even if this plan constitutes a major graphic support for our work, it needs to be completed on three levels.

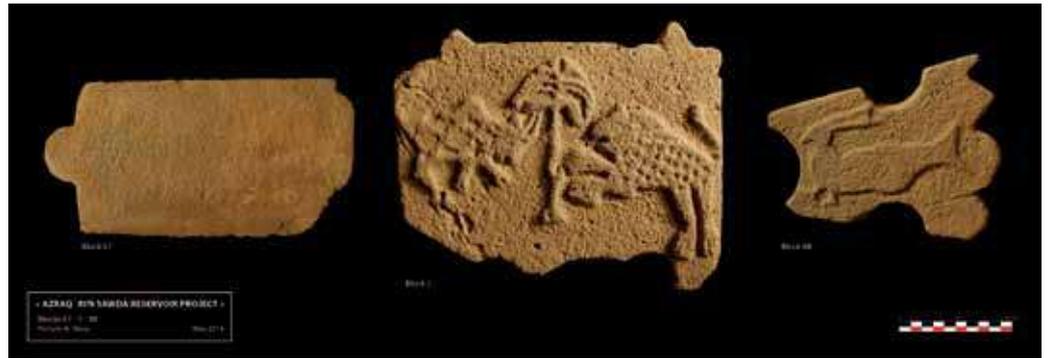
Fig.4: Example of some carved blocks uncovered in the reservoir until 2013 (AS and LAA 2014).

The carved blocks of the `Ayn Sawda reservoir, discovered between 1981 and 2013, are now shown in Qala't Azraq. Only 10 of the 106 blocks are stored in Irbid, in the Yarmouk University. The specificity of these basalt blocks is their shape, often surprising, which present tenons and mortise on one of their faces as well as on the four faces. Only 62 blocks presents a bas-reliefs drawing on their main face, representing human beings, animals and vegetation or even more complex scenes (**Fig.4**).

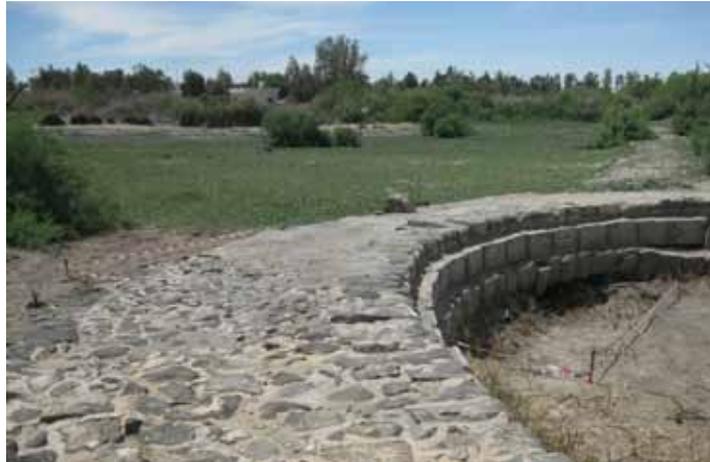
Fig.6: General view of the wall M1 in sector A. Looking to the west (BC 2014).

of the sounding was the study of the structure by observing its foundations and the archaeological layers adjoining, and the seeking of a junction with a wall located on the surface, halfway to the N/E angle of the reservoir<sup>11</sup> (**Fig.6**).

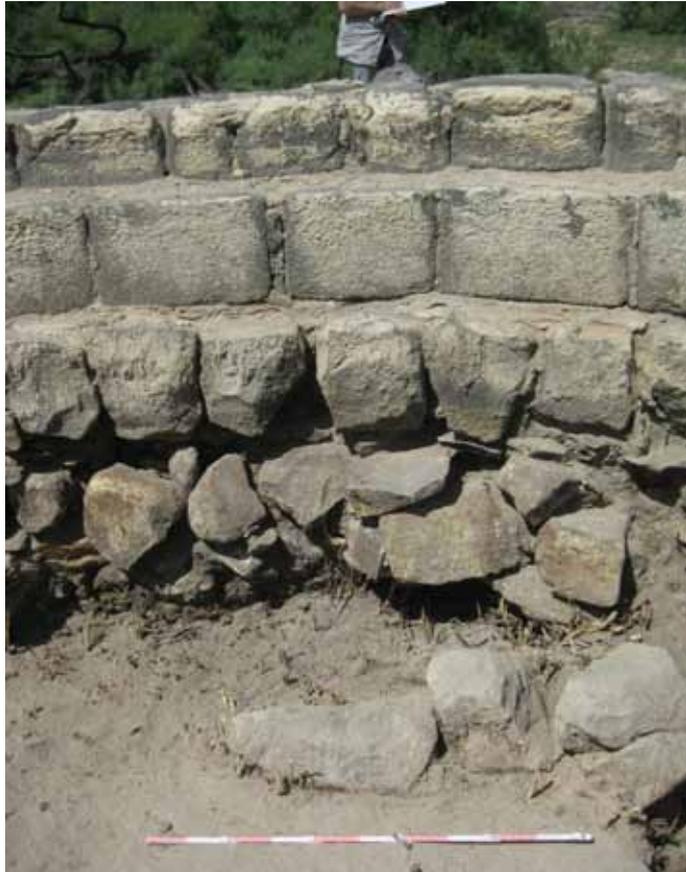
Fig.9: View of the three stone rows and the foundations of circular wall M1. Looking to the south (BC 2014).

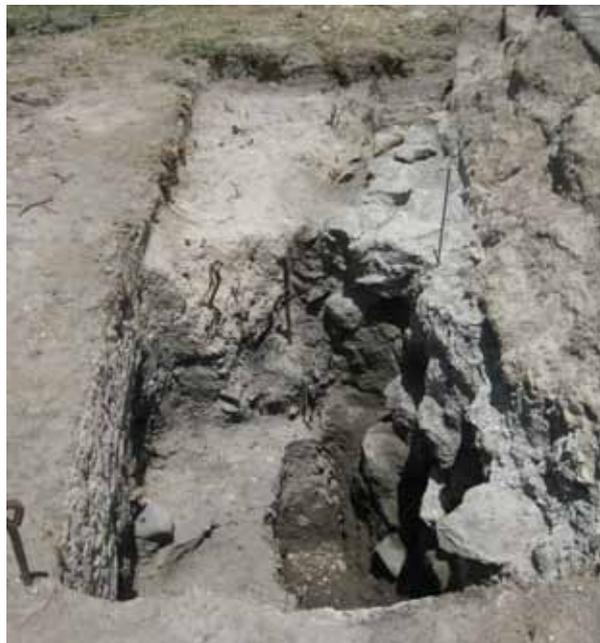
Fig.11: View of sounding A south. First plan: the deep sounding stopped by the water. On the left: the mortar glaci on the basalt rows of the exterior face of M1. Looking to the N/W (BC 2014).

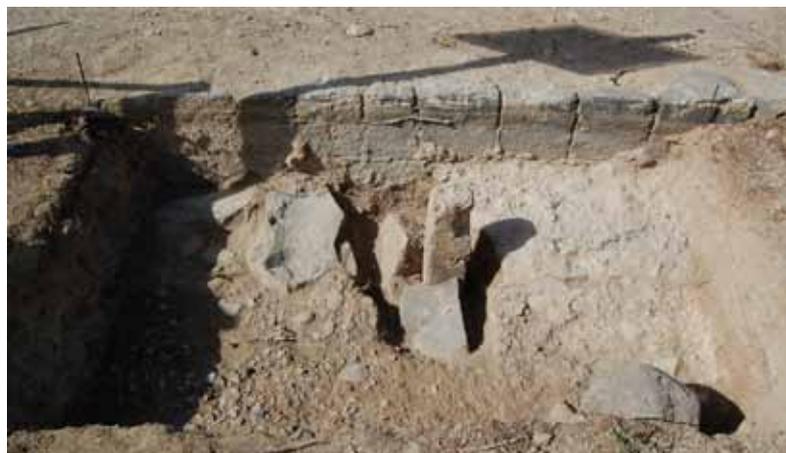
Fig.12: General view of sounding B1 after having reached the mortar glaci (JB 2014).

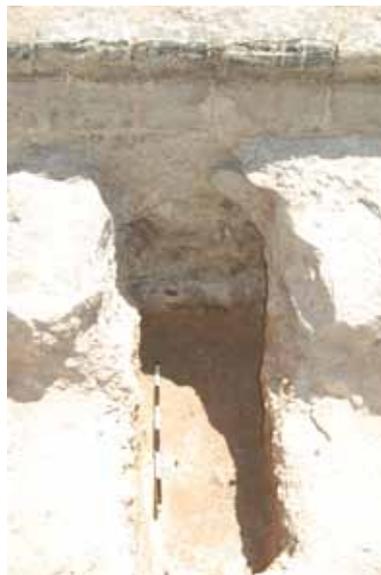
Fig.14: View of sounding B1 after having reached the foundation level (JB 2014).

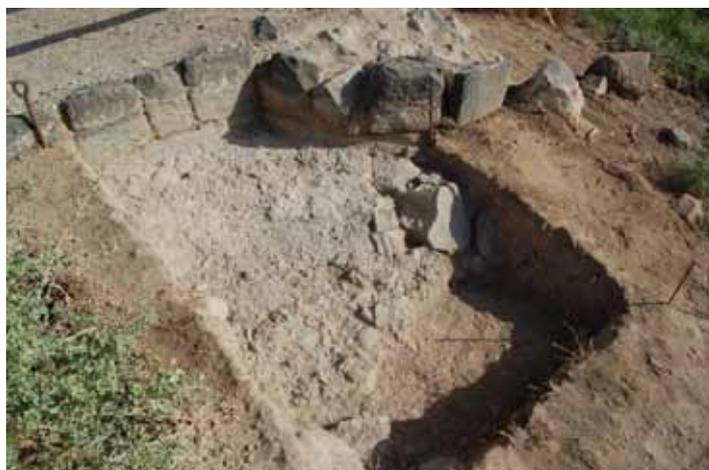
Fig.15: View of sounding B2 after having reached the mortar glacis (JB 2014).

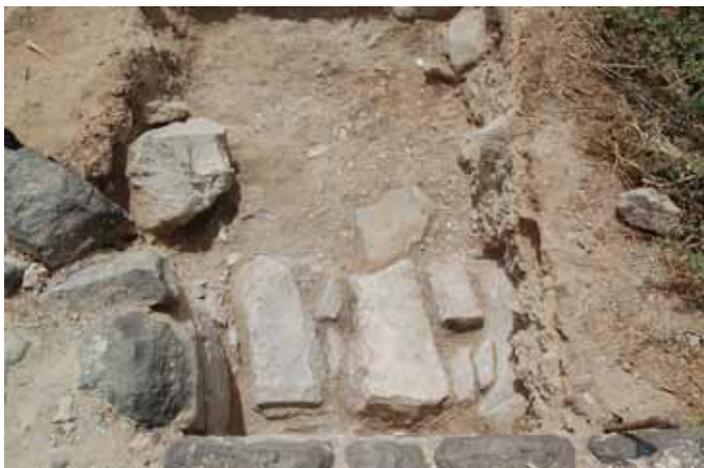
**Fig.18:** View of the slabs appeared under the mortar glaxis in B2 (JB 2014).

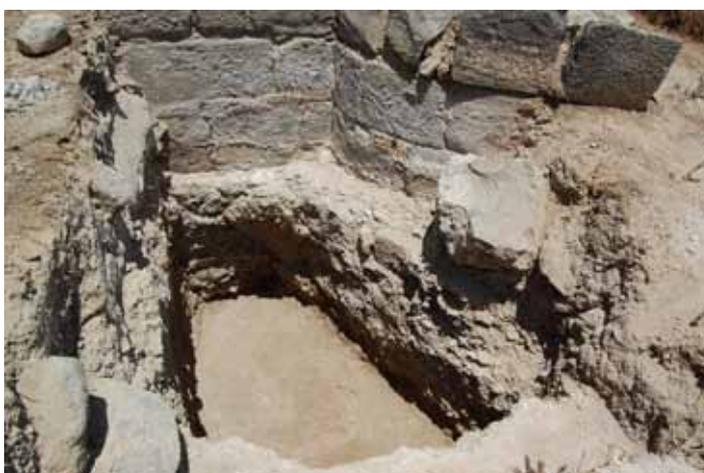
**Fig.19:** General view of B2 looking to the foundation system (JB 2014).

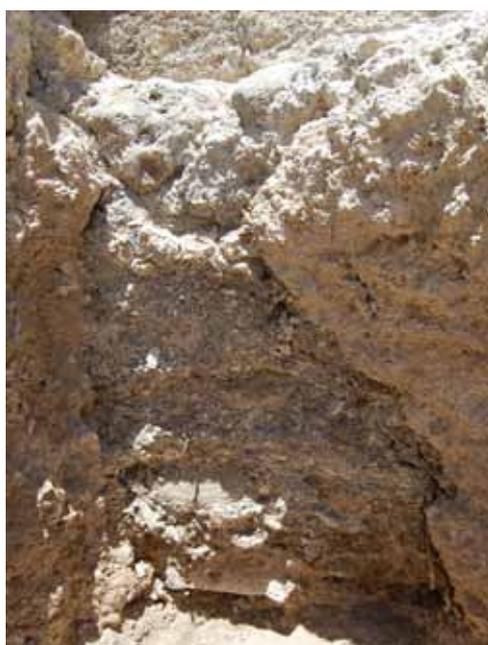
**Fig.20:** Detail of the foundation in B2 under wall M4 (JB 2014).

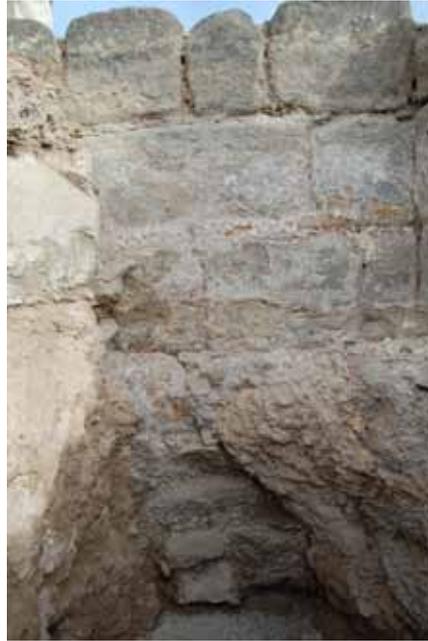
**Fig.21:** Detail of the foundation under wall M4 in B2 after having removed the mortar (JB 2014).

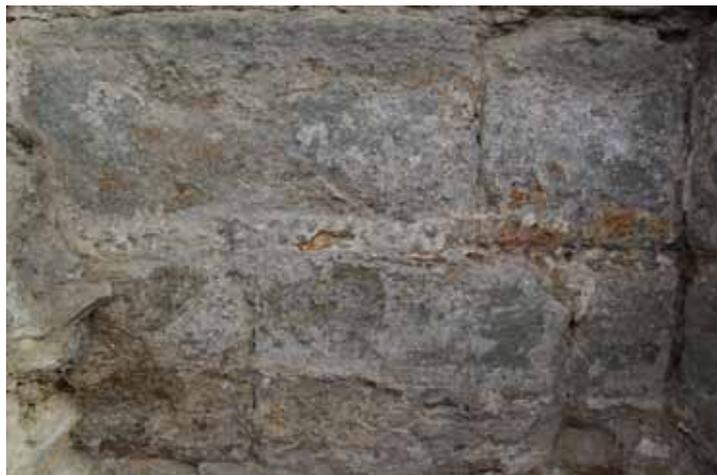
**Fig.22:** Detail of the overthickness joint with the basalt inclusions (JB 2014).

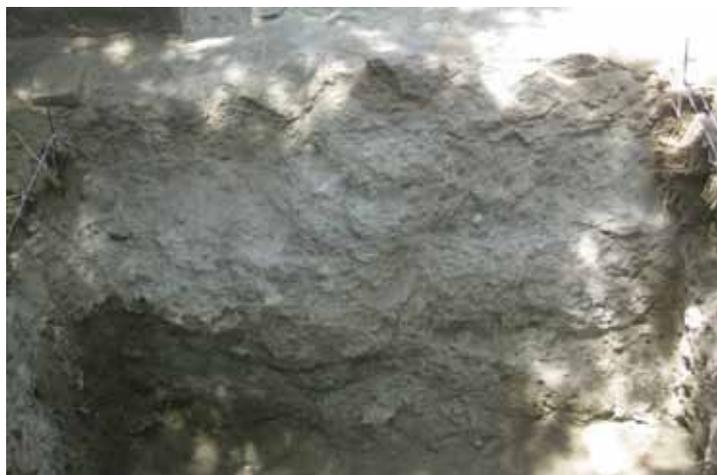
**Fig.23:** Mortar glaucis next to the basalt benches of the platform, sounding C1. Looking to the west (BC 2014).

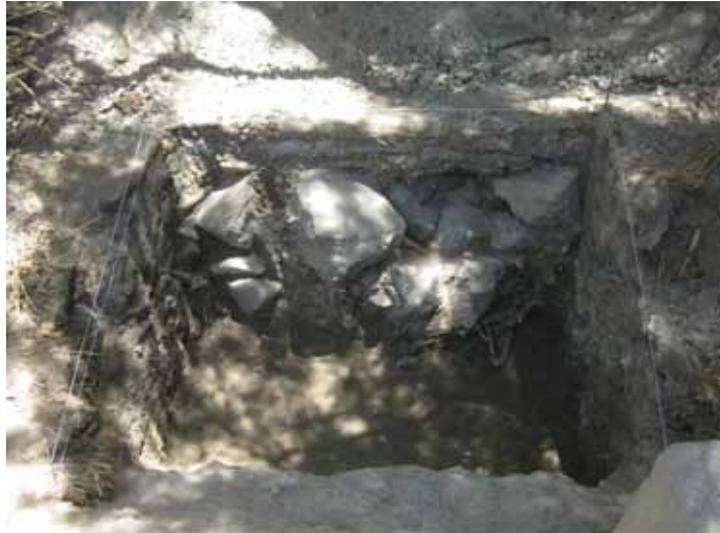
Fig.24: Basalt blocks in the east section of sounding C1 related either to a wall collapse or to the recent Reserve laying out. Looking to the east (BC 2014).

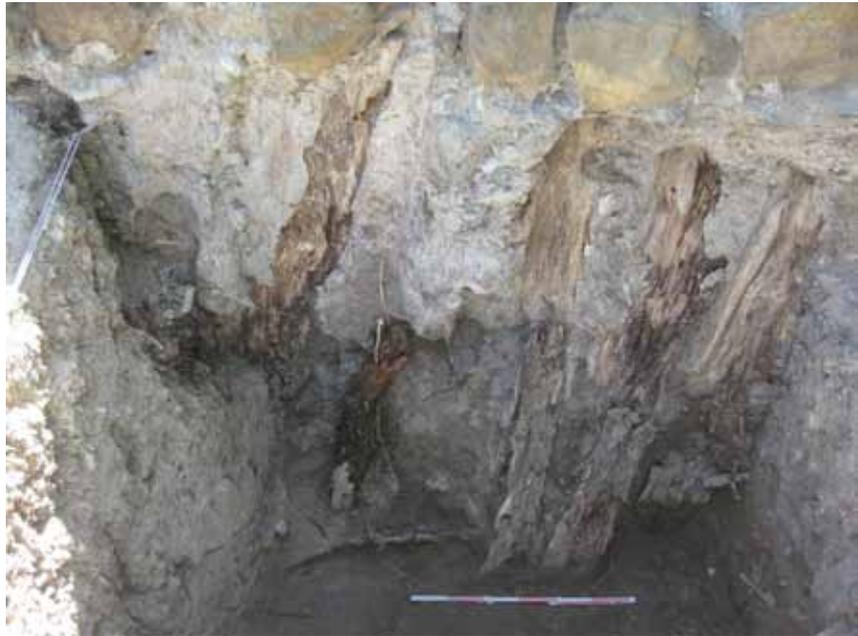
Fig.26: Wooden elements (pillars and boards) under the basalt bench of the platform, in sounding C2. Looking to the east (BC 2014).

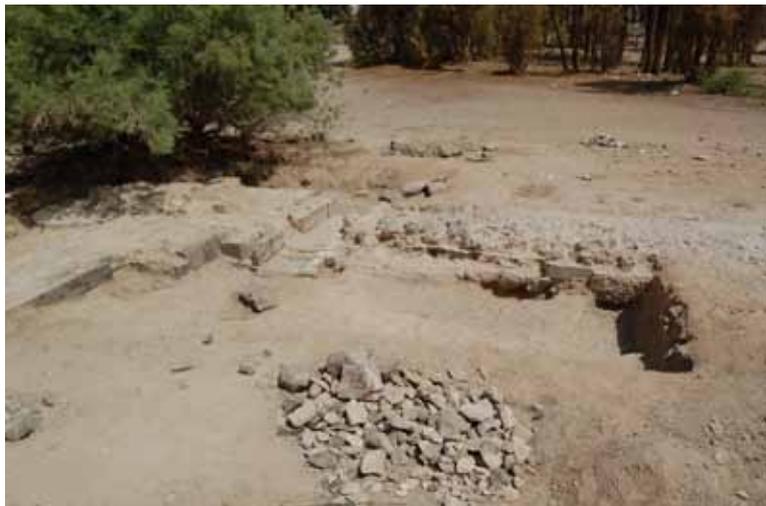
**Fig.31:** General view of sector D during the excavations, the channel is visible (JB 2014).

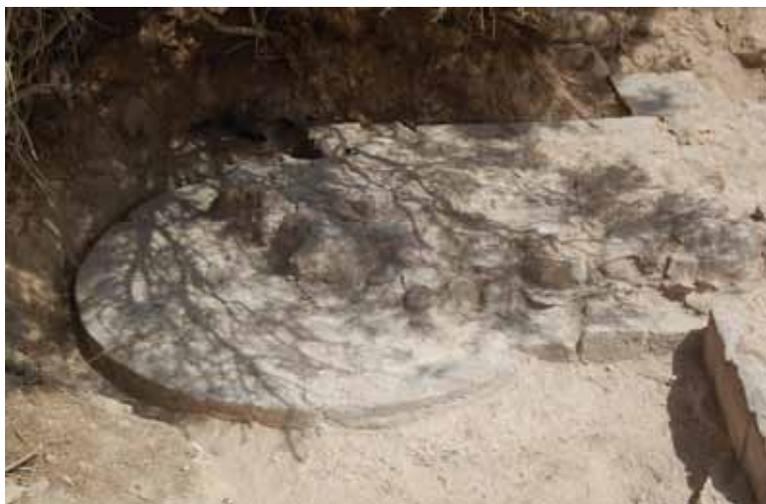
**Fig.32:** View of buttress 18-1, in sector D, uncovered on the west extremity of wall M3 (JB 2014).

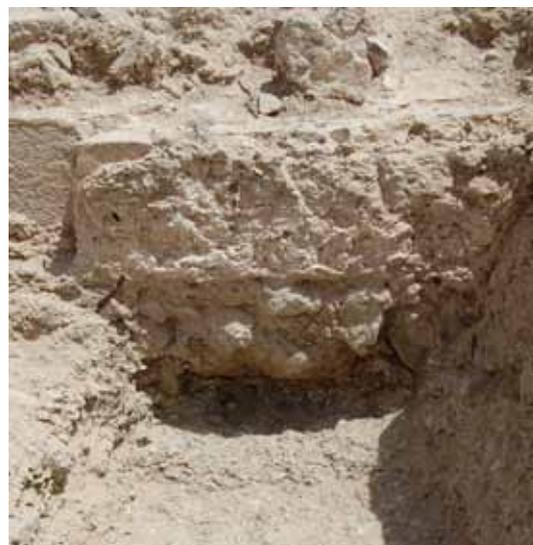
Fig.36: Detail of M3 foundation in sector D (JB 2014).

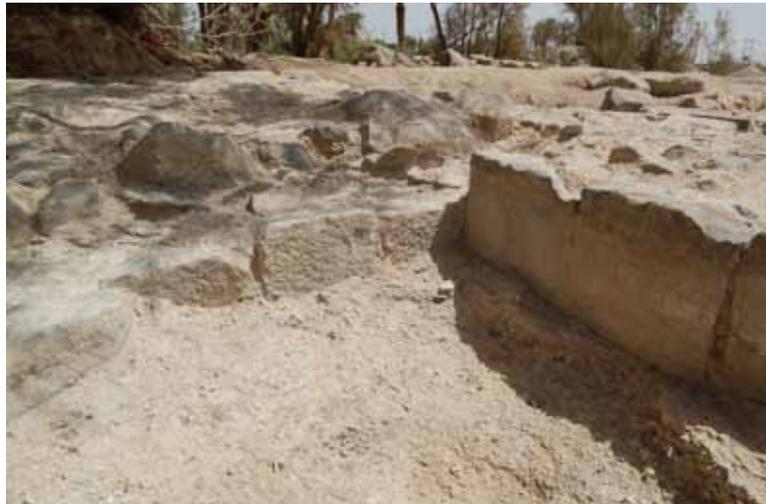
**Fig.38:** Detail of the connection between walls M3 (in front) and M8 (on the right) in sounding D2 (JB 2014).

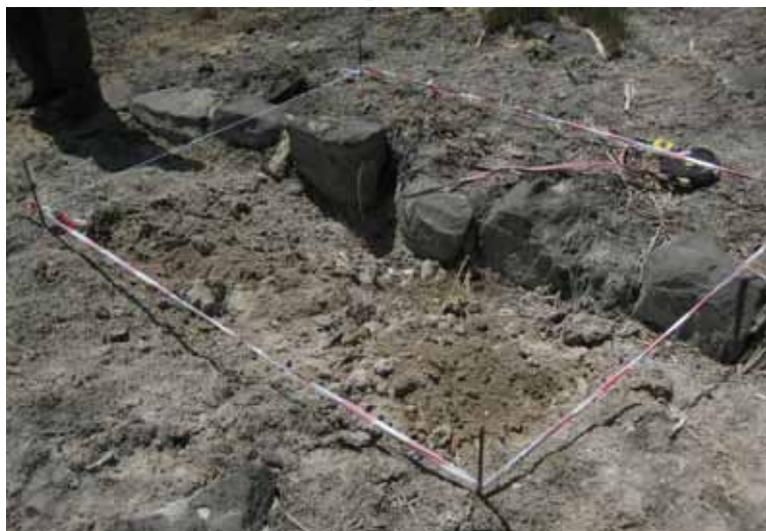
**Fig.39:** Location of sounding E1 on each side of the stone alignment M2, before the excavations. Looking to the S/W (BC 2014).

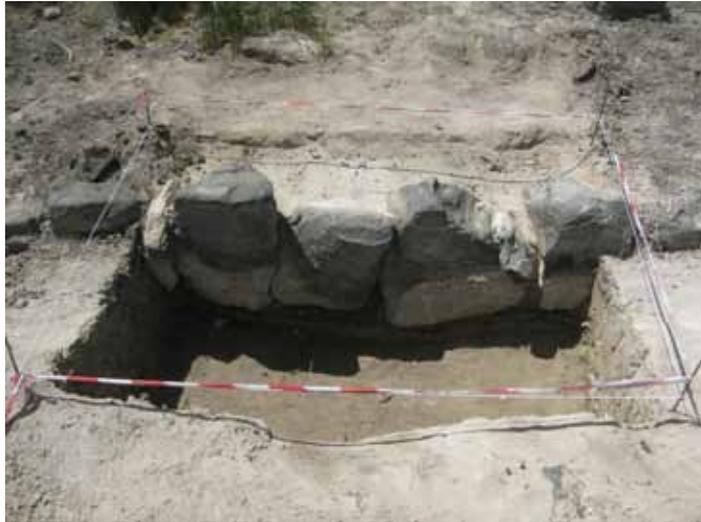
Fig.40: The stones of alignment M2 in sounding E1 (BC 2014).

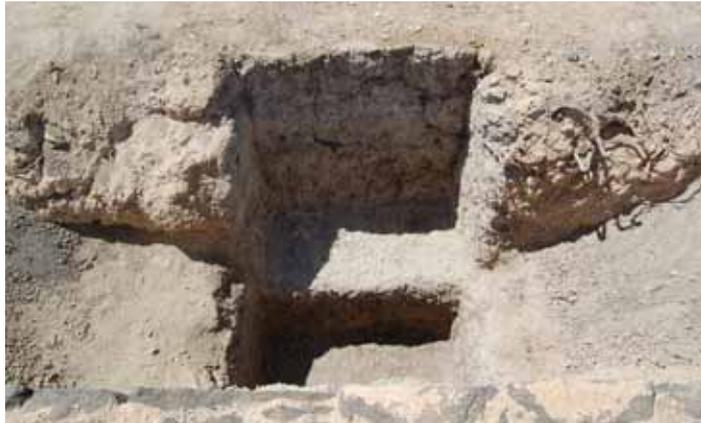
Fig.43: Detail of sounding G1, south of wall M3. Looking to the south (JB 2014).

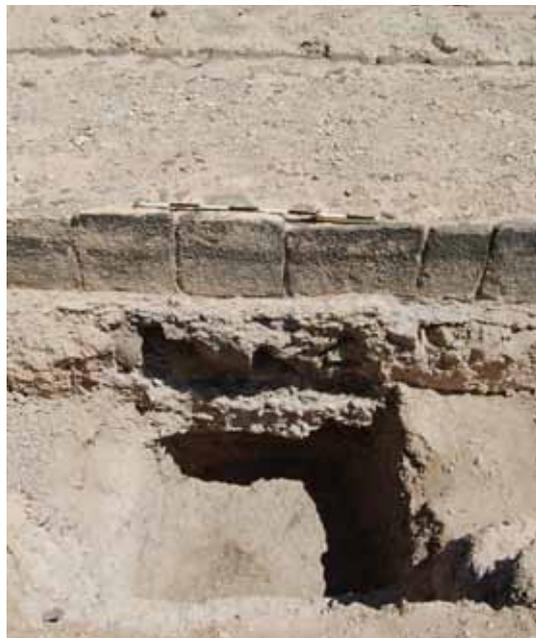
Fig.44: Detail of sounding G1, south of wall M3. Looking to the north (JB 2014).

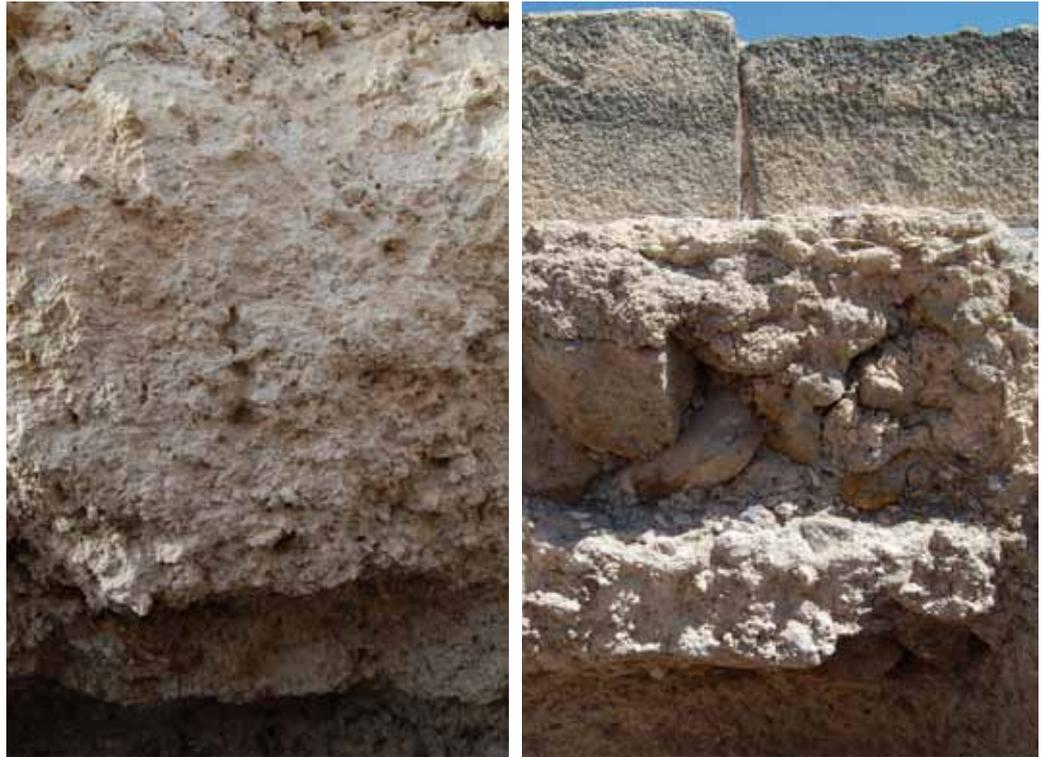
**Fig.46:** Detail of the mortar in sounding G2 **Fig.47:** Detail of the different layers of the foundation in sounding G2 (JB 2014).

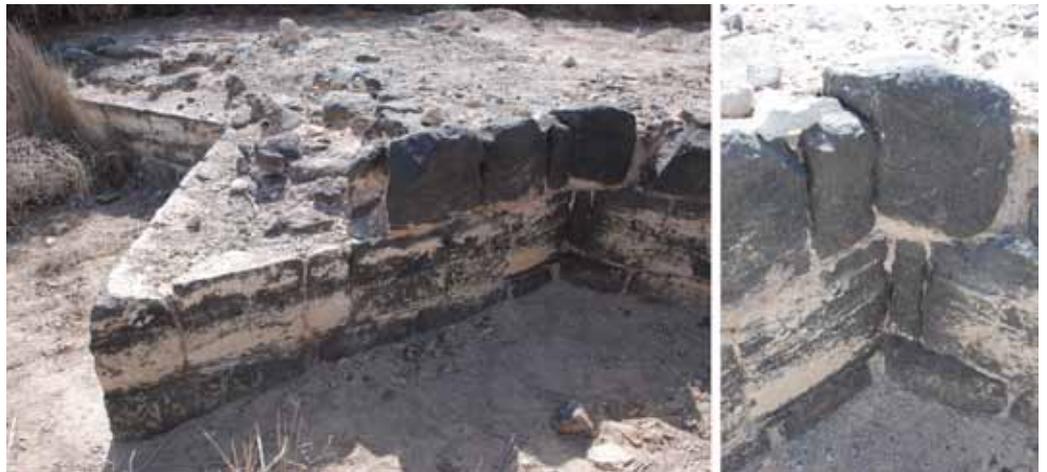
**Fig.48:** Detail of buttress 4-1i and its connection with wall M6 (AS 2014).

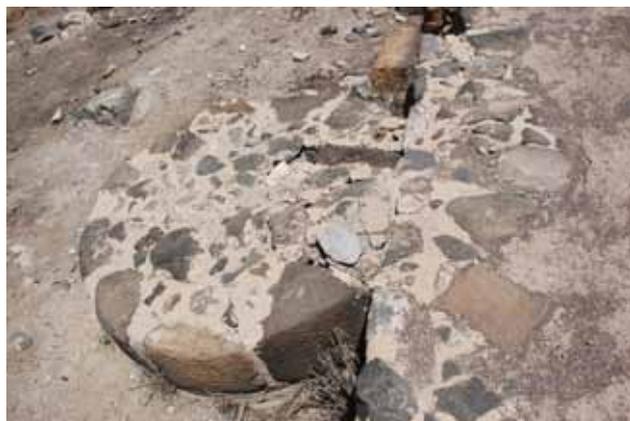
**Fig.49:** Detail of the restored buttress 12-4e with the continued facing of wall M3 (AS 2014).

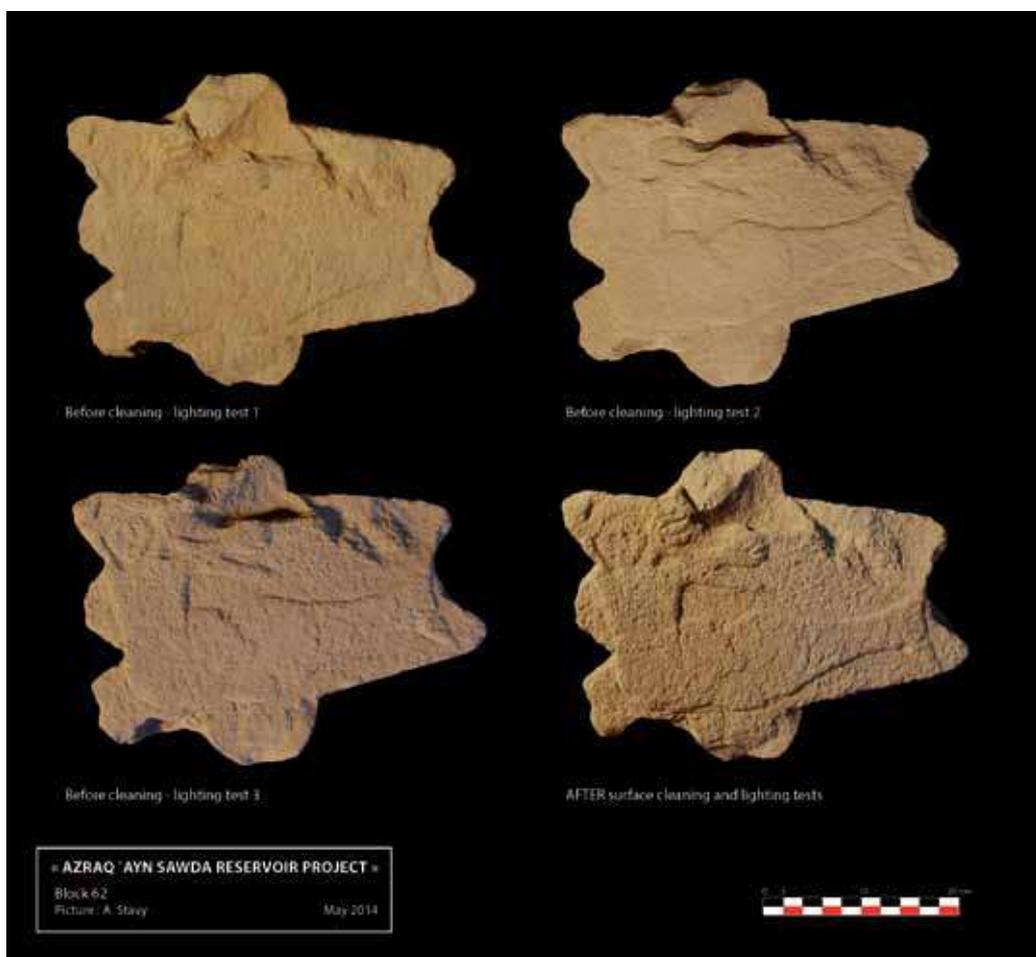
Fig.55: Methodology elements on block 62 (AS and LAA 2014).

The main conclusion of this work, and especially from the photographs, is that the blocks need a full cleaning. Indeed, the accumulation of dust in the exhibition room is very important and doesn't allow distinguishing the bas-reliefs in a correct way. For our fieldwork this year, in the frame of saving time, we proceeded to a surface cleaning with a soft brush of each block before to photograph them. It allowed us to notice that, under the dust, most of the blocks still present earth or vegetation traces giving them their brown/beige color while it is basalt blocks! Beyond the problem that it creates for the photography, it is clear that the blocks are not highlighted from a touristic point of view (**Fig.55**).

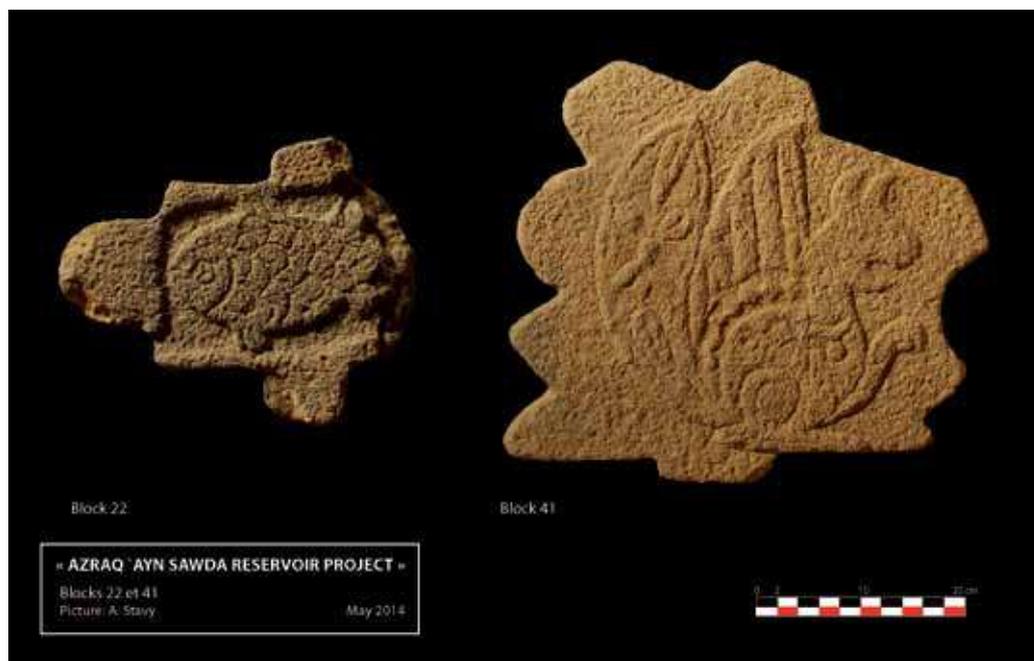
Fig.57: Blocks 22 and 41 used as test for the 3D modelling (AS and LAA 2014).

Because of time issues, we did our tests on two blocks only: the block 41 (representing a senmurv) and the block 22 (decorated with a fish) that we choose for their different stone cutting aspects (**Fig.57**).

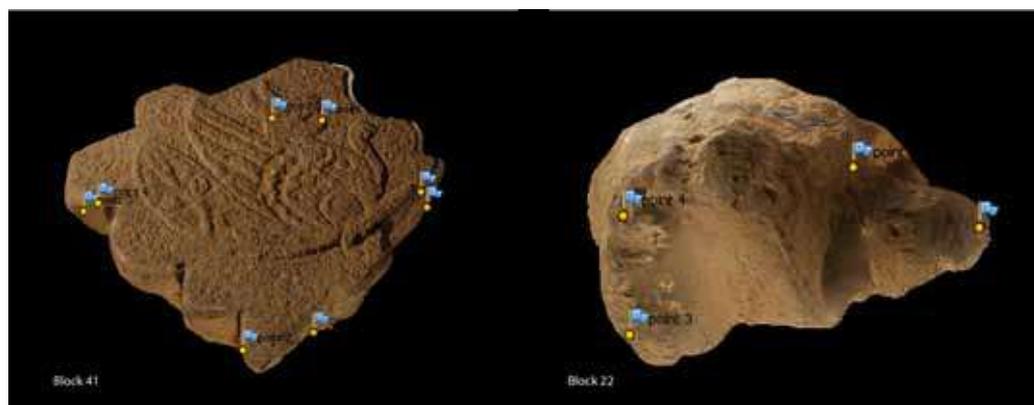
Fig.58: Blocks 22 and 41 under photogrammetry process (AS and LAA 2014).

The results are very positive as we succeed and created the 3D models of blocks 41 and 22 (**Fig.58**). We validated so the first step of the work and extract from the 3D models the orthophotos of each face (**Fig.59 and Fig.60**).

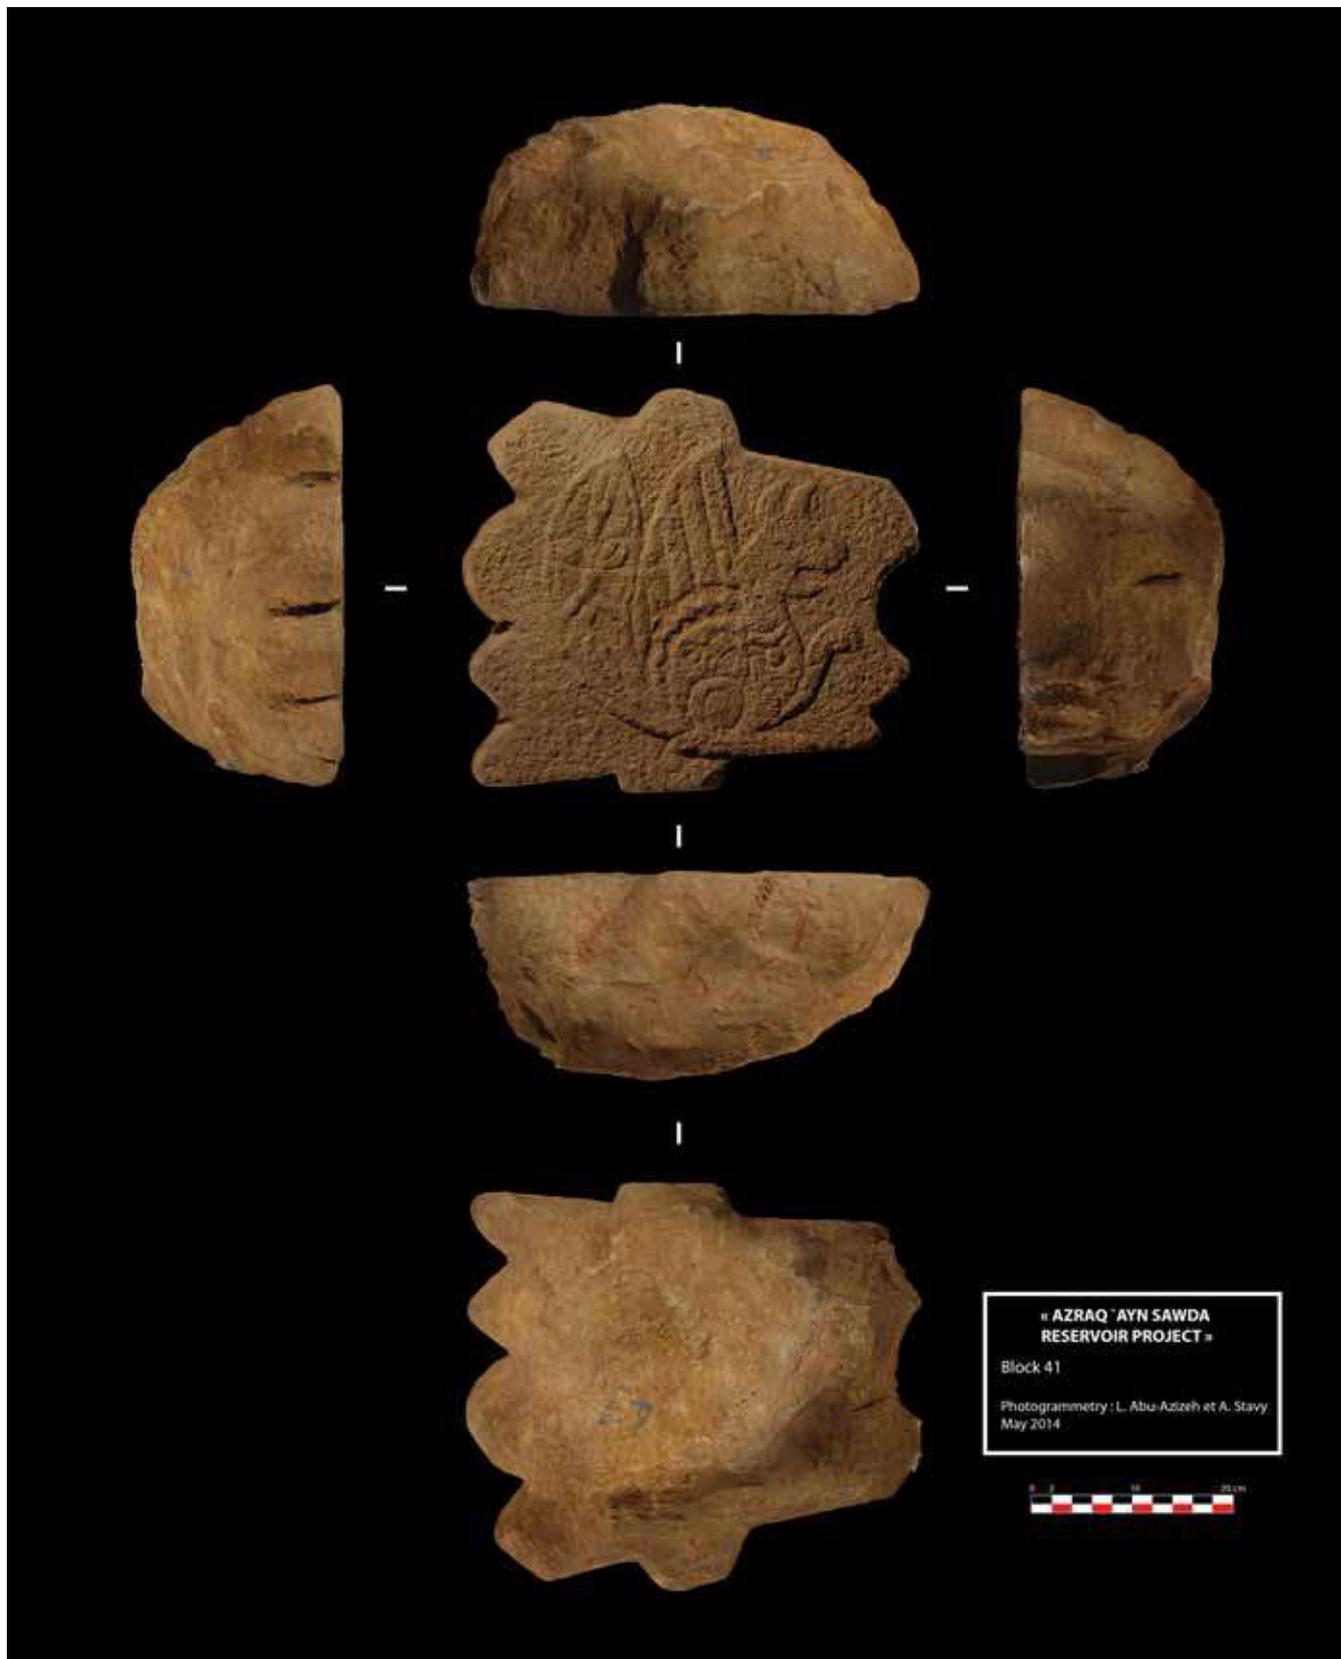
Fig.60: Block 41 orthophotos after the photogrammetry process (AS and LAA 2014).
