# Photogrammetry for the preparation of archaeological excavation. A 3D restitution according to modern and archive images of Beaufort Castle landscape (Lebanon)

Pierre Grussenmeyer, J. Yasmine

Pierre Grussenmeyer, J. Yasmine. Photogrammetry for the preparation of archaeological excavation. A 3D restitution according to modern and archive images of Beaufort Castle landscape (Lebanon). XXth Congress of the International Society for Photogrammetry and Remote Sensing (ISPRS), Jul 2004, Istanbul, Turkey. pp.809-814. halshs-00264014

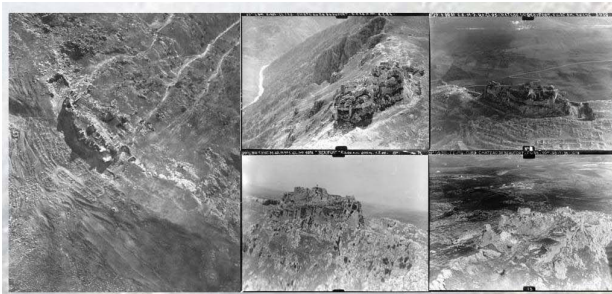
**1930-1936:** Archive images of the French Air Force of the Levant (aerial large format images)

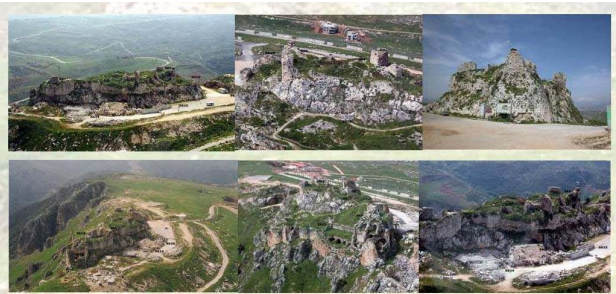
**2003:** Modern digital images (aerial and terrestrial small format images)
