## Can flood risk management restore ecogeomorphologic functioning of fluvial margins along the Rhône River (France, SE)?

4<sup>th</sup> ECRR Conference on River  
Restoration  
Italy, Venice S. Servolo Island  
16-21 June 2008

## CAN FLOOD RISK MANAGEMENT RESTORE ECOGEOMORPHOLOGIC FUNCTIONING OF FLUVIAL MARGINS ALONG THE LOWER RHÔNE RIVER (FRANCE, SE)?

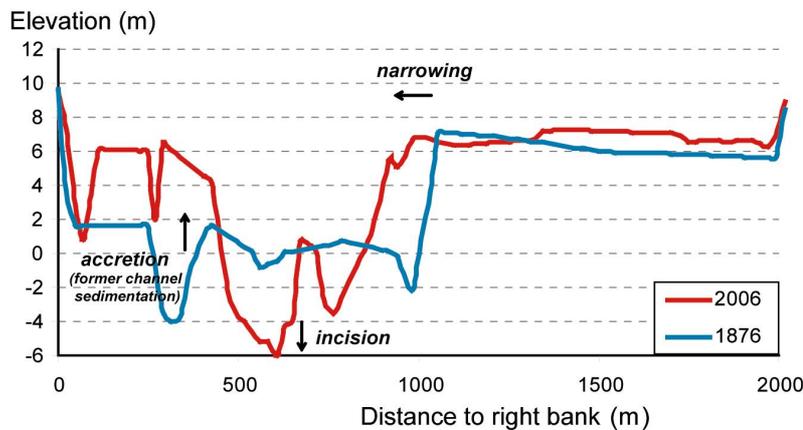
Figure 2: Channel cross sections at the kilometric point (kp) 275.5 in 1876 and 2006. Main changes are illustrated here: channel degradation and narrowing, sedimentation in former channels.

Historical data analysis (old maps and surveys) clearly demonstrate that the lower Rhône River underwent several changes in channel geometry and bank position over the last 150 years (channel incision and narrowing, former channel sedimentation, bank accretion). For example, at the kilometric point (kp) 275.5, the channel has undergone a bed degradation of 2 m as well as a 500 m active channel narrowing between 2006 and 1876 (Figure 2). For the same discharge ( $5800 \text{ m}^3 \cdot \text{s}^{-1}$ ; 2 years return period), increase in water level at this point is close to 0.5 m.

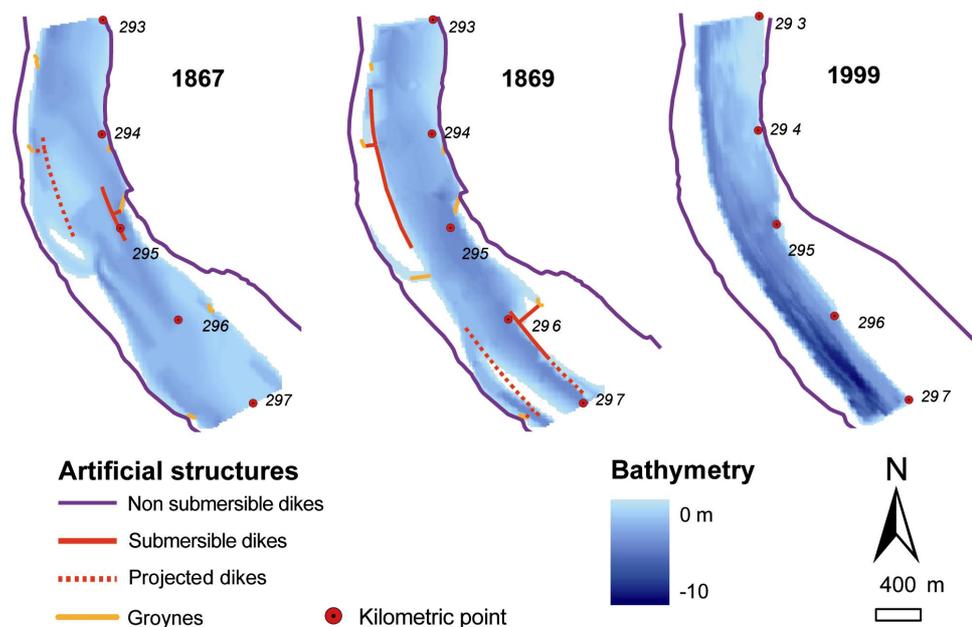
Figure 3: An example of regulation impact on channel geometry (incision and narrowing)

The regulation works (dikes, groynes...) built downstream of Beaucaire between 1870 and 1938, to improve navigation, also greatly participated to the observed adjustments. For example, some groynes and submersible dikes from kp 293 to kp 297 have been built since 1867 (figure 3) to limit lateral mo-

bility in concavities and to close the side channels. They resulted in a very fast channel narrowing of 80 m from 1867 to 1869.
