The early temple of Ptah at Karnak

Guillaume Charloux, Christophe Thiers

Recent excavations in the temple of Ptah at Karnak confirm the existence of an earlier mud-brick sanctuary. **Guillaume Charloux** and **Christophe Thiers** unveil the first elements of the discovery.

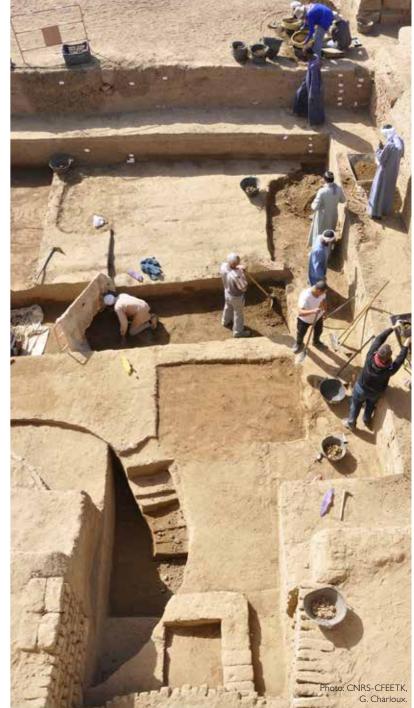
Above right: large stratigraphic sounding south of the temple of Ptah at Karnak in 2016. At the bottom of the image appears the southern angle of the mud-brick temple cleared during the excavation. A small rectangular window was opened in this corner to check for the possible presence of a foundation deposit.
