## The Roman baths at Karnak, between river and temple. Architectural study and urban context

## The Roman Baths at Karnak, Between River and Temples

### Architectural Study and Urban Context

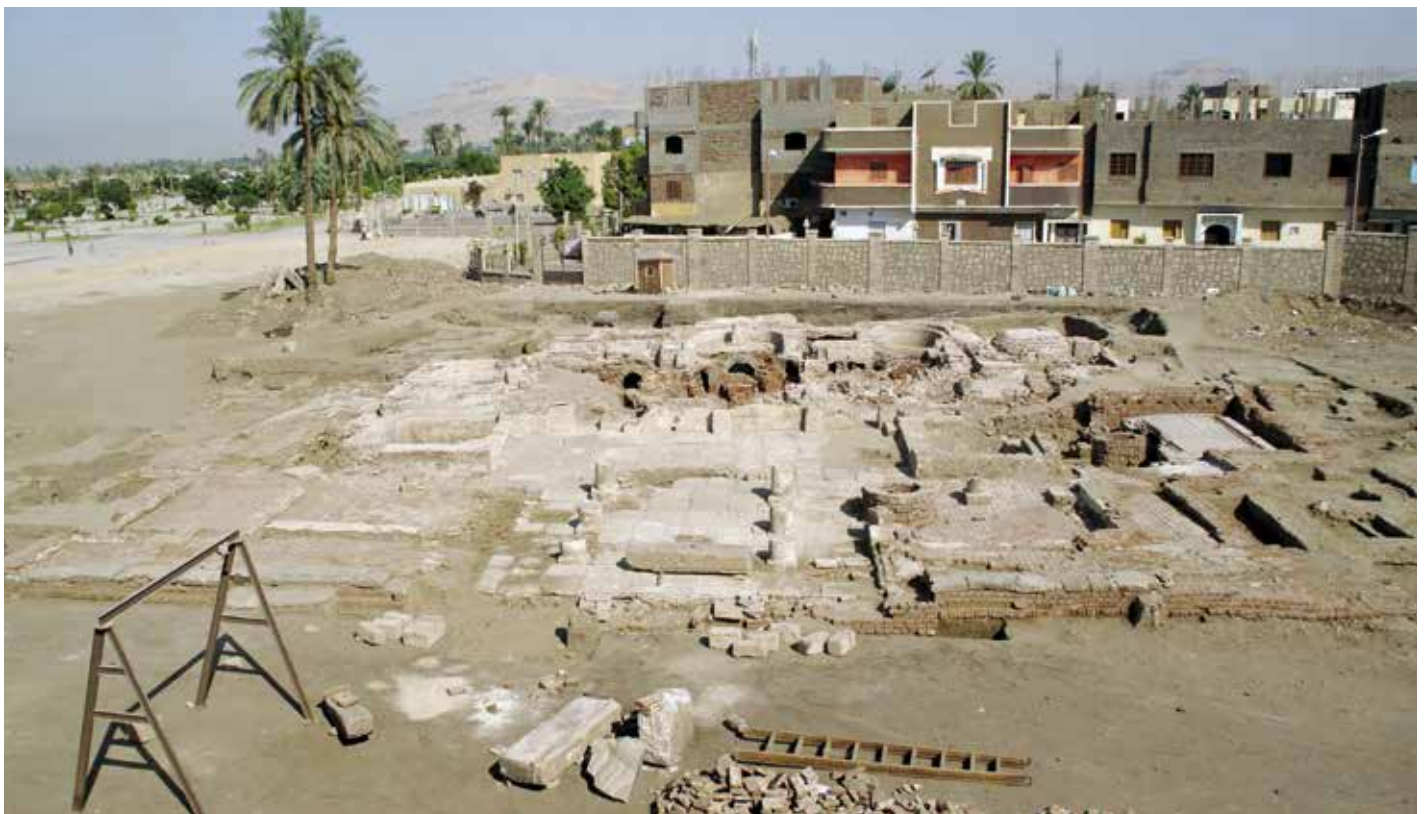
**Fig. 2.** General view, westward, of the Roman baths (© M. Vanpeene 2012).

The bath building covers an area of approximately 1440 m<sup>2</sup> (37 × 39 m, the bathing sector and its ancillary rooms occupying about 1200 m<sup>2</sup>). It is built almost entirely of fired and mud bricks (fig. 2), from the foundation to the vaults, some lying in their position of collapse when discovered.<sup>5</sup> As it stands today, in its last state, the construction had a relatively symmetrical plan along a central east-west axis. The main entrance is to the east, leading to a central courtyard and a large room ending with an apse to the west (fig. 3). Probably accessed from a street parallel to the enclosure wall of the temple, the entrance leads to an area (A) composed of two courtyards (one with a portico, the other hypaethral), two cold pools and some additional rooms (cloakrooms, latrines). This cold area gave access to the heated section (B), located in the centre, consisting of three small rooms opening into three larger rooms. The western section (C) is devoted to the heating system, and the water devices (D) are grouped to the north (aqueduct, reservoirs, *sakieh*, elevated tank)<sup>6</sup>.

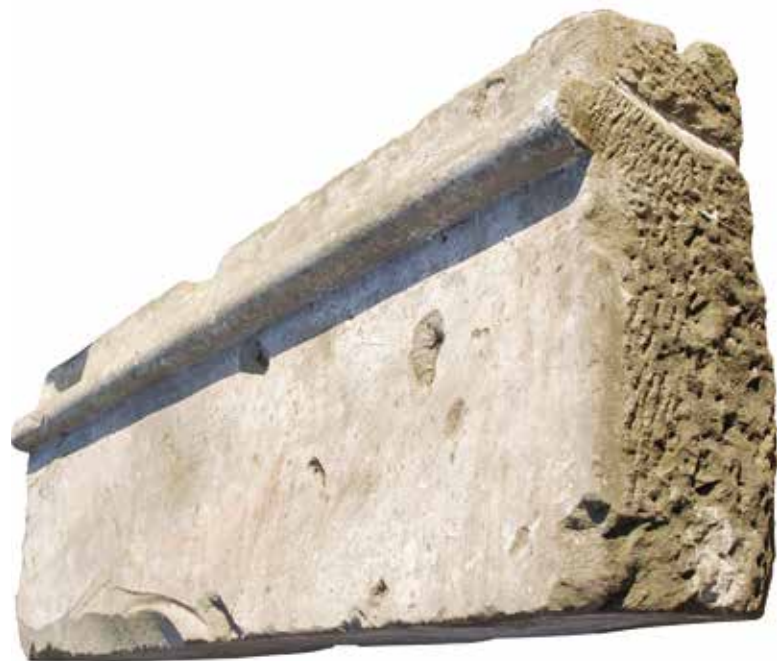
**Fig. 5.** Outer lintel of the front doorway of the baths (© P. Piraud, Fournet 2012).

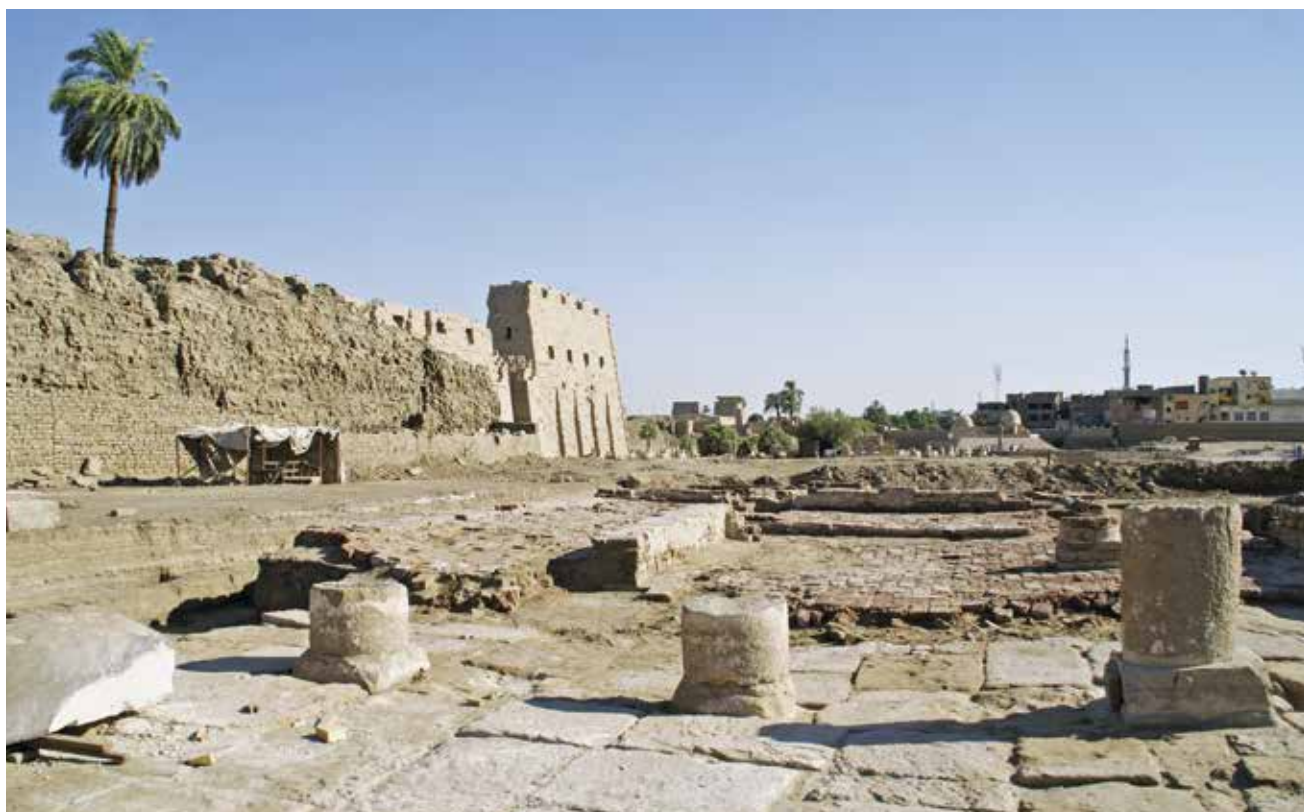
Fig. 7. View, southward, of the columns of Room 1 (© P. Piraud-Fournet 2012).

The six columns of the peristyle are now preserved only to the height of one drum. They were baseless and without moulding, placed on a square die with bevelled corners in their upper part (fig. 7). Five of them were found *in situ* when discovered, the sixth was placed back onto its die. The height of the preserved drums varies between 0.38 and 0.54 m and their diameter of 0.55 m is uniform. Many still have on their top faces the mouth and the cavity where the mortar was poured to affix the upper drum. Two capitals belonging to the baths were found (figs. 8–9). One was lying at the foot of the columns on the stone floor, the other, identical, was re-used in modern buildings that reoccupied the site.<sup>9</sup> In fact, they are only the upper parts of two, extremely pared-down Corinthian capitals, of the so-called Nabataean style (see below on the architectural elements). Their shape fits a square of 0.88 m wide and a rectangle of 0.21 m tall. They have no pattern or decoration, with four prominent and smooth corner horns, and a very prominent axial rectangular button on all four sides. The six drums and two capitals found on the site were covered with a white painted plaster with traces of red and yellow colour.

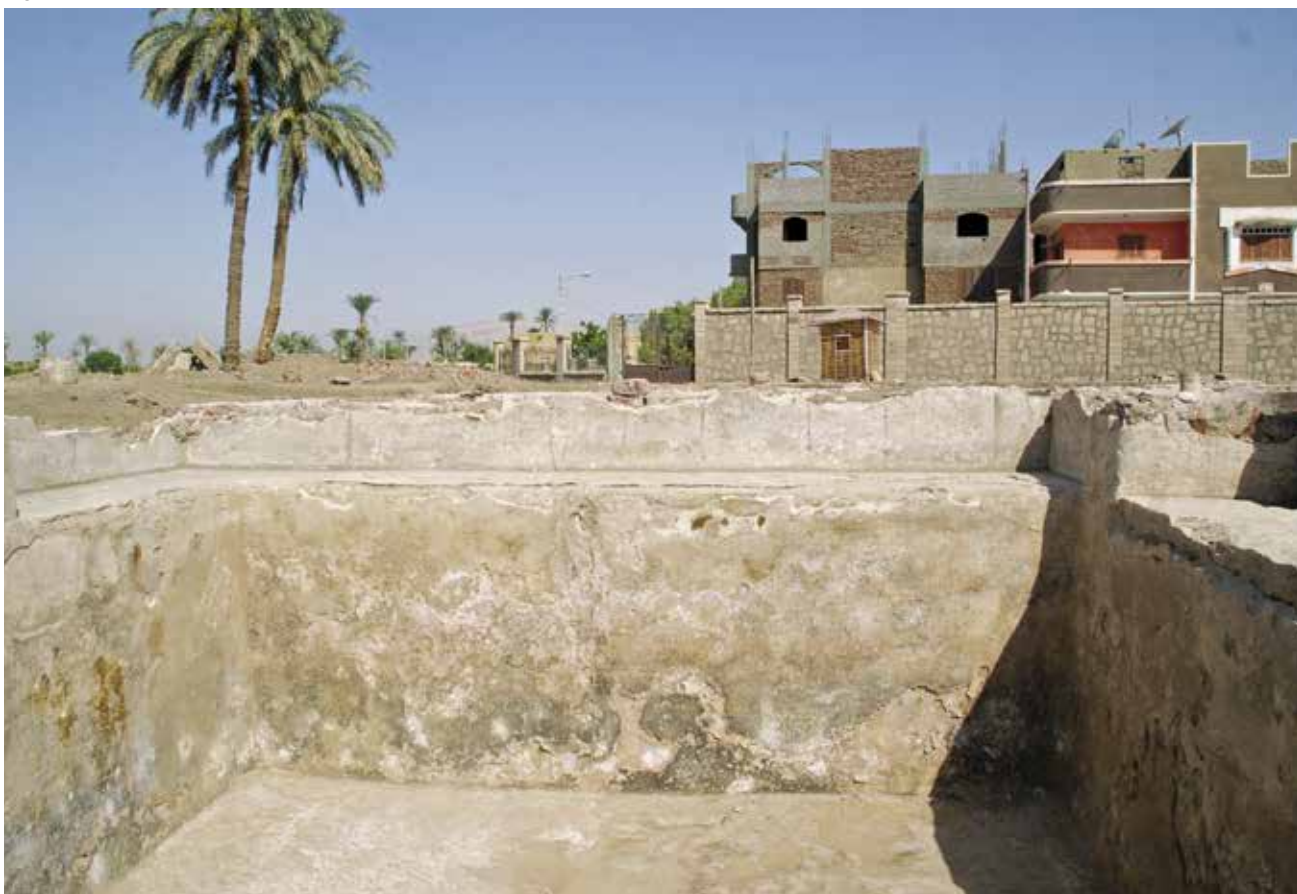
**Fig. 11.** View, westward, of the painted inside wall of Pool 10 (© P. Piraud-Fournet 2012).

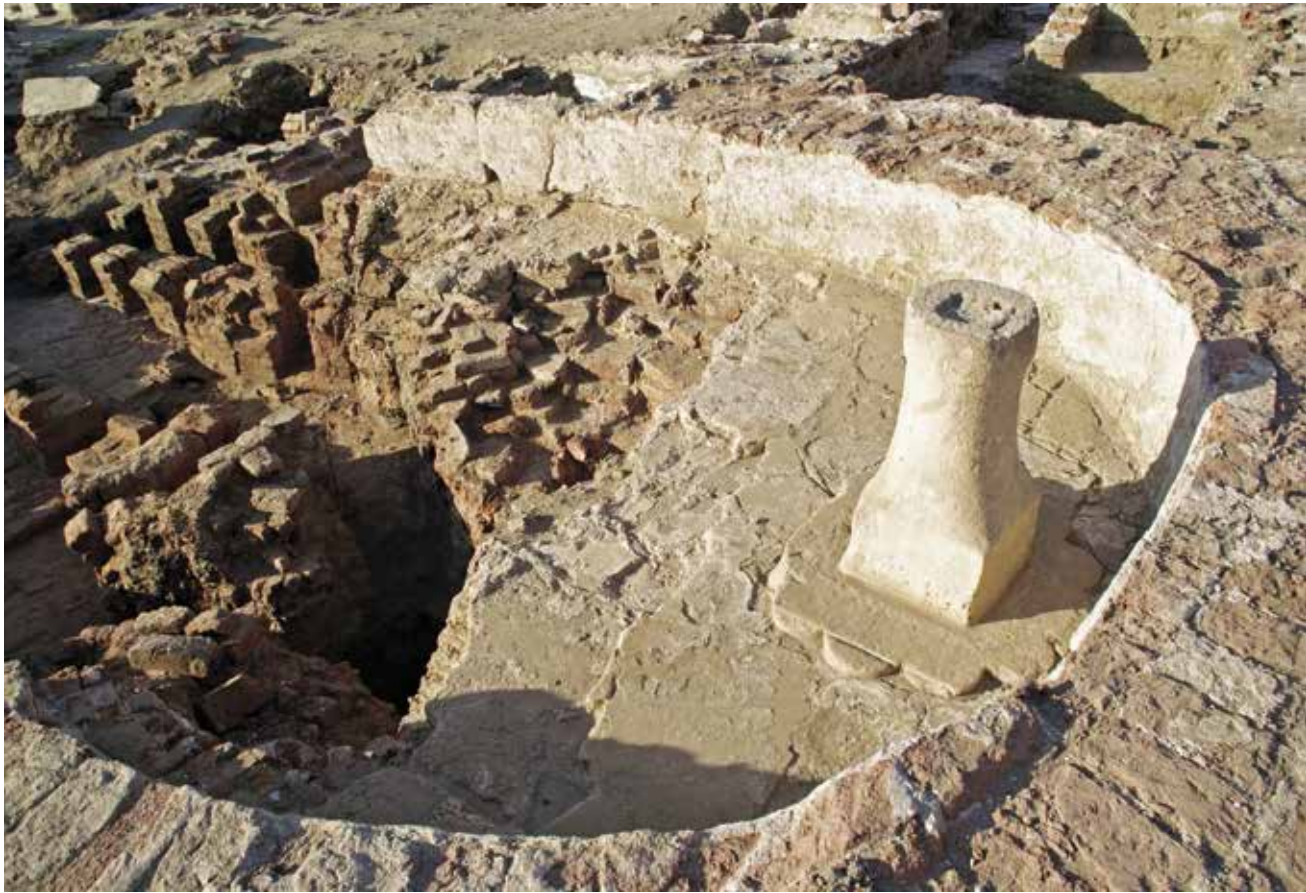
Fig. 17. View, south-eastward, of Apse 5 and the base of the *labrum* (© P. Piraud-Fournet 2012).

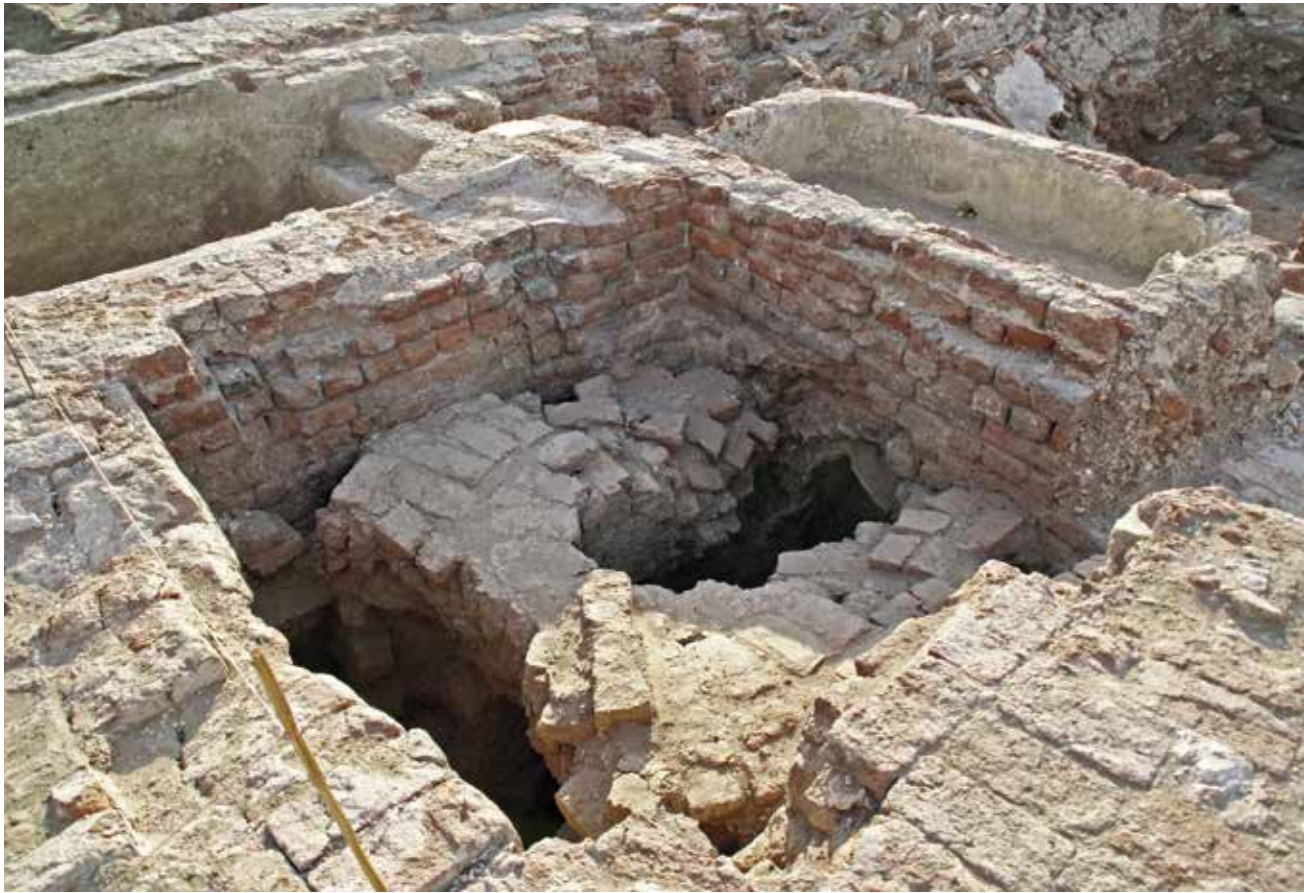
**Fig. 20.** View, north-eastward, of the structures containing Boiler 33 (© Th. Fournet 2012).

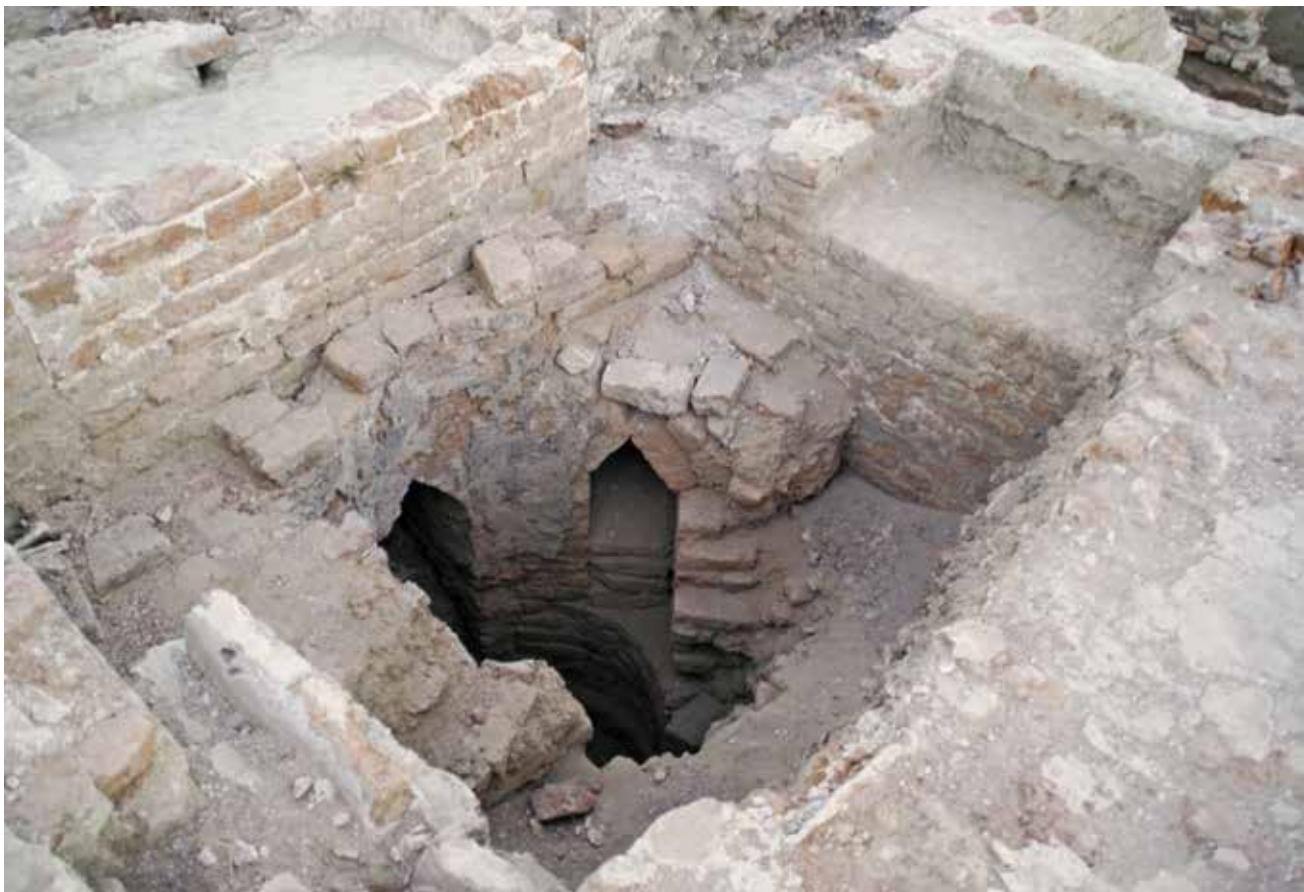
**Fig. 21.** View, south-eastward, of structures containing Boiler 13 (© P. Piraud-Fournet 2012).

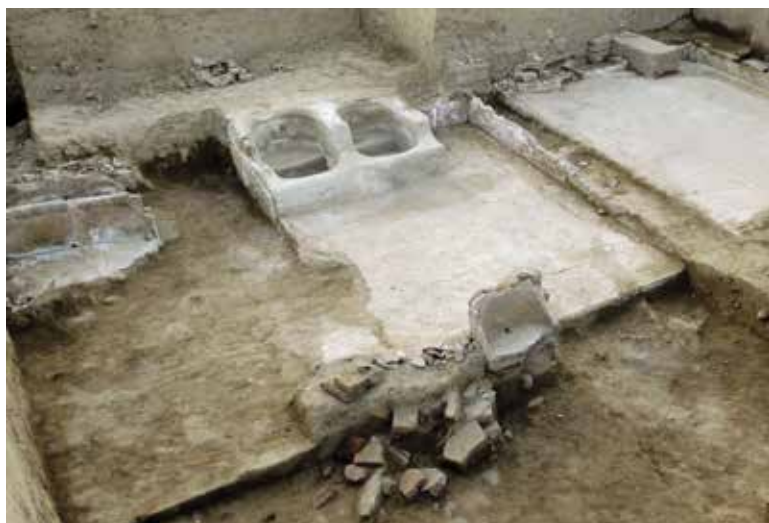
**Fig. 24.** View of the Ptolemaic bathtubs (Room 49) at the end of the excavations (© SCA, S. el-Masekh 2013), looking east.

The southern section of the baths (Latrines 18) is built about 2 m above the remains of two rooms (49 and 50) in which one can easily recognise a small Hellenistic bathroom. The north wall of Room 49 serves as the foundation of the south wall of Room 18, which presents a different technique in its construction. Further east, south-east of Room 17, a wall with a white plastered niche, certainly also belongs to this earlier construction. West and north-west of the baths, two elements seem also to be associated to an earlier phase: north-west, an L-shaped brick wall, of which two courses are visible under Tank 41, follows a different orientation from the bath. It probably belongs to a building destroyed by its construction. South-west, in the service room or Court 45, a second structure, oriented close to the first wall but probably belonging to another building, was also uncovered under the circulation level of the baths.

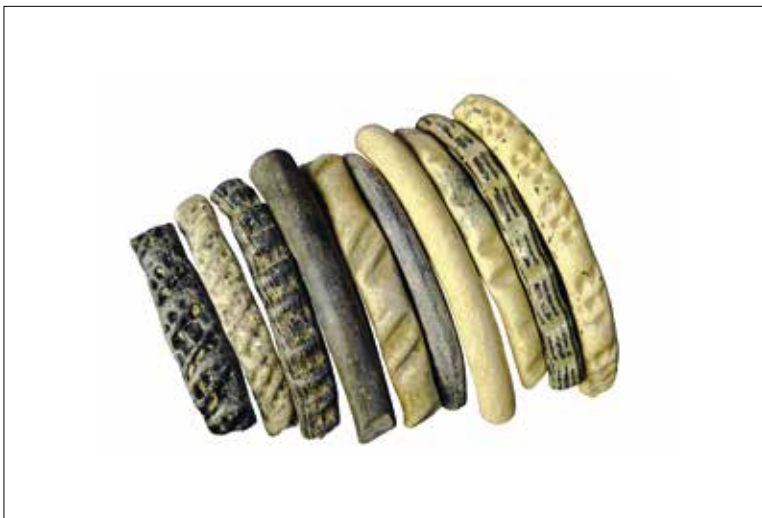
**Fig. 29.** View of the bracelets found in a pipe of the baths (© SCA 2012).

Several black glass bracelets were found in one of the pipes of the baths (fig. 29). According to Marie-Dominique Nenna, who has only seen pictures of these objects, they belong to an identifiable group of pinch decorated bracelets that dates back to the second half of the 4th century and the 5th century AD.<sup>35</sup>
