The Roman Scuttled Ships and Harbour Structures of Caska, Pag Island, Croatia in their Cultural and Historical Context

Irena Radić Rossi, Giulia Boetto

Irena Radić Rossi, Giulia Boetto. The Roman Scuttled Ships and Harbour Structures of Caska, Pag Island, Croatia in their Cultural and Historical Context. *International Journal of Nautical Archaeology*, 2020, 49 (2), pp.263-290. <10.1111/1095-9270.12428>. <halshs-02987373v1>

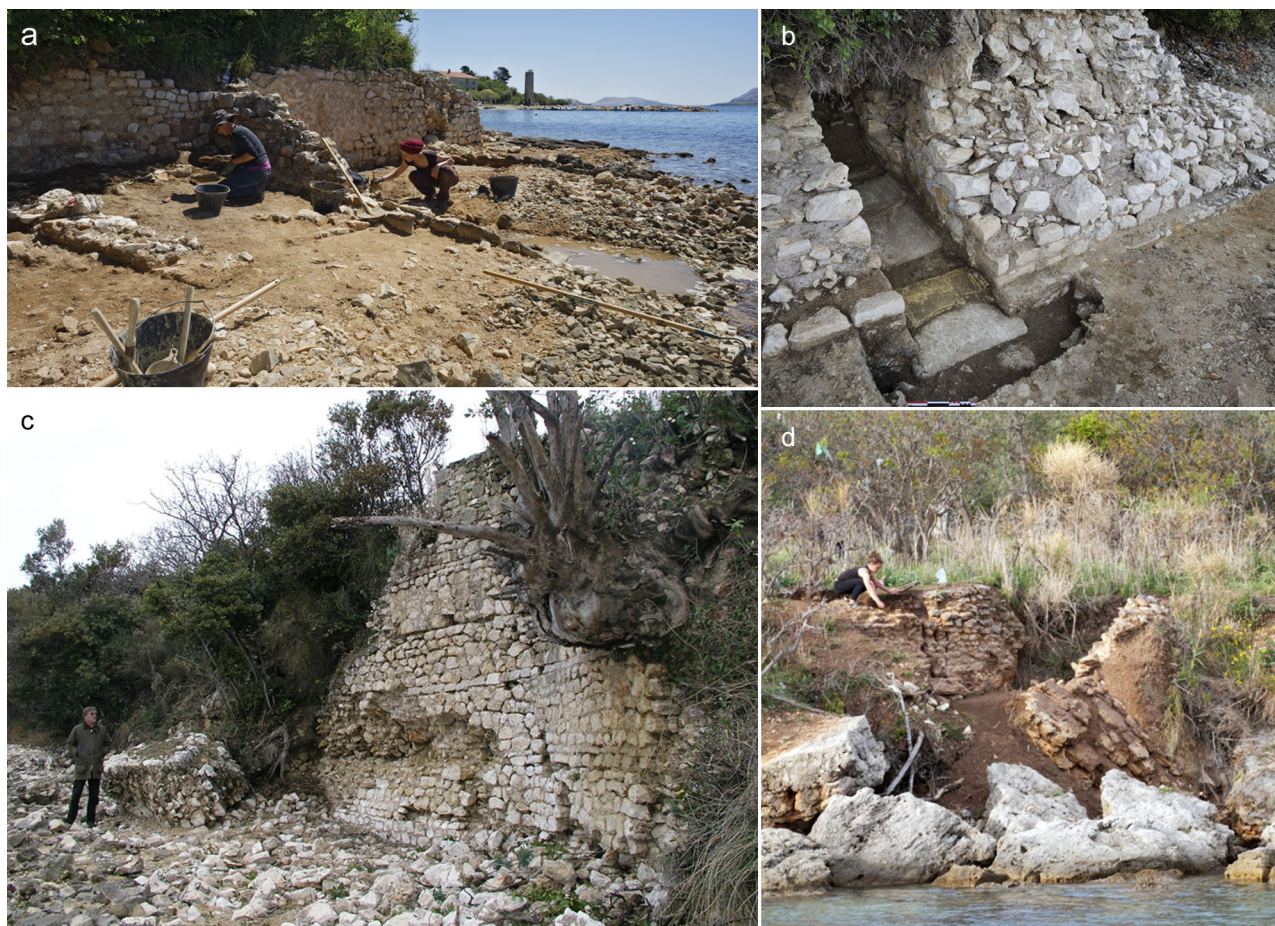
Figure 4. a) View of the structures in Sector 1 (photo Ph. Groscaux, AMU, CNRS, CCJ); b) drainage canal built through the terrace wall (photo Ph. Groscaux, AMU, CNRS, CCJ); c) fragment of the terrace wall (photo I. Radić Rossi, University of Zadar); d) buildings of unknown purpose above breccia slabs (photo Ph. Groscaux, AMU, CNRS, CCJ).

Several places on the terrace behind the wall have evidence of ancient structures, still waiting to be researched. At the point between the inlets of Mala Pošta and Pod Bužu, where the terrace wall changes orientation (Fig. 3), broken slabs of breccia testify to the consequence of its destruction (Radić Rossi and Boetto, 2013: 384). The slabs had been positioned on the flysch substrate, protected by the terrace wall, and likely served as a solid foundation for buildings of unknown function. After the terrace wall was abandoned, the flysch substrate eroded and the breccia slabs fell into the sea, taking with them any built structures (Fig. 4d).

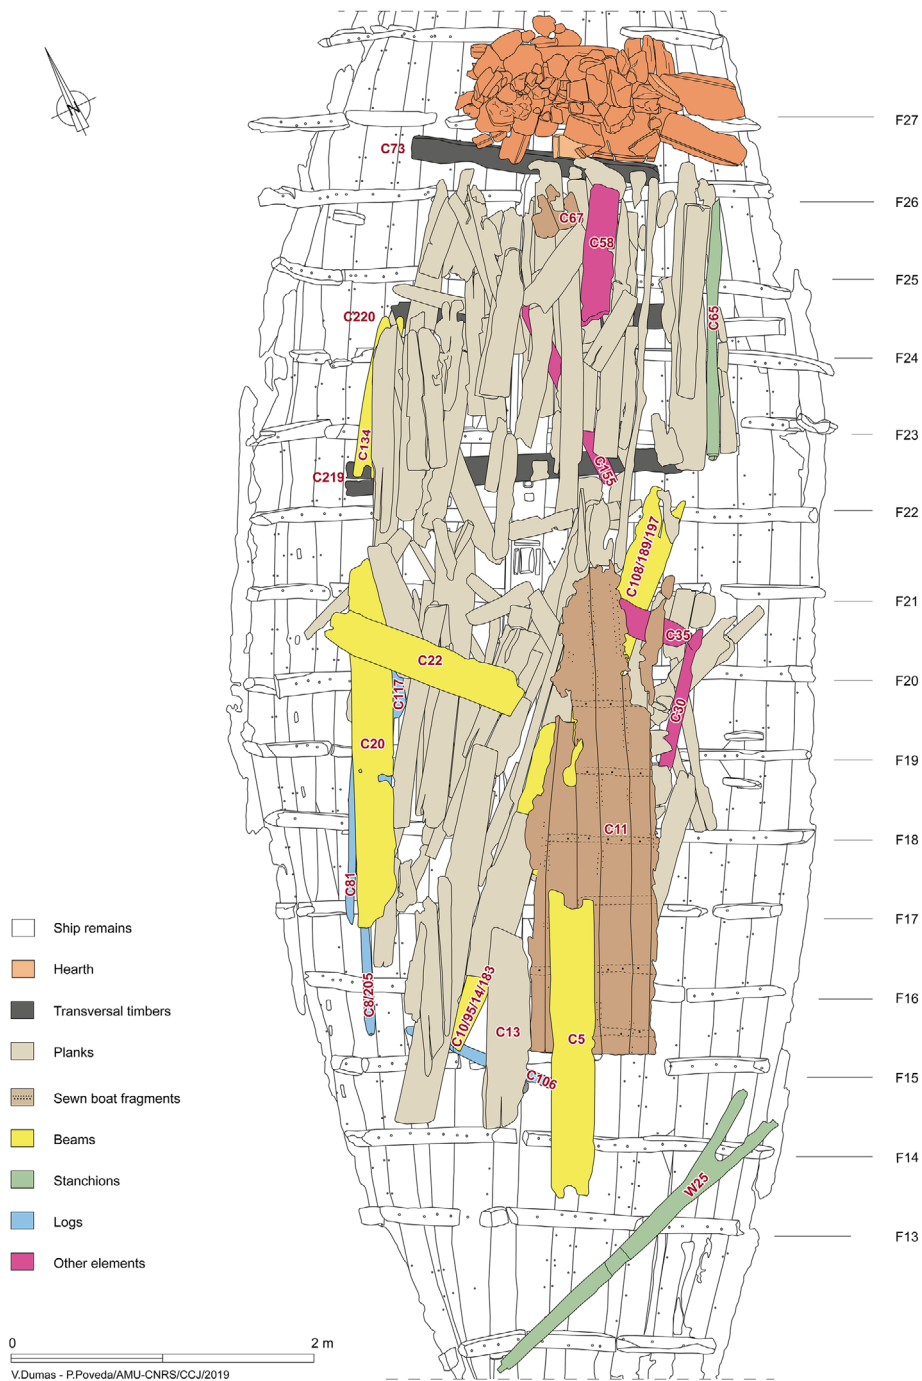
Figure 9. Wooden infill of Caska 2 (drawing P. Poveda, AMU, CNRS, CCJ).

various origin before being filled with rocks (Fig. 9), perhaps due to its greater capacity. A large piece of a sewn boat, Caska 3, was identified among this material found in the hull of Caska 2 (Fig. 10). Other items included a forked stanchion (Fig. 11a), some thwart, and several planks of fir. One timber with recesses (C30) and bearing two letters engraved with a *signaculum*, an iron or bronze instrument, is noteworthy. The letters S·V· could correspond to the initials of a *duo nomina* (Fig. 11b) but, unfortunately, such inscriptions on timbers are rare and difficult to interpret (Tran, 2014).

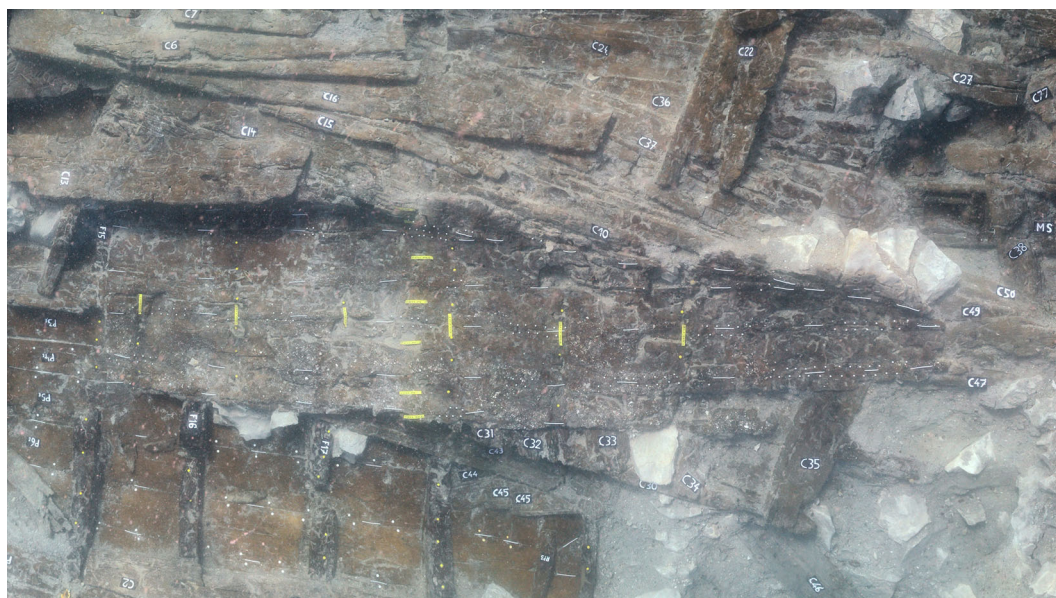
Figure 10. Fragment of sewn boat Caska 3 (photo D. Frka, University of Zadar).

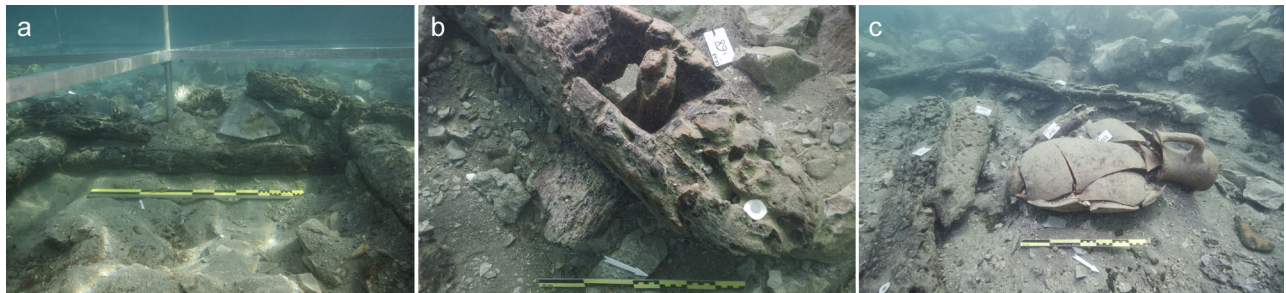
Figure 13. a) Two layers of overlapping logs of the third enclosure; b) mortise cut at the extremity of the log and the pole used to anchor the structure; c) one of the three amphoras found in Zone C (photos Ph. Groscaux, AMU, CNRS, CCJ).

L-shape (Fig. 12). Inside the structure, in the small area defined by a row of vertically driven poles, three almost complete amphoras were found (Fig. 13c). With no evident analogies among well-defined types, it seems likely they were produced in north-eastern Adriatic workshops. From the inner side of the structure described, a small accumulation of *murex* shells was also identified (diam. 1.2 m) (Fig. 12).

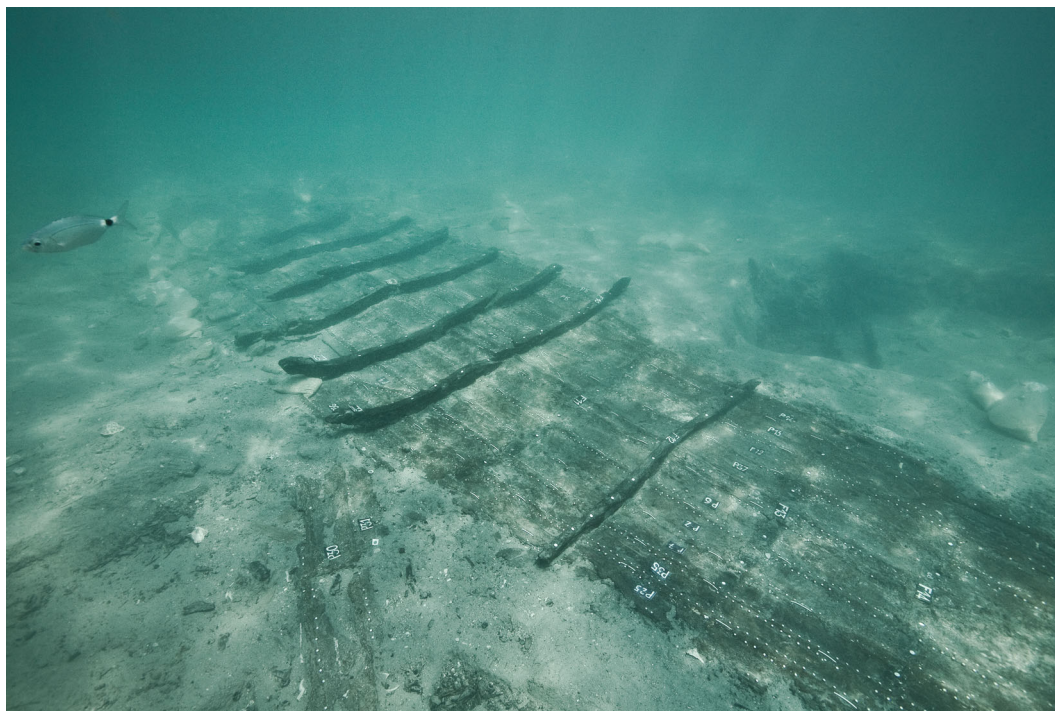
Figure 14. Caska 1 (photo L. Damelet, AMU, CNRS, CCJ).

The scuttled boat Caska 1 made up part of the pier-like wooden shoreline structure, made of two parallel rows of vertical stakes, excavated in Zone A-B (Fig. 6a). The remains of Caska 1 are 8 m long and 1.66 m wide (Figs 14 and 15a). The longitudinal profile is flat, and the transverse section at the main frame is flat with round turn of the bilge (Fig. 15b). The remains consist of the keel, six strakes on each side and seven floor-timbers. The traces of seven more floor-timbers (not preserved) were identified on the planking. Several loose pieces belonging to the boat structure were found around the ship, including a fragment of a rabbeted transitional timber (no. 27), a V-shaped floor-timber or crotch (no. 25) (Fig. 16), three frames (nos 24, 26,

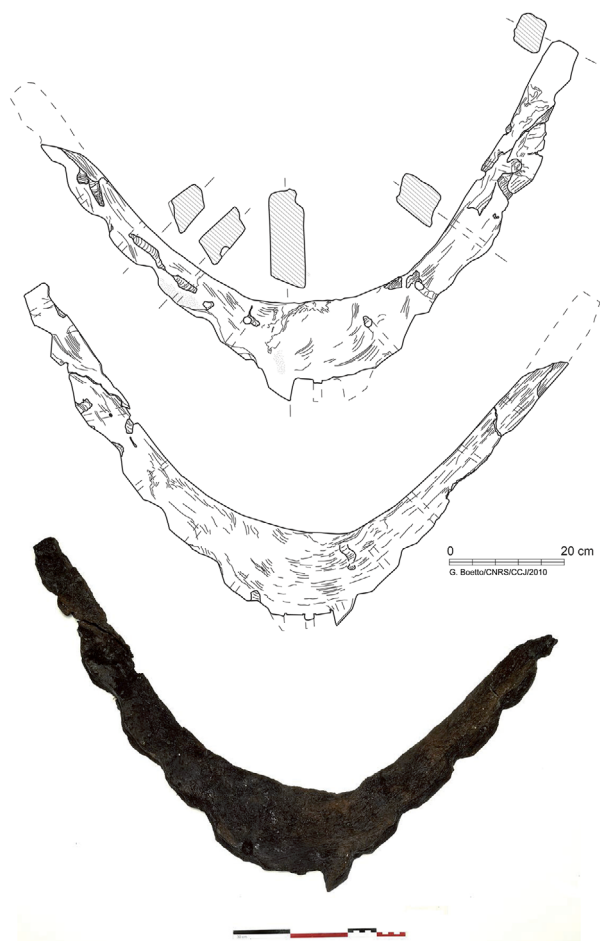
Figure 16. Caska 1: V-shaped floor-timber no. 25 (drawings G. Boetto, photo L. Damelet, AMU, CNRS, CCJ).

the boat, the lower face of the frames is notched to avoid crushing the wadding pad placed over the plank stitching (Figs 21 and 16). These recesses along the bottom of the frames are quadrangular in shape and oversized, so as to function also as limber holes. From the turn of the bilge and up the sides of the hull, the recesses are rounded or triangular in shape and rest tightly against the wadding pad.

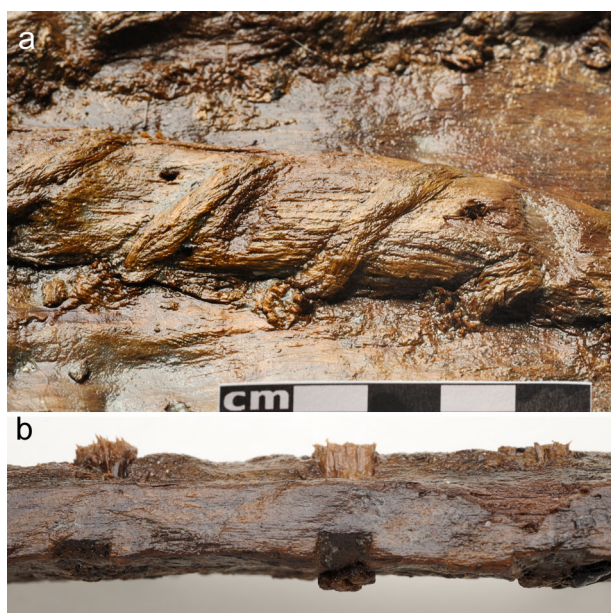
Figure 20. Caska 1: a) detail of the sewing system; b) recesses cut on the plank edges to pass and protect the stitching (photos L. Damelet, AMU, CNRS, CCJ).

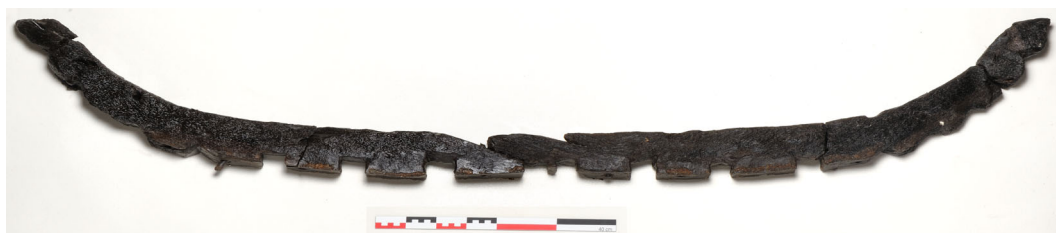
Figure 21. Caska 1: floor-timber F10 (photo L. Damelet, AMU, CNRS, CCJ).

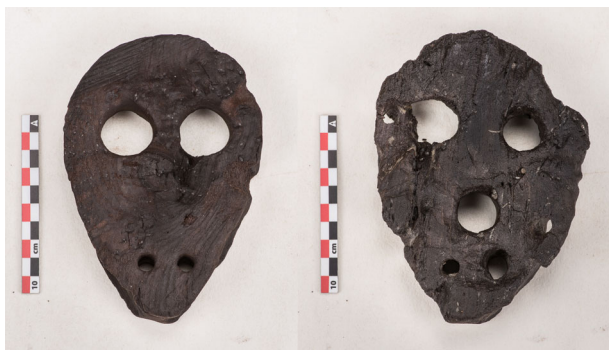
Figure 30. Caska 2: Two deadeyes, RG1 on the left and RG2 on the right (photos T. Seguin).

Finally, two drop-shaped, hard-wood deadeyes were found on the ship (Table 1). These objects served to secure the mast shrouds. The first (RG1) is pierced by two holes, while the second (RG2) has three-holes (Figs 25a and 30). The holes for lanyards are 22–30 mm, and the groove to house the shrouds is 22 mm wide and 6 mm deep. The deadeyes are also pierced by a couple of smaller holes (diam. 9 mm) for strop ropes. The blocks have the letter M incised in the upper extremity, near the small holes. This letter could indicate a set of deadeyes produced by the same maker. Comparative items come from the shipwrecks of Grado (Beltrame and Gaddi, 2005: 80, fig. 1), Laurons 2 (Ximénès and Moerman, 1990: 7–8, figs 2–3), and cape Glavat at the island of Mljet (Radić and Jurišić, 1993: 133, 135, fig. 16). These objects are also commonly found in harbours. One example from Dalmatia comes from Zaton, the harbour of Nin/Enona (Brusić and Domjan, 1985: 81, fig. 6.9).
