The Roman Scuttled Ships and Harbour Structures of Caska, Pag Island, Croatia in their Cultural and Historical Context

Irena Radić Rossi, Giulia Boetto

Irena Radić Rossi, Giulia Boetto. The Roman Scuttled Ships and Harbour Structures of Caska, Pag Island, Croatia in their Cultural and Historical Context. International Journal of Nautical Archaeology, 2020, 49 (2), pp.263-290. 10.1111/1095-9270.12428. halshs-02987373v1

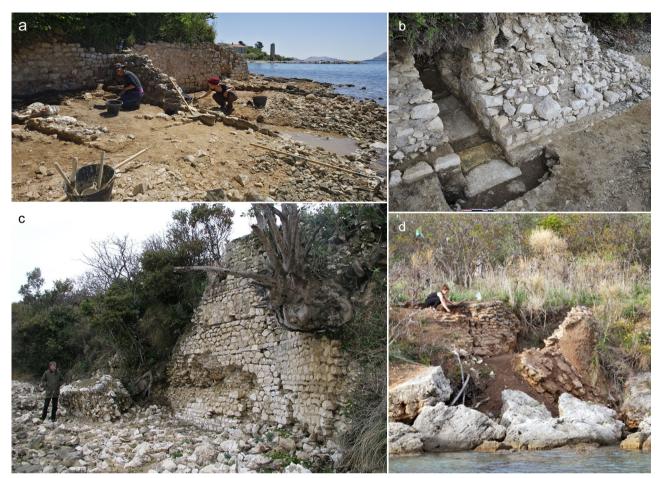
Figure 4. a) View of the structures in Sector 1 (photo Ph. Groscaux, AMU, CNRS, CCJ); b) drainage canal built through the terrace wall (photo Ph. Groscaux, AMU, CNRS, CCJ); c) fragment of the terrace wall (photo I. Radic Rossi, University of Zadar); d) buildings of unknown purpose above breccia slabs (photo Ph. Groscaux, AMU, CNRS, CCJ).

Several places on the terrace behind the wall have evidence of ancient structures, still waiting to be researched. At the point between the inlets of Mala Pošta and Pod Bužu, where the terrace wall changes orientation (Fig. 3), broken slabs of breccia testify to the consequence of its destruction (Radić Rossi and Boetto, 2013: 384). The slabs had been positioned on the flysch substrate, protected by the terrace wall, and likely served as a solid foundation for buildings of unknown function. After the terrace wall was abandoned, the flysch substrate eroded and the breccia slabs fell into the sea, taking with them any built structures (Fig. 4d).

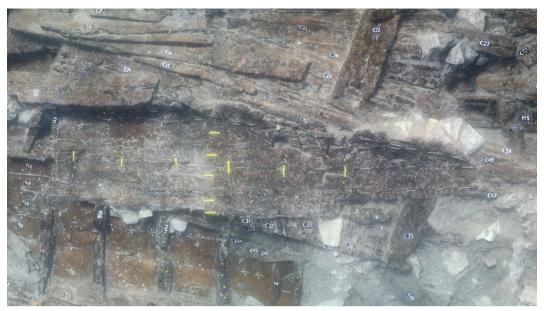
Figure 10. Fragment of sewn boat Caska 3 (photo D. Frka, University of Zadar).

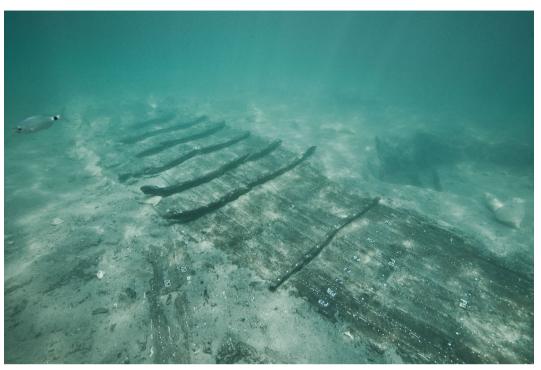
Figure 14. Caska 1 (photo L. Damelet, AMU, CNRS, CCJ).

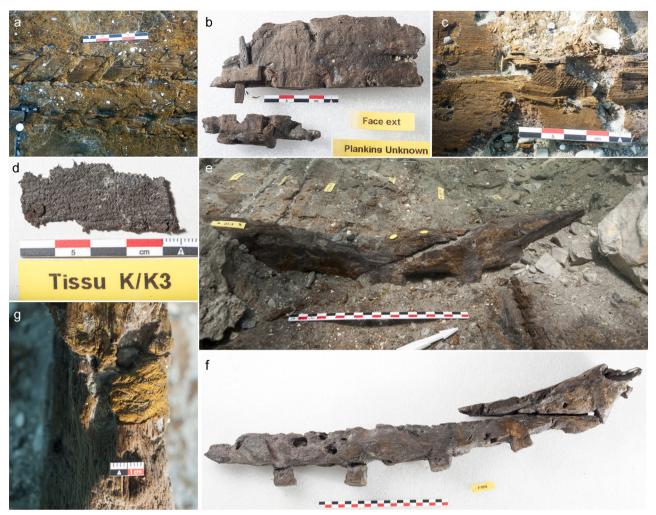
Figure 24. Caska 4: a) sewing system; b) view of the outer face of a fragment of planking P52 with a horizontal dowel; c) textile used in the seams between the southern garboard (P22, on the top) and the second strake (P19); d) textile found in the scarf joining the keel and the eastern transitional timber; e) Southern part of frame F10 from the east. The futtock (to the left) is overlapping the floor-timber and two vertical treenails (yellow pins) join the two elements; f) northern part of the frame F10 and the futtock F10N. The floor-timber has large recesses on the base; g) external lashing on the top of the frame (photos L. Roux, AMU, CNRS, CCJ).

(Fig. 24a). Only one small dowel (coak) made of beech, 0.044 m long and rectangular in section (8 \times 5 mm), was noticed in the edge of a detached fragment of plank. It probably functioned as a pre-assembly element (Fig. 24b). Pegs that lock the stitches in the channels are 7 mm in diameter, and spaced 29 mm on average. They are made not only of fir (Abies alba Mill.) as in Caska 1 and Caska 3, but also of other conifer species, such as spruce (Picea abies L.) and larch (Larix decidua Mill.). The wadding pad is made of vegetal fibres. The use of pieces of textile is also attested in some seams (Fig. 24c) and in the scarf joining the keel and the transitional eastern timber (KGE) (Fig. 24d). This characteristic could be related to repairs or to the original waterproofing system. A thick layer of pitch completed the waterproofing system of the boat.

The ship remains include seven futtocks in very bad condition, made from deciduous and evergreen oak (Fig. 23). They are rectangular, 0.04–0.05 m sided and 0.072–0.10 m moulded. The base is crenelated to avoid crushing the wadding pad. The space is 0.89 m, twice that of Caska 1 and Caska 3. Three of the frames (F10, F11, and F13) are identified as floor-timbers. They were connected to the futtocks by hook scarfs, fixed by two or three vertically driven treenails (diam. 9–10 mm) (Figs 24e and 24g).
