The Roman Scuttled Ships and Harbour Structures of Caska, Pag Island, Croatia in their Cultural and Historical Context

Irena Radić Rossi, Giulia Boetto

Irena Radić Rossi, Giulia Boetto. The Roman Scuttled Ships and Harbour Structures of Caska, Pag Island, Croatia in their Cultural and Historical Context. *International Journal of Nautical Archaeology*, 2020, 49 (2), pp.263-290. 10.1111/1095-9270.12428 . halshs-02987373v2

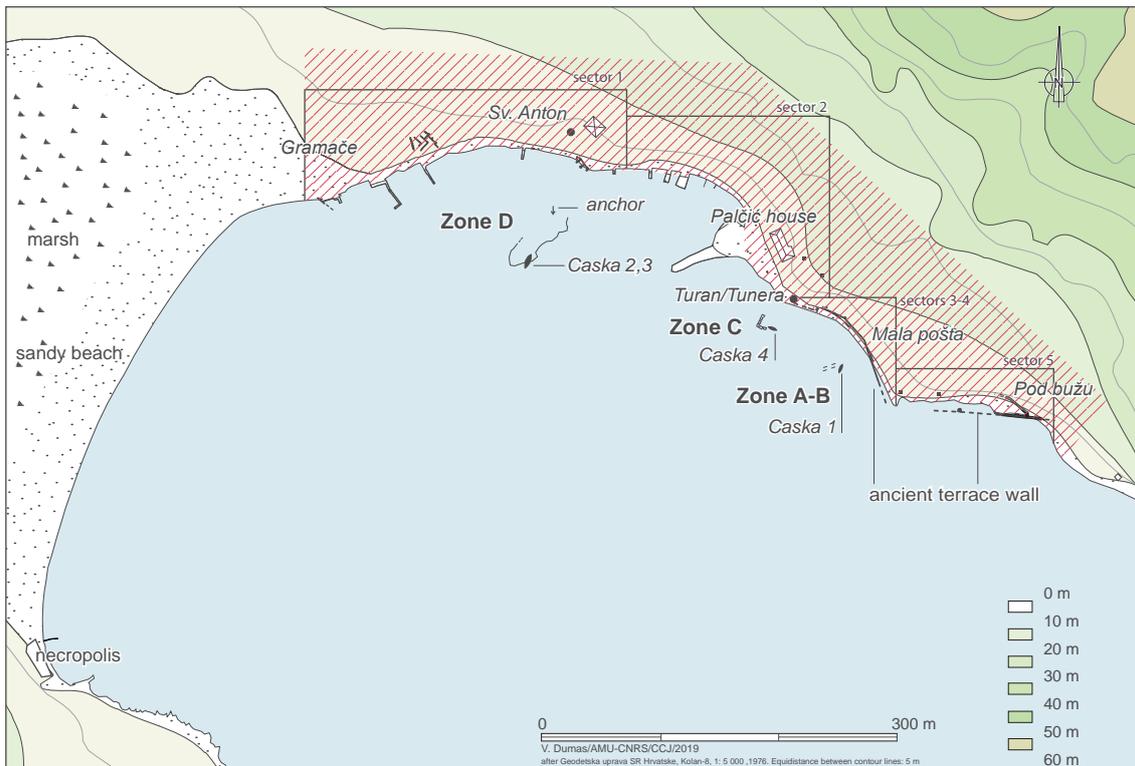
Fig. 5: Zones excavated in the Caska inlet. The red-hatched area gives an idea of the possible extension of the maritime Roman estate (drawing V. Dumas, AMU, CNRS, CCJ).

In the north-eastern part of the bay, close to Gramače (**Fig. 5**), in sector 1, the remains of the *pars rustica* of the Roman villa were excavated in two research campaigns, performed in 2005 and 2006 (Skelac, 2006, 2007; Grisonic, Stepan, 2017: 71-77). The rescue research

The first scuttled boat of Caska was discovered in 2007 in the zone A-B, and was excavated in 2009-2012 (**Figs 5 and 12**). The boat named *Caska 1* lied at the gentle slope of the seabed, at the depth of 1.5 to 2.5 m, oriented north-south, and about 20 m distant from the shore, in front of the highest preserved part of the terrace wall. The excavation trench covered the area of 184 m². Only the bottom of the hull remained in the length of 7 m, with some parts of the sides found nearby, broken and detached from the main structure. The hull was assembled by the prehistoric sewing technique (*cf. infra*) that was still in use in Roman times, probably by the local population of Liburnian origin. It was obviously scuttled in order to form a pier-like coastal structure, as it was filled with a layer of smaller rocks (10-15 cm) between the frames, covered by layer of bigger rocks (up to 50 cm) (**Figs 13**), and was associated with two parallel rows of vertically positioned poles (diameter between 4-6 cm up to 8-13 cm), about 2 m distant from each other.

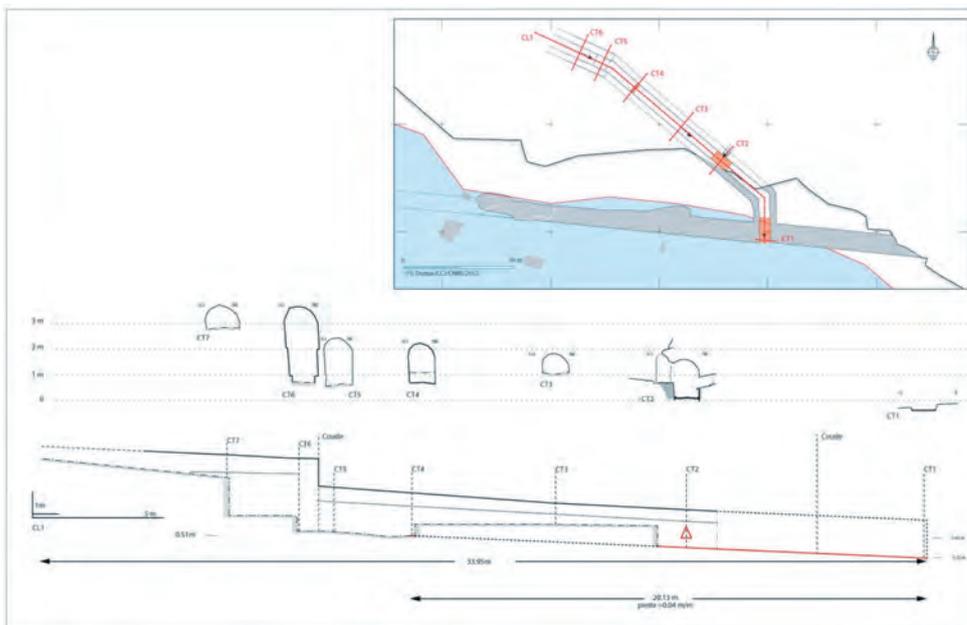
Fig. 10: Plan and cross-section of the underground canal/tunnel (drawing V. Dumas, AMU, CNRS)

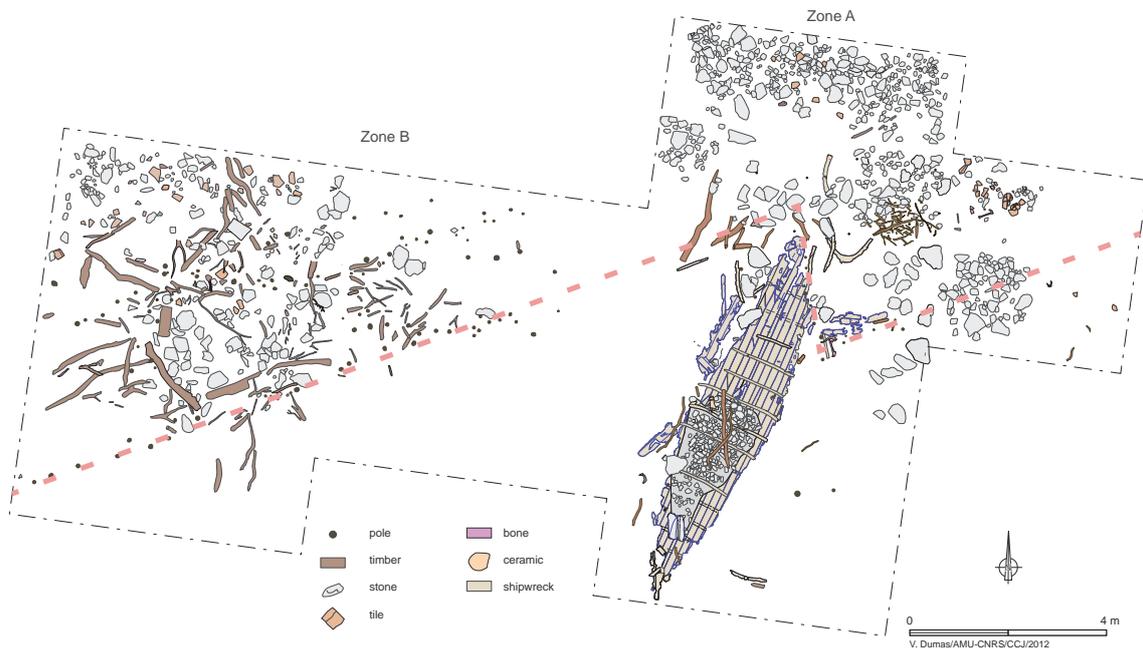
Fig. 12: The zone A-B with the scuttled sewn boat Caska 1 (drawing V. Dumas, AMU, CNRS, CCJ).

As previously explained, the scuttled boat named *Caska I* made part of the pier-like wooden coastal structure, made of two parallel rows of vertically positioned poles, excavated in zone A-B (**Fig. 12**). *Caska I* was 8 m long and 1.66 m wide (**Figs 24 and 25**). The longitudinal section was flat and the transverse section at the main frame was flat, with round turn of the bilge (**Fig. 26**). The remains consisted of keel, six strakes on each side and seven floor-timbers. The traces of seven more floor-timbers (not conserved) were identified on the planking. Several loose pieces, belonging to the boat structure, were found around the shipwreck, including a fragment of rabbeted transitional timber (n° 27), a V-shape floor-timber or crotche (n° 25), three frames (n° 24, 26 and 946), three futtocks with worked upper ends (n° 15, 78 and 324) and a probable small fragment of sheer strake (n° 93).

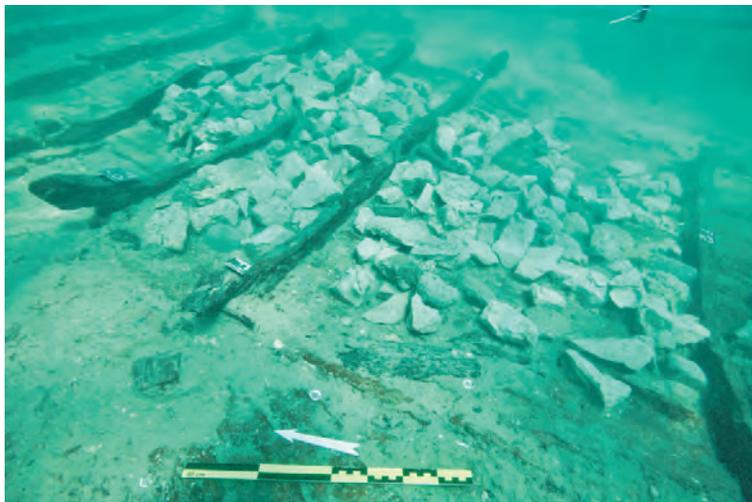
Fig. 13: The layer of small stones covering the bottom of Caska 1 (photo L. Damelet, AMU, CNRS, CCJ).

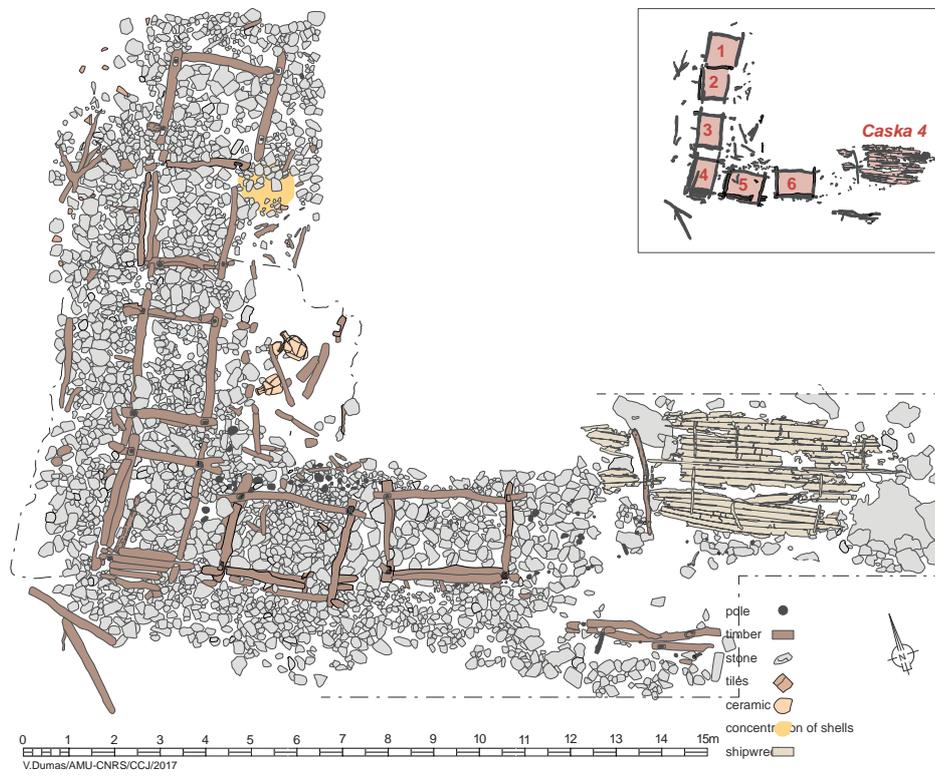
Fig. 20: The zone C and the scuttled sewn boat Caska 4 (drawing V. Dumas, AMU, CNRS, CCJ).

12 meters. The southernmost enclosure is flanked to the east side by two more enclosures of the length of 8.8 m, in the shape of letter L (**Fig. 20**). Inside the structure, in the small area defined by a row of vertically driven poles, three almost complete amphorae were found (**Fig. 23**). With no evident analogies among the well-defined types, it seems that they were produced in some of the north-eastern Adriatic workshops.

The boat *Caska 4* was found at the south-eastern edge of the structure excavated in zone C. It consisted of rectangular enclosures made of logs, poles, freely positioned logs, scuttled boat and bedrock, which formed the rectangular operative platform (Fig. 22). The remains of *Caska 4* were 7 m long and 3 m wide (**Figs 20 and 35**). As in *Caska 1* and *Caska 3*, the sailing direction of the boat remains unknown. The structures were also particularly distorted and fragmented due to the weight of the stone filling, and heavily rotted by the xylophages. The remains consisted of the keel, ten strakes on the northern side, eleven strakes on the southern side, and elements of six frame stations.

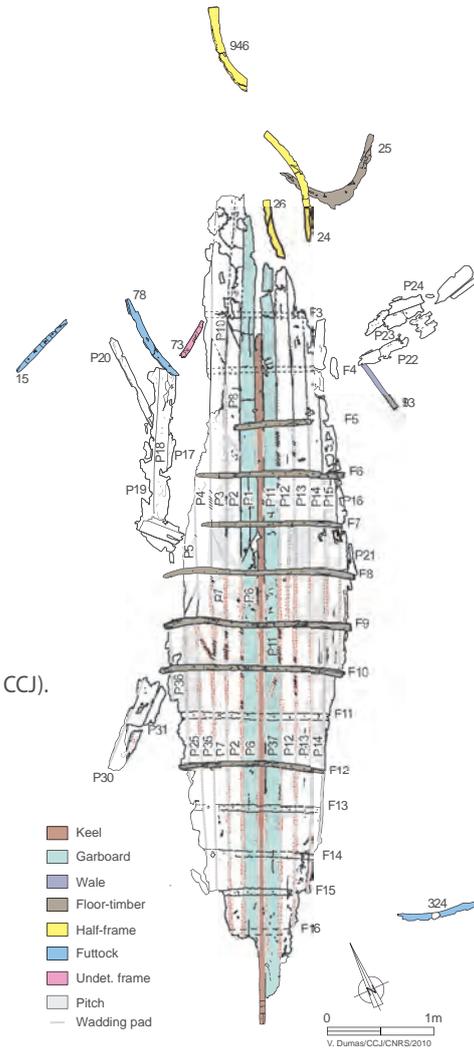
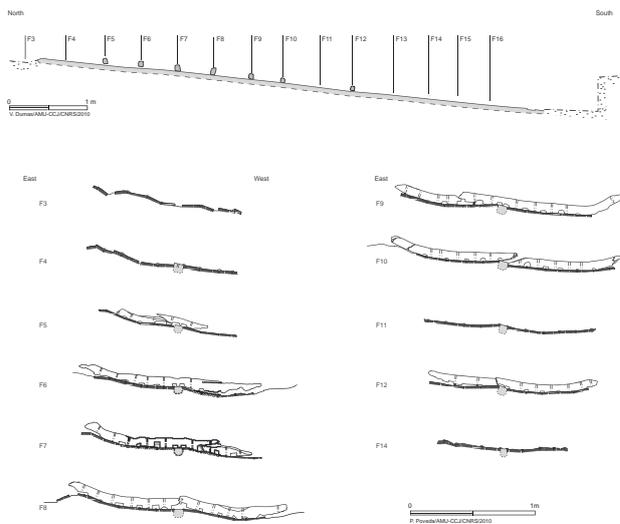
Fig. 26: Longitudinal and cross sections of Caska 1 (drawings V. Dumas & P. Poveda, AMU, CNRS, CCJ).

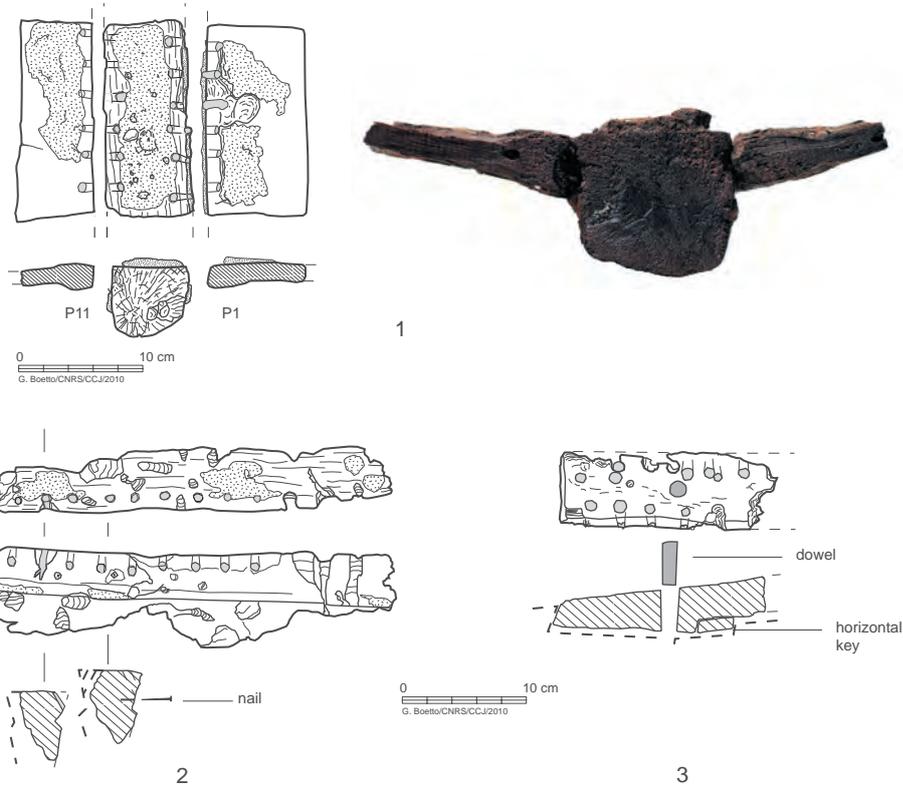
Fig. 27: The axial carpentry: 1. Section of the keel and garboards P1 and P11;
 2. Fragment of transitional timber with rabbets 27;
 3. The northern scarf in the transitional timber 52-54;
 4. The southern scarf on the keel (drawings G. Boetto; photo L. Damelet, AMU, CNRS, CCJ).

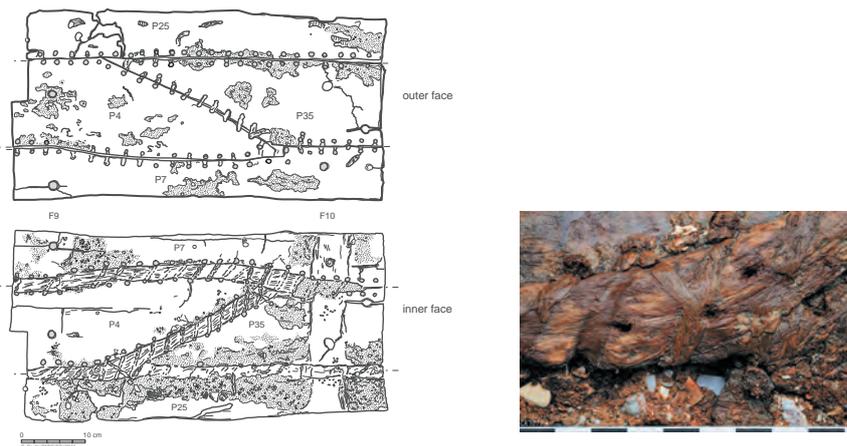
Fig. 28: The sewing pattern (drawing G. Boetto; photo L. Damelet, AMU, CNRS, CCJ).

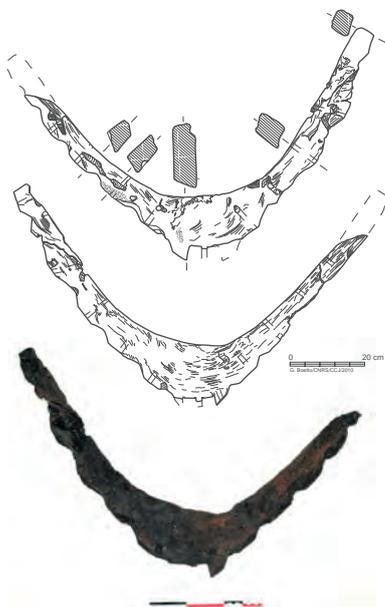
Fig. 32: V-shaped floor-timber (crotche) n° 25 (drawing G. Boetto, photo L. Damelet, AMU, CNRS, CCJ).

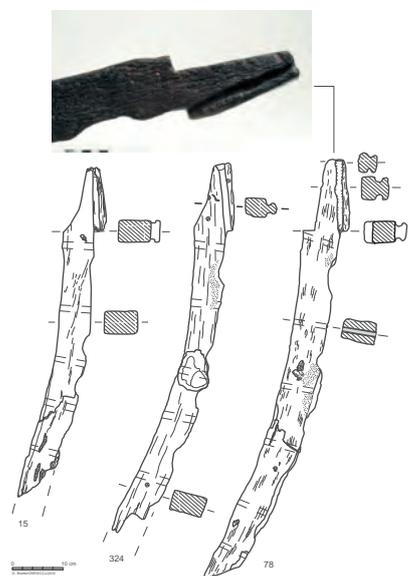
Fig. 33: The three worked futtocks (n° 15, 78 and 324) (drawings G. Boetto, photo L. Damelet, AMU, CNRS, CCJ).

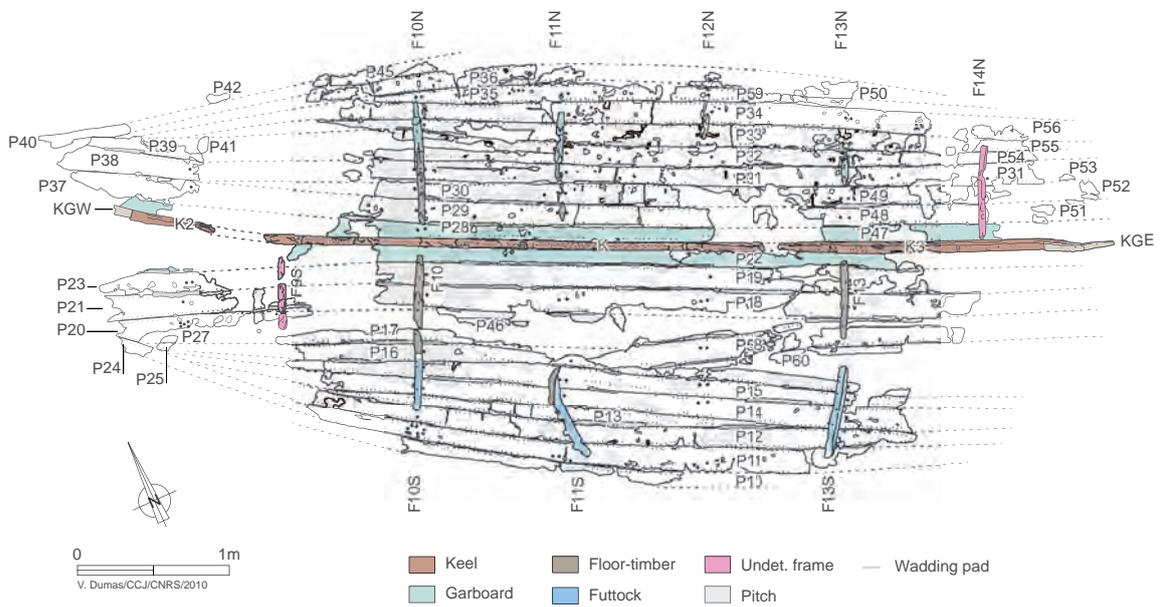
Fig. 35: Plan of the shipwreck Caska 4 (drawing V. Dumas, AMU, CNRS, CCJ).

The shipwreck conserved seven futtocks in very bad conditions, made from deciduous and evergreen oak (**Fig. 35**). They were rectangular, 4-5 cm sided and 7.2-10 cm moulded. The base was crenelated to avoid crushing of the wadding pad. The space was 89 cm, twice the value measured on *Caska 1* and *Caska 3*. Three of the frames (F10, F11 and F13) could have been identified as floor-timbers. They were connected to the futtocks by hook scarf, fixed by two or three vertically driven treenails (diam. 9-10 mm) (**Figs 40 and 41**).

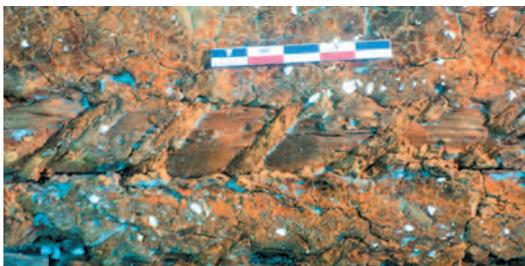
Fig. 36: The sewing system (photo L. Roux, AMU, CNRS, CCJ).

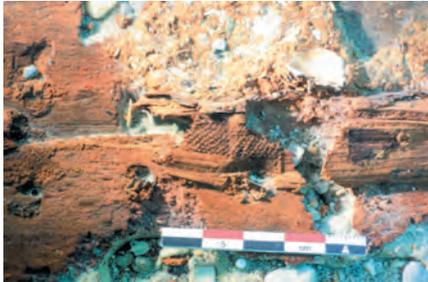
Fig. 38: Textile used in the seams between the southern garboard (P22, on the top) and the second strake (P19) (photo L. Roux, AMU, CNRS, CCJ).

and larch (*Larix decidua* Mill.). The wadding pad was made by using vegetal fibres. The use of pieces of textile was also attested in some seams (**Fig. 38**) and in the scarf joining the keel and the transitional eastern timber (KGE) (**Fig. 39**). This characteristic could be related to ancient repairs, but also to the original waterproofing system. A thick layer of pitch completed the waterproofing system of the boat.

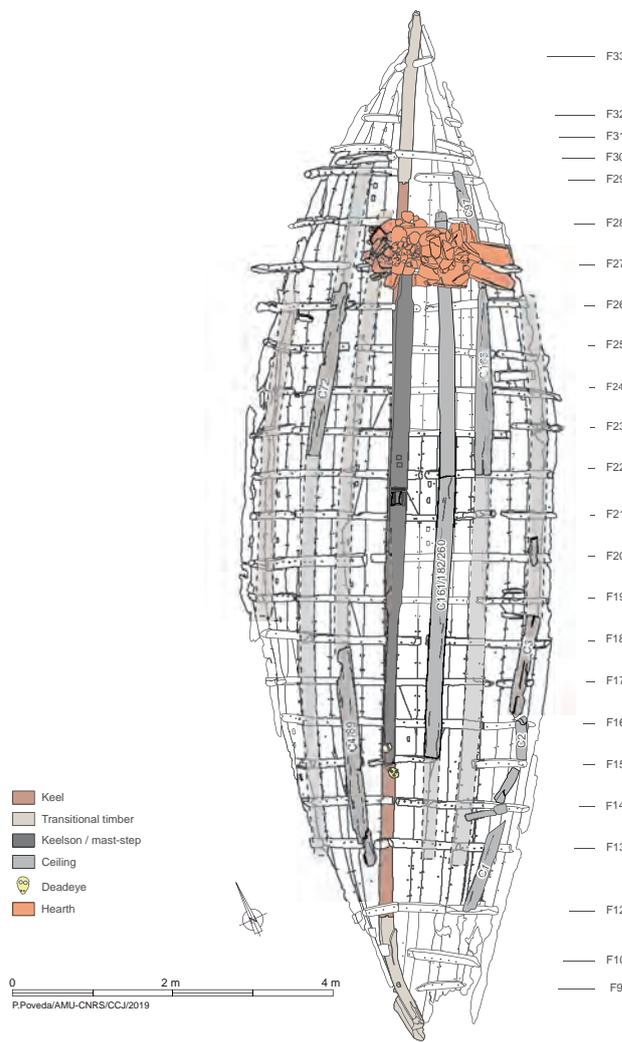
Fig. 43: Plan of the shipwreck Caska 2 (drawing P. Poveda, AMU, CNRS, CCJ).

The scuttled ship *Caska 2* made part of the large breakwater in zone D, reinforcing its most exposed south-eastern end (Fig. 16). The remains of *Caska 2* were 13 m long and 4 m wide (**Fig. 43**). The ship rested on its starboard side (east). The transverse section at the main frame was flat, with round turn of the bilge (**Fig. 44**). The longitudinal section was flat, with convex extremities (**Figs 45**). The remains consisted of the keel, nine strakes on each side (the ninth strake was the lower wale), twenty-four frames, keelson/mast-step and some stringers. Two deadeyes were also found near the aft extremity of the keelson. A noteworthy find was a hearth used for cooking, situated in the bow (**Figs 43 and 46**).

The hearth was situated above the keelson/mast-step, between frames F27 and F28 in the bow area of the ship (Figs 43 and 55-57). It was not on the centreline of the ship; it was located instead toward the starboard side. It was 70 cm wide and 1.70 m long. A layer of planks was arranged as a foundation for its construction. Three planks (H1, H2/8, H3) crossed the keelson/mast-step and the first starboard stringer (C161/182/260), and three others (H5, H6, H7) were placed longitudinally between the first and second starboard stringers (C97) and between F27E and F28E. Some stones were intentionally situated under these planks to wedge the structure. Above the planks there was a layer of mortar and a layer brick. A tile flanked the hearth on the starboard side. All these elements had traces of fire.

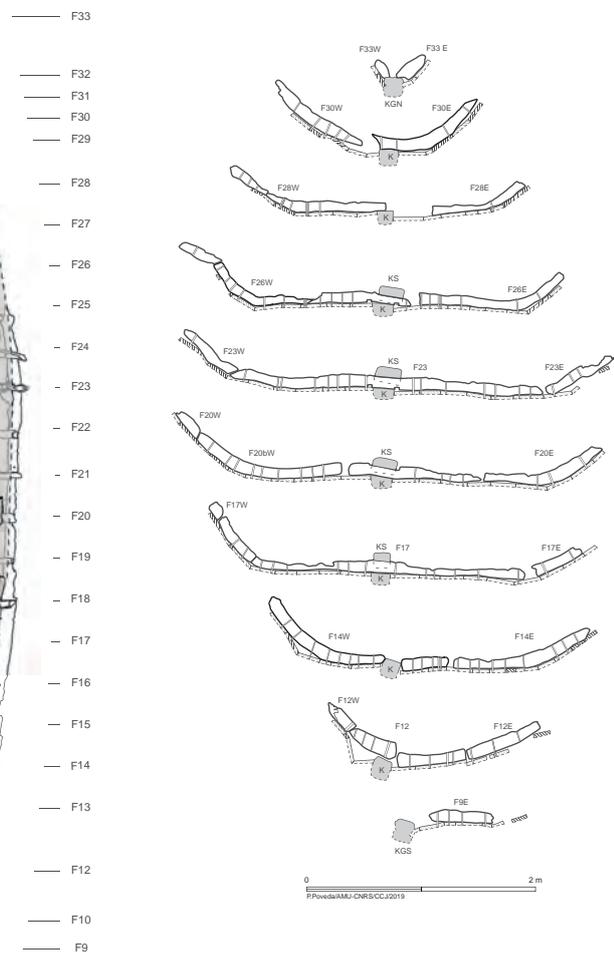
Fig. 44: Cross-sections of Caska 2 (drawing P. Poveda, AMU, CNRS, CCJ).

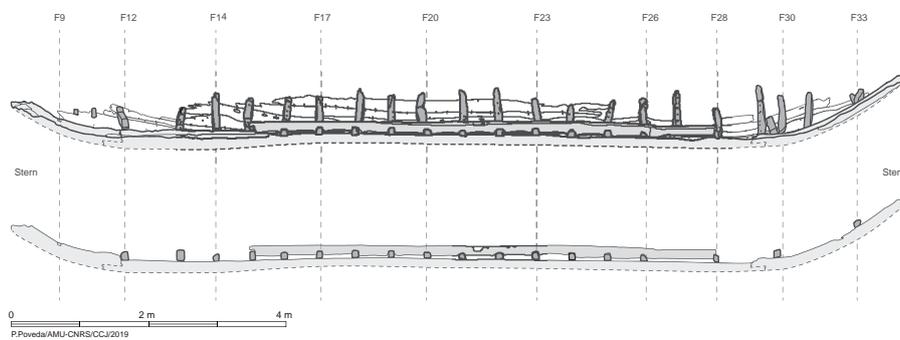
Fig. 45: Longitudinal sections of Caska 2 (drawing P. Poveda, AMU, CNRS, CCJ).

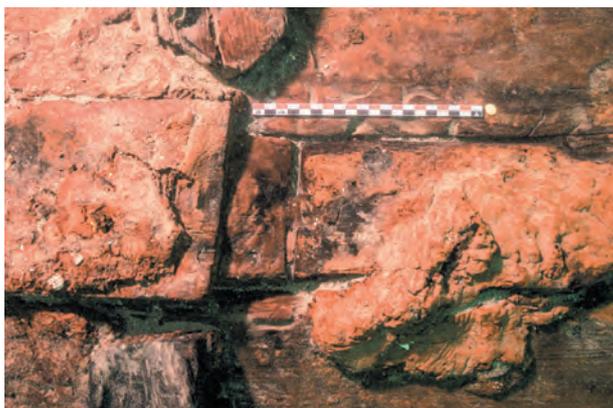
Fig. 48: Scarf between the keel (right) and the stem transitional timber (left). Note the yellow pitch covering the hull (photo T. Seguin).

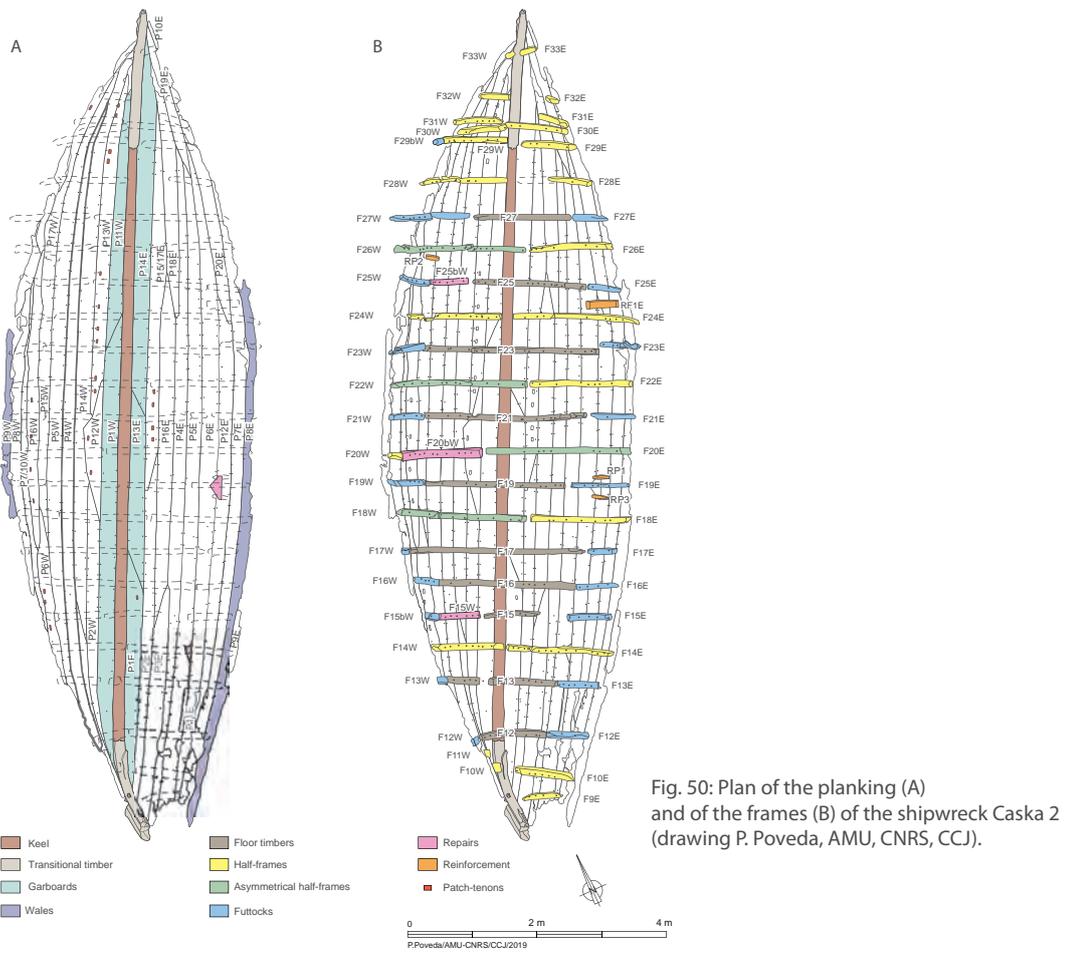
Fig. 50: Plan of the planking (A) and of the frames (B) of the shipwreck Caska 2 (drawing P. Poveda, AMU, CNRS, CCJ).

Twenty-four frames survived, mostly made of evergreen oak, on average 8.6 cm sided and 9.6 cm moulded, with room-and-space of 47 cm (**Fig 50B**). They were not connected to the keel. The frames were connected to the planking by evergreen oak trenails (1.7 cm average internal diameter, average space centre-to-centre 12 cm). No nails were found, but the outer side of the planking wasn't excavated. The general framing pattern was of alternating floor-timbers, extended by futtocks but without fastenings between, and half-frames. Some half-frames overlapped amidships, with one extremity crossing the keel, so that the butt joints of the two half-frames projected beyond the central axis. Consecutive sequences of half-frames were noticed at the extremities, where the shapes of the ship narrow. Sequences of floor-timbers and overlapped half-frames were used at the level of keelson/mast step, thus reinforcing the hull (**Fig. 50B**). The frames were perforated by limber holes 3.5-4.5 cm wide, 2-5.4 cm high, and situated laterally to the keel (**Fig. 52**). As the planking, the frames of the port side were repaired (**Fig. 50B**).

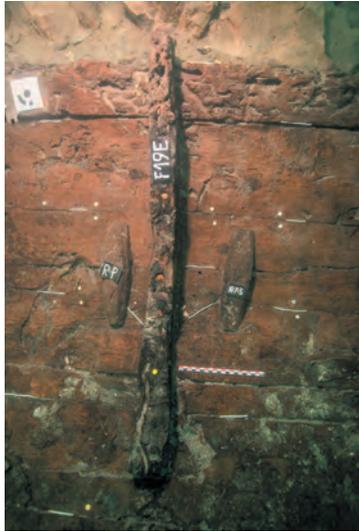
Fig. 51: Tackles on the port side (photo T. Seguin).

Several planks were repaired with patch tenons, and the rectangular and irregularly spaced openings to insert them were recorded only on the internal face of the planks. It is probable that the planking was also repaired using planks simply nailed to the frames but, due to the impossibility to observe the outer side of hull, this assumption is based mainly on the presence of small planks, as observed in the shipwreck Napoli A (Italy, 1st c. CE, Boetto and Poveda, 2018). These planks are associated to tackles of various shapes and dimensions nailed as internal reinforcements (**Fig. 51**).

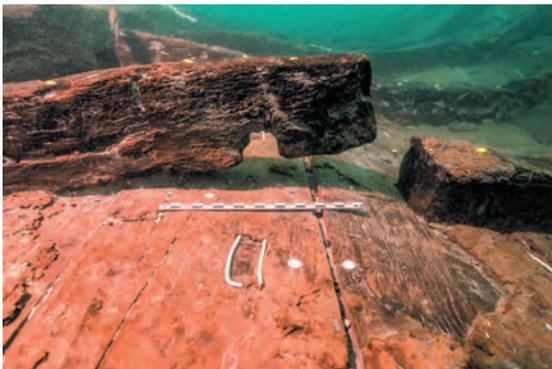
Fig. 52: Limber-hole on a half-frame. The white wire indicates the position of a patch-tenon on the garboard (photo T. Seguin).

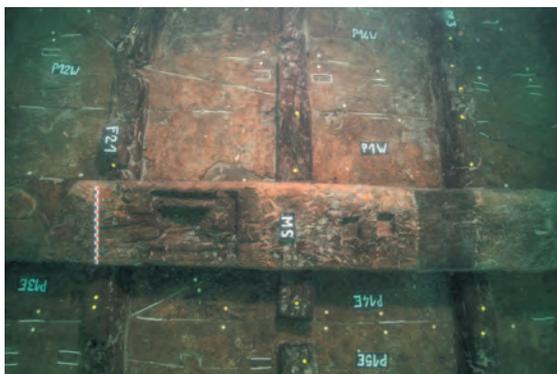
Fig. 53: The mast step and the others recesses for stanchions on the keelson/mast step (photo T. Seguin).

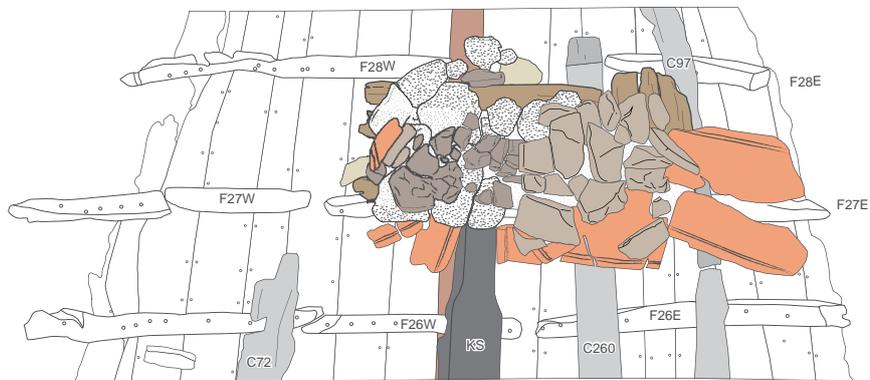
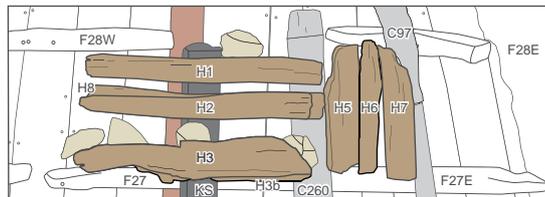
- Keel
- Keelson / mast-step
- Ceiling
- Stones
- Hearth floor
- Mortar
- Tiles
- Bricks
- Burned bricks

Fig. 56: The heart (drawing P. Poveda, AMU, CNRS, CCJ).

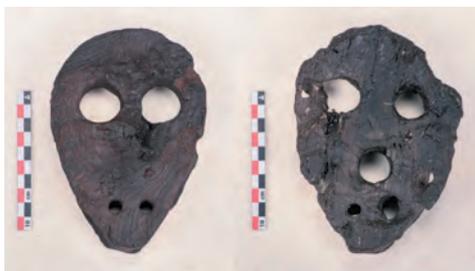
Fig. 58: The two deadeyes, RG1 on the left and RG2 on the right (photos T. Seguin).

Finally, the two deadeyes found on the shipwreck consisted in drop-shaped tablets of hard wood. These objects served to secure the shrouds of the mast of the ship. The first one (RG1) was pierced by two holes set alongside one another, while the second one (RG2) was three-holed (Figs 43, 58 and 59). The holes for lanyards were 2.2-3 cm, and the groove to house the shrouds were 2.2 cm wide and 0.6 cm deep. The deadeyes were also pierced by a couple of smaller holes (diam. 0.9 cm) for strop ropes. The blocks had the letter M incised in the upper extremity, near the small holes. This letter could indicate a set of deadeyes produced by the same maker. Comparative items come from the shipwrecks of Grado (Beltrame and Gaddi, 2005: 80, fig. 1) Laurons 2 (Ximénès and Moerman, 1990: 7-8, figs 2-3), and cape Glavat at the island of Mljet (Radić and Jurišić, 1993: 133, 135, fig. 16). These findings are also commonly found in harbours. One example from Dalmatia comes from Zaton, harbour of Nin/*Enona* (Brusić and Domjan, 1985: 81, fig. 6.9).
