**The Qalhât Project - Preliminary report on the second  
season of excavations of the French mission  
(1/11-16/12/2009)**

Preliminary report on the second season of excavations  
of the French mission  
(1/11-16/12/2009)

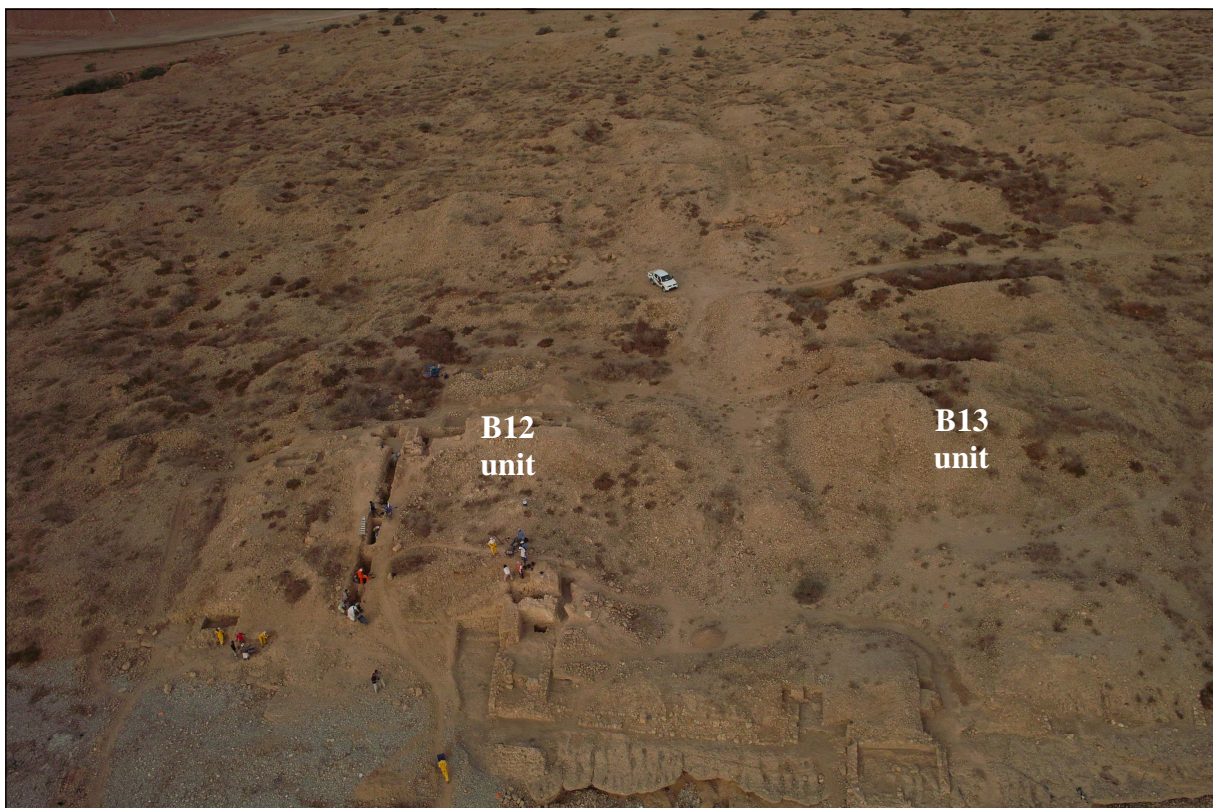
Oblique kite photograph of the B12-B13 complex

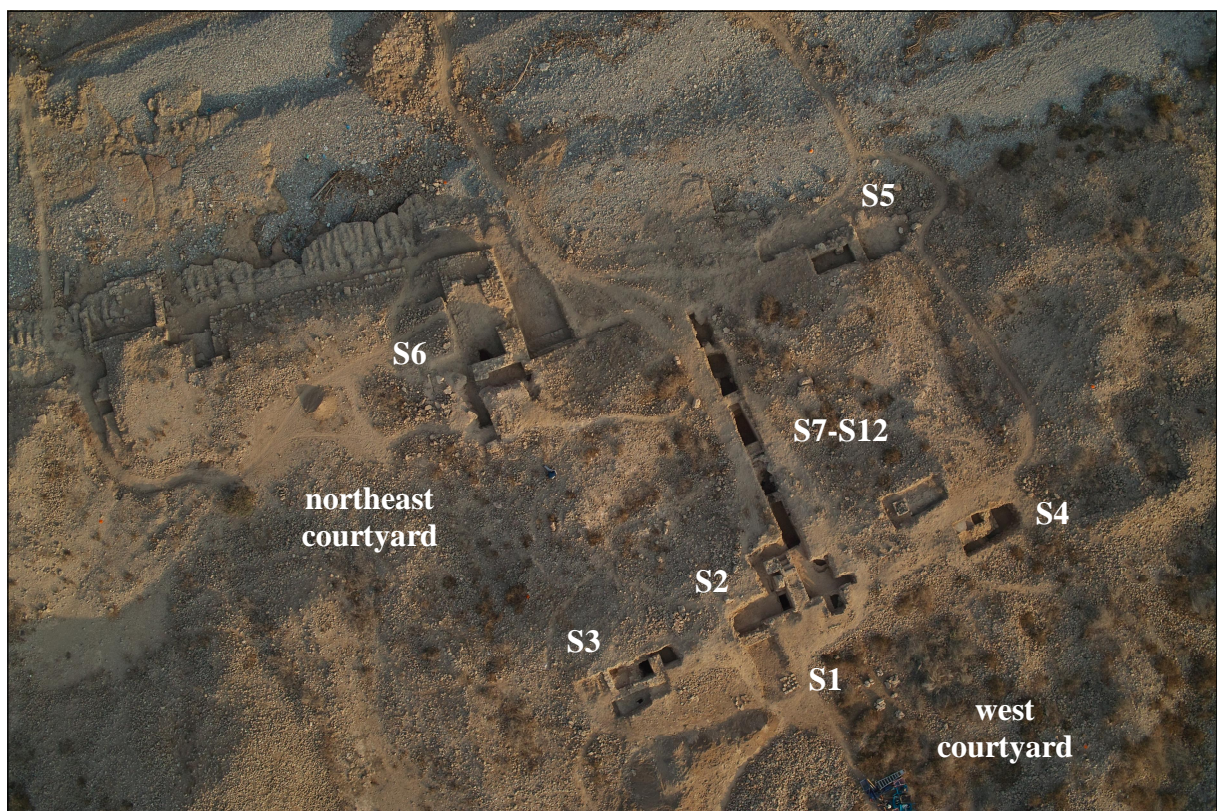
**Vertical kite photograph of the mosque (B12) unit, with the location of the main soundings**

Several wide soundings were dug this year in this area. Four were located in the northwest (S3), southwest (S4), southeast (S5) and northeast (S6) corners, to check the general dimensions and plan of the building, the levels of the floors inside, and the surroundings. Another one was made under the floor of the mosque, near the 2008 stratigraphical excavation on the other side of the *qibla* wall, to complete the study of the foundations (S2). And a long west-east trench, 1.5m large and 25m long, was opened across the mosque from the *mihrab* down to the sea (S7-12), to check the inside plan and the chronological evolution of the building.

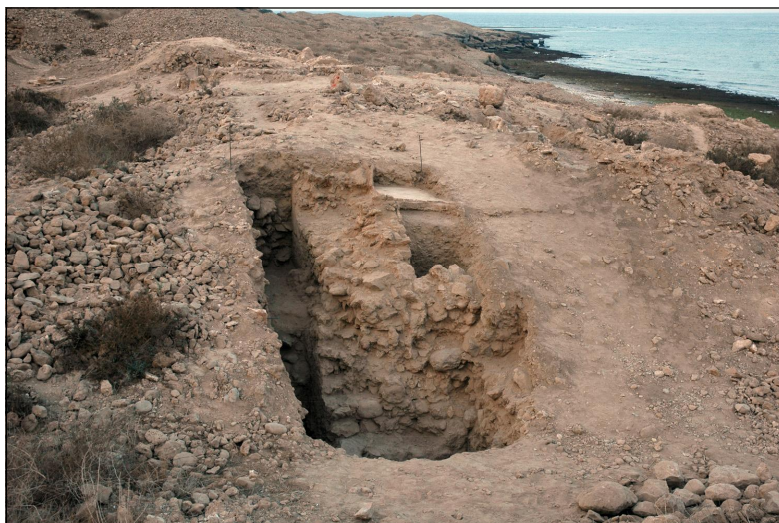
**The eroded sw corner of the basement seen from the south street, with the inside white floor up.**

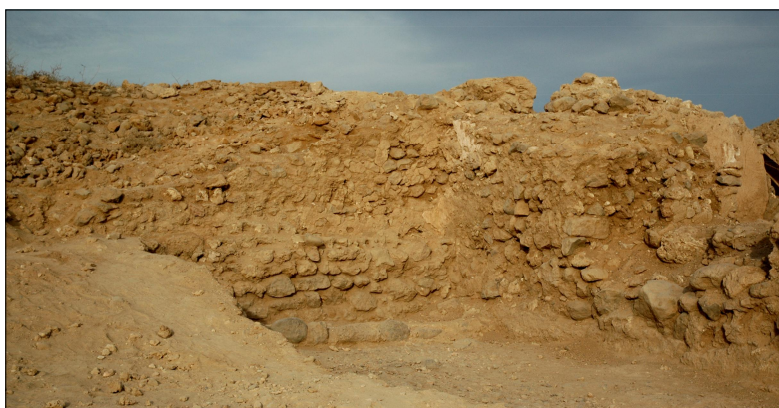
**The angle of the eastern facade of the basement, on the sea, with the corner structure**

basement, protruding on about 9m beyond the façade on the seaside. First a low massif was built to the east on the seaside, to level the surface of the bedrock of the beach, at about  $\Delta 11.10$ . On this foundation was erected a structure with a floor at around  $\Delta 11.30$ , accessible from the south, near the corner with the facade wall of the mosque, through a wide door 1.80m large. After some time of occupation this structure was levelled and the door blocked, to build a terrace with an earth floor based on a layer of pebbles, at level  $\Delta 12.30$ . In the same time a rectangular structure 3m large and more than 6m long was built against the corner of the basement. The inside was completely filled with collapsed fragments of walls and the floor could not be reached. This room had two openings, a door 1.4m wide giving access to the inside of the basement on the southern side, and a gate 2.30m wide opening northwards onto the exterior. West of this passage, a cubic masonry fills the western part of the room, maybe the base for a staircase.

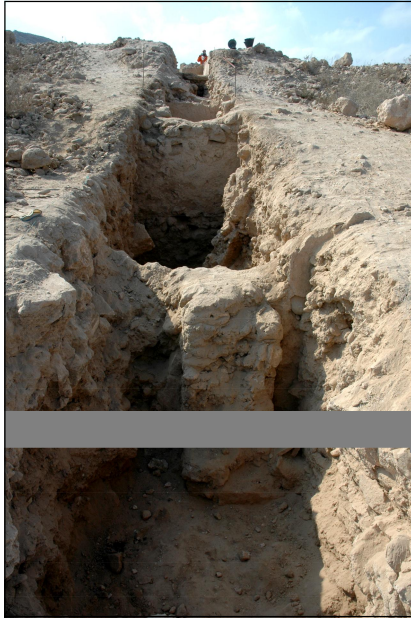
**The trench, seen from the sea side**

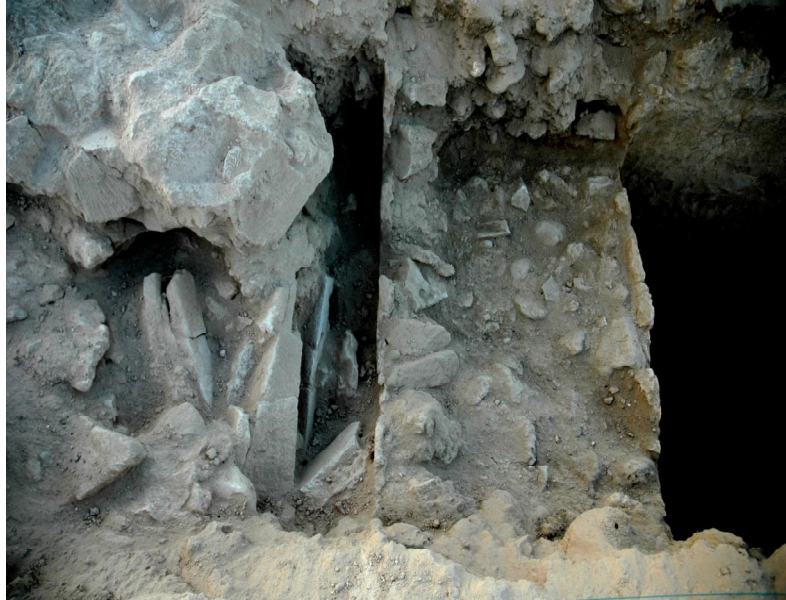
**The third compartment (S9), with the collapse from the superstructures of the mosque inside the basement**

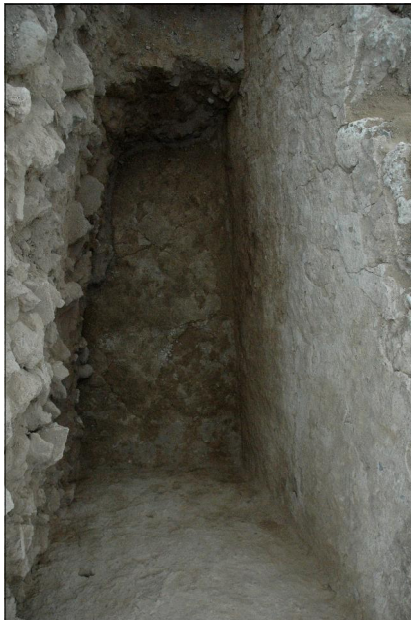
**The fourth compartment (S10)**

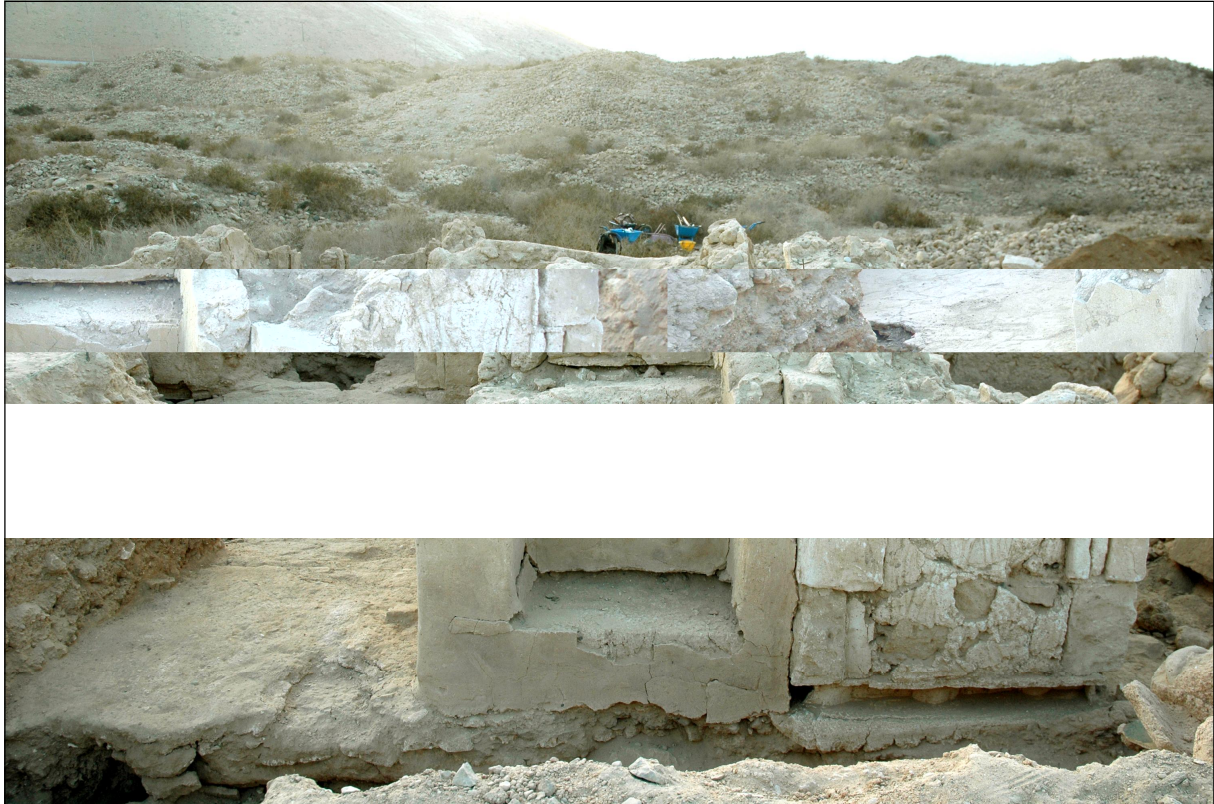
**General view of the preserved part of the mosque, with the *qibla* wall and *mihrab* in the background, the *minbar* and pillar in the foreground.**

The only superstructures of the mosque now preserved are the lower part of the *qibla* wall, *mihrab* and *minbar*, and the base of the pillars of the last nave, up to about 1m at maximum. The *mihrab* was located in the axis of the central nave, a niche 1.5 x 1.5m with several phases of decoration, the last one in stucco with small pilasters and recesses. A *minbar* 1.20m large and 3.8m long was at some time erected to the right of the *mihrab*, leaning against the last pillar of the central nave. This *minbar* is associated with the second floor of the mosque (S2) and the last phase of decoration in the *mihrab*, later than the original floor and the coating of the *qibla* wall, and it could have replaced an earlier structure. Four stairs are now preserved, which were protected by parapets and covered with wood planks now vanished. It probably had originally eight stairs, thus leading to a platform about 2m high.

The preserved lower part of the pillars, in the last bay, is square, 90cm on each side. It is built with square and rectangular cut limestone blocks with a vertical band in recess in its eastern front side, originally the place for a decorated panel. At the base was a deep recess surrounding the pillar and small wood beams were still preserved inside, maybe some kind of hooping to avoid destruction in case of earthquake. Fragments of octagonal and circular columns were also found in the trench and it is therefore possible that the pillars were of different shapes in each bay, or of different shape at their base and upper part.

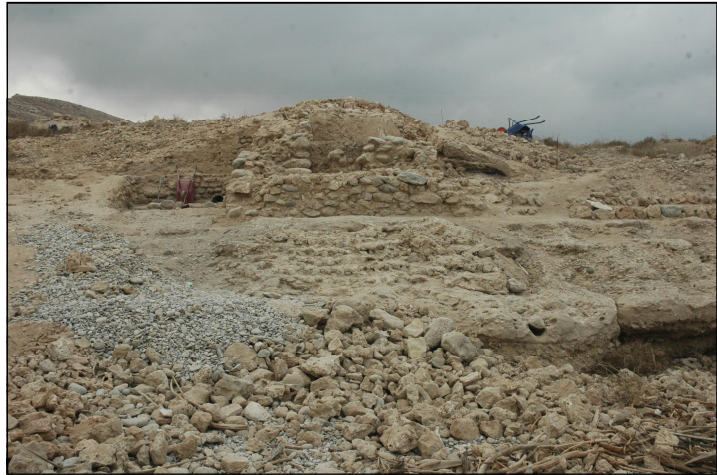
**The northeast corner structure on the beach**

The rectangular structure attached to the northeast corner of the basement was probably a minaret, with a staircase based on the massive masonry found in the western part of the entrance. Five crenellations were found collapsed at its foot, which were crowning the lower part of the tower, encircling the base of an upper and narrower storey. Another minaret was possibly located at the northwest corner where a square structure  $???$  x  $???$ m was at some time built against the northern façade of the basement. Traces of stairs were discernable inside, around a central square pillar.

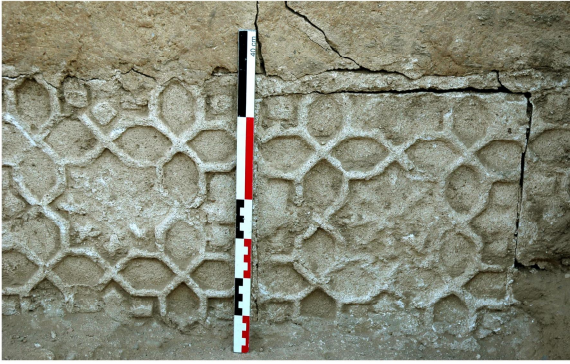
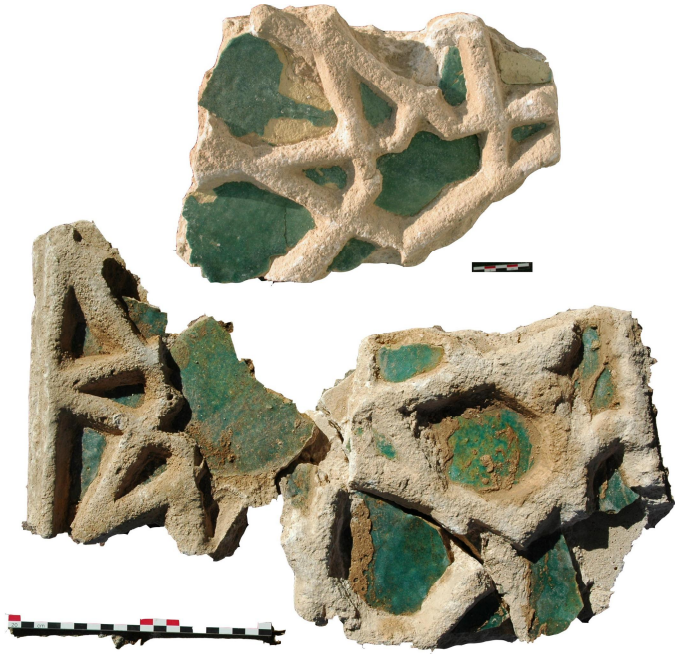
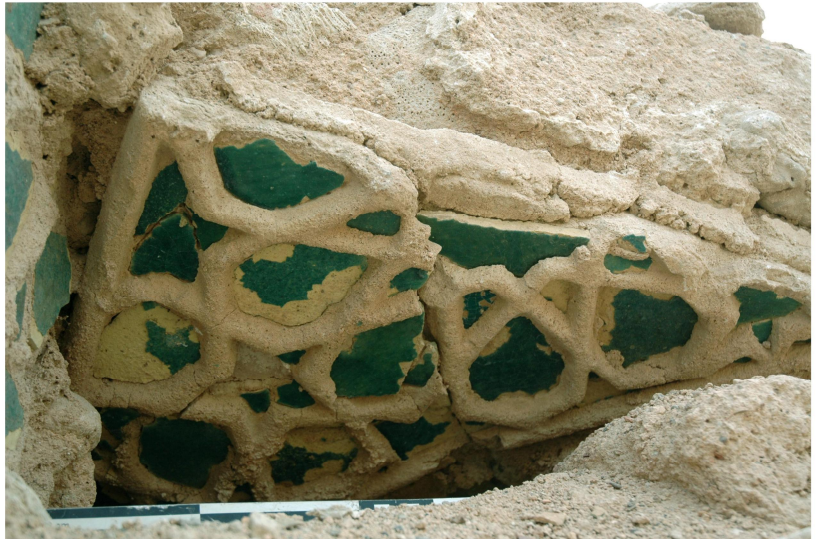
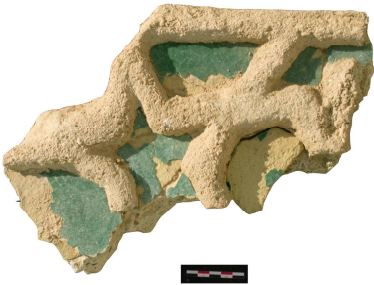
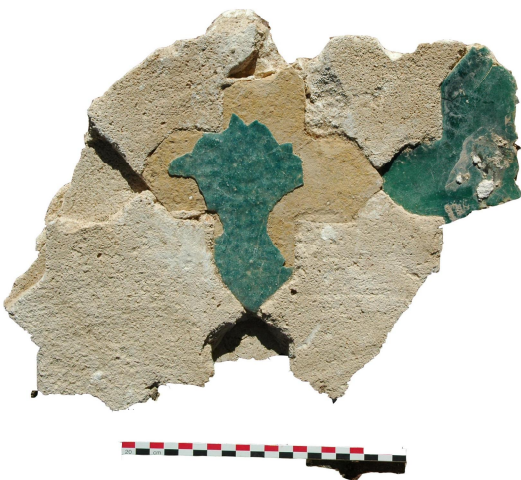
Elements of decoration from the *minbar*, the pillars and the arches

The pillars were all decorated, at least on their eastern face fronting the praying community. As for the arches, they seem to have been also highly ornamented, on all their faces. These are mostly panels with fragments of broken green star or cross tiles, inlaid in plaster and covered with thick stucco lines geometrically arranged to produce the motif of stars, with five, eight or even ten points on the corner pieces; moulds for the production of these stucco lines were even found. Or a coating of plain plaster, inlaid with complete stars and/or crosses tiles, regularly arranged on the intrados. Limestone bilobed or quadrilobed carved blocks were also found which were used in association with stars tiles. We can also mention several fragments of a large plate in Chinese blue and white porcelain inlaid in a plastered panel as decoration; they were found in the cellar room of the fourth bay.

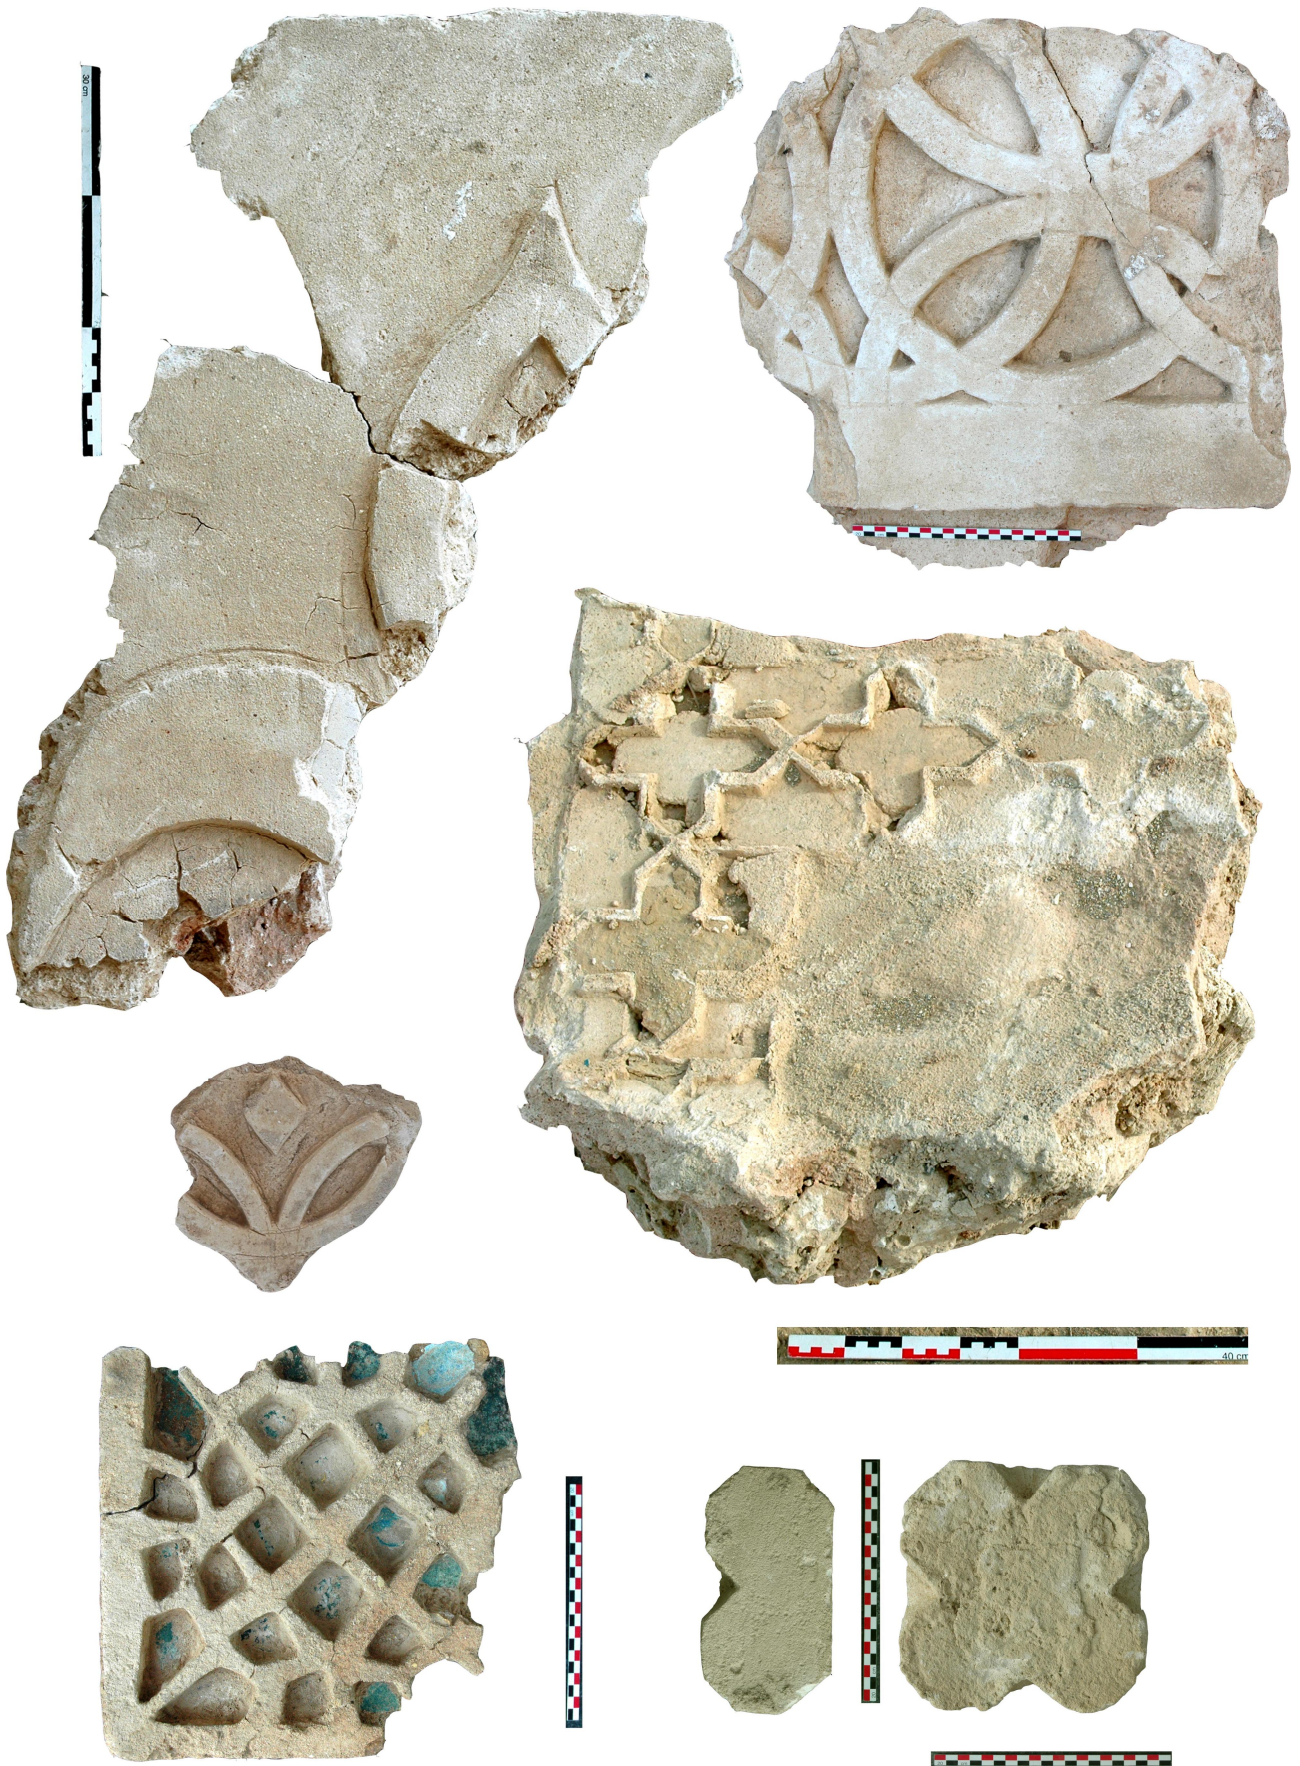
Elements of decoration from the minaret area, and varied

Massive elements of decoration were found in the sounding of the northeast corner of the mosque. Beside the crenellations already mentioned, these are two fragments of a large inscription, and several fragments of a large stucco freeze made of interlacing circles. Given the size of these motifs, they were probably located rather high, which confirms the presence of a minaret in this area.

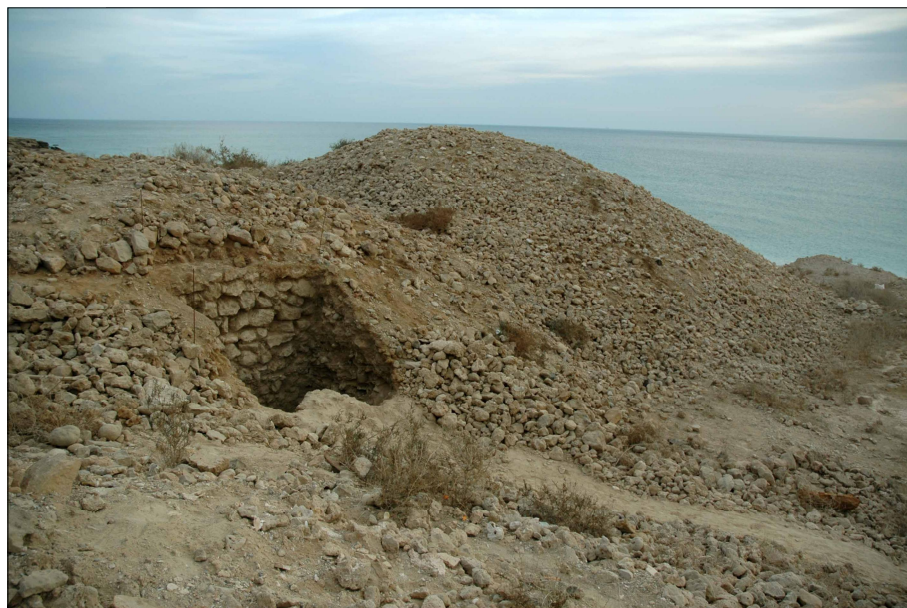
**The southern wall of B13**

A sounding 1.5m large was open this year against this wall to get preliminary information on the function and dating of the building, as excavations are planned there for the 2010 season. The wall is built with large limestone blocks, and preserved up to about 3m (base at  $\Delta$  ???). It was certainly a very impressive construction, most probably with an official function.

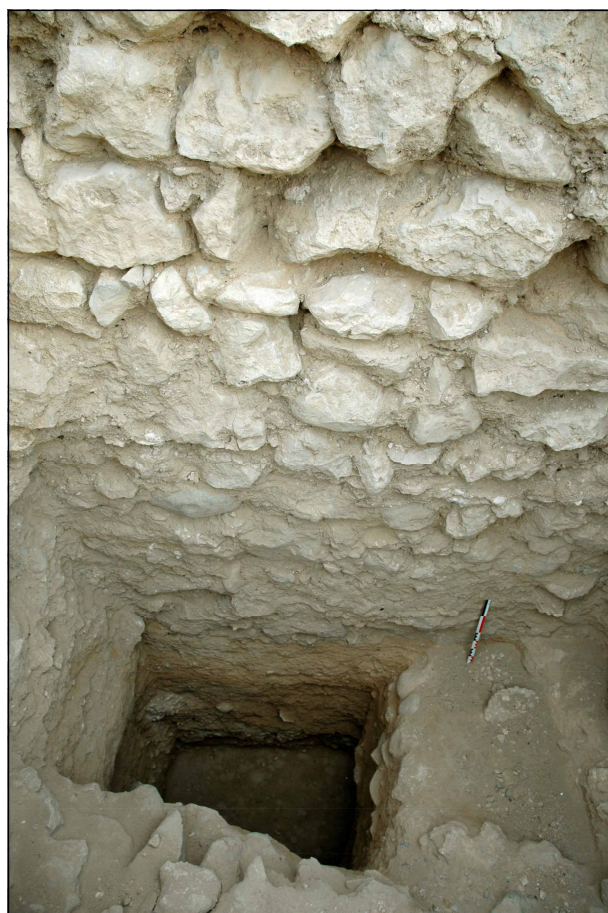
**The deep sounding against the southern facade, showing the layers under the base of the wall**

The base of the wall lies on a thick layer of compacted light brown clay with small gravels, with some intermediary lens of ashes, 35cm thick. Under is an occupation layer with ashes, some charcoal, and gravels, 15cm thick. Then is another layer of compacted clay, associated with a small pit with a filling of small pebbles near the northern section of the sounding. This in turn lies on a thick level of medium pebbles, which becomes more and more compacted as excavation goes down, with no human traces. Although this is probably not the bedrock proper, it is a natural deposit, prior to the foundation of the city, maybe the bed of a small wâdî. Excavations were therefore stopped at level  $\Delta$  ???.

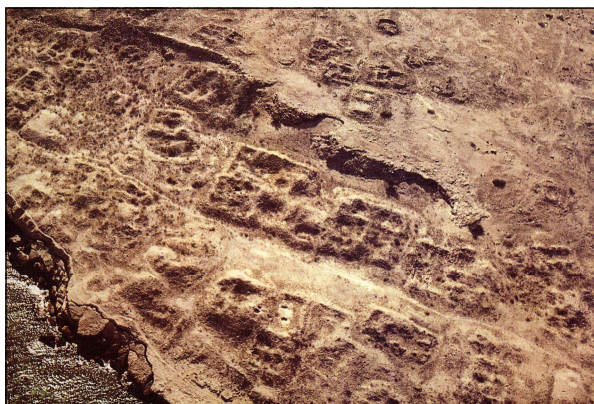
**Kite photograph of the area of B16 and B38**

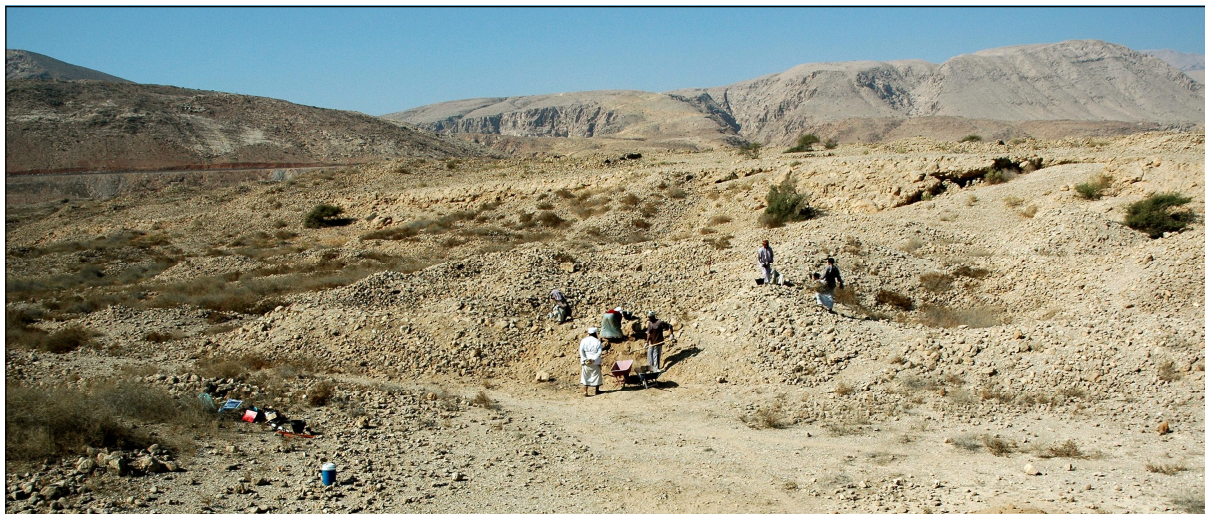
**General view of B16 from the square**

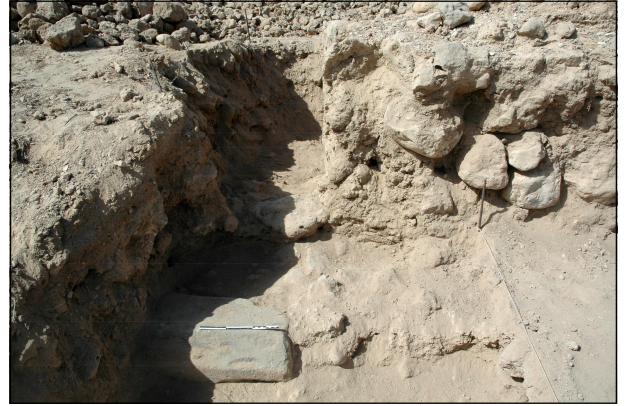
**The street sounding, phase II**

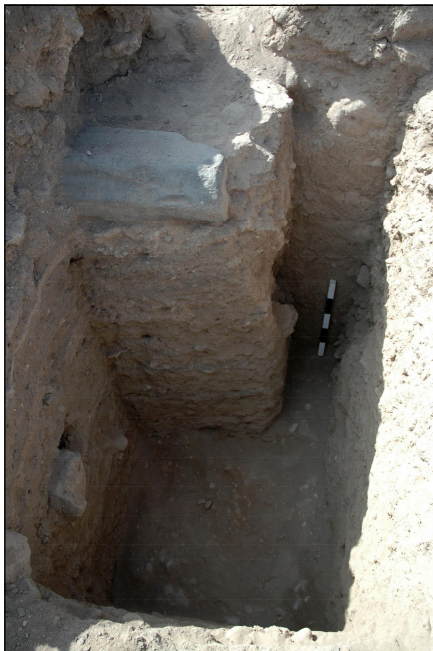
**The street sounding, phase I**

Under the surface collapse, a large parallelepipedic grey stone was found in front of the door (D10.67), used as a step to connect the threshold to the level of the street outside (D10.40), a very compact circulation level, beige in colour. Under it, several layers of powdering earth from grey to beige with some ashes and few charcoals are superposed on a height of about 50cm. Under is a great brown earthy level about 1m thick, which contains numerous organic remains, degraded greenish and sticking to the surface of the ceramic material. All these layers lean against the façade of an earlier wall, phase I, located just under the upper one with nearly no difference in the façade except that it is here covered with a strong coating showing finger prints. This wall was built directly on the bed-rock, here a very strong pudding of medium pebbles in a strong mortar, the base of the wall coating leaking on the earlier layer of the street just above it, at level D9.10.

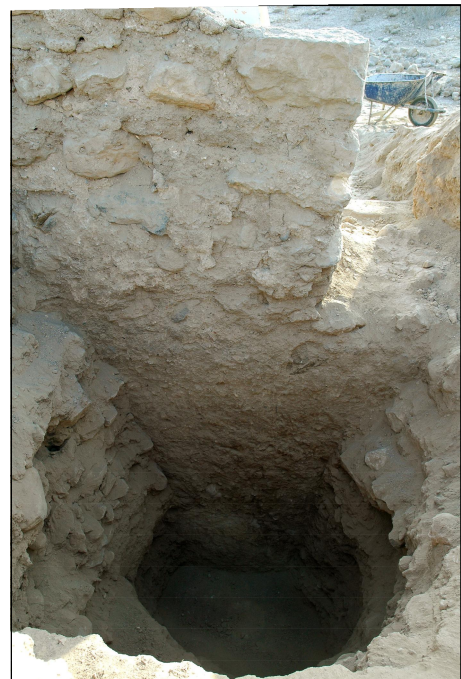
**The entrance sounding, phases I-II**

Under this later occupation phase, another layer of fallen stones was found, many coral blocks and few pebbles in a loose earth, about 60cm thick. Below is a meter thick layer of occupation/accumulation, with powdering earth, gravels, pebbles, bones and other few organic elements and remains. It lies on a floor located at level D 9.07 which is connected with the base of the wall of phase I, here also with a strong coating. To the contrary of phase II, no doorway was found in this early wall. Just under the floor, about level D9.00, the bedrock is similar than in the street sounding.

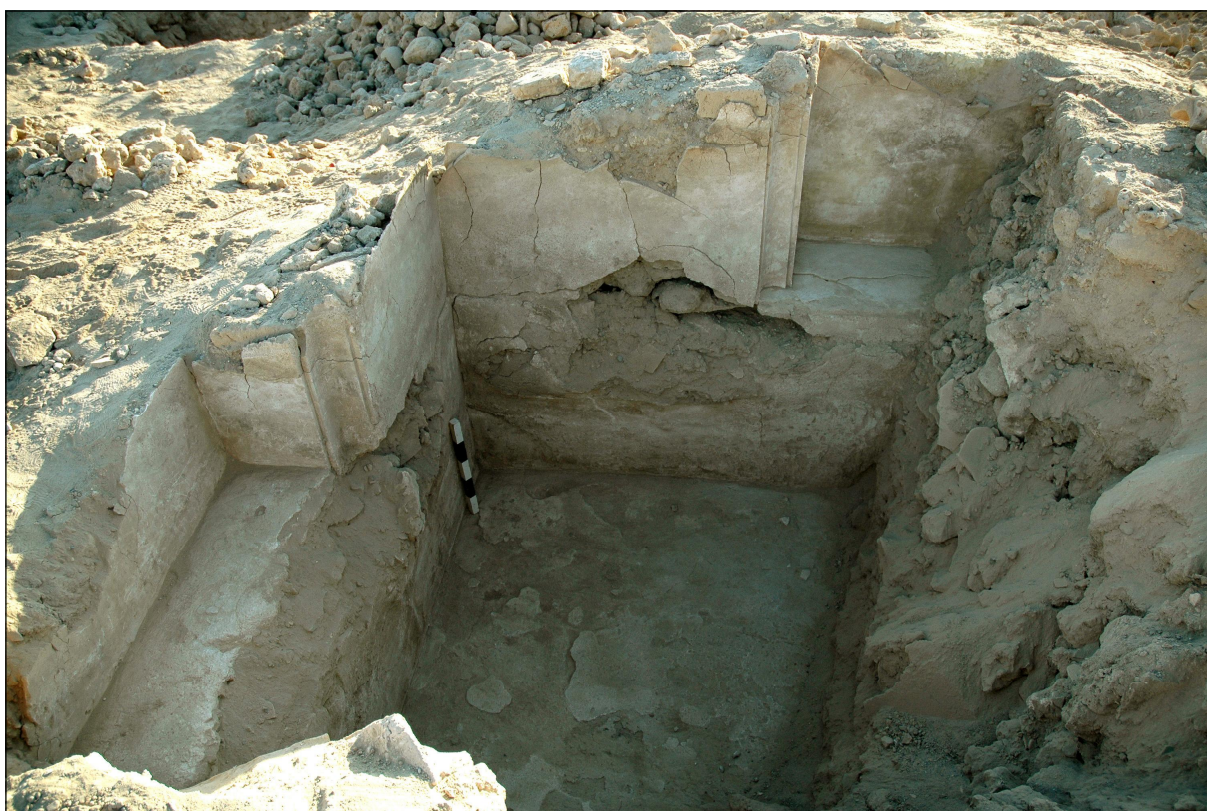
**The main room, with its plastered floor and niches, phase II**

The sounding (2.20x2.20m) was open in the northeast corner of the room, where the plaster was well preserved up to the surface. The top layer is a level of collapse about 1.20m thick (D12.70 > D11.45) made of many stones, coral blocks, mortar and numerous fragments of plaster coating, with few ceramic sherds, in a powdering earth; the base of the niches appear at layer c. D11.95, about 75cm under surface. Under this collapse a rather homogeneous layer of earth was found, with some charcoal and plaster fragments, c. 50cm thick. It rests on the floor of the room, located at level D11.00, an altitude similar to the one of the threshold of the doorway to B16 and the floors of phase II in the street and entrance soundings. Here this floor is an extremely strong white plaster, ca 5cm thick, lying on a preparation layer of small gravels and mortar, altogether ca 20cm thick. These floor layers are leaning against the base of the coating of the walls which were therefore entirely plastered and completed before starting the construction of the floor, the best technique to build a beautiful clean and even surface. The lower part of the walls, under the plaster and floor, is only covered with mortar coating and no niches are visible; it is associated with a 30cm thick layer of earth with stones, few pebbles and coral blocks and a lot of ceramic sherds, bones and fish remains, dating back to the period of construction of the room. This layer lies on a very compacted construction level with pebbles in a dumped earth, which is associated with the base of the walls, at D10.45.

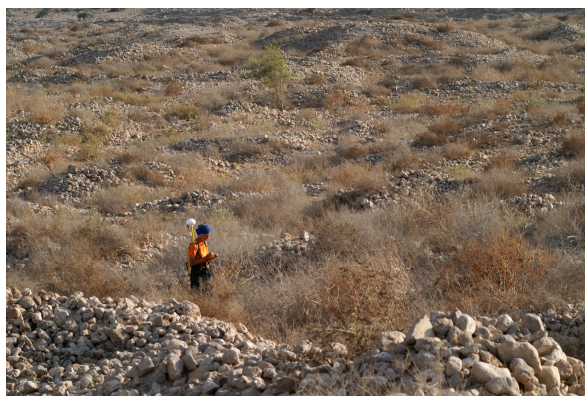
**DGPS recording in a complex zone**

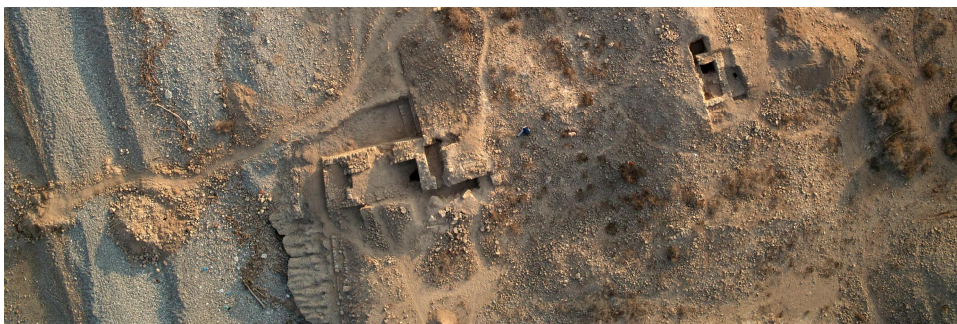
**Vertical kite view of the mosque**
