## Rediscovered earth heritage becomes motor for local change - The Guérande Peninsula (France)

## Rediscovered earth heritage becomes motor for local change

### The Guérande Peninsula (France)

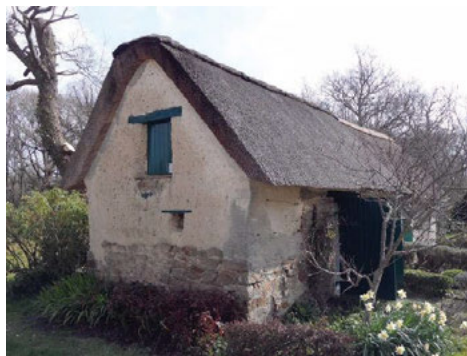
Fig. 1. A cob outhouse at Kerhebé, dating from the mid-19th century (Source: Hilton, 2015).

Traditionally, raw earth was used extensively in buildings in the northwest of France. In Brittany, cob dwellings have been built since the sixteenth century and represent 20 % of the built heritage on this territory (Bardel & Maillard, 2009). The cob technique is also found in the Vendée marshes, where squat dwellings known as bourrines, dating back to the fourteenth century, bear witness to the use of local, natural resources (Patte & Streiff 2006; Bonnet et al., 2021). Between these two well-documented earth-building territories lies the **Guérande Peninsula** where earthen heritage (see Fig.1), until recently little-known and neglected, has become the object of mapping and inventory studies.

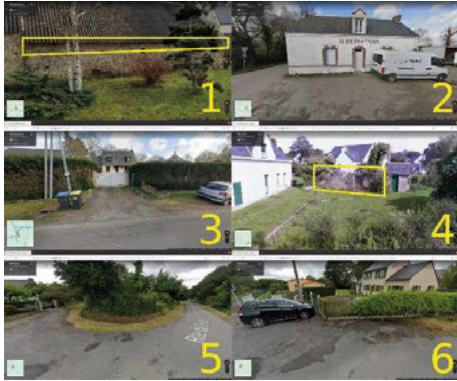
Fig. 5. Examples of Google StreetView investigation to find cob buildings - the numbers correspond with the circled buildings on Fig. 4.

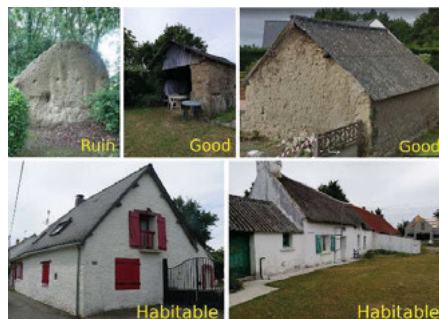
Fig. 7. Cob buildings in different states of preservation

We classified the 46 cob buildings identified according to one of four states of preservation (Fig. 7):

- *Destroyed*: present on old photographs collected from local inhabitants but not present on site
- *Ruin*: not usable, no roof, only the walls or part of the walls
- *Good*: usable as an outhouse, existing roof
- *Habitable*: the building is still used as a permanent dwelling
