Histria archaeol. 52/2021

Giulia BOETTO, Vincent DUMAS, Ida KONCANI UHAČ, Pierre POVEDA,
Marko UHAČ

THE LATE ANTIQUE WRECK OF DEBELJAK COVE (CAPE KAMENJAK, PREMANTURA, ISTRIA)

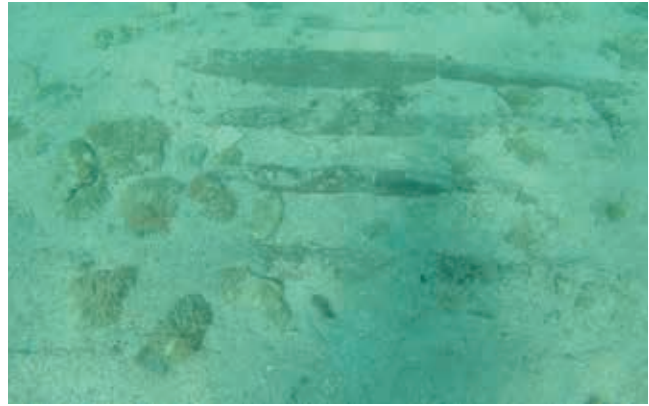
Sl. 4 Brodska rebra prilikom uvidaja 2015. (fotografija: I. Koncani Uhač).
Fig. 4 Frames appearing from the sea bottom in 2015 (photo: I. Koncani Uhač).

The presence of the wreck was reported to the Archaeological Museum of Istria in 2015 by members of the Eko More Association and Diving Club Centre from Medulin, who noticed a few visible frames appearing in some places through the sandy bottom (Fig. 4). The remains were located approximately in the centre of the inner part of Debeljak Cove, about 80 m from its western shore, and at a depth of 3-3.5 m (Figs. 5 and 6).

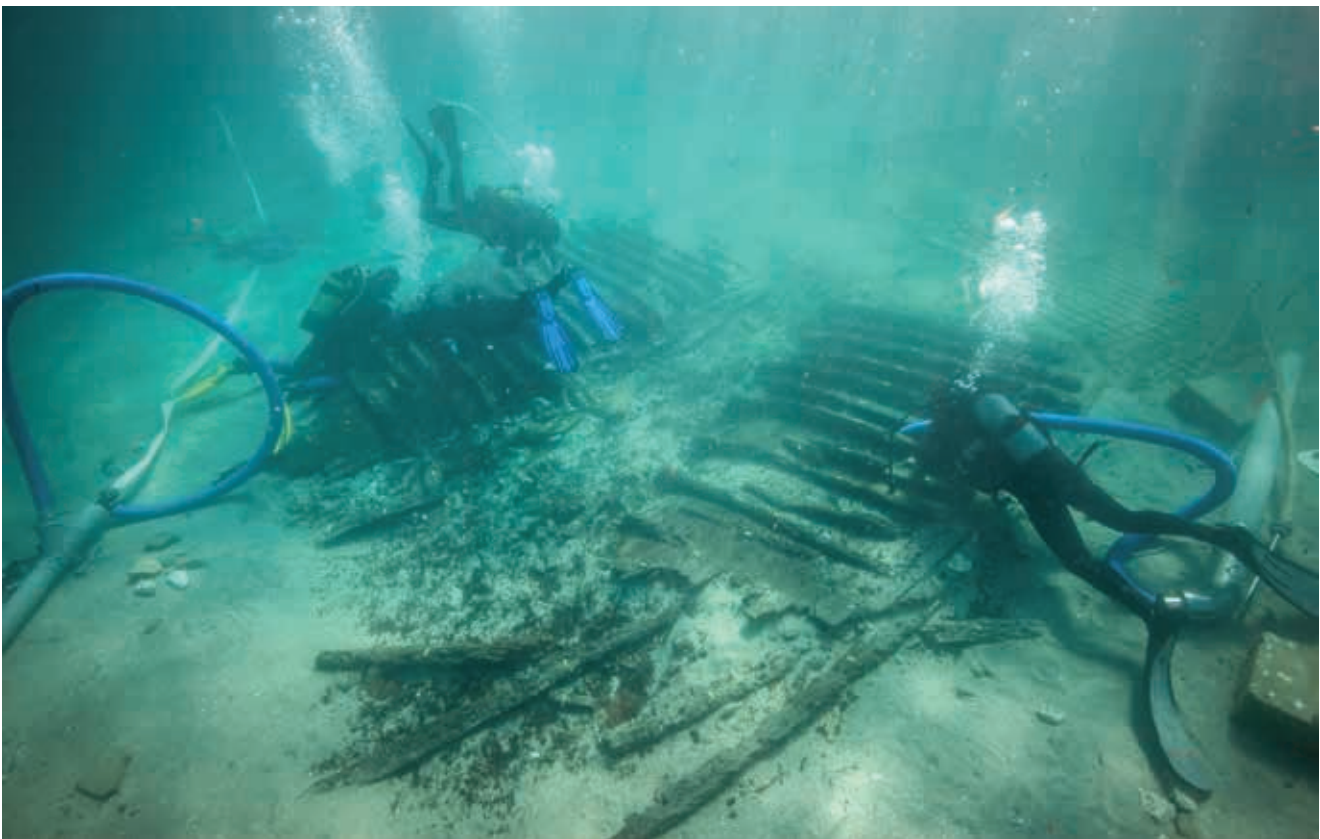
Sl. 5 Istraživanje brodske konstrukcije tijekom arheološke kampanje 2017. (fotografija: L. Damelet).
Fig. 5 Excavation of the wreck during the 2017 campaign (photo: L. Damelet).

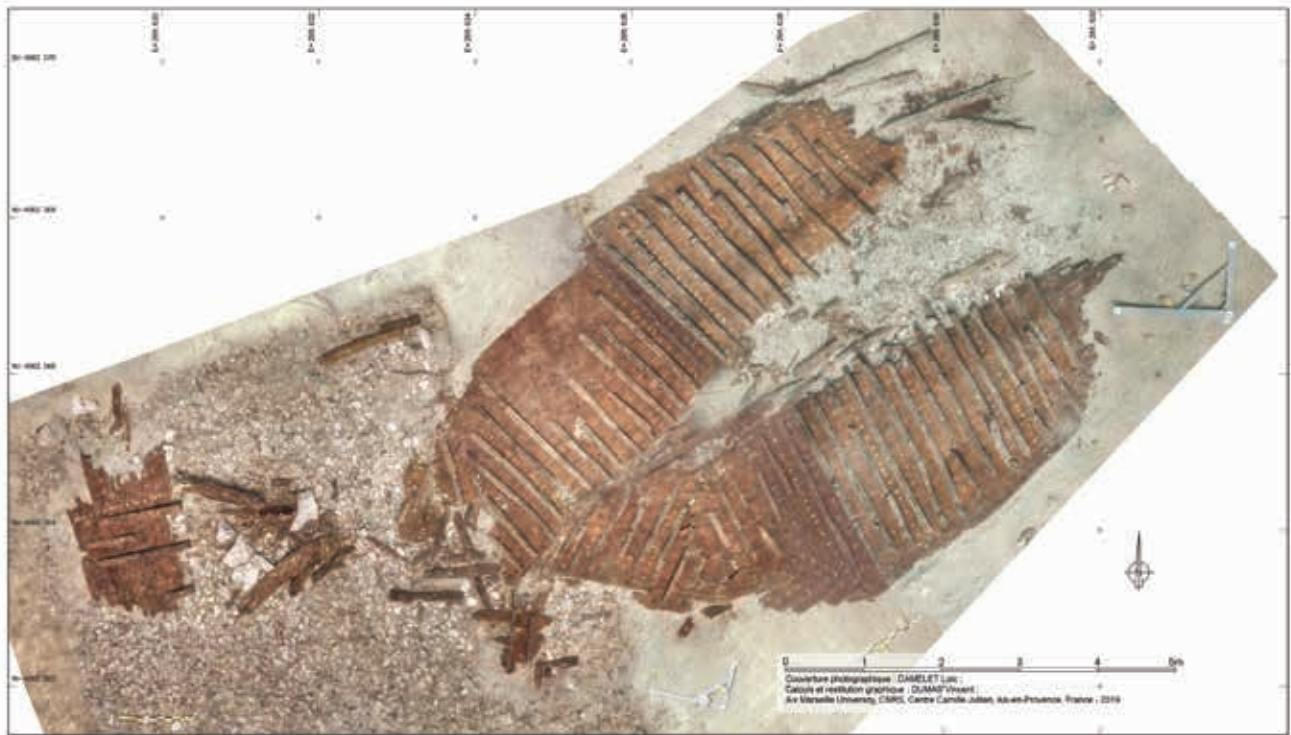
Sl. 10 Ortofotografija brodske konstrukcije (fotografija: L. Damelet; fotogrametrija: V. Dumas).
 Fig. 10 Ortho-image of the wreck (photo: L. Damelet; photogrammetry: V. Dumas).

The remains of the ship are scattered over an area of approximately 90 m², and consist of seven separate assemblages and a large number of individual pieces resulting from the disintegration of the hull (Figs. 9–11). Assemblages no. 1 and no. 2 form the main part of the deposit, measuring 9 m in length and 6.2 m in width. They correspond, respectively, to the north and south sides of the ship. These are oriented north-east/south-west, converging at their south-west end and separated by 1.8 m to the north-east end. Partially below and between these two sides is a third segment of the hull (Assemblage no. 3, 2.5 x 1.8 m), possibly belonging to the southern side (Assemblage no. 2) (Fig. 12).

The wreck is heavily distorted and lies flat on the seafloor under a layer of sand (Fig. 13). Some larger rocks are also visible in the vicinity of Assemblage no. 7 (Figs. 10 and 11). The excavation reached a layer of pebbles and small stones only in the area opened during the 2019 campaign (Fig. 14), which corresponds to the ancient seafloor, underneath the wreck.

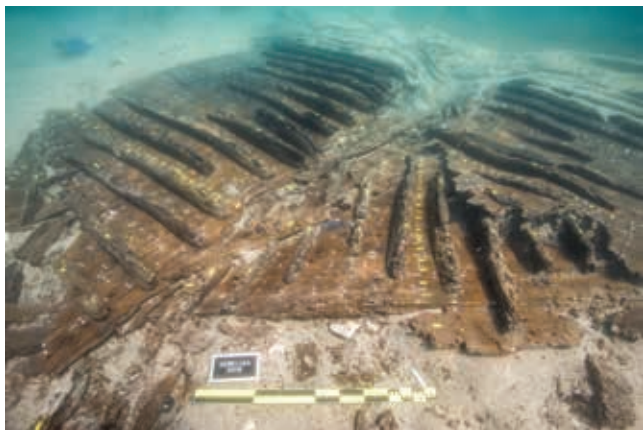
Fig. 12 View from the south-west of the wreck during the 2019 campaign: in the foreground is the partially covered third section of the hull bottom (photo: L. Damelet; photogrammetry: V. Dumas).

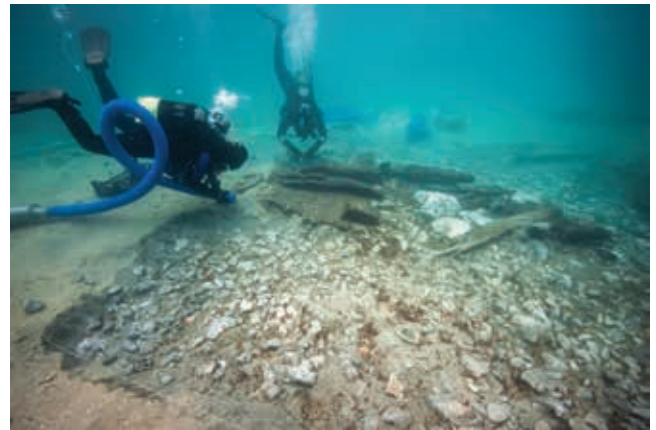
Fig. 14 View from the south of the westernmost section of the wreck (No. 7) resting on pebbles and small stones corresponding to the ancient seafloor (photo: L. Damelet).

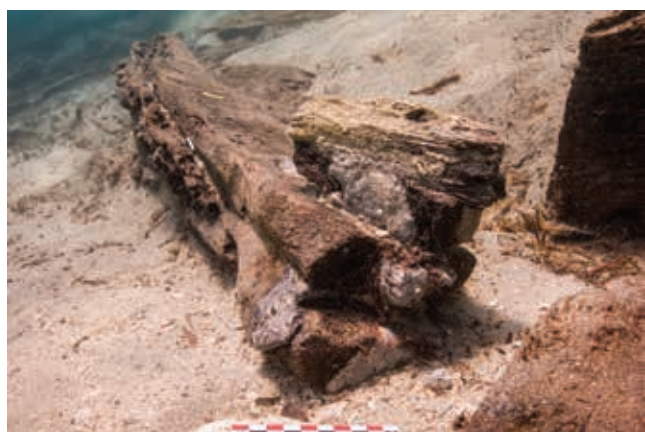
Sl. 17 Detalj statve K, pogled sa zapadne strane. U prvom planu spoj na ključ s ulomkom rebrenice spojene s gornje strane. Konkrecija odgovara svornjaku i metalnom limu koji je služio za brtvljenje spoja (fotografija: L. Damelet).
Fig. 17 Detail of view from the west of transitional timber K. In the foreground, the hook scarf with a fragment of floor timber attached on the top. The concretions correspond to the bolt and the sheet of metal waterproofing the scarf (photo: L. Damelet).

The hook scarf was locked with a horizontal key (not preserved). A bolt, which has turned into a shapeless concretion (shaft diameter 2.5 cm), secured the scarf and connected a floor timber (F121), a small fragment of which is preserved on the upper surface of K. Thus, the total height of the transitional timber K and the floor timber F121 is 32 cm.

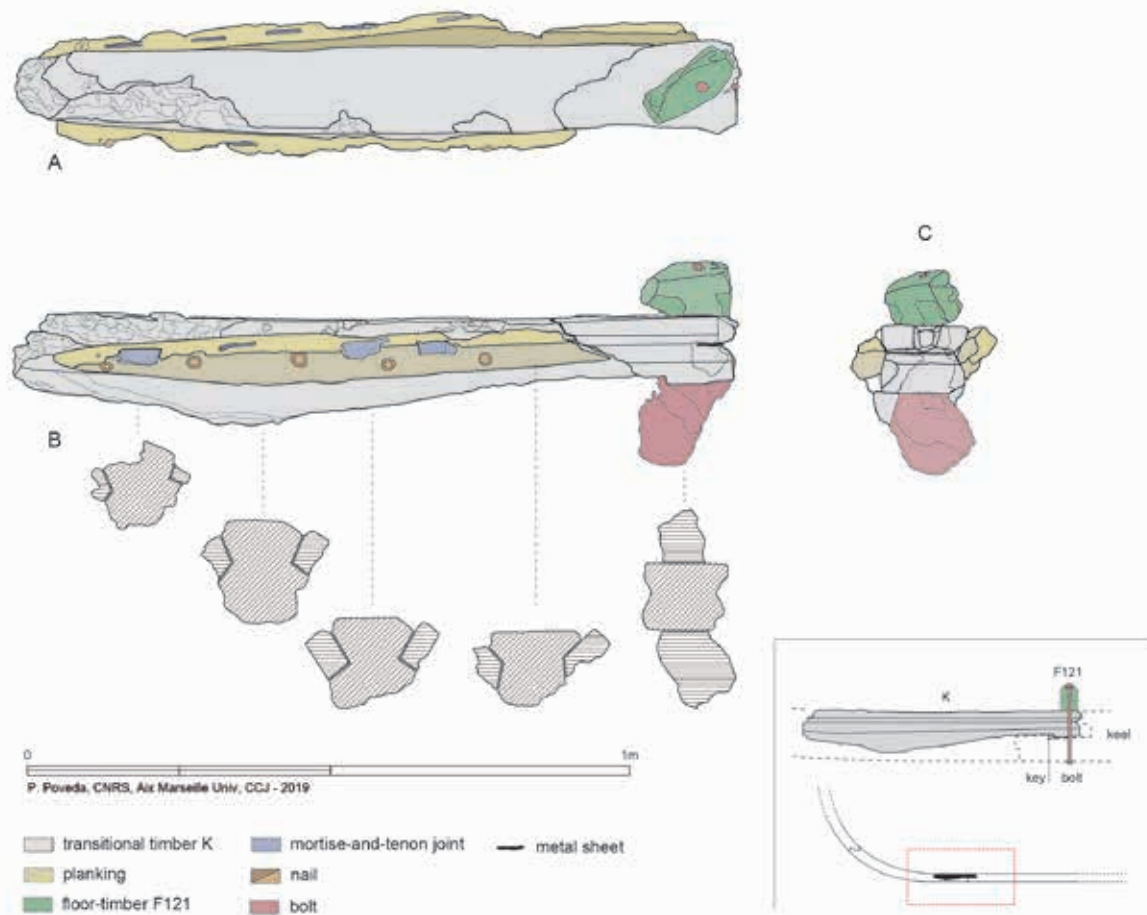
Sl. 18 Statva K: A) pogled odozgo; B) sjeverna strana; C) zapadna strana sa spojem na ključ (crtež: P. Poveda).
 Fig. 18 Transitional timber K: A) top view; B) north side; C) west side with hook scarf (drawing: P. Poveda).

The piece, made of elm (*Ulmus* sp.), is slightly curved, 14 cm sided and 18 cm moulded (Fig. 18). Although the underside is badly deteriorated, the original mould could be evaluated at about 20–25 cm. The rabbet is triangular in shape (6.6–7.7 cm high and 3–3.3 cm deep). Two fragments of planks are attached to the piece by pegged tenons, each plank being secured by five nails (average diameter 2.2 cm, spaced 16.2 cm apart). Nails driven into the thickness of the planks lock their ends into the rabbets. The top edge of the planks has a row of mortise-and-tenon joints. The mortises are 6.3 cm wide, 8 mm thick, 3–3.5 cm deep and spaced 8.5 cm apart (side-to-side).

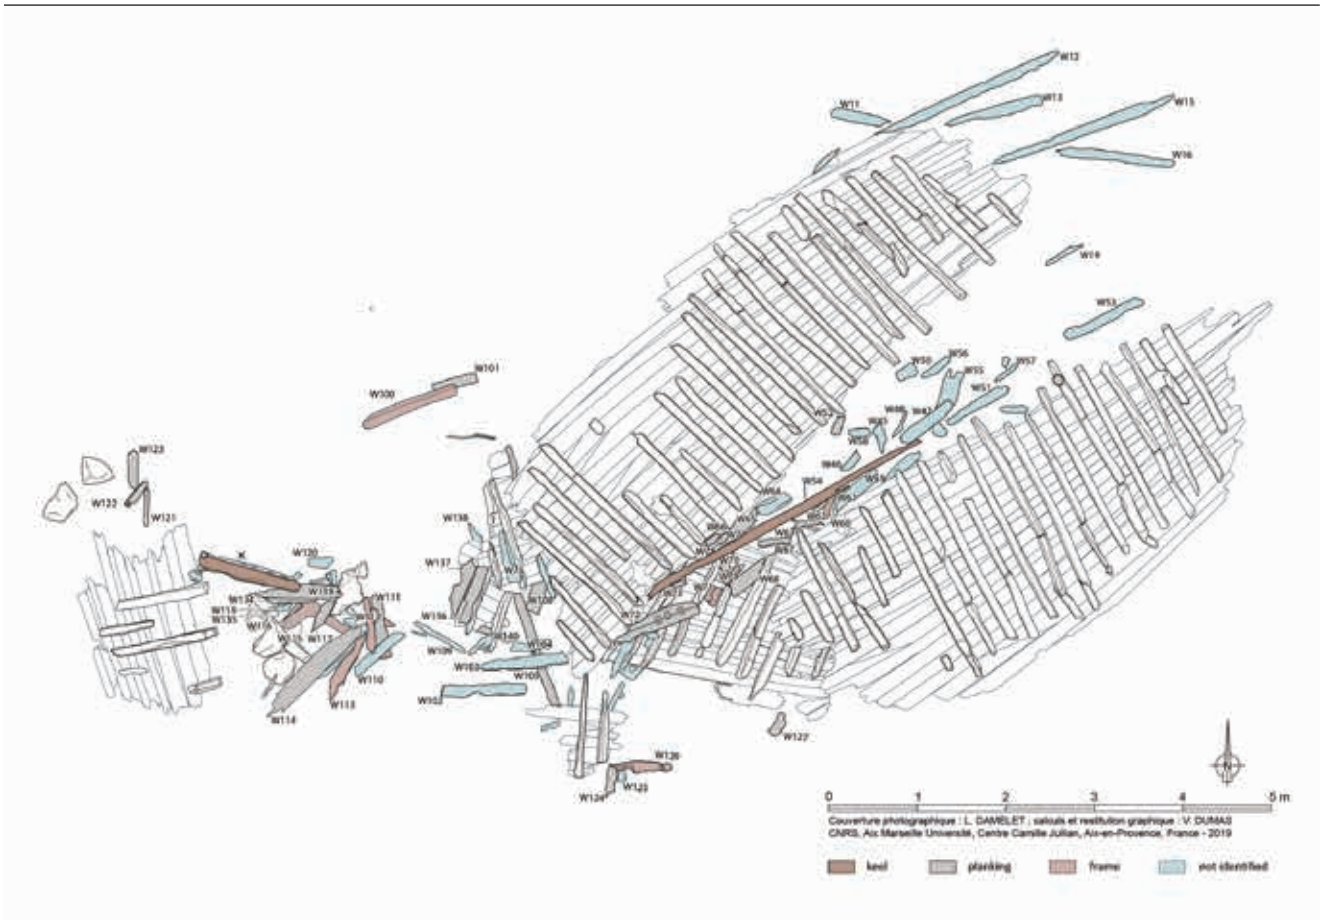
Sl. 19 Lokacija dislociranog drvenog elementa (crtež: V. Dumas).
 Fig. 19 Location of the displaced timbers (drawing: V. Dumas).

A timber designated as W54 was found between the two sides of the wreck. Although heavily damaged by shipworm, it is preserved over a length of 3.5 m (Fig. 19).

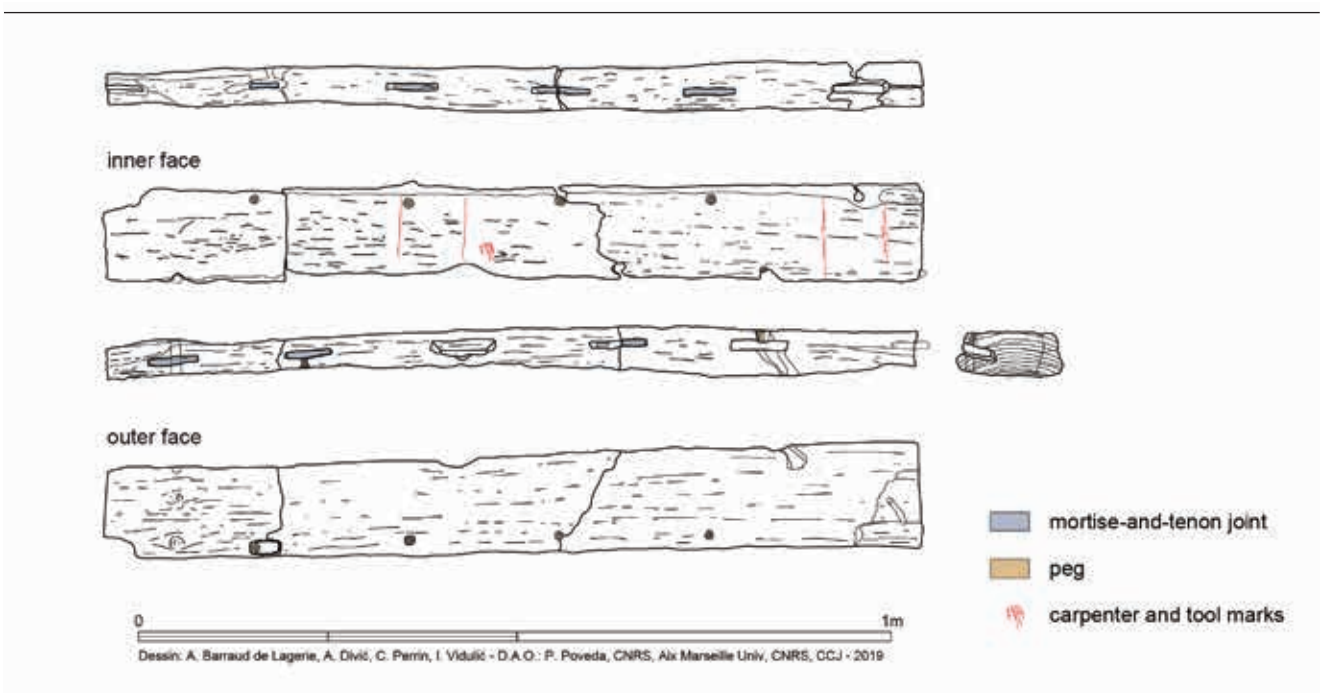
Sl. 20 Element W54 identificiran kao kobilica (crtež: P. Poveda).
 Fig. 20 Timber W54 identified as the keel (drawing: P. Poveda).

A segment of W54, 1.8 m long, was recovered in 2019 and examined on land (Fig. 6d). The timber, of elm (*Ulmus* sp.), is 12.7 cm sided and 5.5 cm moulded (Fig. 20). The edges are cut by mortise-and-tenon joints. The mortises are, on average, 6.5 cm wide, 4–5 mm thick and spaced 12 cm. Tenons are 5.8 cm wide. Small pegs secure the tenons; they are on average 12 mm inner diameter, 9–10 mm outer diameter, and spaced 18 cm centre-to-centre. No treenails or nails for joining the frames were observed, but a few parallel lines, inscribed with a sharp point and spaced 47 cm apart (side-to-side), mark the position of the frames. These marks were also observed in other areas of the hull (see infra).

hypotheses can be put forward: it is part of the keel, or part of a garboard strake. As it was found in the gap between the two sides of the ship and is made from a wood species similar to that employed for transitional timber K (elm), whereas the planking was homogeneously made from coniferous species (see infra), the hypothesis that W54 is the keel of the ship seems convincing. If this is the case, the ship had a flat keel, at least along some sections of its length.

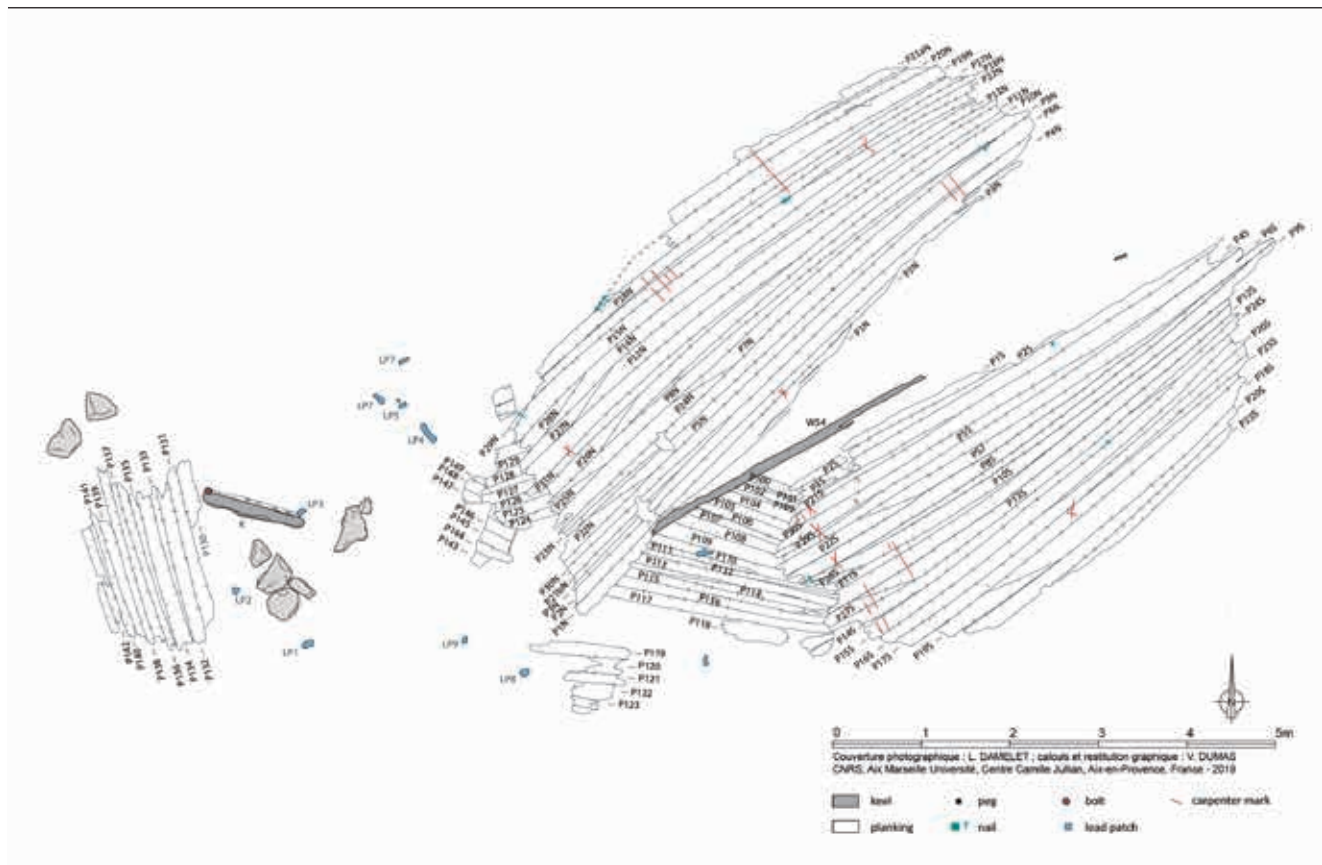
Fig. 21 The planking (drawing: V. Dumas).

Only one lead patch was found in place, attached to the inner surface of the planking (Assemblage no. 3). Eleven other patches, complete or fragmentary, were scattered on the seabed, mostly toward the west (Figs. 21 and 36), and were probably attached to the outer hull. Most of them are strips with an average width of 5 cm and a maximum length of 29 cm (Fig. 37). Only one has a roughly square shape (DE19/LP3, 6x5.3 cm).

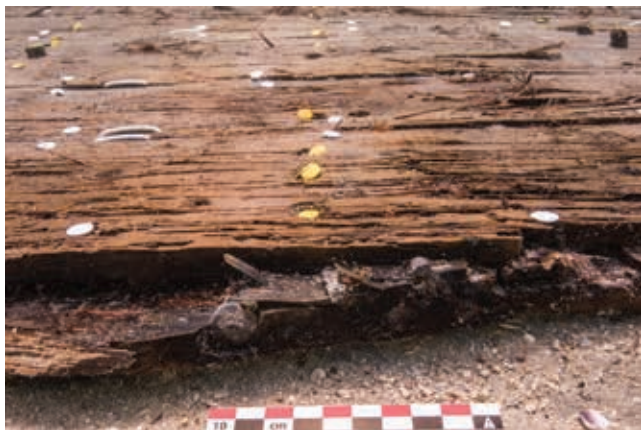
Fig. 22 Detail view of three horizontal nails fixing the tip of plank P19N to the adjacent plank P18N (photo: L. Damelet).

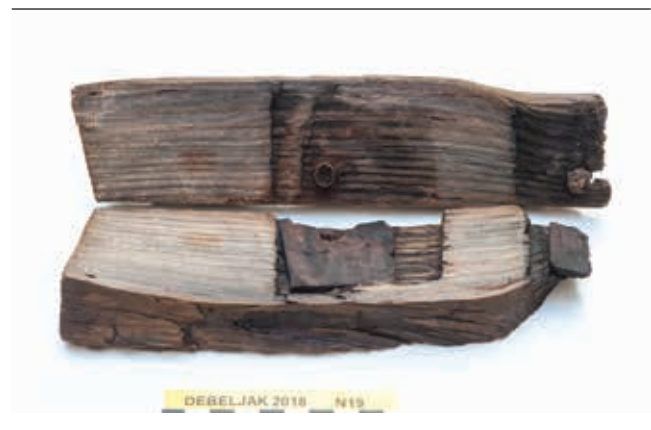
Sl. 23 Ulomak platice sa spojem jezičac i utor: utor je blago trapezast i veći od jezičca (fotografija: L. Damelet).

Measurements of the fasteners were taken on some of the individual pieces and, where possible, on the hull (Figs. 23–25). The mortises are larger than the tenons. They are, on average, 6.2 cm wide, 8 mm thick, 4.5 cm deep, and spaced 12 cm apart (side-to-side). The pegs are tapered (inner diameter 11 mm, outer diameter 9.2 mm) and spaced 10 cm apart (centre-to-centre). The tenons are 8.2 cm long, 4.7 cm wide, 6 mm thick. One tenon (DE18/N10), found detached, is longer than the others (13 cm) and was secured by three pegs. It was used to join three planks at an oblique scarf or a stealer (Fig. 25).

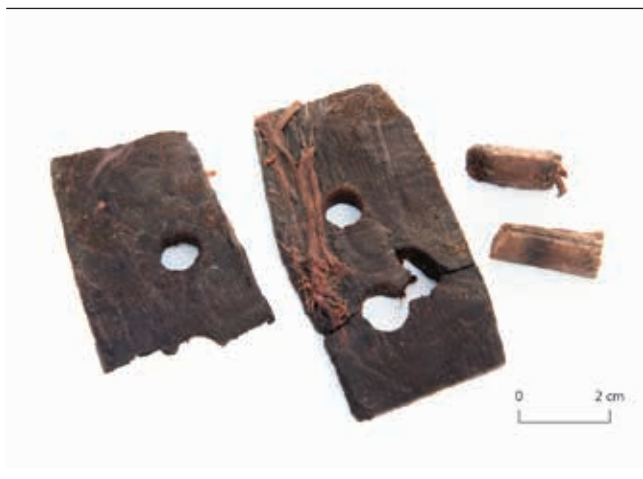
Fig. 24 Tenons and pegs from displaced plank W39 (photo: L. Damelet).

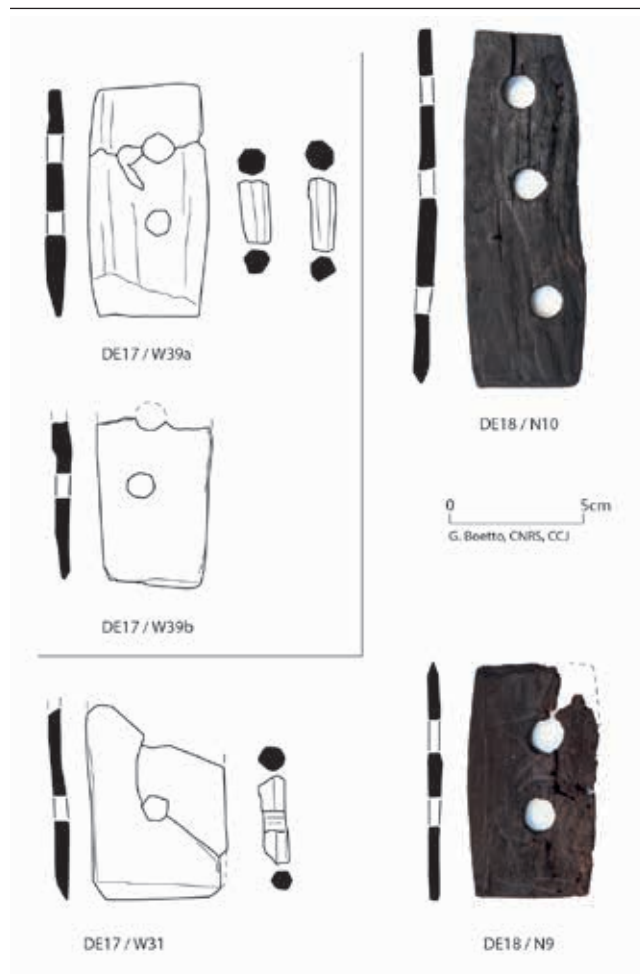
Sl. 25 Jezičci iz spojeva oplata (fotografije: L. Damelet; crteži: G. Boetto).
Fig. 25 Tenons from the assemblies (photos: L. Damelet; drawings: G. Boetto).

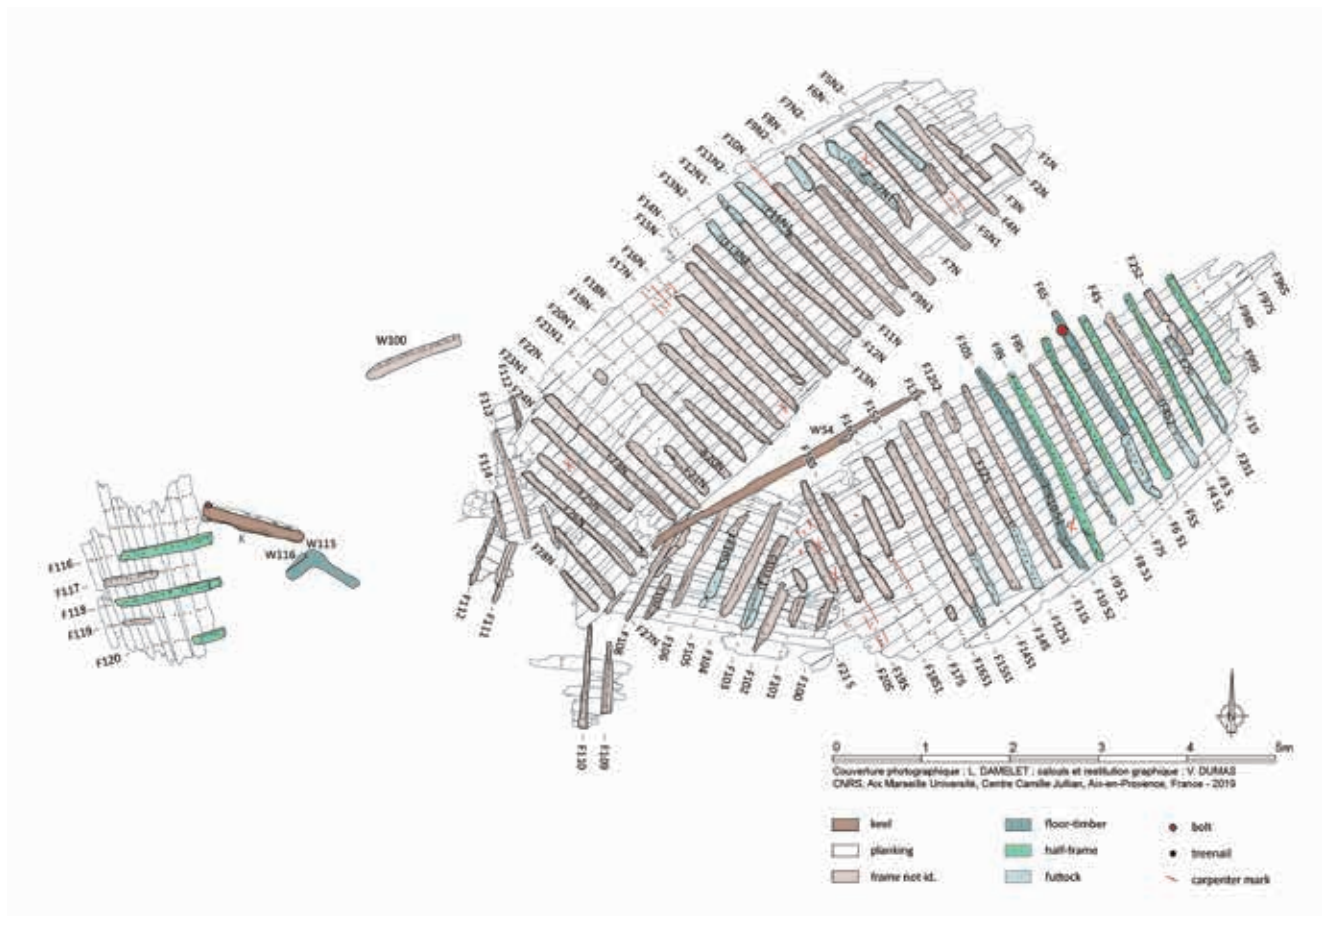
Fig. 26 The frames (drawing: V. Dumas).

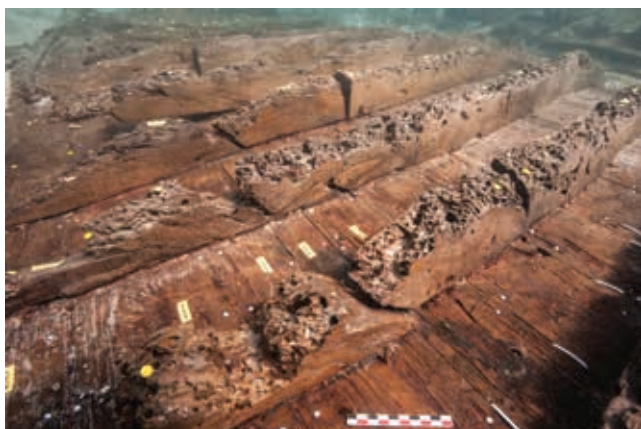
Sl. 27 Pogled sa sjeverozapada na rebro sa sljubljenim elementima. U prvom planu, tri emelenta rebra F13 na sjevernoj strani (fotografija: L. Damelet).
Fig. 27 View from the north-west of a frame with butt-jointed components. In the foreground, the three components of frame F13, north side (photo: L. Damelet).

The frames are rectangular in section (9.4 cm sided and 12.2 cm moulded) and spaced 16.8 cm apart (side-to-side). The general framing pattern with a typical alternation between floor timber prolonged by futtocks and half-frame is recognisable on the south side. The alternation is difficult to recognise elsewhere as most of the frames are broken at their ends. Some of the frames are made up of two or three pieces which are not joined together but are simply butt-jointed (Fig. 27).

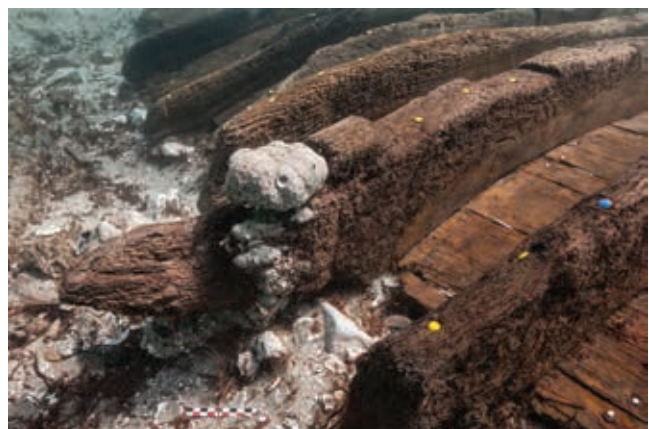
Sl. 28 Pogled sa sjeverozapada na rebro F6S: gornja površina je obrađena s utorima za smještaj dohrptenice i proveze (nisu sačuvane); kongrecija je gornji dio svornjaka (fotografija: L. Damelet).
Fig. 28 View from the north-west of floor timber F6S: the upper surface is carved with recesses to house a sister keelson and a stringer (not preserved); the concretion is the upper part of the bolt (photo: L. Damelet).

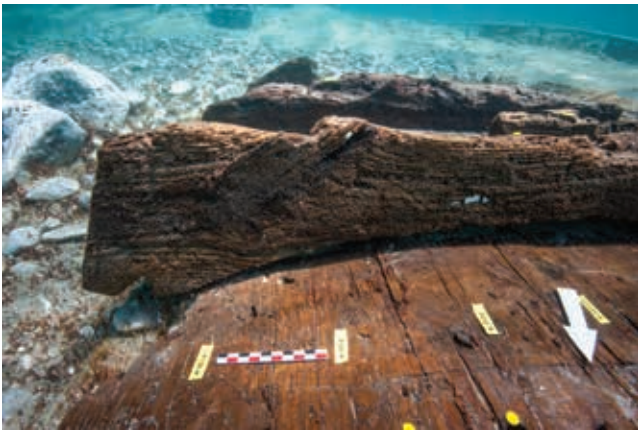
Sl. 29 Polurebrenica F116 s trokutastom rupom za slivnicu i udubljenjem za smještaj kobilice, pogled sa sjevera (fotografija: L. Damelet).
Fig. 29 View from the north of half-frame F116 with a triangular limber hole and a recess to house a keelson (photo: L. Damelet).

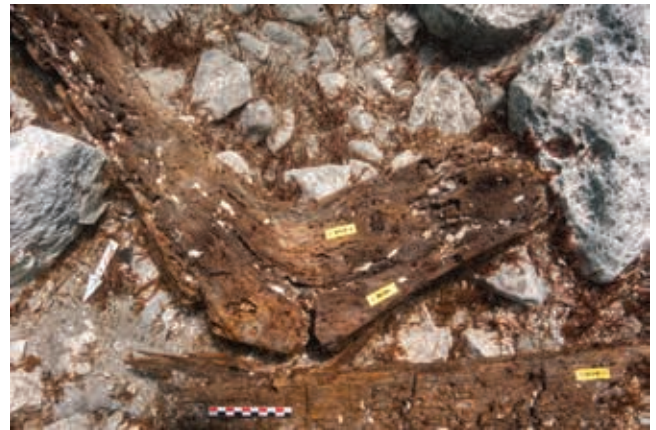
Sl. 30 Komad drva W115 iskorišten za učvršćenje rebra F116 (fotografija: L. Damelet).
Fig. 30 Floor timber W115 and its filling piece F116 (photo: L. Damelet).

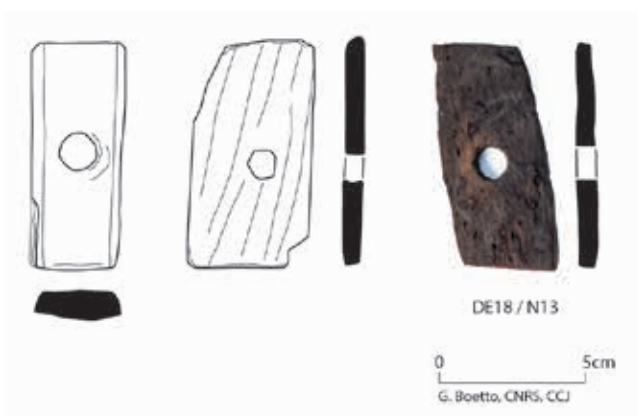
Sl. 31 Tri drvena umetka (fotografija: L. Damelet; crtež: G. Boetto).
Fig. 31 Three wedges (photo: L. Damelet; drawing: G. Boetto).

Three small rectangular pieces of wood with a hole in the middle (average 8 cm long, 3.7 cm wide, 8 mm thick) were found during the excavation (Fig. 31). These are probably wedges that have been inserted under some frames.

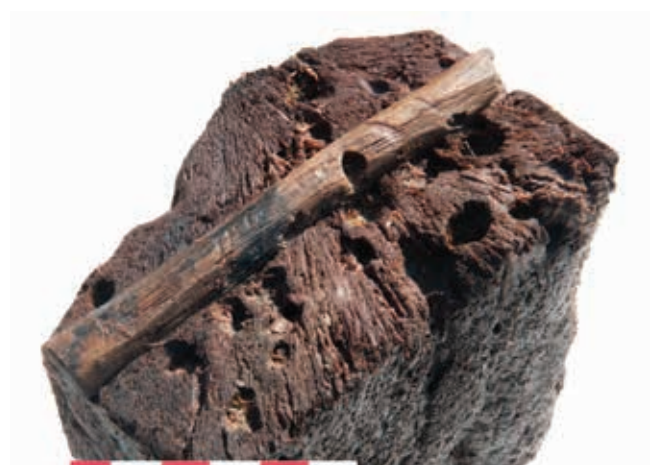
Sl. 32 Čivija na dislociranom brodskom rebro W20 (fotografija: L. Damelet).
Fig. 32 Treenail driven into the displaced frame W20 (photo: L. Damelet).

The frames are attached to the planking with tapered treenails (average diameter 1.4 cm, Fig. 32) and nails: 27 individuals were found scattered on the seabed (Figs. 33 and 34). They are, on average, 8.7 cm long (from 6.6 cm to 12.4 cm) with an average head diameter of 1.4 cm and a square shank. A SEM-EDS microanalysis was carried out on the nail DE18/N1. It revealed that it is made of a copper-tin alloy, or a type of bronze with the addition of lead⁴. A high proportion of carbon detected on the surface indicates the presence of a protective agent of an organic nature (e.g. pitch).

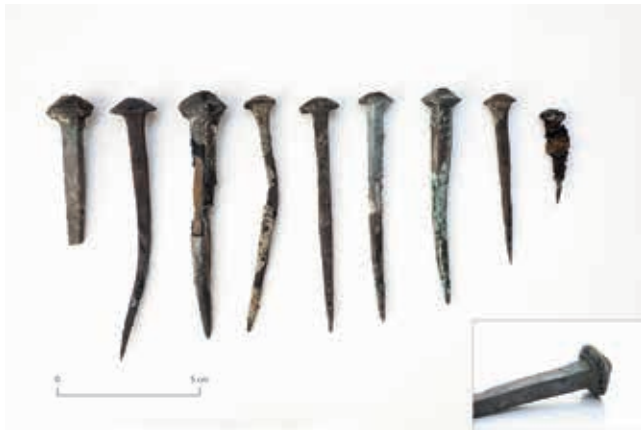
Fig. 33 Nails joining the frames to the planking and detail of a head (photos: L. Damelet).

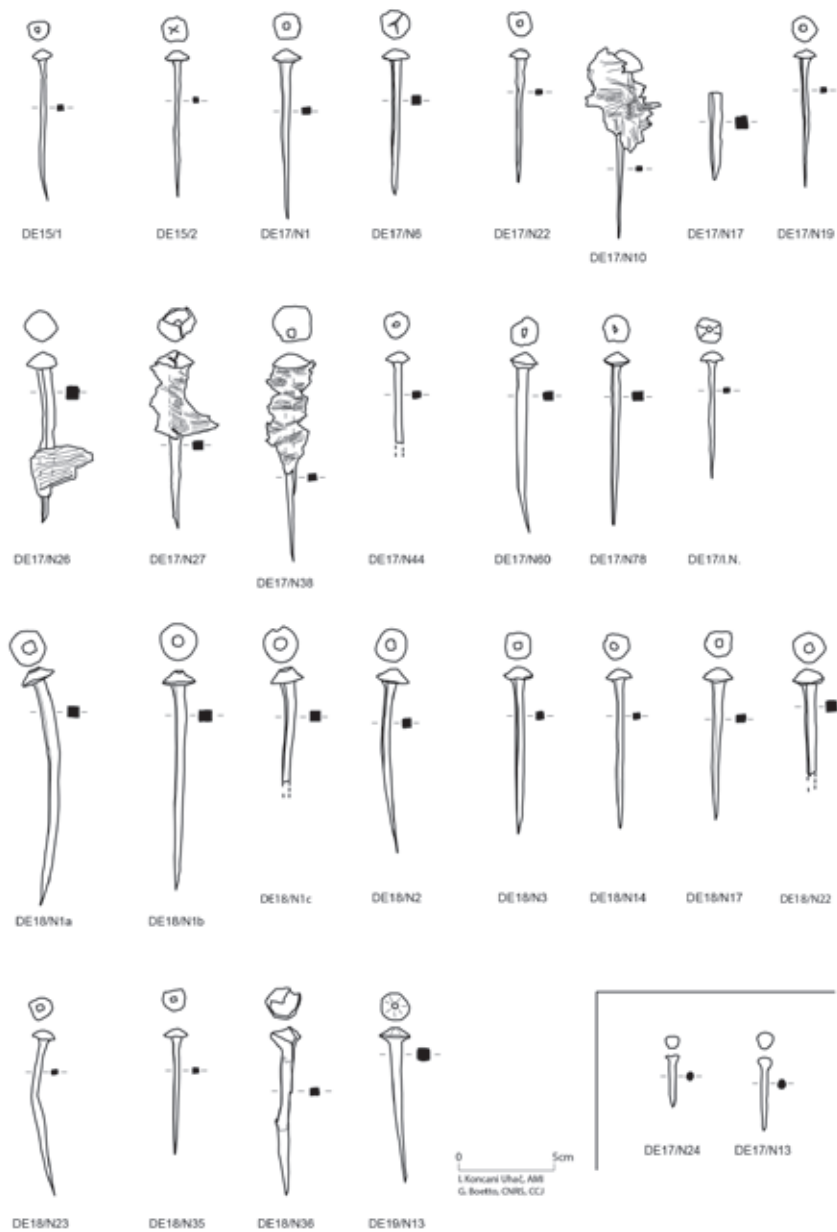
Sl. 34 Čavli za rebra i dva mala čavla za pričvršćivanje olovnih zakrpa (crteži: I. Koncani Uhač).

The patches were attached to the hull with tacks, as evidenced by the perforations visible on their perimeter (Fig. 37). Only two tacks used for this purpose were found, DE17/N24 and DE18/N1 (Fig. 34). They are respectively 3.8 and 2.7 cm long, with a head diameter of 7-8 mm and a circular shaft. SEM-EDS microanalysis of the tack DE17/N24 revealed that its composition was similar to that of nail DE18/N1: a tin-copper alloy with the addition of lead. It also has traces of an organic protective agent, such as pitch (see *supra*).

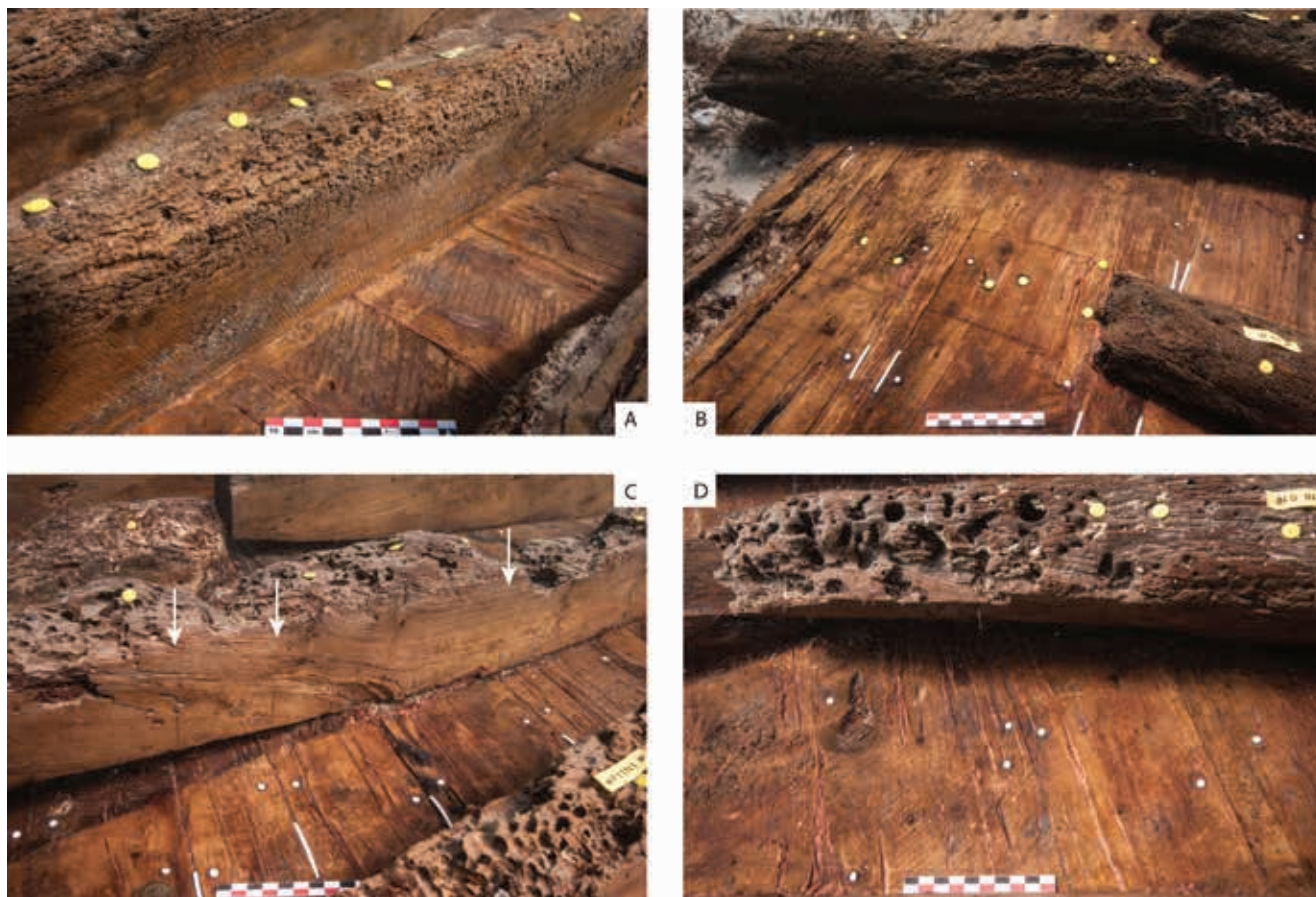
Sl. 35 a) Tragovi pile vidljivi na oplati i brodskom rebru; b) dvije paralelne linije urezane oštrim predmetom koje označavaju položaj brodskog rebra F05N; c) X oznaka između F10S1 i F09S1; d) Okomite linije ispisane ugljenom na zapadnoj strani rebra F10N: linije se nalaze na spojevima vojeva (fotografija: L. Damelet).

Black vertical lines made with a charred stick (Fig. 35c) are preserved on the mould of five frames (F5N2, F6N, F10N, F12N1, F7S). These marks are located at the joints between the strakes and were important indications during the construction of the ship, especially for positioning and adjusting the shape of the frames after the planking was joined. Similar lines were found on the wreck Jules-Verne 4 (1st-2nd century AD, Pomey 1999, 322). All these carpenter marks are significant indications that the ship was built using the shell-first construction method.

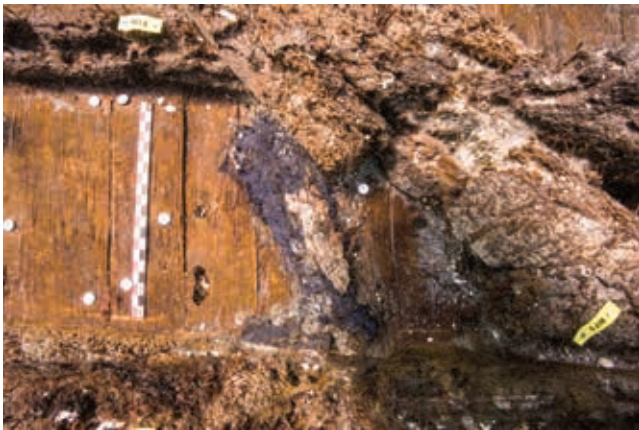
Fig. 36 Detail view of the lead patch attached to plank P110 (photo: L. Damelet).

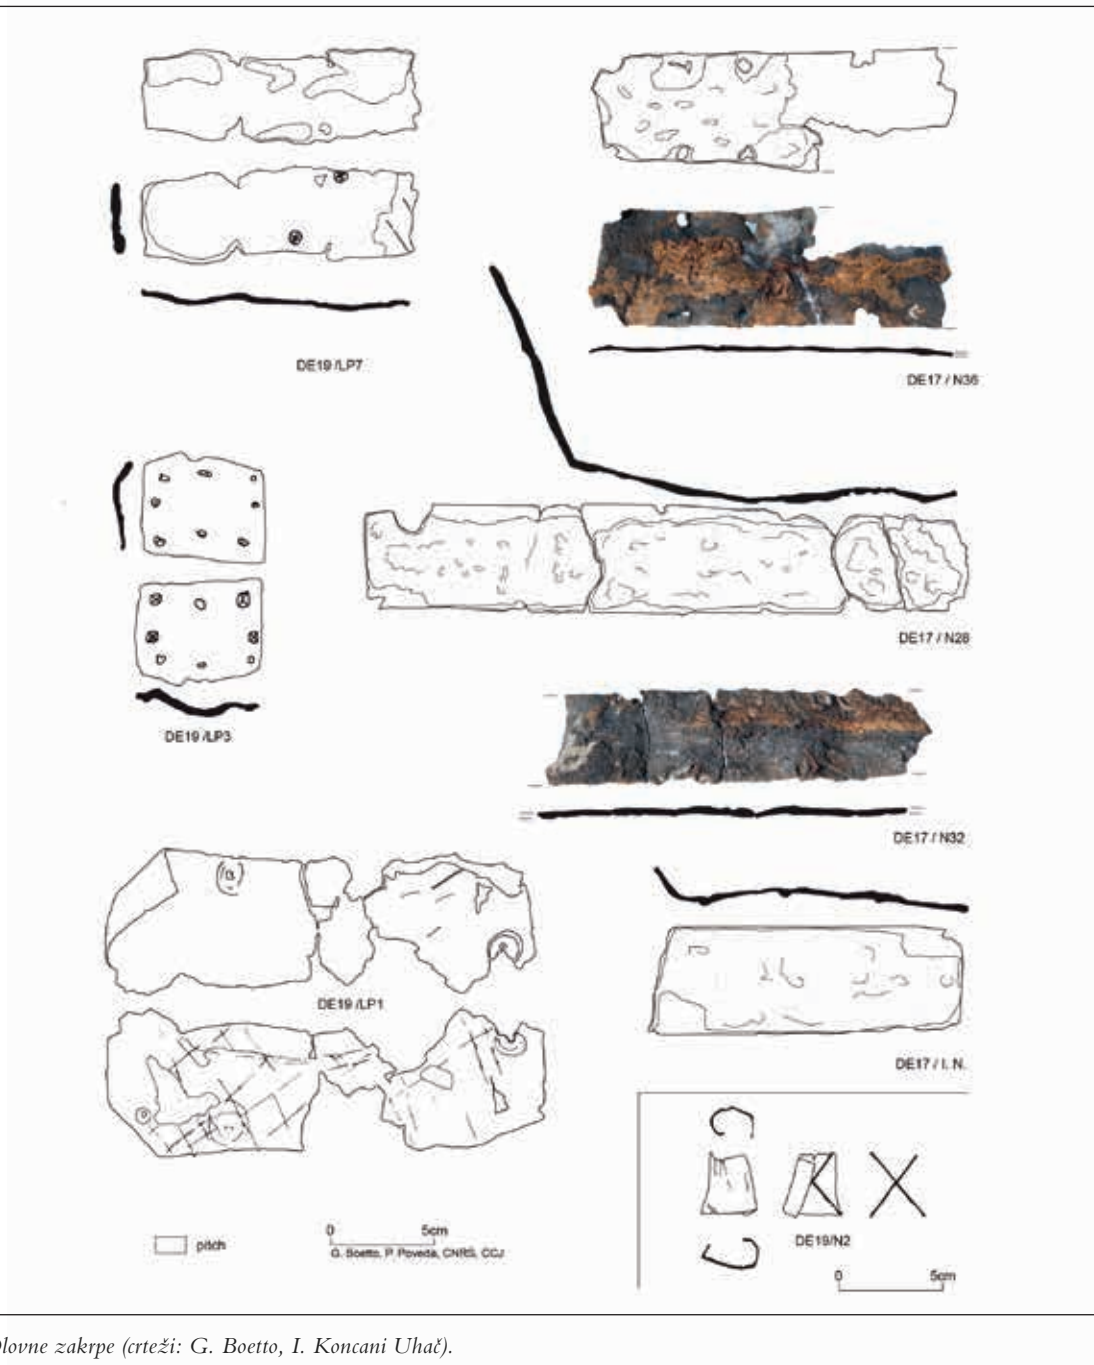
Fig. 37 Lead patches (drawings: G. Boetto, I. Koncani Uhač).

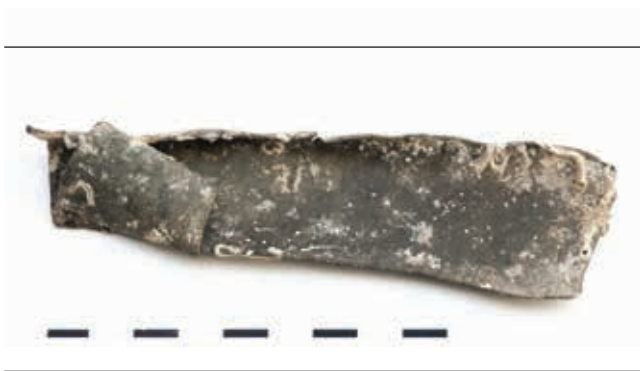
Fig. 38 Folded piece of lead with no traces of nail holes (DE18/N39) (photo: L. Damelet).

Finally, two folded pieces of lead with no traces of nail holes (DE19/N2 and DE18/N39) were kept among the tools and accessories to repair the hull in case of need (Figs. 37 and 38). They can be compared with a similar piece found on the Pakoštane wreck (Boetto et al. 2018, 62, Fig. 80).

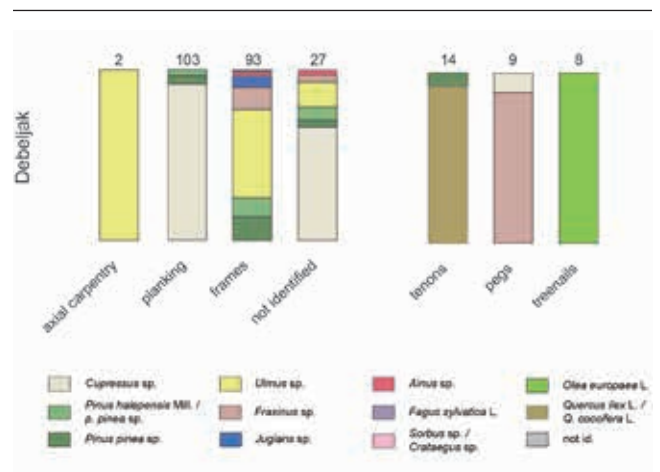
Fig. 39 Graph showing the number of pieces per different type of wood.

Transitional timber K and the keel W54 are made of elm (*Ulmus* sp.). The planking is mainly of Mediterranean cypress (*Cupressus sempervirens* L.) and to a lesser extent of stone pine (*Pinus pinea* sp., five planks) or Aleppo pine/stone pine (*Pinus halepensis* Mill. / *Pinus pinea* L., four planks). The preferential use of Mediterranean cypress for planking is interesting. It was widely cultivated from ancient times and was also highly valued and employed for its durability. Homogenous Mediterranean cypress planking has been found in some wrecks in Italy: Fiumicino 4 and 5 (Portus, 2nd-3rd century AD, Boetto 2006), Napoli B (Naples, 2nd-3rd century AD, Allevato et al. 2010), and Pisa D (second half 6th-beginning 7th century AD, Giachi et al. 2017). Mediterranean cypress was also used sporadically in the planking of the late antique Pakoštane ship (Guibal et al. 2018, 84, Fig. 98).

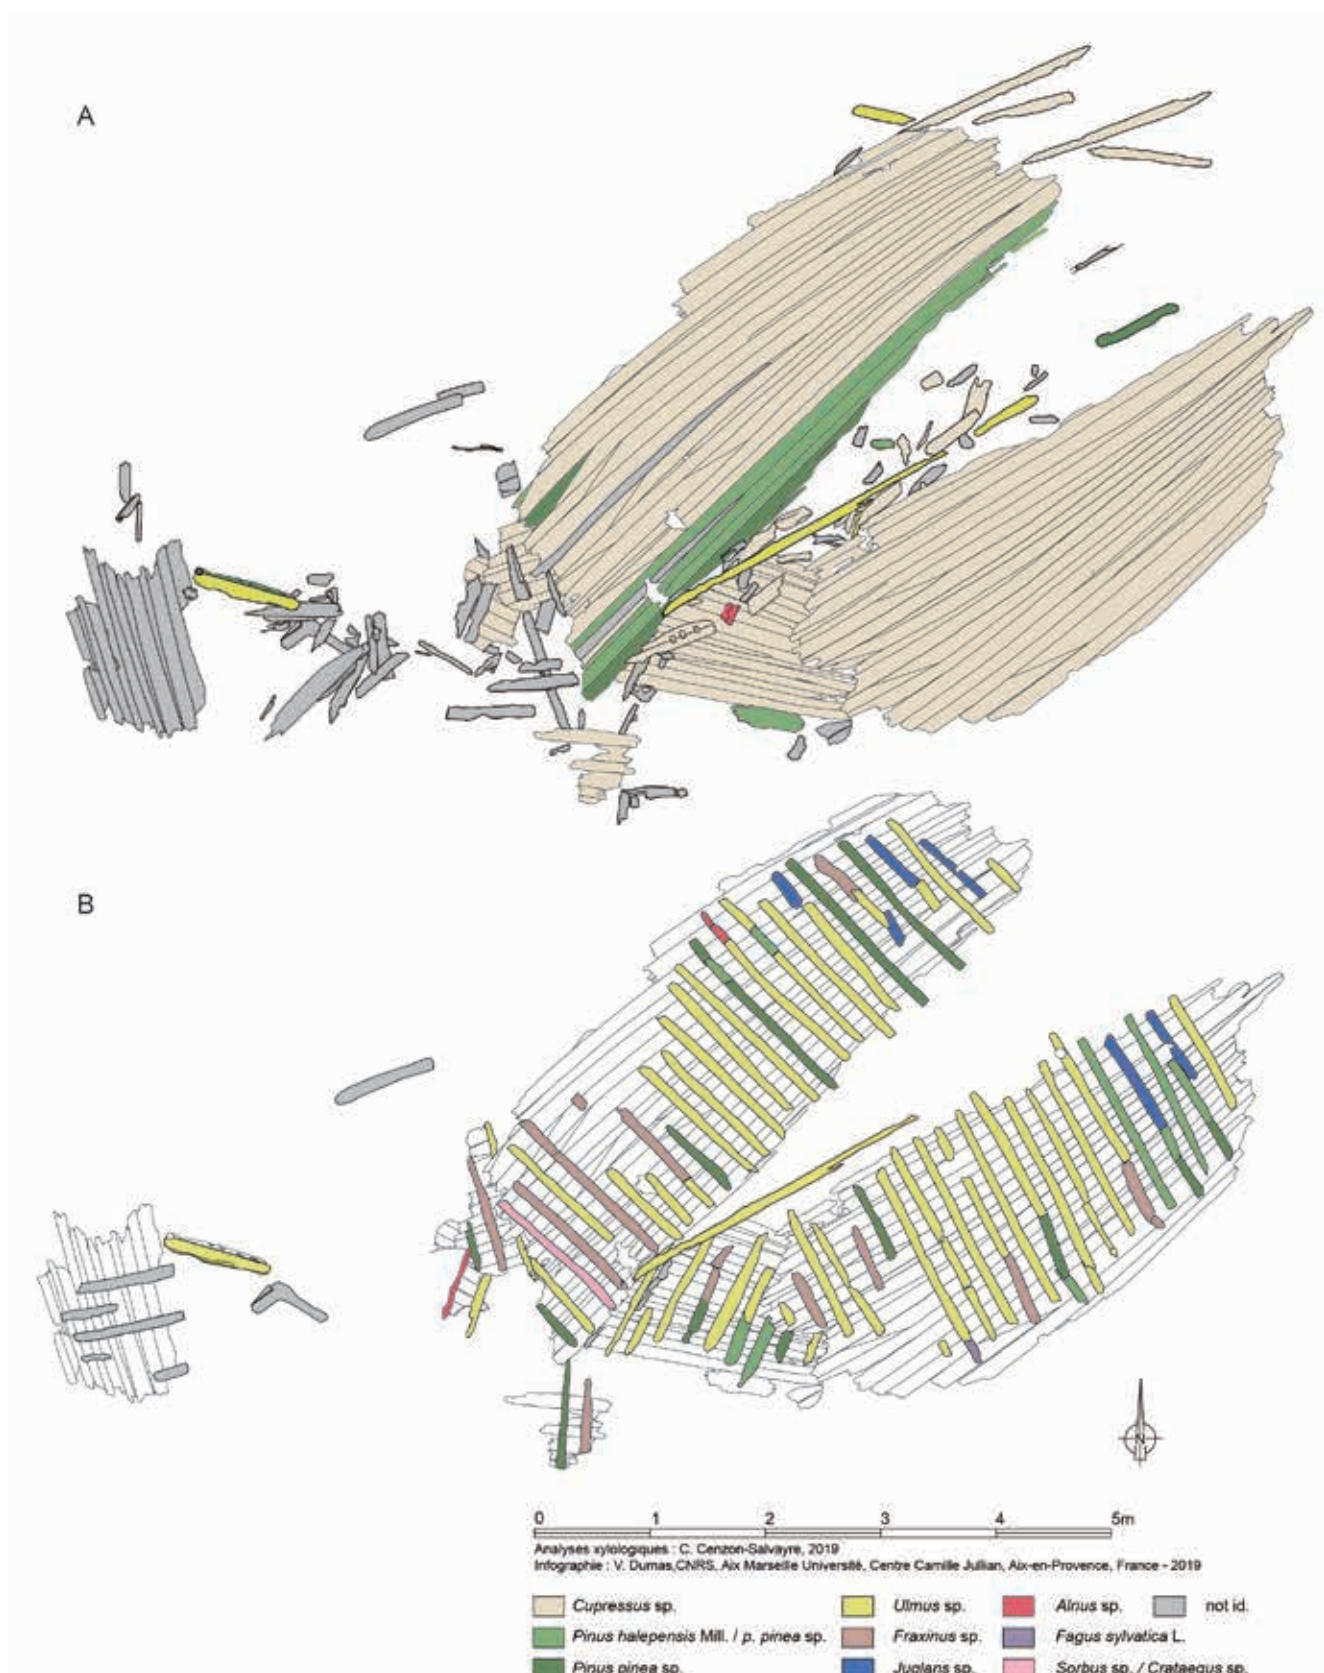
Sl. 40 Raspodjela različitih vrsta drva na brodskoj konstrukciji (crtež: V. Dumas).
 Fig. 40 Distribution of the different species of wood in the wreck (drawing: V. Dumas).
