Histria archaeol. 52/2021

Giulia BOETTO, Vincent DUMAS, Ida KONCANI UHAČ, Pierre POVEDA,
Marko UHAČ

THE LATE ANTIQUE WRECK OF DEBELJAK COVE (CAPE KAMENJAK, PREMANTURA, ISTRIA)

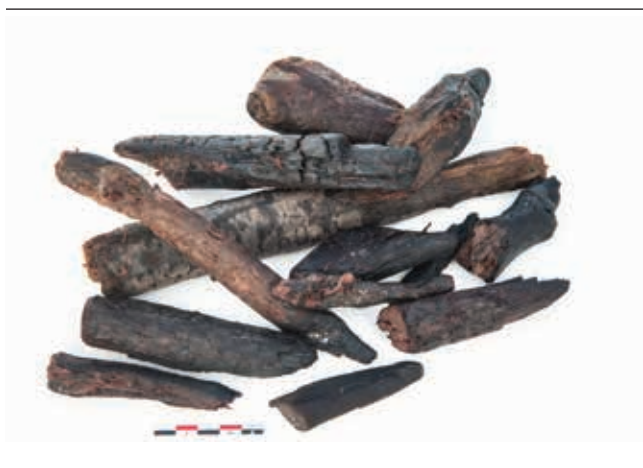
Sl. 41 Karbonizirane grančice (fotografija: L. Damelet).
Fig. 41 Carbonised sticks (photo: L. Damelet).

A few fragments of common and kitchen ware are from vessels used on board, and fragments of three bricks or tiles are probably from the hearth. A well-preserved hearth was constructed in the hold near the bow of the 1st century AD ship, *Caska 2* (Rossi Radić, Boetto 2020, 280, Fig. 29), while on the late antique *Pakoštane* wreck, as at *Debeljak*, the bricks and tiles constituting the hearth were found in scattered fragments, although concentrated in a small area (Huguet 2018, 76-78, Fig. 22). A few charred sticks may also be related to cooking activities (Fig. 41). Two of them are from holm oak/

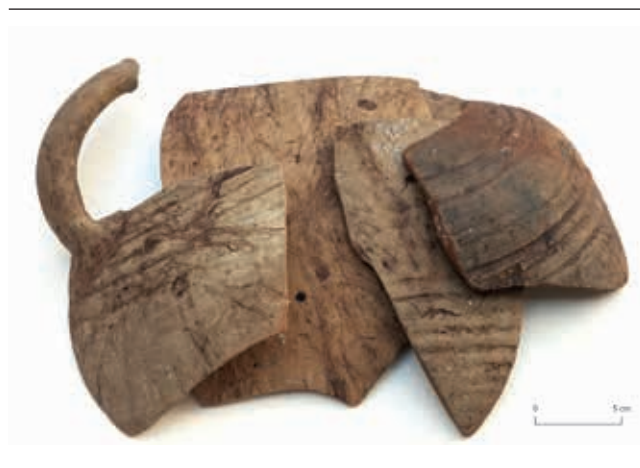
Sl. 42 Ulomci amfora s okomitim linijama (fotografija: L. Damelet).
Fig. 42 Fragments of amphorae with horizontal striations (photo: L. Damelet).

The identification of amphora types and their provenance is very difficult from body fragments, especially without petrographic thin-section analysis of the inclusions in the clay. For example, some of the body fragments have horizontal striations similar to those of Late Roman amphorae (Fig. 42), however the clay clearly does not indicate an eastern Mediterranean, but possibly a regional production. Indeed, a neck with handles has been identified as an Empoli amphora (Fig. 43), a wine vessel from northern Tuscany (Valdarno and the coastal areas of Pisa and Volterra), whose production continued into late antiquity. This type of vessel is rare in the Adriatic region and only one example is attested in Jesolo (Negrelli 2018, 47-48). In fact, these vessels represent the commercial networks of the Tyrrhenian and the western Mediterranean Seas, including Tuscany, Lazio, Campania, Corsica and Sardinia, in addition to North Africa and Spain.

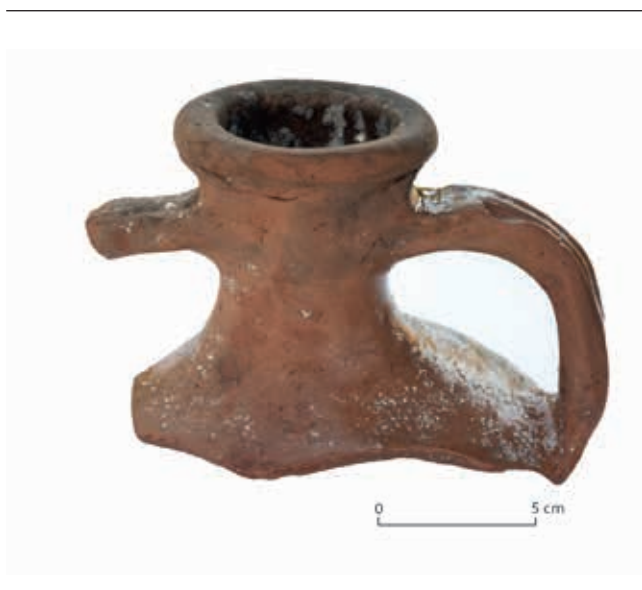
Sl. 43 Vrat Empoli amfore (fotografija: L. Damelet).
Fig. 43 Neck of an Empoli amphora (photo: L. Damelet).

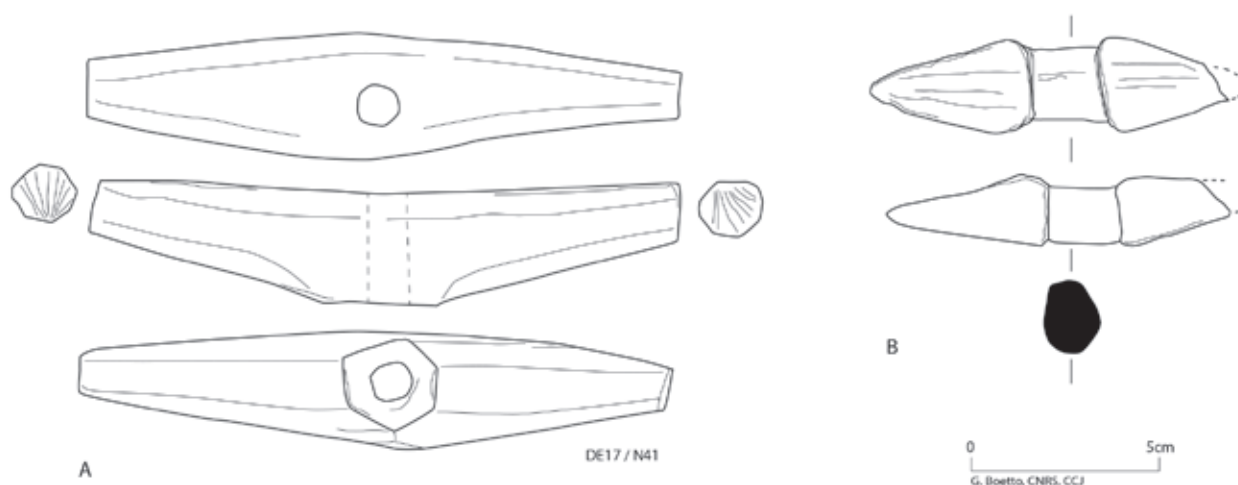
Sl. 44 Drveni predmeti: A) drška svrdla; B) zatezač (crteži: G. Boetto).
 Fig. 44 Wooden finds: A) auger handle; B) toggle (drawings: G. Boetto).

Finally, two small wooden objects were found in 2017. The first is an auger handle, 15.7 cm long, 3 cm high, that was probably part of the tools and accessories for hull repairs, as were some of the pieces of lead (see *supra*) (Fig. 44, A). The second find is a toggle, a bi-conical piece with a carved groove around its centre, maximum 2.5 cm wide and with a reconstructed length of 10 cm. From its small dimensions, this toggle was probably part of the rigging of the ship (Fig. 44, B).
